Test Report No. 440592

**DEVELOP GUIDELINES FOR INSPECTION, REPAIR, AND USE OF
PORTABLE CONCRETE BARRIERS—VOLUME 2: CRASH REPORT
COOPERATIVE RESEARCH PROGRAM**

Texas Department of Transportation
<https://tti.tamu.edu/documents/0-7059-R1-Vol2.pdf>

Report 0-7059-R1-Vol2
Project 0-7059

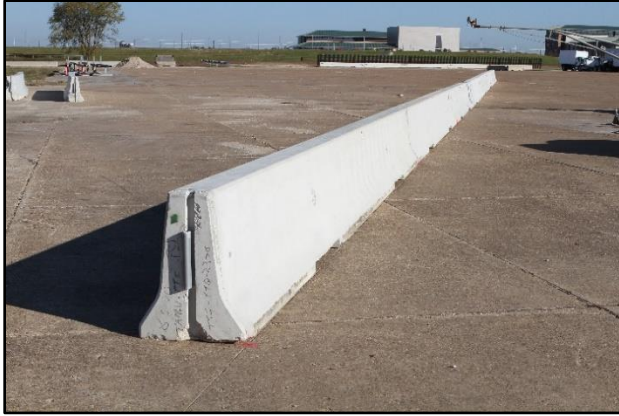
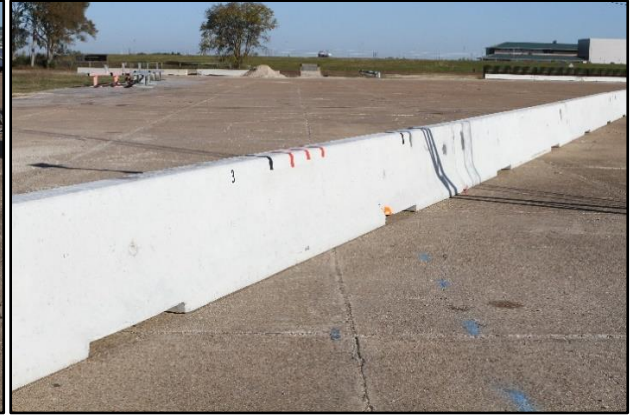
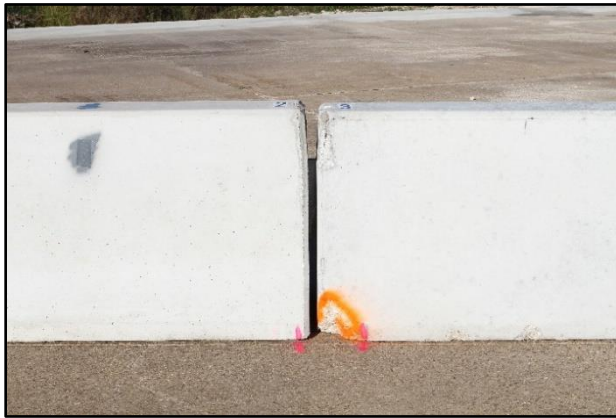
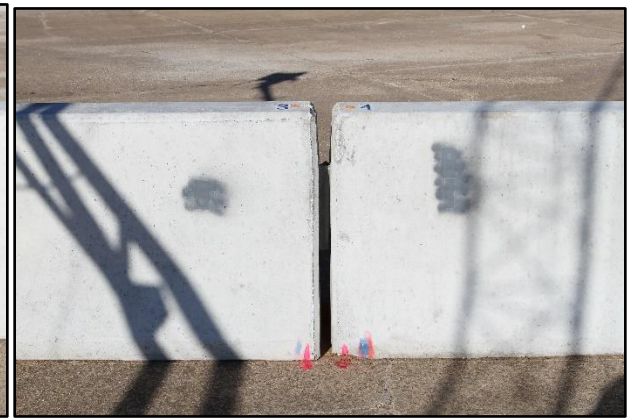
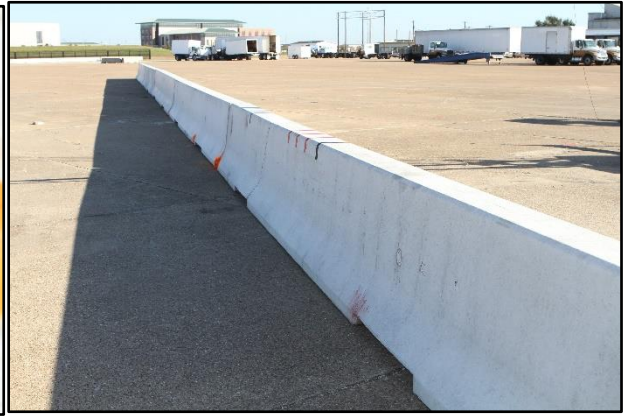
Figure 2.1. Damaged Portable Concrete Barriers prior to Test No. 440592-1.

For the first test (440592-1), Barrier 3 was selected due to a large 6-mm wide crack located on the field side of the installation that ran vertically 246 inches downstream from the joint of barriers 2 and 3. The downstream JJ hook on barrier 2 was bent 8 degrees. The upstream JJ hook on barrier 3 was not damaged, and the downstream JJ hook was bent 12 degrees. The upstream JJ hook on barrier 4 was not damaged.

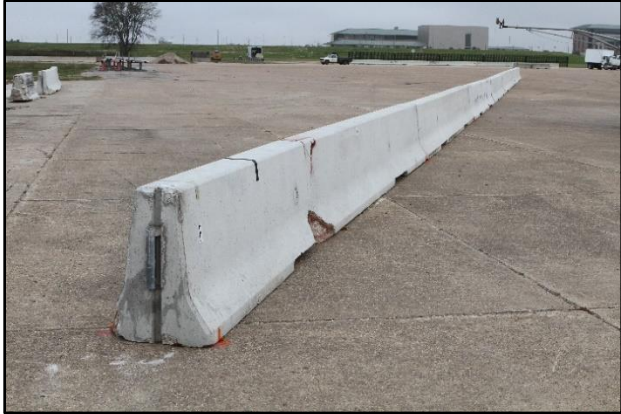
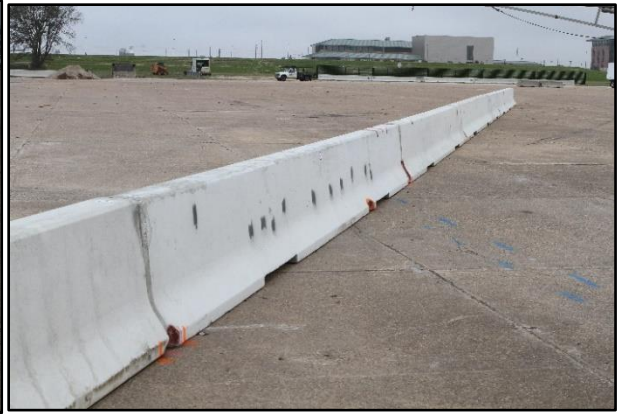
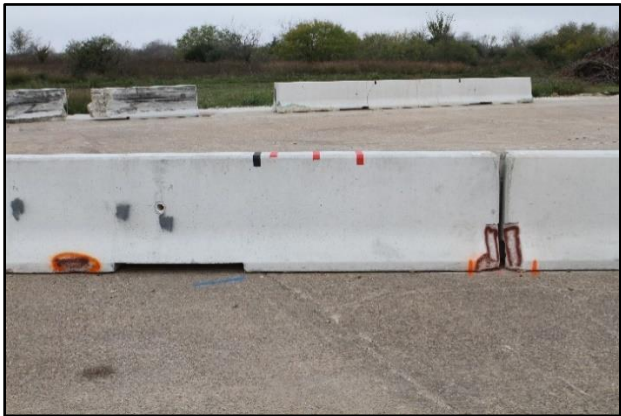
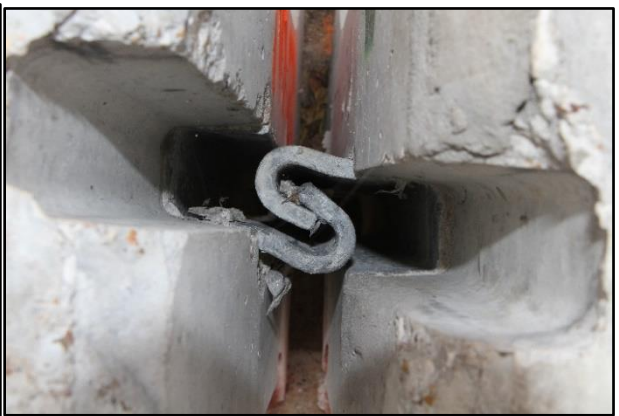
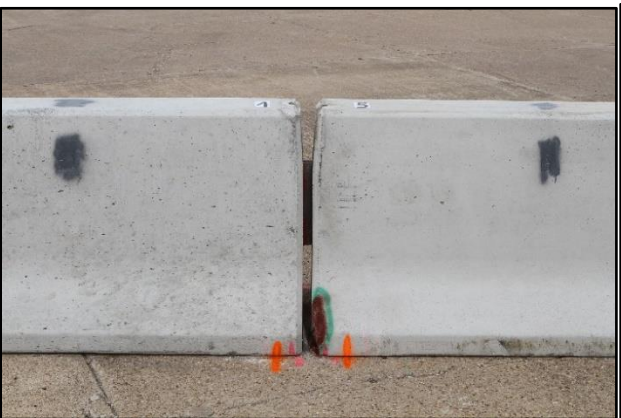
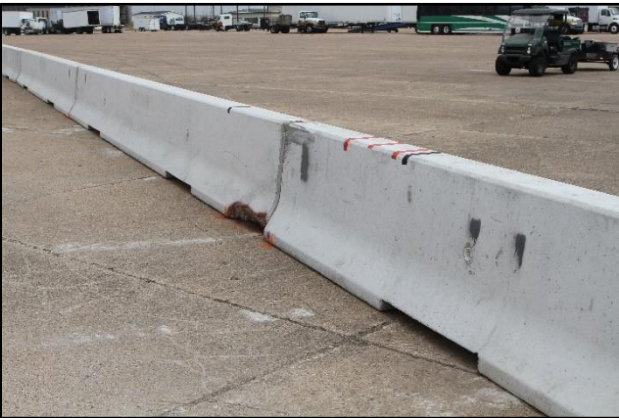
Figure 2.2. Damaged Portable Concrete Barriers prior to Test No. 440592-2.

For the second test (440592-2), spalling was manufactured by Texas A&M Transportation Institute (TTI) personnel on the traffic side toe of barriers 3 and 4 at their joint. Each had a spall measuring approximately $3\frac{3}{4}$ inches wide \times 13 inches high \times 2 inches deep. At the same joint on the field side, the toe of barrier 4 was intentionally spalled and measured approximately 24 inches wide \times 5 inches high \times 2 inches deep. The JJ hooks at the joint of barriers 2 and 3 were not damaged. The downstream JJ hook on barrier 3 was bent 19 degrees, and the upstream JJ hook of barrier 4 was bent 15 degrees.

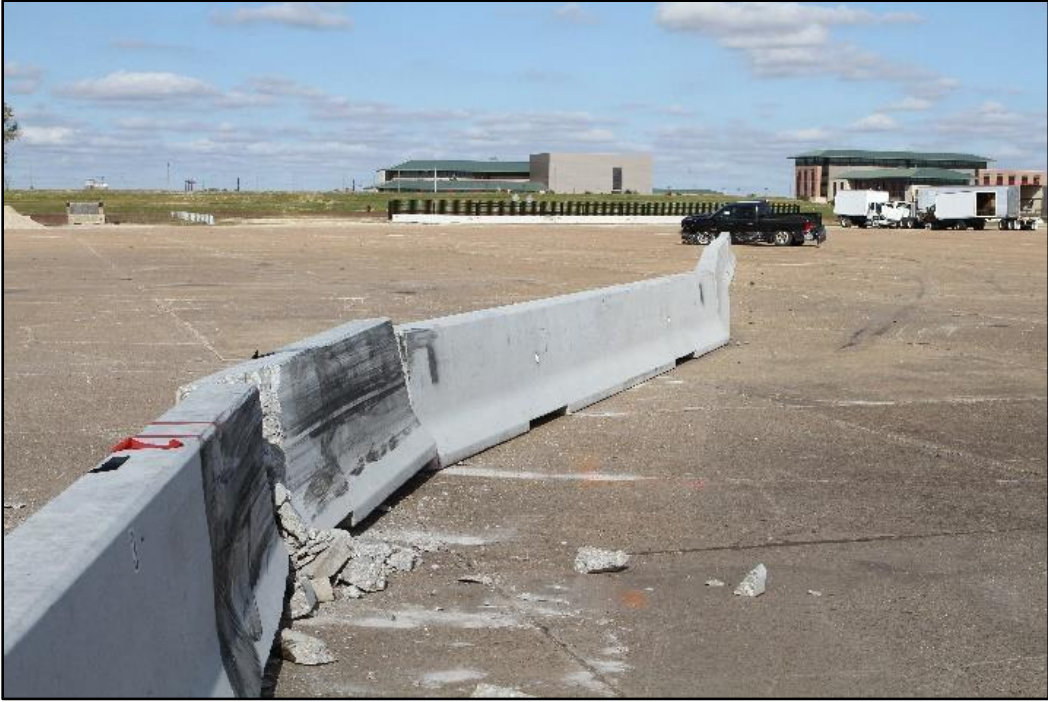
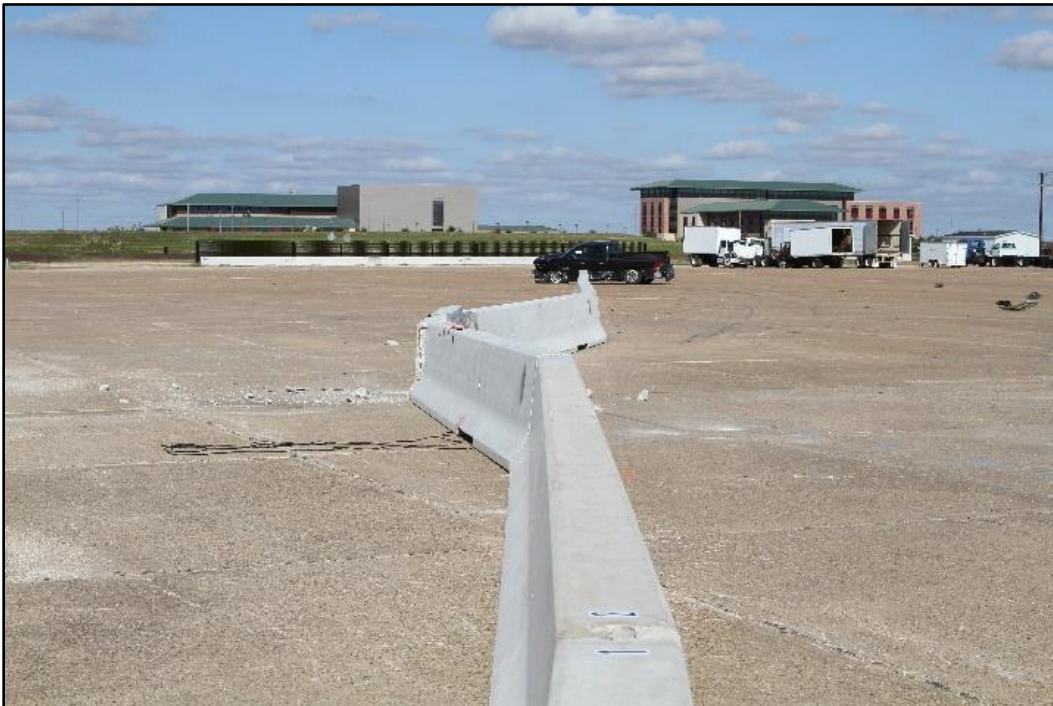
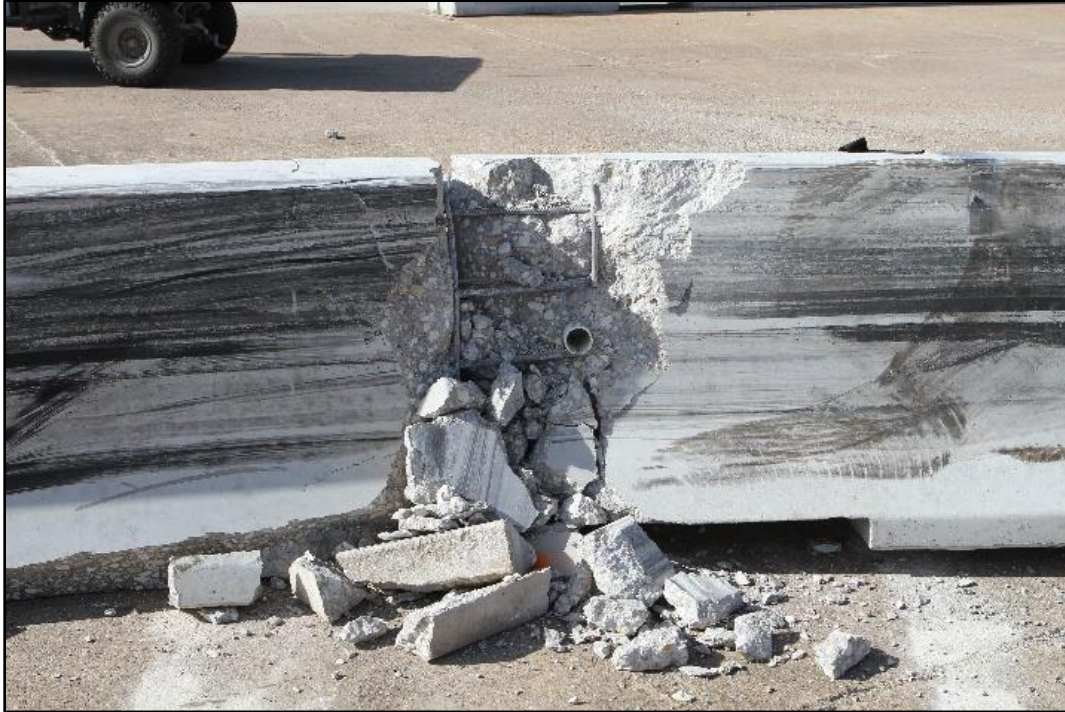
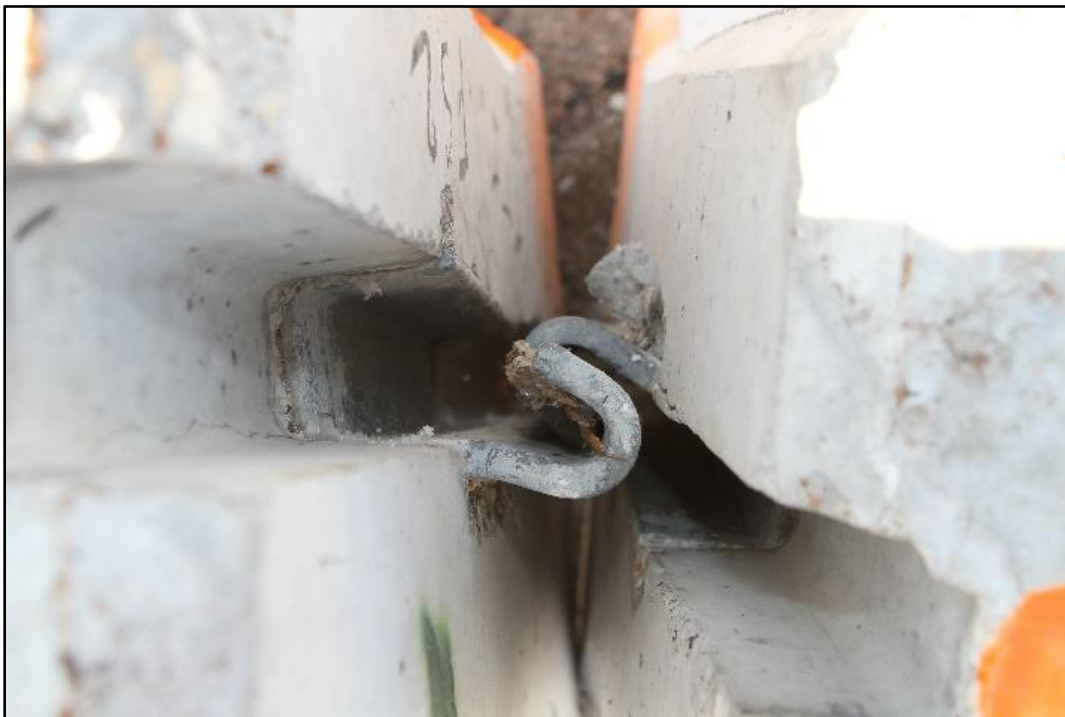
Figure 5.5. Damaged Portable Concrete Barriers after Test No. 440592-1.

Major cracking and spalling were observed at the downstream scupper of barrier 3. There was a significant amount of exposed rebar, which was severed by the impact of the test vehicle. The existing cracks before impact ranged in size from 0.1 mm to 6 mm, and post impact, they were between 0.1 mm and 108 mm. The main crack of concern, which was located on the field side of the third barrier 246 inches downstream from the joint of barriers 2 and 3, widened from 6 mm to 108 mm, and a secondary crack extending from the main crack widened from 2.5 mm to 102 mm. The JJ hook on the downstream end of barrier 2 bent 2 degrees, and the JJ hook on the upstream end of barrier 3 bent 13 degrees. The JJ hook on the downstream end of barrier 3 bent 3 degrees, and the JJ hook on the upstream end of barrier 4 bent 34 degrees.

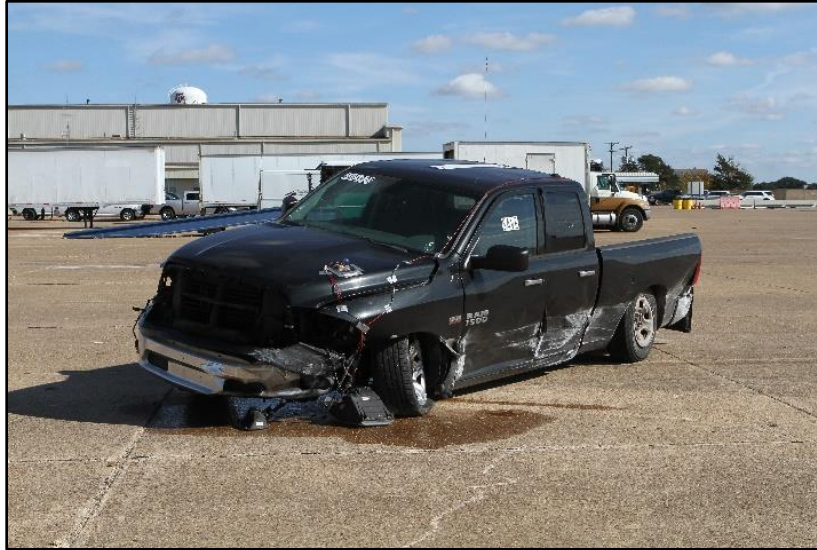
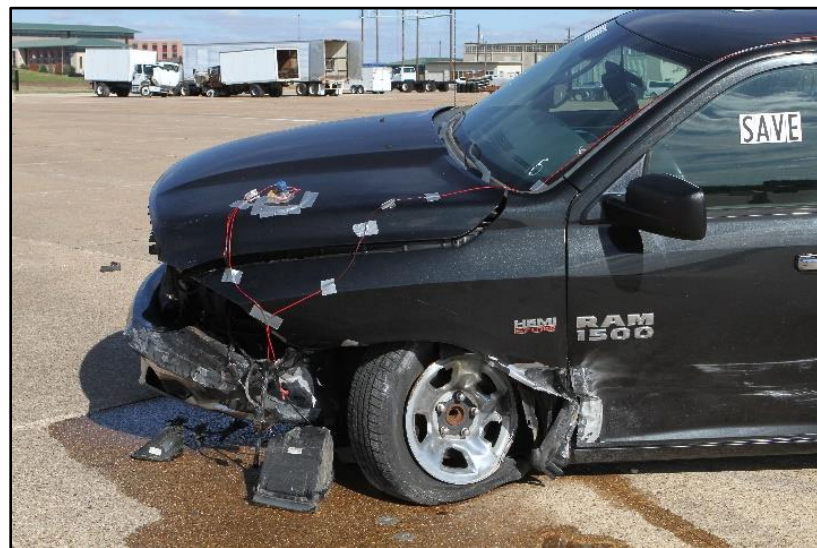
Figure 5.6. Test Vehicle after Test No. 440592-1.

Side Windows	Side windows remained intact
Maximum Exterior Deformation	12 inches in the left plane at the front corner at bumper height
VDS	11LFQ5
CDC	11FLEW3
Fuel Tank Damage	None
Description of Damage to Vehicle:	The front bumper, hood, grill, left headlight, left front fender, left front tire and rim, left front door, left rear door, left cab corner, left rear quarter fender, left rear tire and rim, left taillight, tailgate, and rear bumper were damaged.

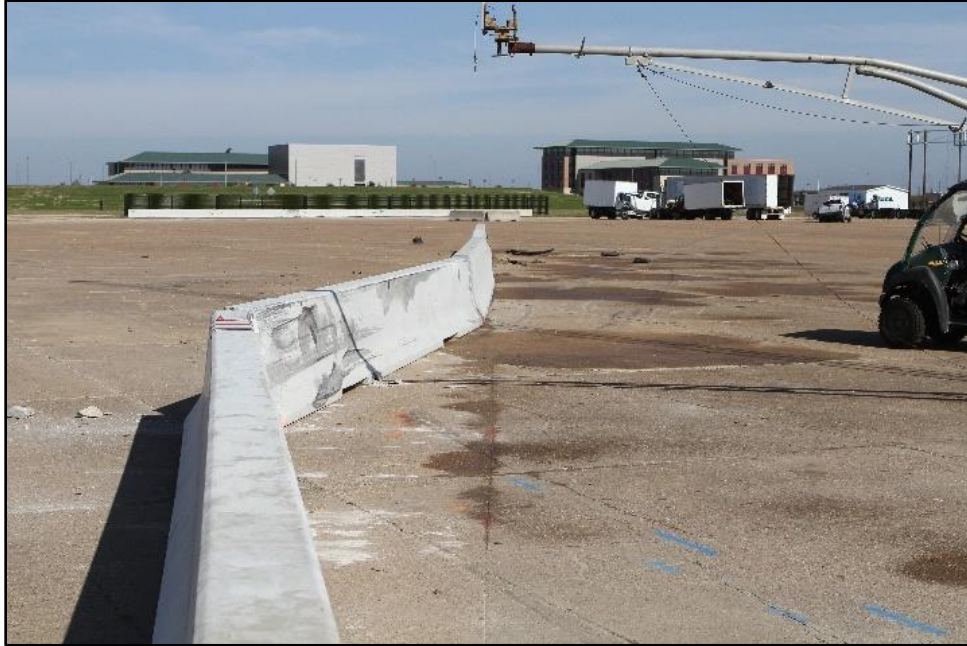
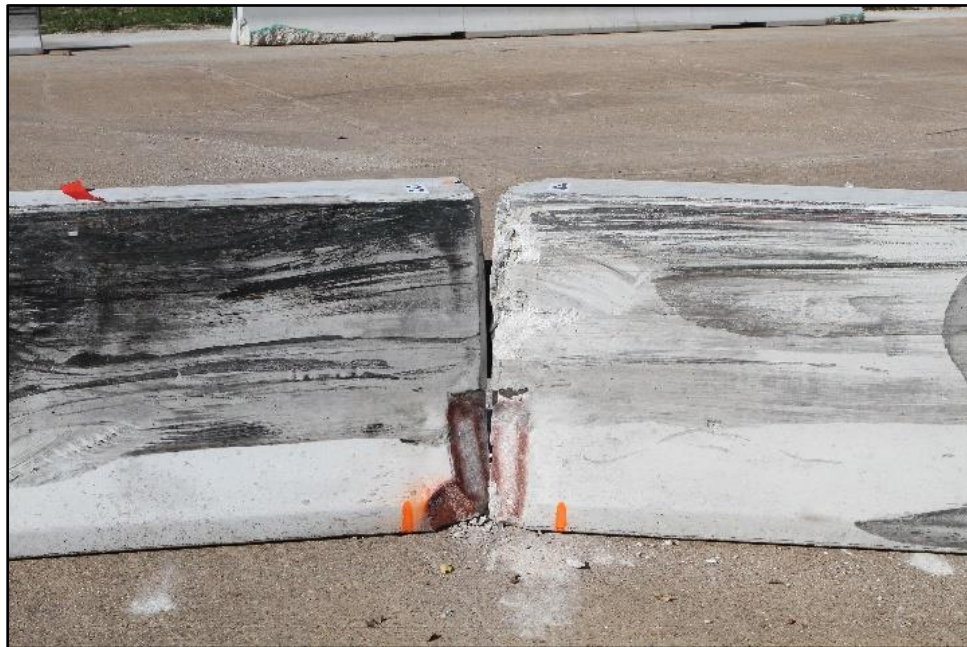
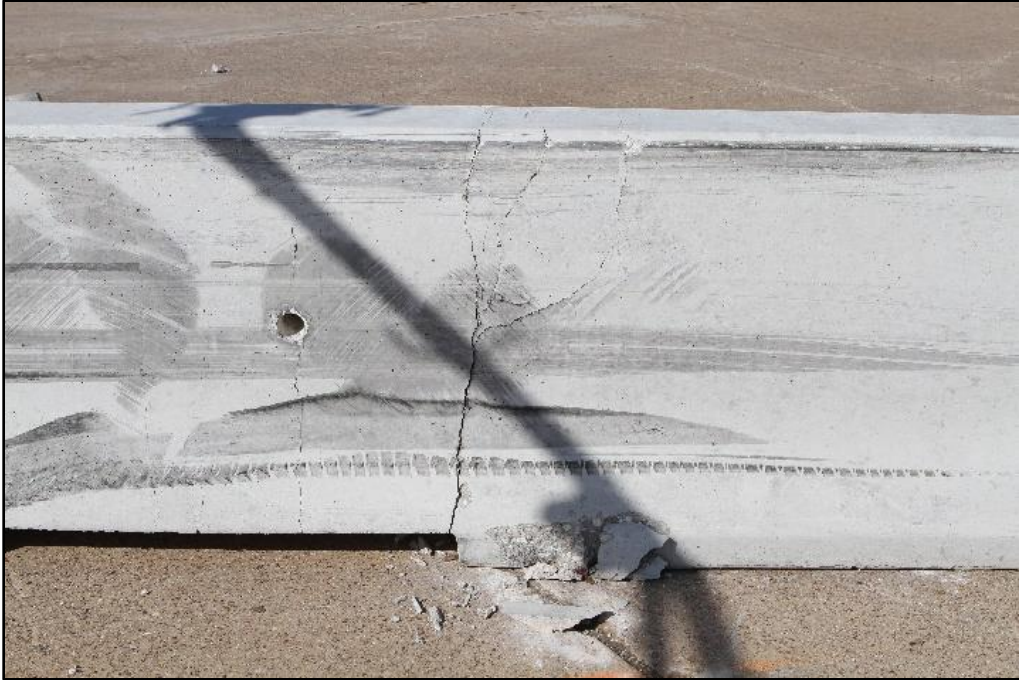
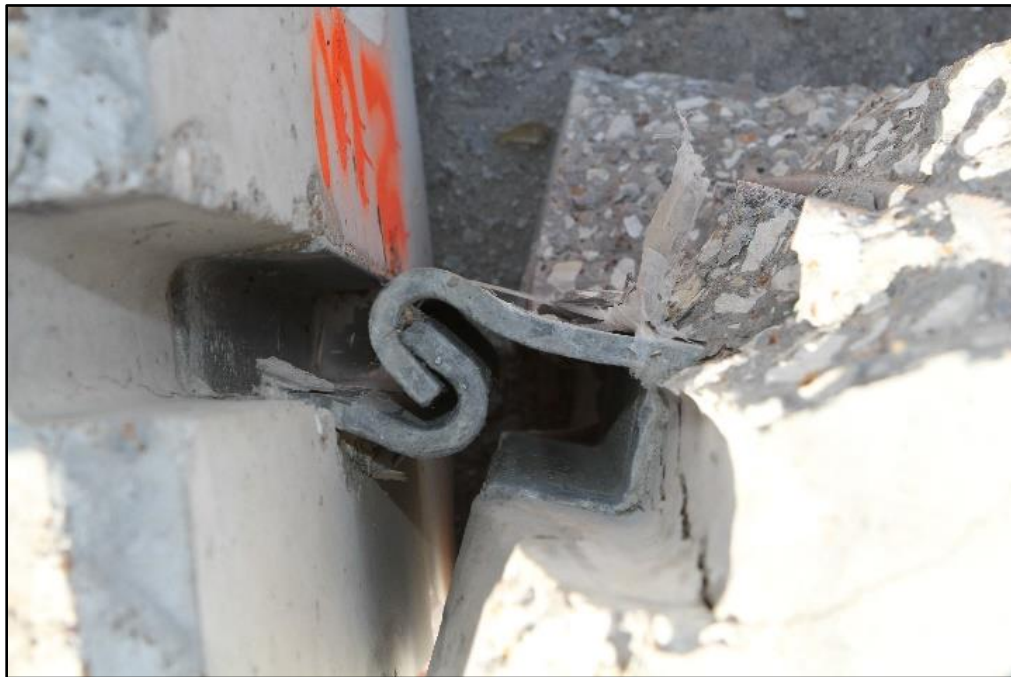
Figure 6.5. Damaged Portable Concrete Barriers after Test No. 440592-2.

Time (s)	Events
0.0000	Vehicle impacts the installation
0.0410	Vehicle begins to redirect
0.0425	Crack begins to form on field side of barrier 4 near joint 3–4
0.0790	Front passenger side tire lifts off pavement
0.1440	Rear passenger side tire lifts off pavement
0.2340	Vehicle travels parallel with installation
0.5910	Front passenger side tire makes contact with the pavement
