## EXPERIMENTAL PROJECTS FINAL REPORT

### CONTECH® A-2000 POLYVINYL CHLORIDE (PVC) PLASTIC PIPE

**Project Name:** Checkerboard - Martinsdale (CN 4803000)

**Project Number:** STPP 14-2(20)63

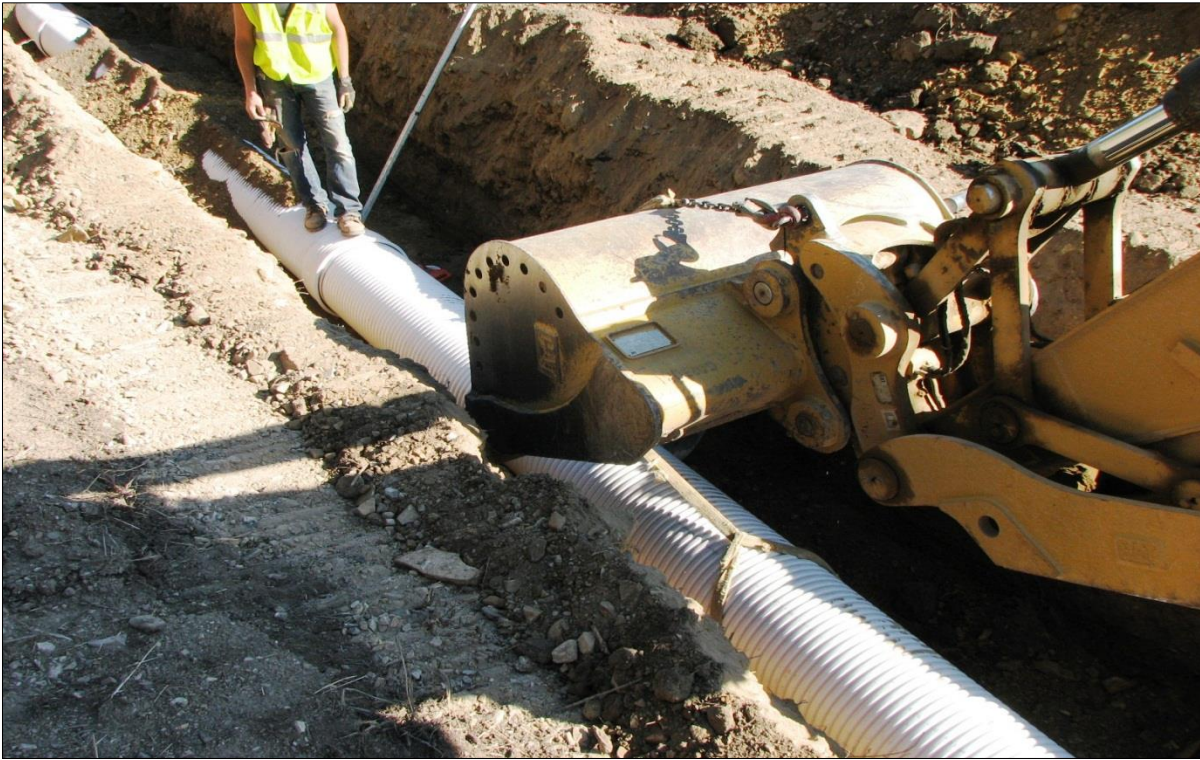
↓ Example of a properly homed bell and spigot connection.

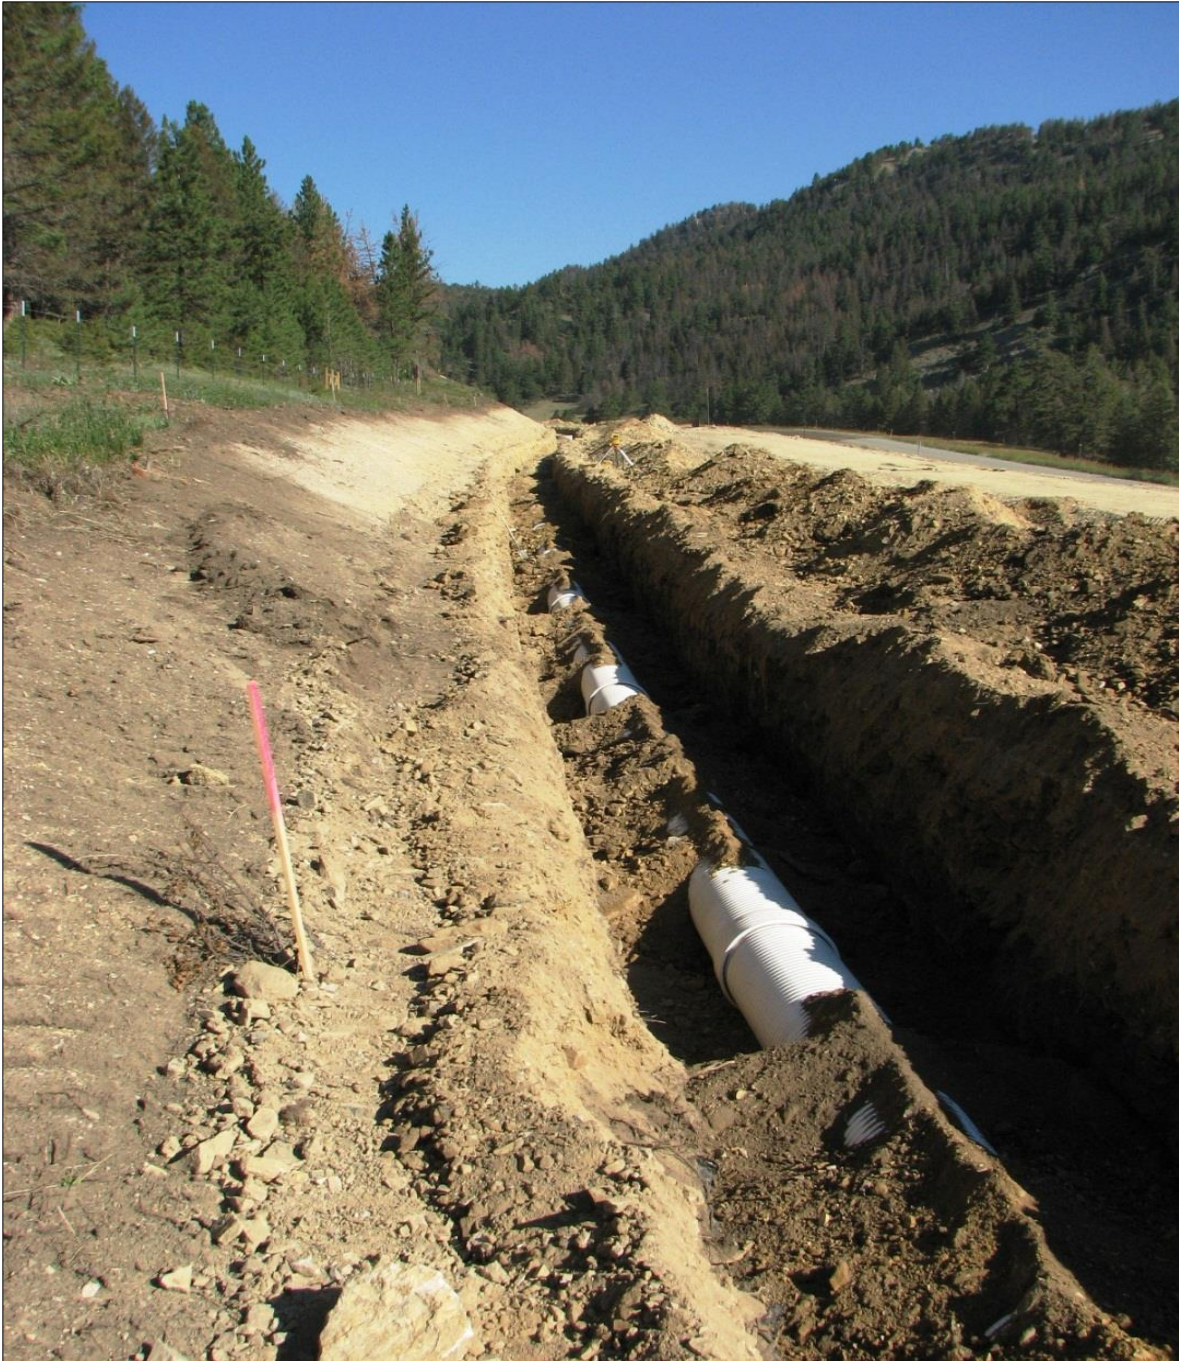
- ↑ As stated earlier in this report, the contractor was using the excavated trench material as fill for the A-2000 pipe. No bedding was prepared or haunching process observed during installation.

The Contech representative on-site was concerned that there may not be sufficient haunching to insure proper density and side wall support to prevent deflection of the PVC pipe once the fill and compaction was complete.

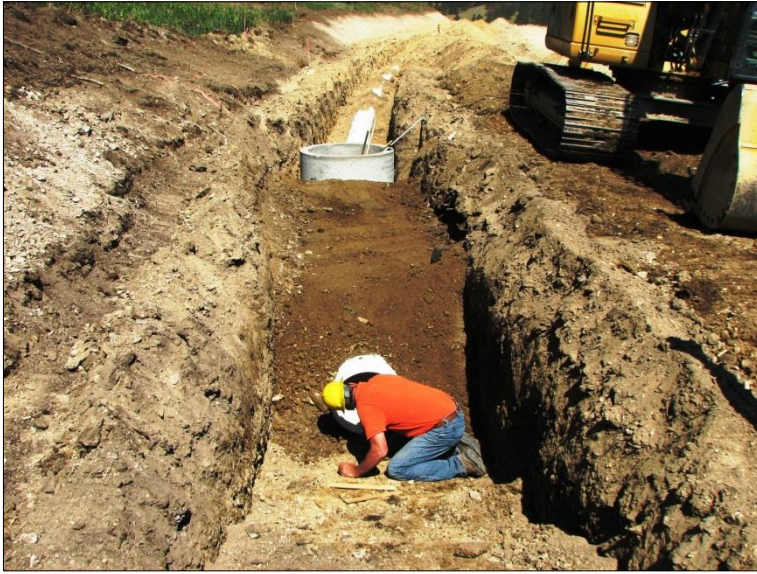
← In order to determine if using the trenched material as fill, and with the contractors planned method of compaction which may affect the integrity of the pipe, the Contech representative asked if a 20' section of the trench be filled as it would for the entire project to determine if any deflection may be observed. Here the contractor has placed the fill and internal measurements are taken prior to compaction.

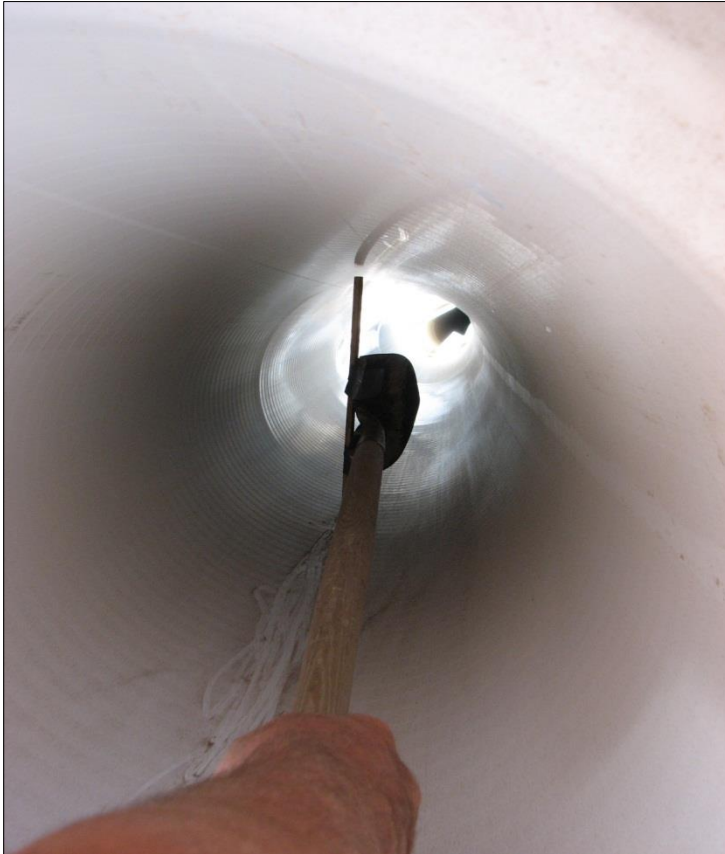
In this image the survey stick (affixed to the blade of a shovel) which was measured and cut to detect deflection up to 1.5% (approximately .27"/7mm) of the inside diameter of 18"; is run through the pipe to a depth of approximately 7 ft. No visual indication of deflection was observed.

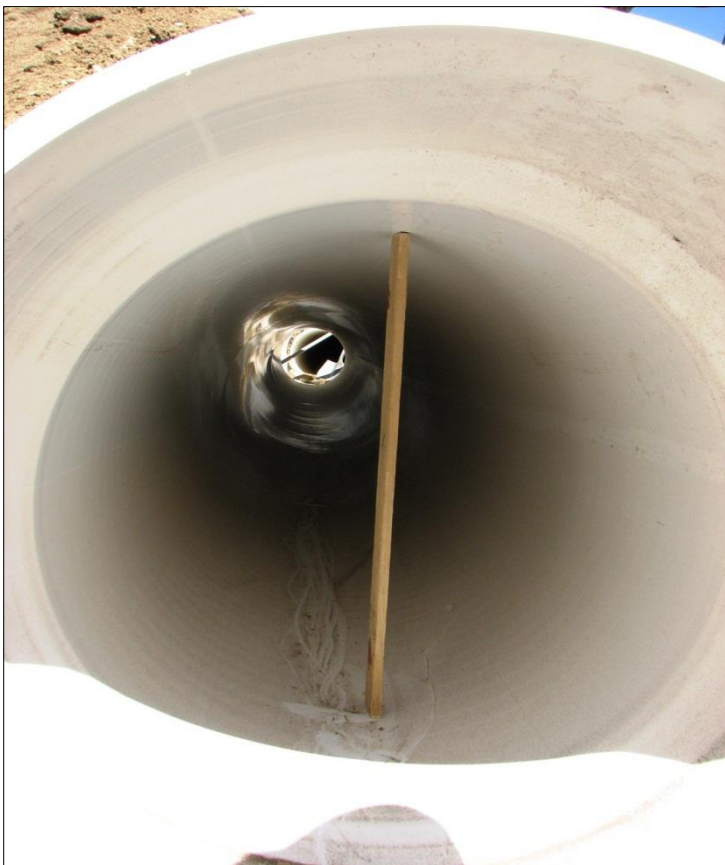
← This section of survey stick was cut to approximate 18" and run through the pipe in the same manner as indicated in the previous image. No visual deflection was observed.

Note: This was a very simplistic method to test for deflection and representative of a very small fraction of the entire length of the pipe layout and may not be indicative of current or long-term performance of the pipe in this application.

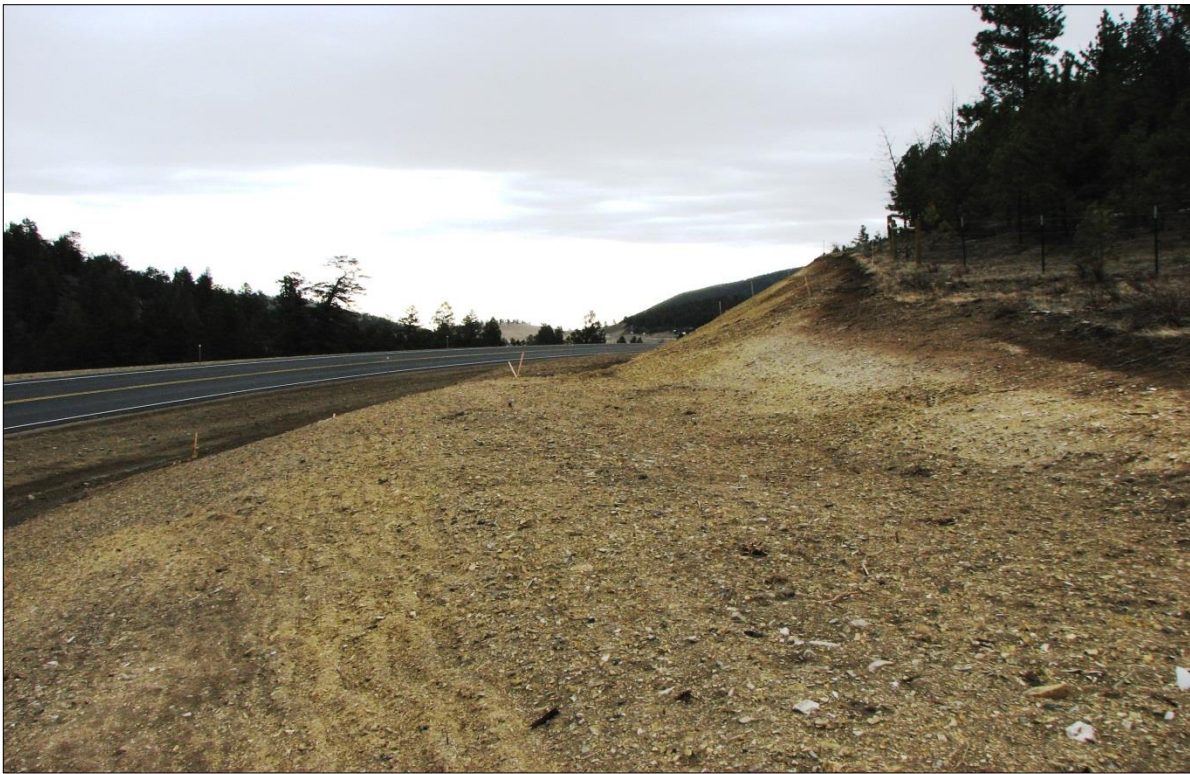
A site inspection of the 18" (46 cm) A-2000 was conducted on April 2, 2013 by research staff. A walk through of the approximately 2084 ft. length section showed no evidence of visual disturbance on the surface or surrounding area of the irrigation line or the manhole connections. Page 18 of this report has representative images of the April 2013 inspection.

↑ View east: Start of approximate location at the west end of the 18" A-2000.

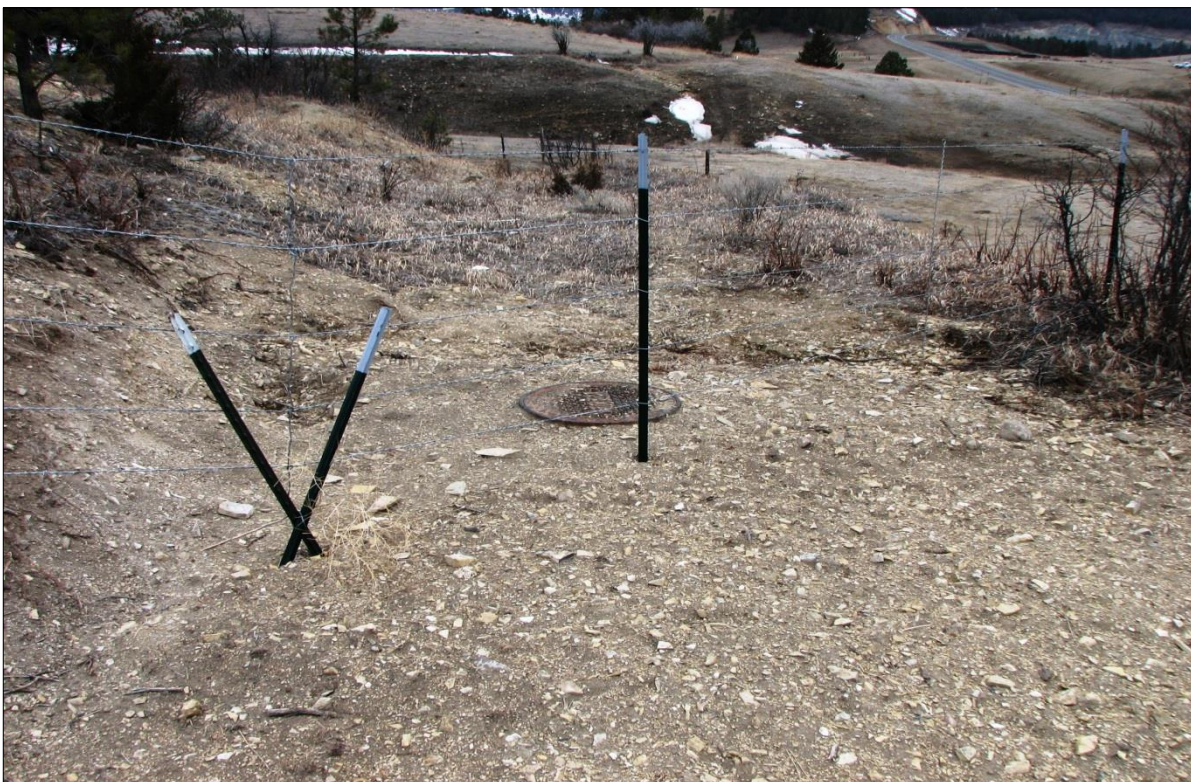
↓ View west: Manhole connection at the existing 15" PVC and 18" A-2000 pipes.

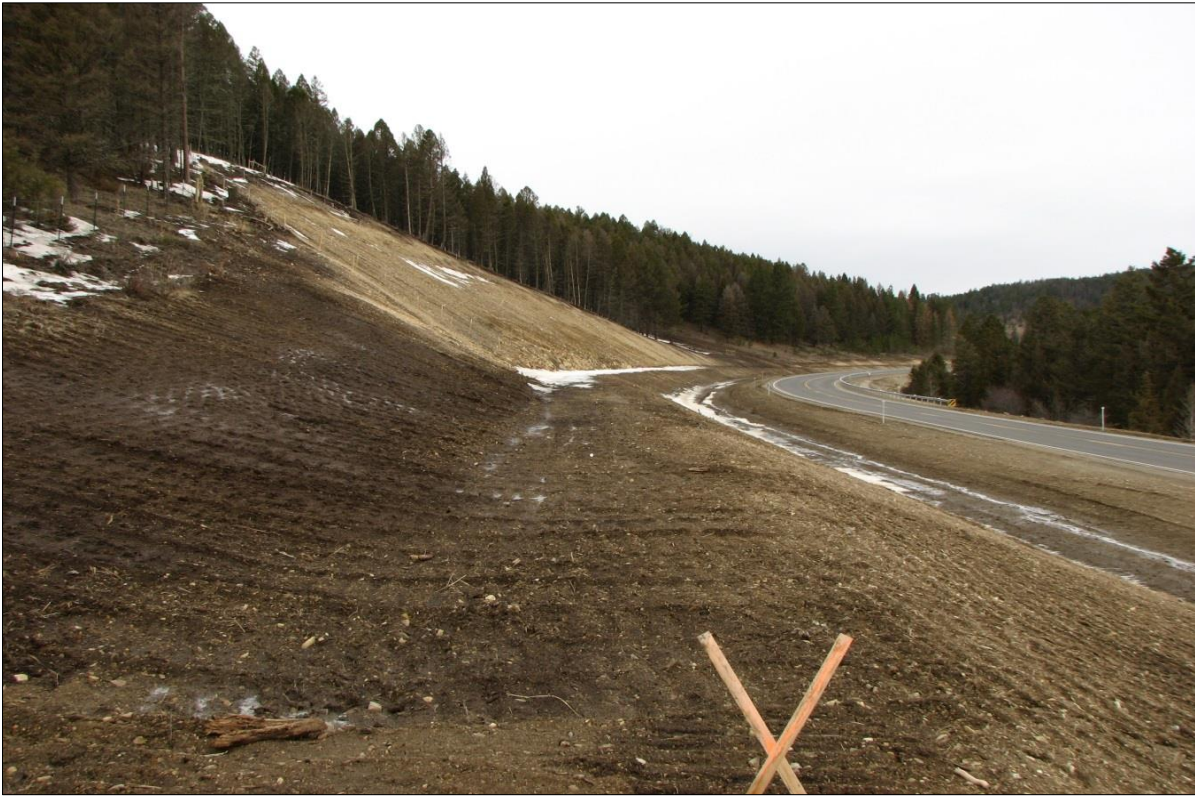
↑ View west: Start of approximate location at the east end of the 18" A-2000.

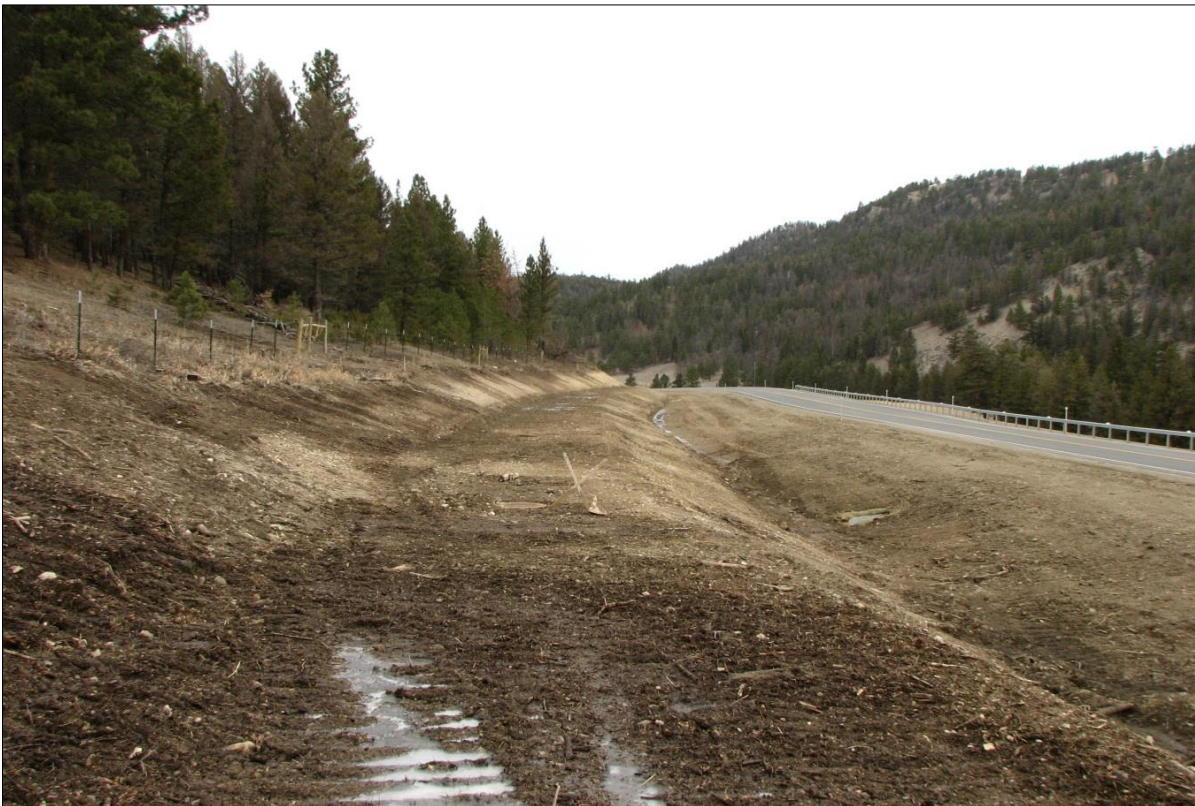
↓ View west: Midway point of the 18" A-2000 section.

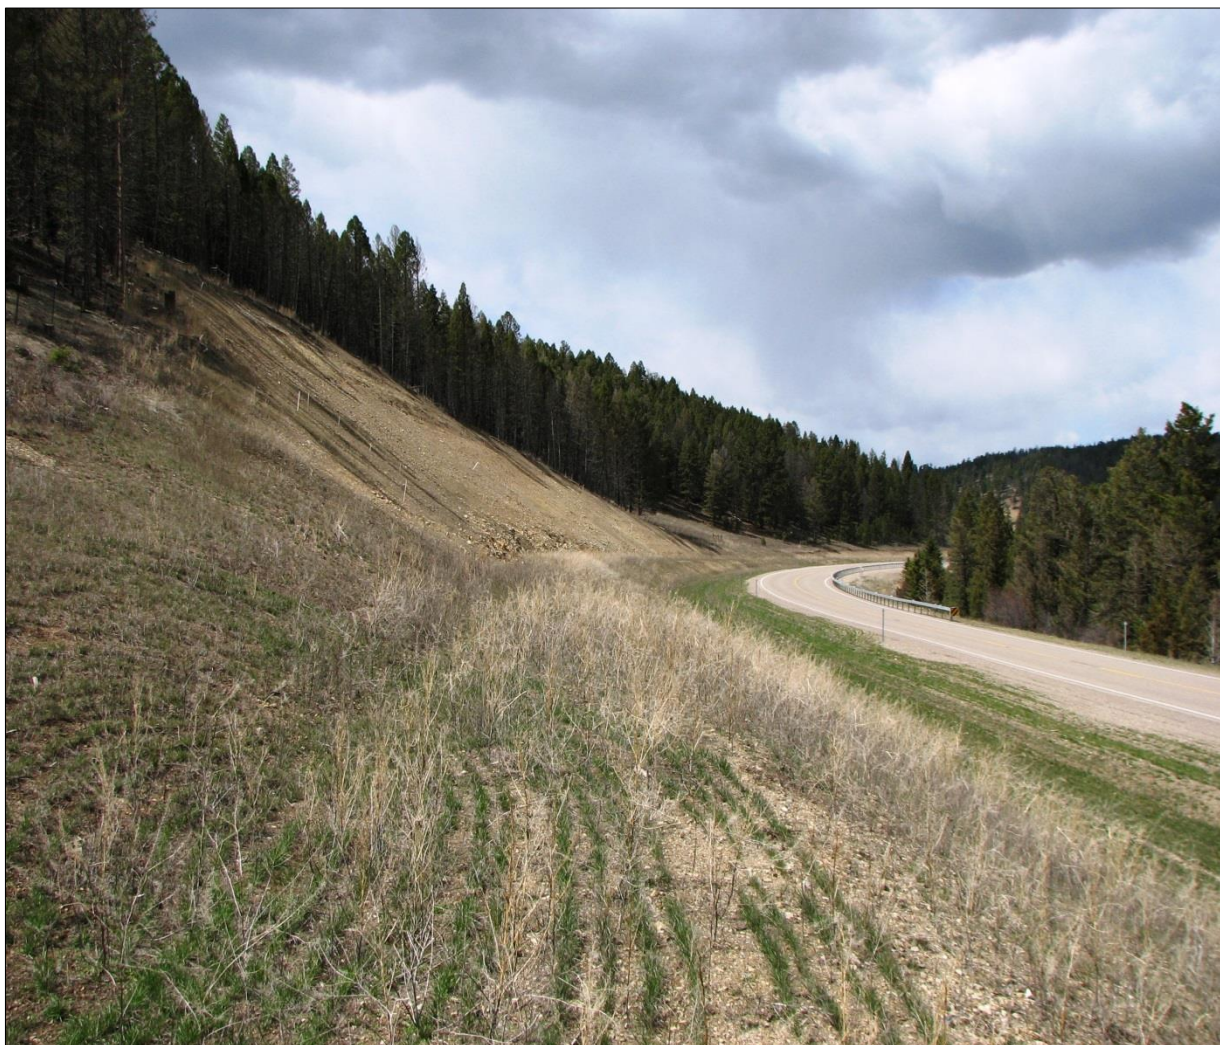
A site inspection of the 18" (46 cm) A-2000 was conducted on May 15, 2014 by research staff. A walk through of the approximately 2084 ft. length section showed no evidence of visual disturbance on the surface or surrounding area of the irrigation line or the manhole connections. Page 20 of this report has representative image of the 2014 inspection. District staff has reported no incident involving pipe performance since installation.

↑ View west: Start of approximate location at the east end of the 18" A-2000.

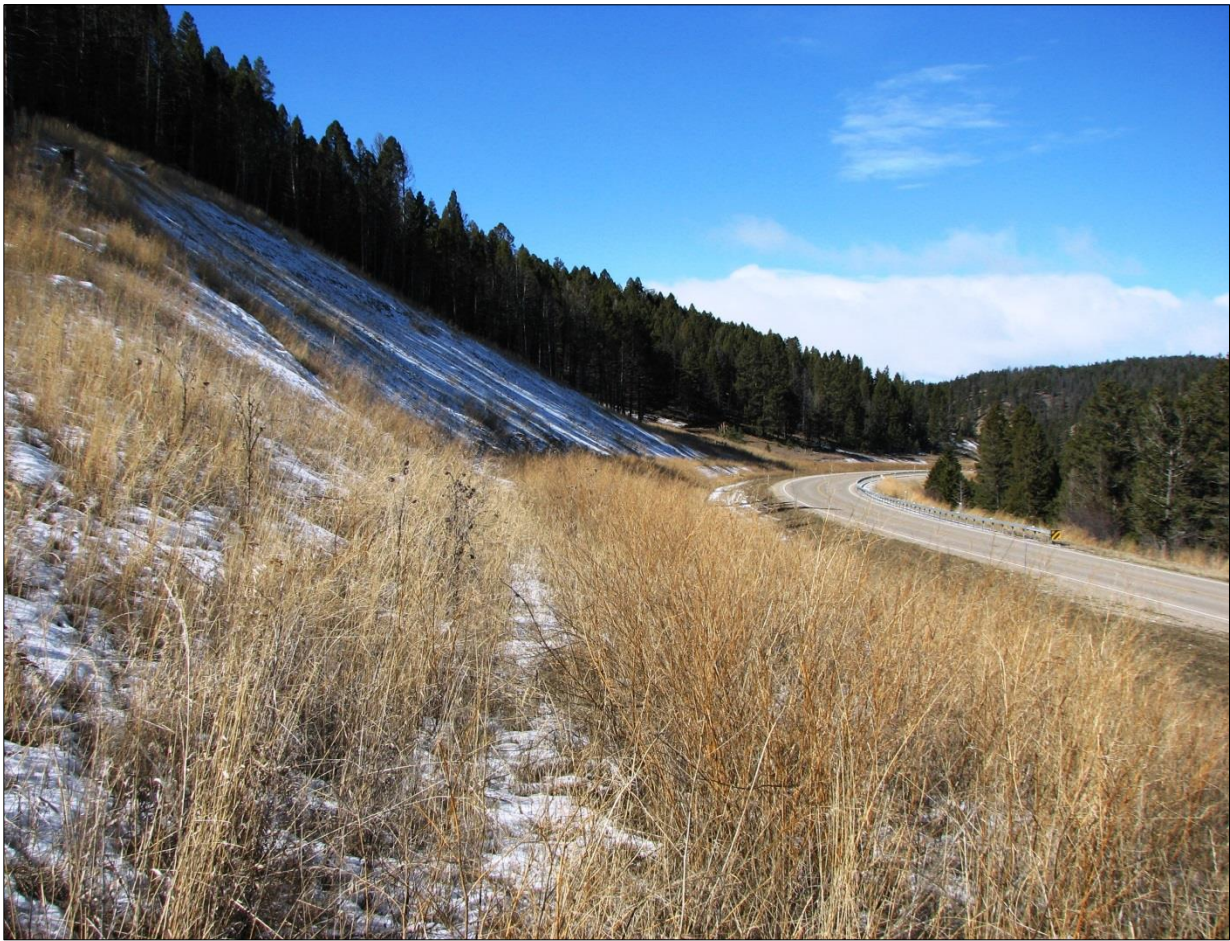
Same report as stated in May 2014. Page 21 of this report has representative image of the 2015 inspection. District staff has reported no incident involving pipe performance since installation.

↑ View west: Start of approximate location at the east end of the 18" A-2000.

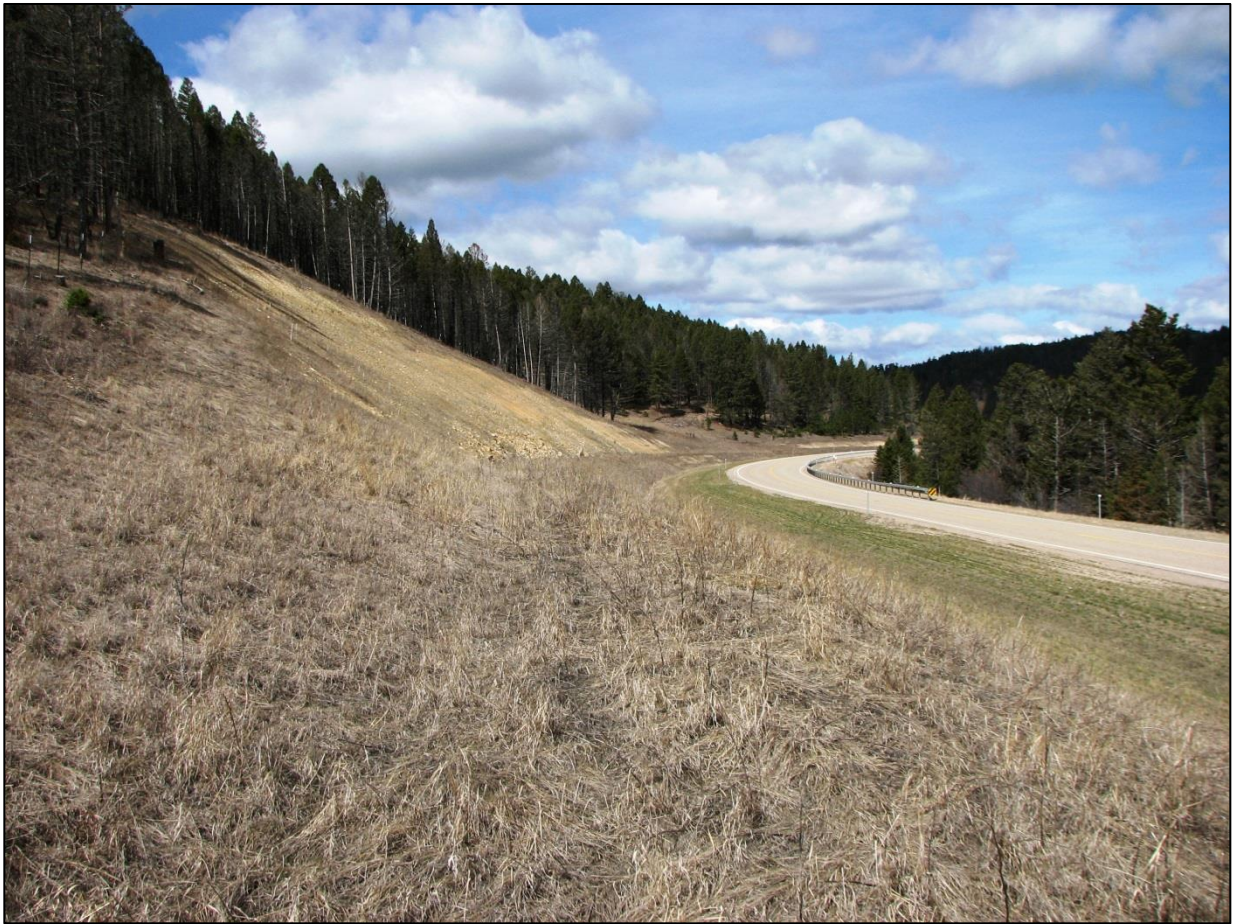
Same report as stated in May 2015. Page 22 of this report has representative image of the 2015 inspection. District staff has reported no incident involving pipe performance since installation.

↑ View west: Start of approximate location at the east end of the 18" A-2000.

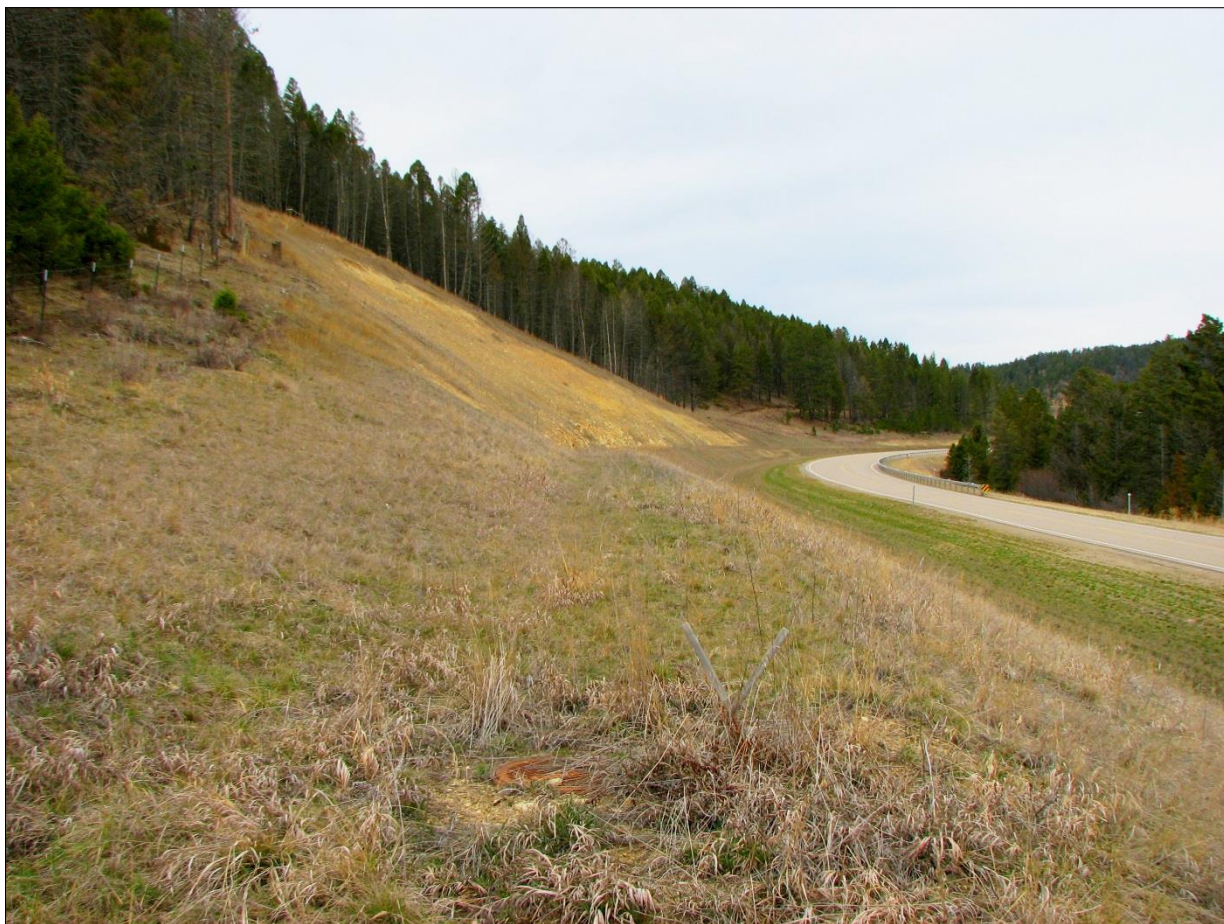
Same report as stated in May 2016. Page 23 of this report has representative image of the 2017 inspection. District staff has reported no incident involving pipe performance since installation.

↑ View west: Start of approximate location at the east end of the 18" A-2000.
