Laboratory and Field Evaluation of a Composite Glued-Laminated Girder to Deck Connection

Final Report
February 2019

Sponsored by
Iowa Highway Research Board
(IHRB Project TR-680)
Iowa Department of Transportation
(InTrans Project 14-511)

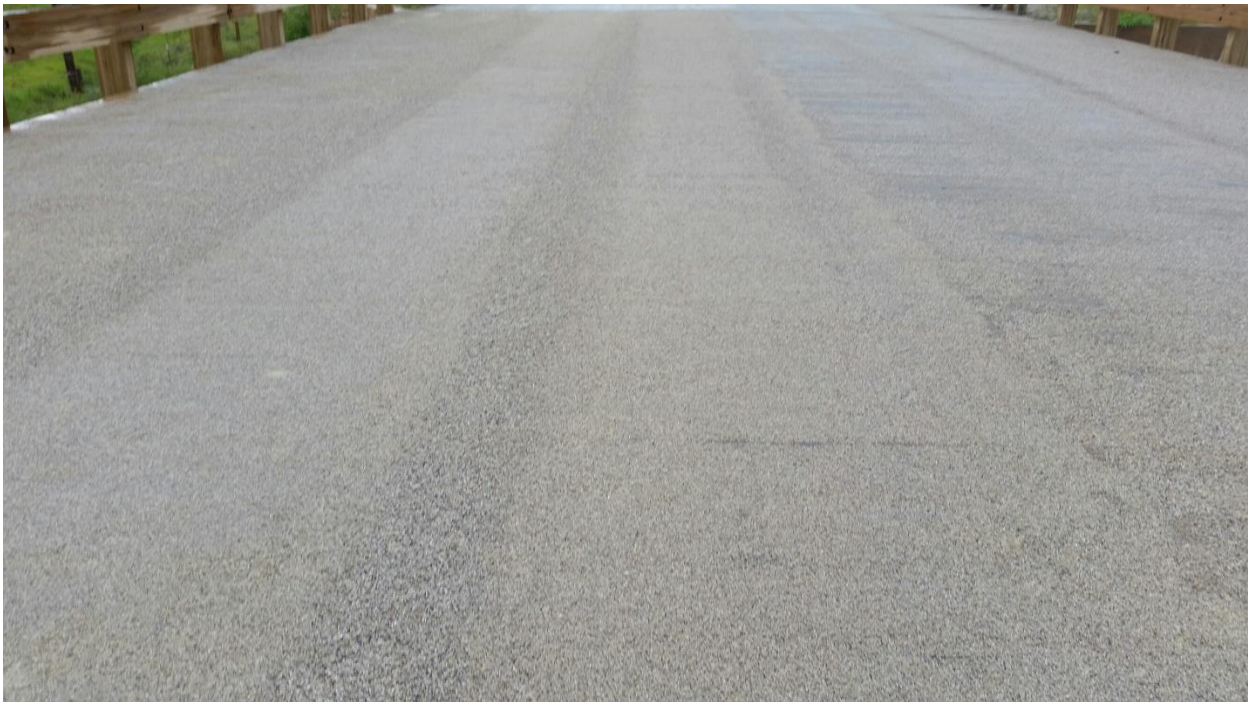
Figure 10. Epoxy chip seal wearing course on the composite timber bridge

Due to extreme weather conditions at the time of installation, only one layer of epoxy was installed, rather than the two called for in the plans. The following year, after field testing was

conducted, the bridge was overlaid with a chipseal wearing course in lieu of an additional epoxy overlay for cost reasons.

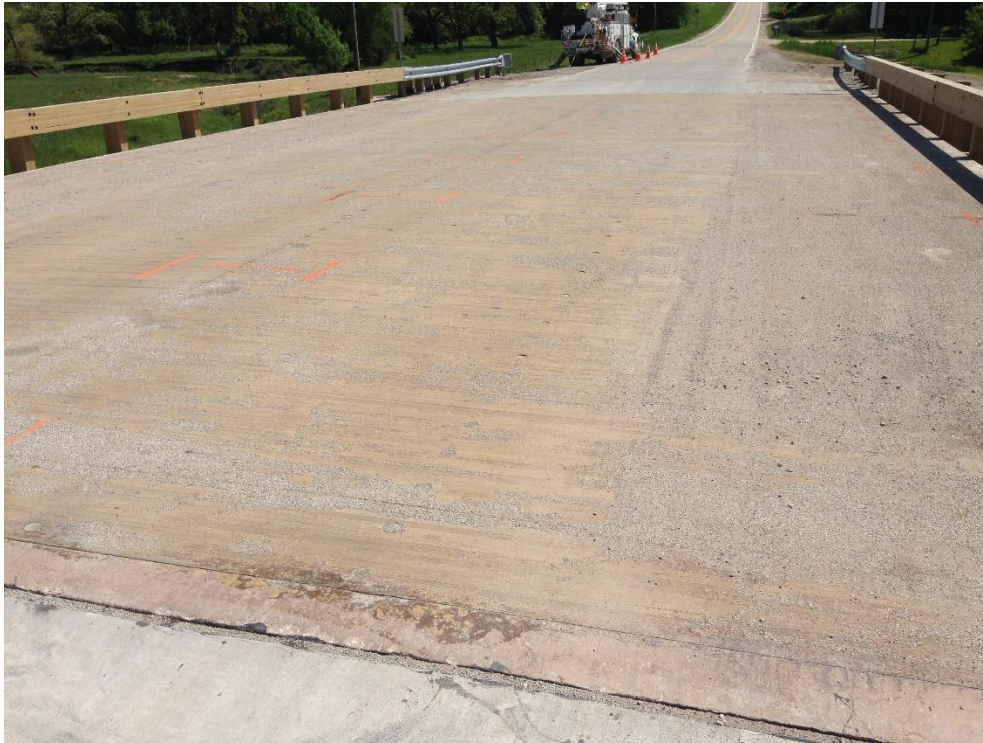
Figure 48. Epoxy wearing surface May 2015

Visual inspection of the epoxy wearing surface applied to the bridge deck was completed during the live load test conducted in 2015. Initial findings by the research team were that the epoxy wearing surface was performing quite well in terms of a moisture barrier; however, much of the aggregate applied to the epoxy had been worn off by traffic, primarily in the wheel lines of the traffic lanes (see Figure 48).

Lastly, the epoxy wearing surface applied to the deck of the demonstration bridge performed better as an impermeable joint filler than a wearing surface. Typical asphalt wearing surfaces on transverse glulam decks crack relatively quickly, unless designed appropriately, and subsequently allow moisture through the transverse deck panel joints. The epoxy used on the wearing surface filled all these joints and currently prevents moisture from getting through the joints. In the future, the combination of an initial epoxy overlay, to fill the joints and seal the gaps, followed by a well-designed asphalt wearing surface may be the key to prolonging the life of these structures.
