# JOINT TRANSPORTATION RESEARCH PROGRAM

## Assessment of Bridges Subjected to Vehicular Collision

Wang, Y., & Thrall, A. P. (2019). *Assessment of bridges subjected to vehicular collision* (Joint Transportation Research Program Publication No. FHWA/IN/JTRP-2019/01). West Lafayette, IN: Purdue University. <https://doi.org/10.5703/1288284316870>

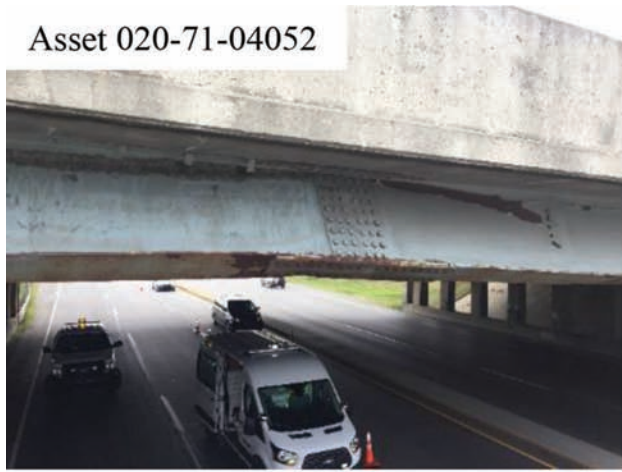
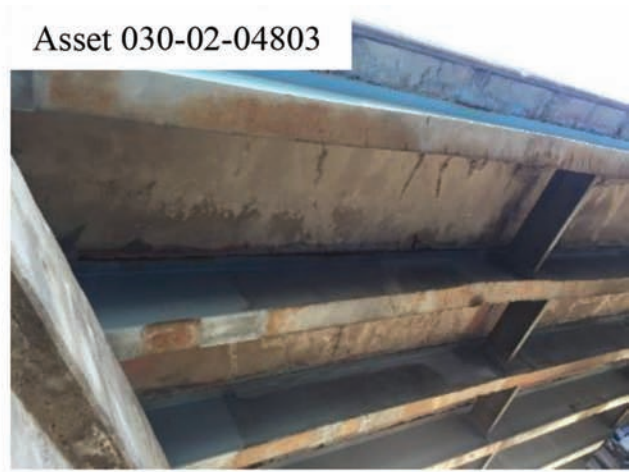
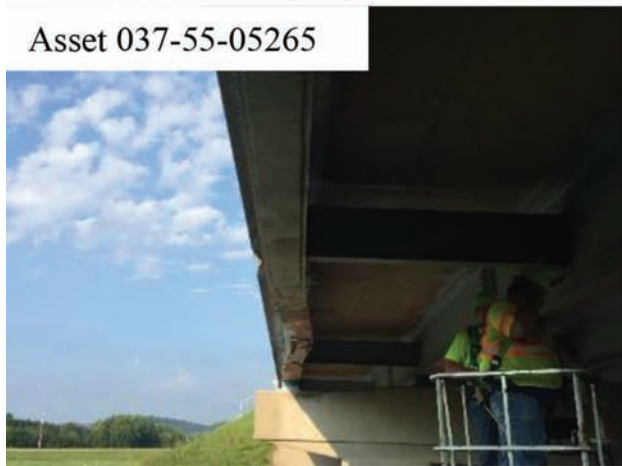
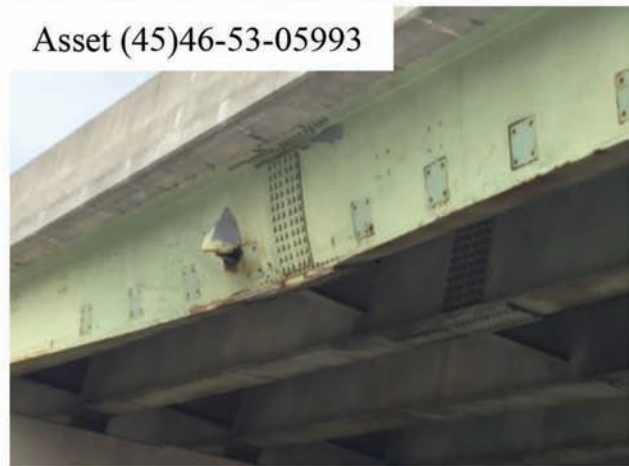
**Figure 1.2** Damage to steel girders in the four bridges tested in this project.

Field monitoring was performed by measuring strains in each bridge under quasi-static truckloads (i.e., two heavily loaded dump trucks). Four bridges with Category T damage were monitored (Figure 1.2). The research proposal planned to monitor six. However, there were few vehicular collisions during the project and there were challenges in obtaining lane closures to monitor damaged bridges due to high traffic volumes. The plan to monitor four bridges was agreed upon by the Business Owner and Principal Investigator. The focus was on monitoring the behavior of exterior damaged girders, symmetric undamaged girders, and adjacent girders. Surface strains were measured using a 3D DIC system consisting of two cameras ( $2448 \times 2050$  pixels, 0.472 in. lenses) mounted on a rigid bar (Figure 2.1). Strains were calculated using ARAMIS (2017), with a gauge length of 2.97 in. Specifically, twenty frames were taken within 15 seconds of one another for each load case (i.e., the trucks stayed in place when photographs were taken). Time averaging was implemented using the temporal binomial filter in ARAMIS (2017), averaging data over 10 frames for each load case. The spatial median filter in ARAMIS (2017) was used to reduce outlying data points. Area averaging was also performed, including data across the entire pattern but excluding the 0.5 in. development length of the tape along all edges. Full-field strain maps included in this report feature only temporal and spatial filtering.

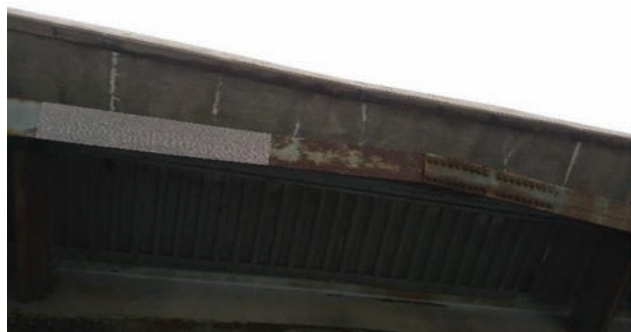
Asset 020-71-04052 (Figure 4.2 and Figure 4.3) is a three-span (50 ft. 6 in., 90 ft. 6 in., 50 ft. 6 in. spans) continuous composite bridge in South Bend, IN, built in 1966 and reconstructed in 1997. In 2016, 14 of the 22 girders were damaged near the East pier by a collision from an equipment hauler, with the heaviest damage incurred by the North exterior girder (Figure 4.4). Because of the vehicular collision, the lower flange was plastically deformed with a sweep of approximately 16 in. The bearing was also kicked out and retrofitted with a wedge.

Figure 4.4 Damaged girder of Asset 020-71-04052.

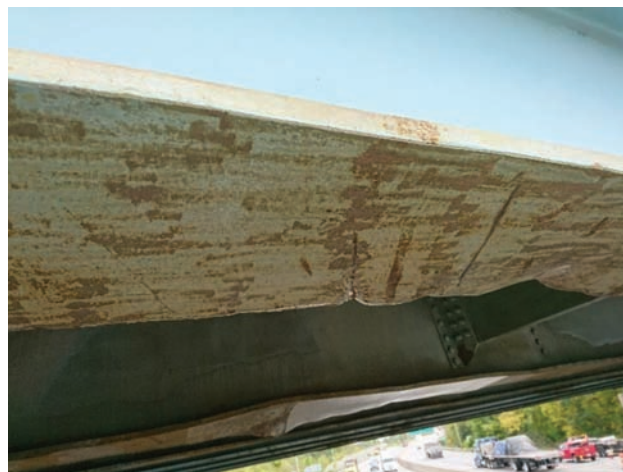
Figure 4.10 1st and 2nd damaged girder from West of Asset 030-02-04803.

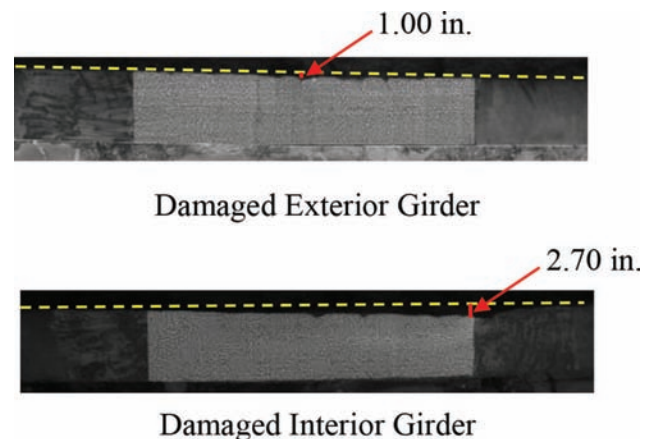
Figure 4.12 Displacement at the peak point of the damage of Asset 030-02-04803.

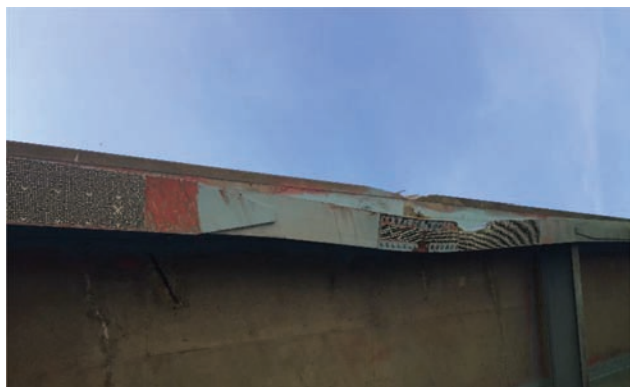
On August 21, 2018, a lift struck the East exterior girder in the North span. The girder was bent inward approximately 13 in. and the diaphragms punched through the girder in four locations including a hole near the splice plate at the approximate location of the impact (Figure 4.21). The Business Owner called the Principal Investigator that day to mobilize monitoring of this structure prior to any repairs. The researchers rapidly responded and performed monitoring—facilitated by

Figure 4.16 Damaged girder of Asset 037-55-05265.

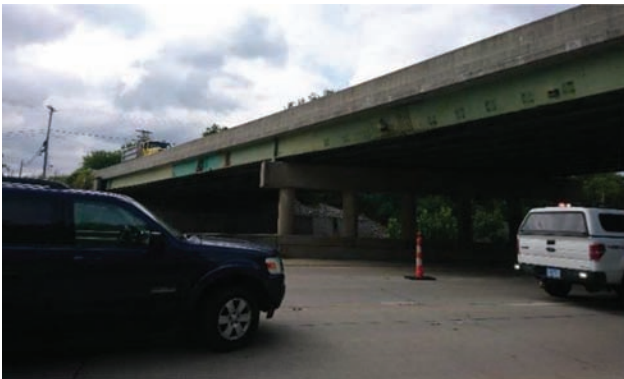
Figure 4.21 Damaged girder of Asset (45)46-53-05993.

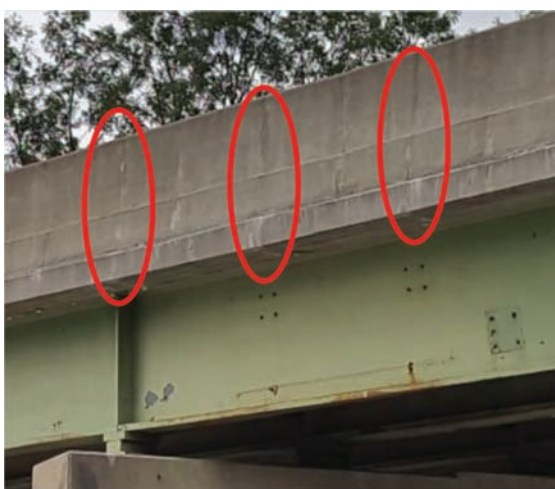
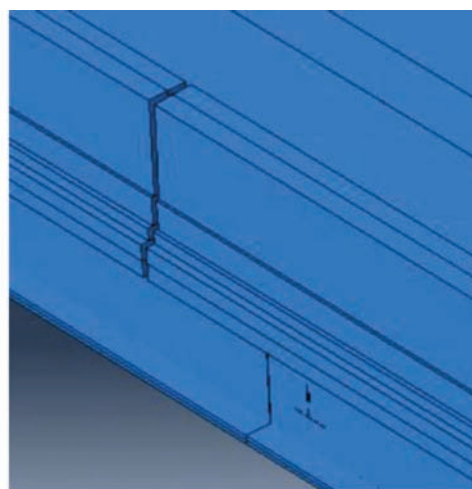
**Figure 4.24** Cracks in the bridge and FE model.
