Guidelines for Detection, Analysis, and Treatment of Materials-Related Distress in Concrete Pavements Volume 3: Case Studies Using the Guidelines

PUBLICATION NO. FHWA-RD-01-165

AUGUST 2002

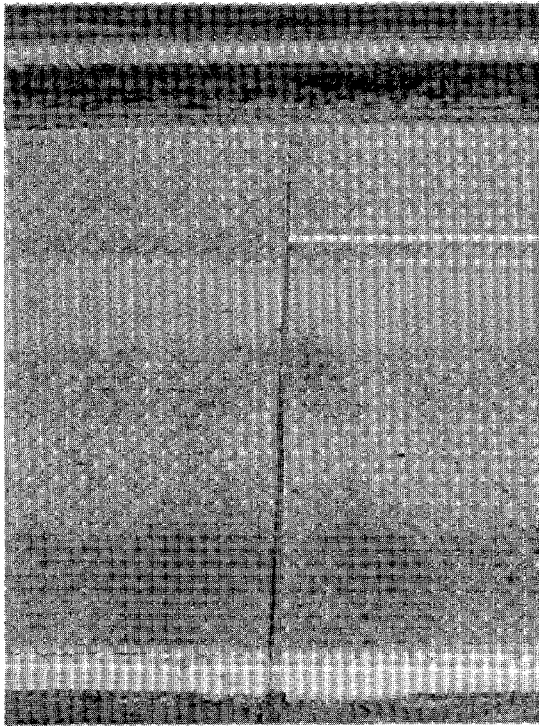
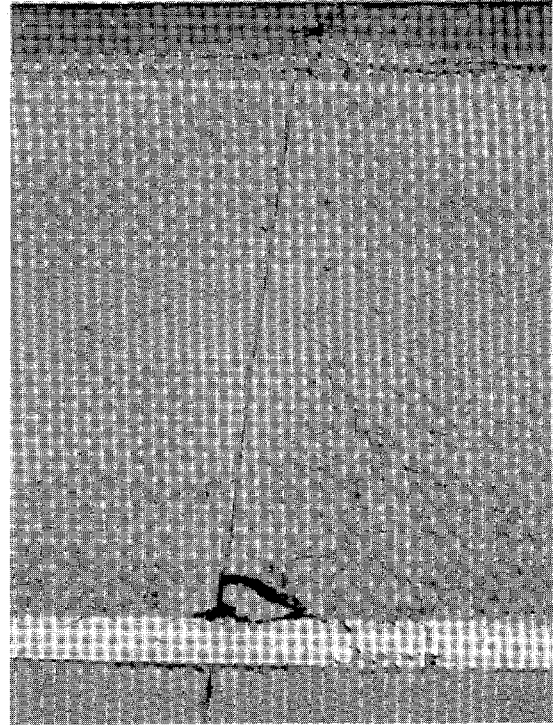
Figure 3-2. Typical distress manifestation observed on SD-090-019-002.

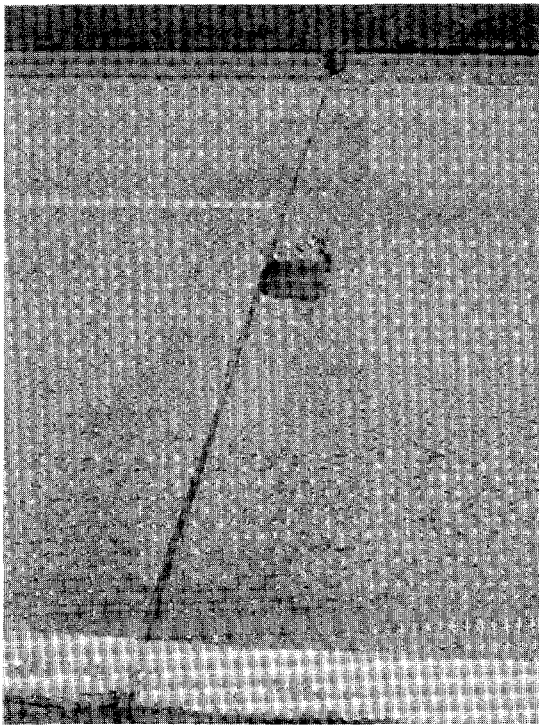
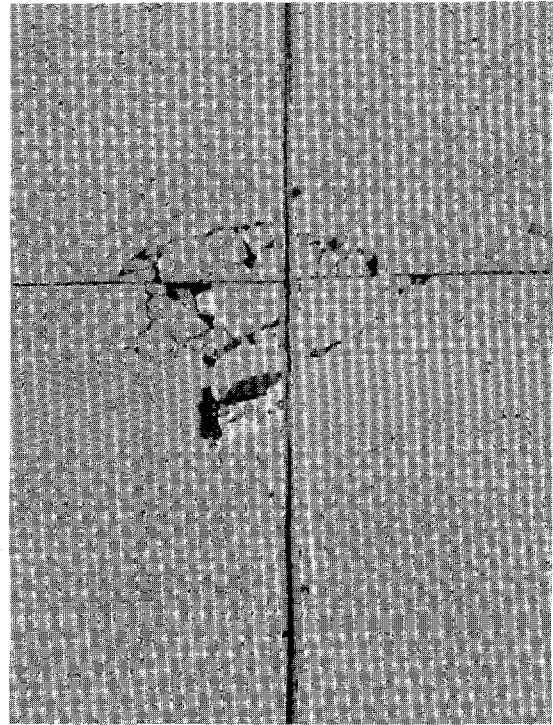
Figure 3-3. Typical distress manifestation observed on SD-090-019, Sections 1 and 2.

On both pavement sections, map cracking was observed throughout the entire area. On Section 001, the cracks appear to be confined to the upper 50 mm at the pavement surface. The majority of cracks run perpendicular to the centerline, but there are some cracks that run parallel to the centerline. The combination of cracks forms a criss-cross pattern on the surface. Although the cracking pattern is similar on Section 002, the transverse cracks on Section 001 are more pronounced and some are opened at the surface.

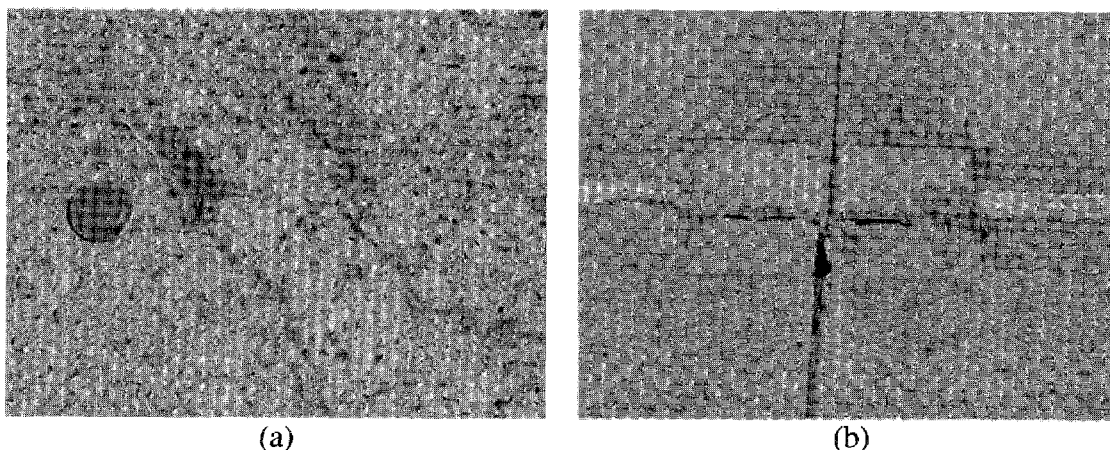
Figure 3-4. Typical distress manifestation observed on SD-090-019-002.

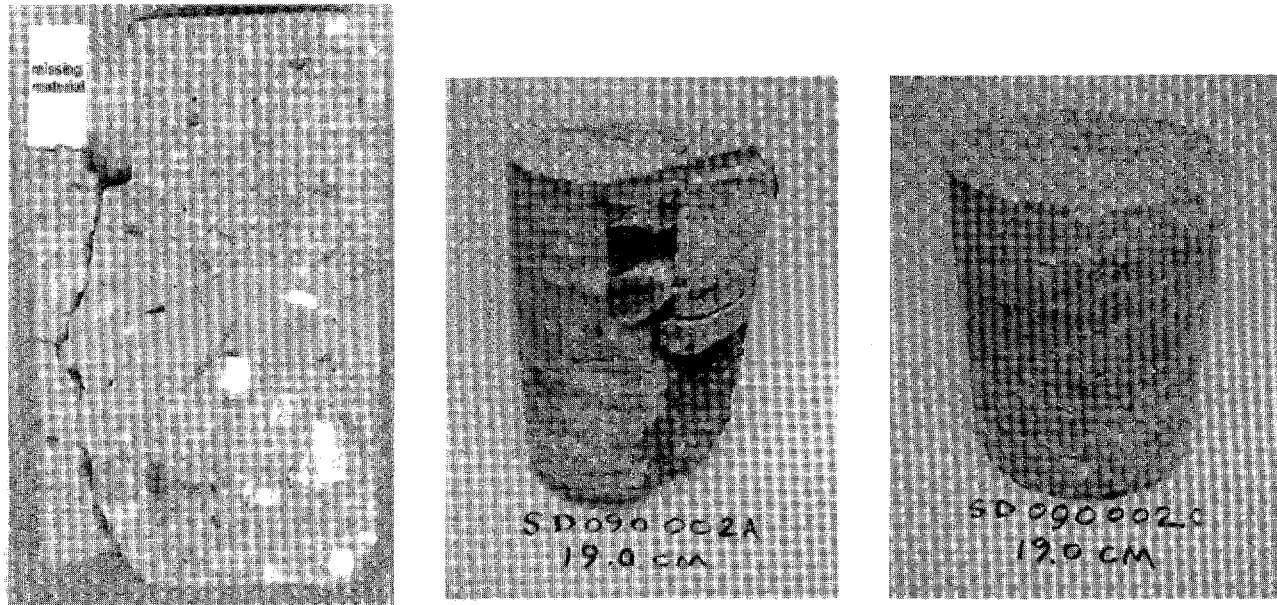
Figure 3-5. Core specimens from SD-090-019.

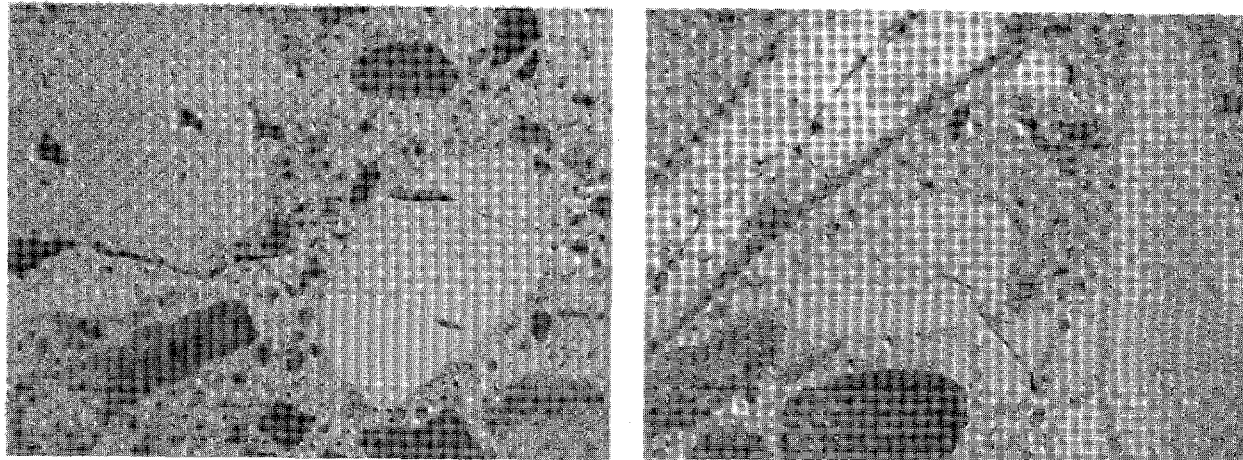
Figure 3-6. Stereo optical micrographs of typical cracking pattern associated with porous siltstone aggregate SD-090-019.

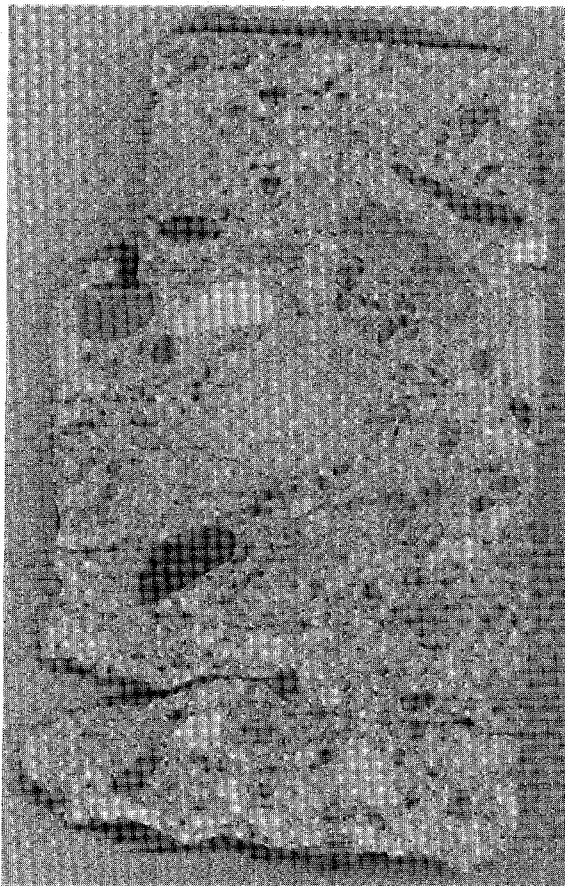
Figure 3-8. Slab 1B stained with sodium cobaltinitrite/rhodamine B from SD-090-019-001.

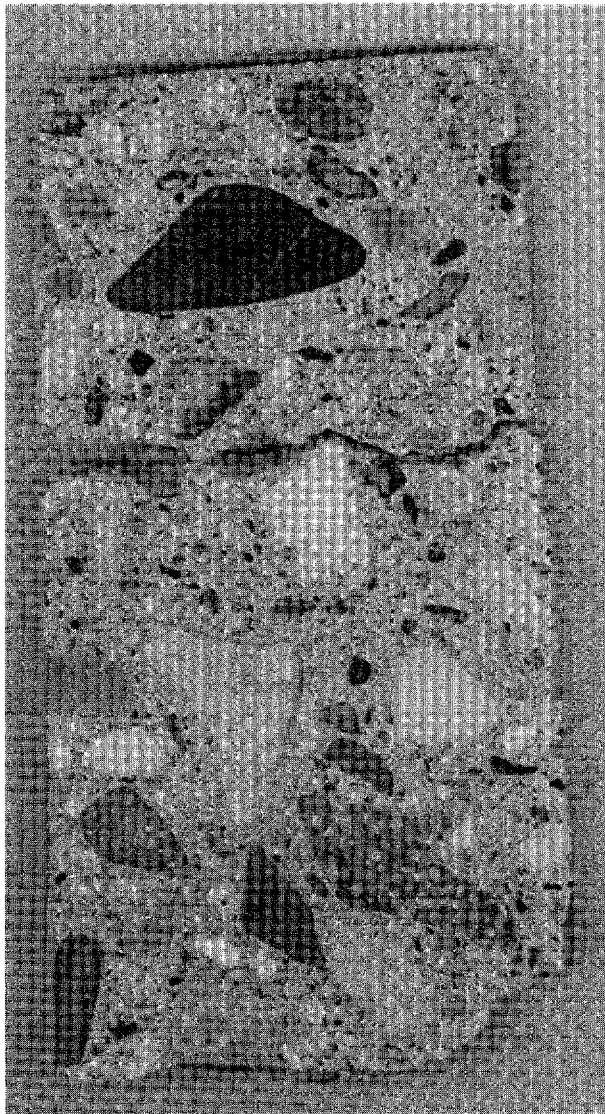
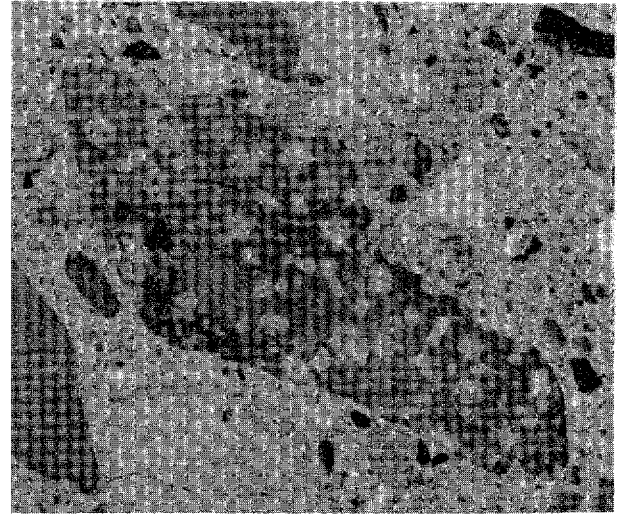
(b) Stereo optical micrograph of reactive rhyolite particle

Figure 3-9. Slab 1B stained with sodium cobaltinitrite/rhodamine B from SD-090-019-001.

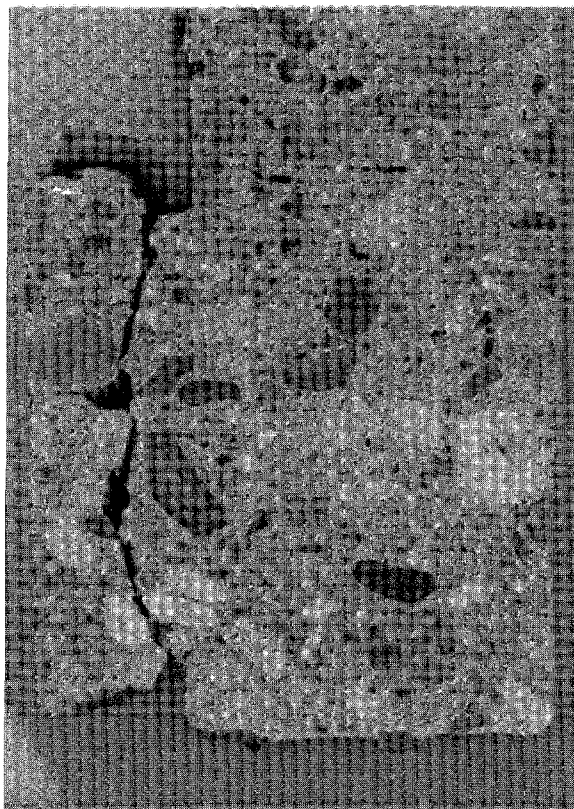
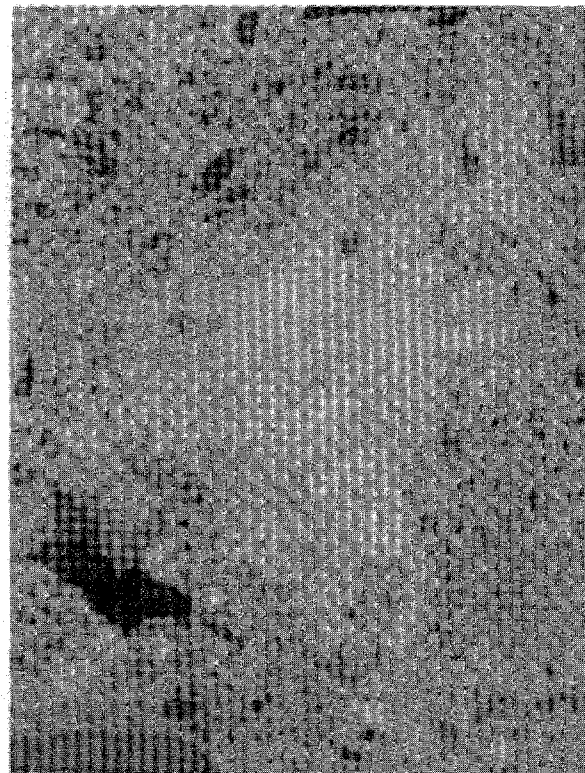
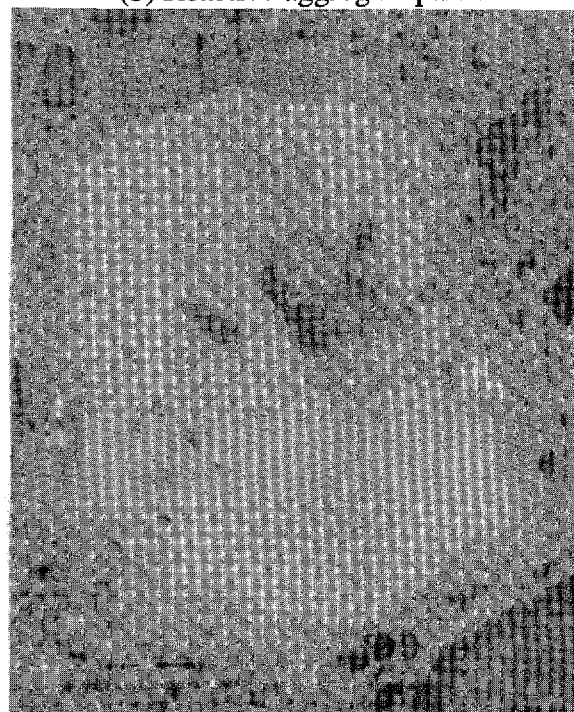
(b) Reactive aggregate particle

(c) ASR gel filled void

(d) Reactive aggregate particle

Figure 3-10. Slab 2B stained with sodium cobaltinitrite/rhodamine B from SD-090-019-002.

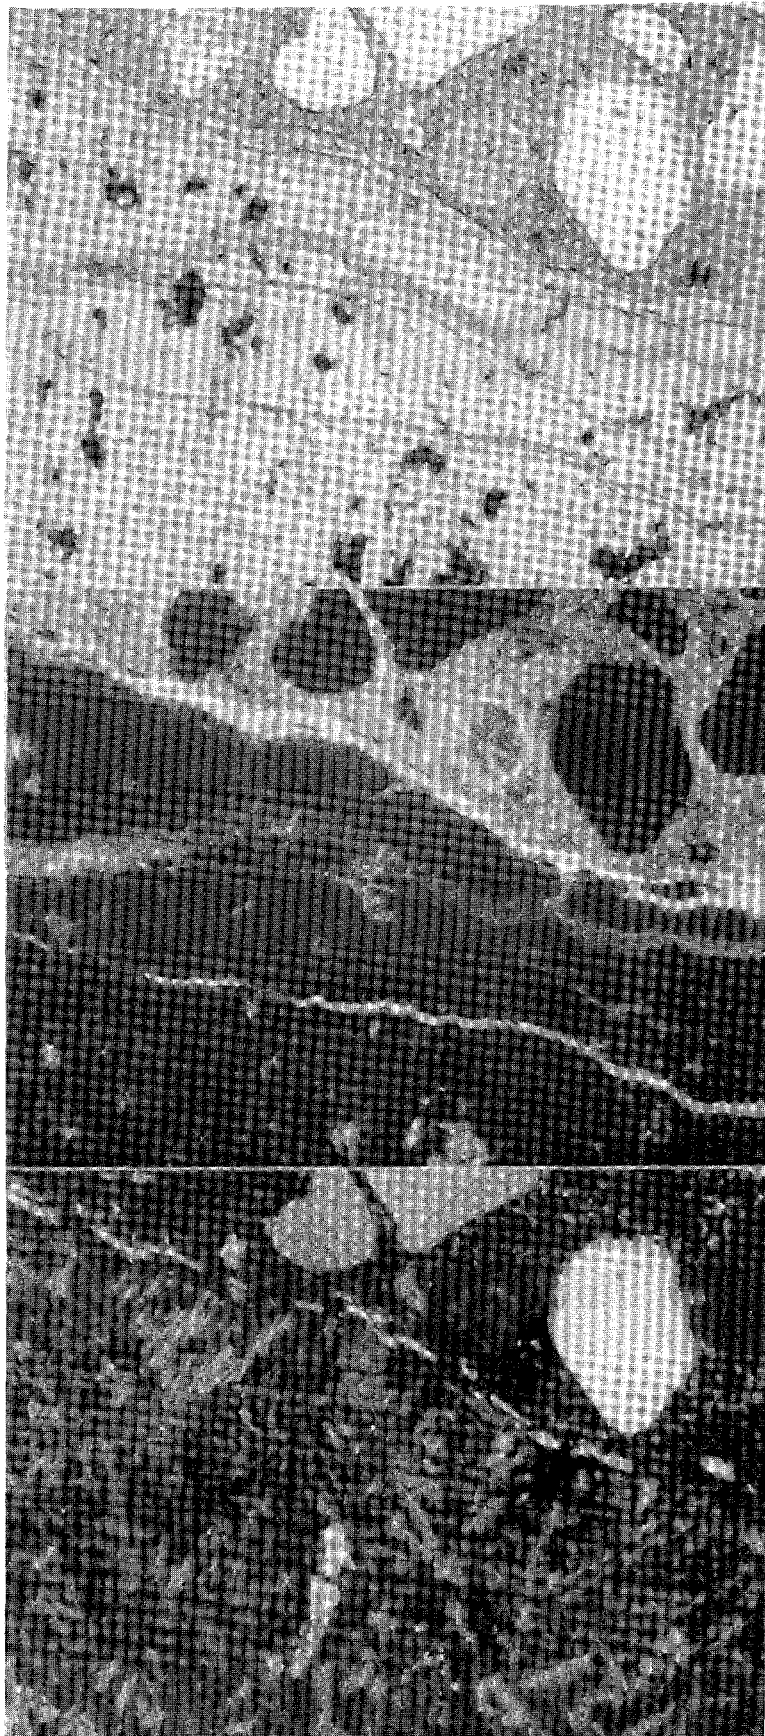
Figure 3-12. Core SD-090-019-001B, thin-section micrographs of same rhyolite aggregate that was stained with sodium cobaltinitrite ASR stain as shown in figure 3-9 (b). From top to bottom: transmitted plane polarized light, epifluorescent mode, and transmitted cross polarized light. Ettringite can be seen filling the entrained air void, ASR gel can be seen in the crack within the aggregate, and hydrocalumite can be seen in the crack along the contact between the aggregate and the cement paste. This same area was analyzed with the SEM to collect quantitative chemical information about the gel, ettringite, and hydrocalumite.

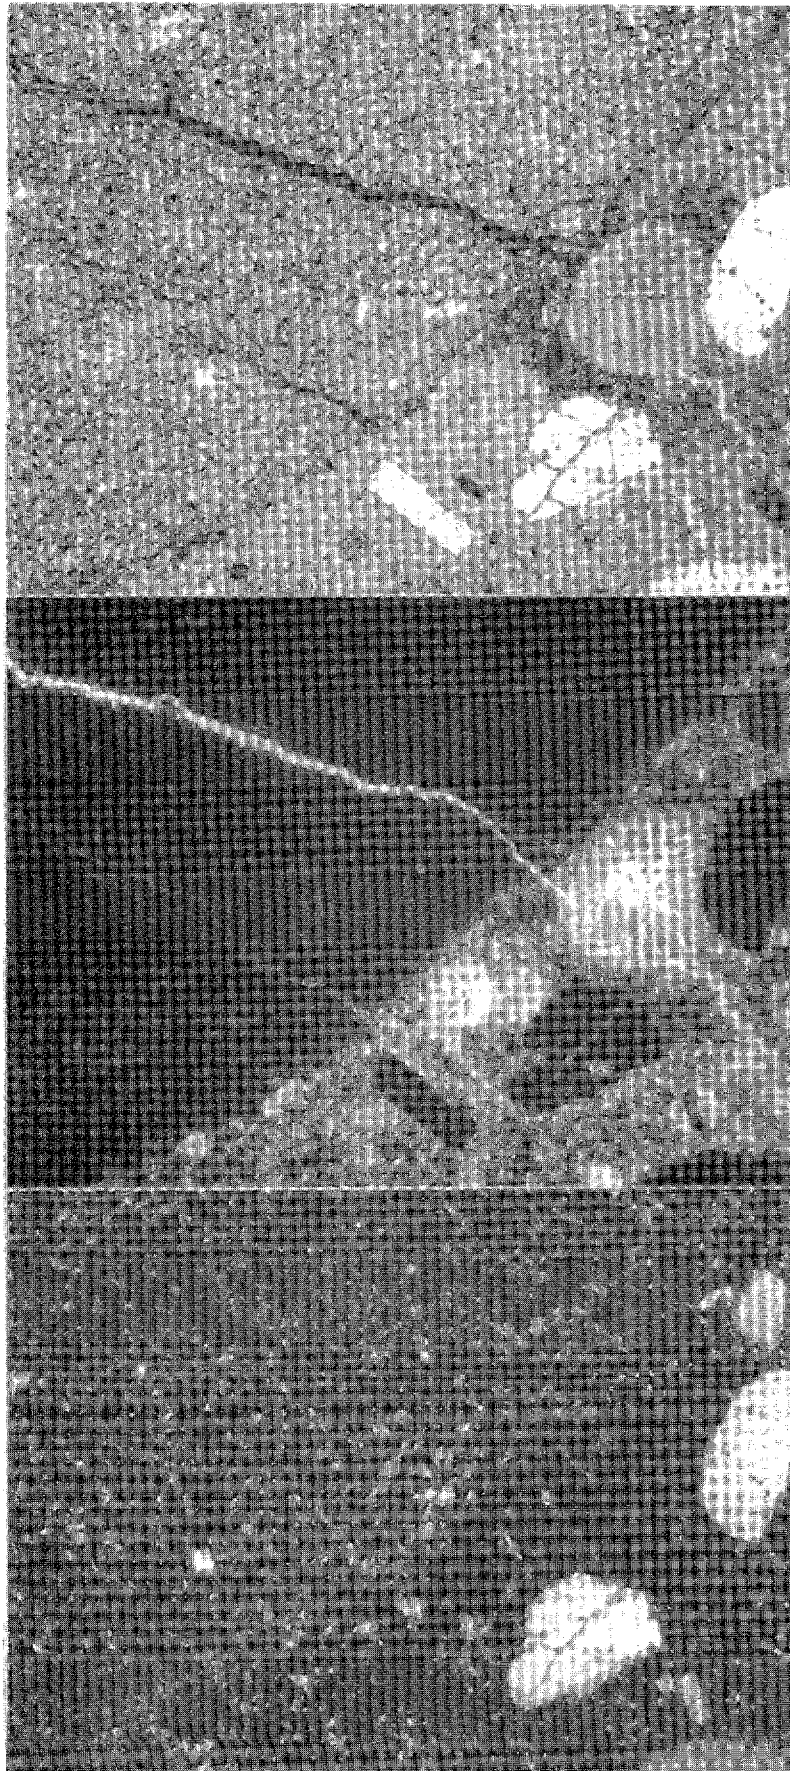
Figure 3-13. Core SD-090-019-001B, thin-section micrographs of same volcanic aggregate that was stained with sodium cobaltinitrite ASR stain as shown in figure 3-8 (c). From top to bottom: transmitted plane polarized light, epifluorescent mode, and transmitted cross polarized light. Ettringite can be seen filling the entrained air void, ASR gel can be seen in the crack within the aggregate, and hydrocalumite can be seen in the small entrained air void in the lower right hand corner. This same area was analyzed with the SEM to collect quantitative chemical information about the gel, ettringite, and hydrocalumite.

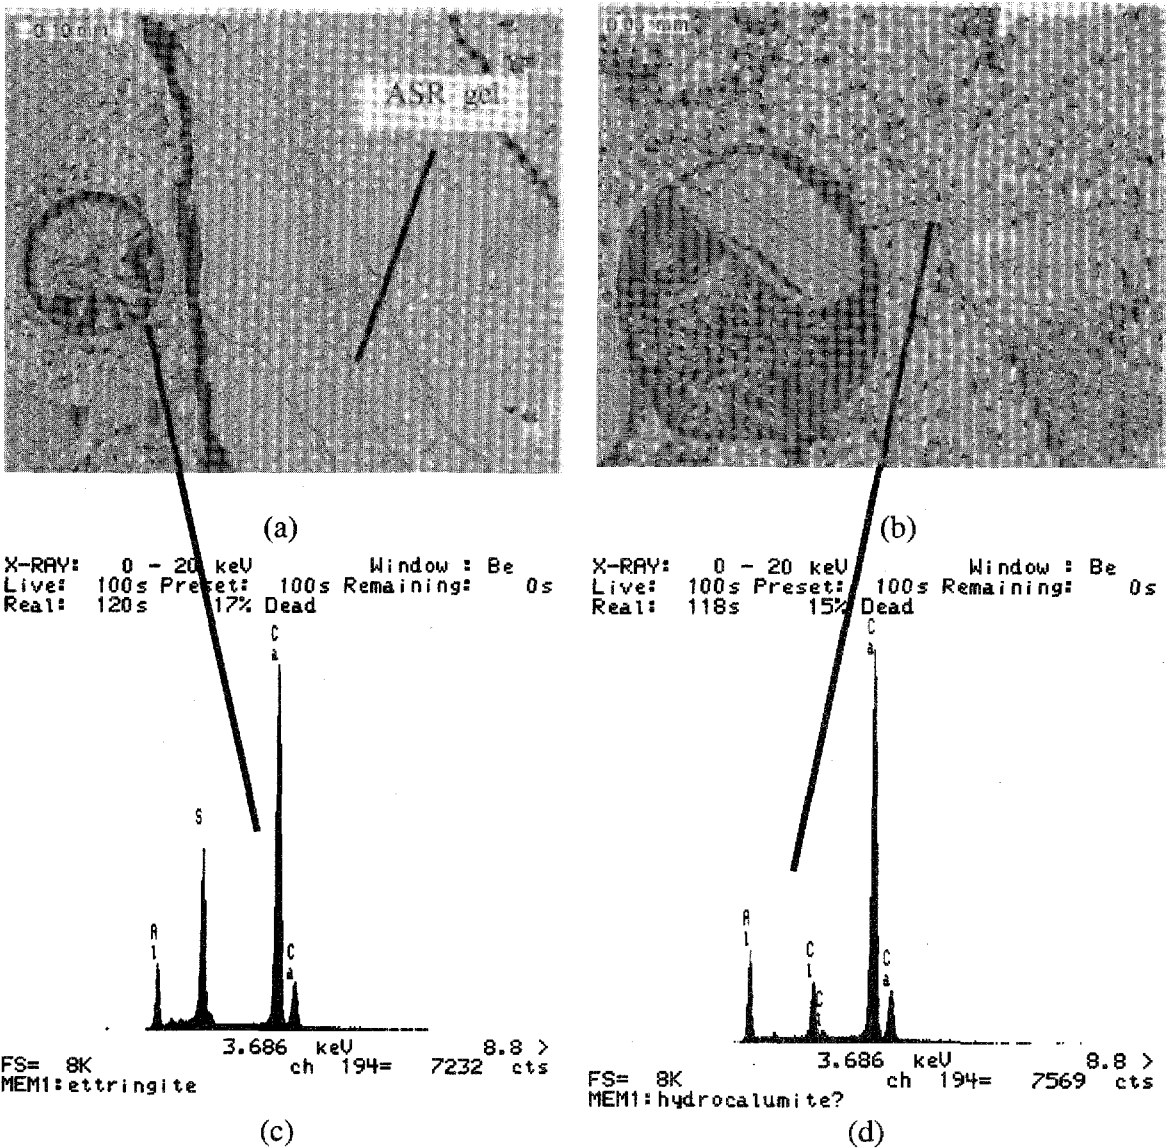
Figure 3-14. Ettringite (a) and hydrocalumite (b) infilling in void and crack, respectively. Example spectra from each phase are shown in (c) and (d), respectively.

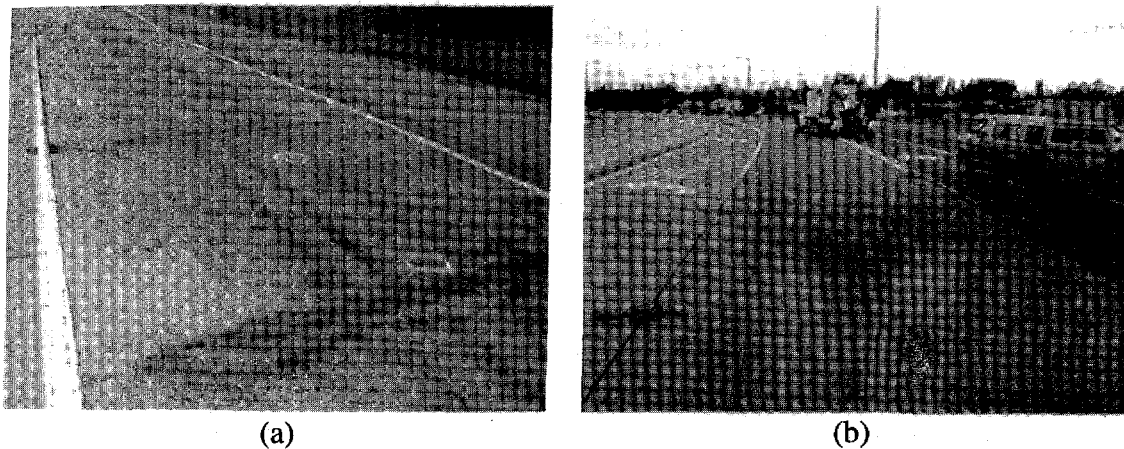
Figure 3-21. Typical distress manifestations observed at MN-065-064.

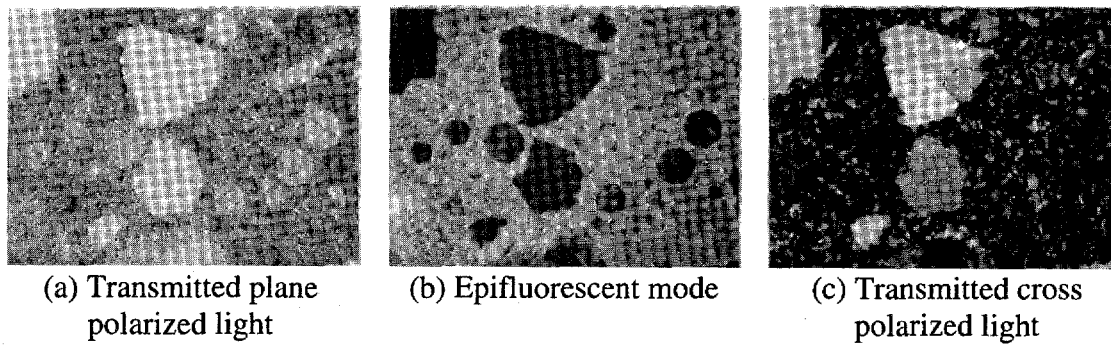
Figure 3-50. Petrographic micrographs from spall obtained from NC-440-015 showing ettringite filled entrained air voids. Ettringite growths are unusually dense.

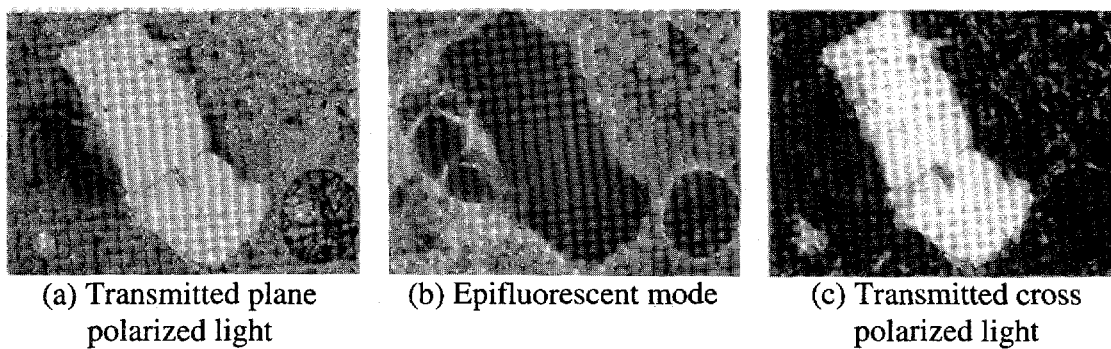
Figure 3-51. Petrographic micrograph of a tan to red coating observed on some of the fine aggregates that appears to undergo ASR from spall obtained from NC-440-015.

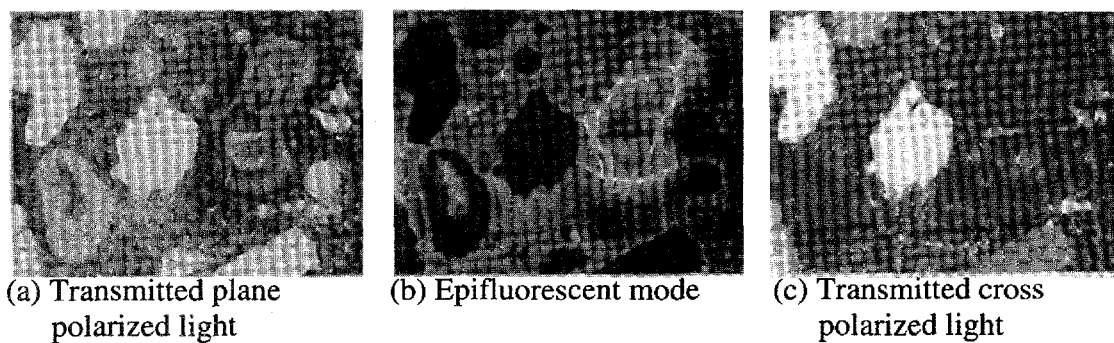
Figure 3-52. Petrographic micrograph of ettringite and “ASR gel blob” from spall obtained from NC-440-015. The term ASR gel is misleading in this example, since the reaction product is slightly birefringent and, therefore, crystalline.

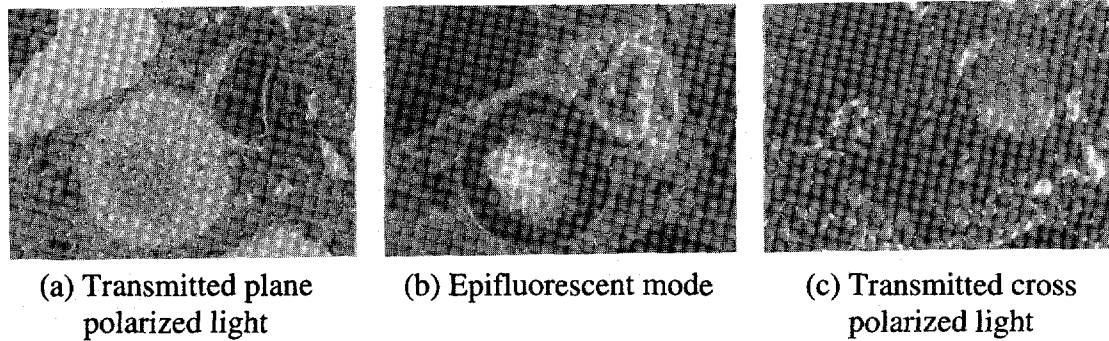
Figure 3-53. Petrographic micrograph of ettringite intermixed with ASR gel. As in figure 3-52, the ASR “gel” in this image is birefringent and crystalline.

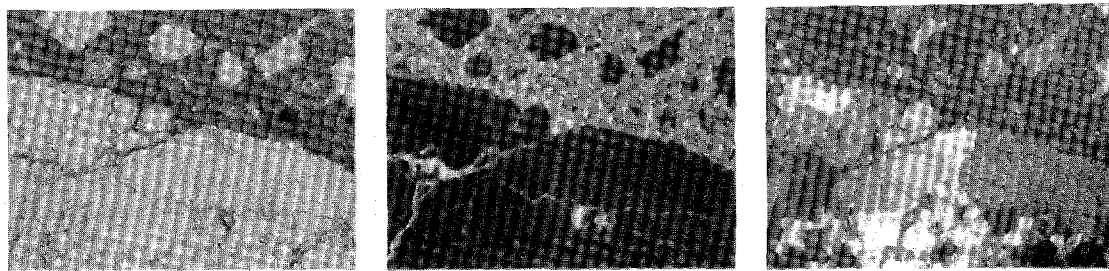
Figure 3-54. Petrographic micrograph of ASR gel in crack within coarse aggregate. The gel deposit in this image was analyzed with the SEM. Again, the ASR “gel” in this image is birefringent and crystalline.

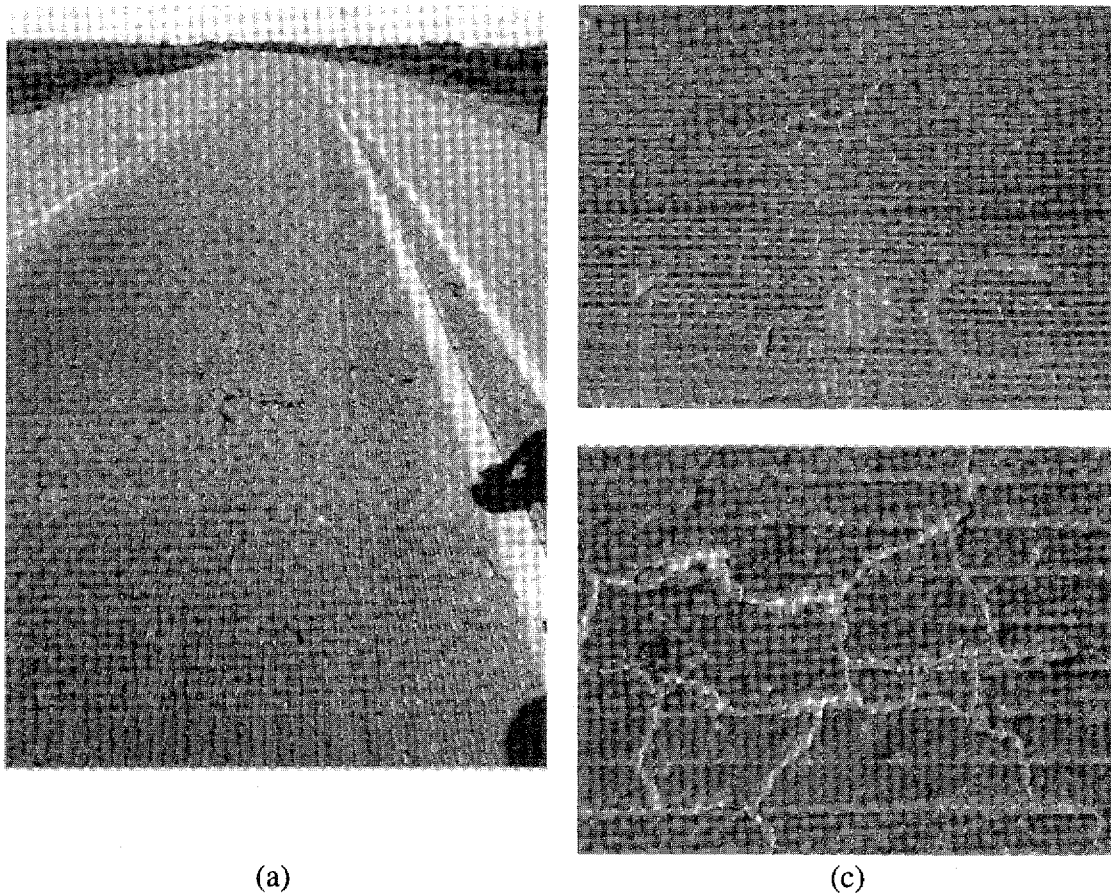
Figure 3-63. Typical conditions at CA-058-141.

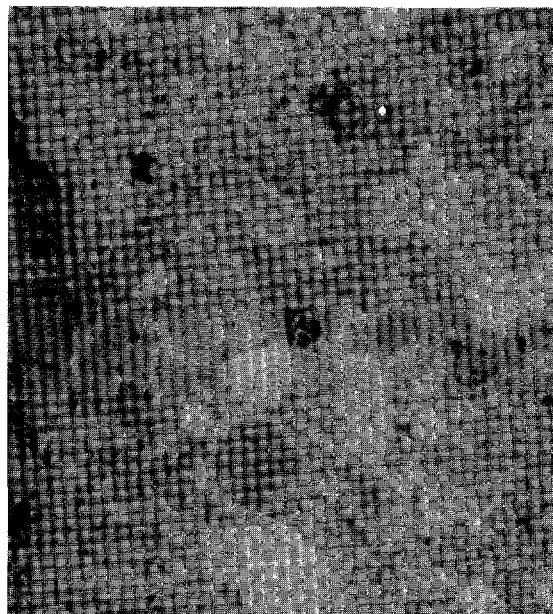
(b) An unpolished cut surface that has been stained to show ettringite filled cracks and voids

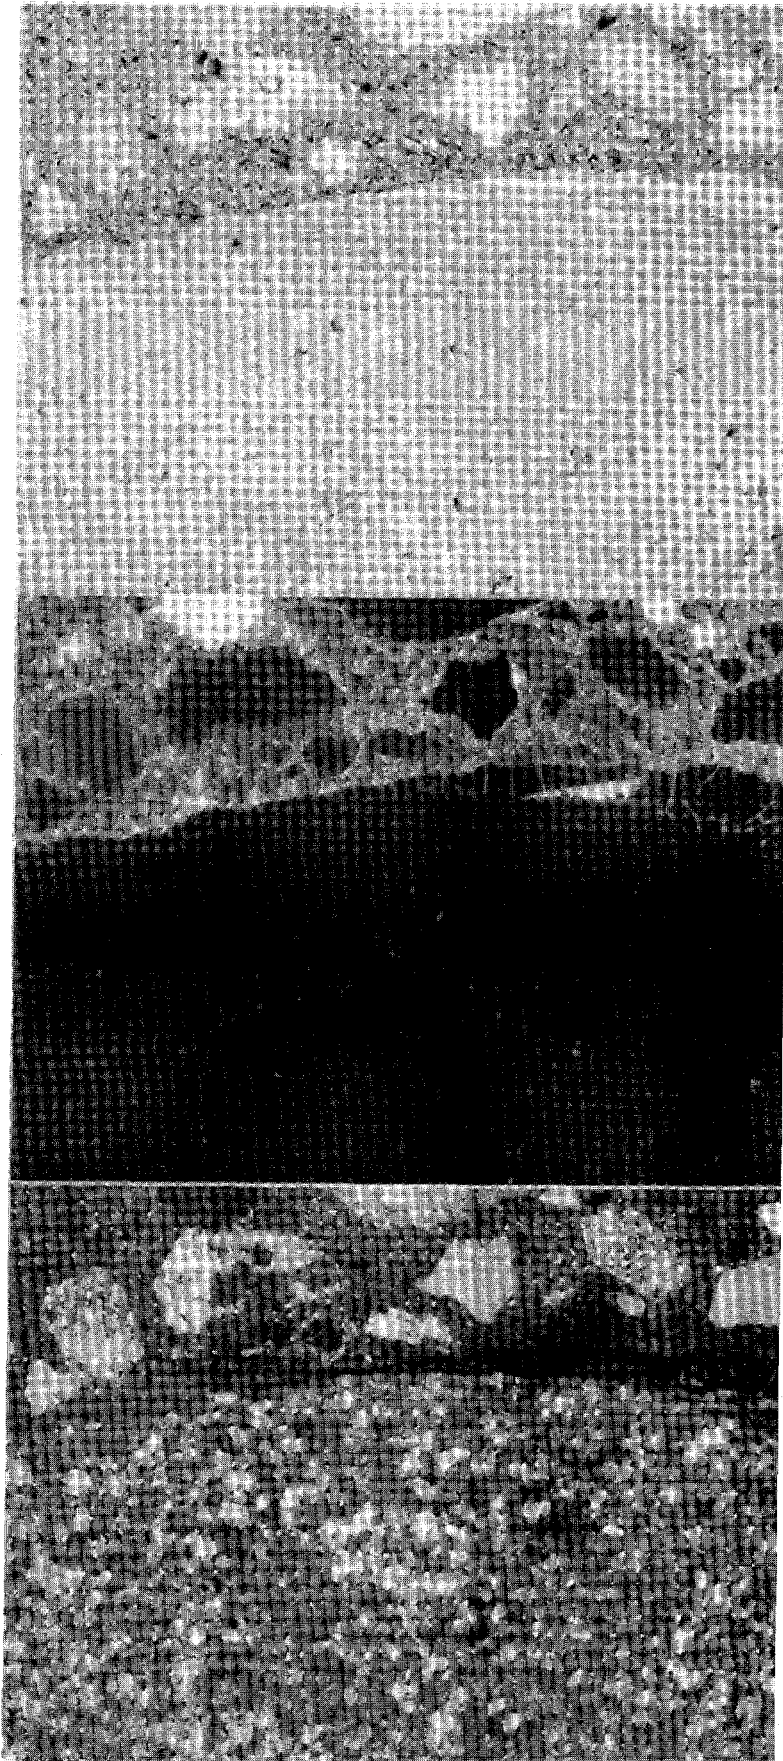
Figure 3-66. Petrographic micrograph of core CA-058-141-001E, thin-section micrographs of ASR gel deposit in crack along felsic volcanic aggregate. The same deposit was analyzed with the SEM to collect quantitative chemical information about the gel. From top to bottom: transmitted plane polarized light, epifluorescent mode, and transmitted cross polarized light (magnified 48x).

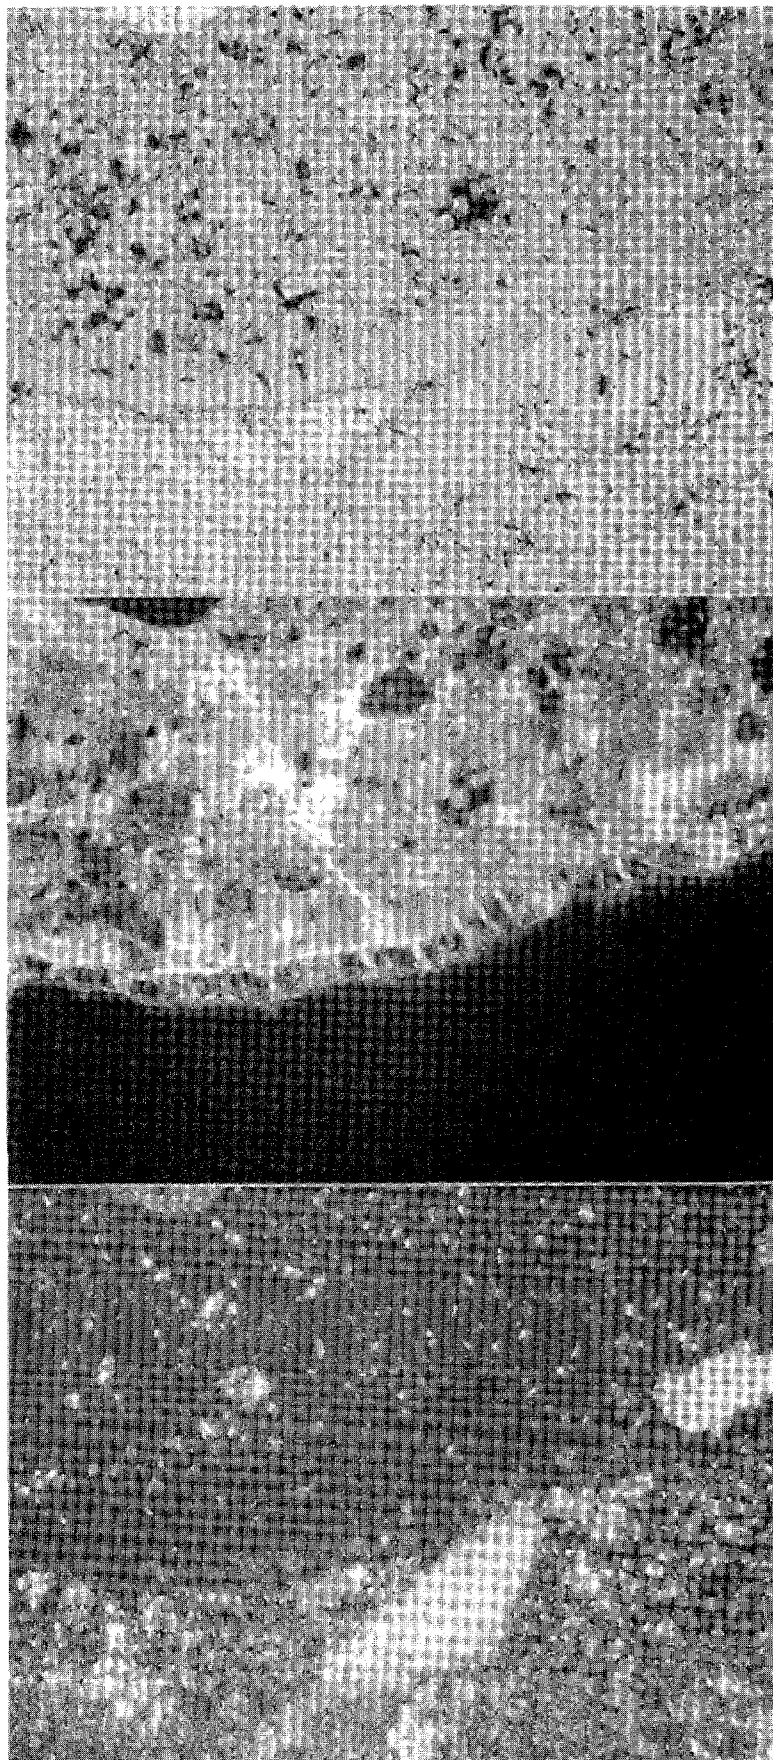
Figure 3-67. Petrographic micrograph of core CA-058-141-001E, thin-section micrographs of ettringite filled crack along contact between coarse aggregate and cement paste. From top to bottom: transmitted plane polarized light, epifluorescent mode, and transmitted cross polarized light (magnified 188x).

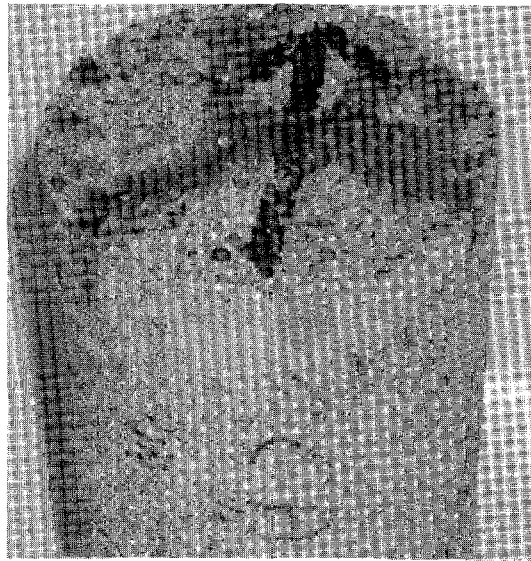
Figure 3-75. Map cracking pattern on core CA-014-011-001E, emphasized by wetting down the surface.

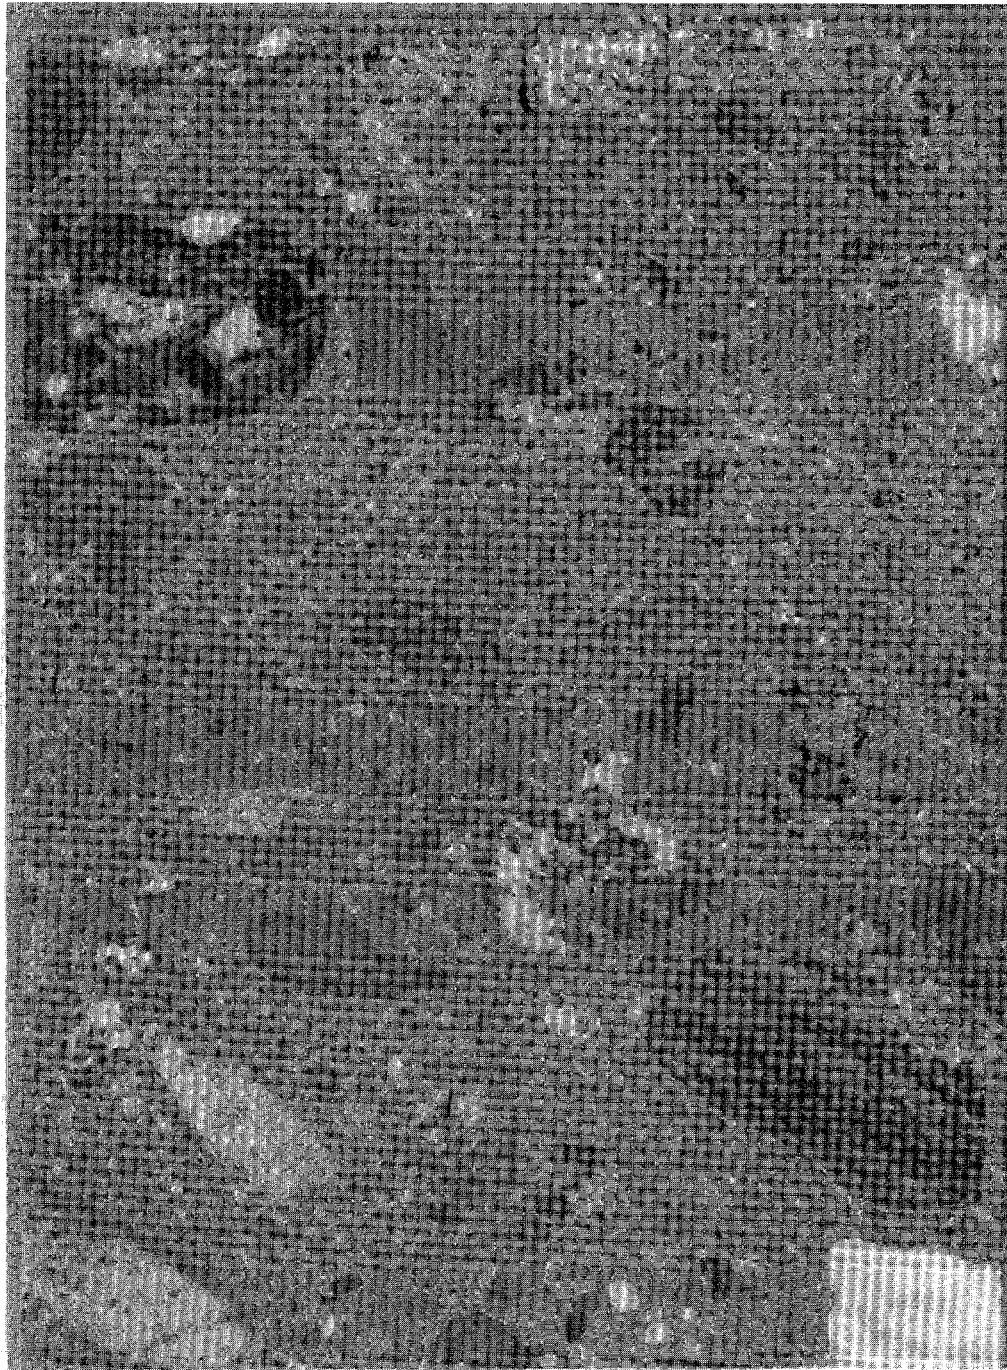
Figure 3-77. Same area of core CA-058-011-001E as shown in figure 3-78, included to show darkened reaction rims on some of the coarse aggregate (magnified 1.5x).

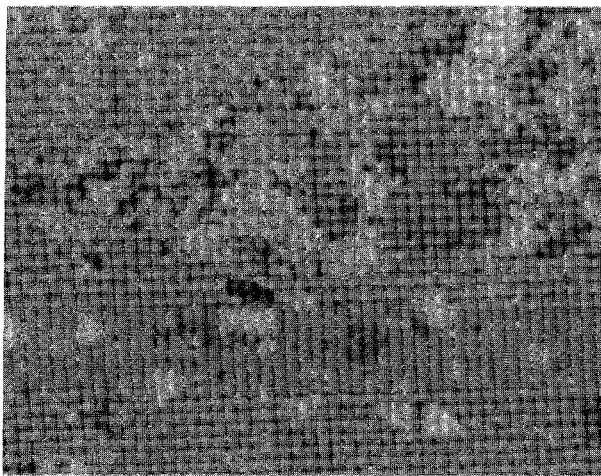
(a) Yellow sodium cobaltinitrite stain for ASR gel in cracks associated with granitic coarse aggregate

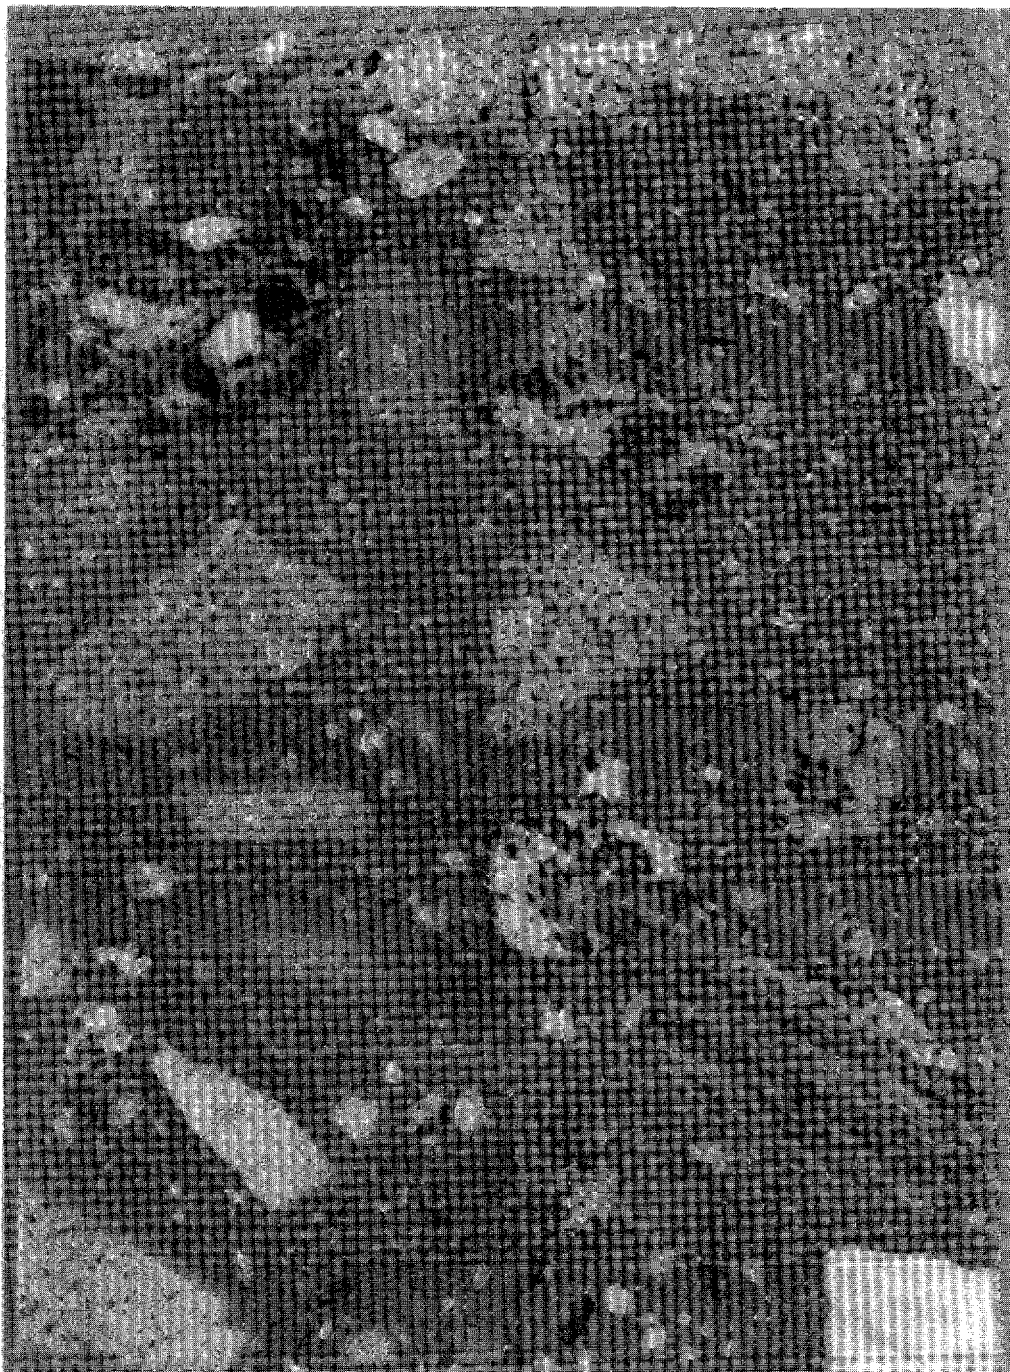
Figure 3-79. Phenolphthalein stained polished slab, showing carbonation along plastic shrinkage crack (magnified 1.5x).

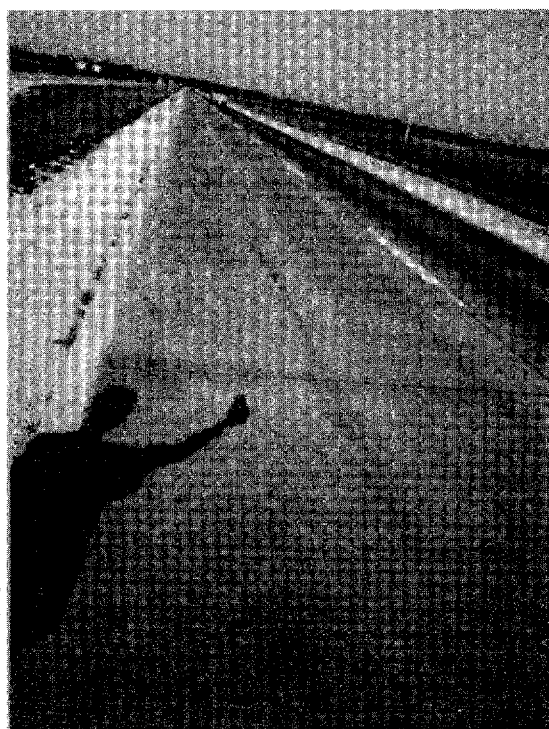
(a) Staining along longitudinal cracks

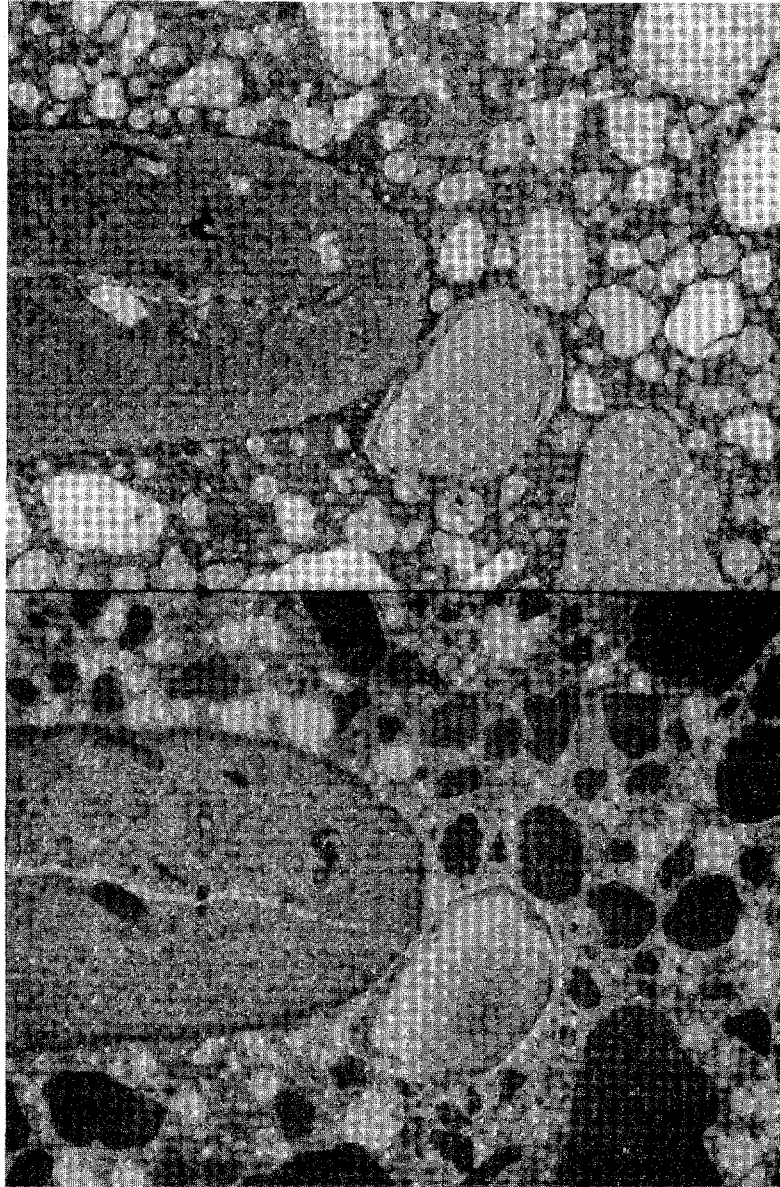
Figure 3-85. Reactive fine aggregate particle with alkali-silica gel filled air voids as viewed in thin section. Top image is transmitted plane polarized light, bottom image is in epifluorescent mode, magnified 20x.
