Water Intrusion in Base/Subgrade Materials at Bridge Ends: Final Report

Department of Civil Engineering
Texas Tech University

Report No. 0-5096-1

October 2005

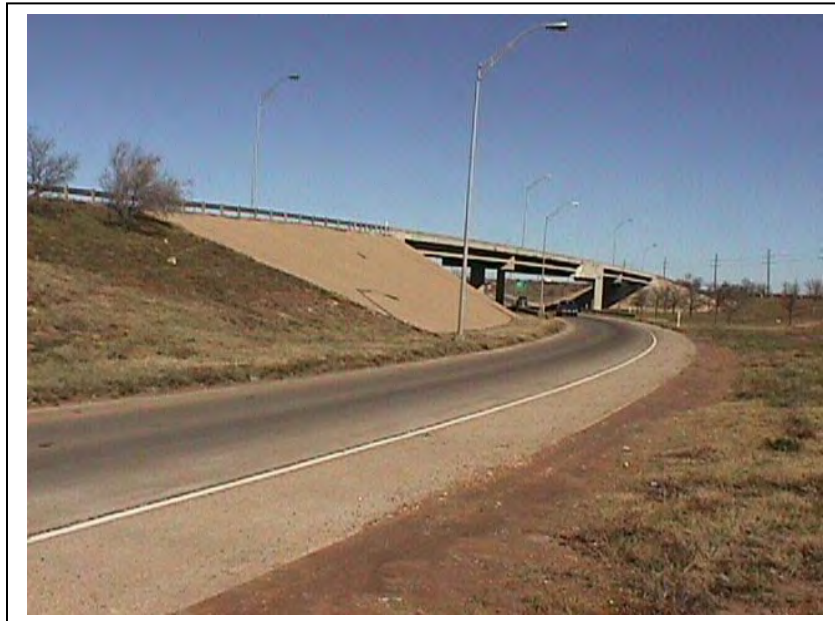
Figure 4.1 Side View of Riprap with Washed-Out Fines at Toe

The Lubbock District now places filter fabric beneath joints in the riprap slabs to prevent the loss of fines as shown in Figure 4.5. Filter fabric is also placed near any point that might become a location for loss of fine materials (Figure 4.6). Details for the use of the filter fabric are provided in Appendix (Filter Fabric).

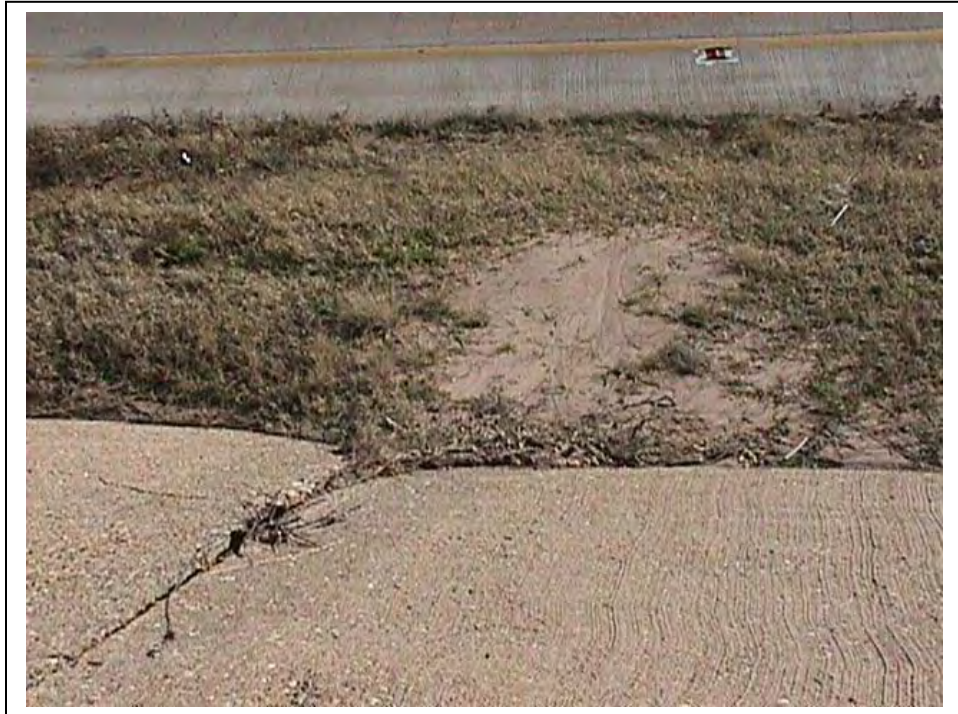
Figure 4.2 Top View of Riprap with Washed-Out Fines at Toe

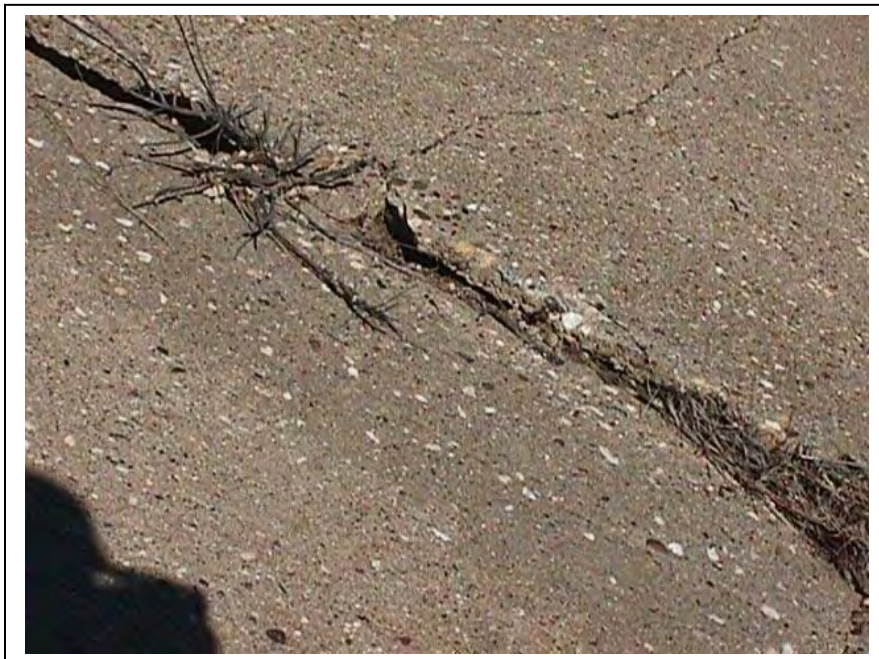
Figure 4.3 Damaged Joint in Riprap Slab

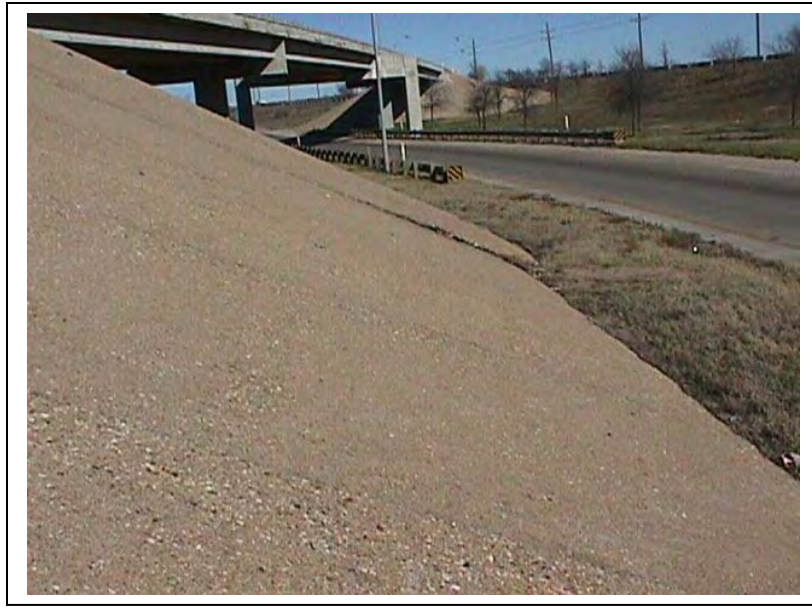
The survey response from the Lubbock district indicated that although they do not experience many problems with water intrusion associated with approach slabs, they have noted problems with water intrusion in riprap and washing out of material at the toe of the riprap. Loss of material beneath the riprap causes large voids to develop beneath concrete slabs and can create differential settlement of the slabs along with concerns for collapse of the slab. The IH 27 overpass over 4th Street in Lubbock is an example of the problem. Figures 4.1 and 4.2 show washed-out fine material at the toe of the embankment. Water is able to enter through damaged or poorly sealed joints between the concrete slabs (Figure 4.3) and wash out fines in the embankment fill. Differential settlement of the slabs is evidenced in Figure 4.4.

Figure 4.4 Differential Settlement of Riprap Slab (Side View)

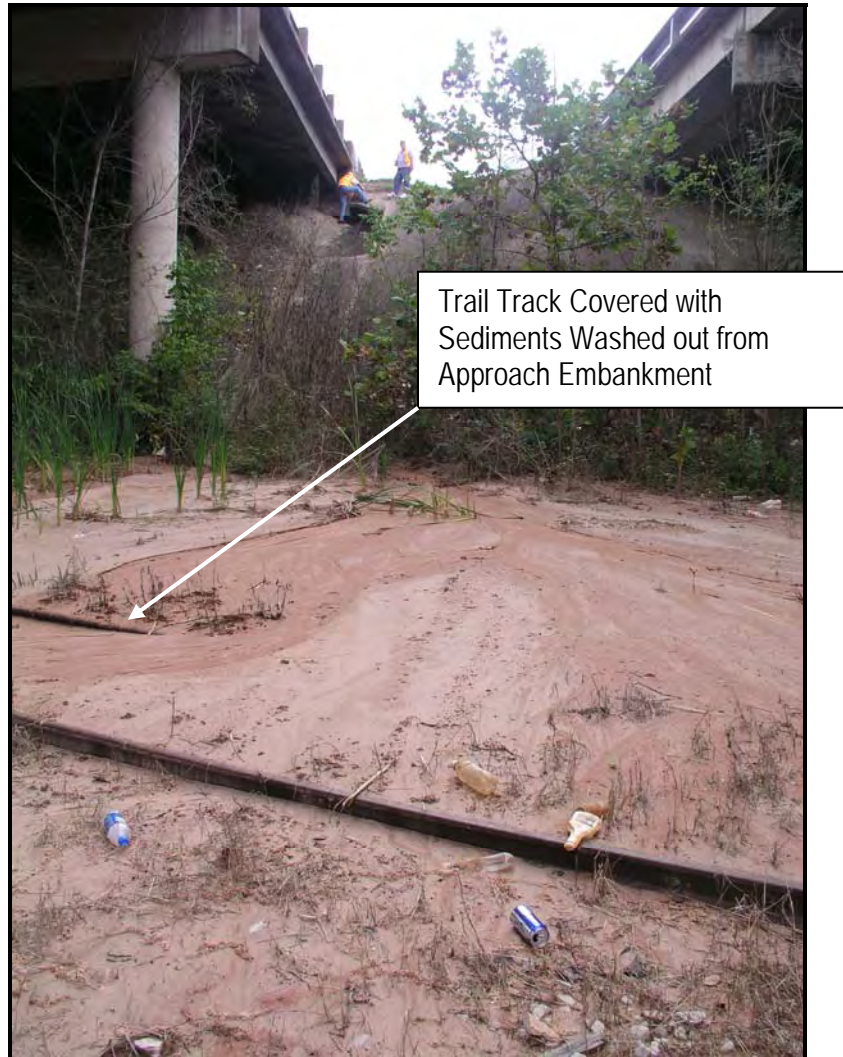
Trail Track Covered with
Sediments Washed out from
Approach Embankment

Figure 5.1 Extensive Erosion at Business 69 Overpass over Southern Pacific Railroad in Lufkin District

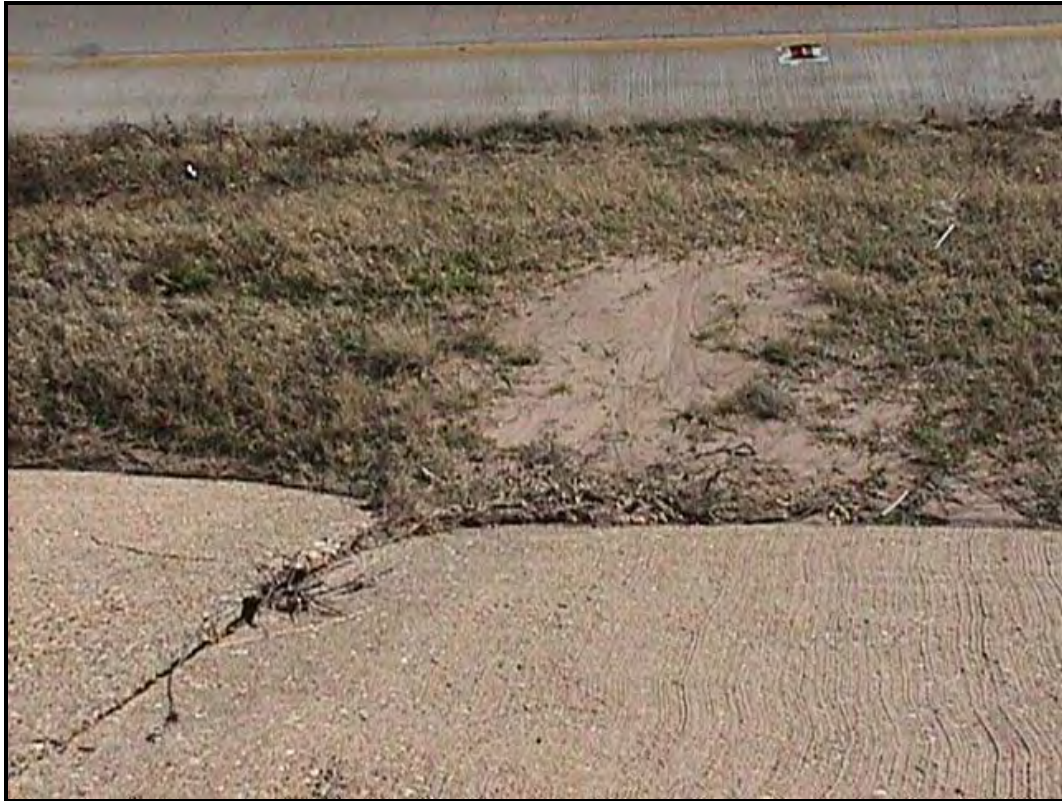
Figure 5.2 Signs of Embankment Fill Erosion at IH-27 Overpass over 4th Street in Lubbock District

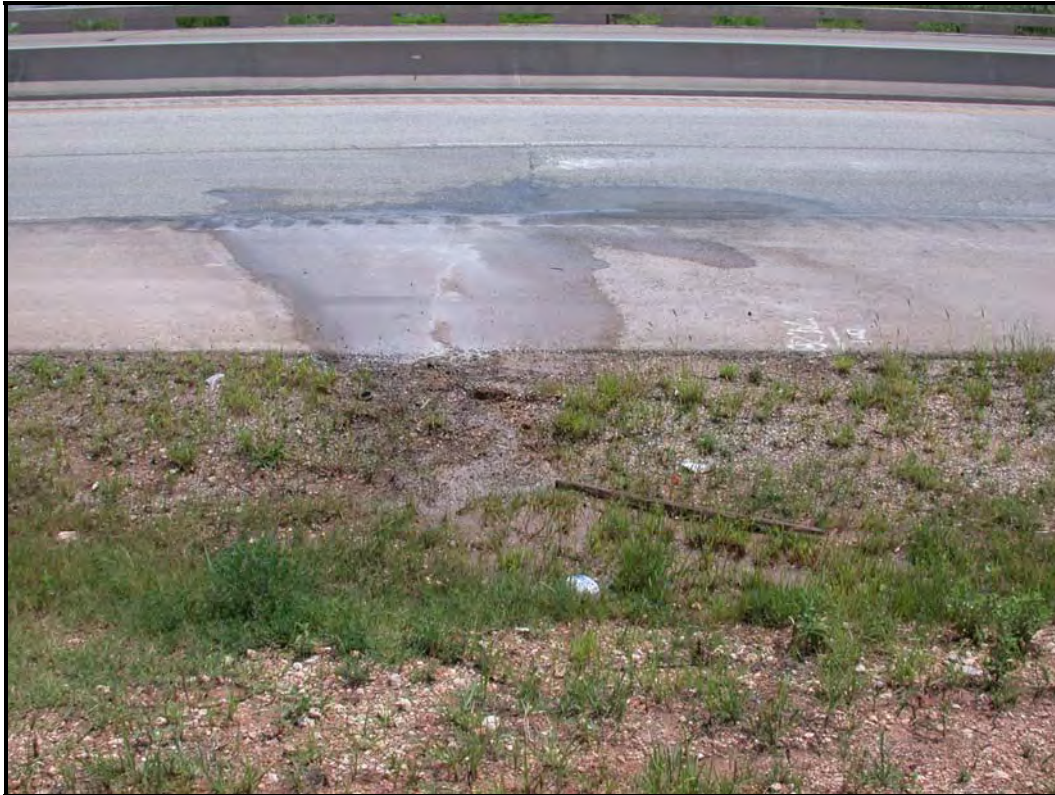
- c) *Evidence of Water Seepage:* Sometimes, water seepage can be seen although there are no signs of material loss accompanying it. Once again, this is a clear indication that there is a water intrusion problem that must be addressed during repair of the bridge approach. These conditions were found in the US-83 Overpass

Figure 5.3 Water Seepage at the US-83 Overpass Bridge Departure over Antilley Road in Abilene District

- A detailed design of a repair and installation of a under drain should be accomplished for the US 83 overpass of Antilley Road in Abilene. The under drain design should be similar to the detail provided by the Tyler district.

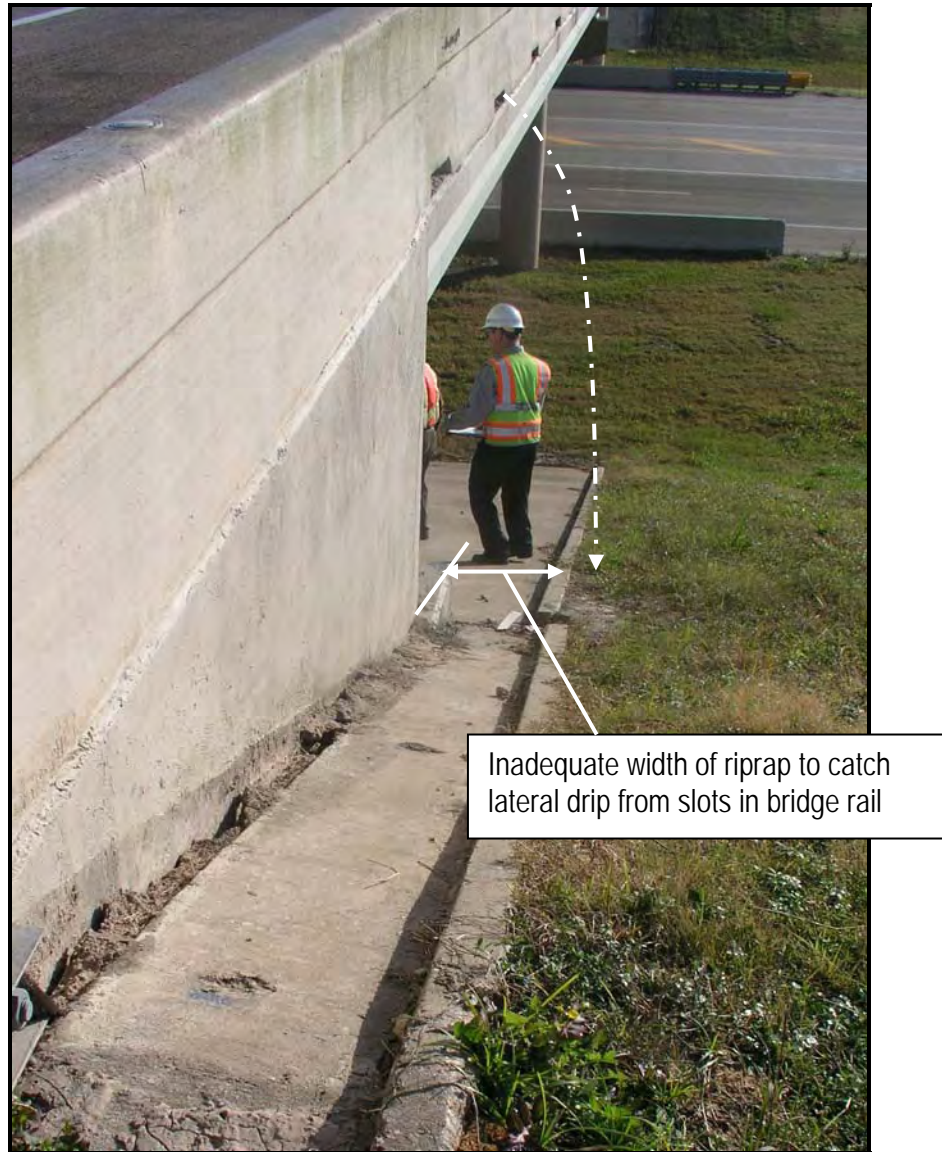
Figure 5.5 Inadequate Riprap Width (Houston District)

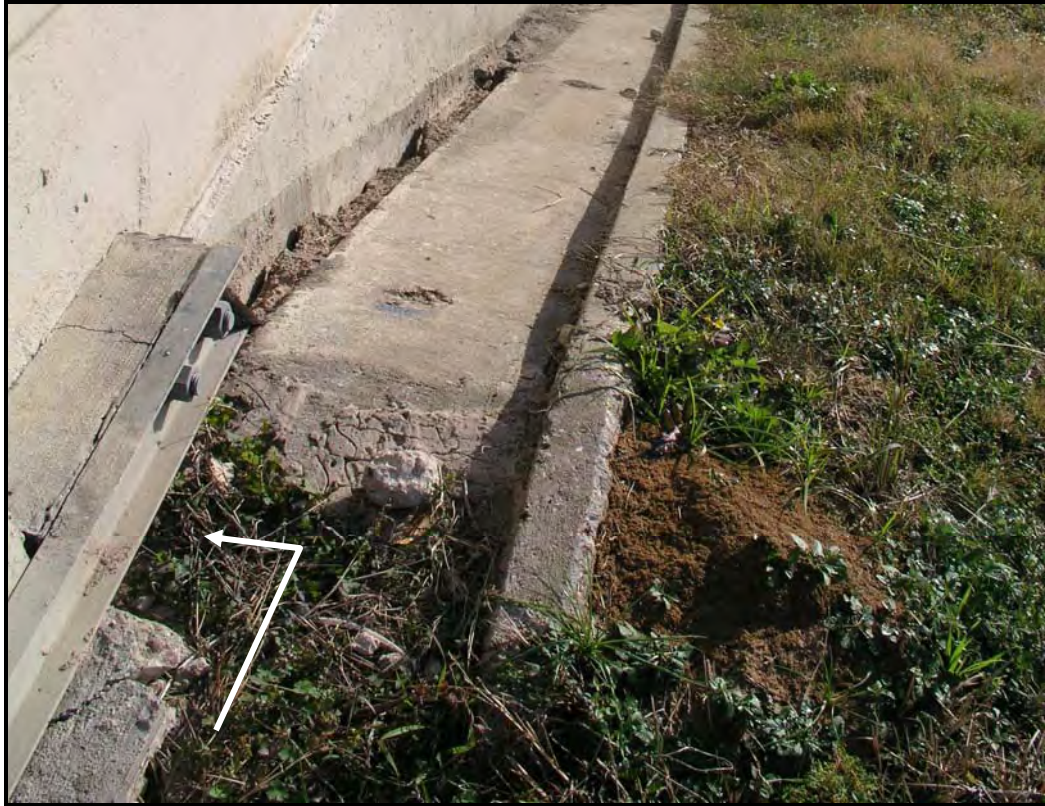
Figure 5.6 Badly Damaged Drainage Flume Allowing Water to Flow Underneath Approach Slab

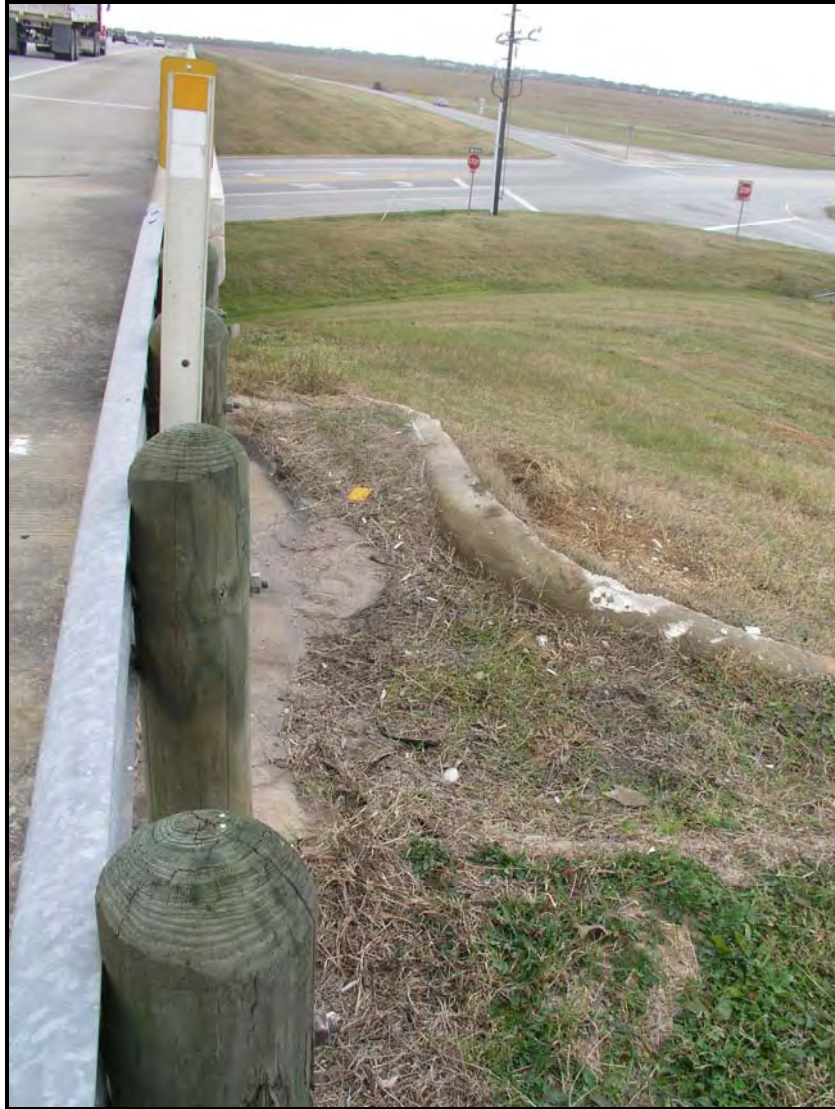
Figure 5.7 Effectiveness of Drainage Flume Impaired by Weeds and Debris Collection

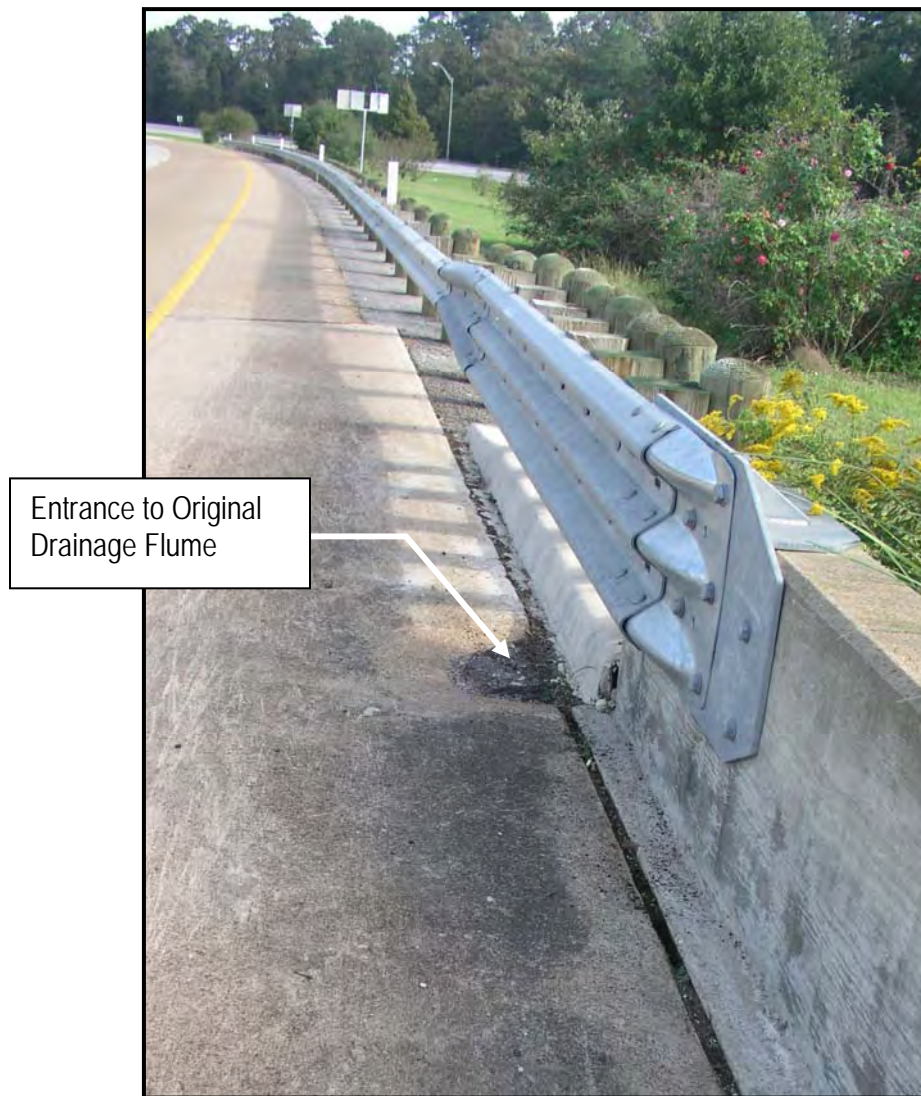
Figure 5.8 Entrance to Original Drainage Flume Blocked by the Installation of the Monocurb in the New Thrie Beam Guardrail System

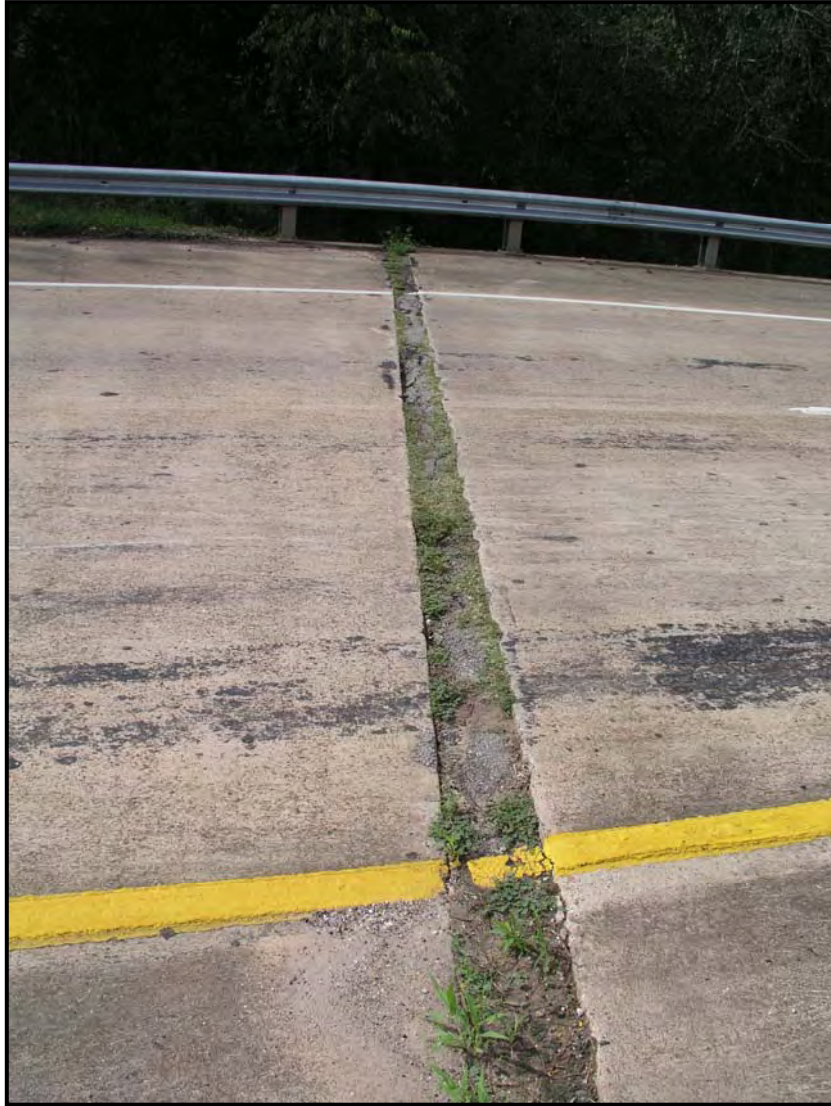
Figure 5.9 Poorly Maintained 5-inch Wide Joint between Bridge Deck and Approach Slab

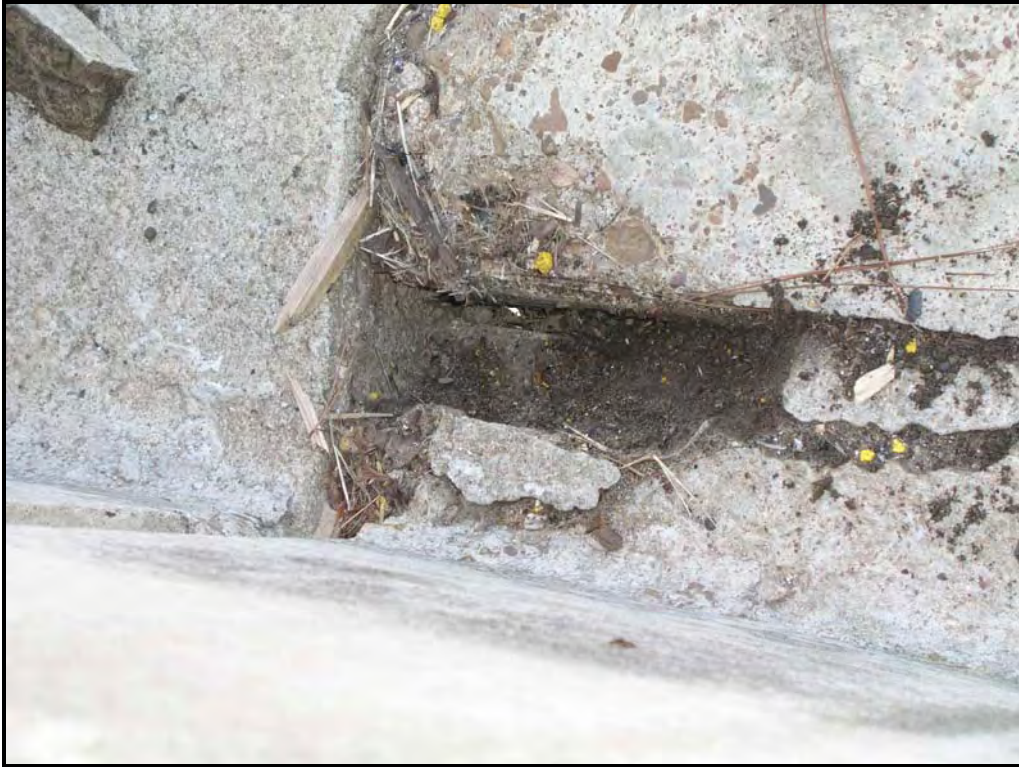
Figure 5.10 An Access Point for Intrusion of Bridge Surface Water Runoff

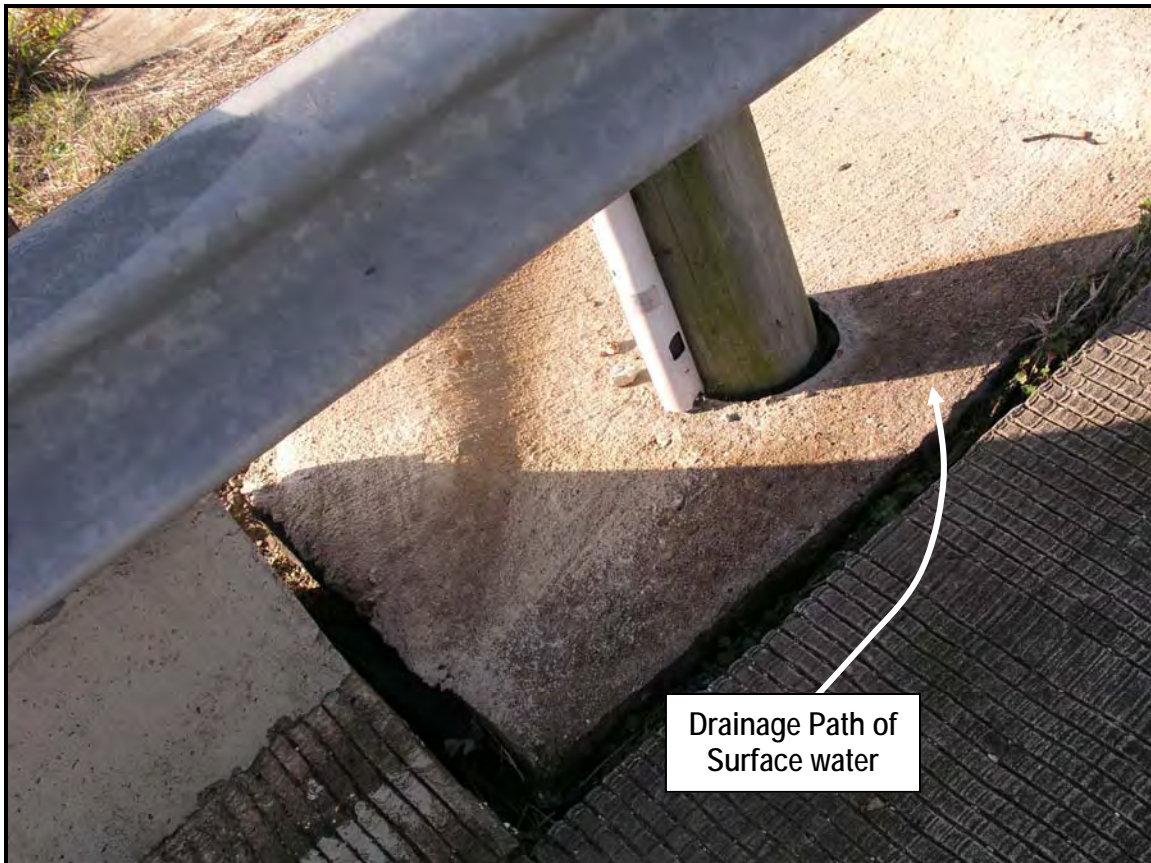
Figure 5.11 Open Joint between Approach Slab and Mow Strip
