Reasons for Drivers Failing To Yield at Multi-Lane Roundabout Exits: Transportation Pooled Fund Study Final Report

PUBLICATION NO. FHWA-HRT-23-023

MARCH 2023

U.S. Department of Transportation
Federal Highway Administration

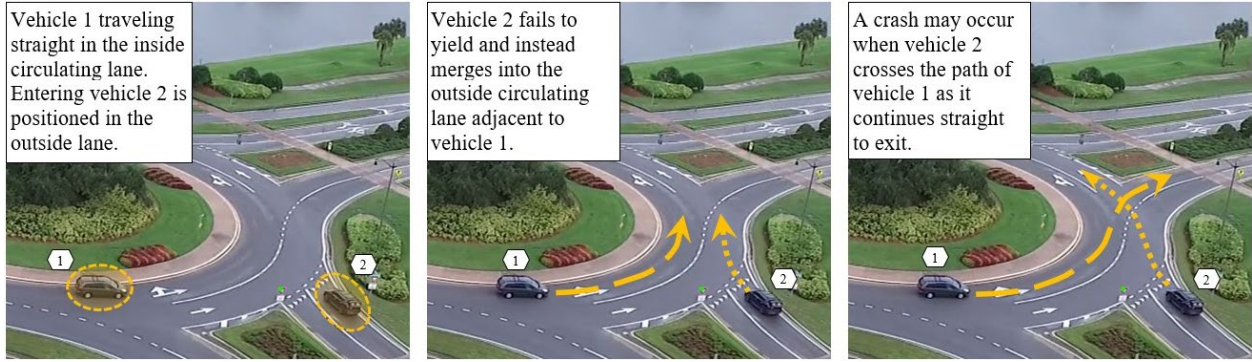
- Failure of entering vehicles to yield to vehicles in both circulating lanes (figure 3).
- Left-turn movement from the incorrect outside lane (figure 4).
- Right-turn movement from the incorrect inside lane (figure 5).

Figure 3. Photo. Entering vehicle failing to yield to both lanes.
