## **Durability Assessment of Externally Bonded Fiber-Reinforced Polymer (FRP) Composite Repairs in Bridges**

**November 30, 2022**

**Ajay Baniya, Sandra Milev, Rachel Henry, Jovan Tatar  
University of Delaware**

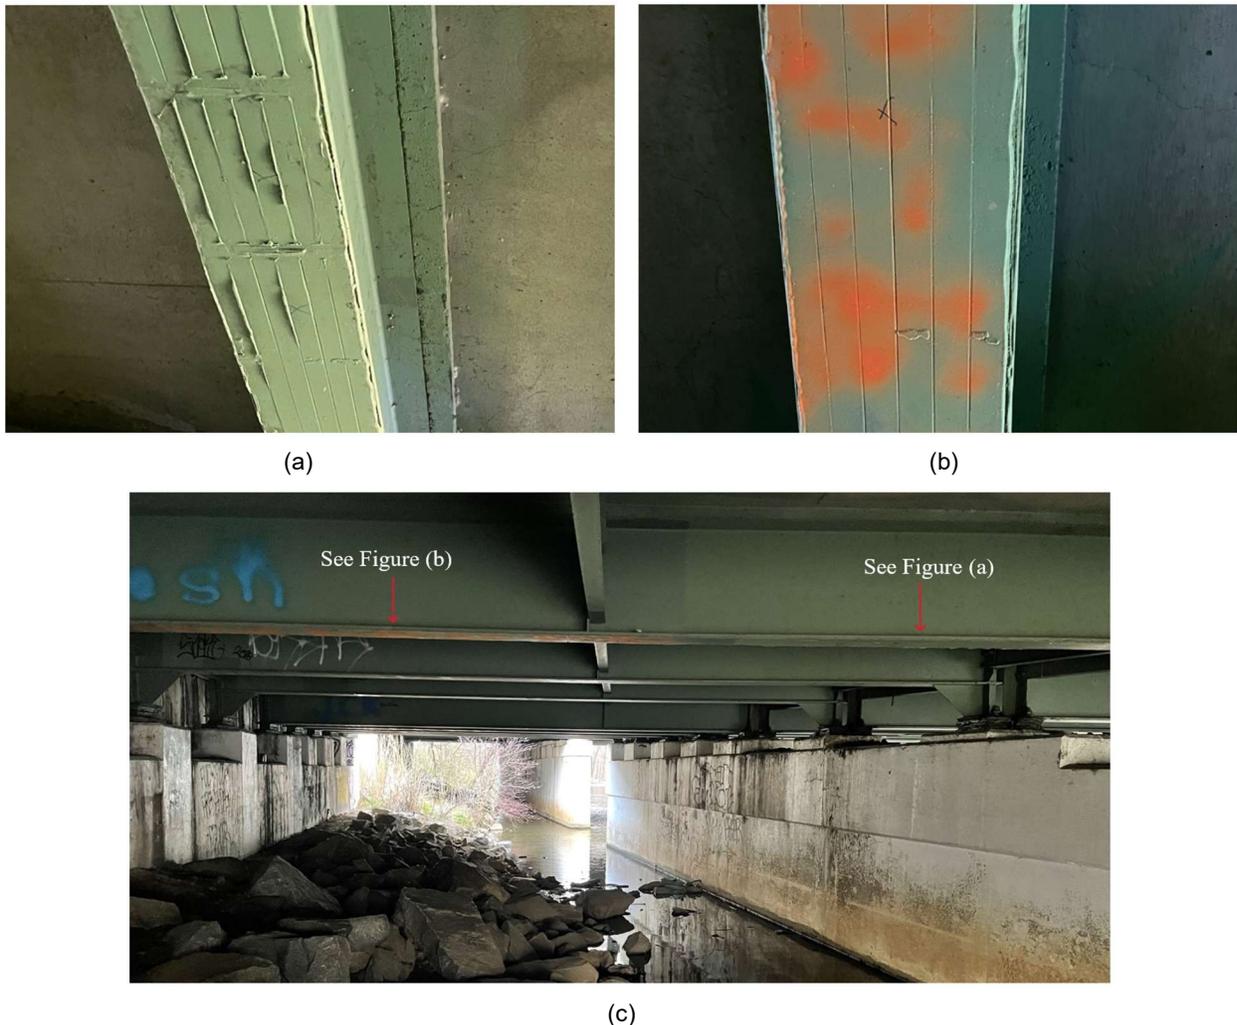
**Figure 75. Condition of CFRP composite girder repaired in 2000.**

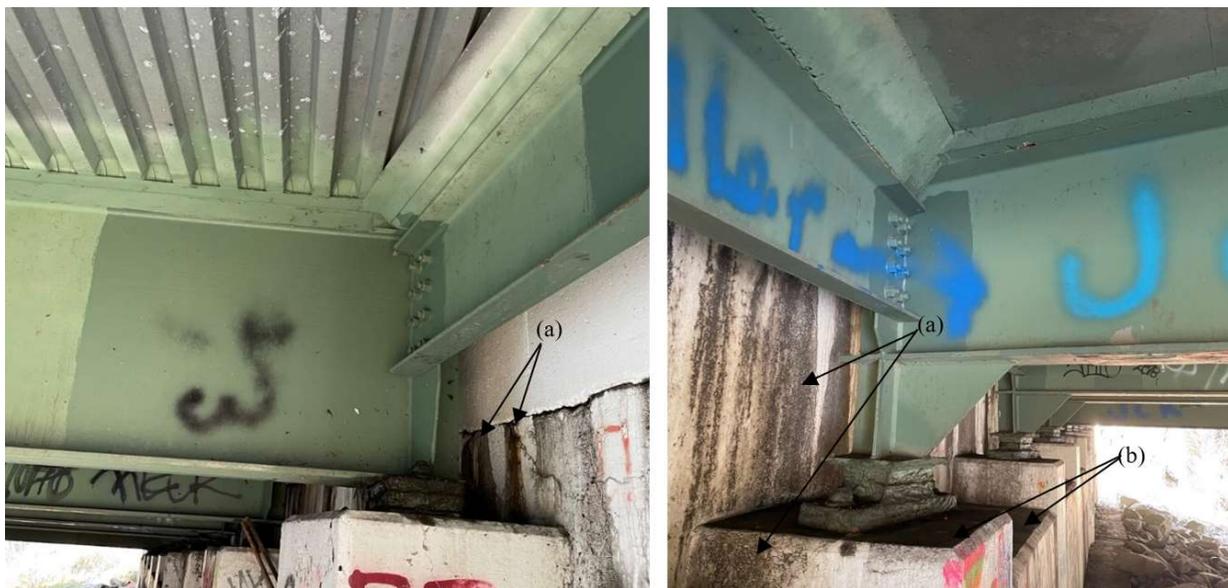
Notes: (a) Stains visible on the concrete retaining wall and abutment; (b) fine sediment aggregates visible on top of concrete abutment.

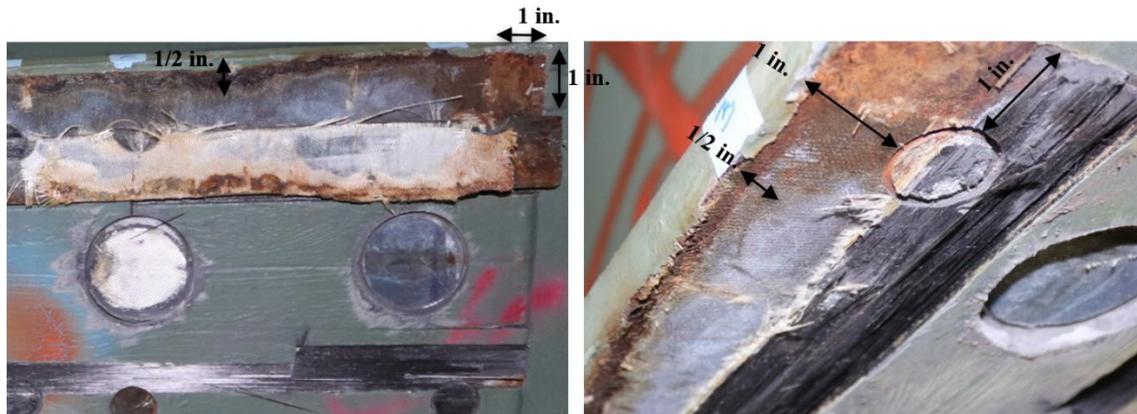
**Figure 88. Presence of rust on the northern end of the girder, located 4–10 ft. away from the centerline of abutment 2 (shown in Figure 55).**

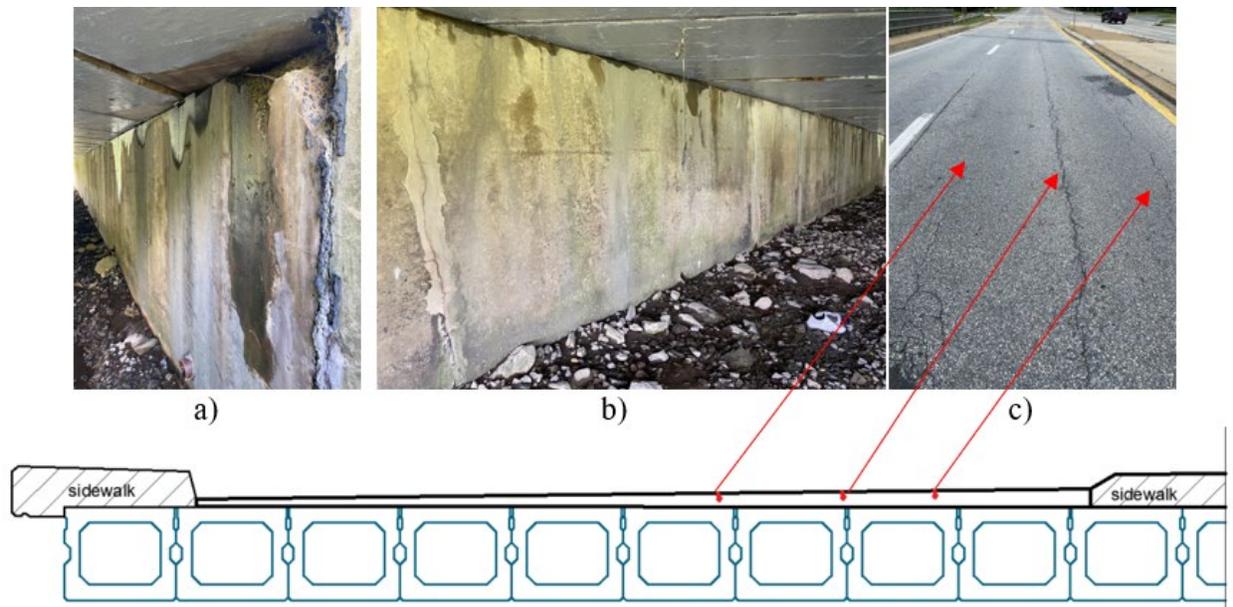
**Figure 95. (a) Spalling of the south abutment wall, (b) vertical cracks in the abutment wall, and (c) reflective cracking of the asphalt pavement.**

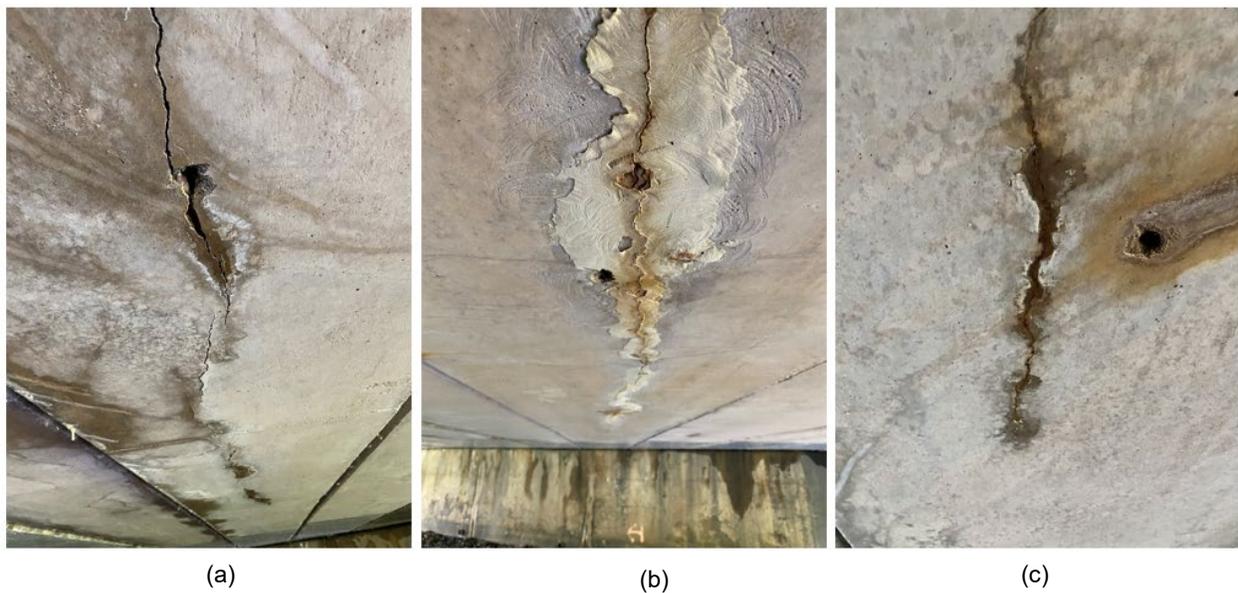
**Figure 96. Longitudinal cracks in G7, G15, and G17.**

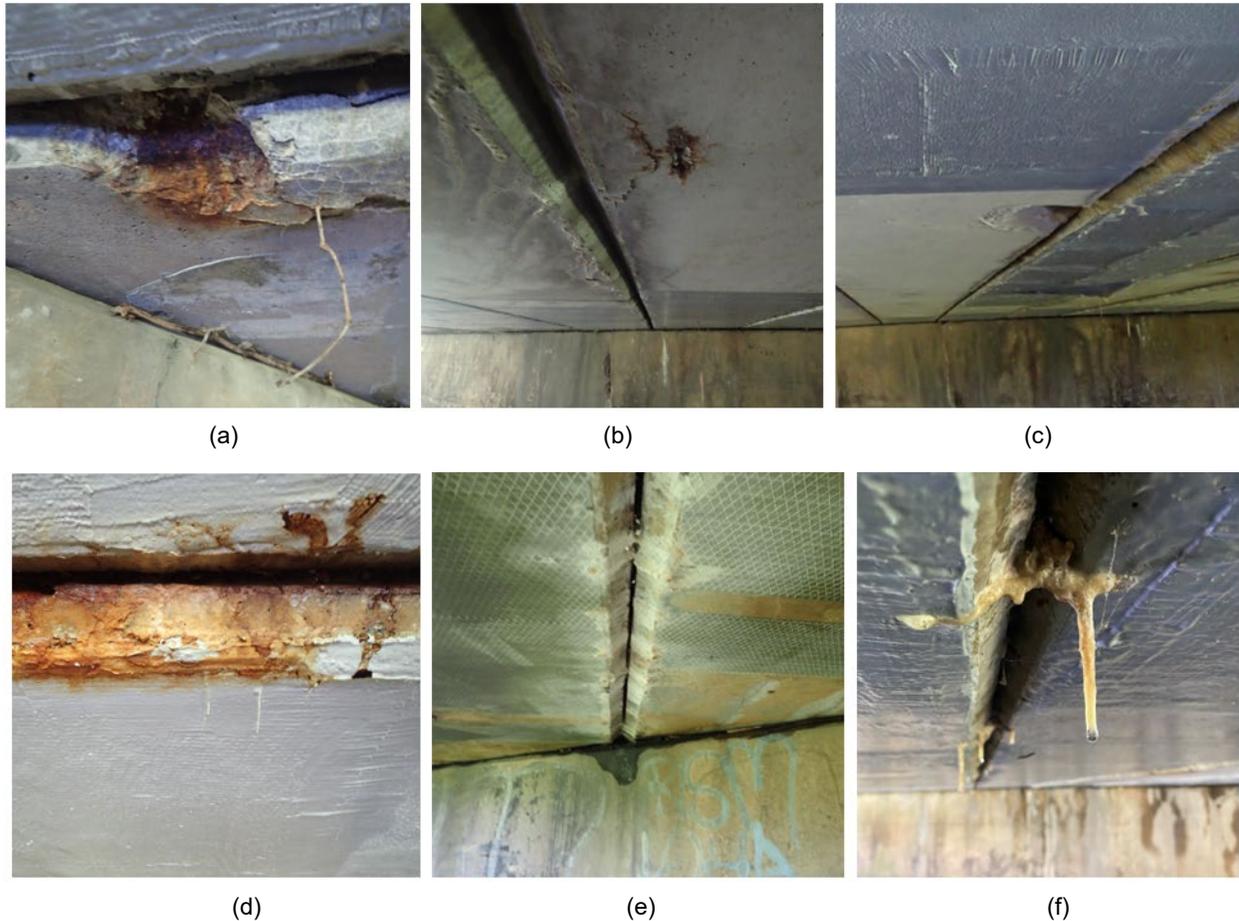
**Figure 97. Examples of damaged girders and condition of joints: (a,b,c) concrete spalling, (d) motor oil in the joint, and (e,f) efflorescence.**

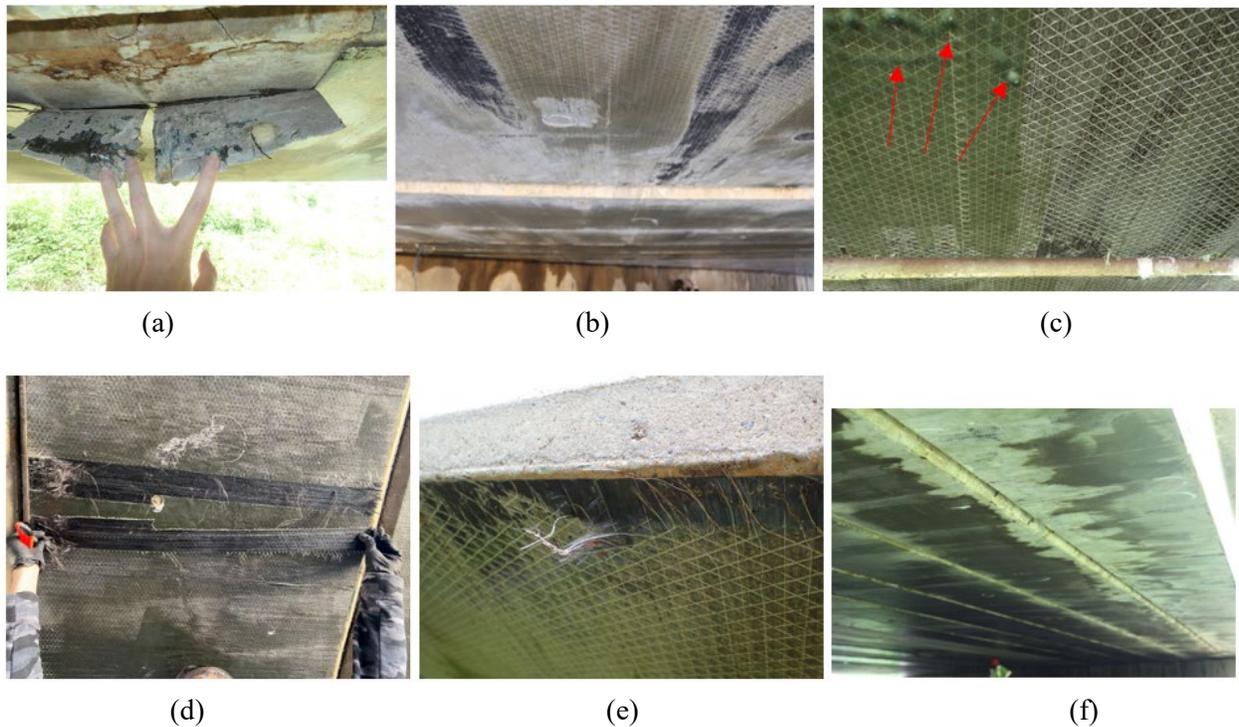
**Figure 98. Examples of damage of unidirectional CFRP: (a) end peeling, (b) insufficient saturation, (c) blistering, (d) delamination, (e) frayed fiber, and (f) water stains.**

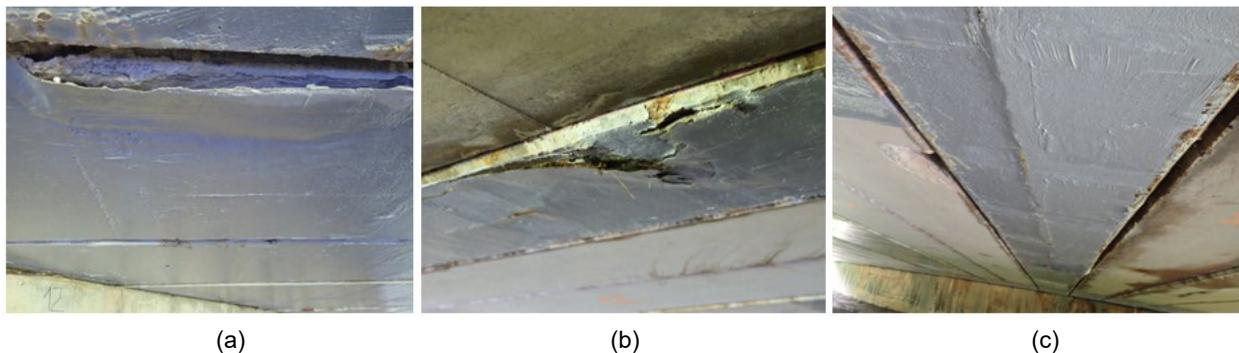
**Figure 99. Examples of damage of bidirectional CFRP: (a,b) spalling/CFRP tearing, and (c) bulging below the CFRP indicates the presence of a longitudinal crack.**

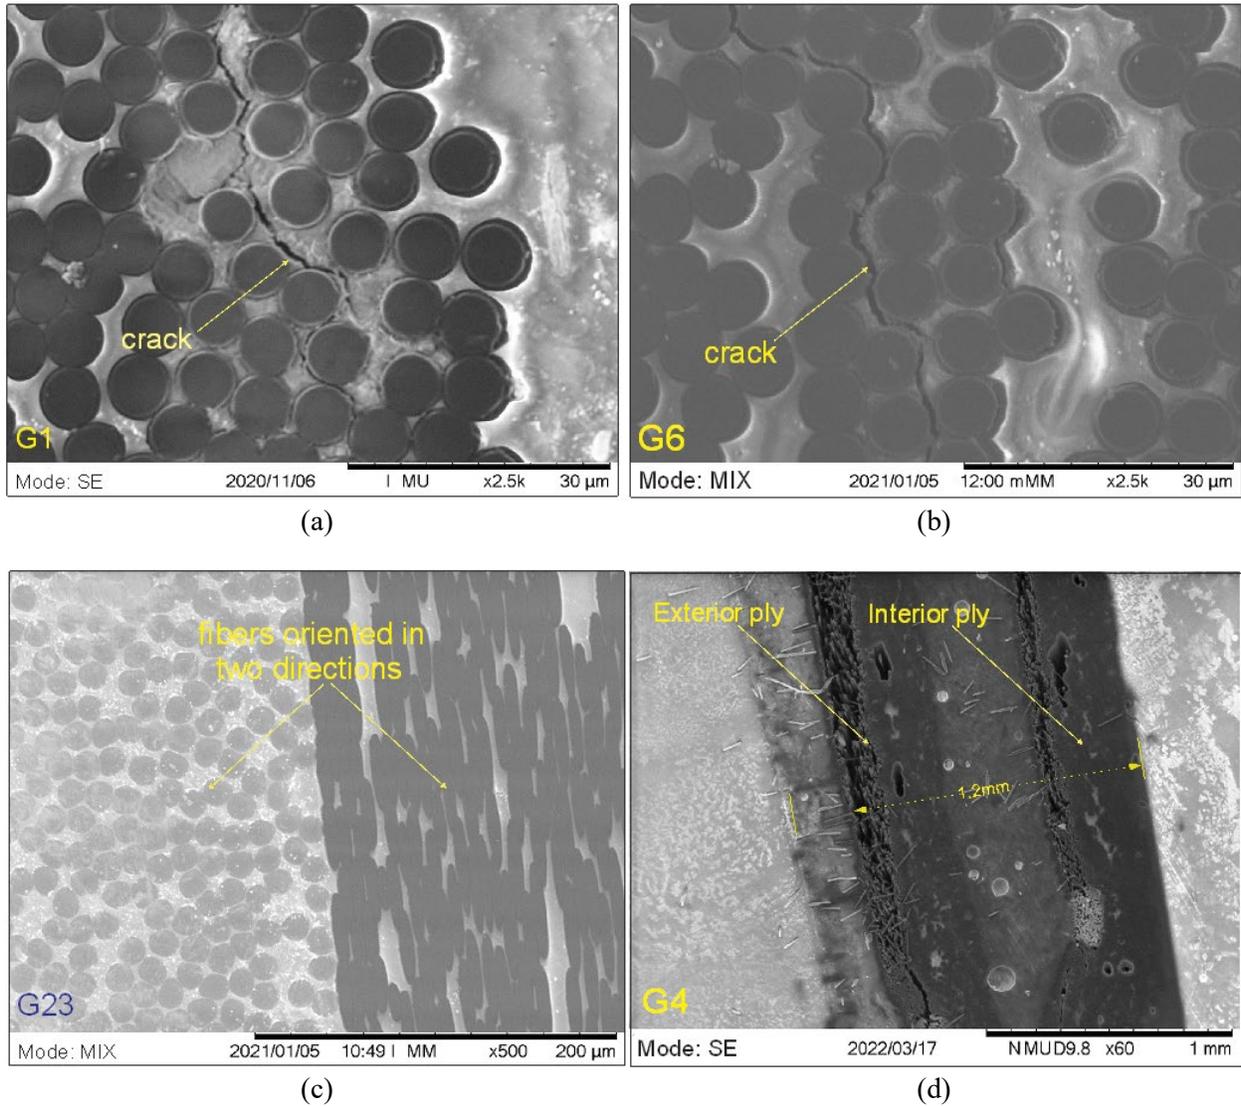
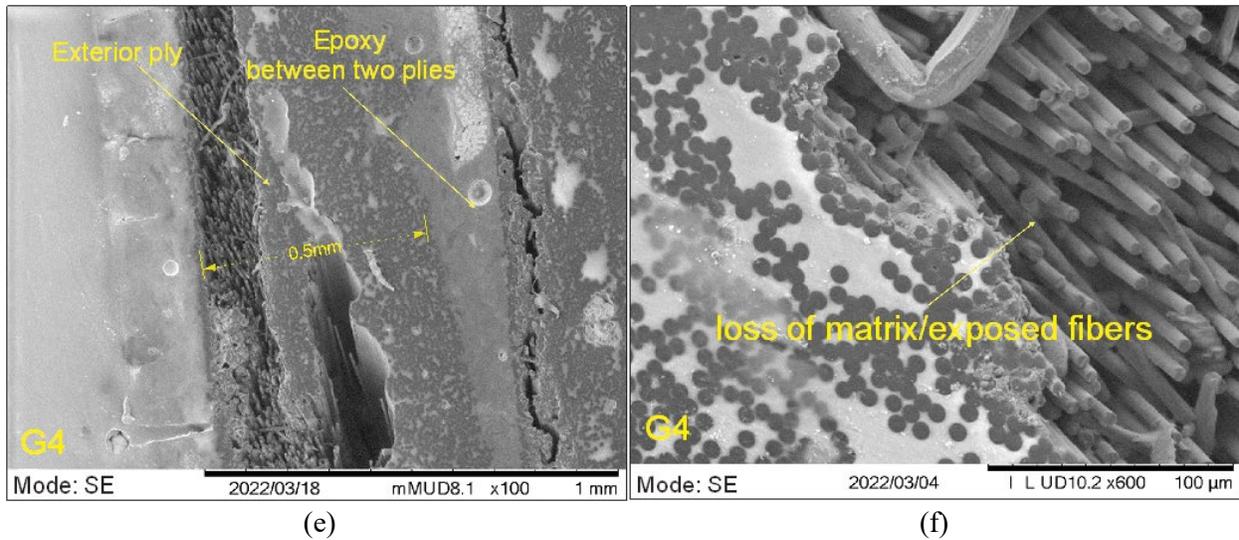
**Figure 104. SEM images of CFRP: (a) cracking at the fiber/matrix interface in G1, (b) cracking in the region of closely spaced fibers in G6, (c) bidirectional CFRP, (d,e) cracking and loss of matrix two-ply CFRP on G4, and (f) high magnification image showing exposed fibers in G4.**

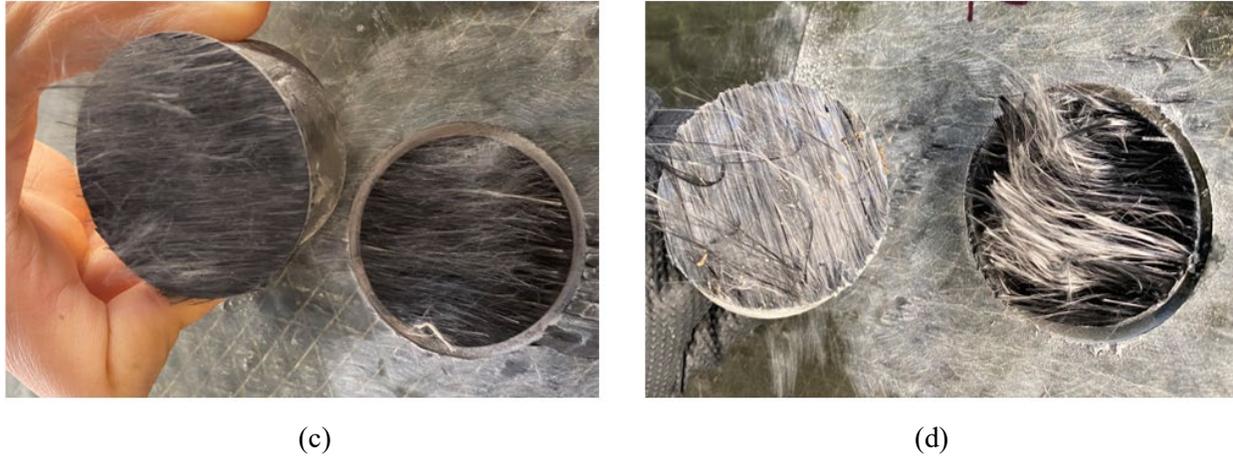
**Figure 107. Two failure modes observed: (a) mode B on G1-U1, (b) mode E on G23-B1, (c) mode B on G4-UD1, and (d) mode B on G4-UD2.**
