Performance Evaluation of Recent Improvements of Bridge Abutments and Approach Backfill

Sponsored by:
The Iowa Highway Research Board
TR-736

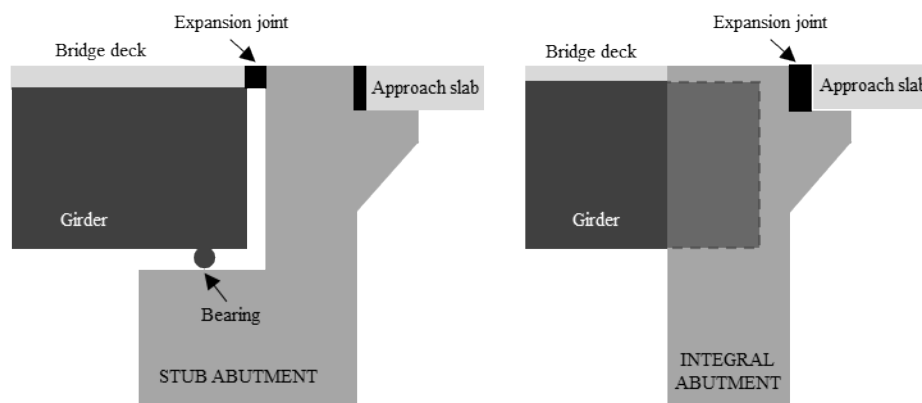
Figure 2.1. Schematics of a stub abutment (left) and an integral abutment (right).

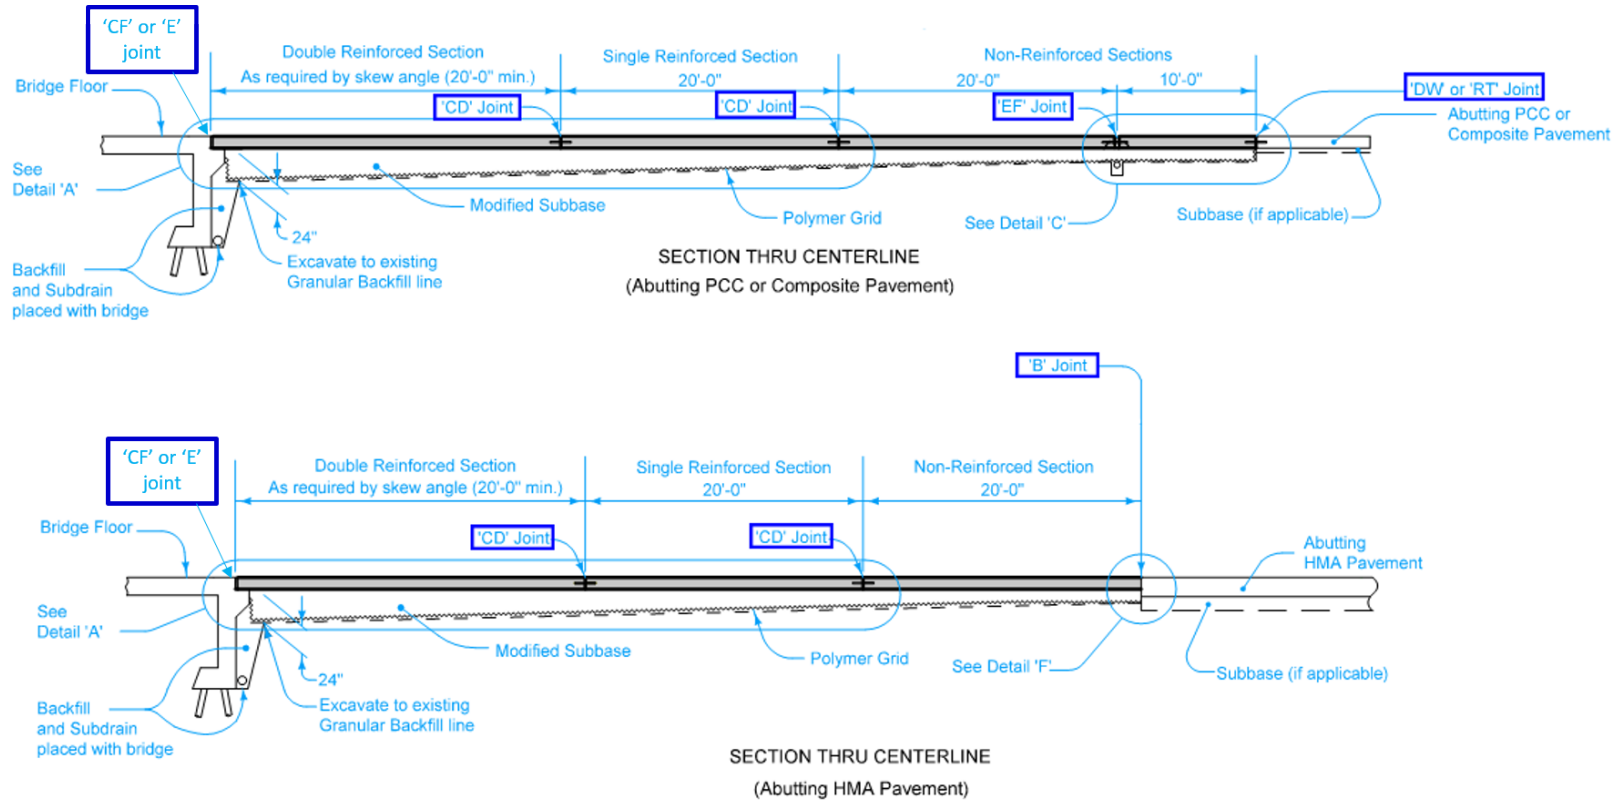
Figure 3.3. Section views of the approach slabs from the Iowa DOT standard (IowaDOT Standard Road Plans).

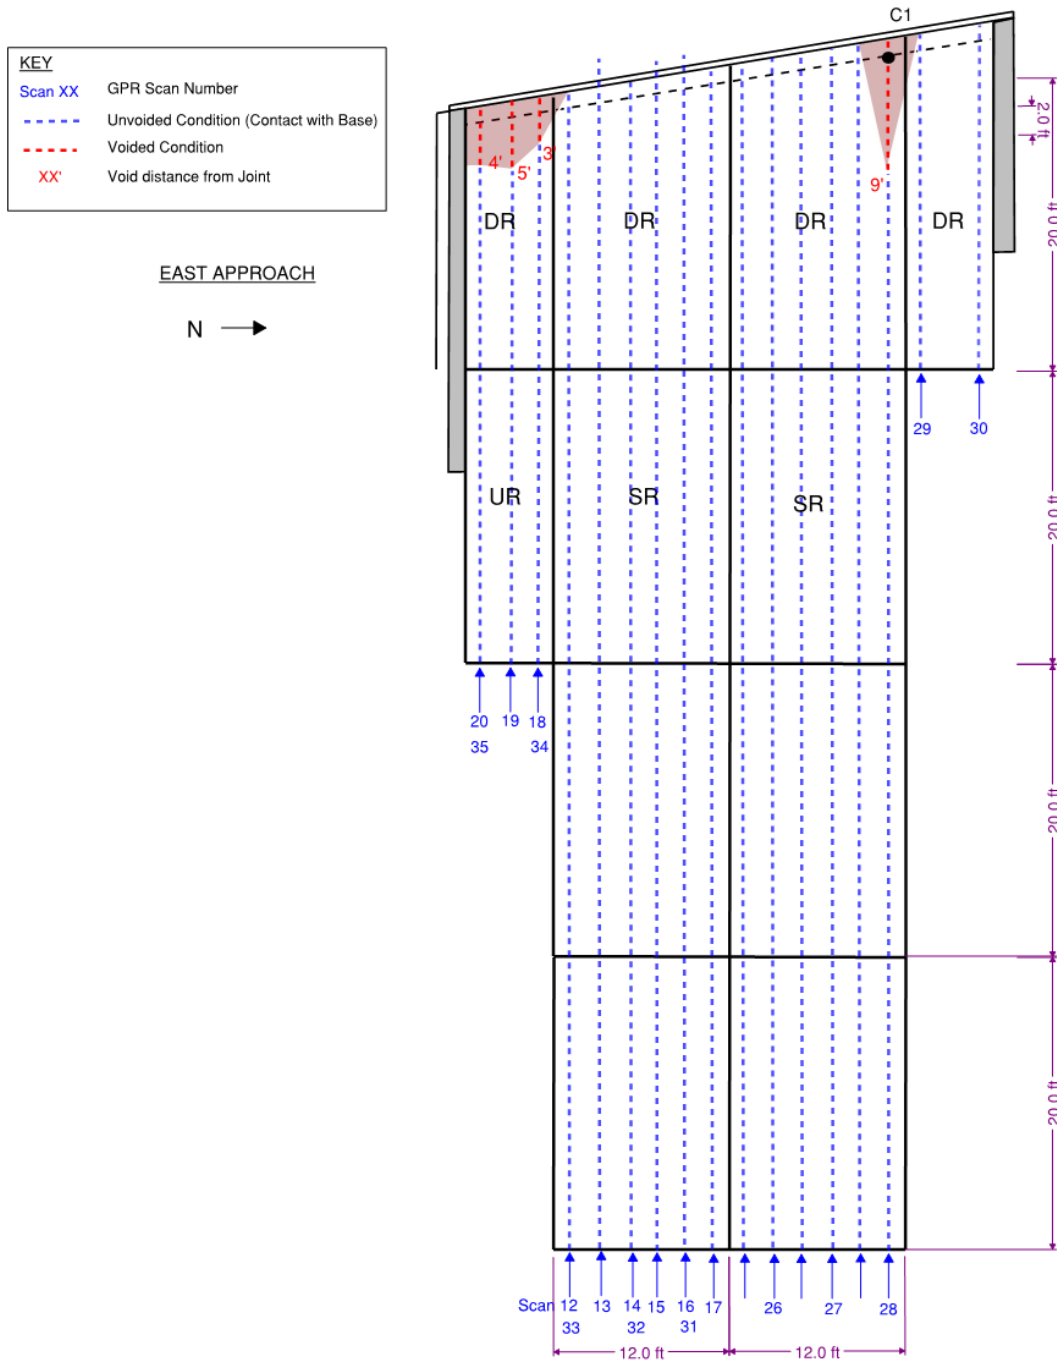
Figure 3.10. GPR results and core location at east approach of Bridge 5111.50034.

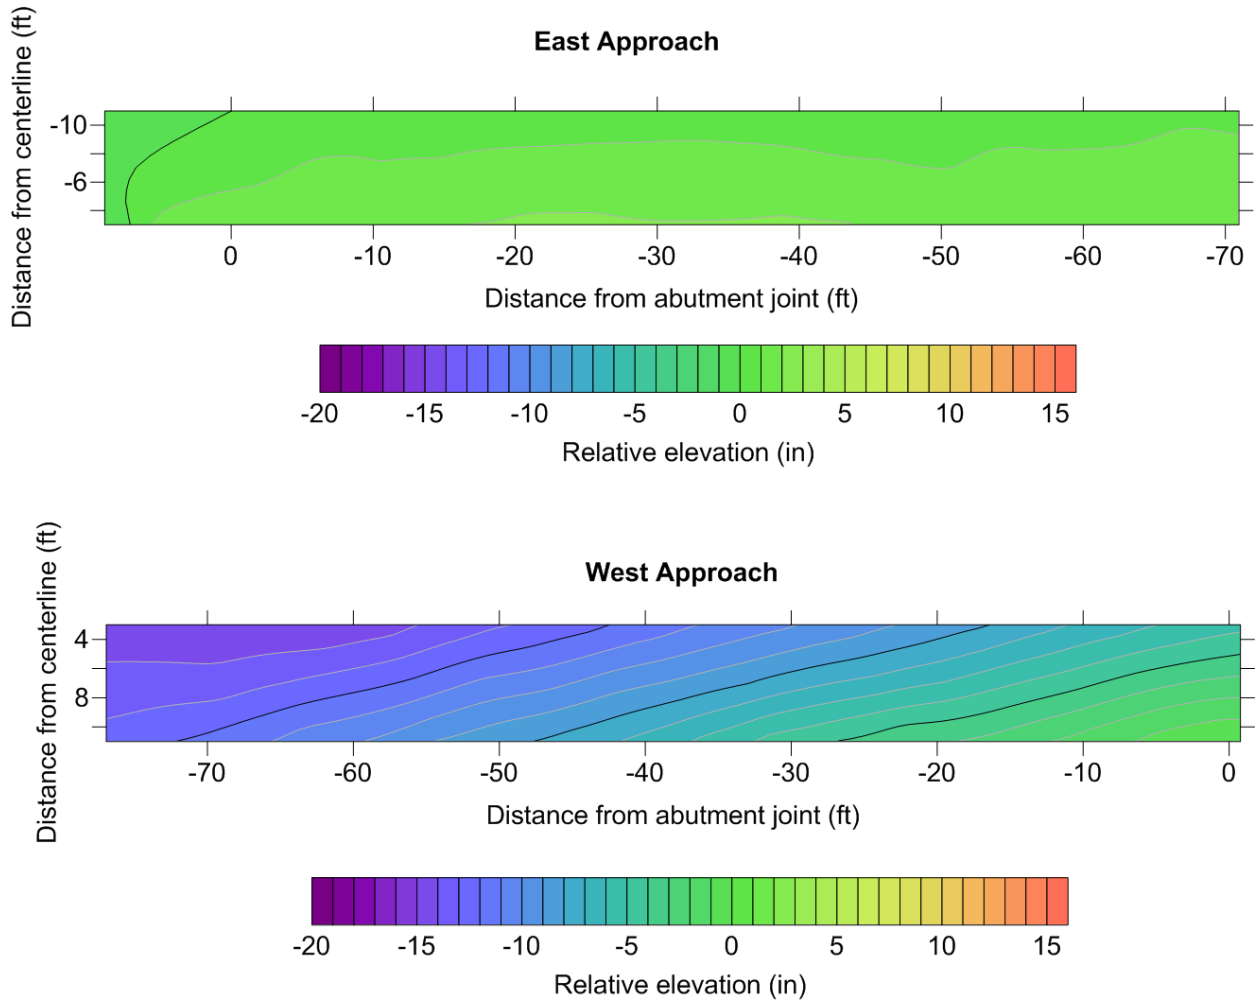
Figure 3.13. Contour maps of the elevations of the approaches of Bridge 5111.5O034.

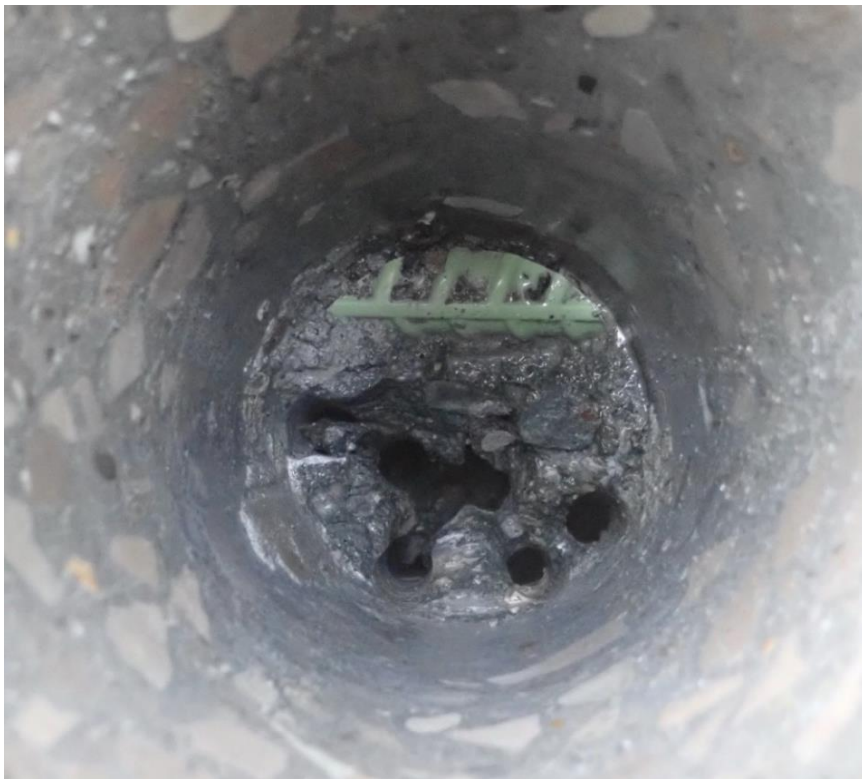
Figure 3.19. Epoxy-coated rebar and voids found under Core 2 of Bridge 5126.5S078.

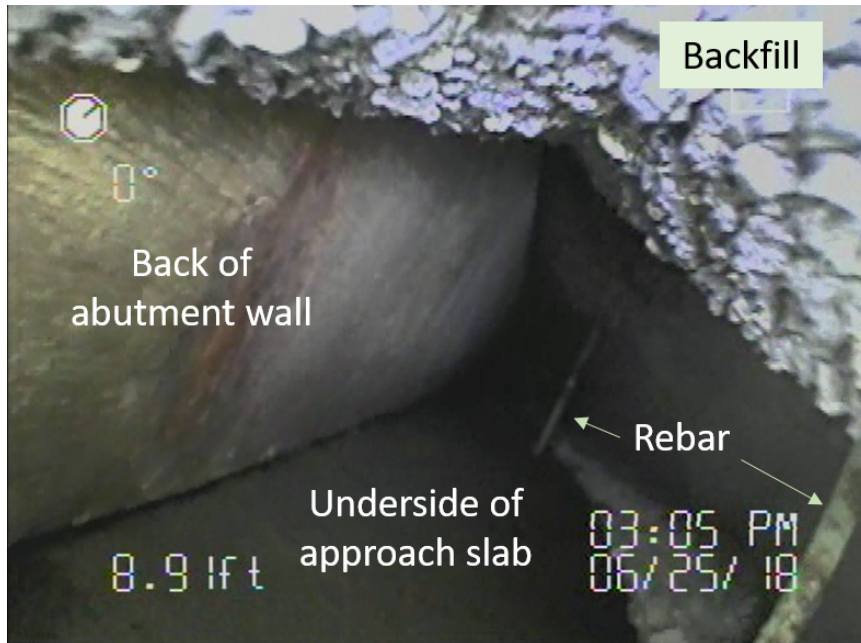
Figure 3.20. View of void beneath east approach slab of Bridge 5126.5S078 from borescope.

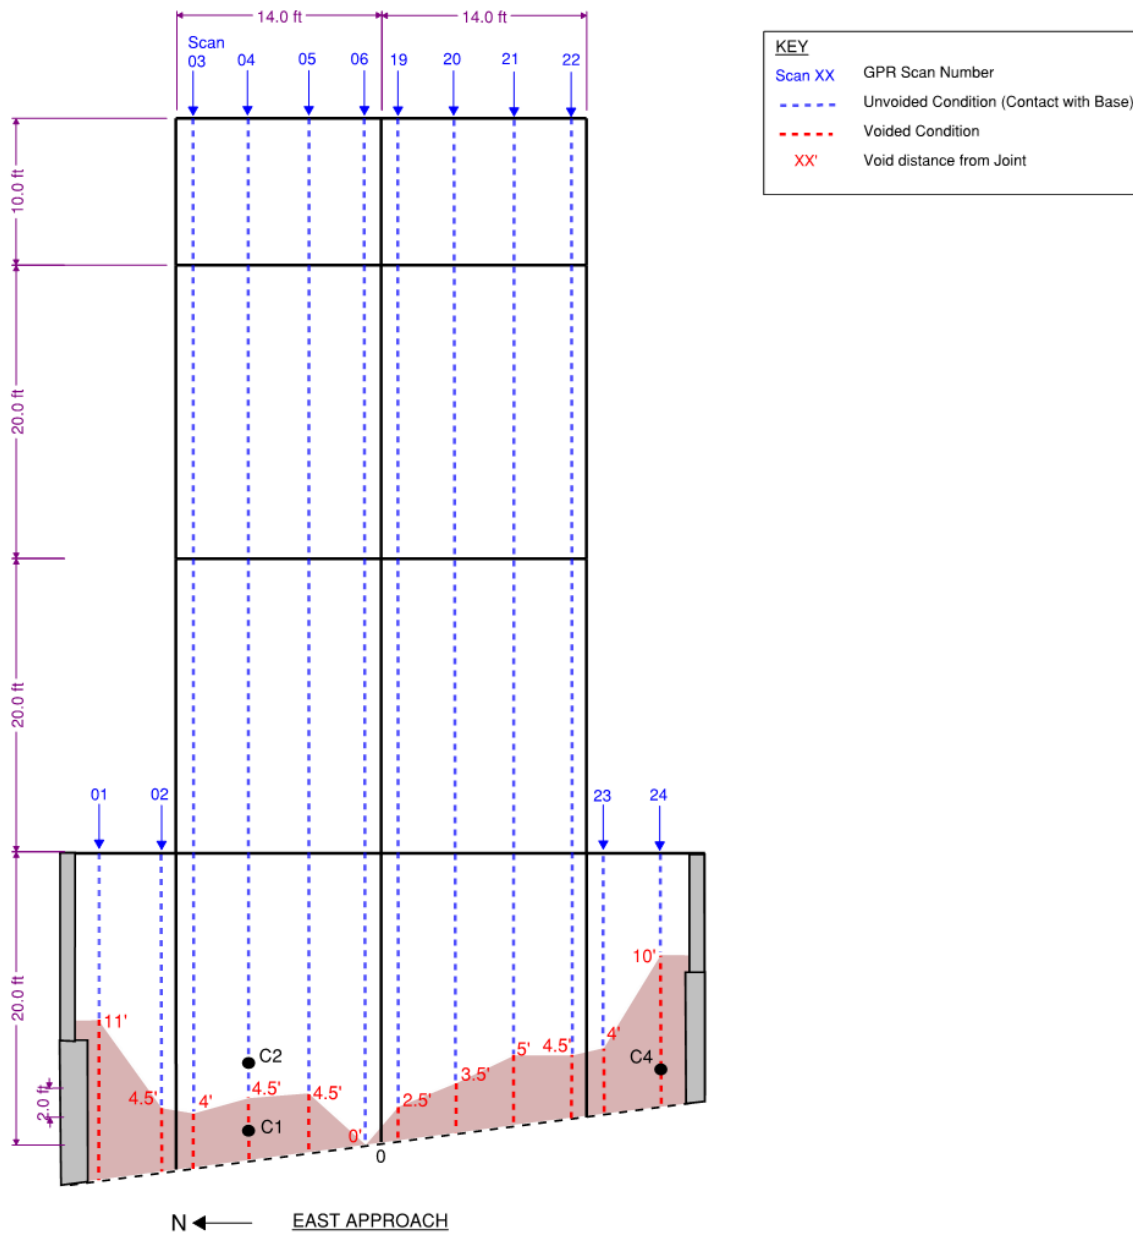
Figure 3.25. GPR results and core locations at east approach of Bridge 5622.50061.

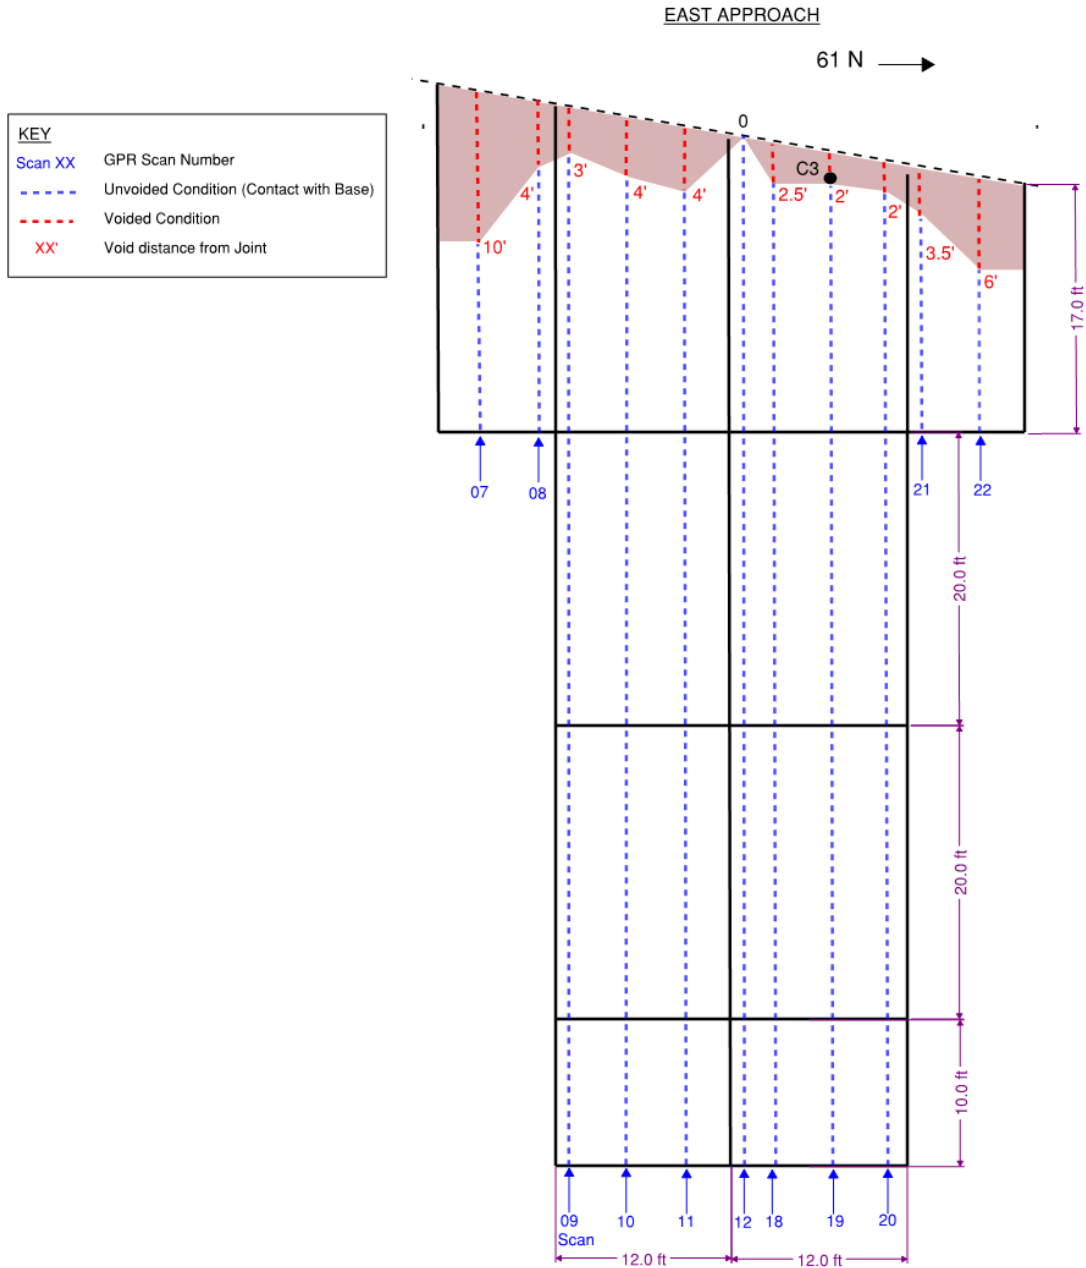
Figure 3.35. GPR results and core locations for east approach of Bridge 5624.20061.

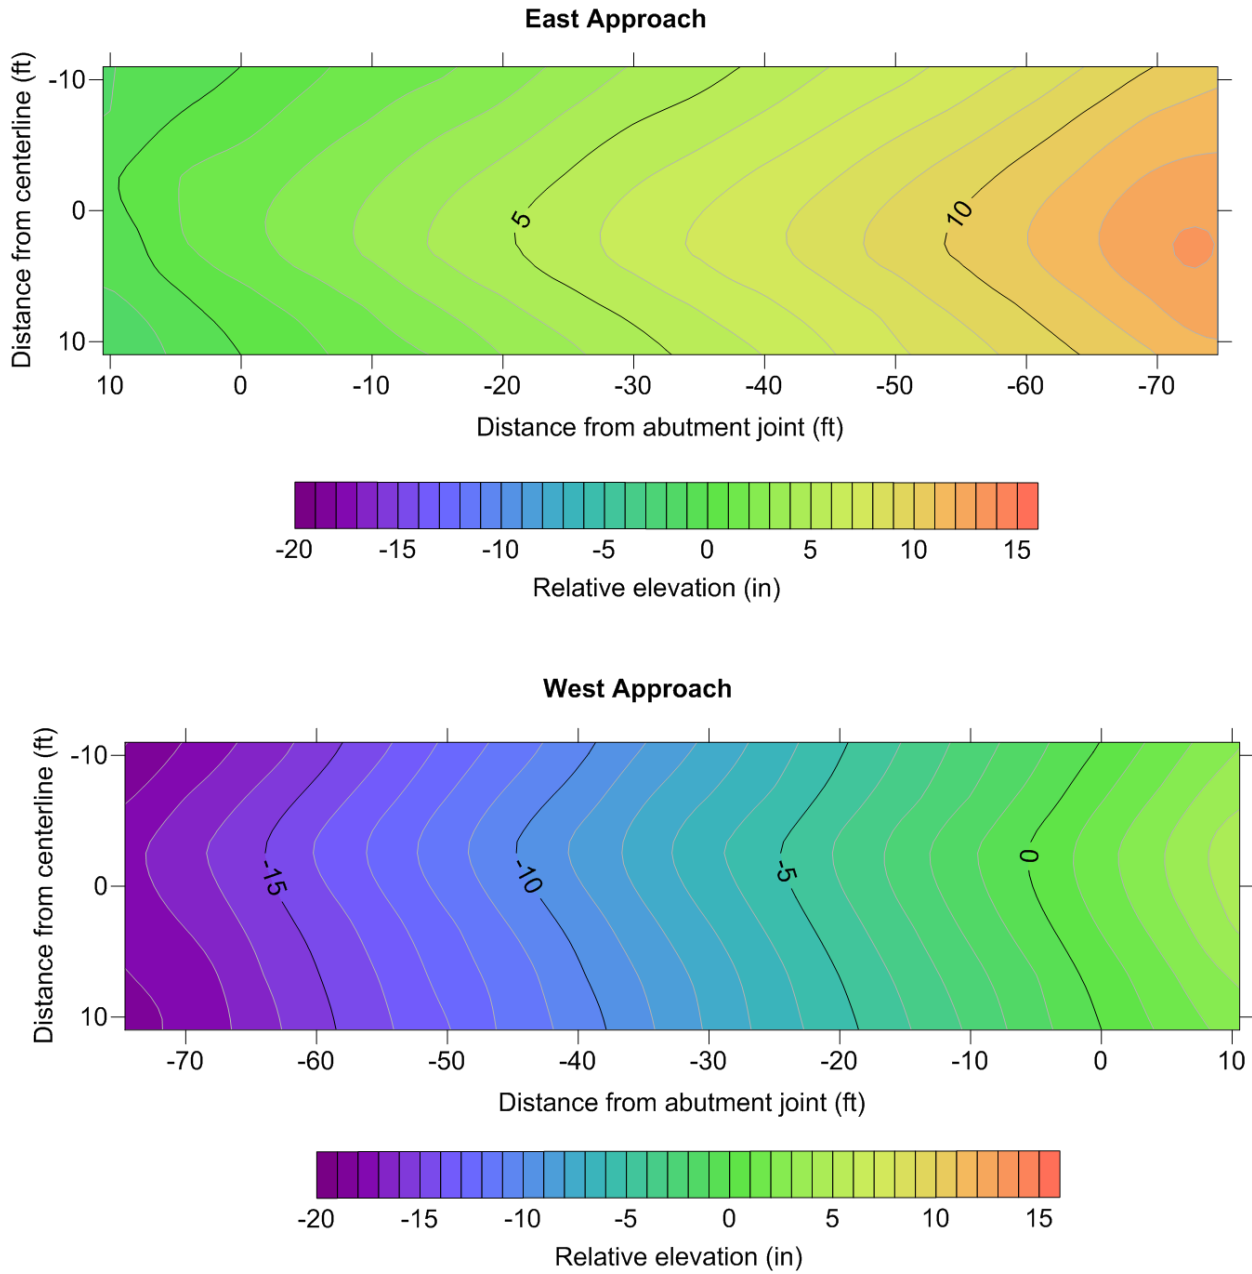
Figure 3.41. Contour maps of the elevations of the approaches to Bridge 5624.20061.

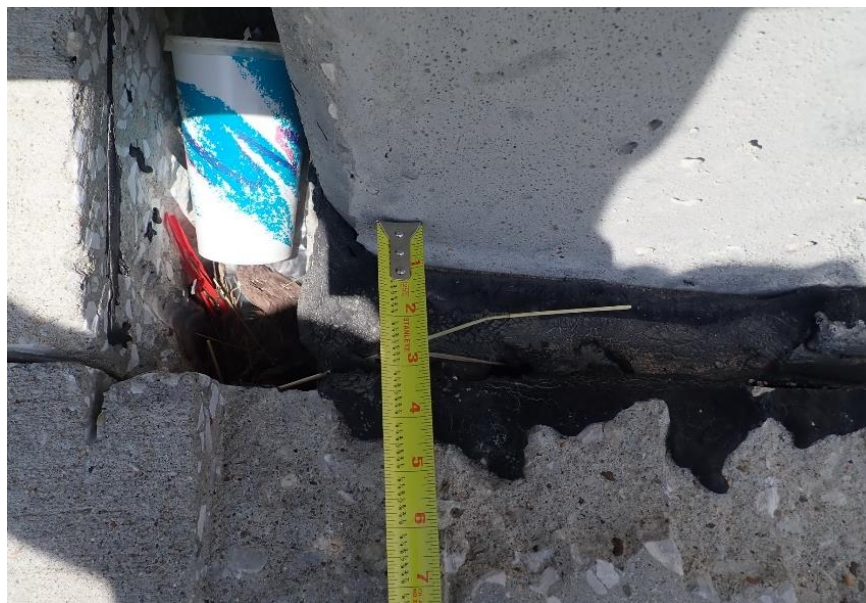
Figure 3.49. Debris in gap between shoulder and north barrier at west approach of Bridge 5622.50061.

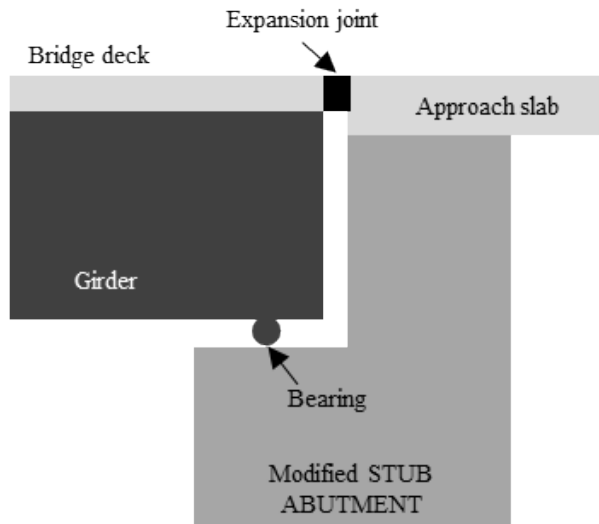
Figure 4.1. Schematic of the proposed detail for ‘modified stub abutment’.
