Improving Transportation Infrastructure Resilience against Hurricanes, other Natural Disasters, and Weathering: Part I - Analysis of failure of transportation signs due to Hurricane Maria

FINAL REPORT
June 2022

Transportation Infrastructure Research Center – TIRC
Polytechnic University of Puerto Rico
377 Ponce de Leon Ave, San Juan, PR 00918

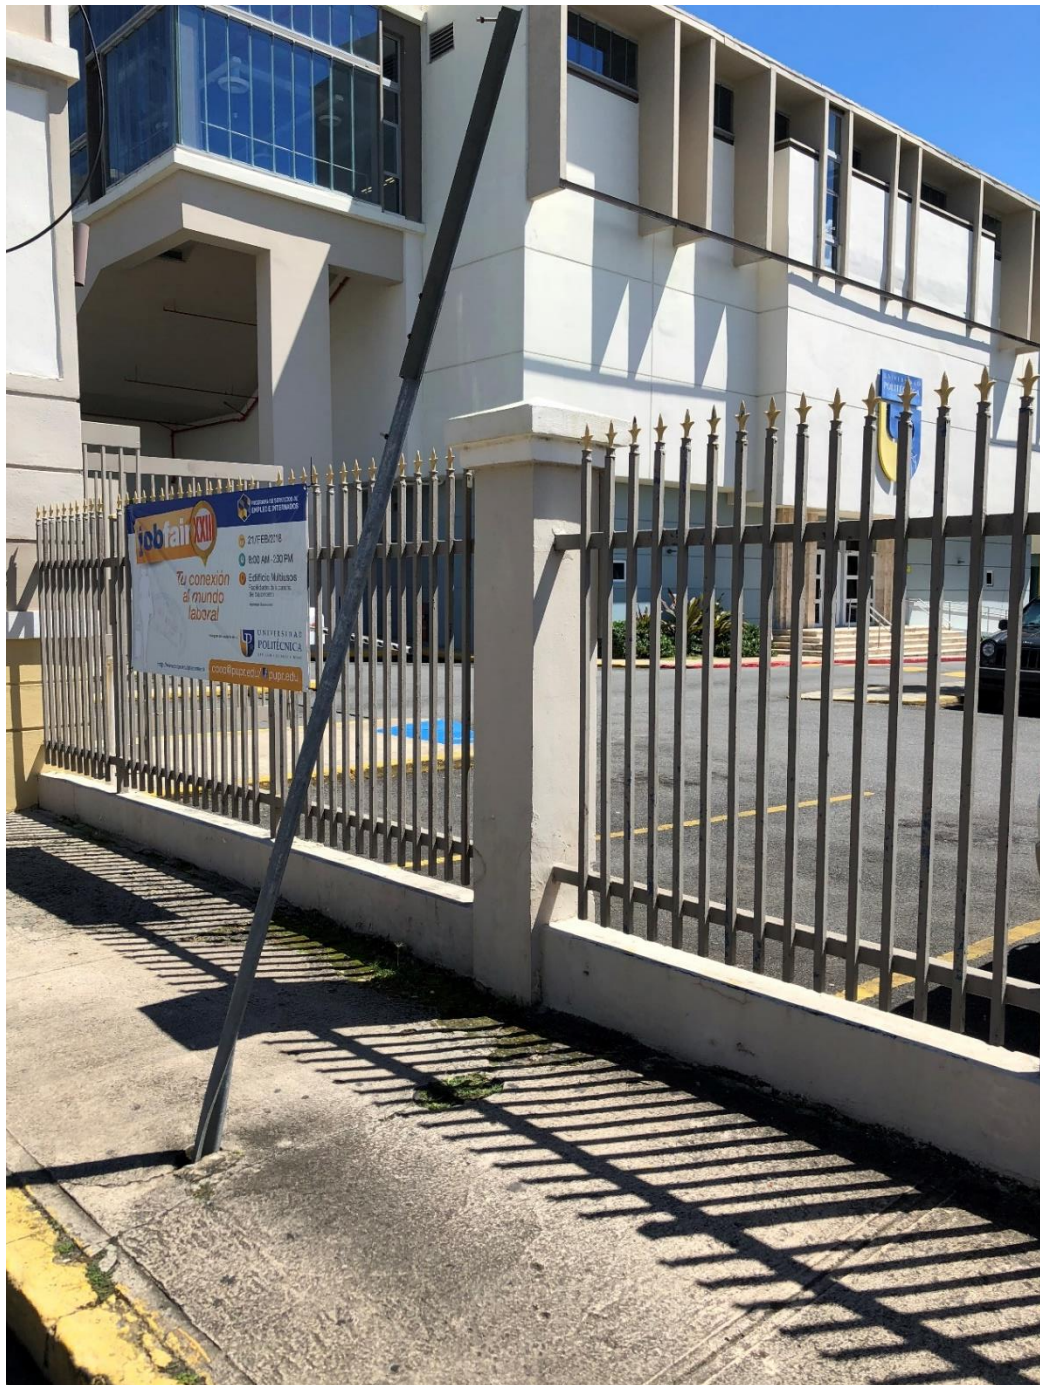
After hurricane Maria, the post was found without the transit sign, as shown in Figure 6.4. Therefore, it was concluded that the sign panel was blown away during the hurricane. It can be noticed in the figure that the post exhibits permanent twisting deformation near its base.

Figure 6.4: Case Study 2 after Hurricane Maria

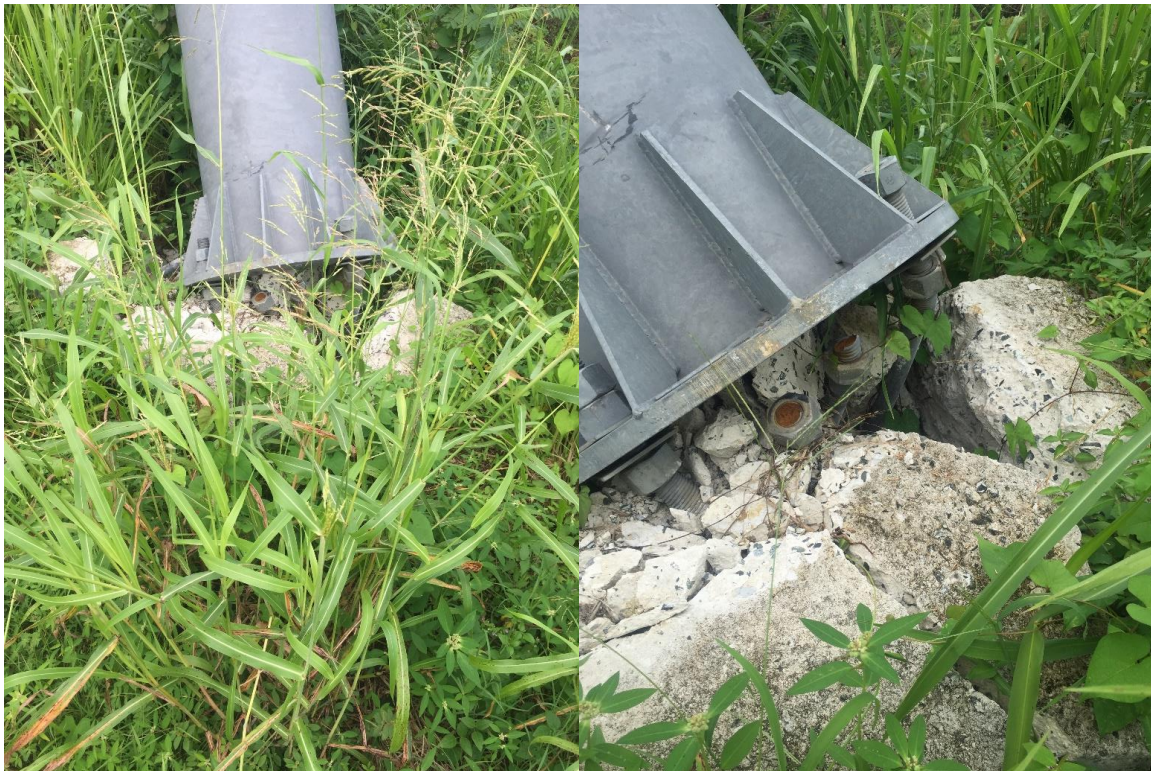
Figure 5-35: Photo of Cantilever Sign Foundation Structural Failures on the Pedestal at P-106

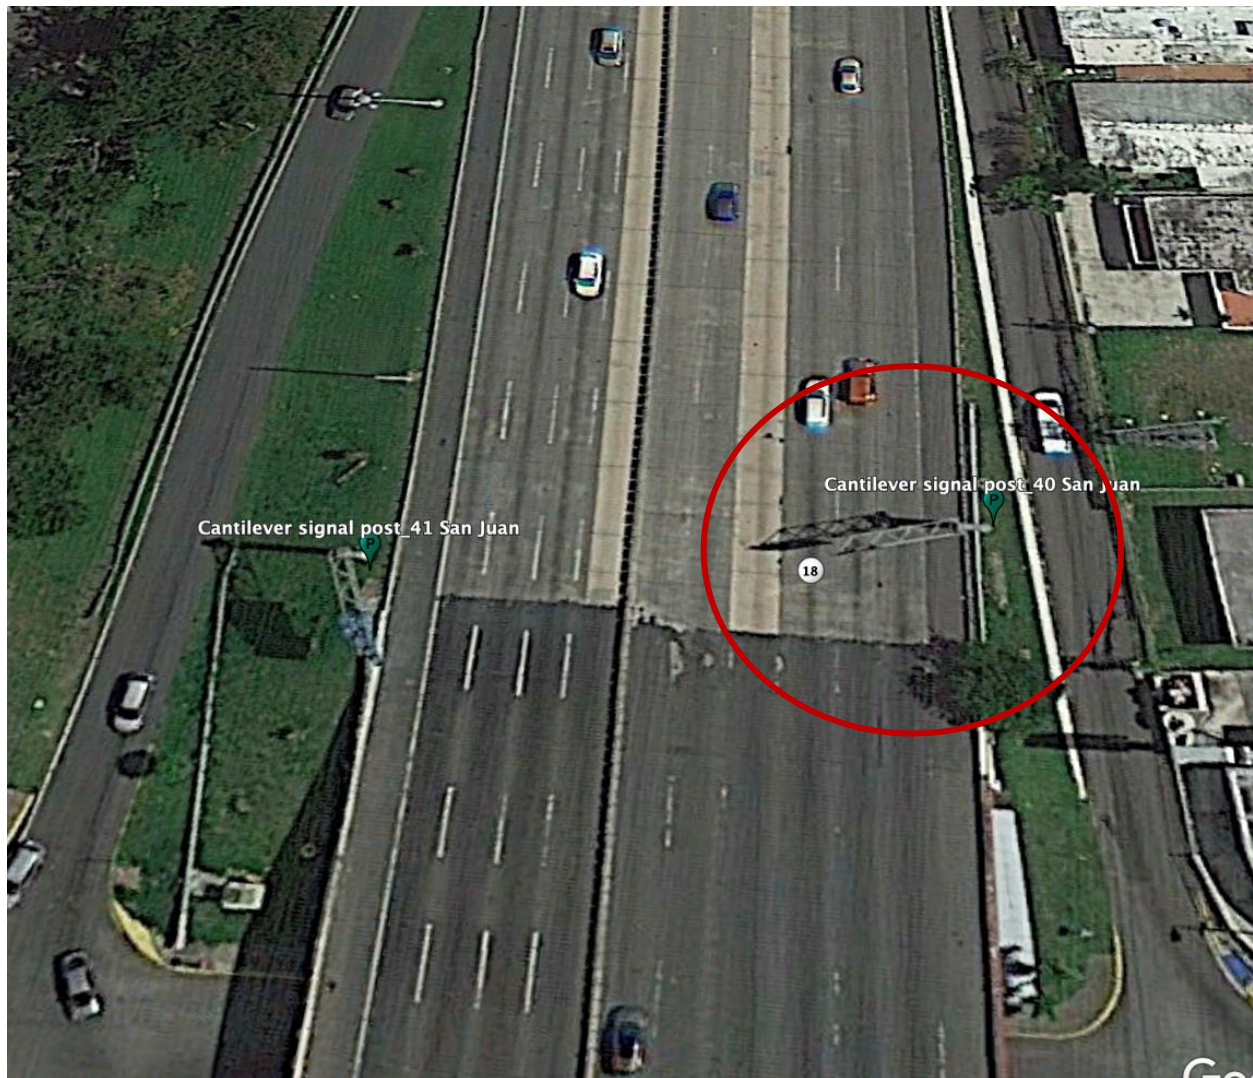
Figure 5-71: Satellite Image of Cantilever Sign Soil Foundation Failure (Torsional Rotation) at P- 40 Photo Location: 18.413125°N; 66.06986944°W

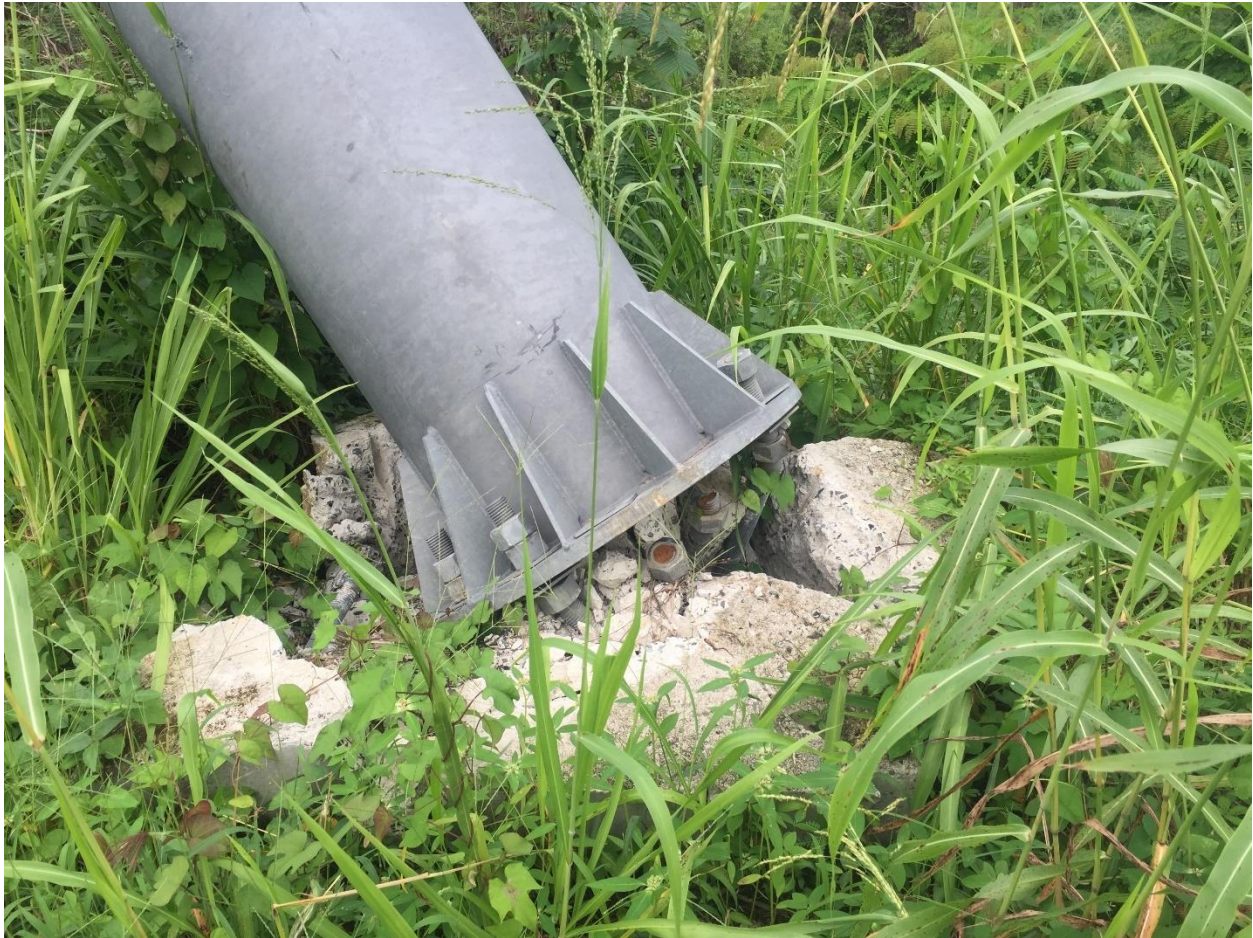
Figure 6-11: Large Deflections of Anchor Bolts due to Lack of Lateral Confinement (Sign P-106)

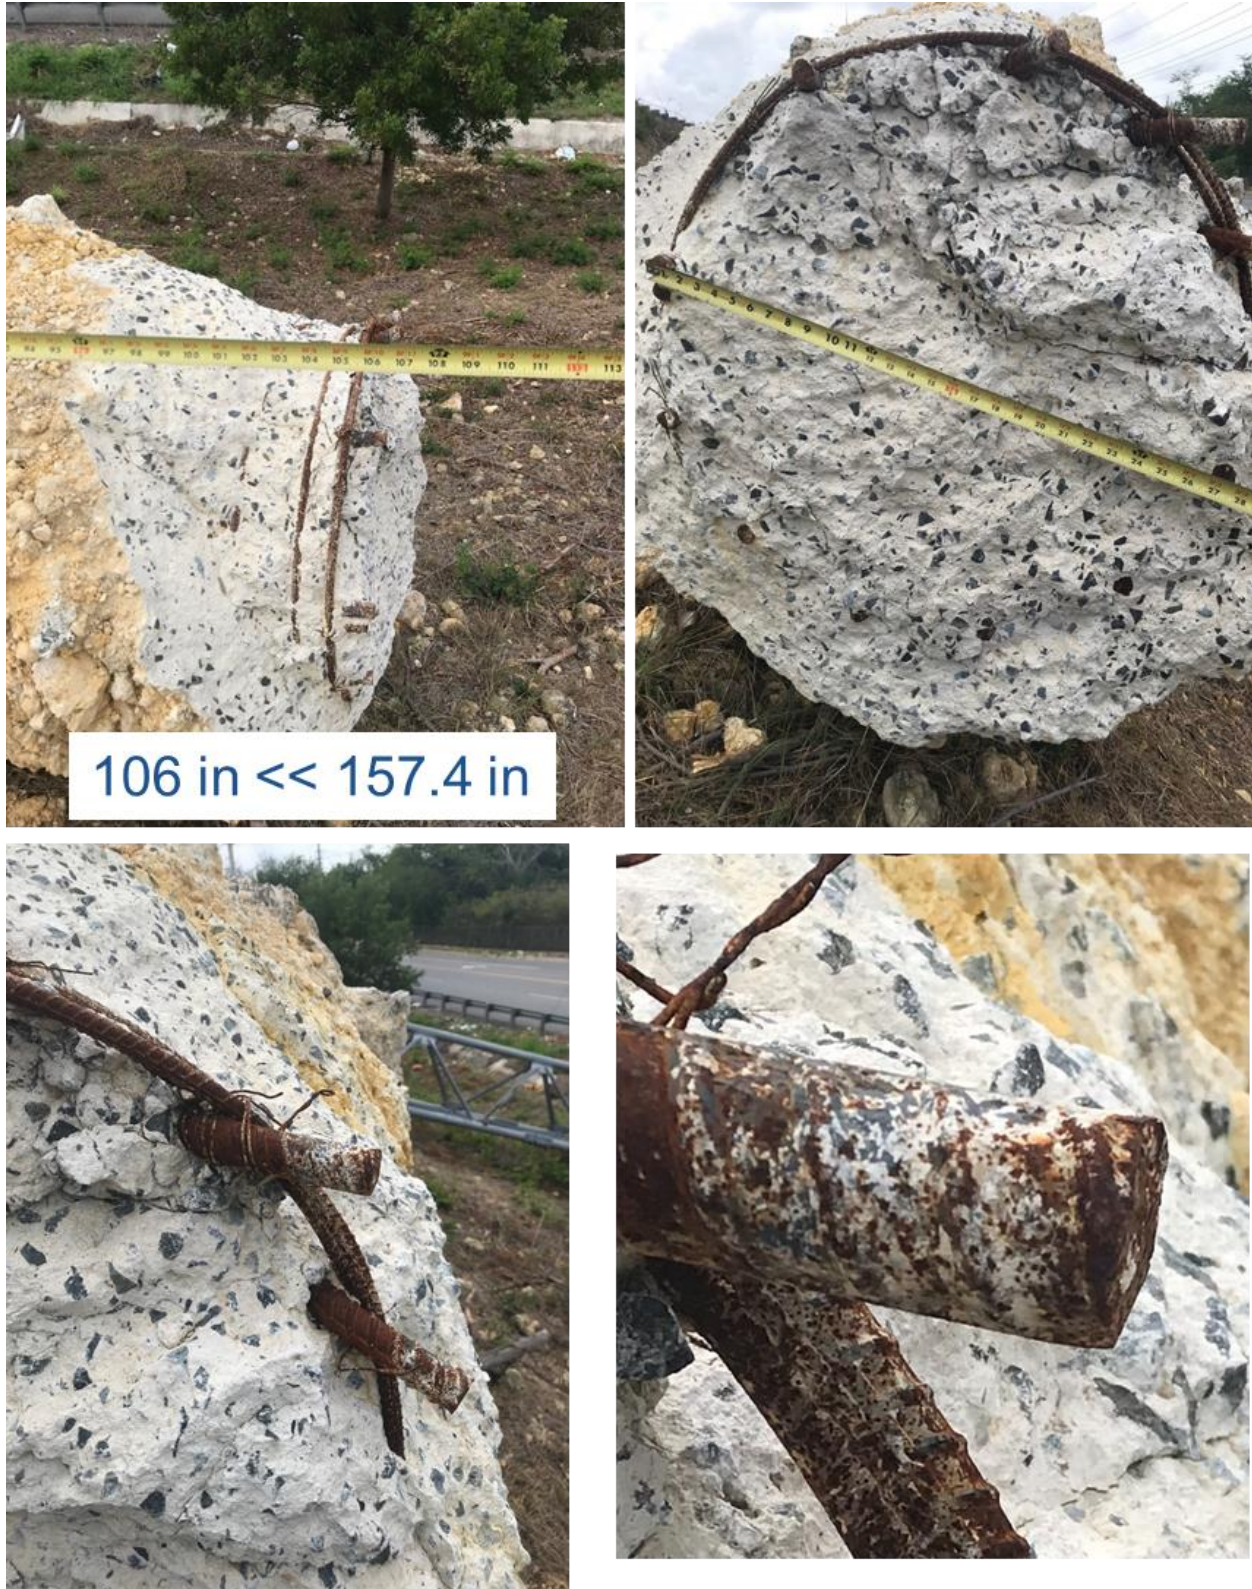
Figure 6-19: Interrupted Steel and Shear Fracture of the Concrete of the Drilled Shaft
