Improving Transportation Infrastructure Resilience Against Hurricanes, Other Natural Disasters, and Weathering: Part II - Analysis of Pedestrian Bridges Failures Due to Hurricane Maria

Volume 1

FINAL REPORT
August 2021

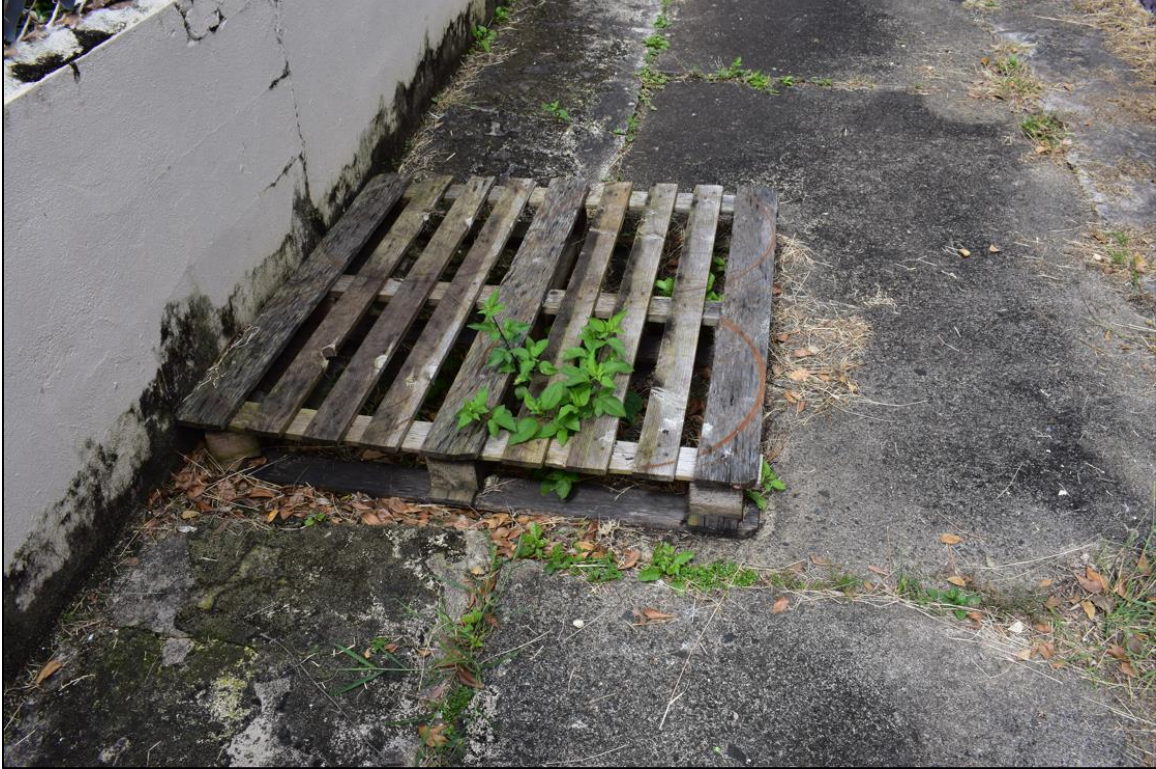
Figure 5.12: Holes in sidewalk covered with a pallet

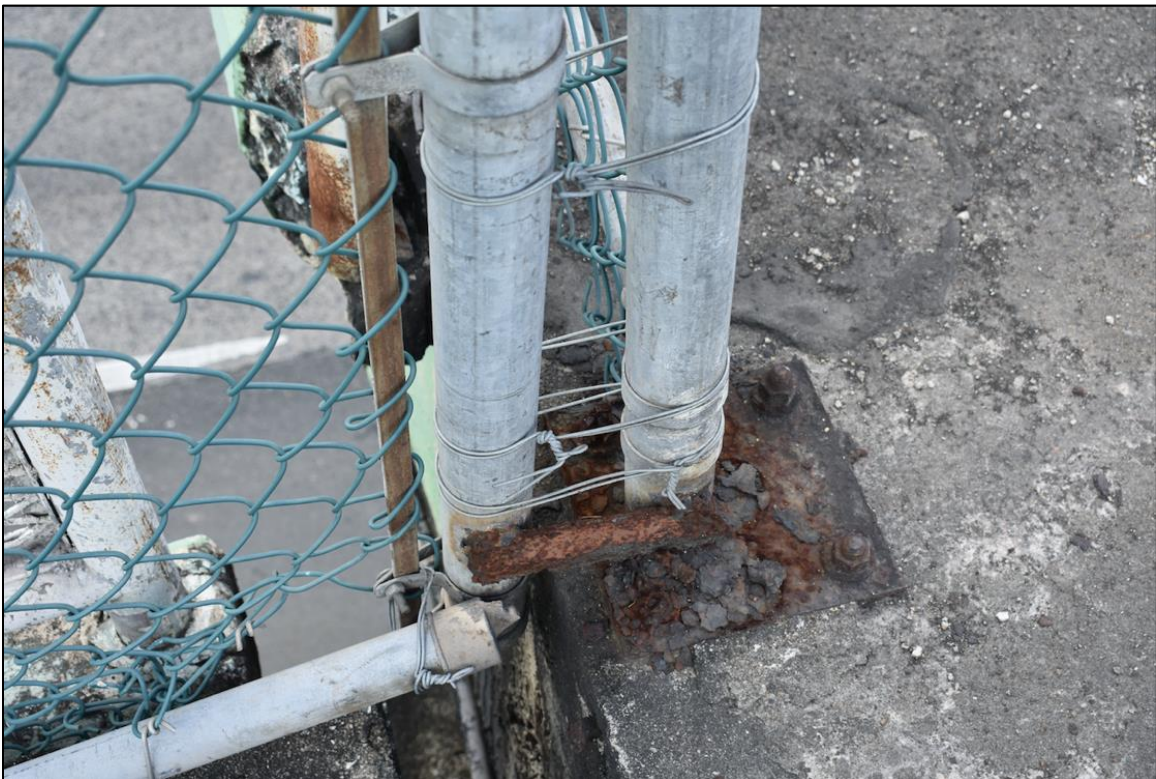
During the visit, a neighbor approached the inspection team and expressed concern for the safety of the people that use the bridge. One of the concerns was that the sidewalk (at the location indicated in Figure 5.11) used to approach the bridge ramp on the west side has a hole with a depth of more than 1 ft. This hole was covered with a pallet, as shown in Figure 5.12. In the same area, a section of the sidewalk has sunk, as shown in Figure 5.13. Other observations made by the inspection team were the growing vegetation on the chain-link fence of the ramp (see Figure 5.14) and presence of corrosion on the support bases of the chain-link fence (see Figure 5.15).

Figure 5.15: Corrosion in base support of chain-link fencing

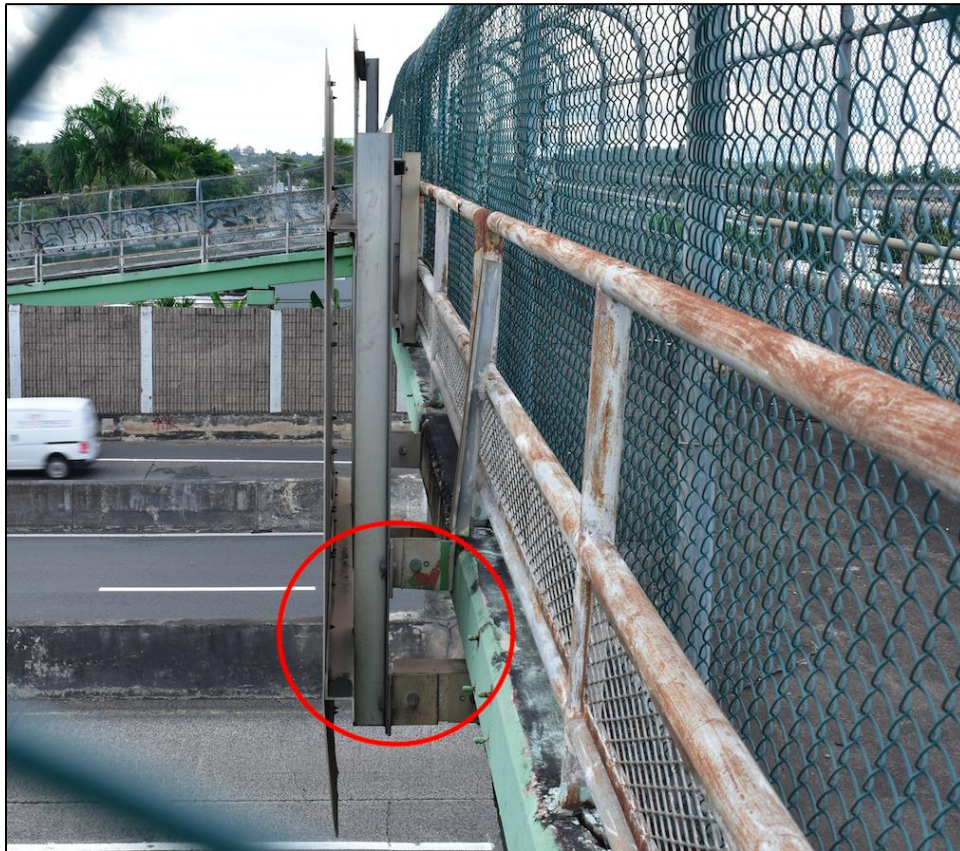
At the time of the inspection, the bridge had attached five signs of different sizes, as it can be appreciated in Figure 5.1 and Figure 5.2. In terms of possible damages caused by Hurricane Maria, it was observed that one of the traffic signs mounted on the bridge was detached at the bottom end from the mounting assembly, as indicated in Figure 5.16. It is theorized that the detachment was due to wind induced vibrations that occurred during the hurricane.

Figure 5.16: Traffic Signs partially detached from support

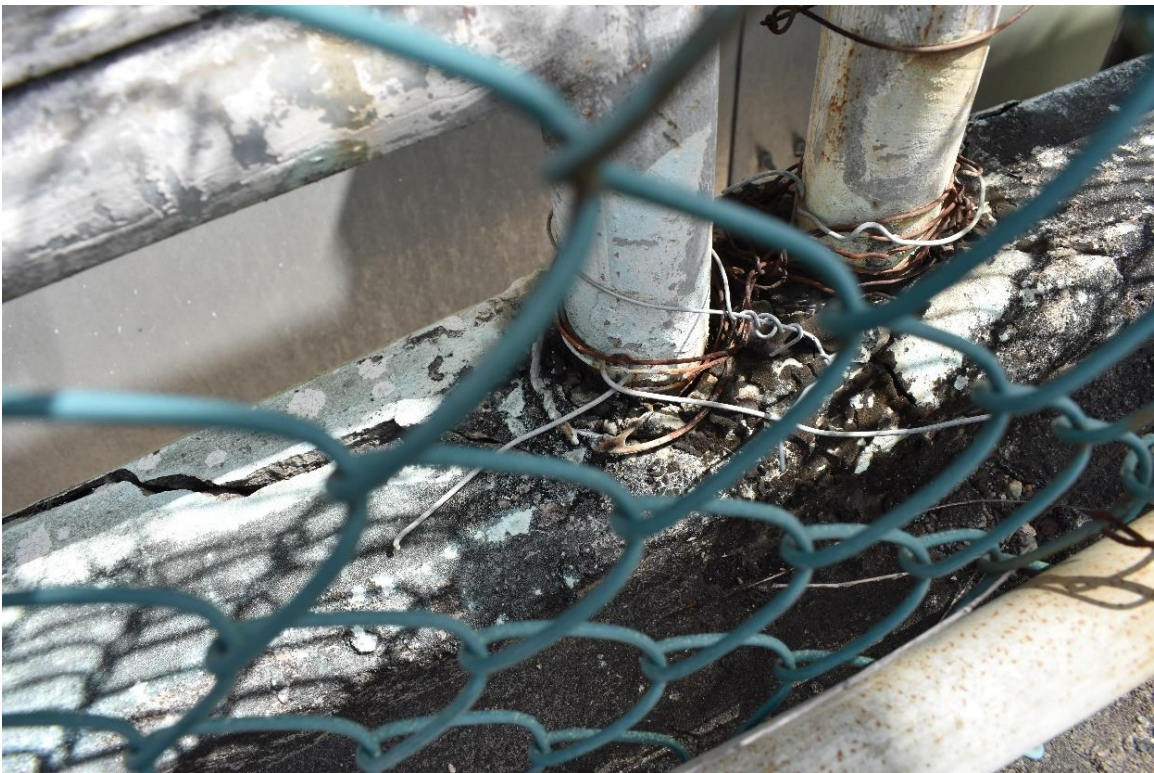
It was observed that all the traffic signs mounted on the bridge were attached to the handrails, as shown in Figure 5.17. It was noticed that there were cracks at the base of handrails posts (see Figure 5.18), and one section was detached (see Figure 5.19) and bent, affecting the sign (see Figure 5.20). Wind vibrations may have induced the cracks and triggered the bent.

Figure 5.18: Cracks at the base of the handrail posts

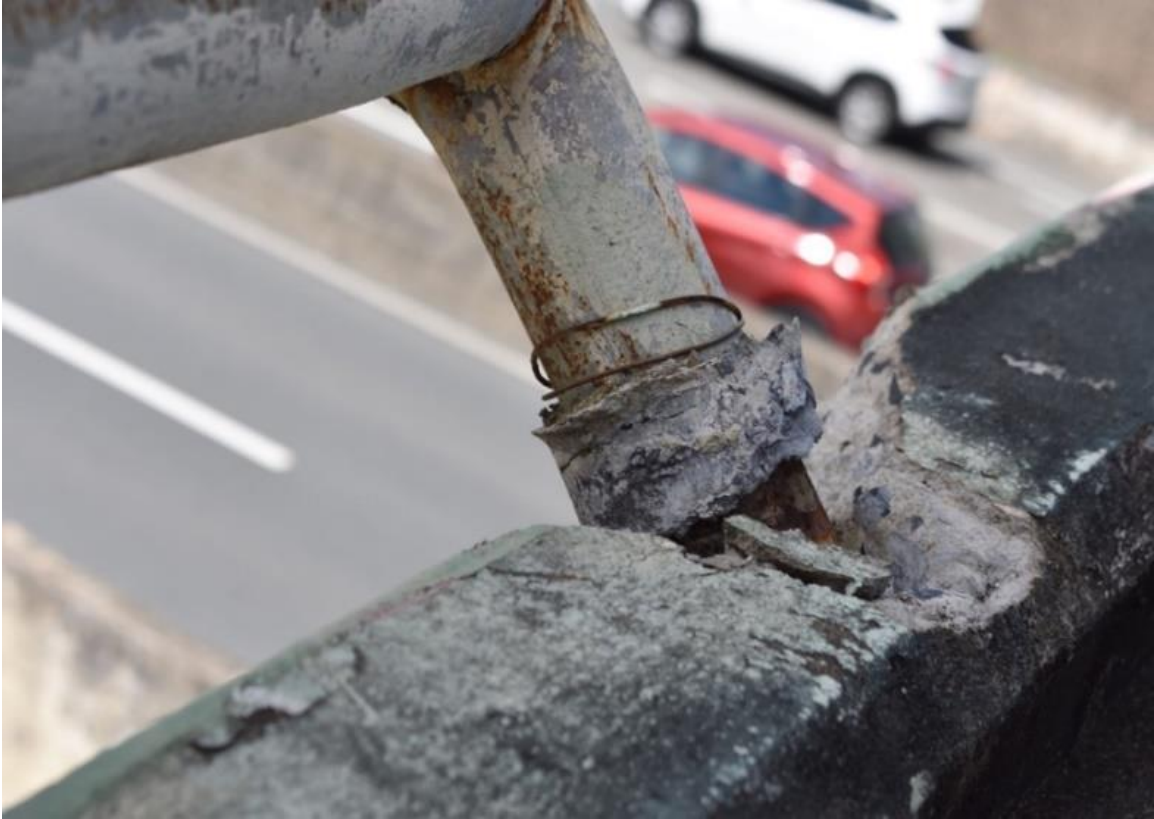
Figure 5.19: Detached handrail post

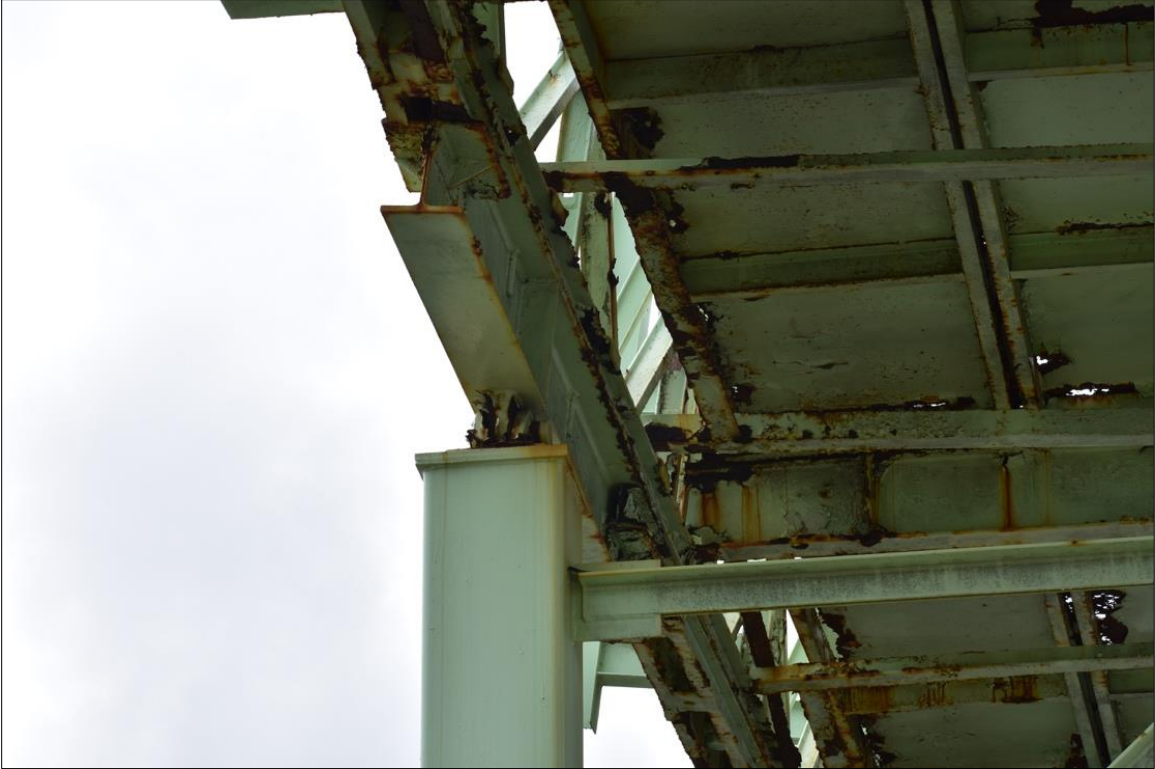
During the visit, it was evident that the bridge had corrosion problems in many components. Corrosion had caused holes in the walkway, as shown in Figure 5.38 and Figure 5.39. Some transversal elements were missing, as shown in Figure 5.40. (Further details about the inspection of this bridge can be found in Volume 2 of this document).

Figure 5.38: Some holes in the steel

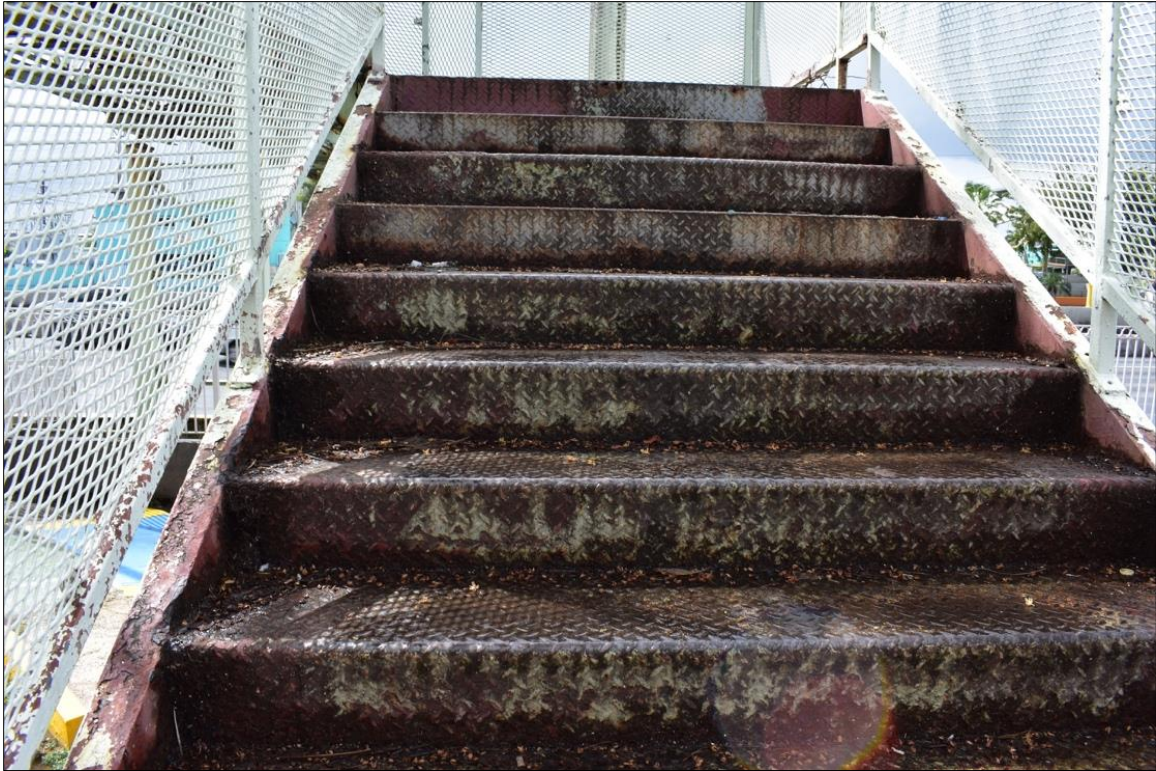
Figure 5.61: Corrosion on stairway

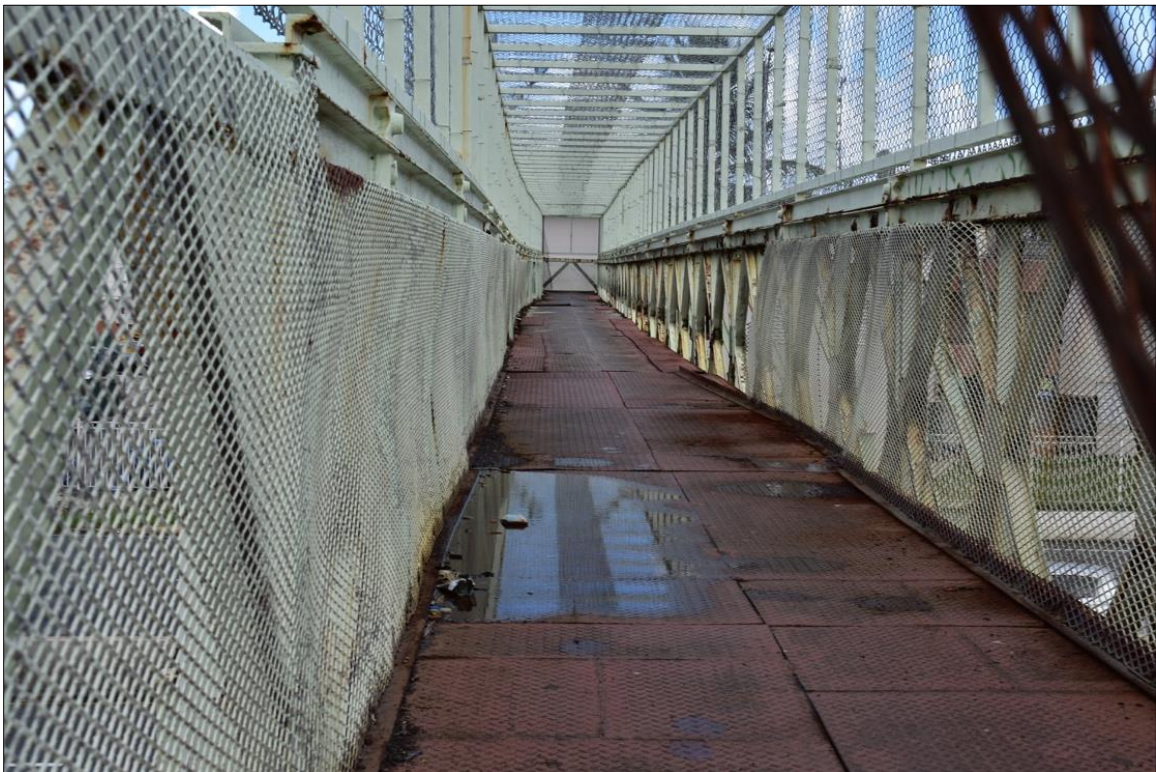
Figure 5.62: Corrosion on deck and section of guardrail without security meshing

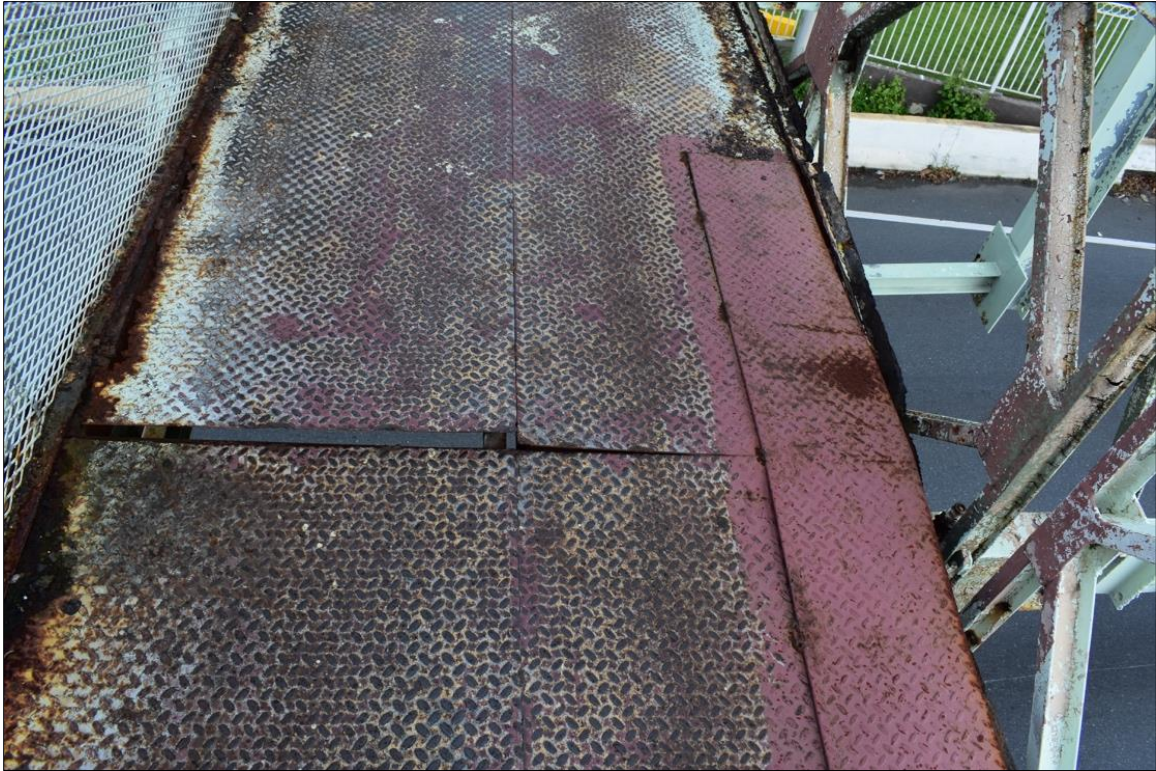
Figure 5.63: Detached plates

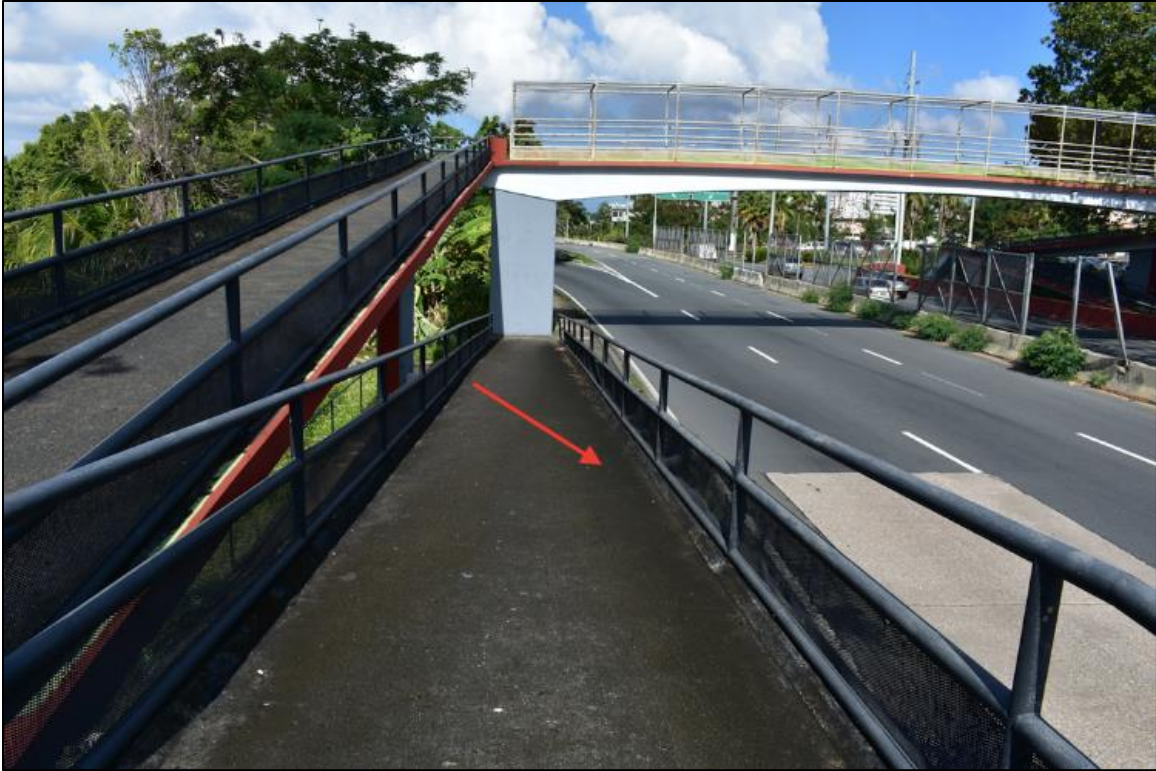
Figure 6.1: Mold and silt in the access ramps of PB 0626

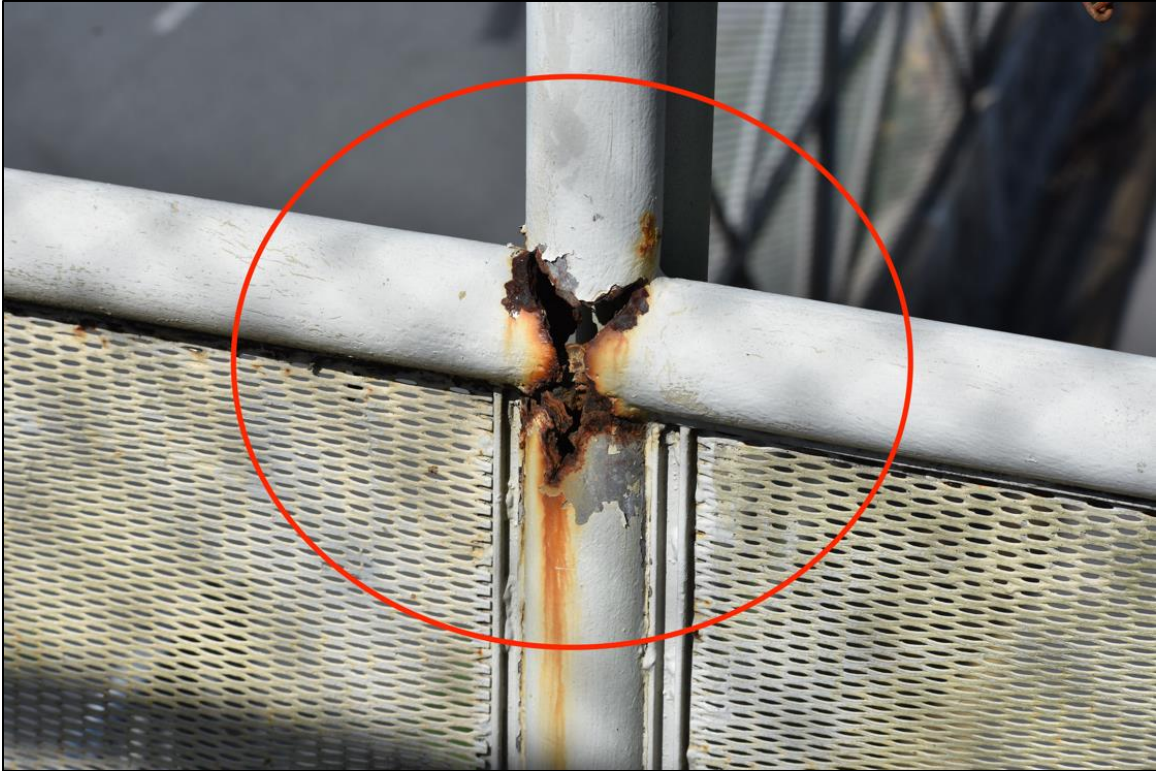
Figure 6.3: Corrosion in the railings of PB 0626

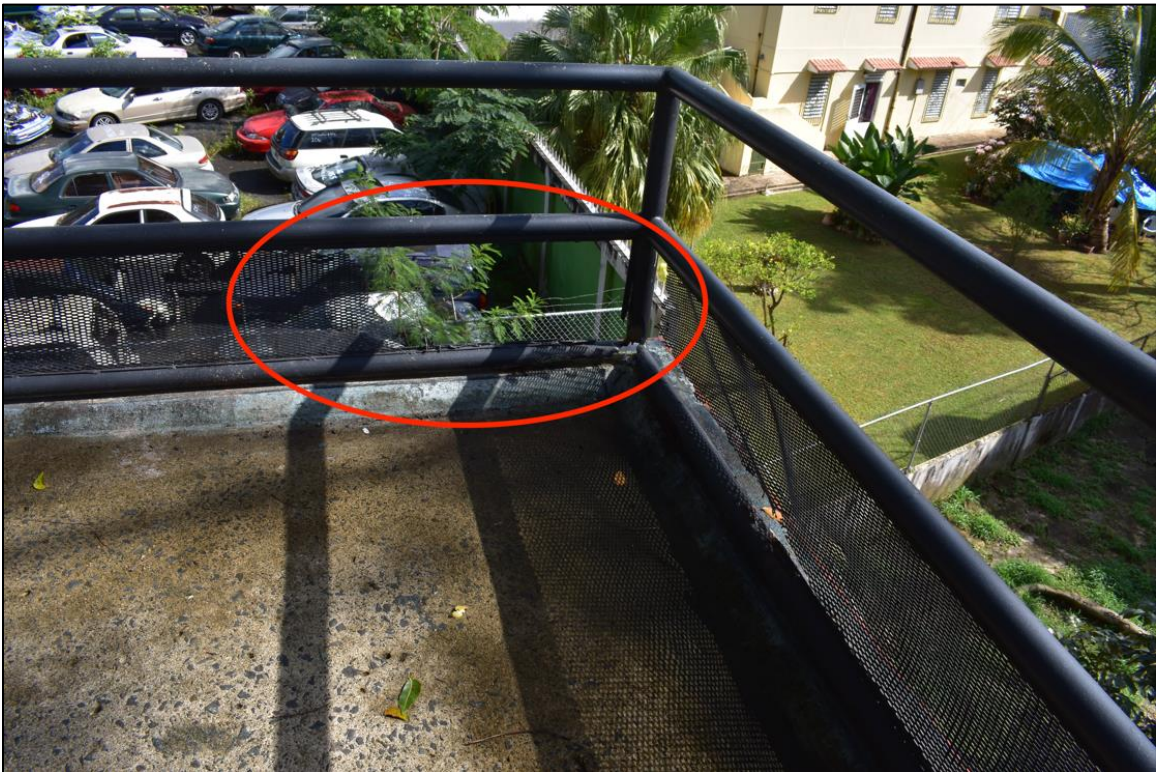
Figure 6.4: Missing section of safety meshing on PB 0626

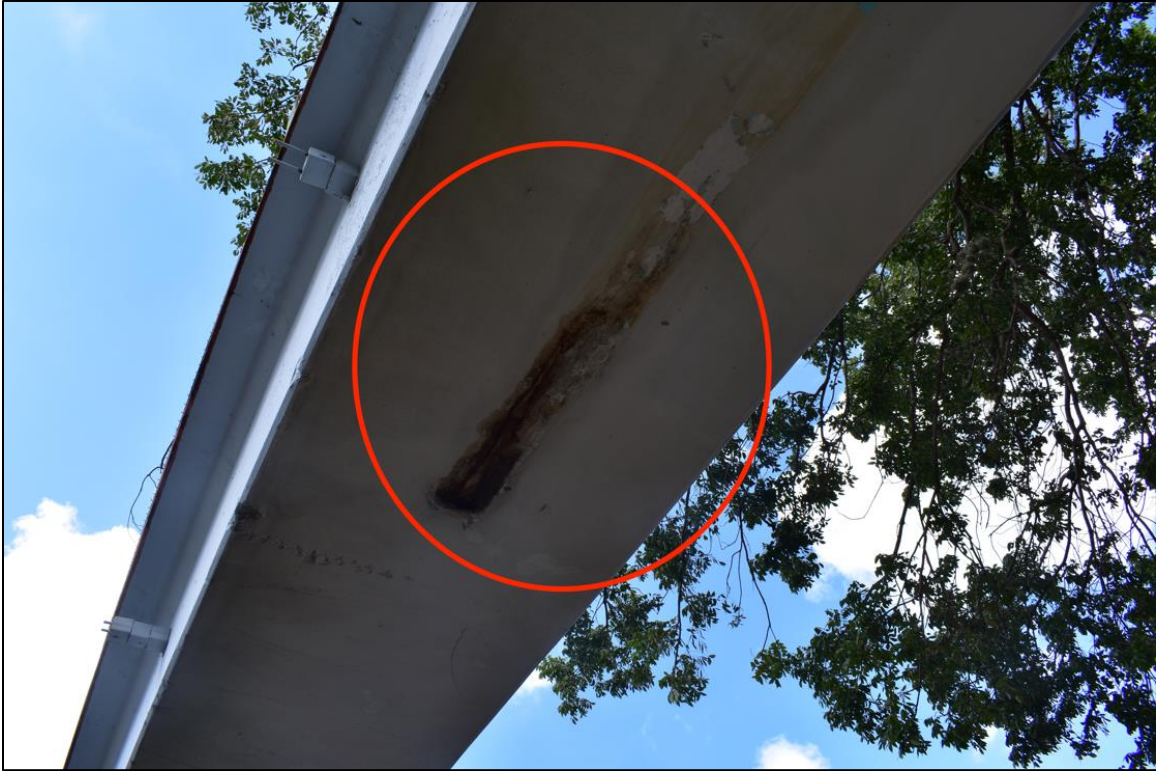
Figure 6.5: Exposed rebar on PB 0626

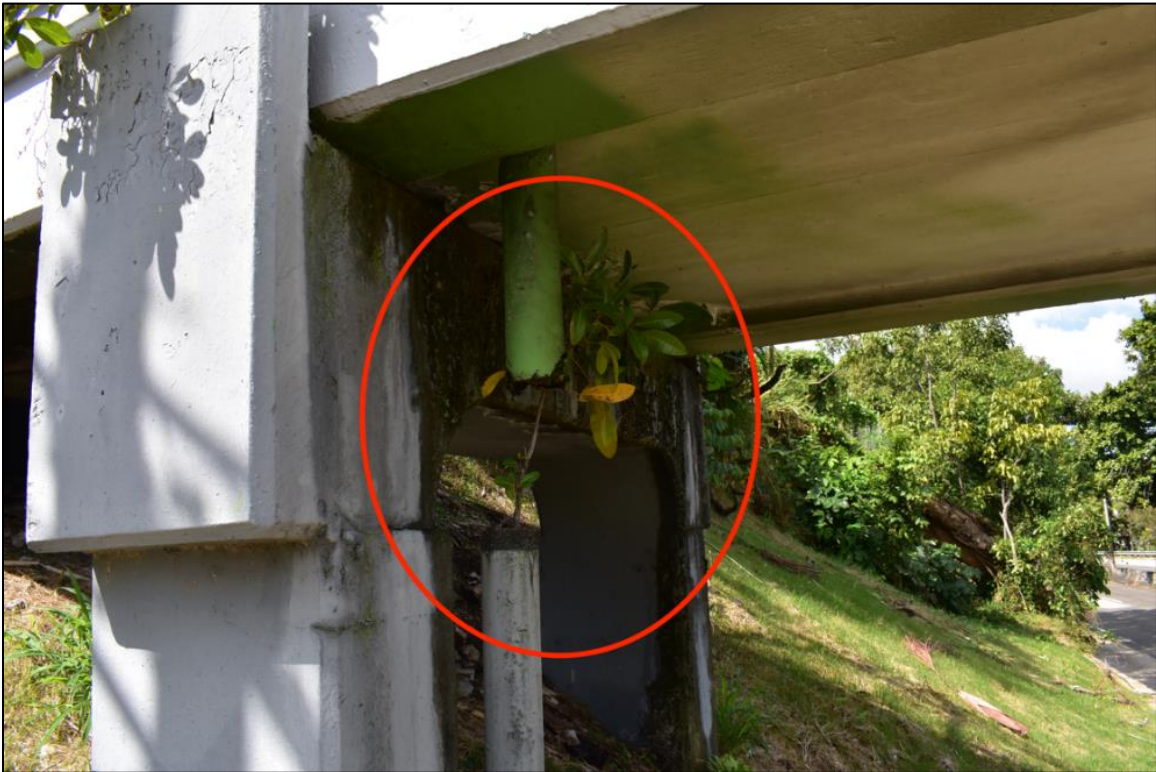
Figure 6.8: Broken drainpipe blocked with vegetation on PB 0748

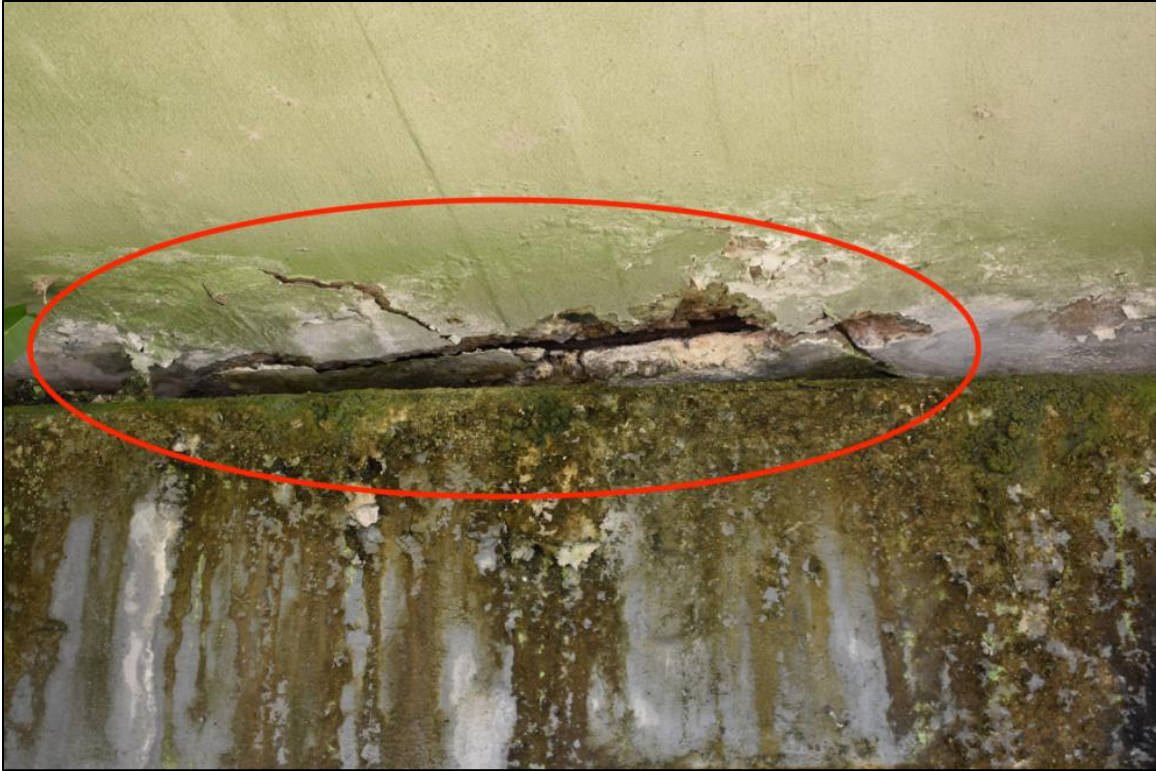
Figure 6.9: Exposed rebar on PB 0748

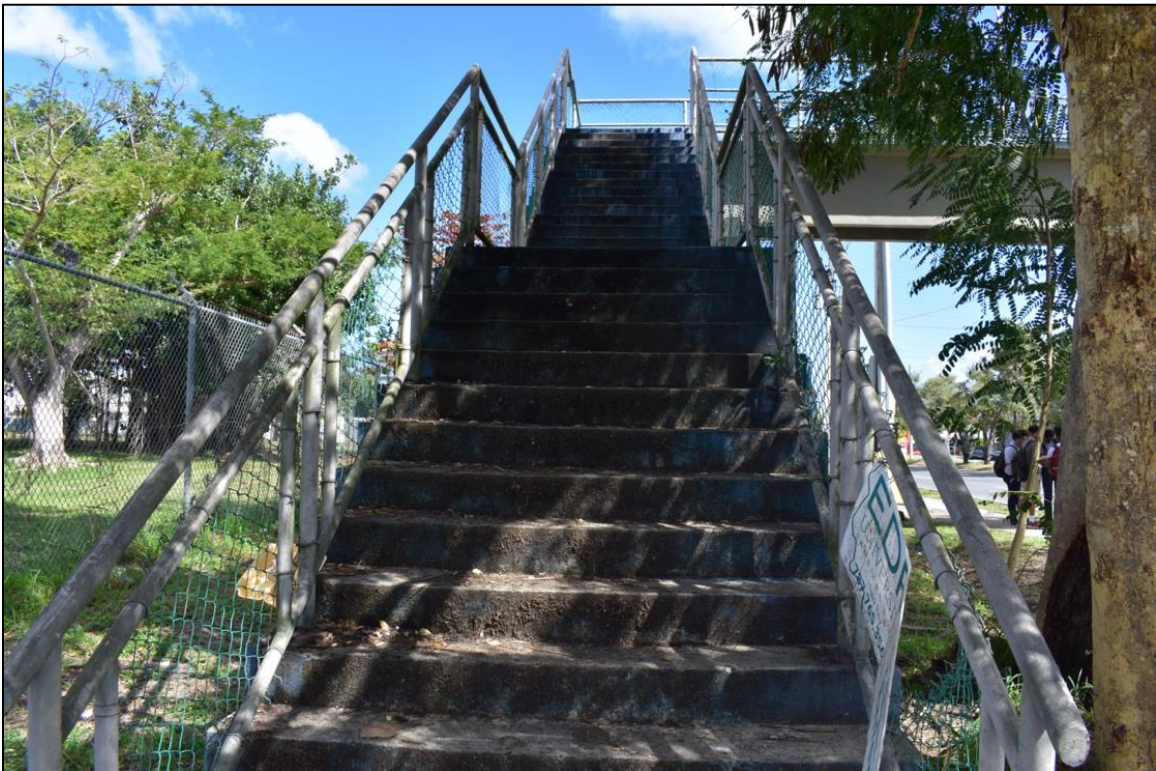
Figure 6.12: Mold on stairways of PB 1418

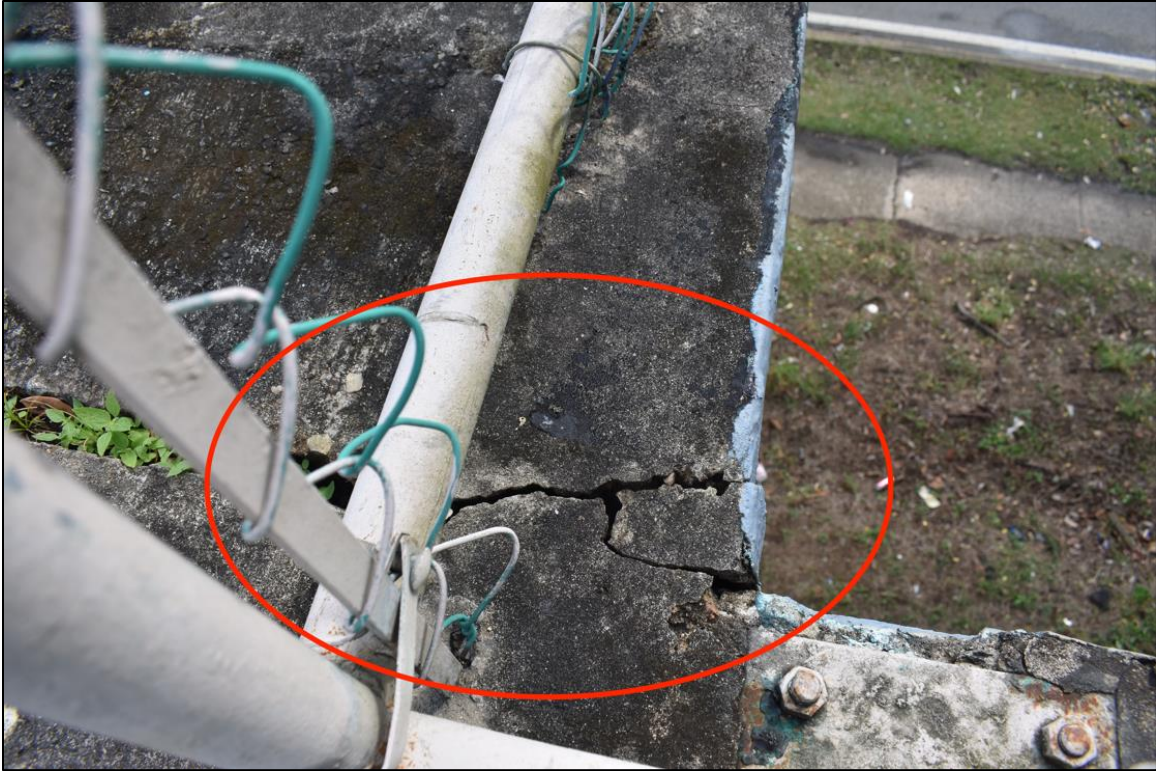
Figure 6.13: Cracks on PB 1418

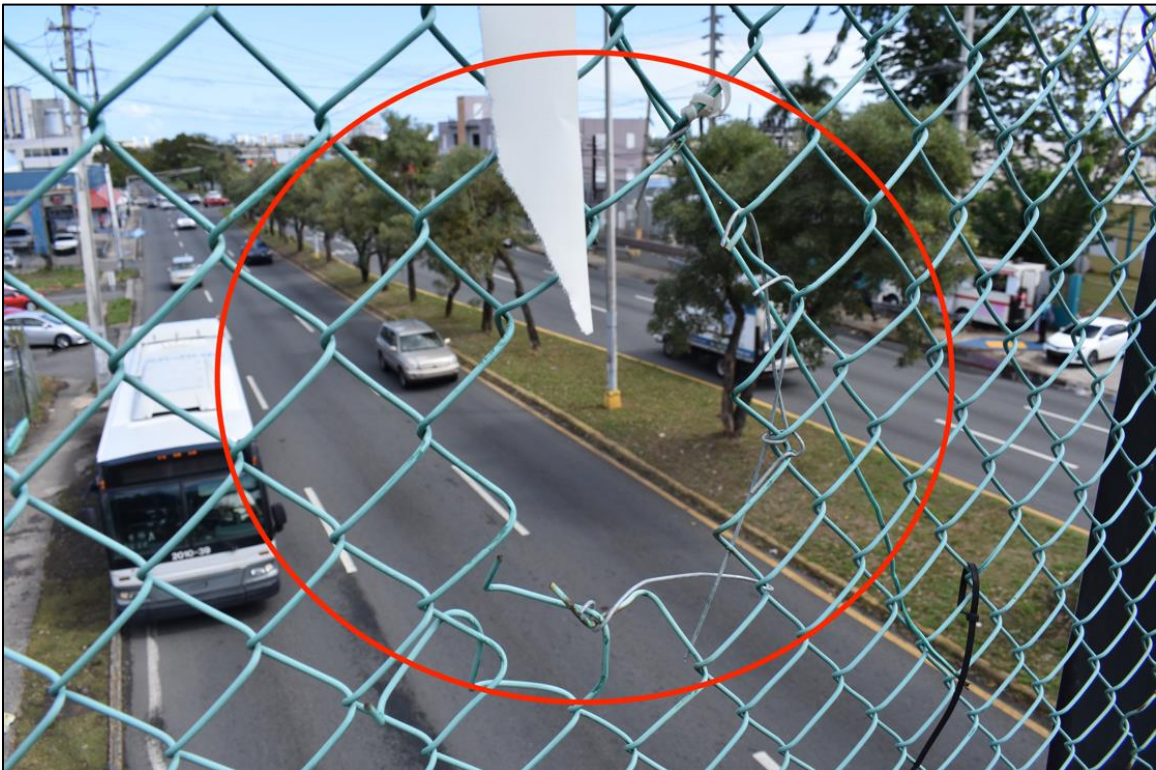
Figure 6.14: Hole in security fence of PB 1418

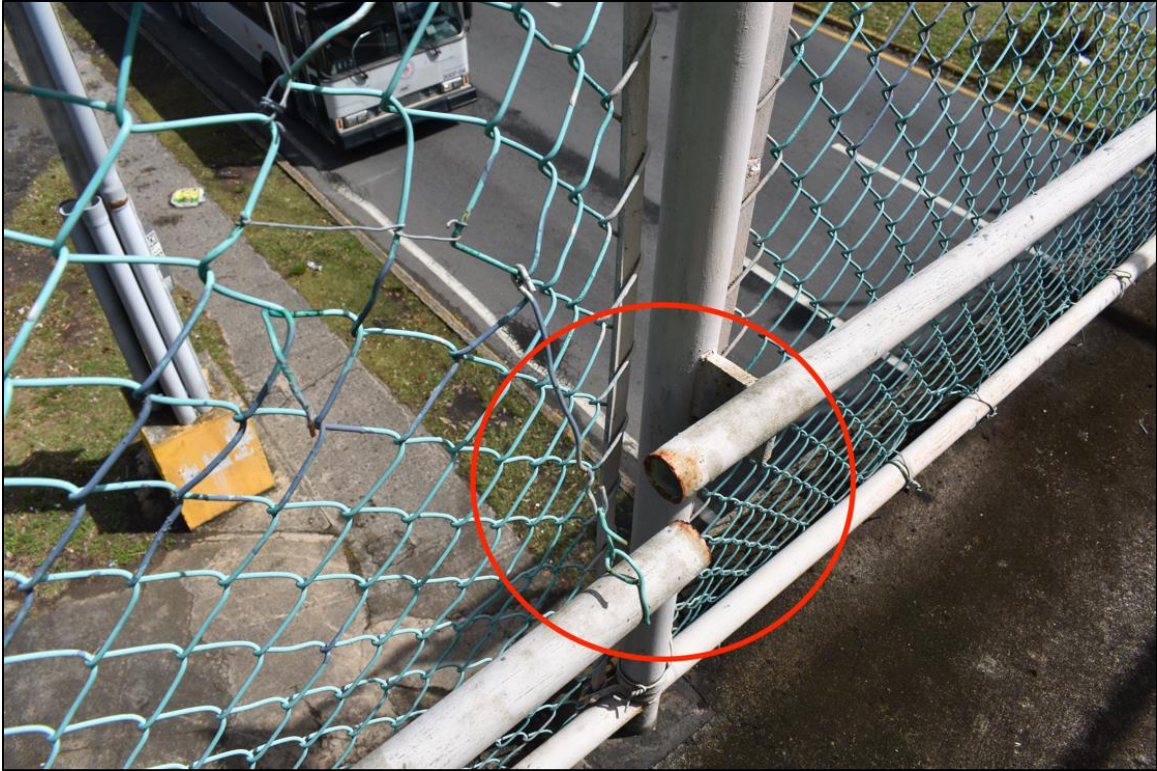
Figure 6.15: Broken railings on PB 1418

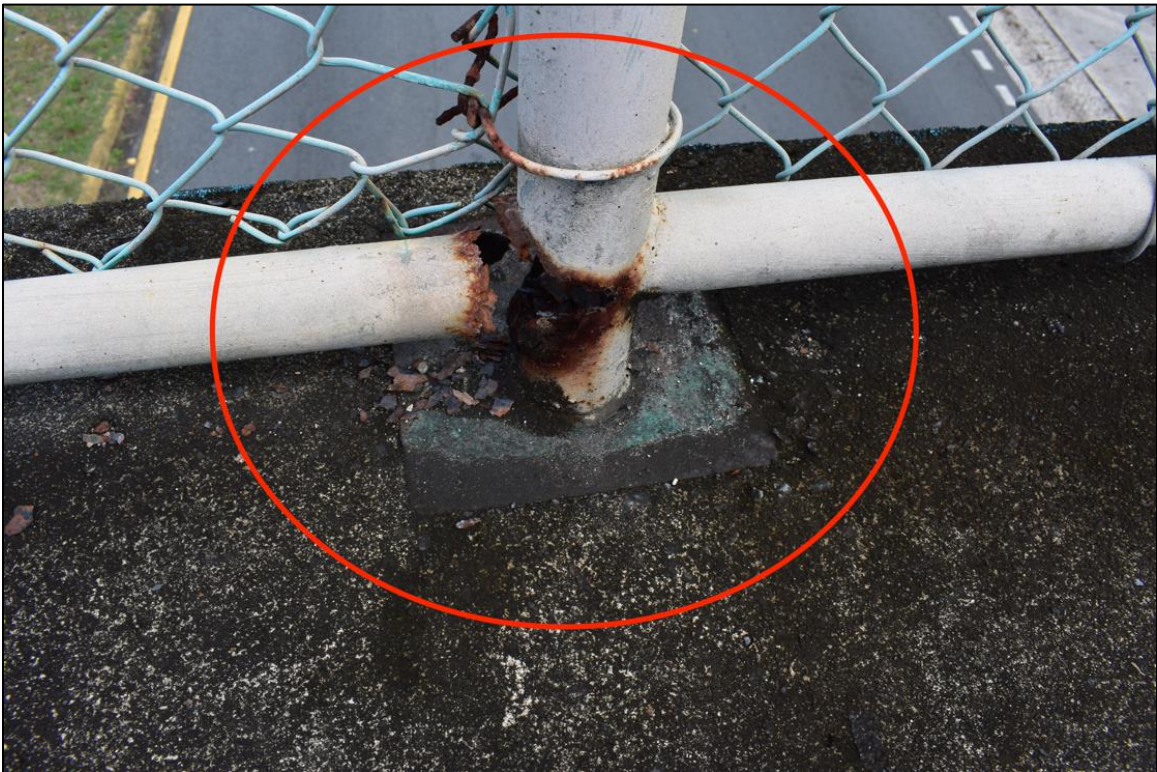
Figure 6.16: Corrosion on railing on PB 1418

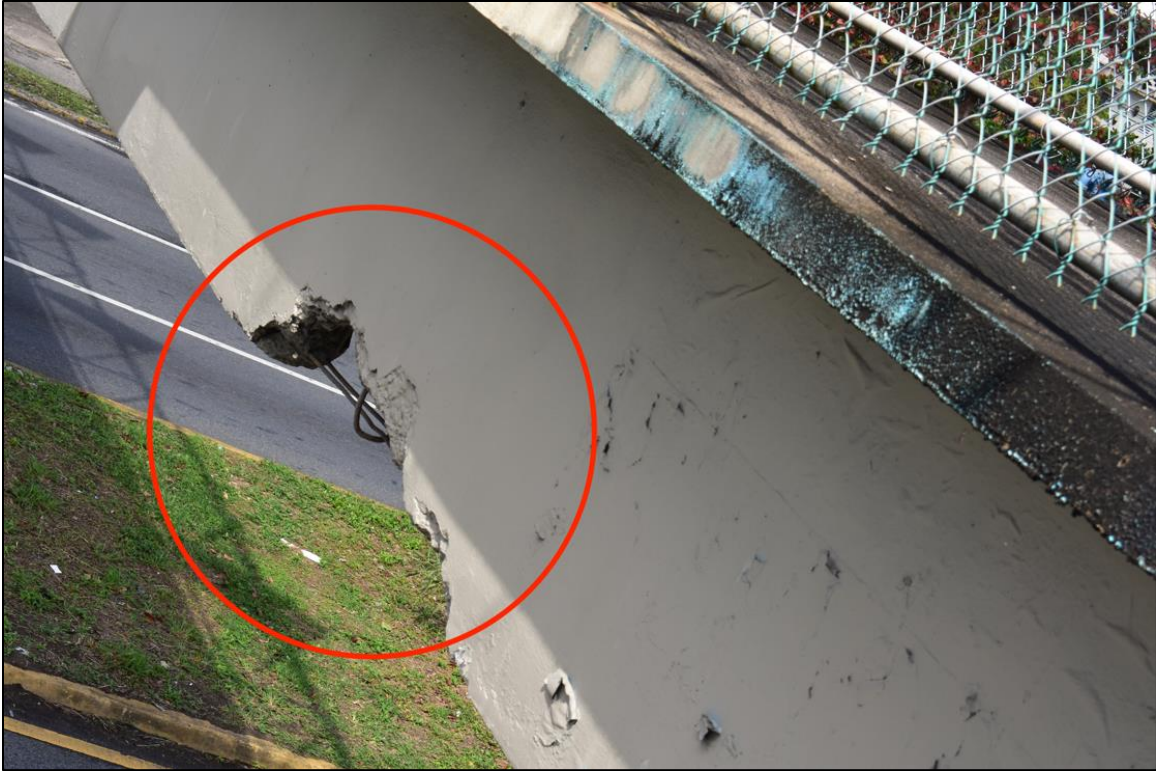
Figure 6.17: Exposed steel tendon on PB 1418

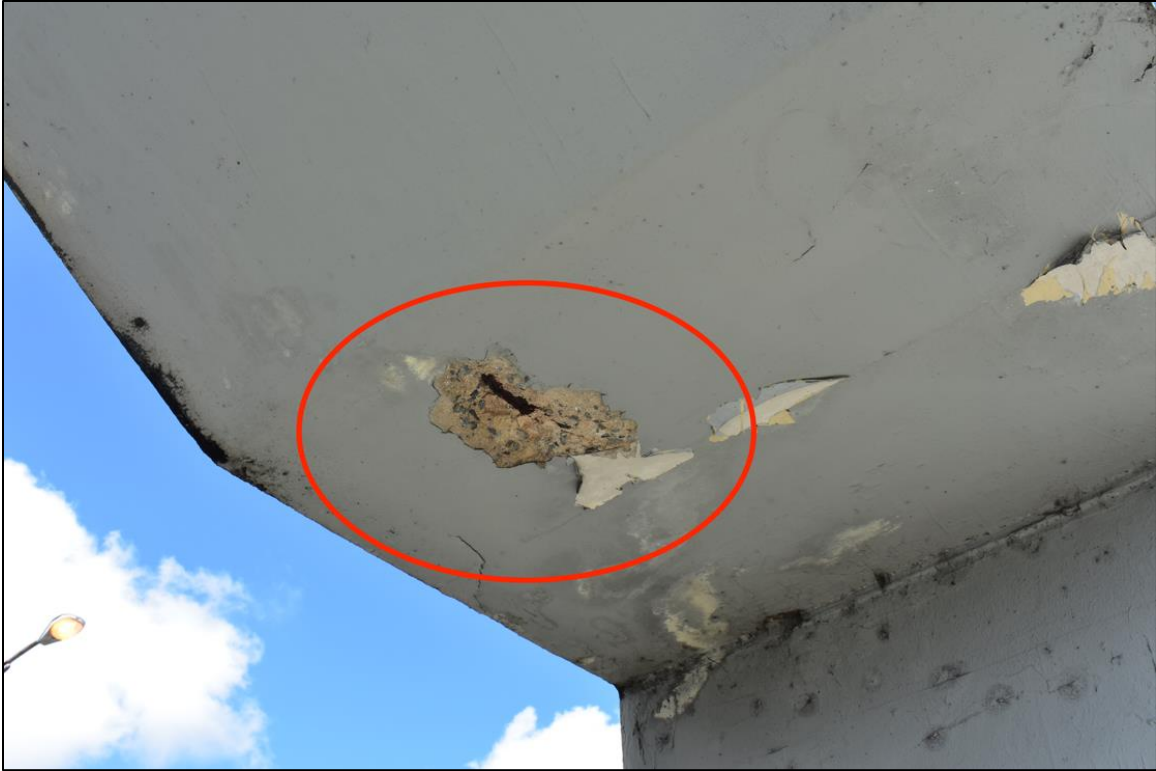
Figure 6.18: Exposed rebar on PB 1478

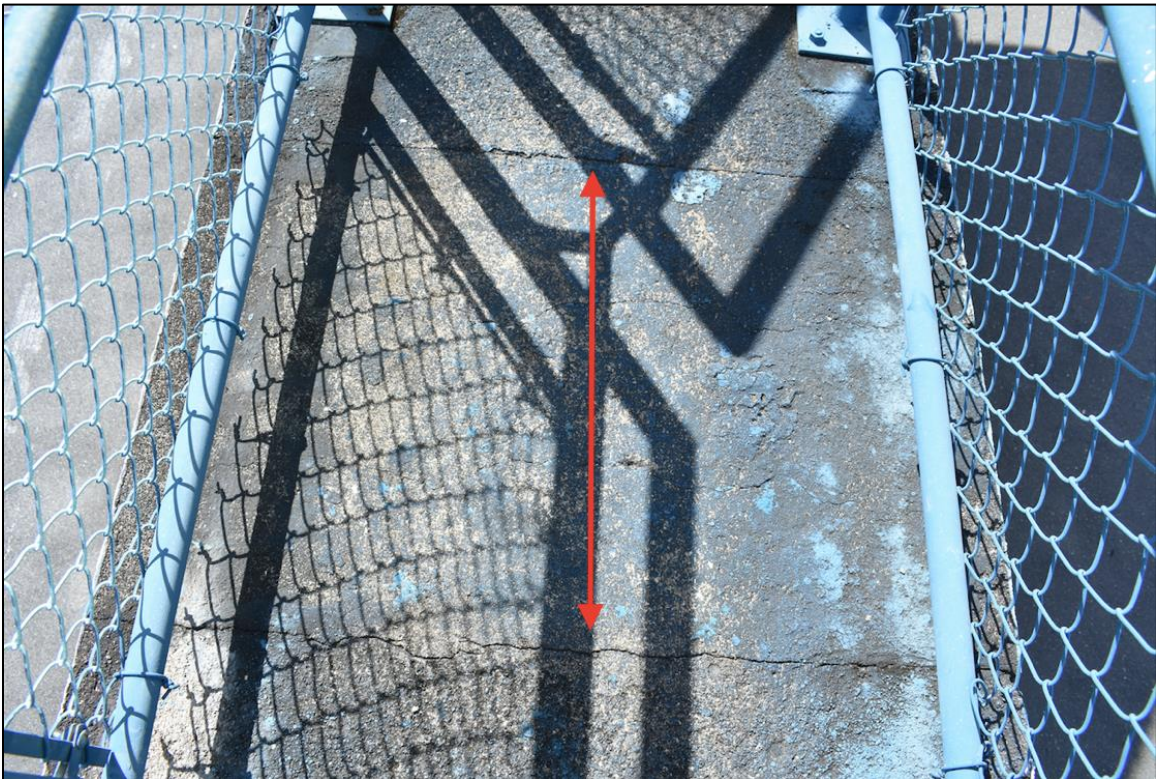
Figure 6.19: Transversal cracks on deck of PB 1478

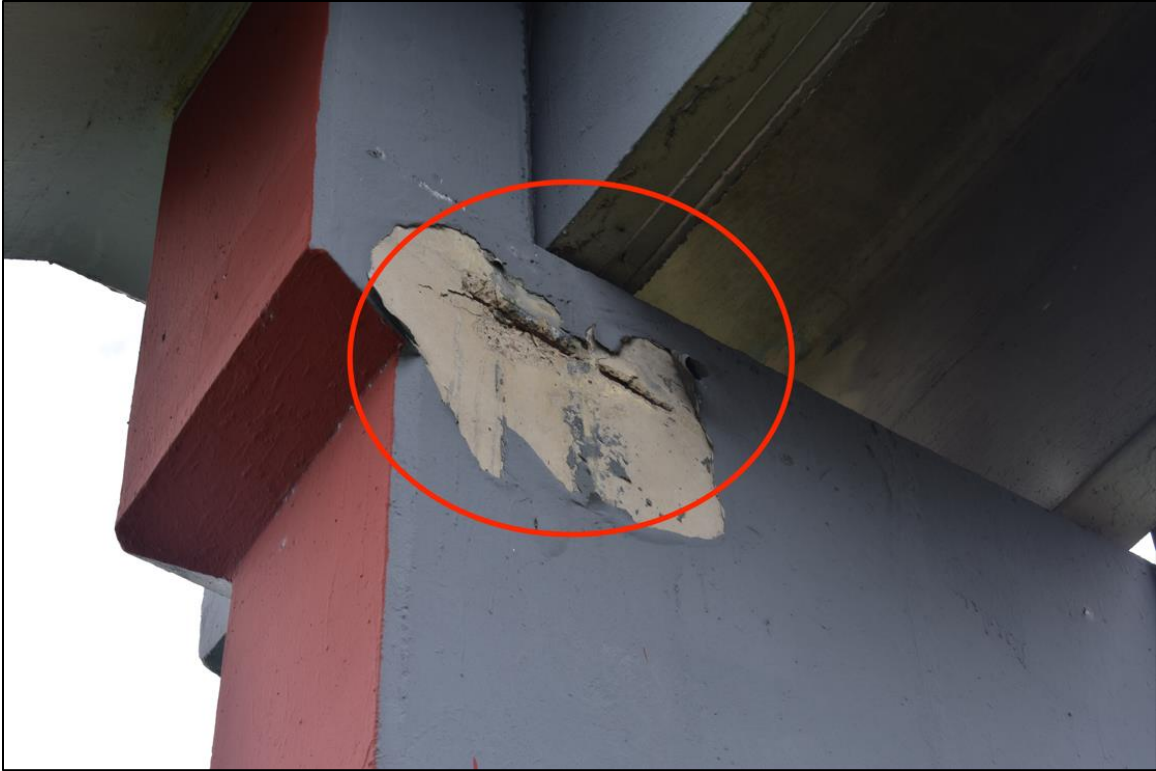
Figure 6.21: Exposed rebar on PB 1736

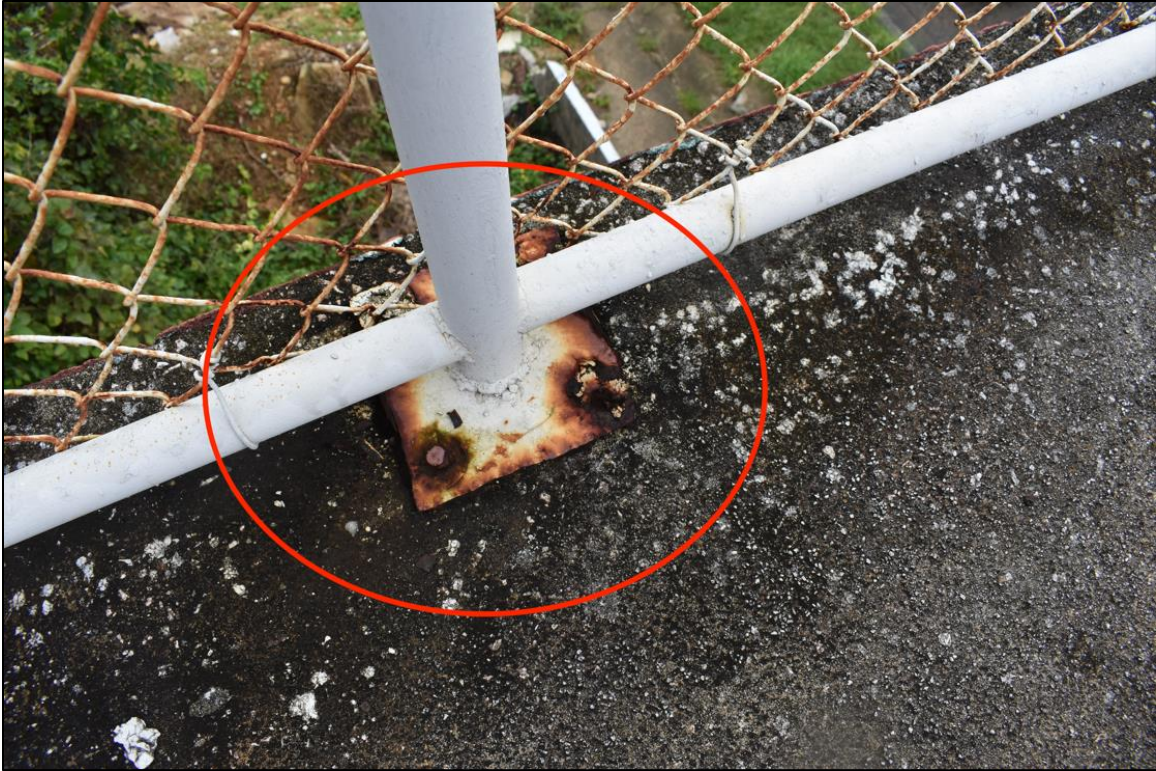
Figure 6.23: Corrosion of security fencing on PB 1736
