Improving Transportation Infrastructure Resilience Against Hurricanes, Other Natural Disasters, and Weathering: Part II - Analysis of Pedestrian Bridges Failures Due to Hurricane Maria

Volume 1

FINAL REPORT
August 2021

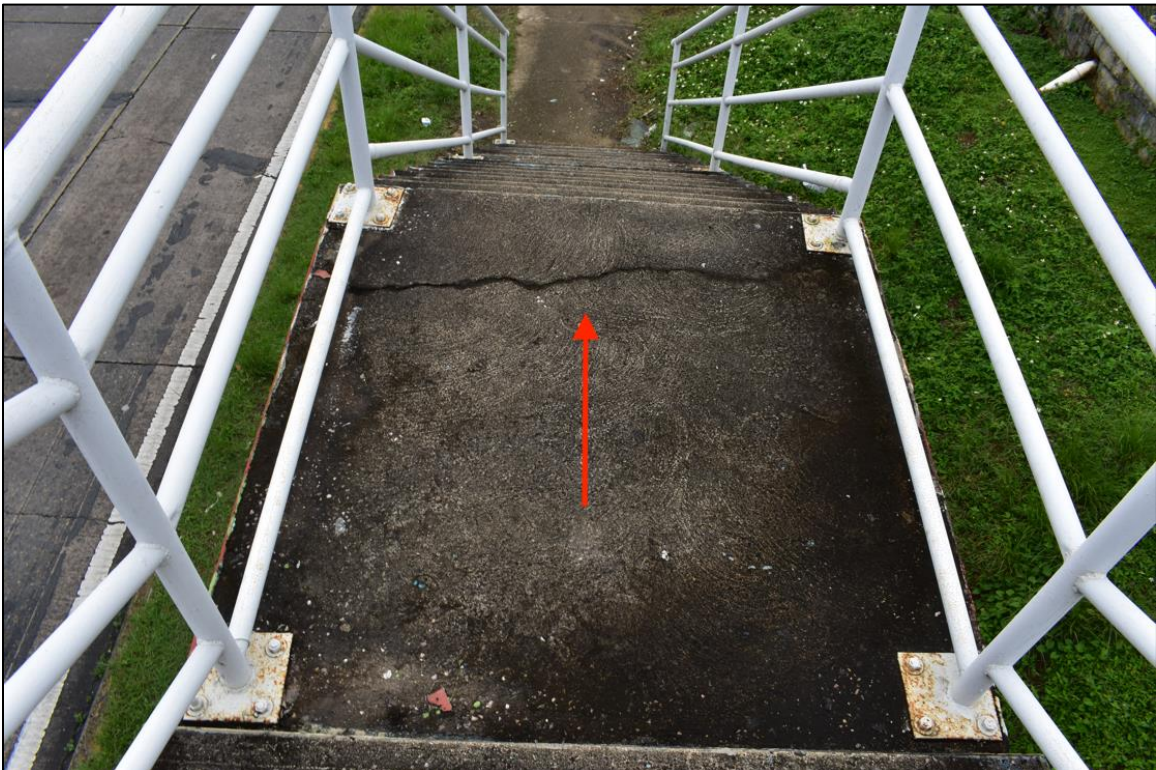
Figure 6.24: Crack on stairway of PB 1736

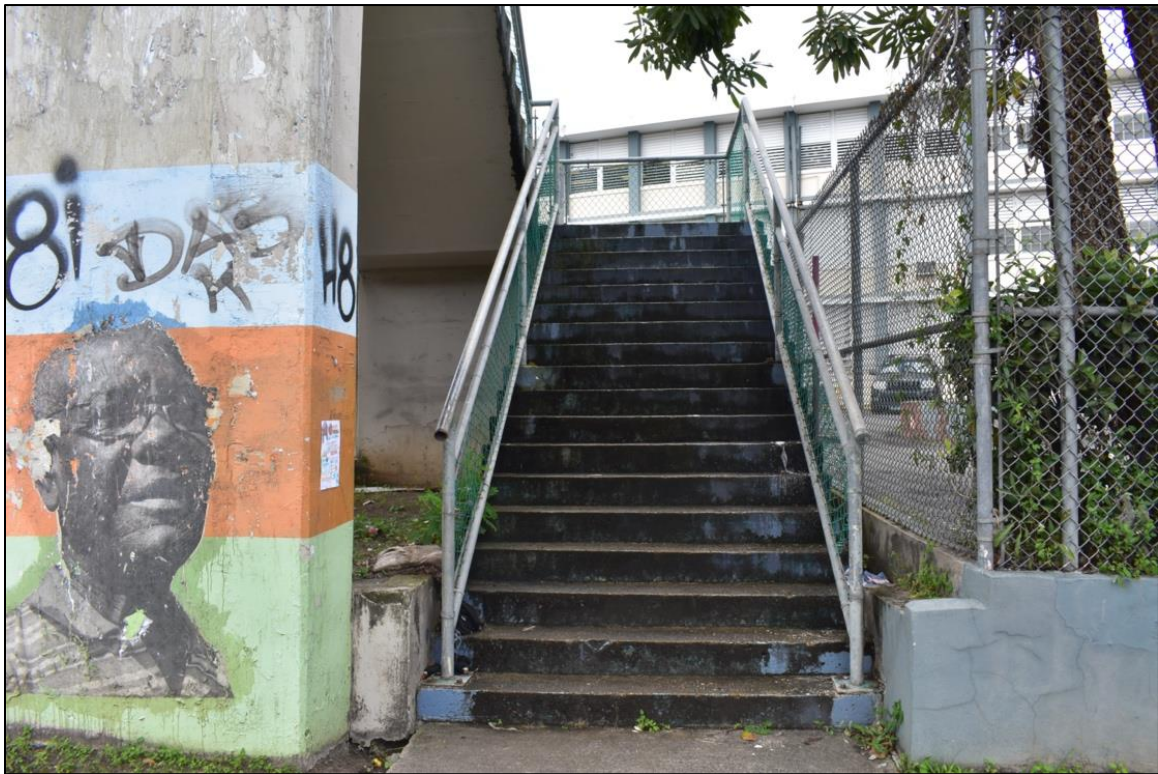
Figure 6.25: Mold and silt on stairway of PB 1743

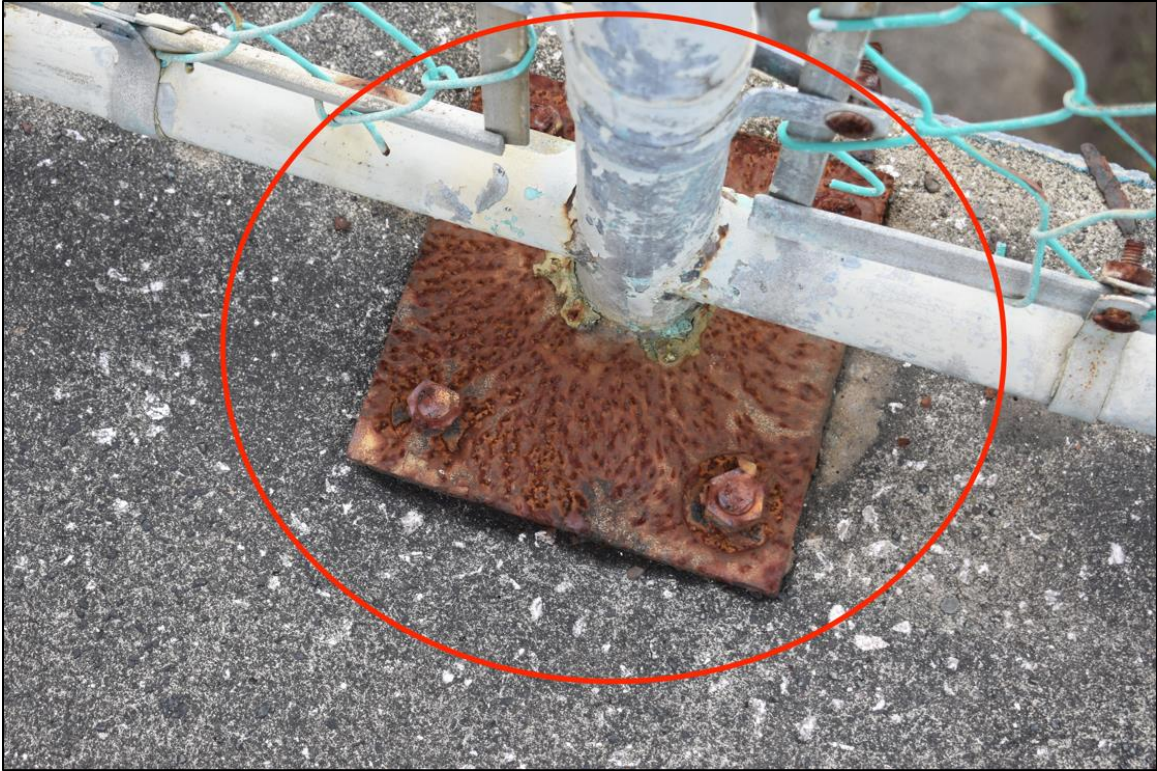
Figure 6.26: Corrosion of security fencing of PB 1743

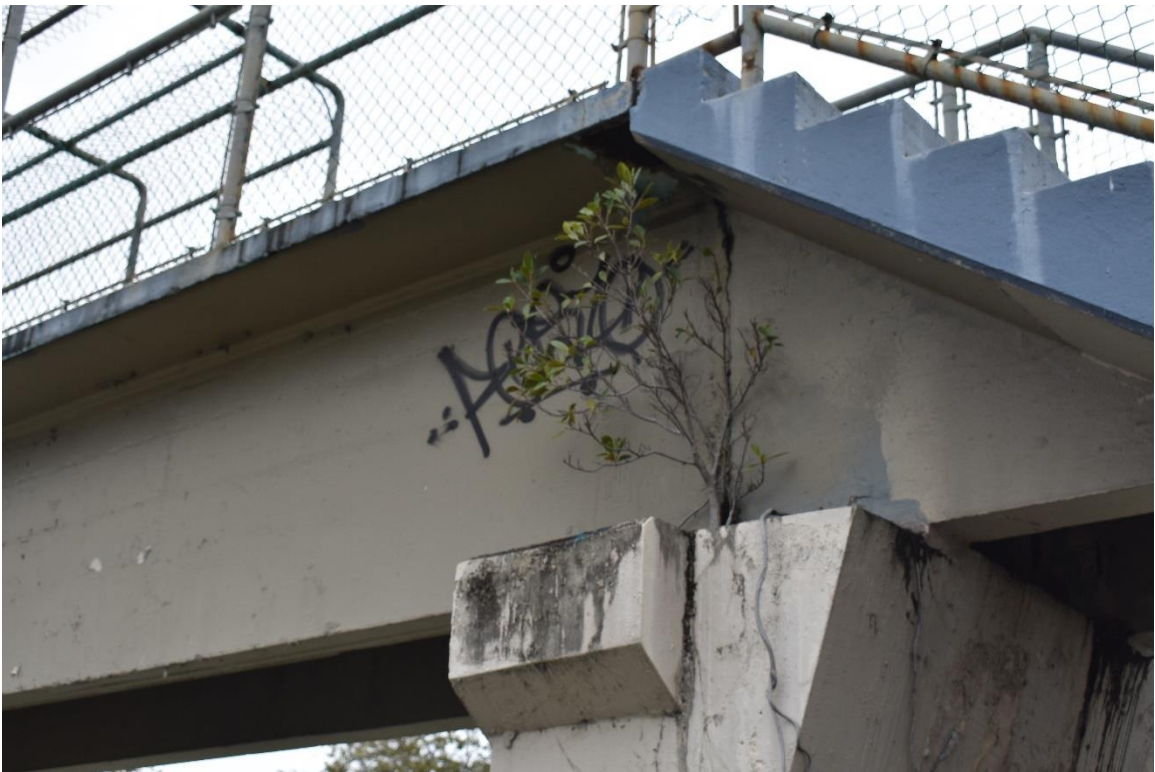
Figure 6.27: Vegetation on pier of PB 1743

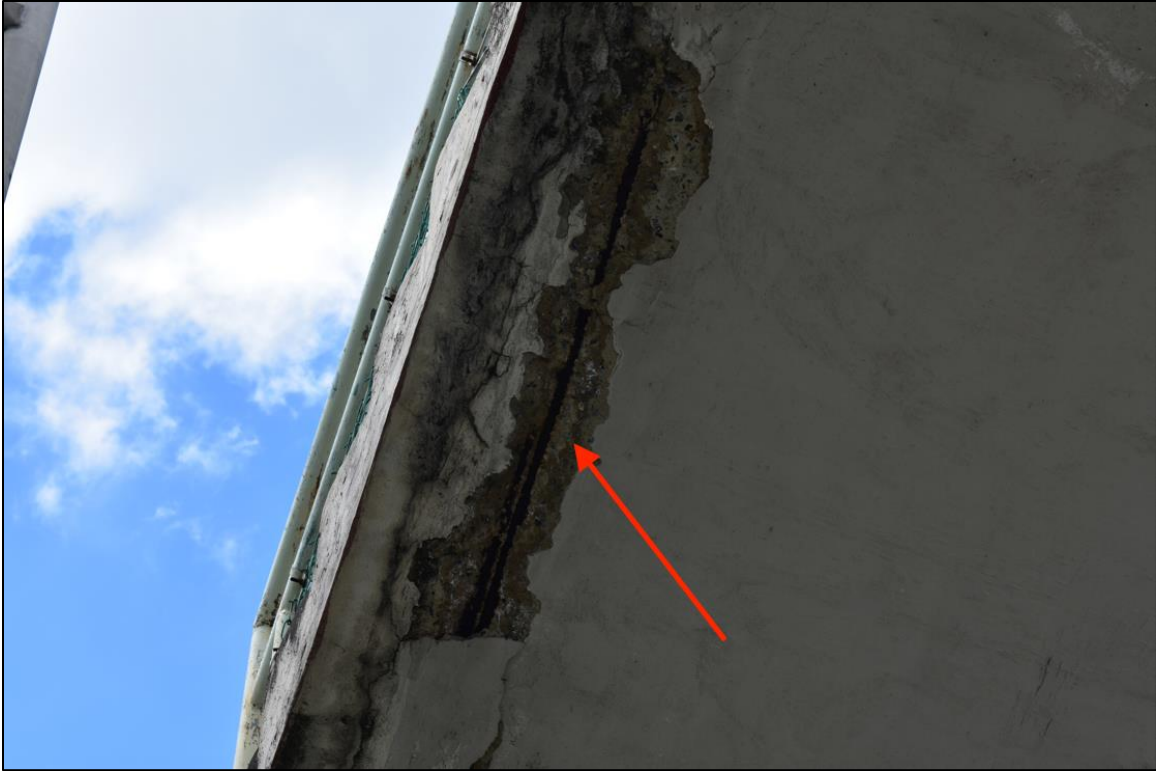
Figure 6.30: Exposed rebar on PB 2087

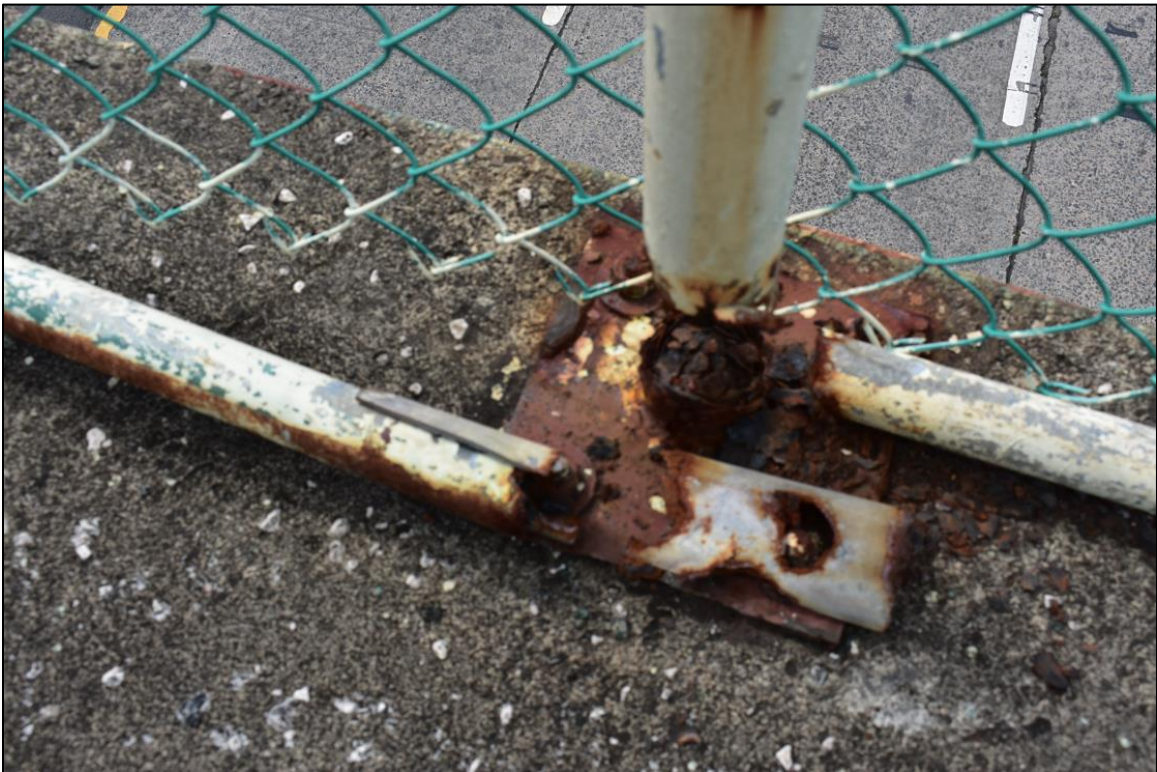
Figure 6.33: Corrosion of security fencing on PB 2087

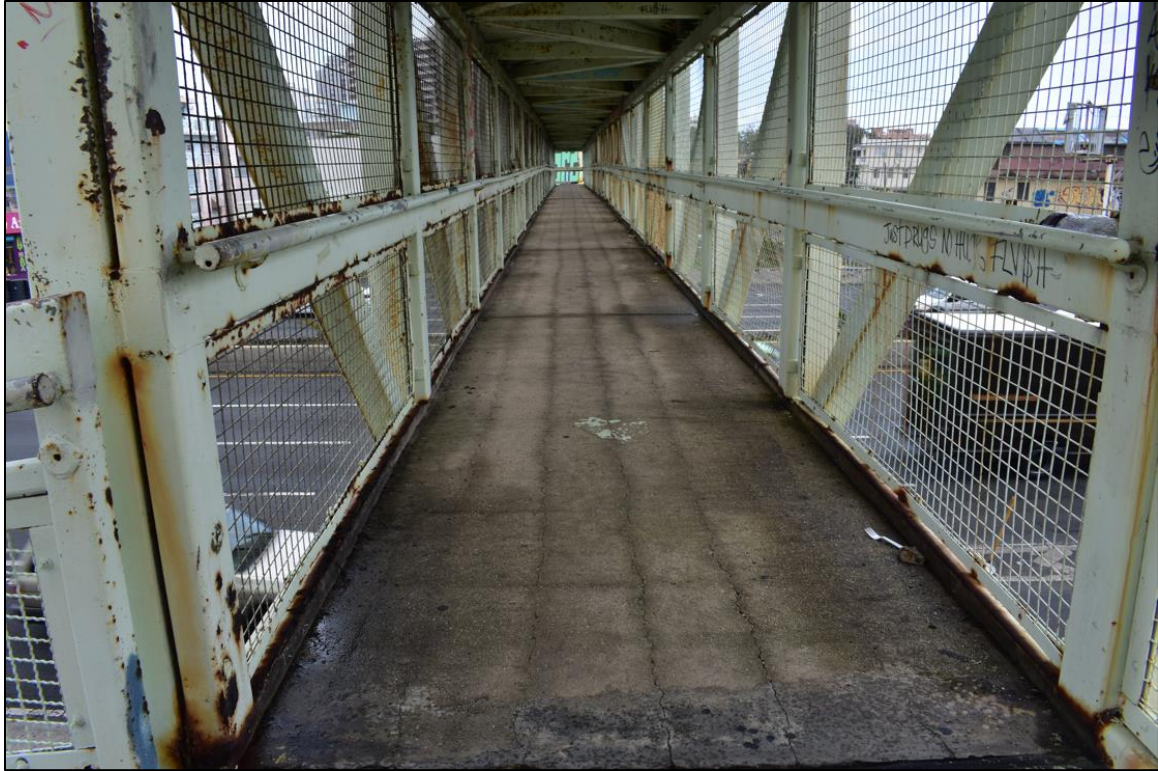
Figure 6.38: Corrosion on the superstructure of PB 2682

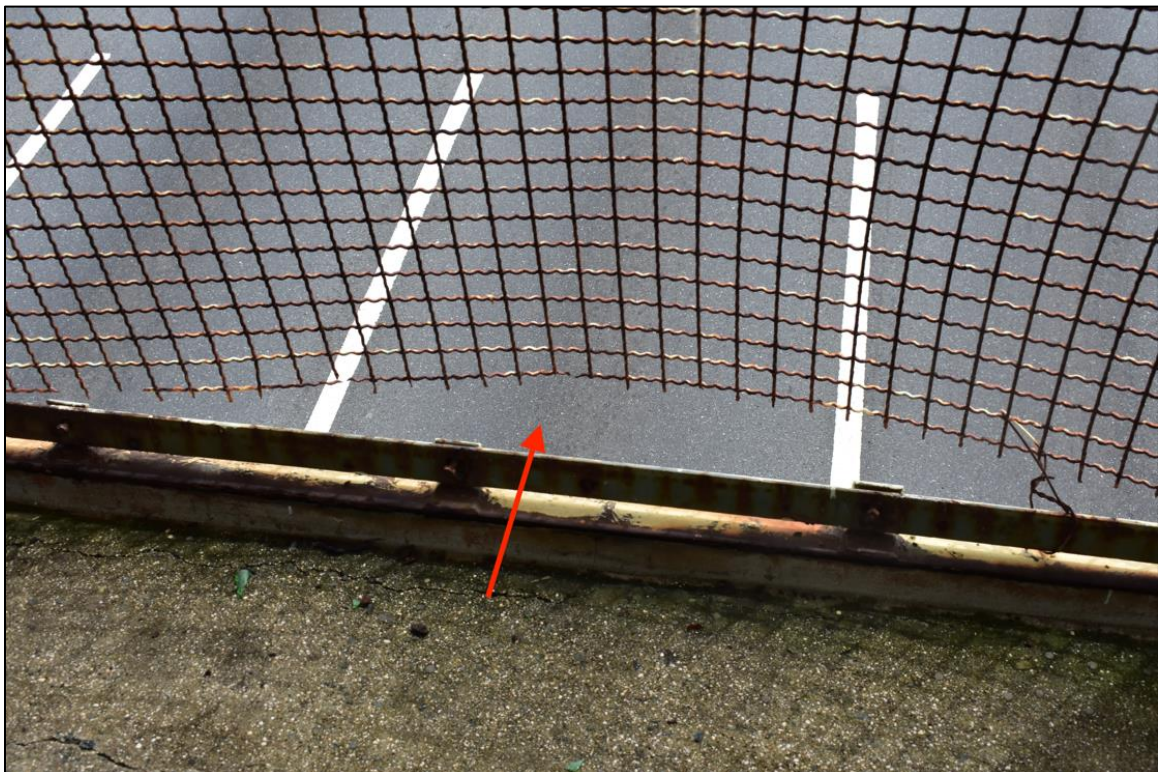
Figure 6.39: Detachment of security mesh on PB 2682

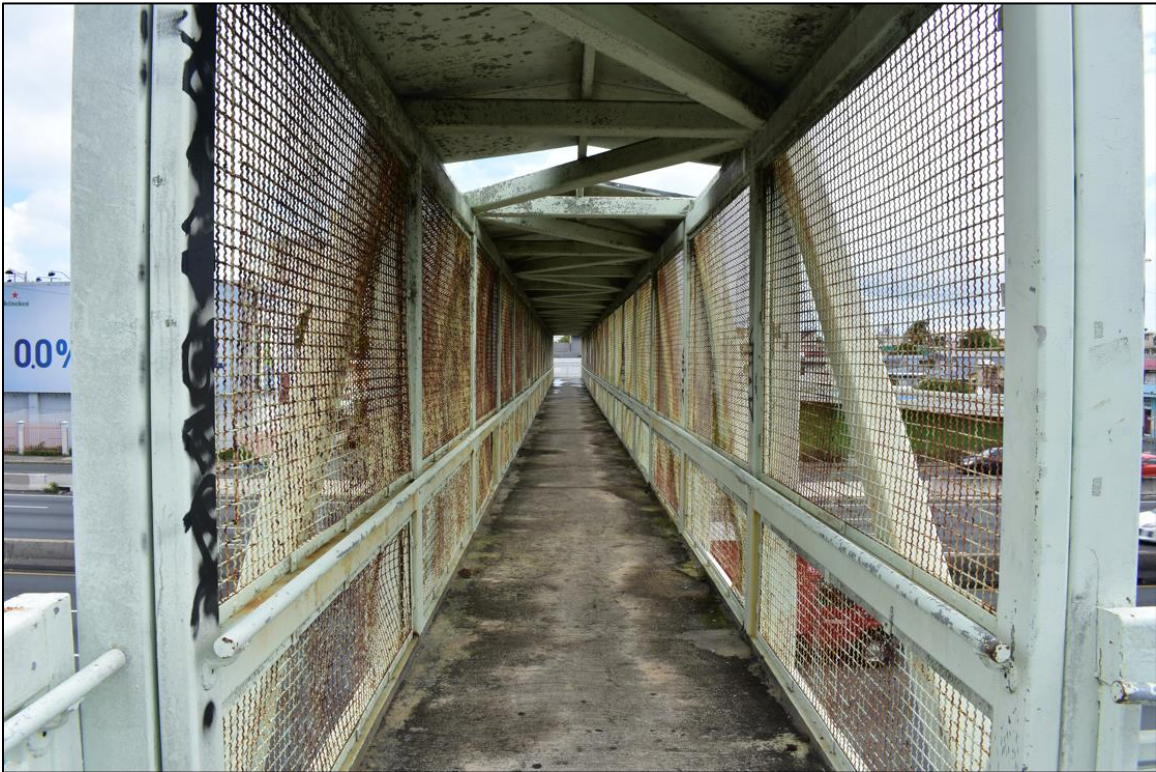
Figure 6.40: Corrosion on the superstructure of PB 2683

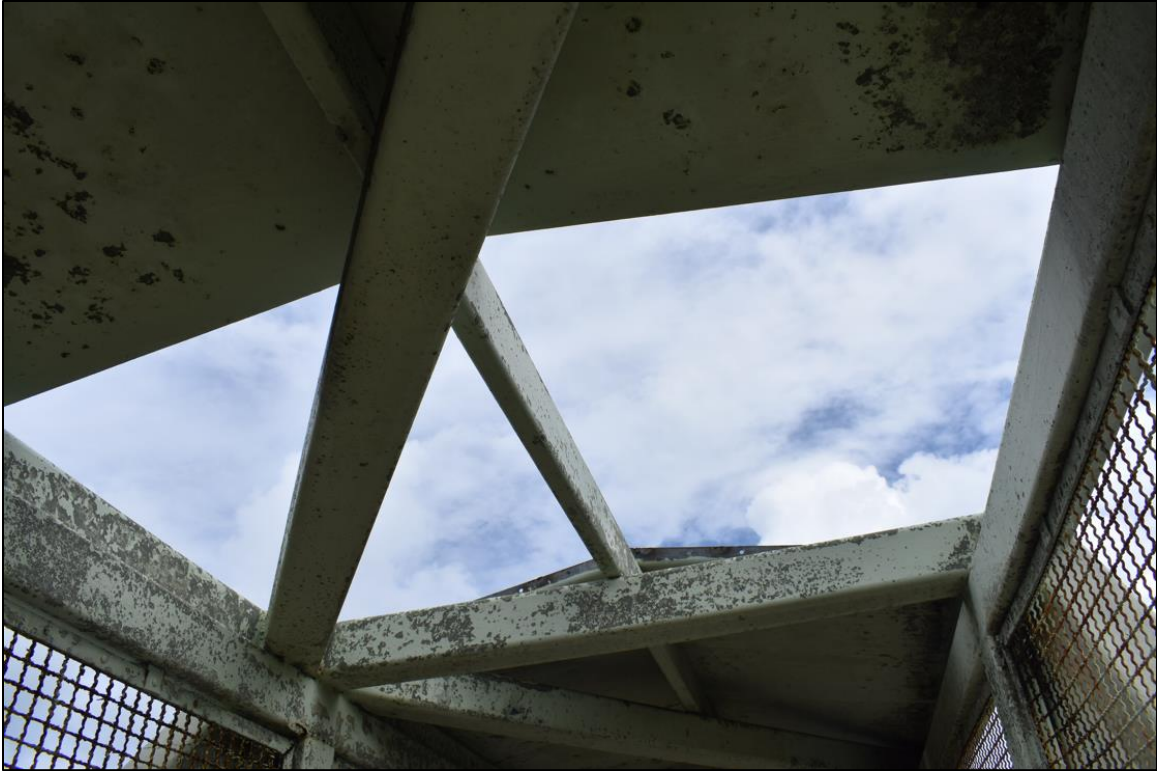
Figure 6.41: Missing roof panel on PB 2683

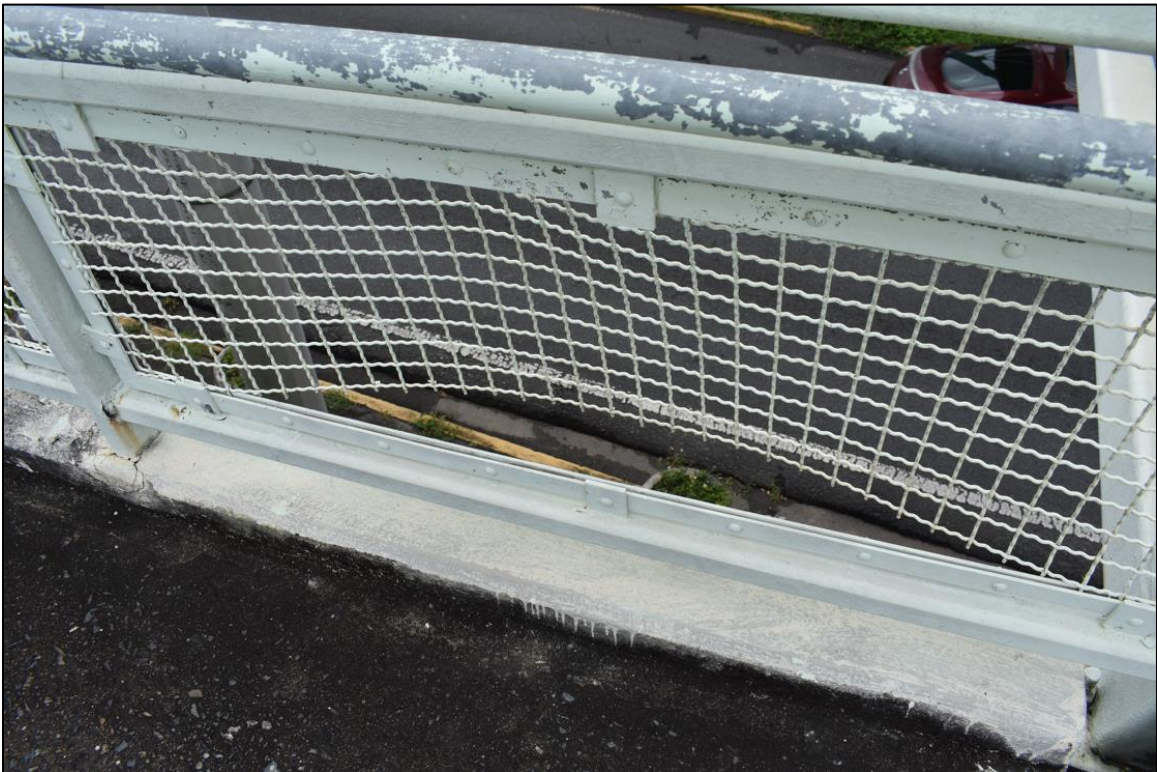
Figure 6.42: Detachment of security mesh on PB 2683

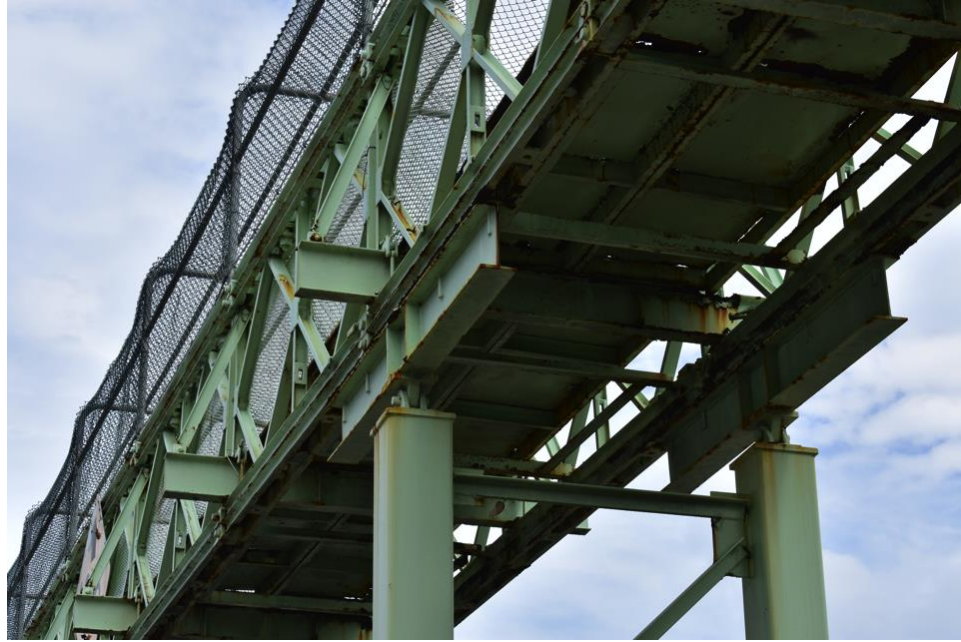
- Deck - Condition State 4 - It was evaluated in this condition due to the corrosion along the complete deck, causing some holes. Also due to corrosion, some bracing elements had fallen off. Falling elements are a major threat to safety since the bridge is located above a principal roadway of Puerto Rico. Figure 5.8 shows that corrosion had already eaten up part of the steel deck surface (as appreciated by the sunlight passing through the deck) and that diagonal bracings have fallen off. The type of diagonal bracing that is missing in Figure 5.8, can be somewhat appreciated in Figure 5.9, which itself shows an incomplete set of diagonals.

Figure 5.8: Loss of Decking due to Corrosion and Missing Bracing Elements

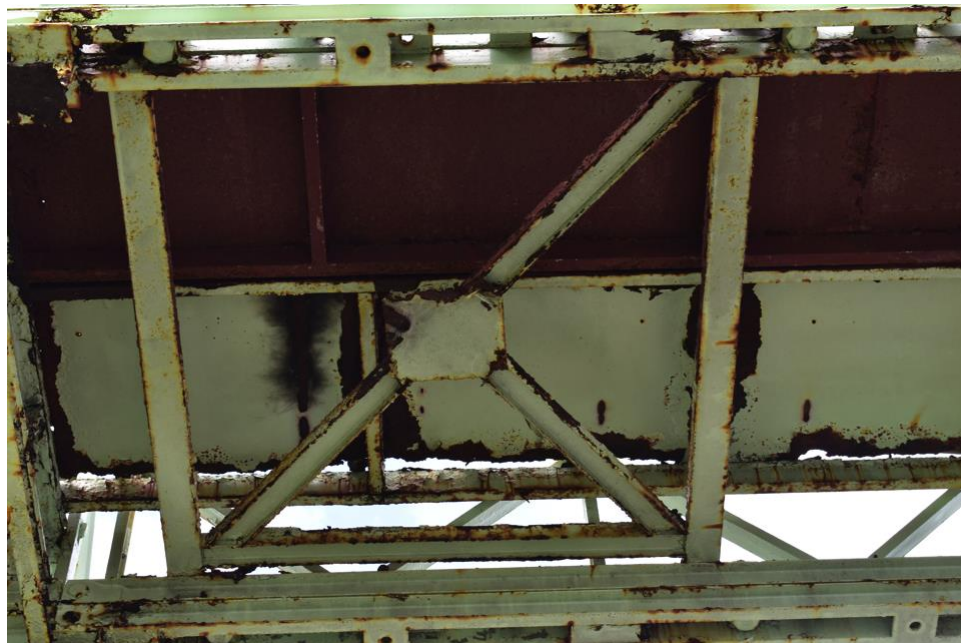
Figure 5.9: Missing Bracing Elements

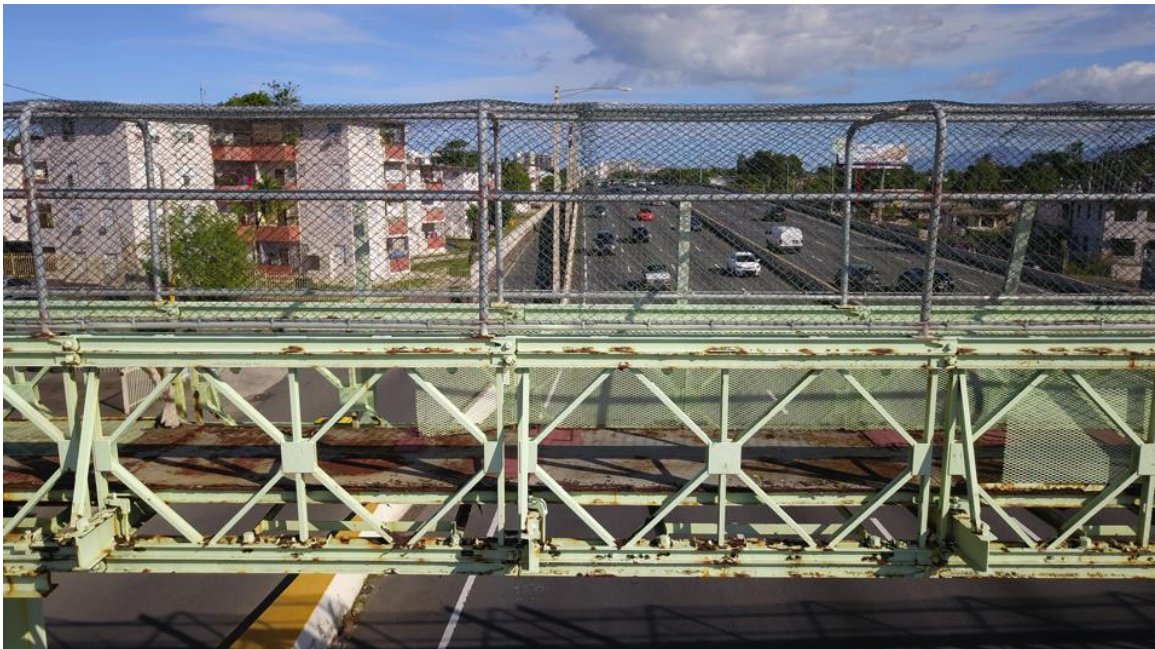
state 4, the whole superstructure was determined as this state. This determination was based on if a truss element fails, it will compromise the integrity of the whole structure. In Figure 5.10, Figure 5.11 and Figure 5.12 the uniform corrosion along the truss may be seen. Going even further, in Figure 5.11 and Figure 5.12 some areas have holes in the channel of the truss due to the corrosion. Because of this level of corrosion, the channels were given a condition state 4. In Figure 5.13 and Figure 5.14 a uniform corrosion may be seen on top of the beam and crevice corrosion may be seen where the beam is in contact with the channel. It is evident that corrosion is present, but since the bridge was closed at the time of the inspection, a closer observation was not possible. From afar, section loss of the beams was not evident, so they were evaluated as condition state 2.

Figure 5.10: Corrosion in Truss Element (Example 1)

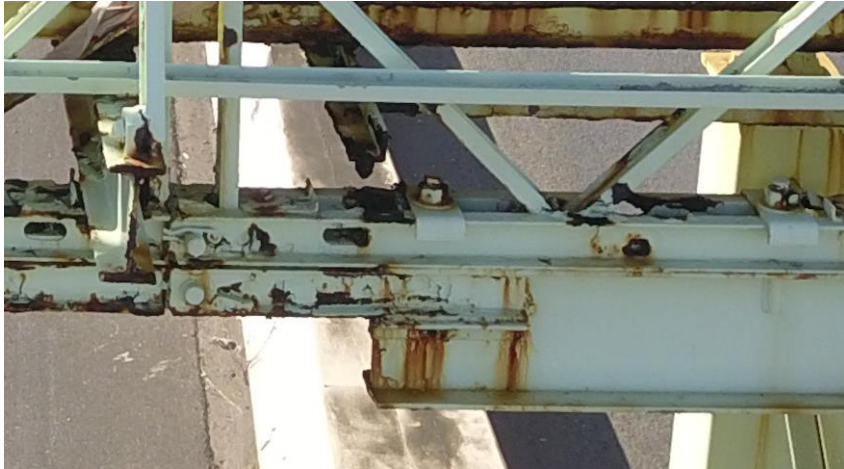
Figure 5.11: Corrosion in Truss Element (Example 2)

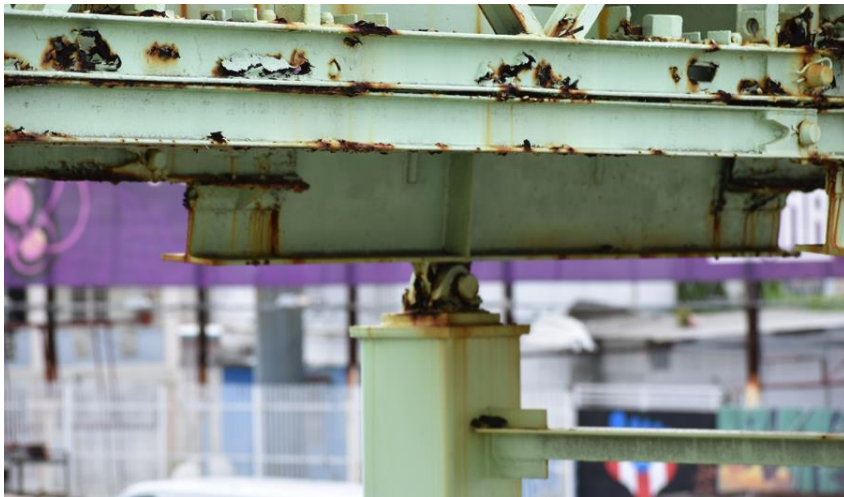
Figure 5.12: Corrosion in Truss Element (Example 3)

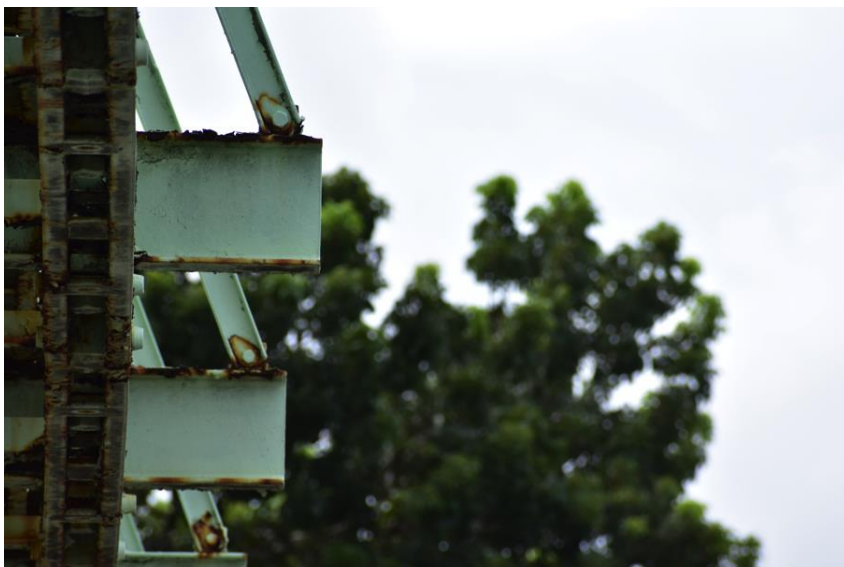
Figure 5.13: Corrosion in Floor Beams (Example 1)

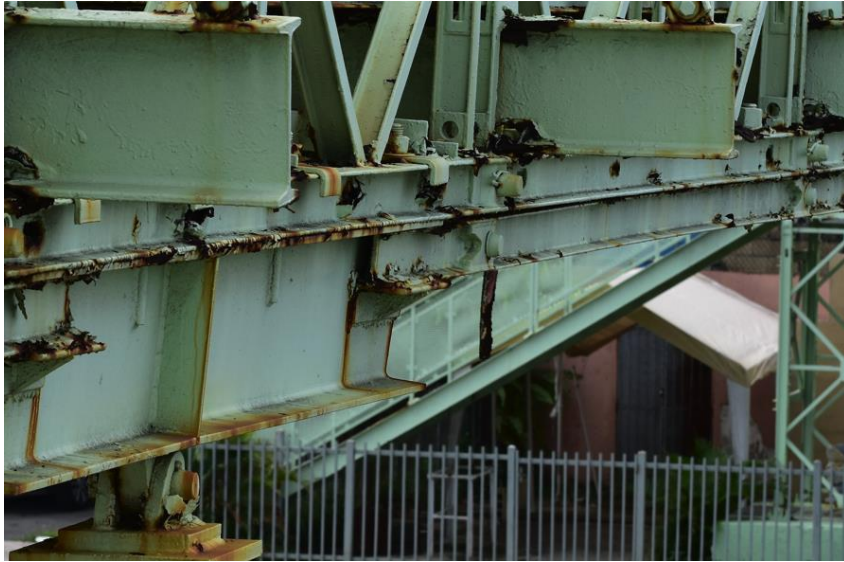
Figure 5.14: Corrosion in Floor Beams (Example 2)

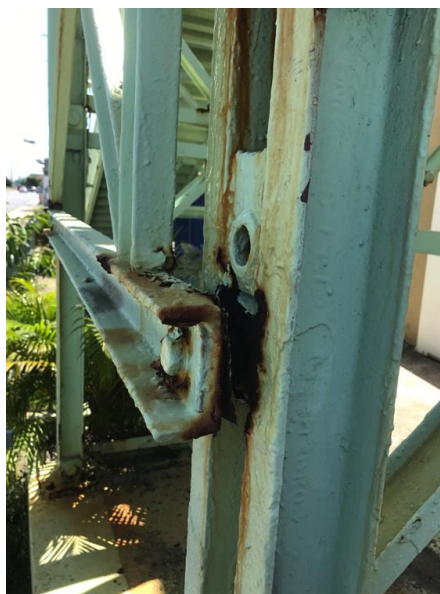
- Substructure - Condition State 4 - The substructure consists of the columns and the column tower. Even though the columns were found in good condition, the column towers were missing connections. Due to the missing connections the overall condition given to the substructure was 4, as in the case of the superstructure. In Figure 5.15 and Figure 5.16 a loose connection and a section loss due to corrosion are presented, respectively.

Figure 5.15: Loose Connection at Column Tower

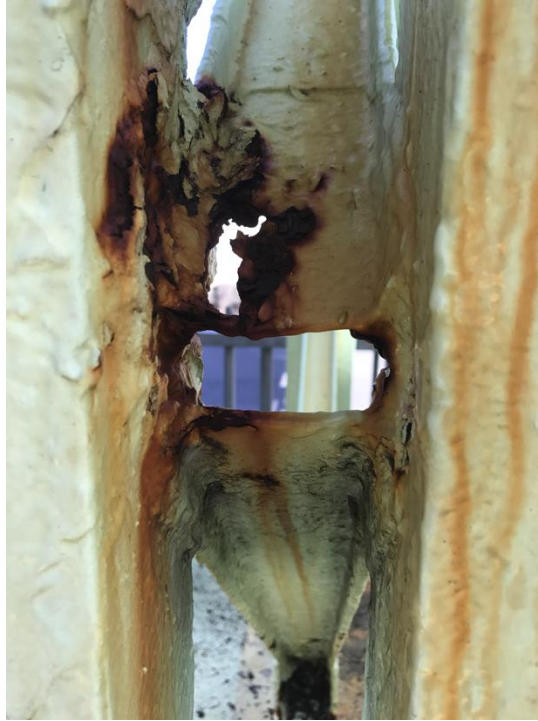
Figure 5.16: Section Loss due to Corrosion at Column Tower

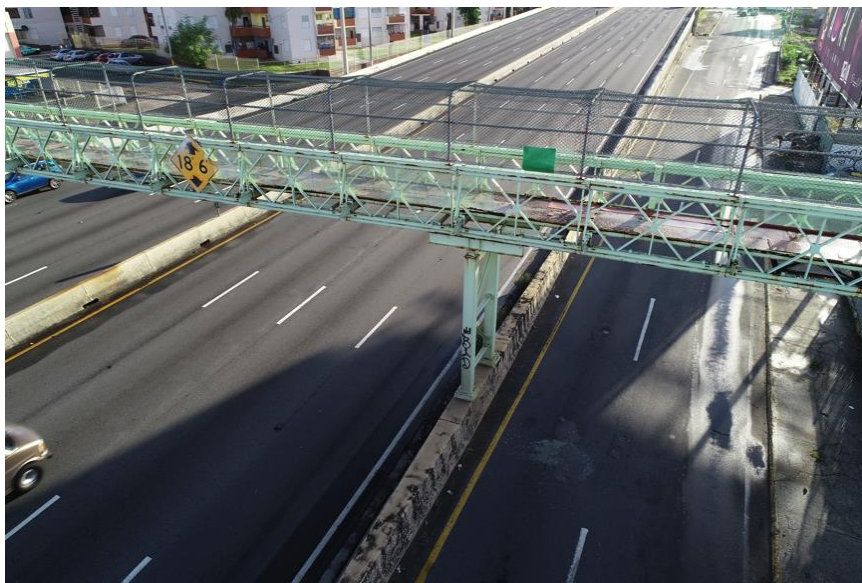
- Wearing Surfaces - Condition State 3 - This item was evaluated in the condition state 3 because of the limited effectiveness the paint has, due to the evident corrosion in the structure, as it may be appreciated in Figure 5.17.

Figure 5.17: Painting Effectiveness in Corrosion

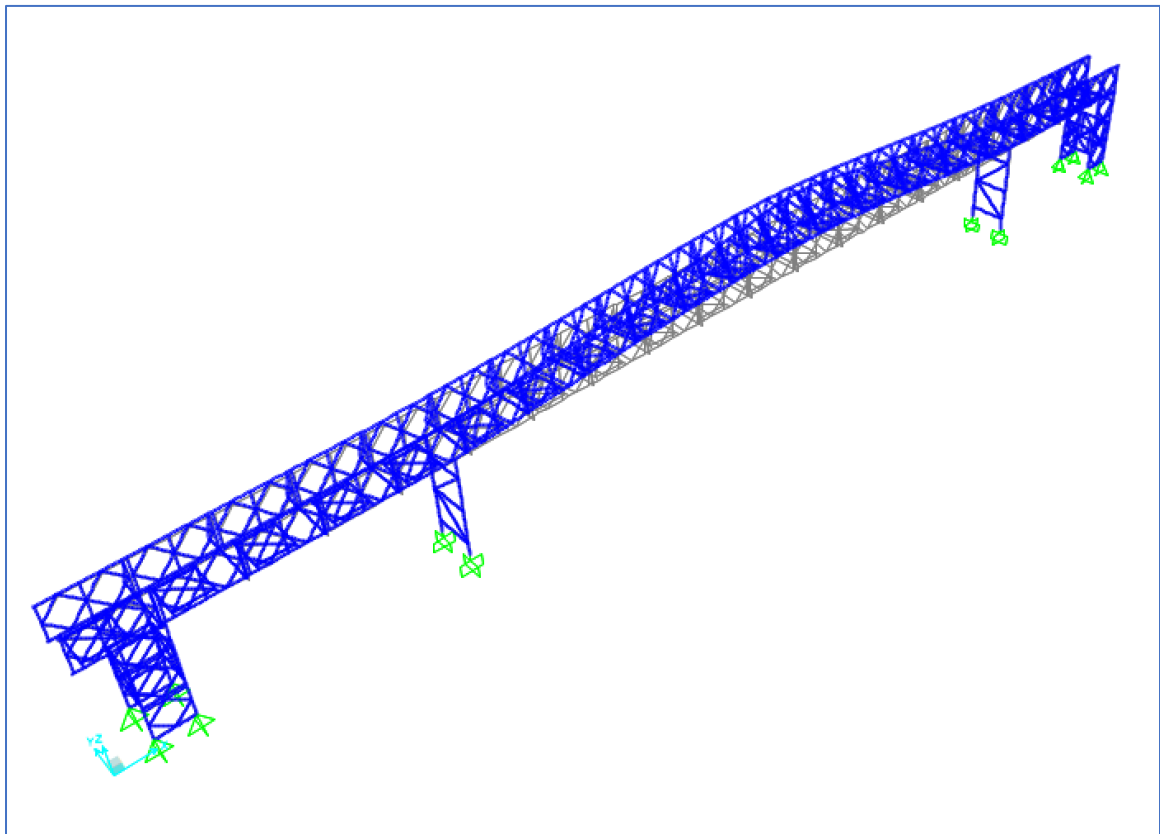
Figure 8.12 presents an image of the resulting lateral deflections due to wind action. It can be appreciated that the general behavior observed on the bridge, with the plastic deformation, is captured.

Figure 8.12: Lateral Deflections due to Wind - With Signs Included

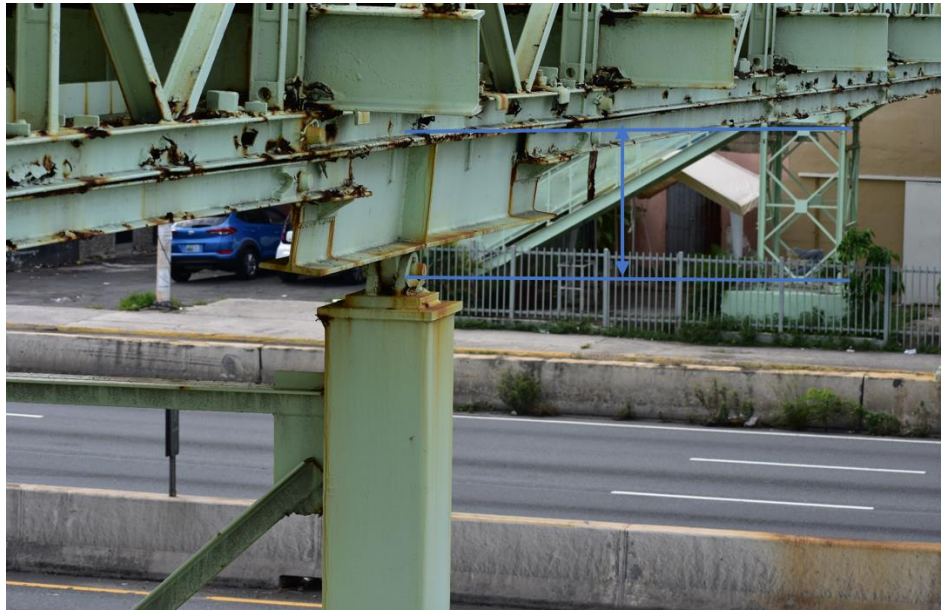
Figure 8.14 displays that the hinge support plate appeared to have experienced lateral deflection, resulting in twisting of the upper beam. This situation may be probably due to eccentricity between the lateral load applied by chords on top of the beam and the hinge location. Figure 8.15 presents other view of this situation. This condition requires further study to assess a proper design and may be an extension of current project.

Figure 8.14: Eccentricity of Pin-Plate and Lateral Load

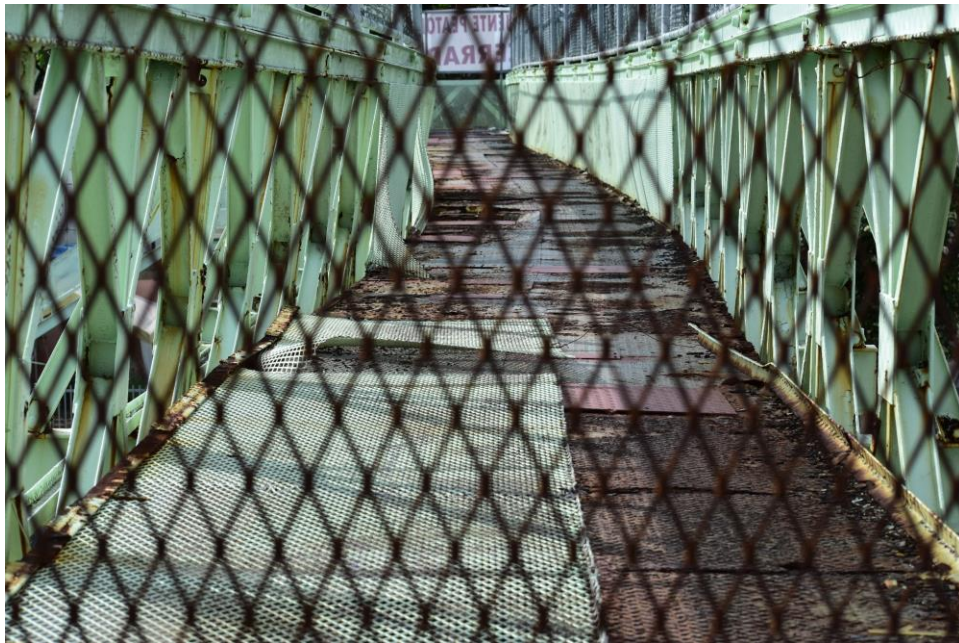
Figure 8.17: Twist of the Truss Panel
