# Non-Cementitious Repair Materials Study

Final Report

WisDOT Project No. 0092-18-02  
June 2019

WISCONSIN HIGHWAY RESEARCH PROGRAM

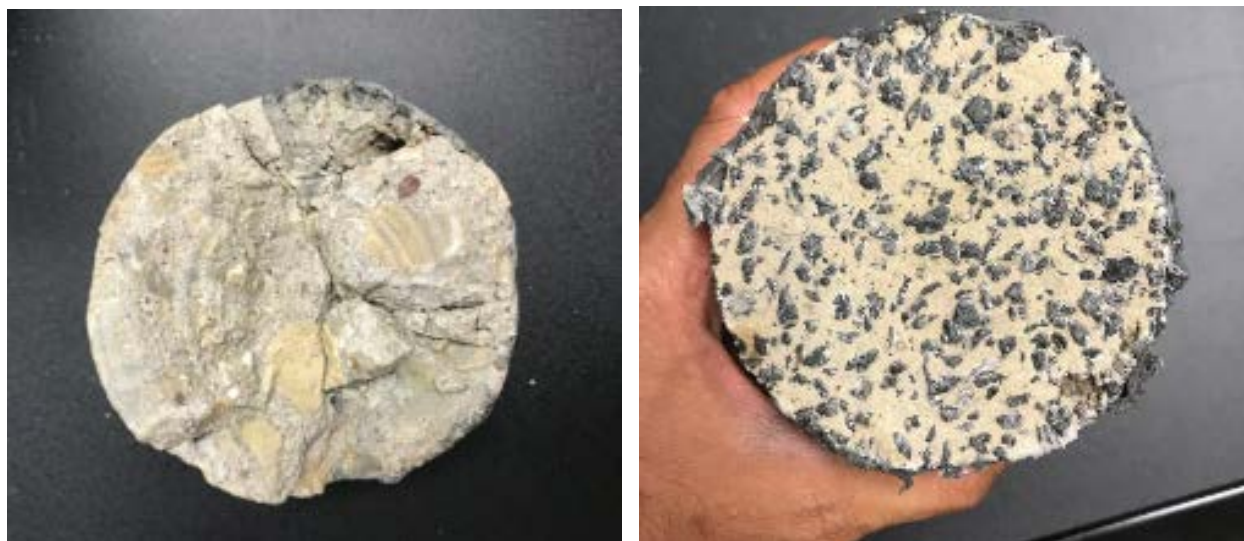
The PDR was debonded from the substrate concrete, but upon examination of the bottom of the debonded repair material (see figure 3-4), it was evident that the failure had occurred in the concrete and not in the repair material.

Figure 3-4. Close-up view of the bottom (left) and top (right) of RM-1 core #1.

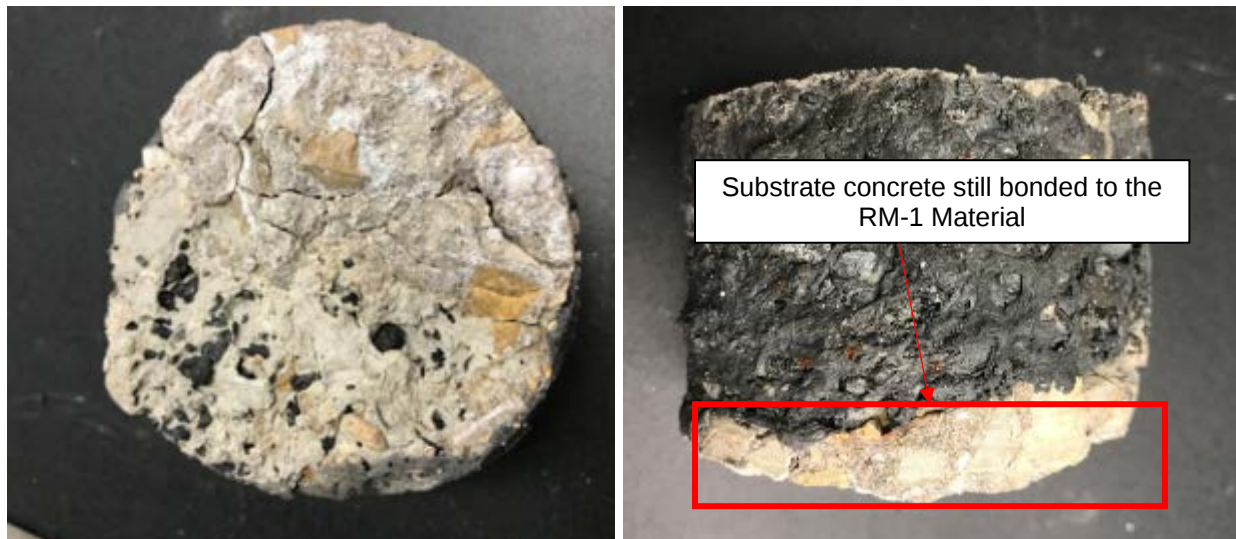
Figure 3-6. Close-up view of the bottom (left) and side (right) of the debonded portion from core #2.

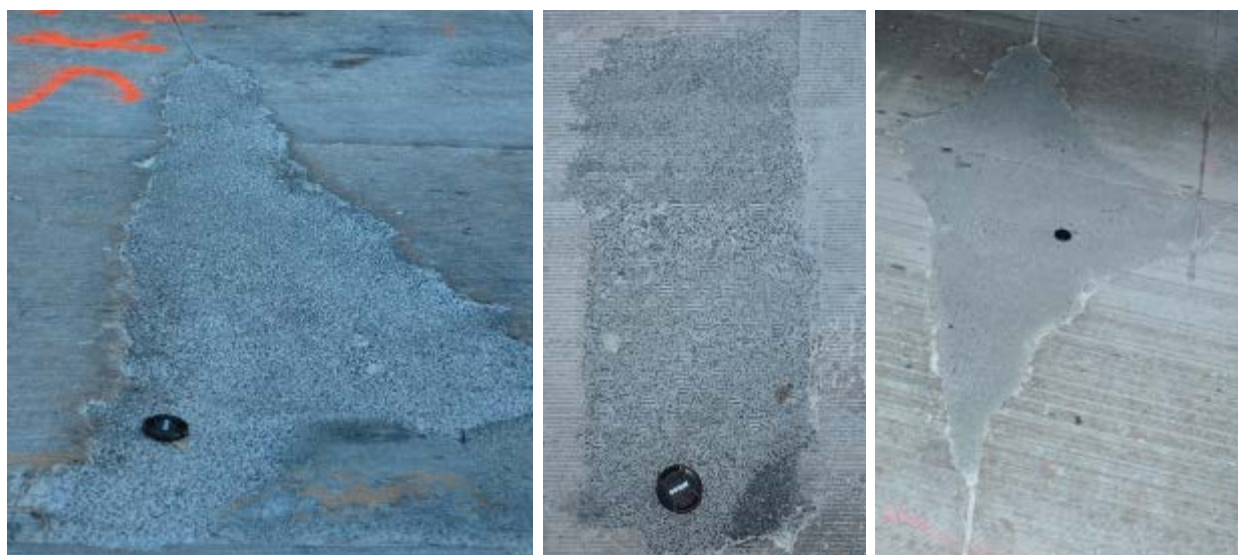
Several other RM-1 PDRs were visually inspected at this site (site #1). On the surface, most of the PDRs showed no signs of damage (see figure 3-9) and the surface condition was noted to be Good to Excellent for most of the PDRs. However, some of the thinner PDRs simply peeled off from the surface (see figure 3-10) when a hydraulic pavement breaker was used to remove the RM-1 PDRs and prepare the repair areas for full-depth repairs using conventional concrete material. Significant amount of substrate concrete material was still bonded to the bottom of the RM-1 PDRs that peeled off. Appendix B includes additional photos from the RM-1 field investigations.

Figure 3-9. RM-1 PDRs on the Madison Beltline.

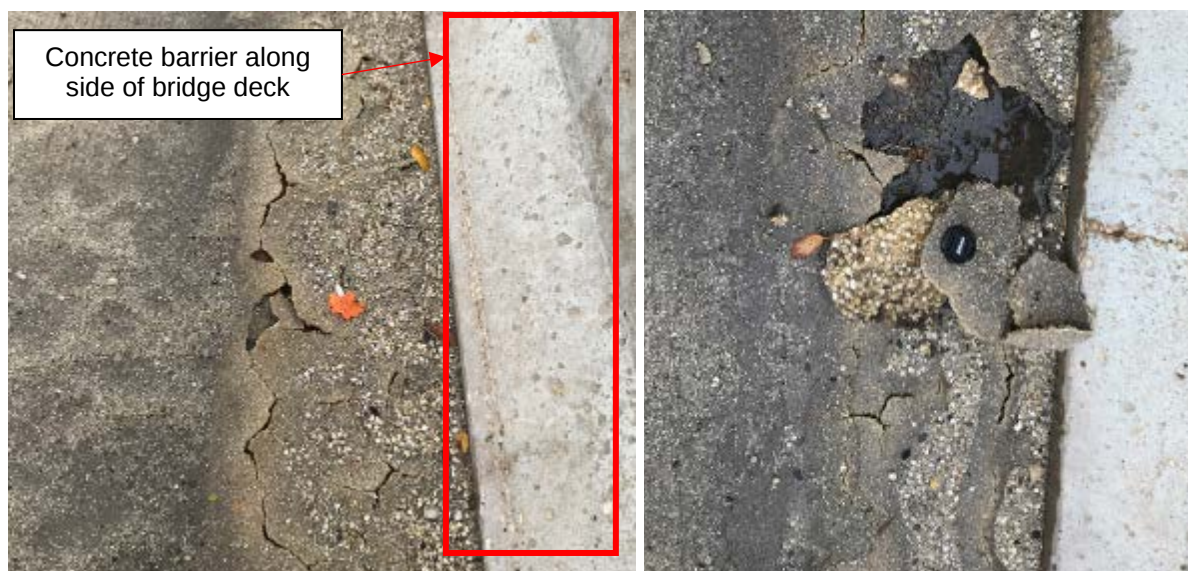
The RM-2 overlay was generally in Excellent condition on all of the bridge deck sites visited. The only exception was Site #3, where the top 0.25 inches of the overlay was peeling off from the deck. This deterioration was isolated to the edge of the decks (see figure 3-12). The material manufacturer has investigated the failure and deduced that the material was either under-catalyzed or the presence of moisture in the mix aggregates resulted in the failure noted. The contractor had agreed to remove and replace the deteriorated areas.

Figure 3-12. Top one-third of the RM-2 overlay peeling off along the deck edge (Site #3).

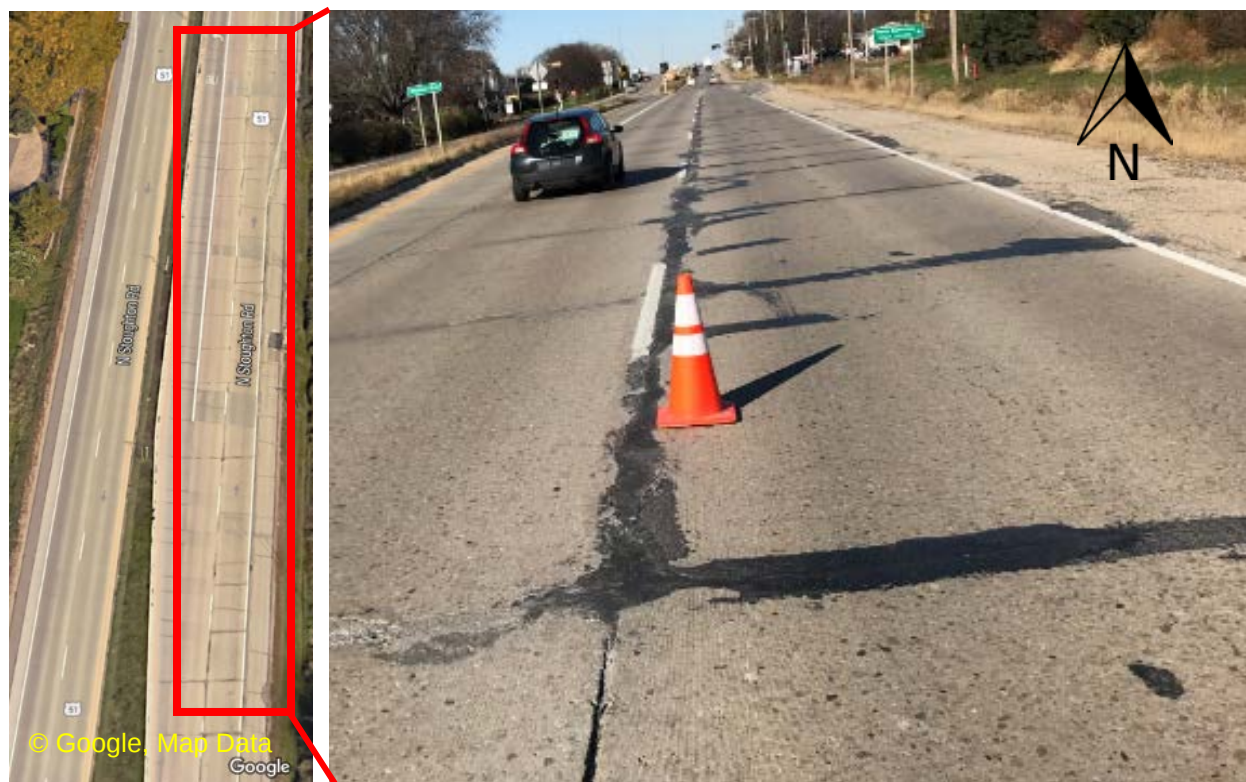
One core each was extracted from the Madison (Site #20) and Waukesha (Site #23) sites. At Site #20, the material was used to repair a heavily distressed transverse joint with severe spalling and cracking along the slab edges. Site #20 is located on US-51/N. Stoughton Road (Northbound lanes, see figure 3-23). Almost every single transverse joint is severely deteriorated at this location (especially the right lane) and has been repaired with either cold patch material or conventional hot mix asphalt. Considering the fact that the material was used to repair a severely distressed area, the performance after two winter seasons has been Good.

Figure 3-23. Overview of US 51/N. Stoughton Rd northbound lanes(top) and satellite imagery showing severely distressed condition of the north bound lanes.

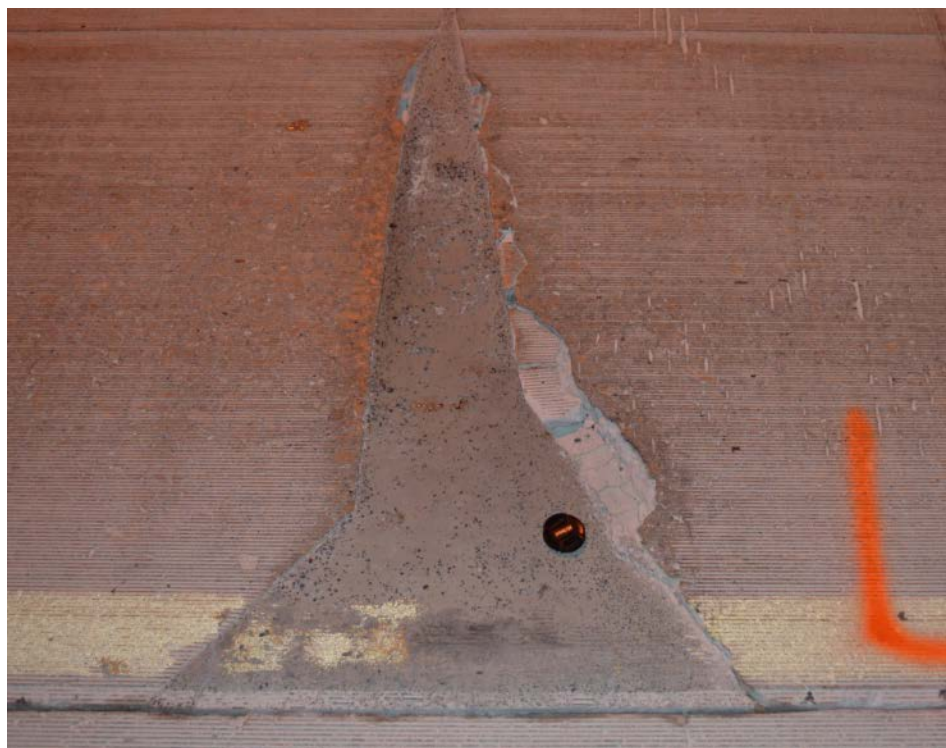
Figure B-6. RM-1 PDR (6)—deterioration along patch edges  
(Site #1, US 12/18, Madison Beltline).

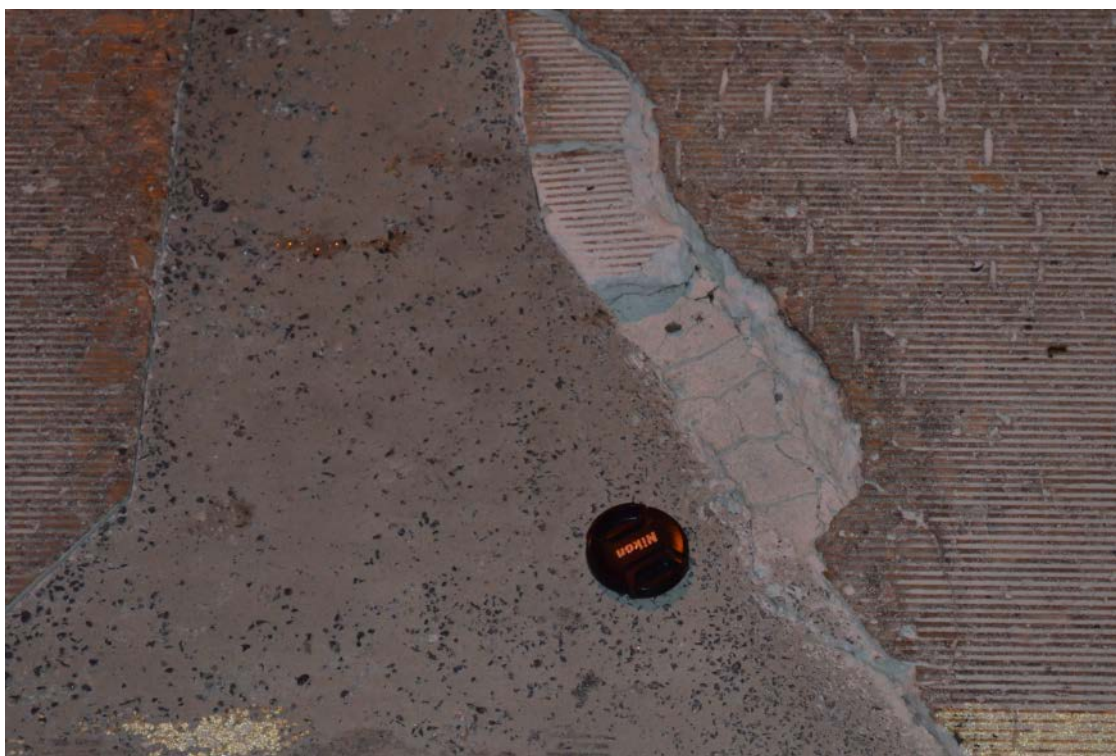
Figure B-7. RM-1 PDR (6)—close-up of deterioration along patch edge (Site #1, US 12/18, Madison Beltline).

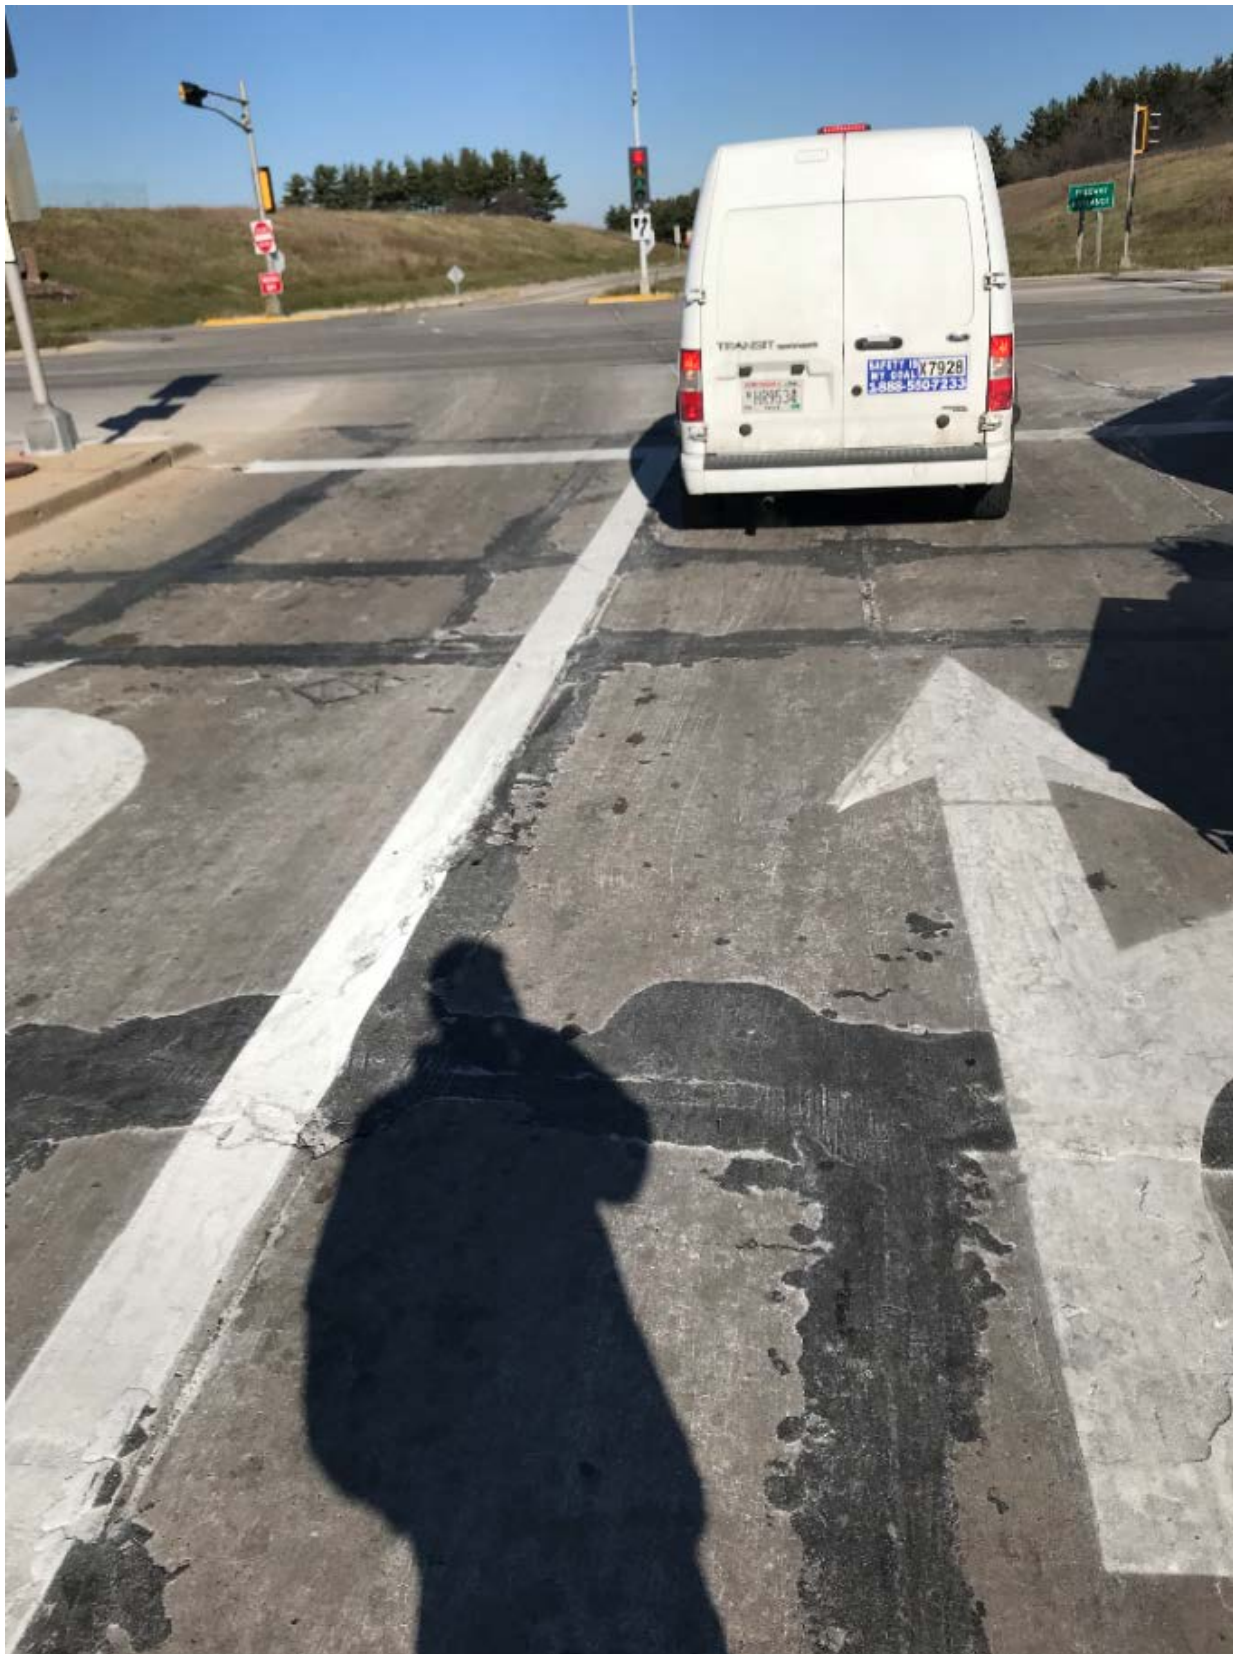
Figure D-1. RM-3 used to repair spalls, deteriorated joints and traffic loops  
(Site #5, W. Wisconsin Ave, Oconomowoc).

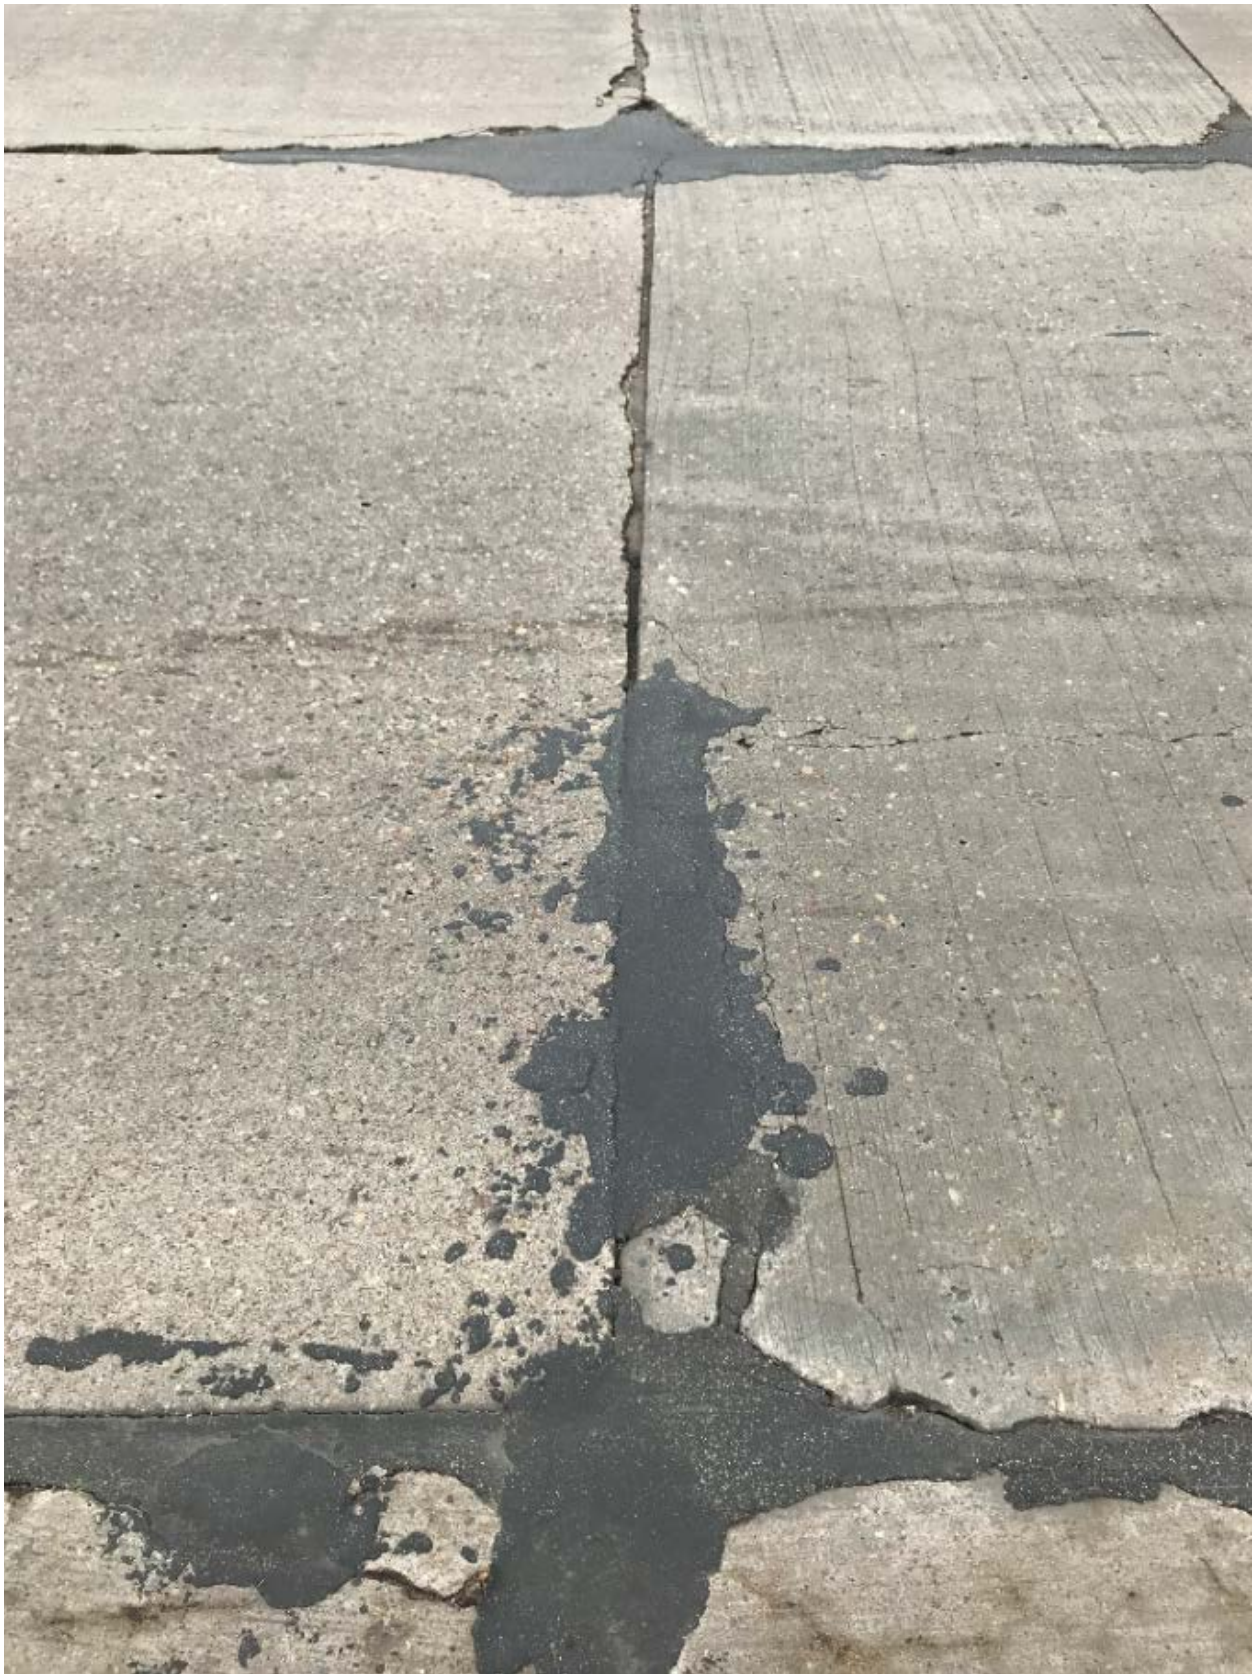
Figure D-2. PDRs to address spalling and deteriorated joints  
(P Site #6, lower Rd., Plover).

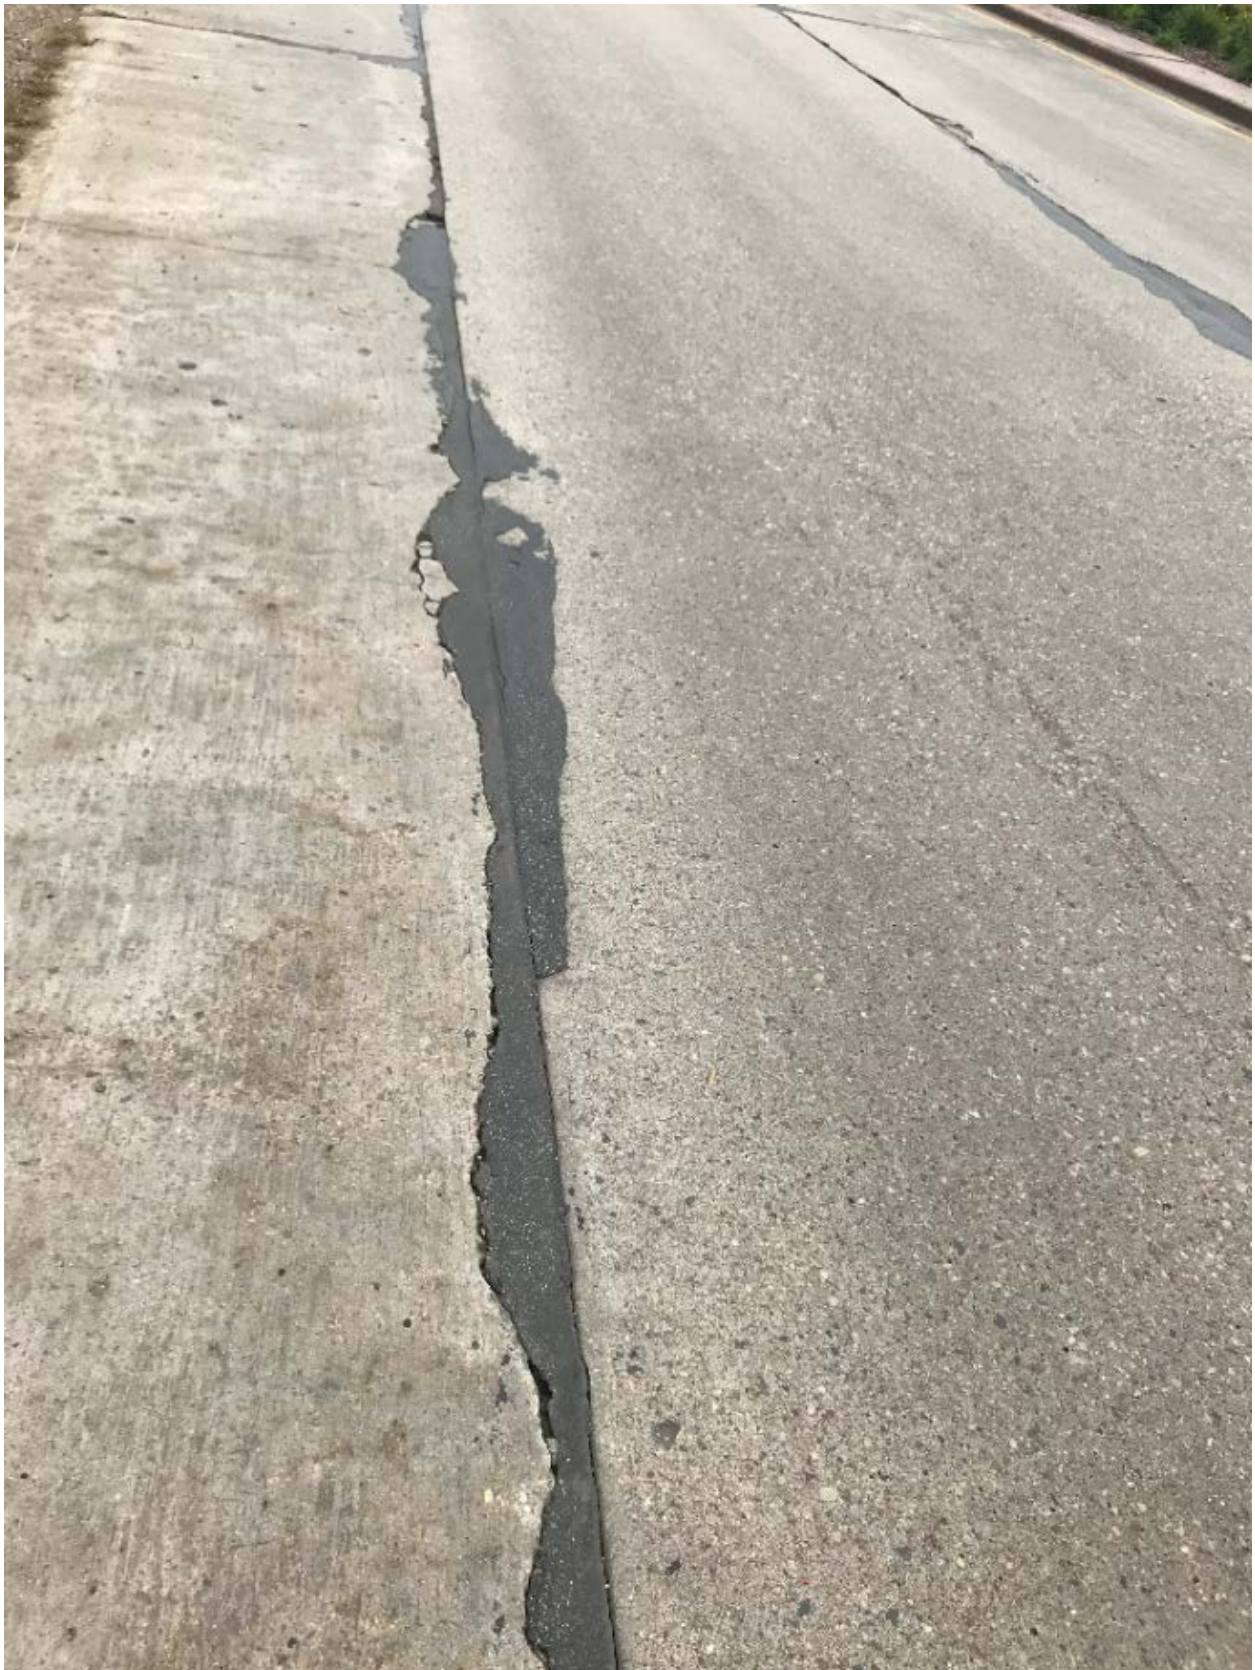
Figure D-3. PDRs to address spalling along lane-shoulder joint  
(Site #6, Plover Rd., Plover).

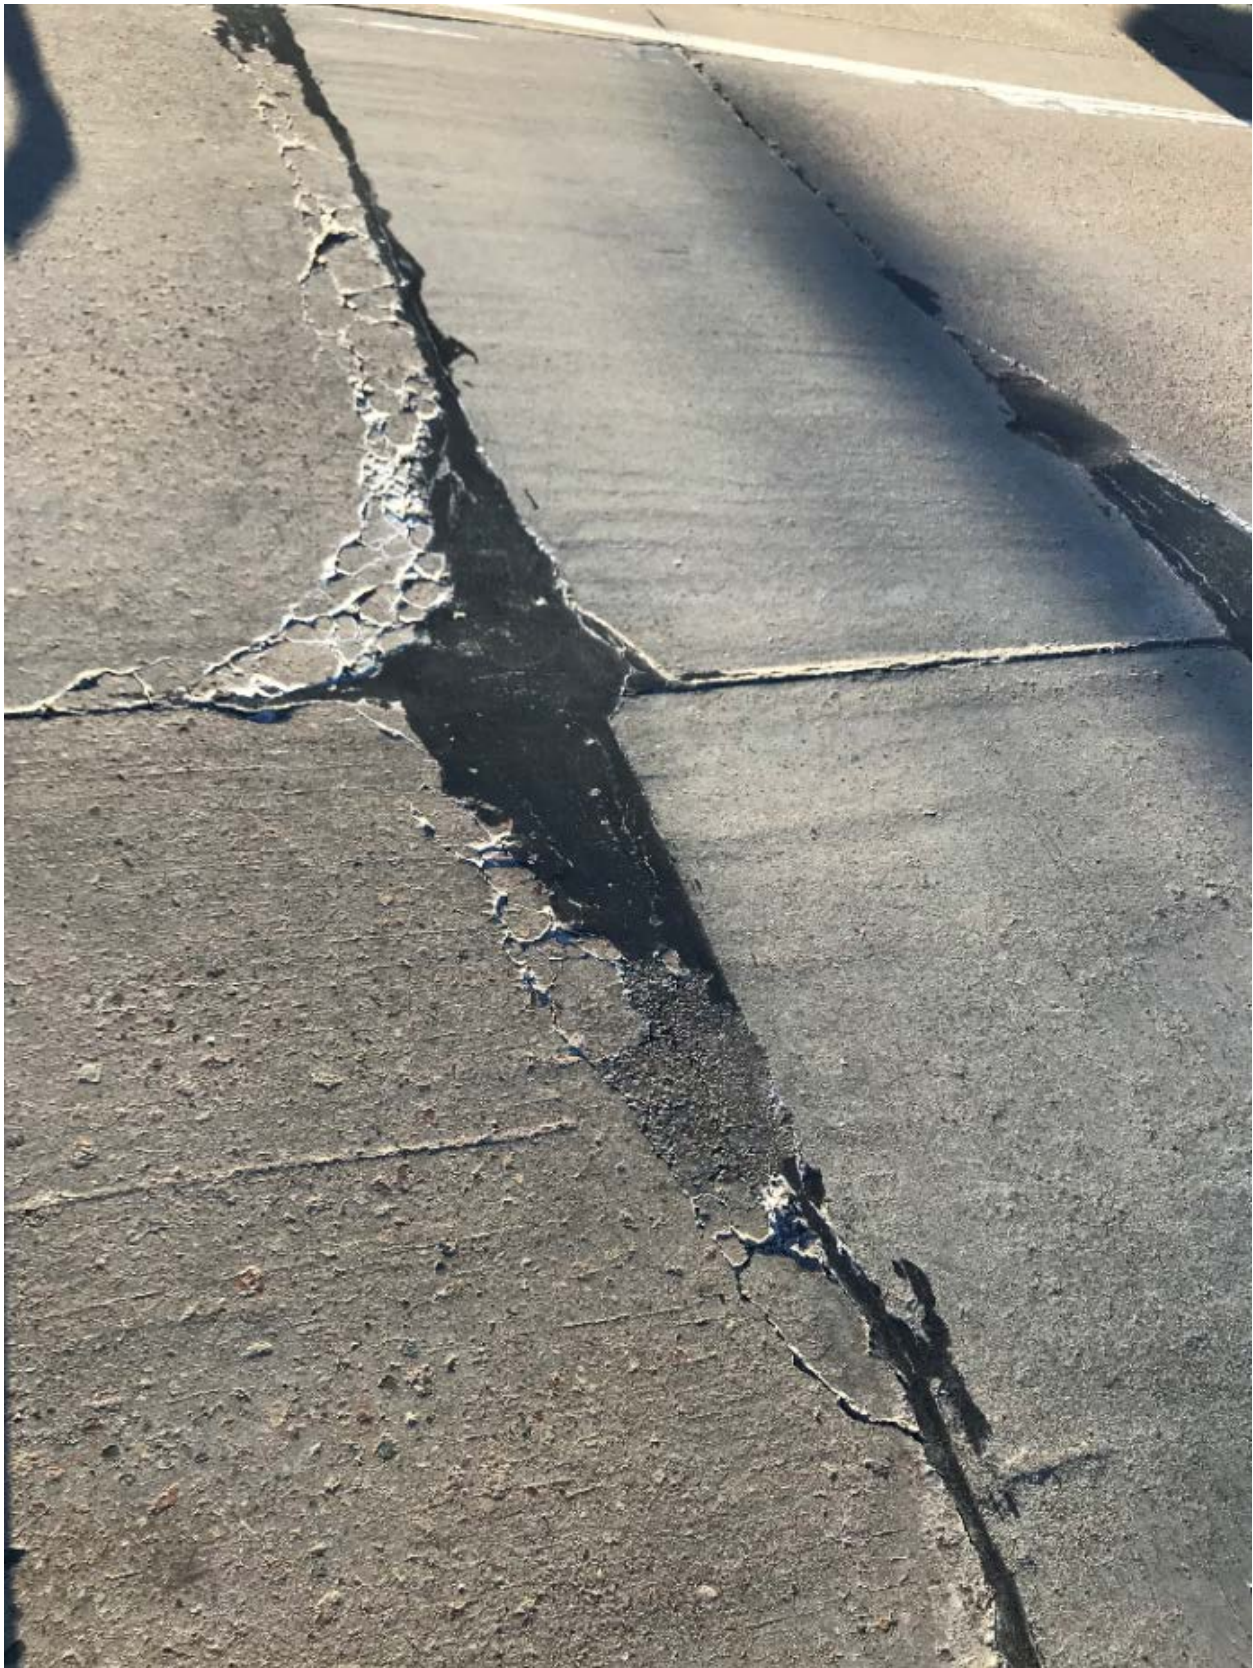
Figure D-8. D Cracking and full-depth repairs in existing concrete pavement (Site #8, State Road 66, Stevens Point).

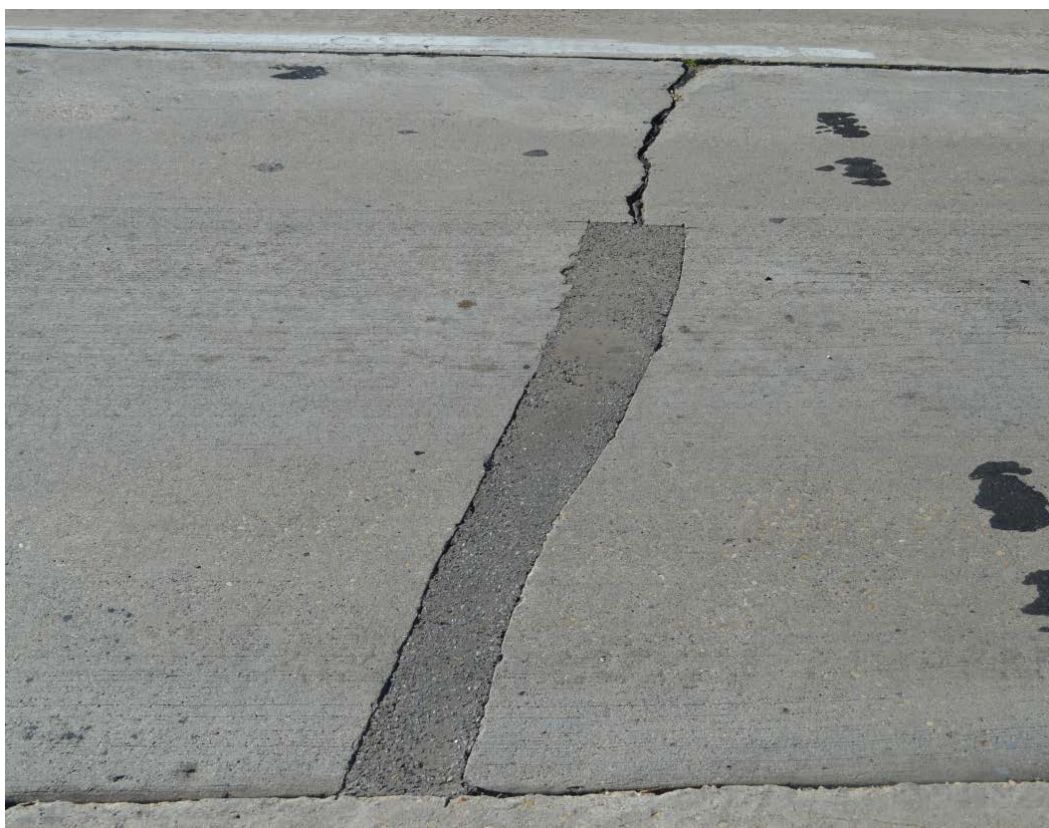
Figure E-3. PDR over a transverse crack  
(Site #9, State Road 66, Stevens Point).

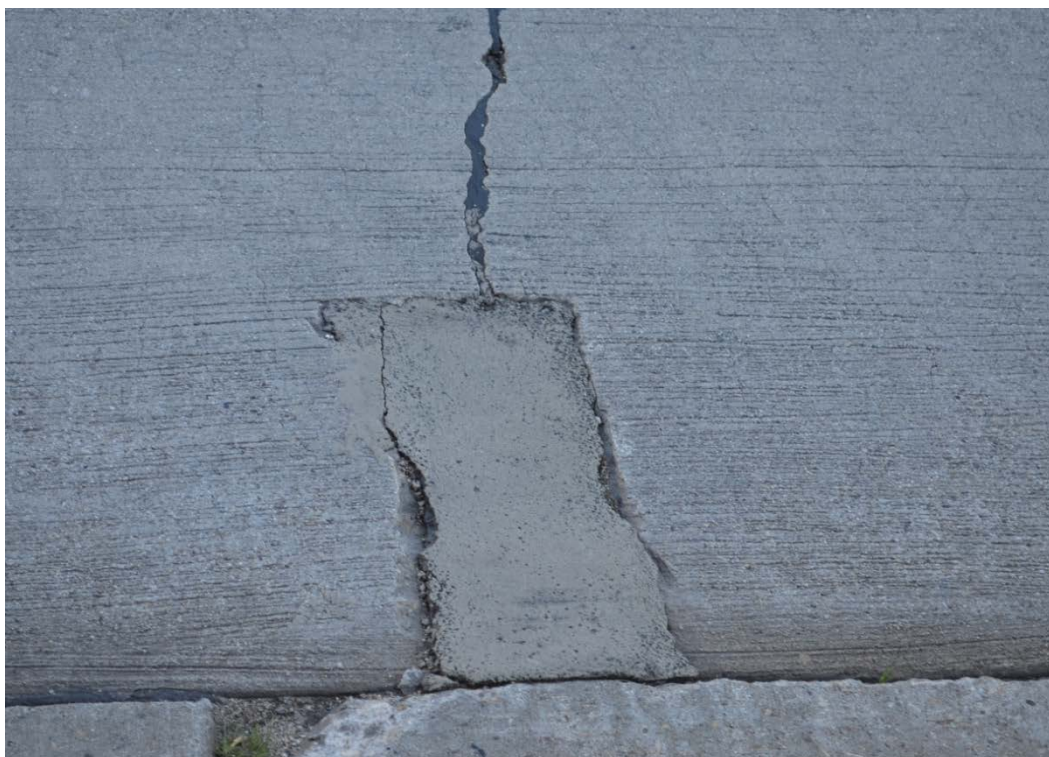
Figure E-4. Material loss along edges of a small PDR  
(Site #9, State Road 66, Stevens Point).

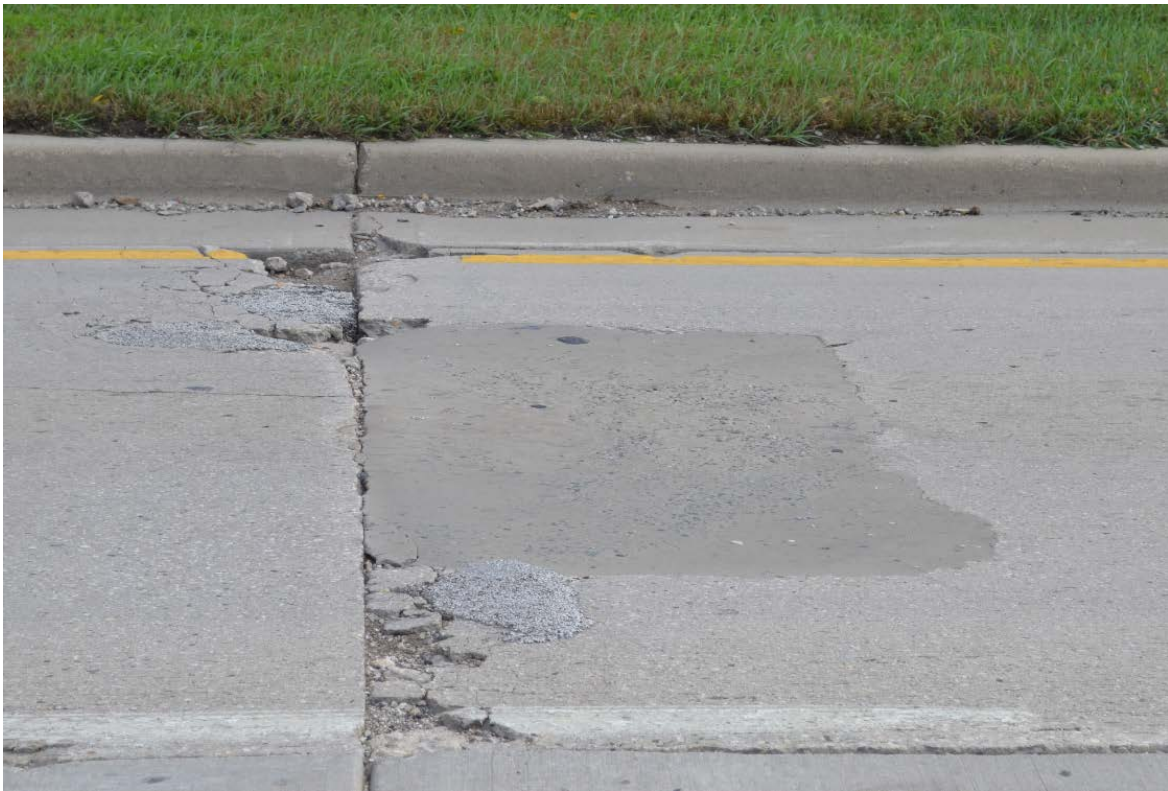
Figure E-5. Concrete pavement deterioration adjacent to PDR  
(Site #10, State Road 145, Menomonee Falls).

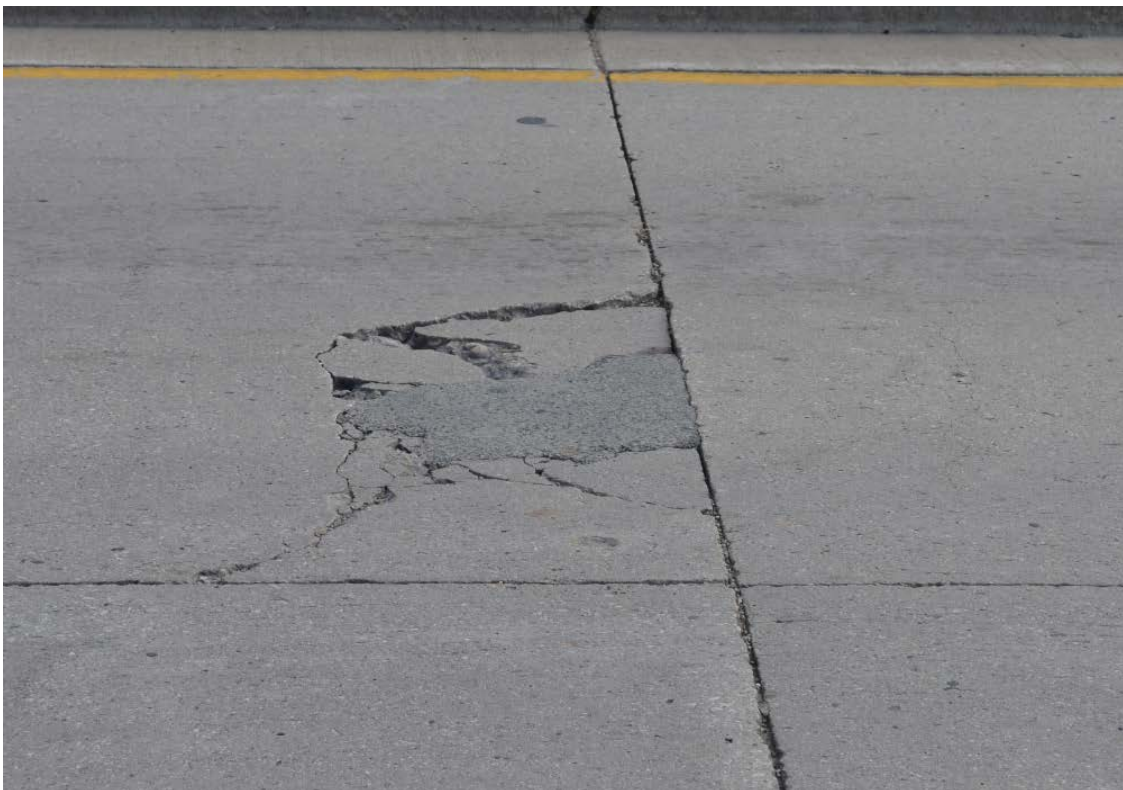
Figure E-6. Concrete pavement deterioration around PDR  
(Site #10, State Road 145, Menomonee Falls).

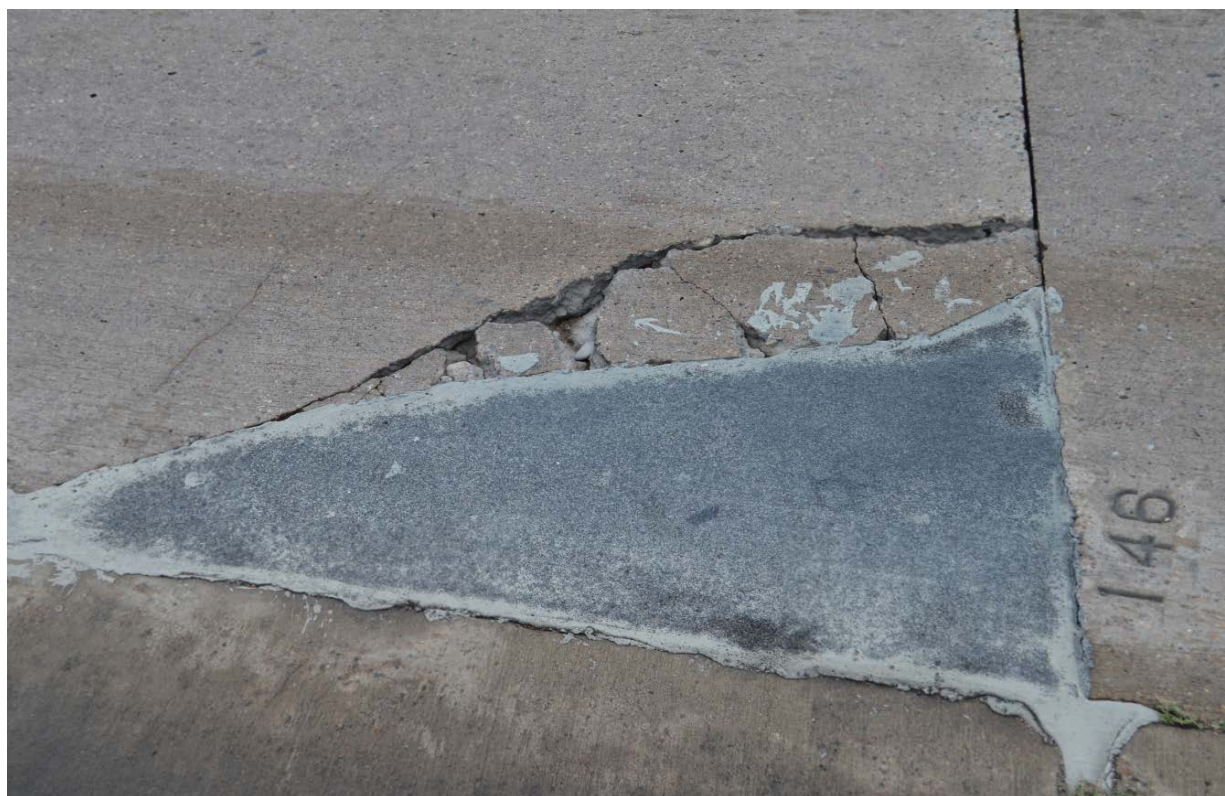
Figure E-8. Concrete pavement deterioration around PDR  
(Site #11, US 10, Stevens Point).

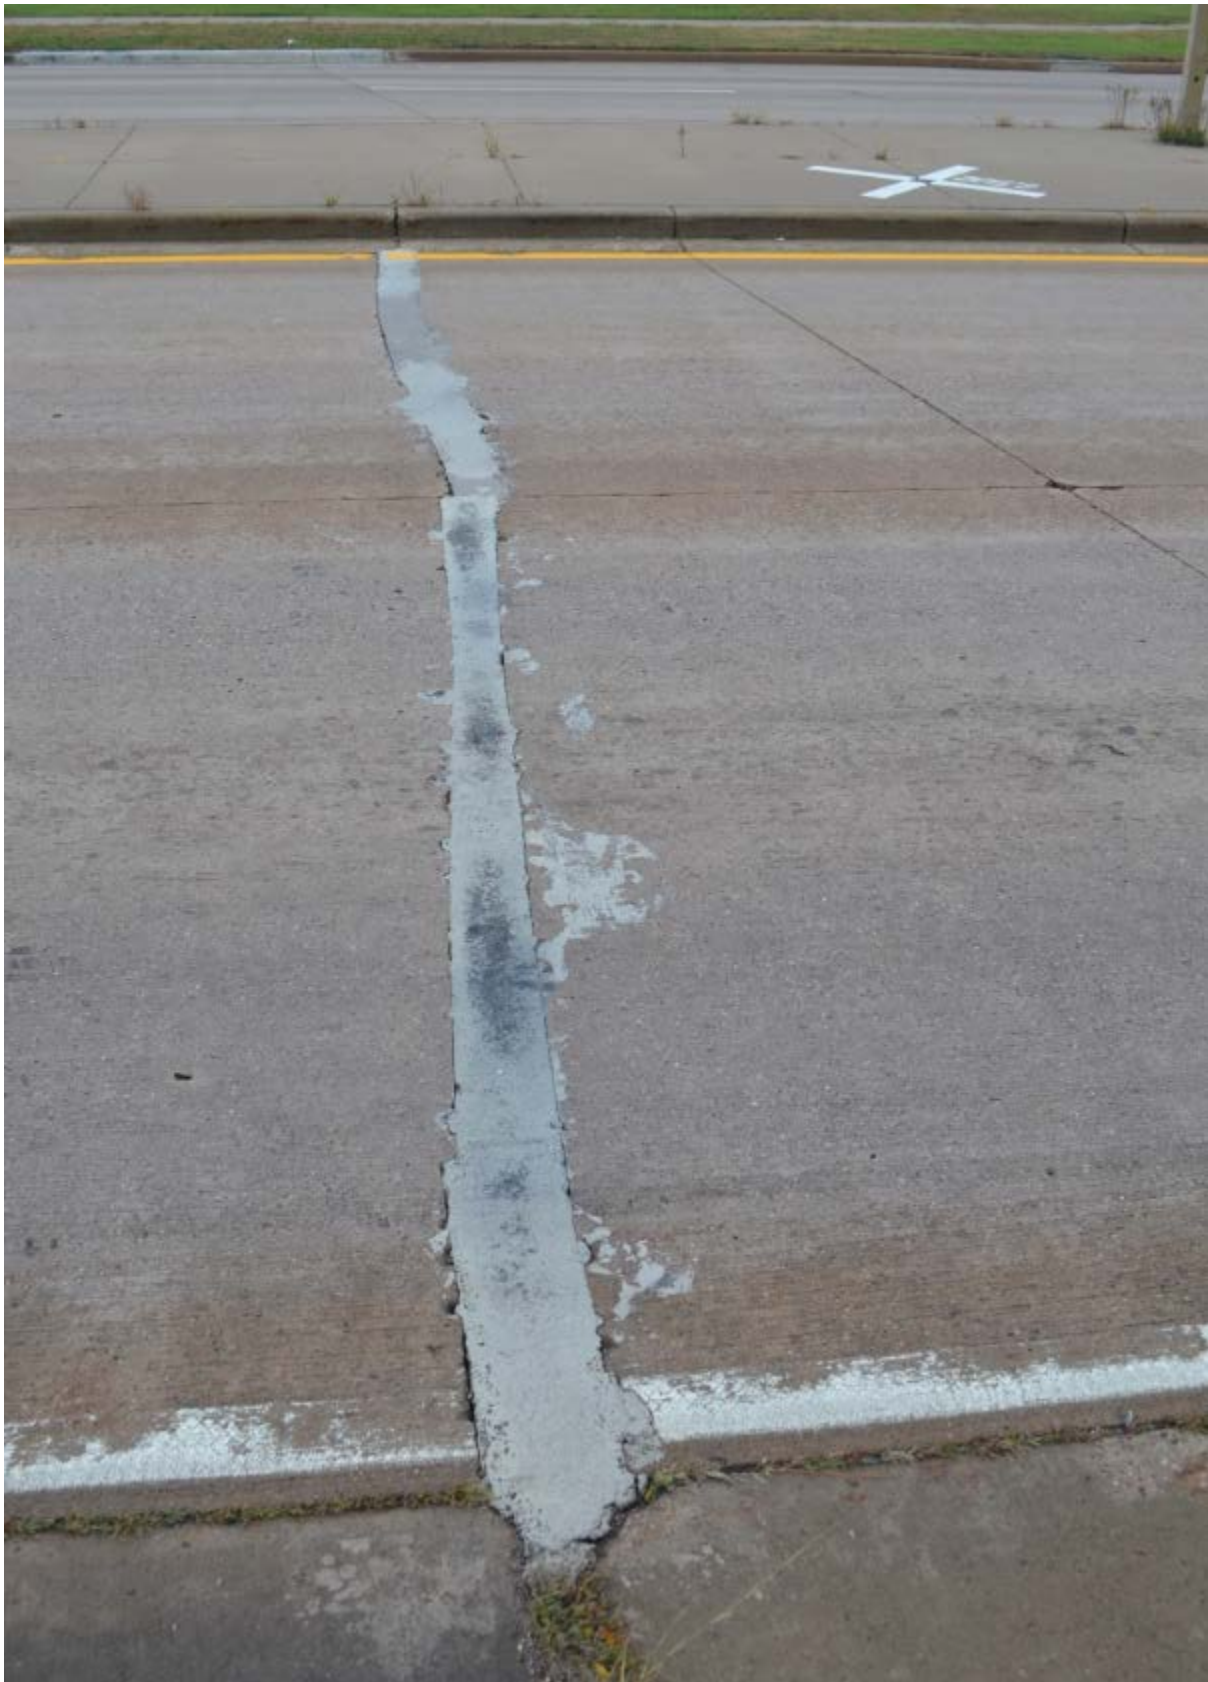
Figure E-9. PDR used to address transverse cracking  
(Site #11, US 10, Stevens Point).

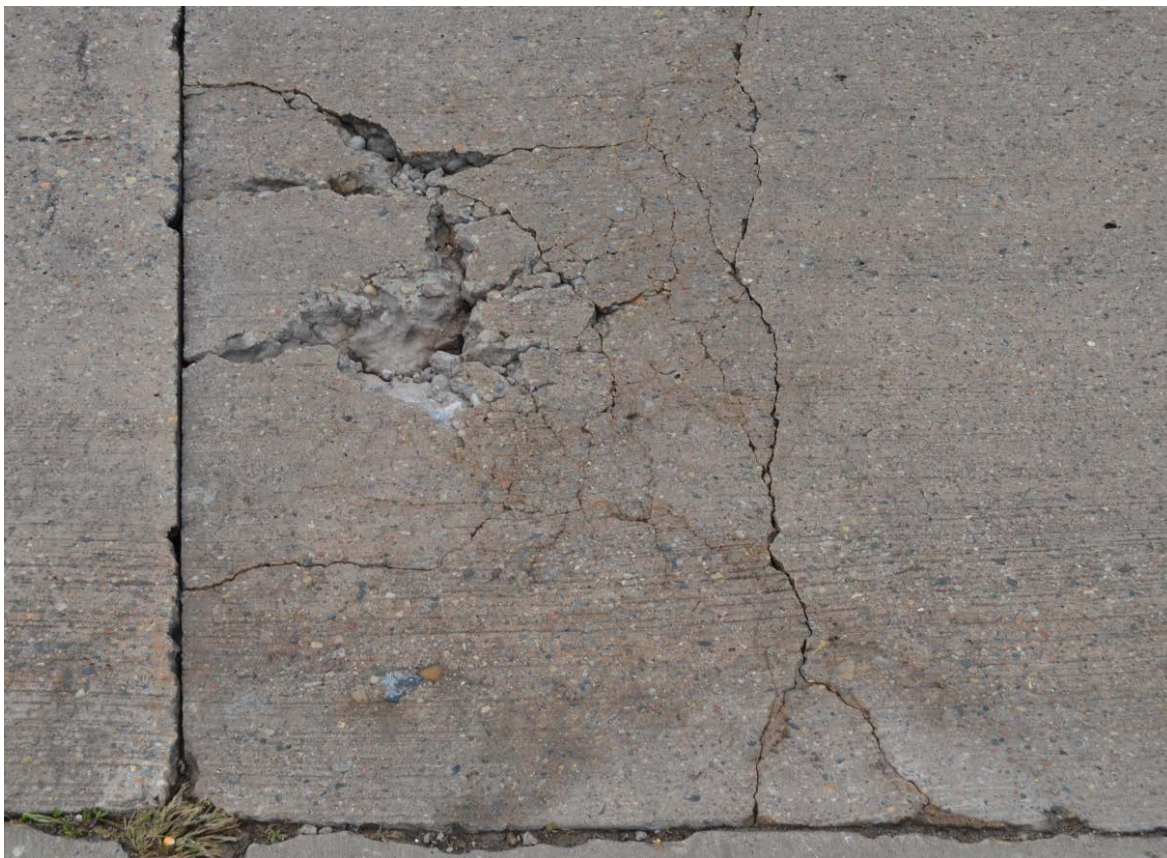
Figure E-10. Severely deteriorated areas in existing concrete pavement (Site #11, US 10, Stevens Point).

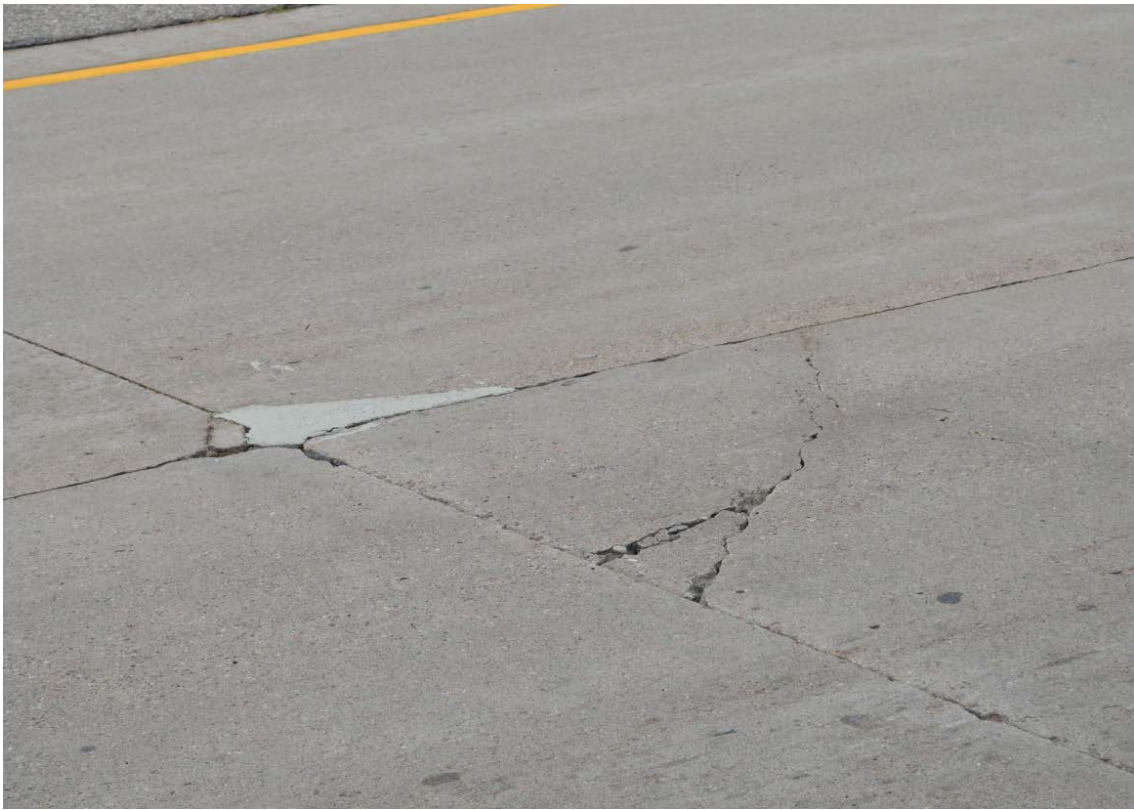
Figure E-12. Corner break in existing concrete pavement  
(Site #11, US 10, Stevens Point).
