# Non-Cementitious Repair Materials Study

Final Report

WisDOT Project No. 0092-18-02  
June 2019

WISCONSIN HIGHWAY RESEARCH PROGRAM

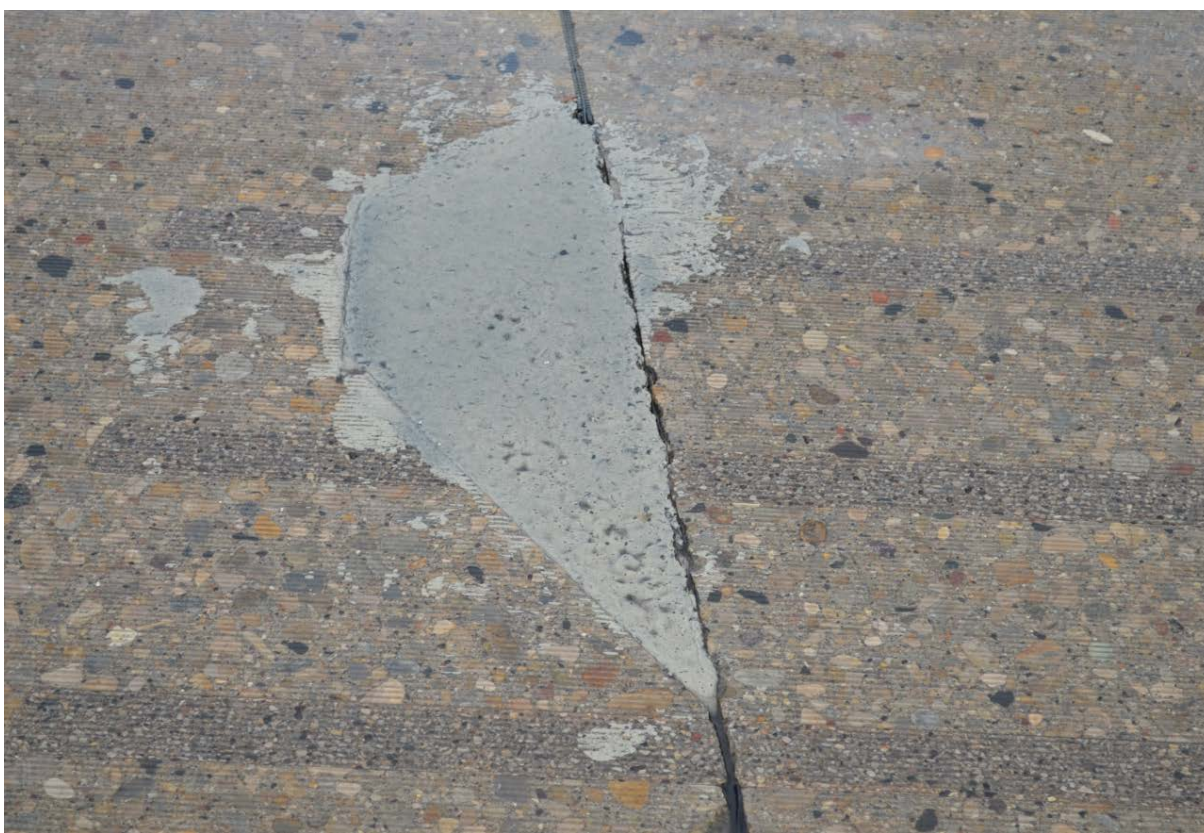
Figure E-15. PDR to address spalling at a transverse joint  
(Site #12, US 41, Marinette).

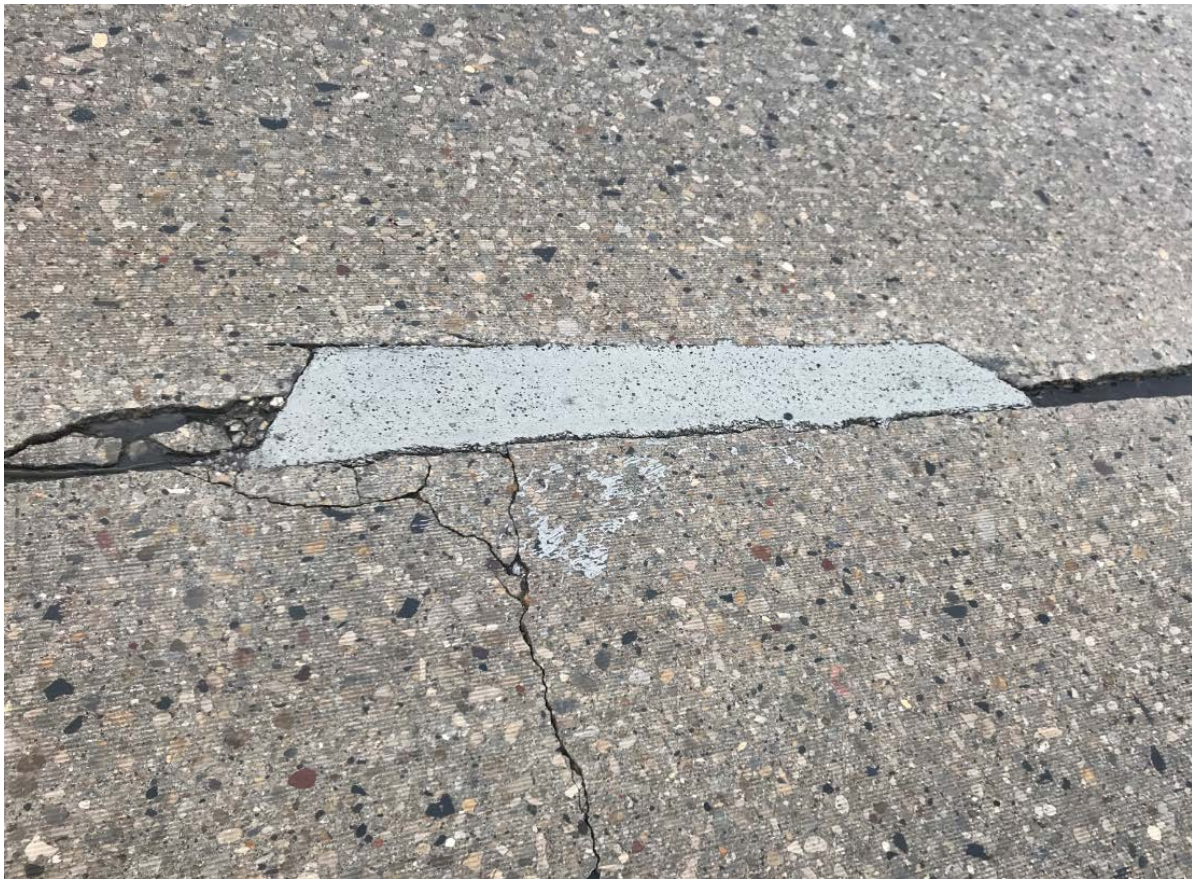
Figure E-16. Concrete pavement deteriorating around the PDR  
(Site #12, US 41, Marinette).

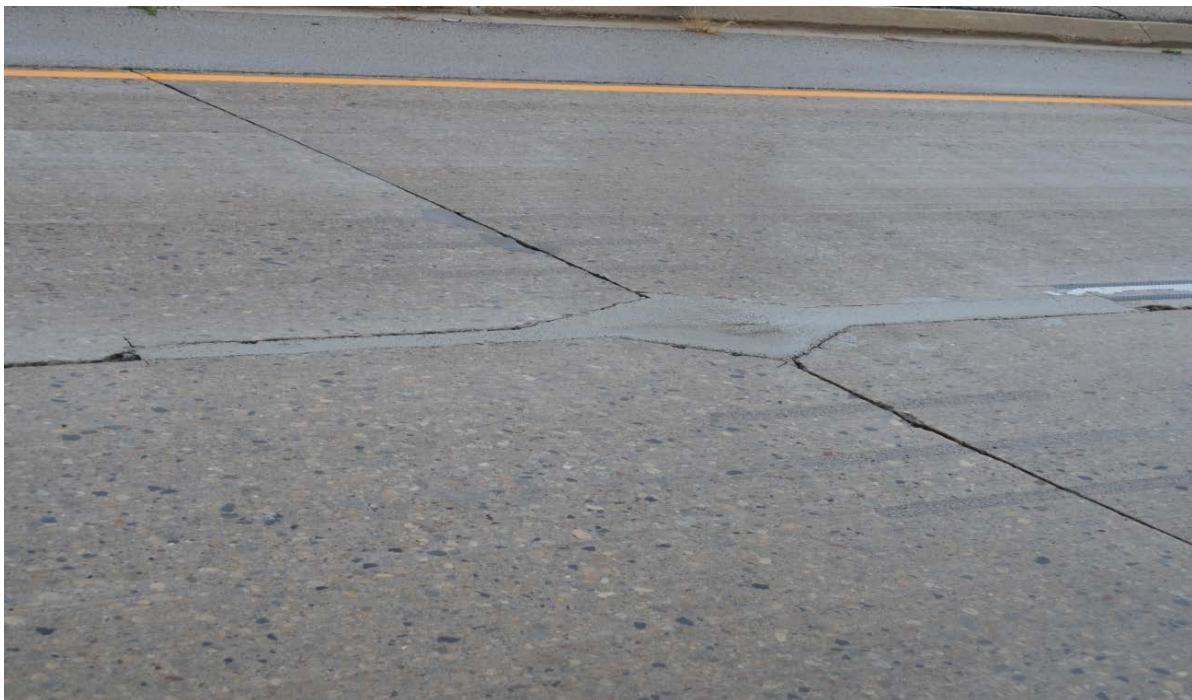
Figure E-17. PDR used to address deteriorated longitudinal joint  
(Site #12, US 41, Marinette).

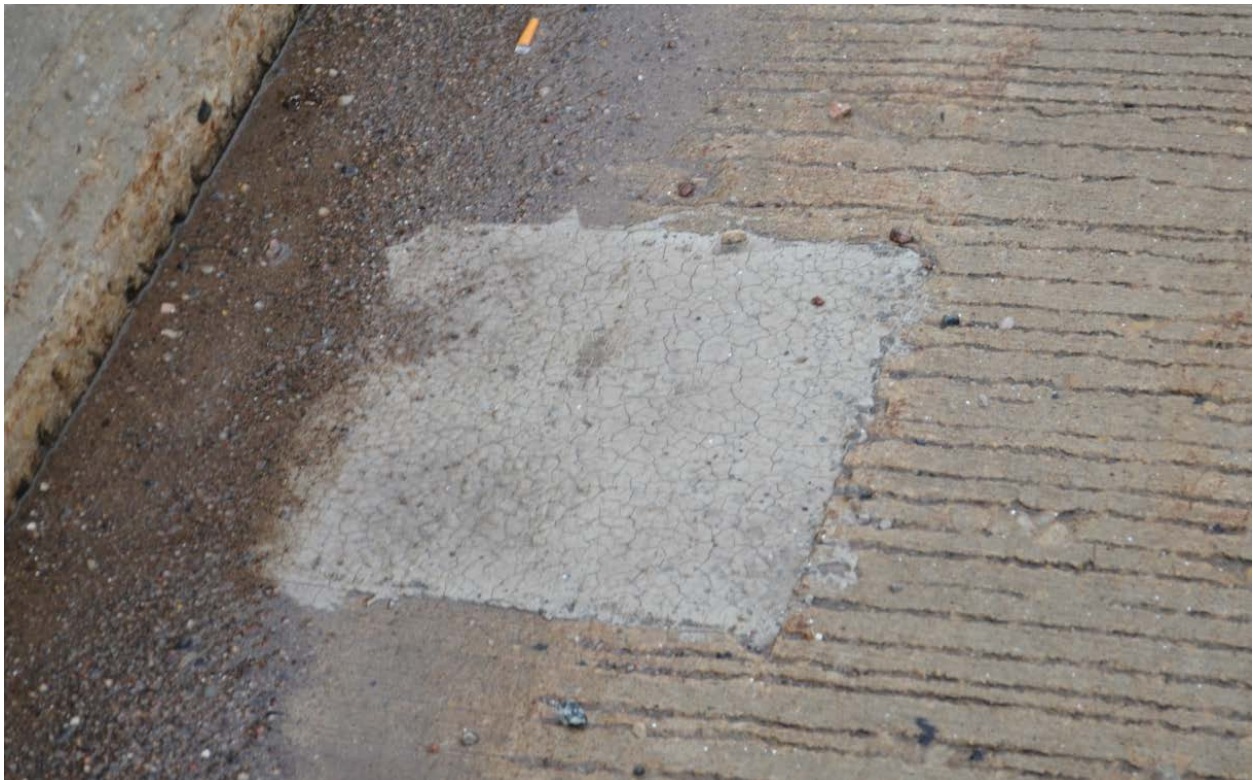
Figure E-19. Map cracking pattern on PDR surface  
(Site #13, State Road 32, Mountain).

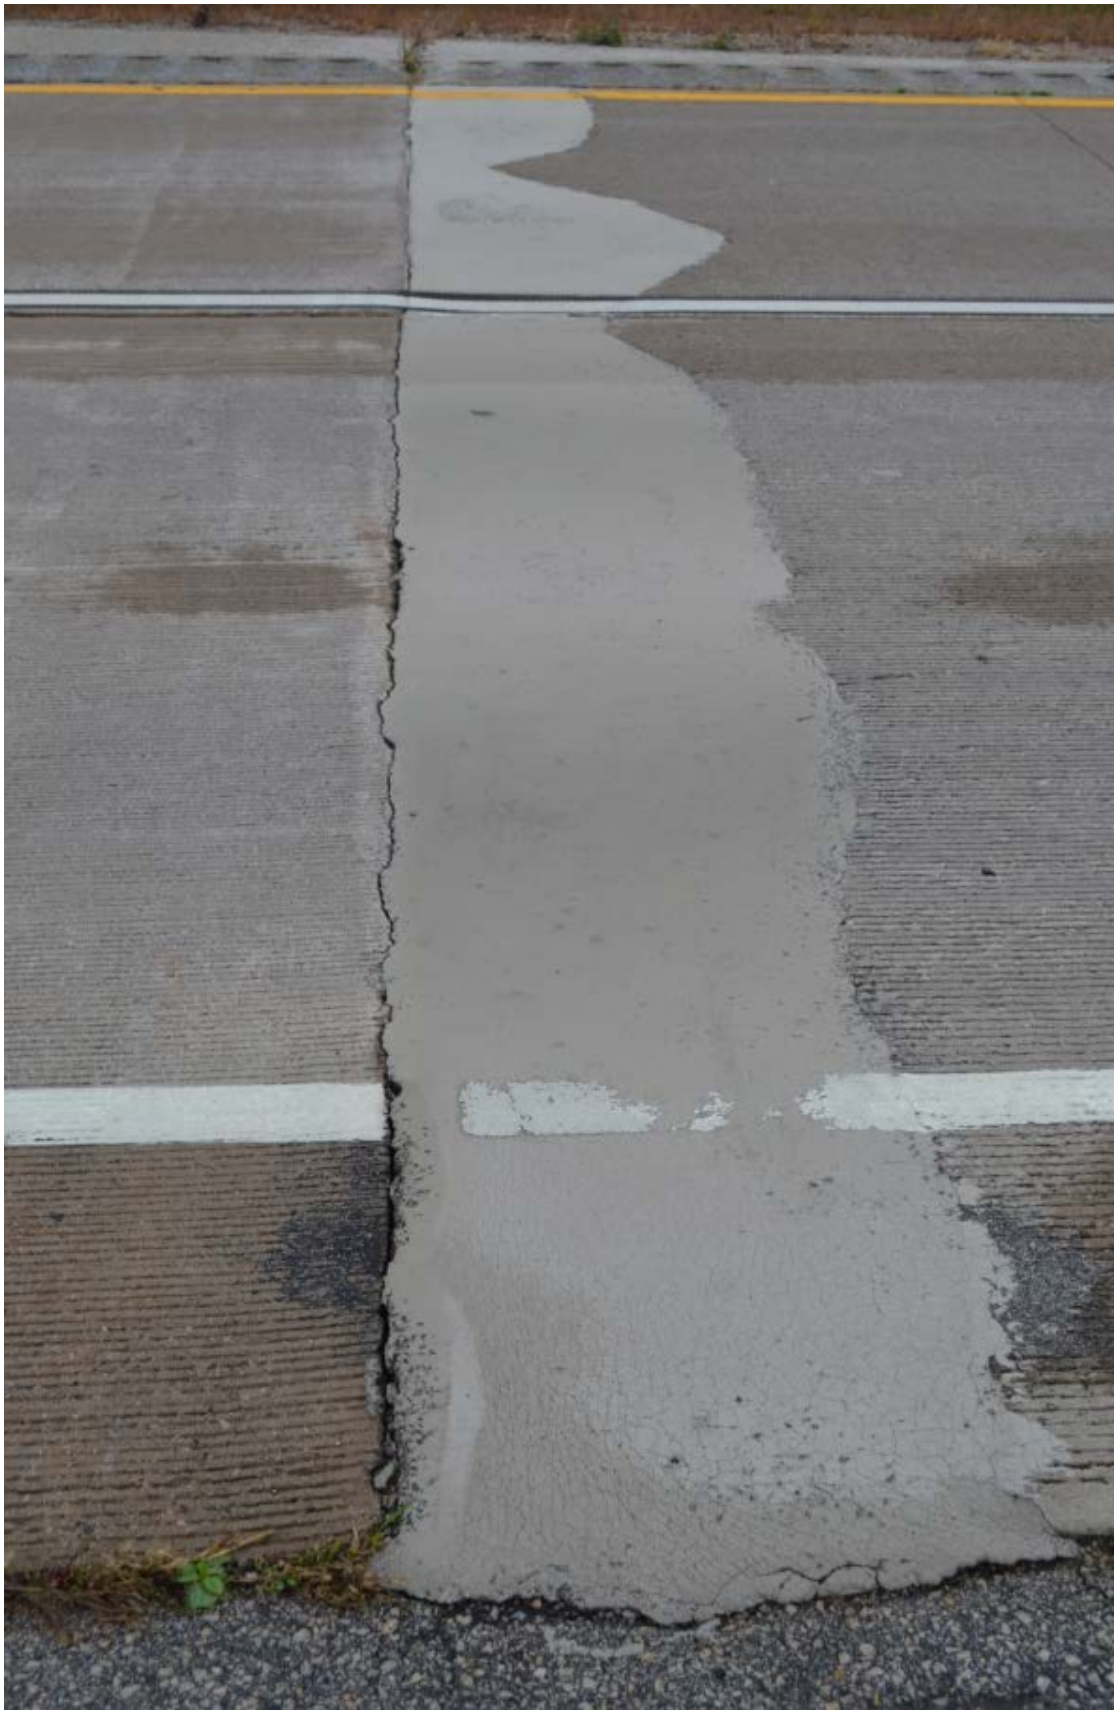
Figure E-21. PDR on bridge deck approach slabs, surface map cracking in shoulder area (Site #14, US 141, Pound).

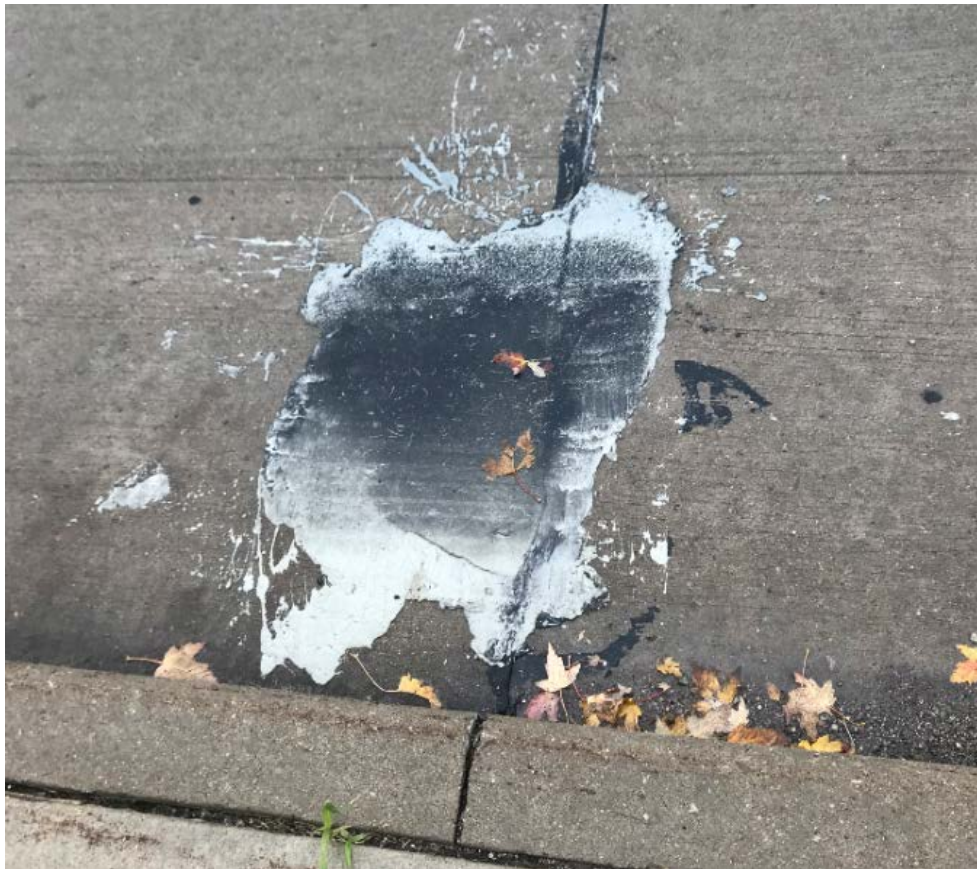
Figure E-22. PDR to address joint spalling  
(Site #15, Calumet St., Appleton).

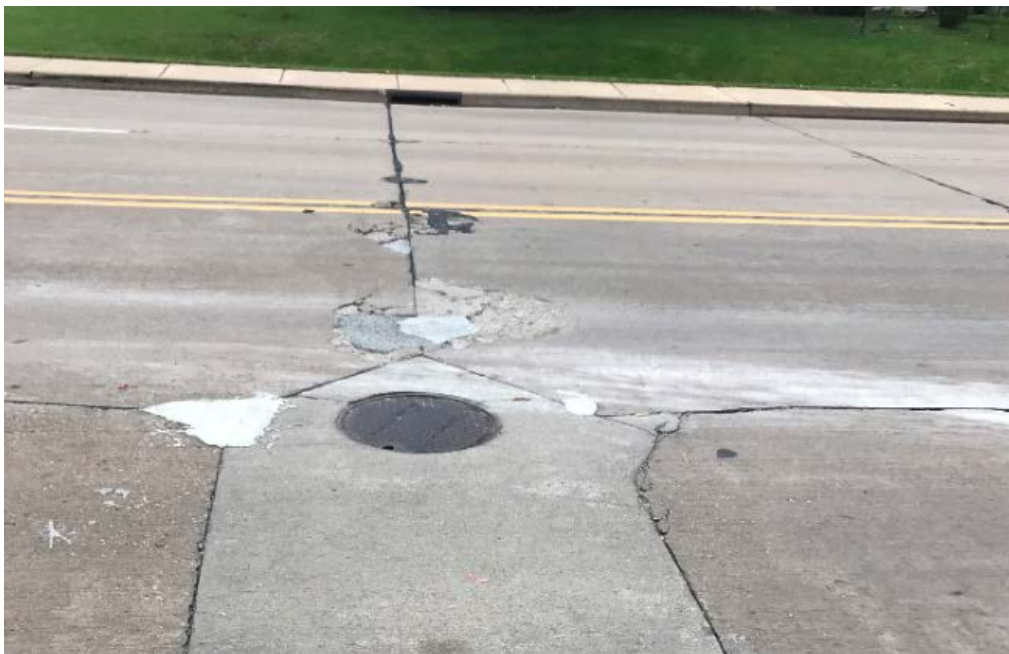
Figure E-23. Existing concrete pavement deteriorating around PDRs  
(Site #15, Calumet St., Appleton).

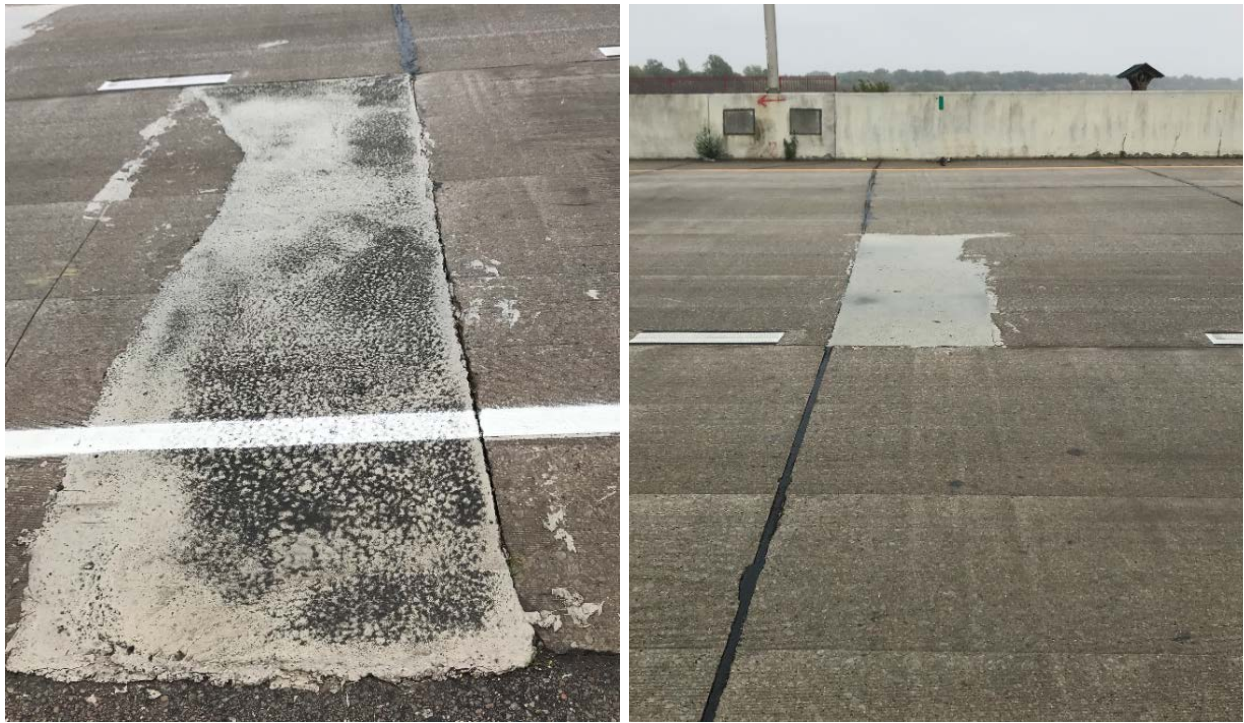
Figure E-28. PDR to address deterioration along transverse joints  
(Site #18, I 41, Oshkosh).

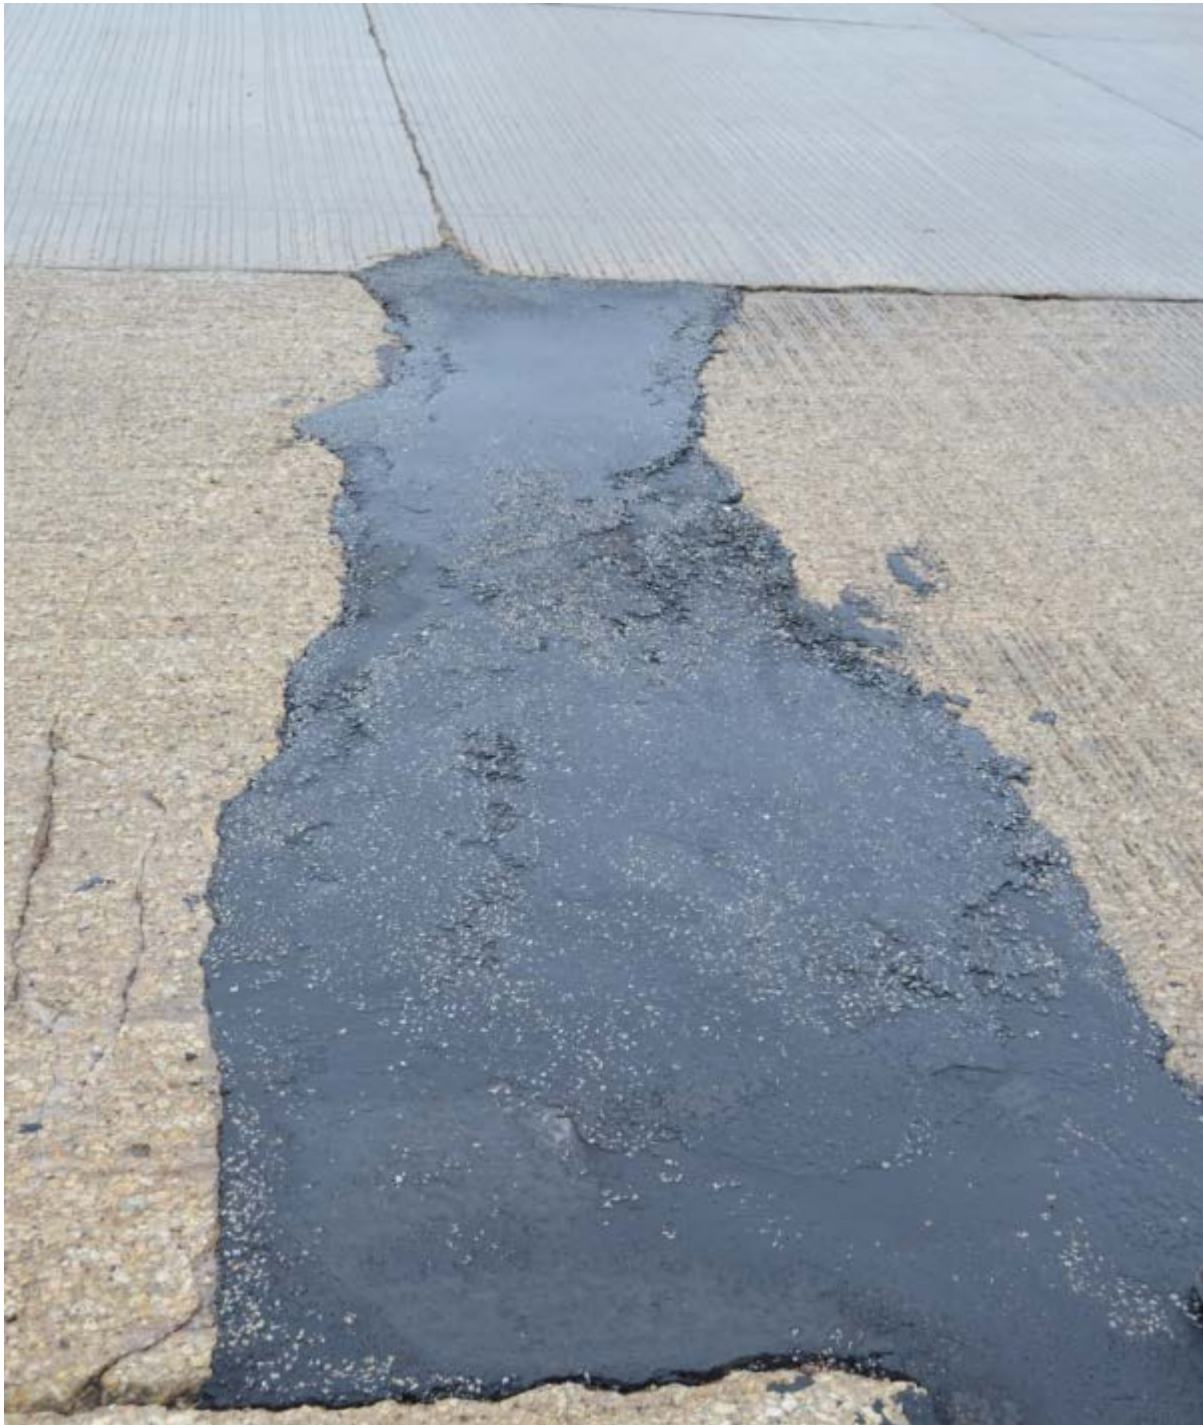
Figure F-1. PDR to address deterioration along transverse joint  
(Site #19, State Road 93, Eau Claire).

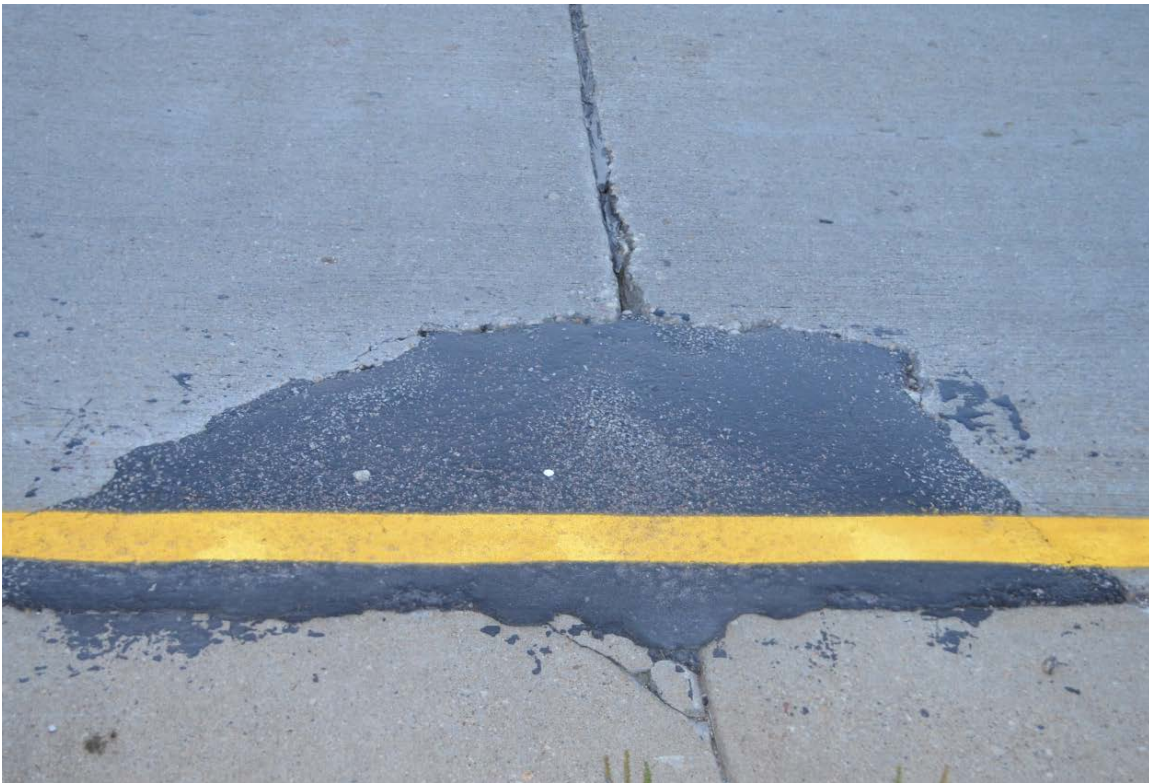
Figure F-6. PDR to address corner spalling  
(Site #21, State Road 59, Waukesha).

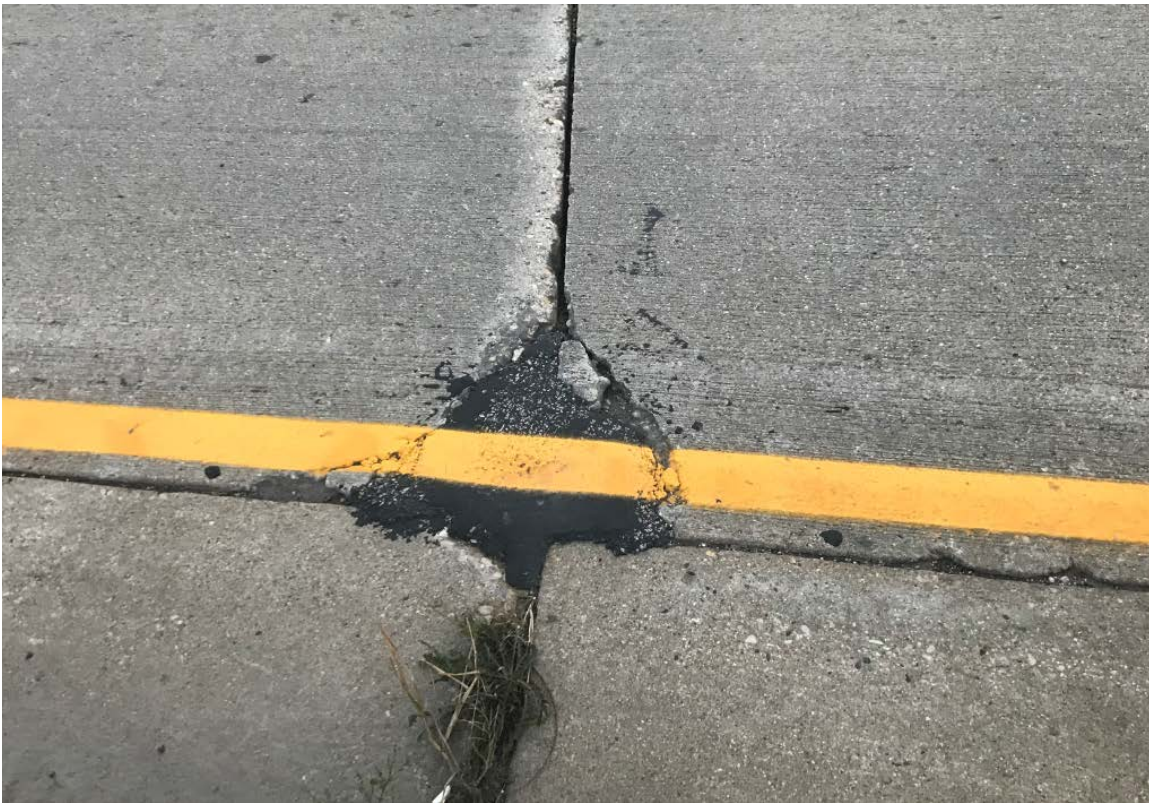
Figure F-7. Existing pavement deteriorating around PDR  
(Site #21, State Road 59, Waukesha).

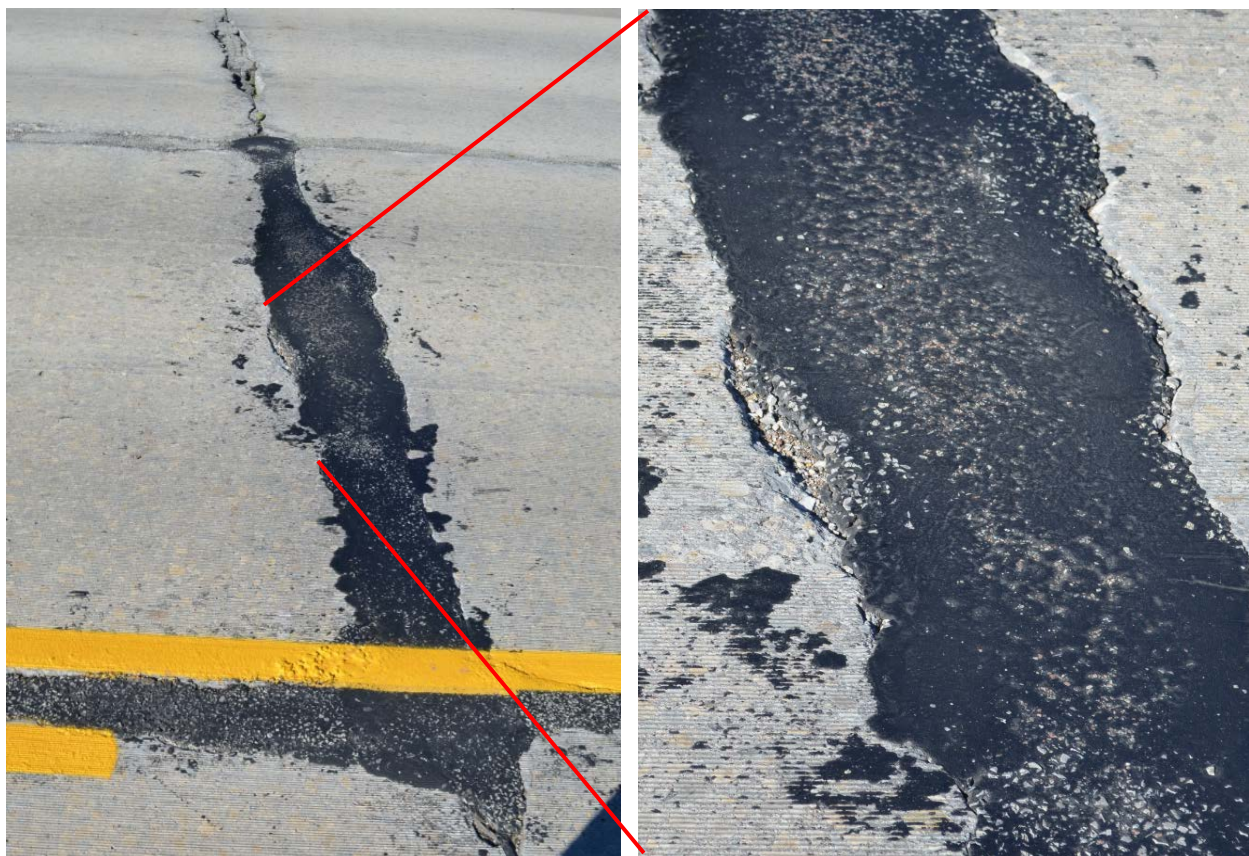
Figure F-9. PDR to address deteriorated joint (left) and existing pavement deteriorating around PDR (right) (Site #22, N. Ballard Rd., Appleton).

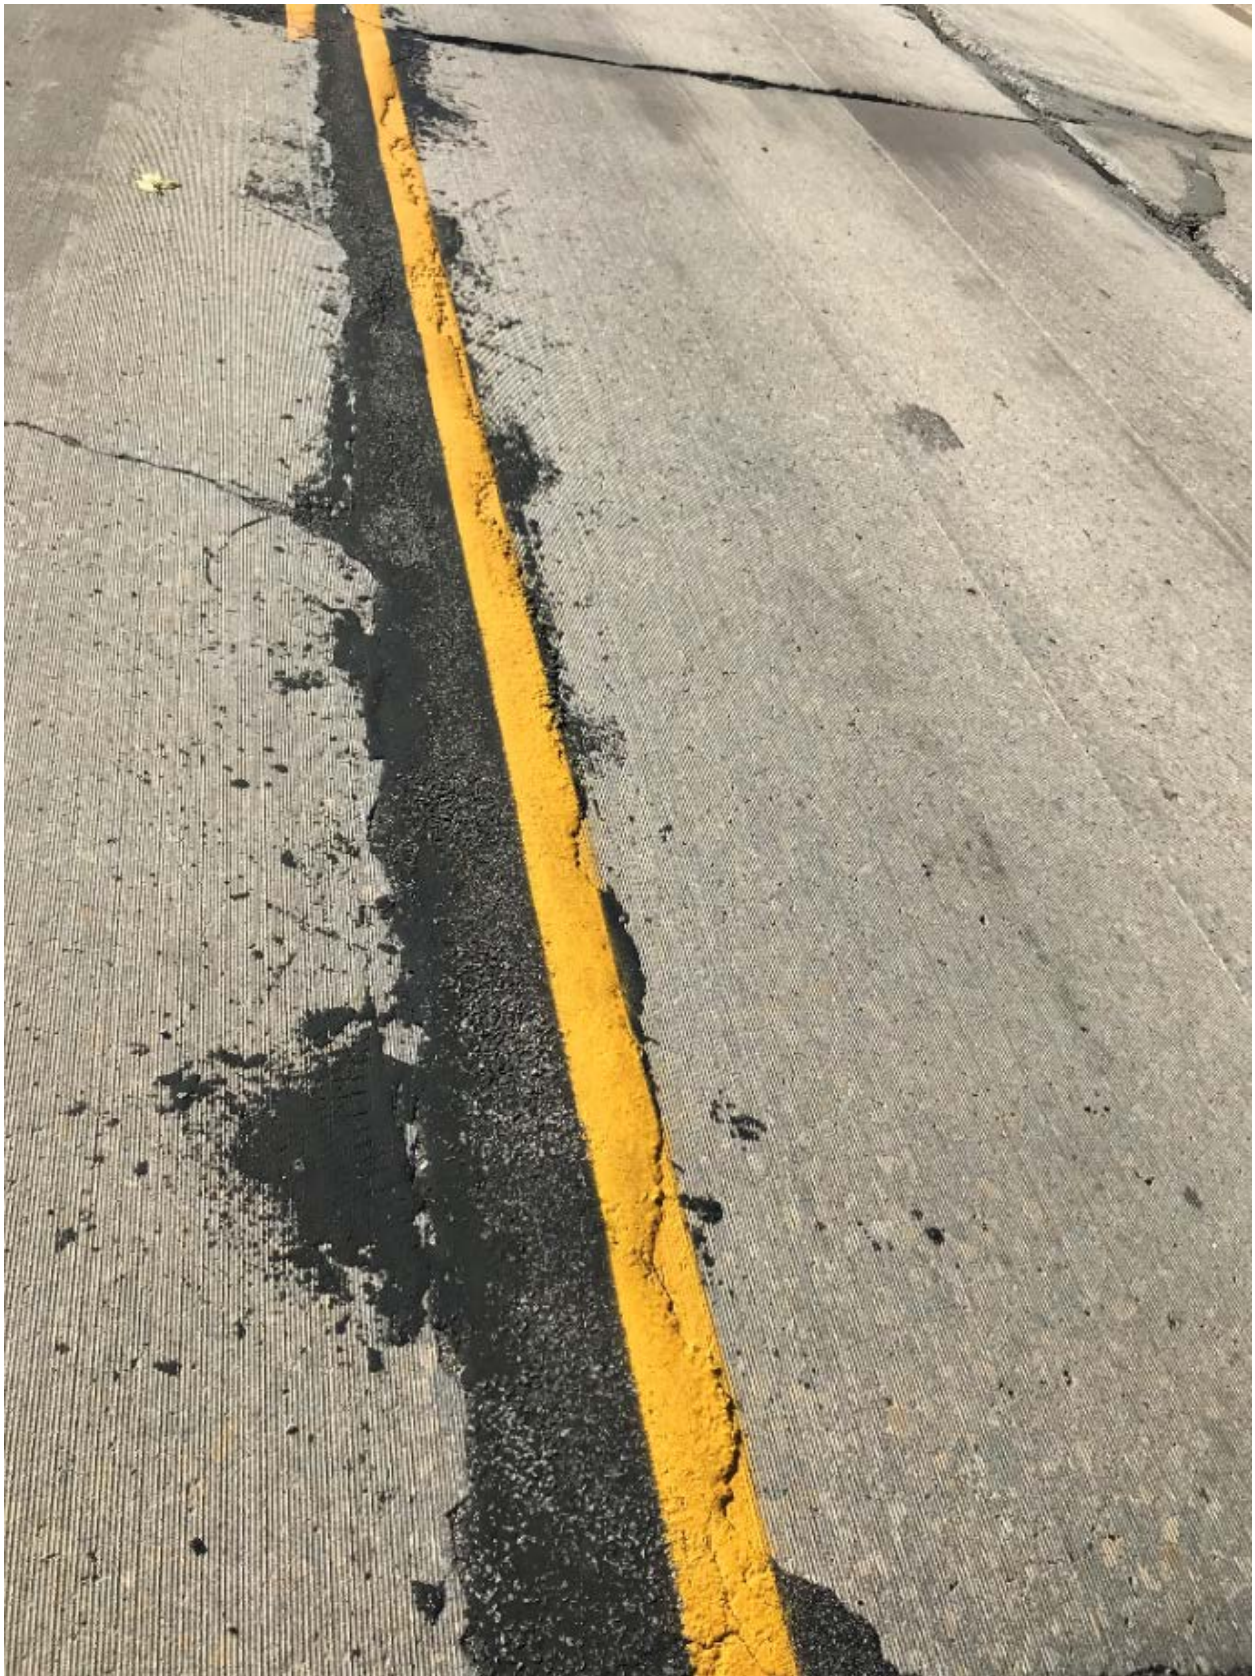
Figure F-10. PDR to address longitudinal joint deterioration  
(Site #22, N. Ballard Rd., Appleton).

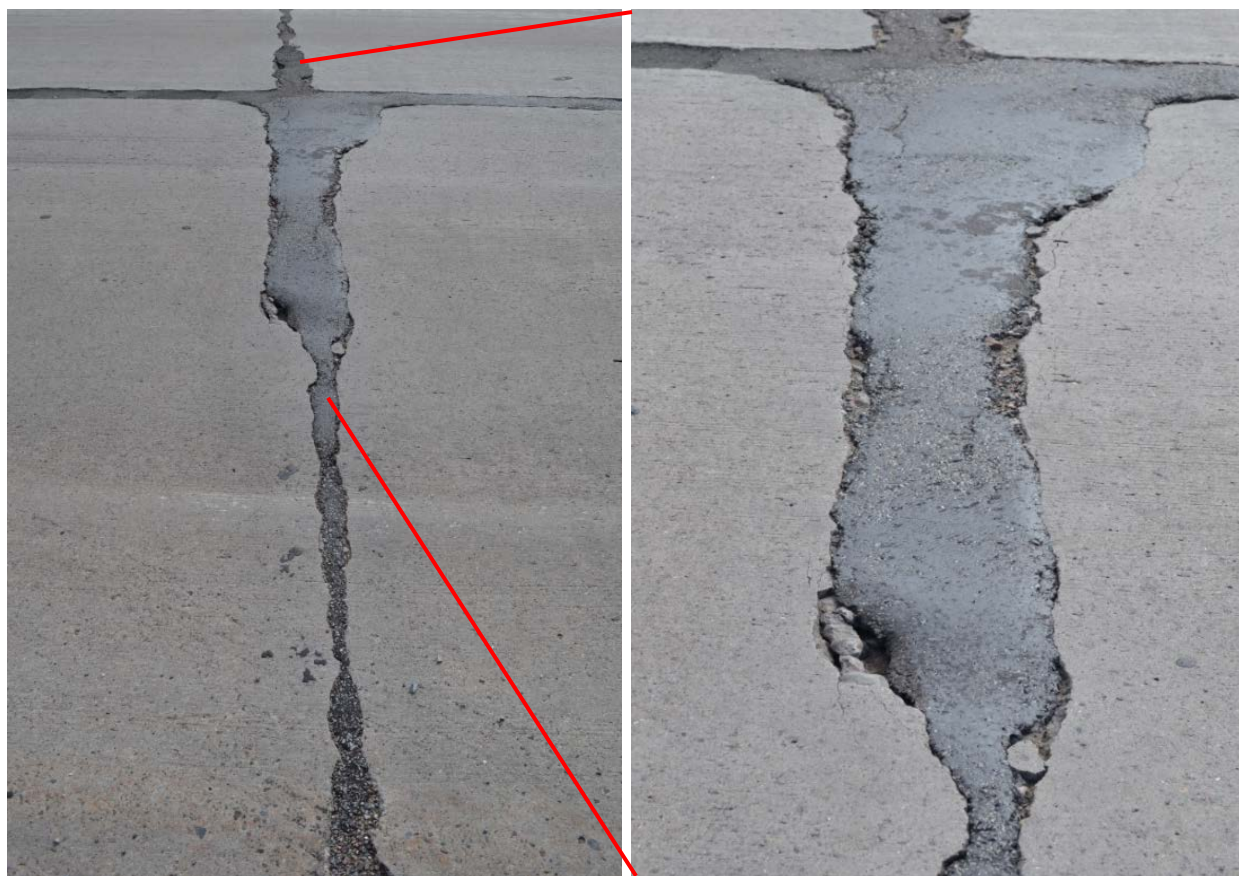
Figure F-12. PDR to address transverse joint deterioration (left) and surrounding concrete pavement deteriorating around PDR (Site #23, W. Kemp St., Rhinelander).
