DOT/FAA/TC-23/11

Evaluation of Airport Pavement Designs for Seasonal Frost and Permafrost Conditions

March 2023

Final Report

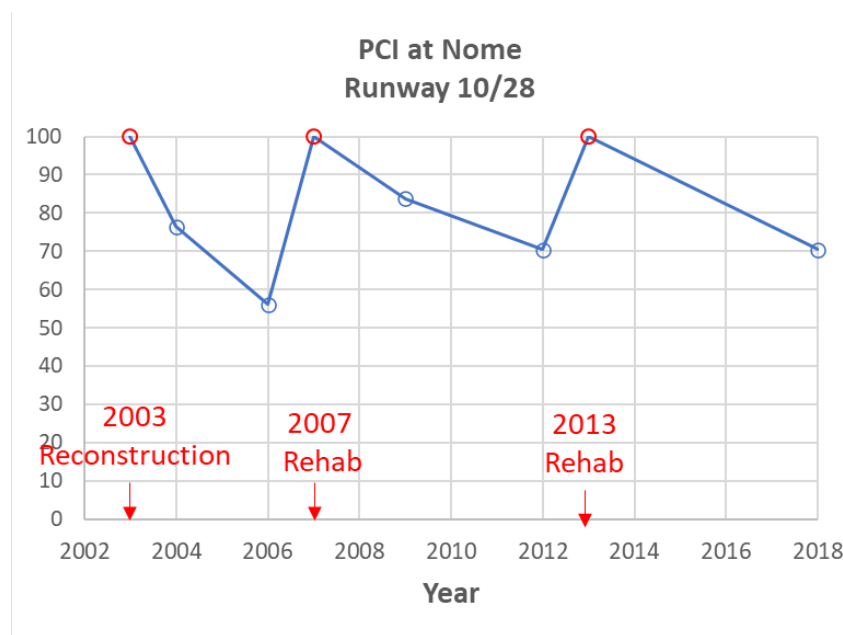
Figure 2. Nome Airport PCI Variation

Alaska Airport Pavement Inspection Reports that report Pavement Condition Index (PCI) are available for the following years: 2004, 2008, 2009, 2012, and 2018 (Alaska DOT&PF). These reports summarized the PCI values for different pavement sections within the airport. Details of the stress type and severity are not included in the reports. Figure 2 shows the overall runway PCI at different years. The PCI deteriorated rapidly, from 100 to 56 within 3 years after the 2003 rehabilitation/reconstruction project. The PCI also dropped by 30 points over 5 years, after the 2007 rehabilitation project. The PCI also dropped by 30 points over 5 years, after the 2013 rehabilitation project.

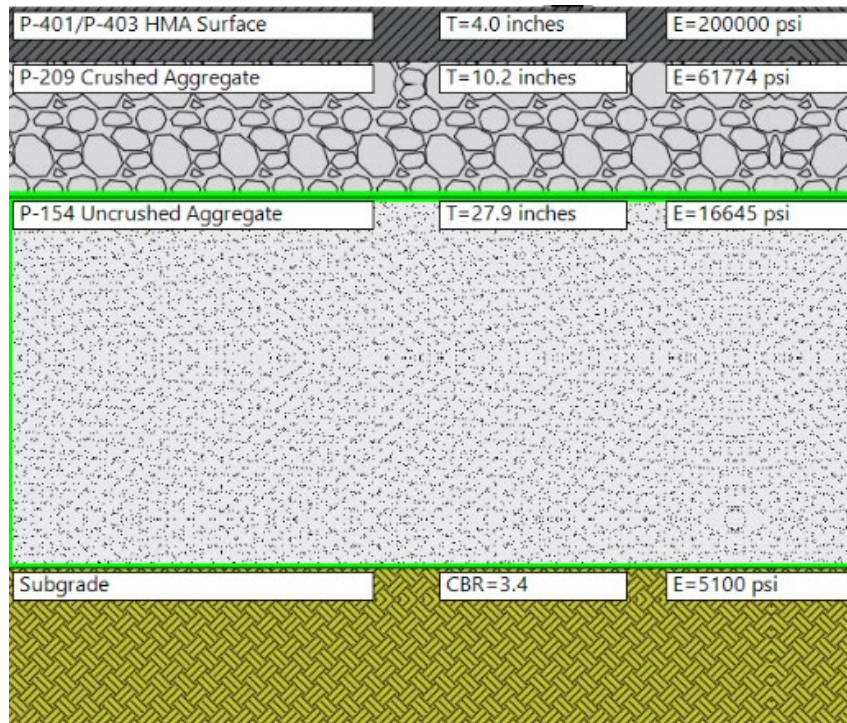
Figure 7. FAARFIELD Design Based on AC 150/5320-6G Using Design Traffic at Nome Airport

Figure 7 shows the required pavement thickness computed by FAARFIELD using the design traffic and spring CBR. Complete FAARFIELD pavement design reports are provided in Appendix B. Table 9 presents a summary of required pavement structure to support the design and actual traffic for both the spring and summer CBRs. The required subbase thickness for frost protection is also included in Table 9. Results indicate that the existing pavement structure is not adequate to protect the pavement for the effect of seasonal frost. Table 10 summarizes the pavement design from different methods.

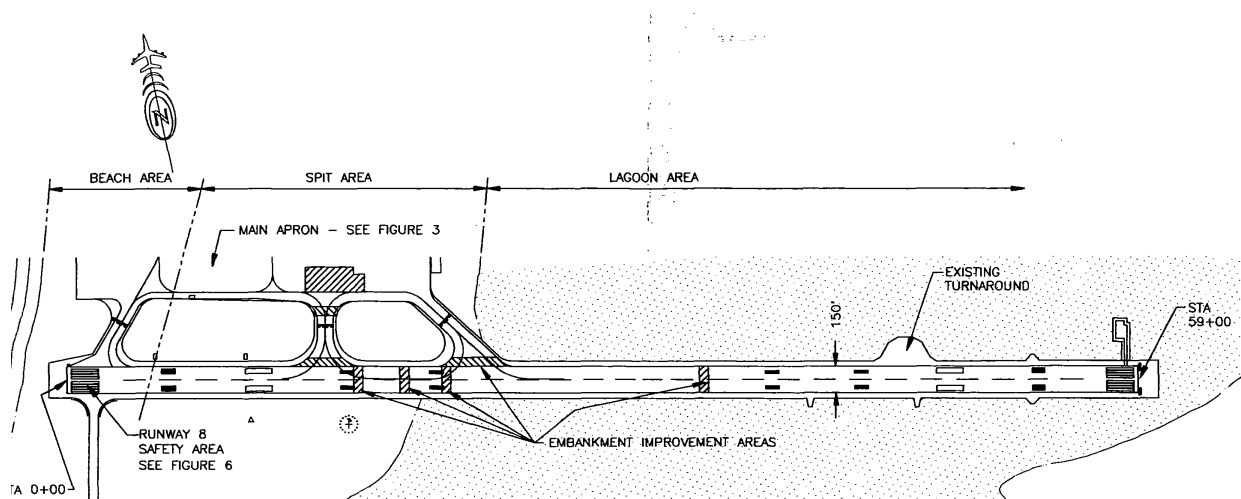
Figure 9. Three Geotechnical Areas within Runway 9/27 at Kotzebue Airport (R&M Consultants, 1992)

R&M Consultants performed an extensive geotechnical investigation in 1992 (R&M Consultants, 1992, 1993). The report divides the subsurface conditions beneath the airport pavements into three areas: beach, spit, and lagoon (Figure 9). The embankment ranged from about 3 to 5 feet thick in the beach and spit areas, to 12 to 15 feet thick where the runway crosses the lagoon.

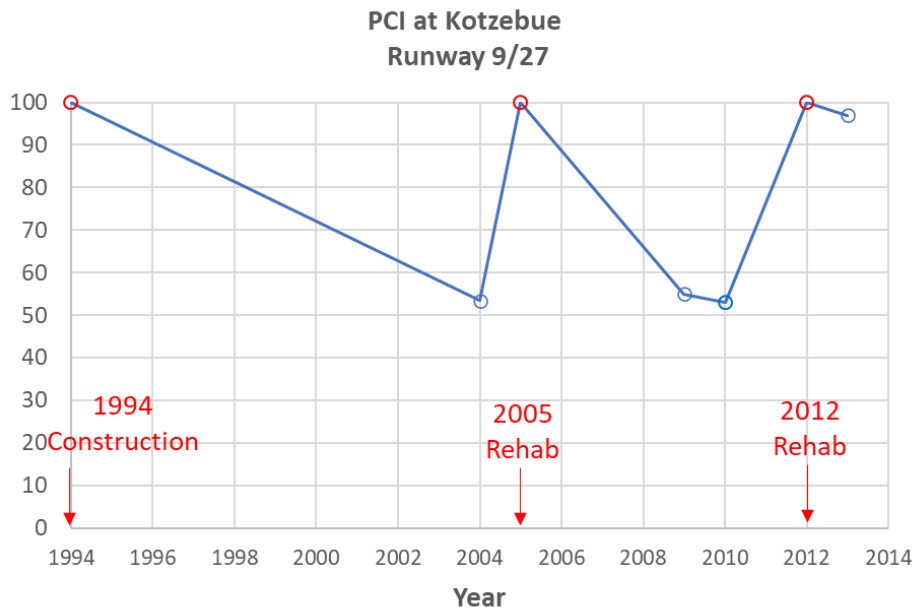
Figure 10. The PCI Values for Runway 9/27 at Kotzebue Airport

PCI survey reports are available for the following years: 2004, 2007, 2010, 2013, and 2016. These reports summarized the PCI values for different pavement sections within the airport. Details of the stress type and severity are not included in the reports. Figure 10 shows the PCI values at those dates. The PCI dropped by 45 points nearly 10 years after the 1994 construction. The 2005 rehabilitation must have restored the PCI, but the PCI dropped to 55 in 2009. The PCI increased to 95 in 2013, approximately one year after the 2012 rehabilitation.

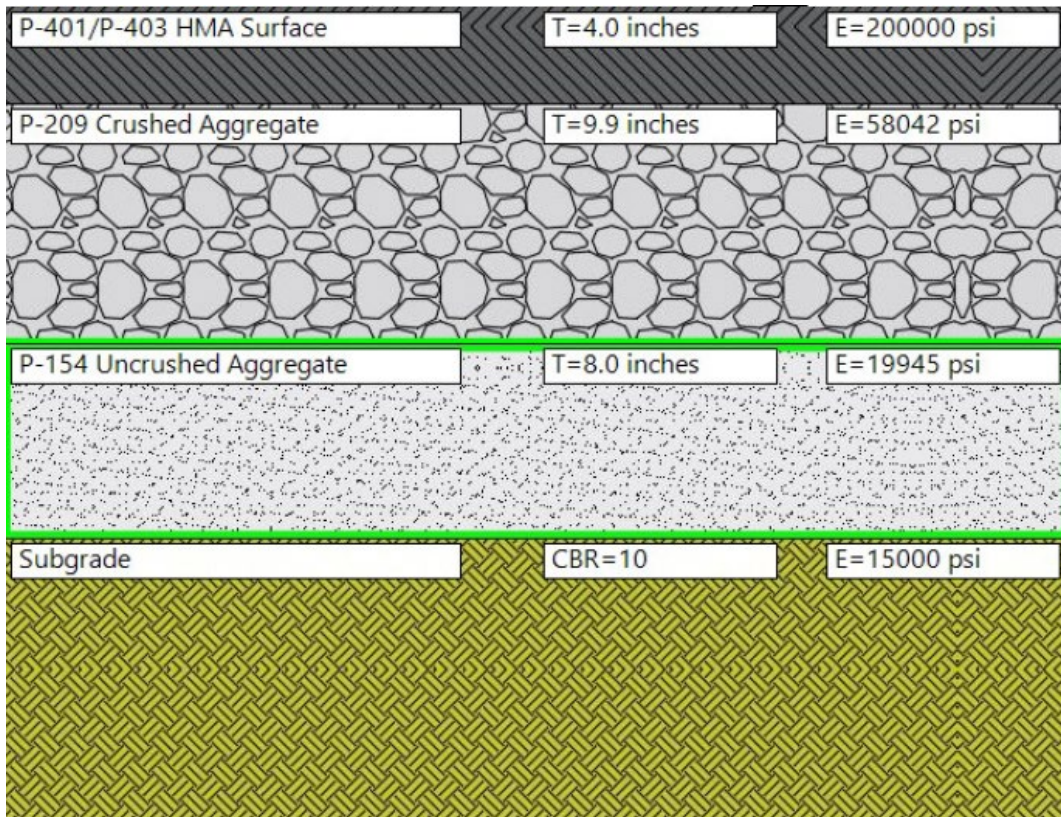
Figure 12. FAARFIELD Design Based on AC 150/5320-6G Using Design Traffic and Frozen Subgrade CBR at Kotzebue Airport

Figure 12 shows the required pavement thickness computed by FAARFIELD using design traffic for the failed insulation condition. The complete FAARFIELD pavement design reports are provided in Appendix B.
