# Investigation and Evaluation of Iowa Department of Transportation Bridge Deck Epoxy Injection Process

Final Report  
February 2019

Sponsored by  
Iowa Department of Transportation  
(InTrans Project 10-381)

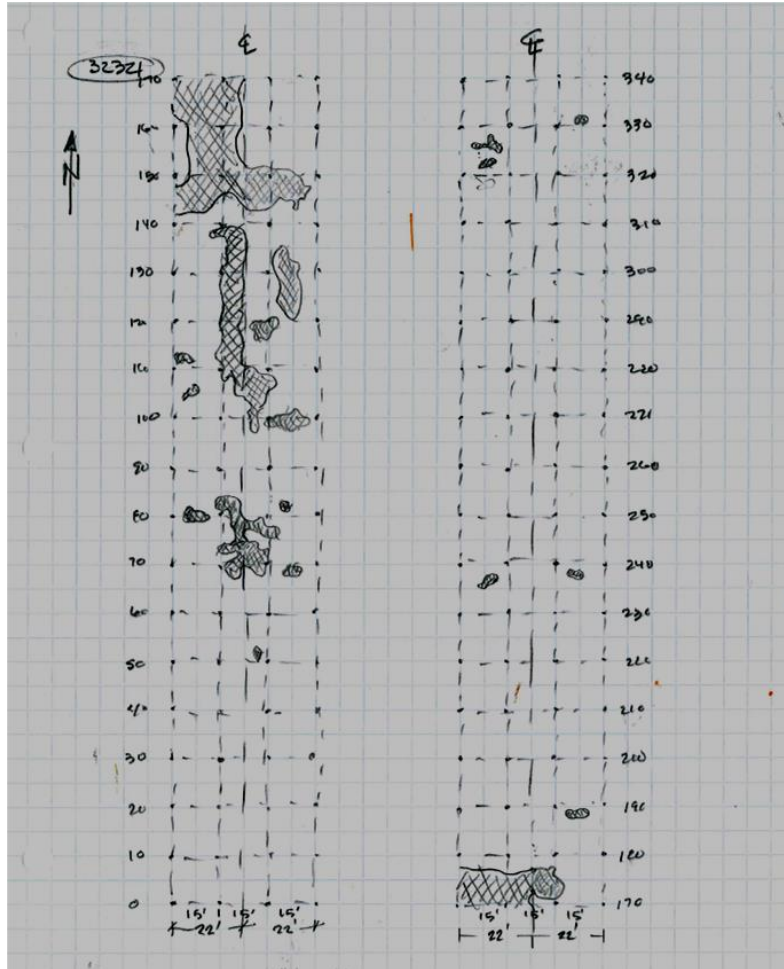
**Figure 3.3. Typical delamination map**

A map locating the delaminated portions of the overlay was generated upon completion of sounding. This was achieved by creating a grid of the entire bridge deck surface and transferring the located delaminations to the corresponding sectors of the map. The map shows the locations and sizes of delaminated portions of the overlay, and offers a snapshot of the overall health of the surface. From these maps, data were collected and used to analyze the group of bridges. An example of a delamination map is provided in Figure 3.3.

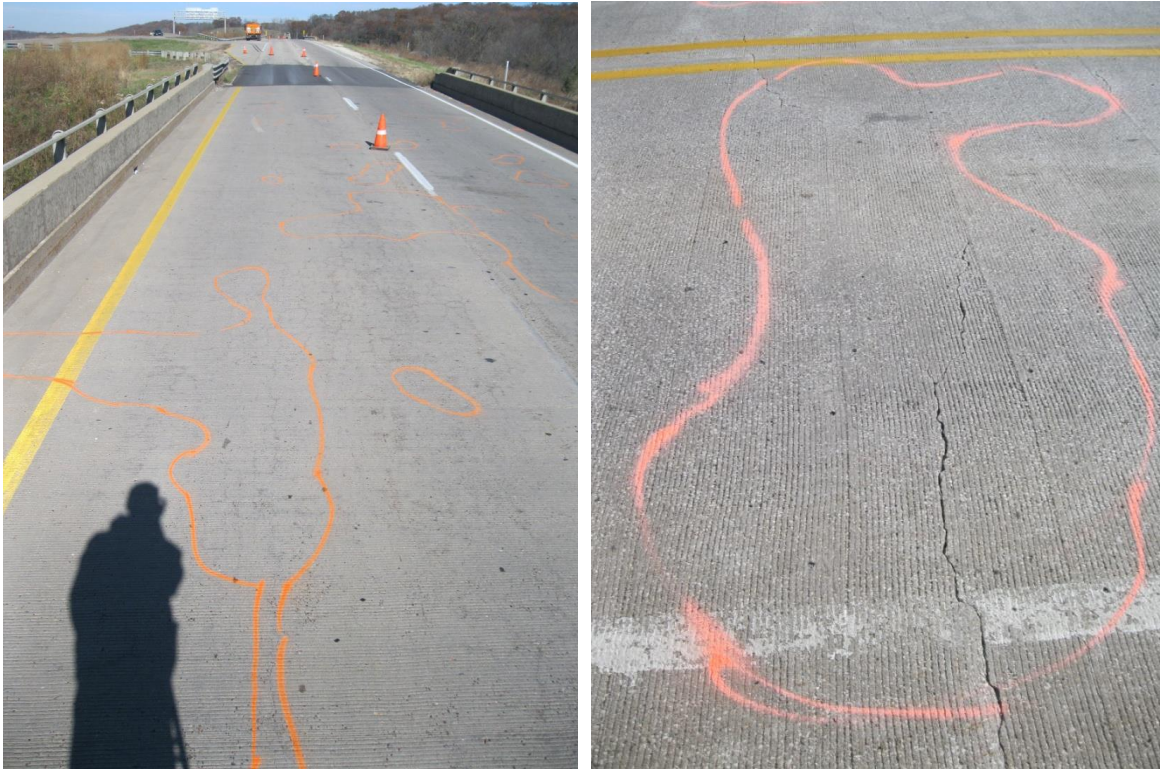
**Figure 3.4. Photographic documentation of delamination**

In addition to sounding the deck, photographs were taken to visually document the surface condition. Figure 3.4 shows an example of conditions seen at many of the bridges.

It was common to find delaminated portions of the overlay at or very near locations where both longitudinal and transverse surface cracking were present. It appeared that cracking often resulted in delamination and vice versa, as intuition would suggest. Additionally, delaminated portions of the deck often appeared to originate where cold joints were present, such as at the centerline of bridge. This agreed with the cases of cracking as cold joints are another port of entry for water and chloride ions. Additionally, the condition of the overlay was commonly the poorest where the bridge approach slab met the overlay. This may be due to several factors including: water entry at approach slab-overlay interface, snow plow impact, or magnified localized stresses attributable to thermal behavior (especially at acute angle portions of skewed decks).

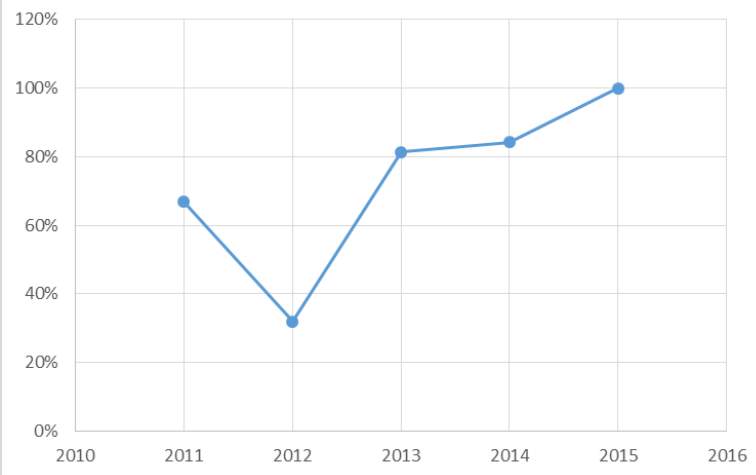
It is also worth highlighting that one of the bridges (FHWA #47860) had a delamination rate of 67 percent before epoxy injection. This delamination rate was reduced to 32 percent one year after injection, and had delamination rates of 81 percent and 84 percent, respectively, for the second and third years. The bridge deck was replaced in the fourth year. This observation may indicate that epoxy injection should not be applied to a bridge deck with a high delamination rate. However, due to the scope of this research, this observation needs to be further validated. When possible, a recommended delamination rate threshold should be established via future research work.

Due to the performance of bridge #47860 and its deviation from the other observed bridge performances, it was taken as an outlier and was removed from subsequent data analysis. In Table 6.3, the mean and standard deviation of the delamination rate were recalculated after excluding this bridge.

Deck replaced in 2015
