Assessment, Repair, and Replacement of Bridges Subjected to Fire

**Final Report
August 2022**

Sponsored by
Iowa Department of Transportation
(InTrans Project 20-734)
Federal Highway Administration

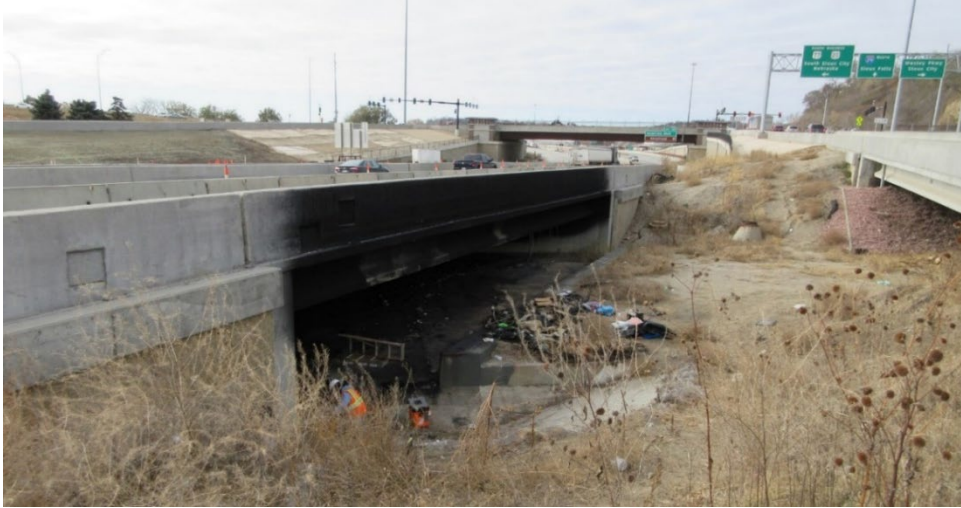
Figure 1. I-29 Bridge fire in Sioux City, Iowa (north side of bridge looking toward west abutment)

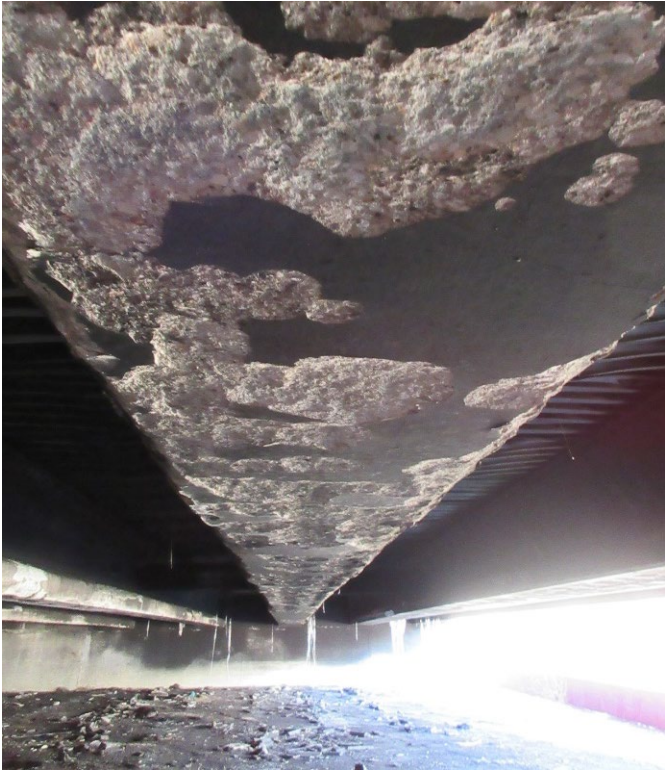
Figure 2. Concrete spalling on concrete girder

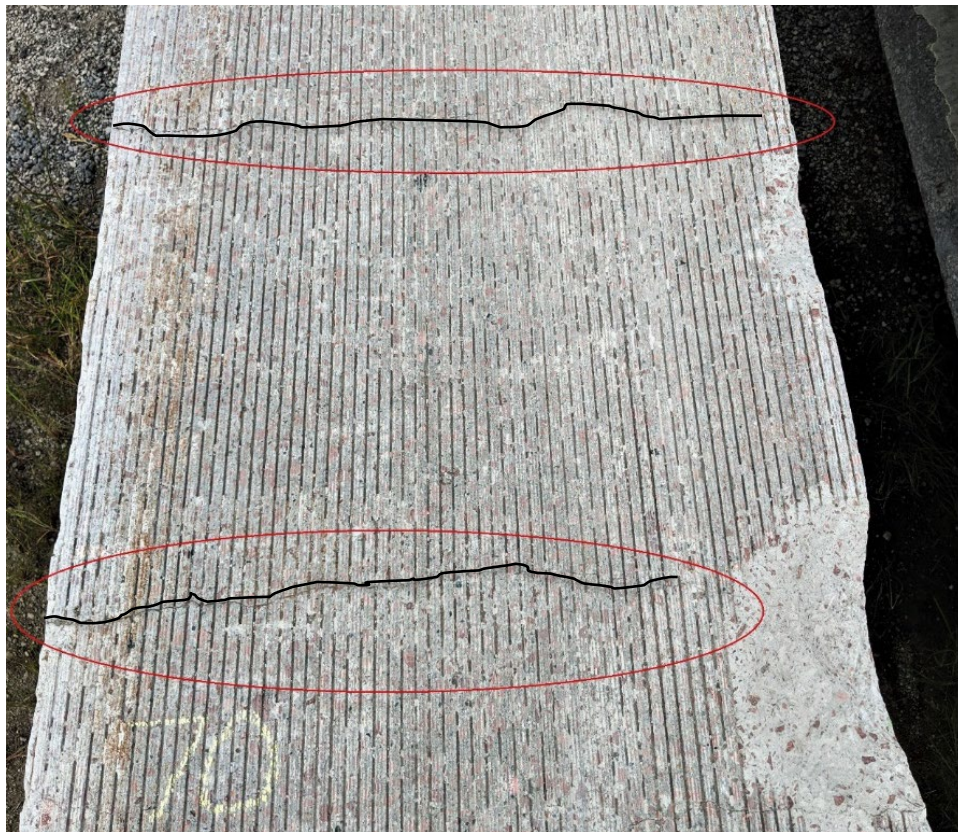
A visual assessment indicated that Girder B was least effected by the fire. Cracks observed on the deck surface were documented, but they were not considered to be a result of the fire. Rather, they appeared to be a result of concrete shrinkage typically observed on bridge decks. Figure 43 shows an example of the typical transverse cracks observed (annotated for clarity).

Figure 43. Typical deck surface cracking observed on Girder B

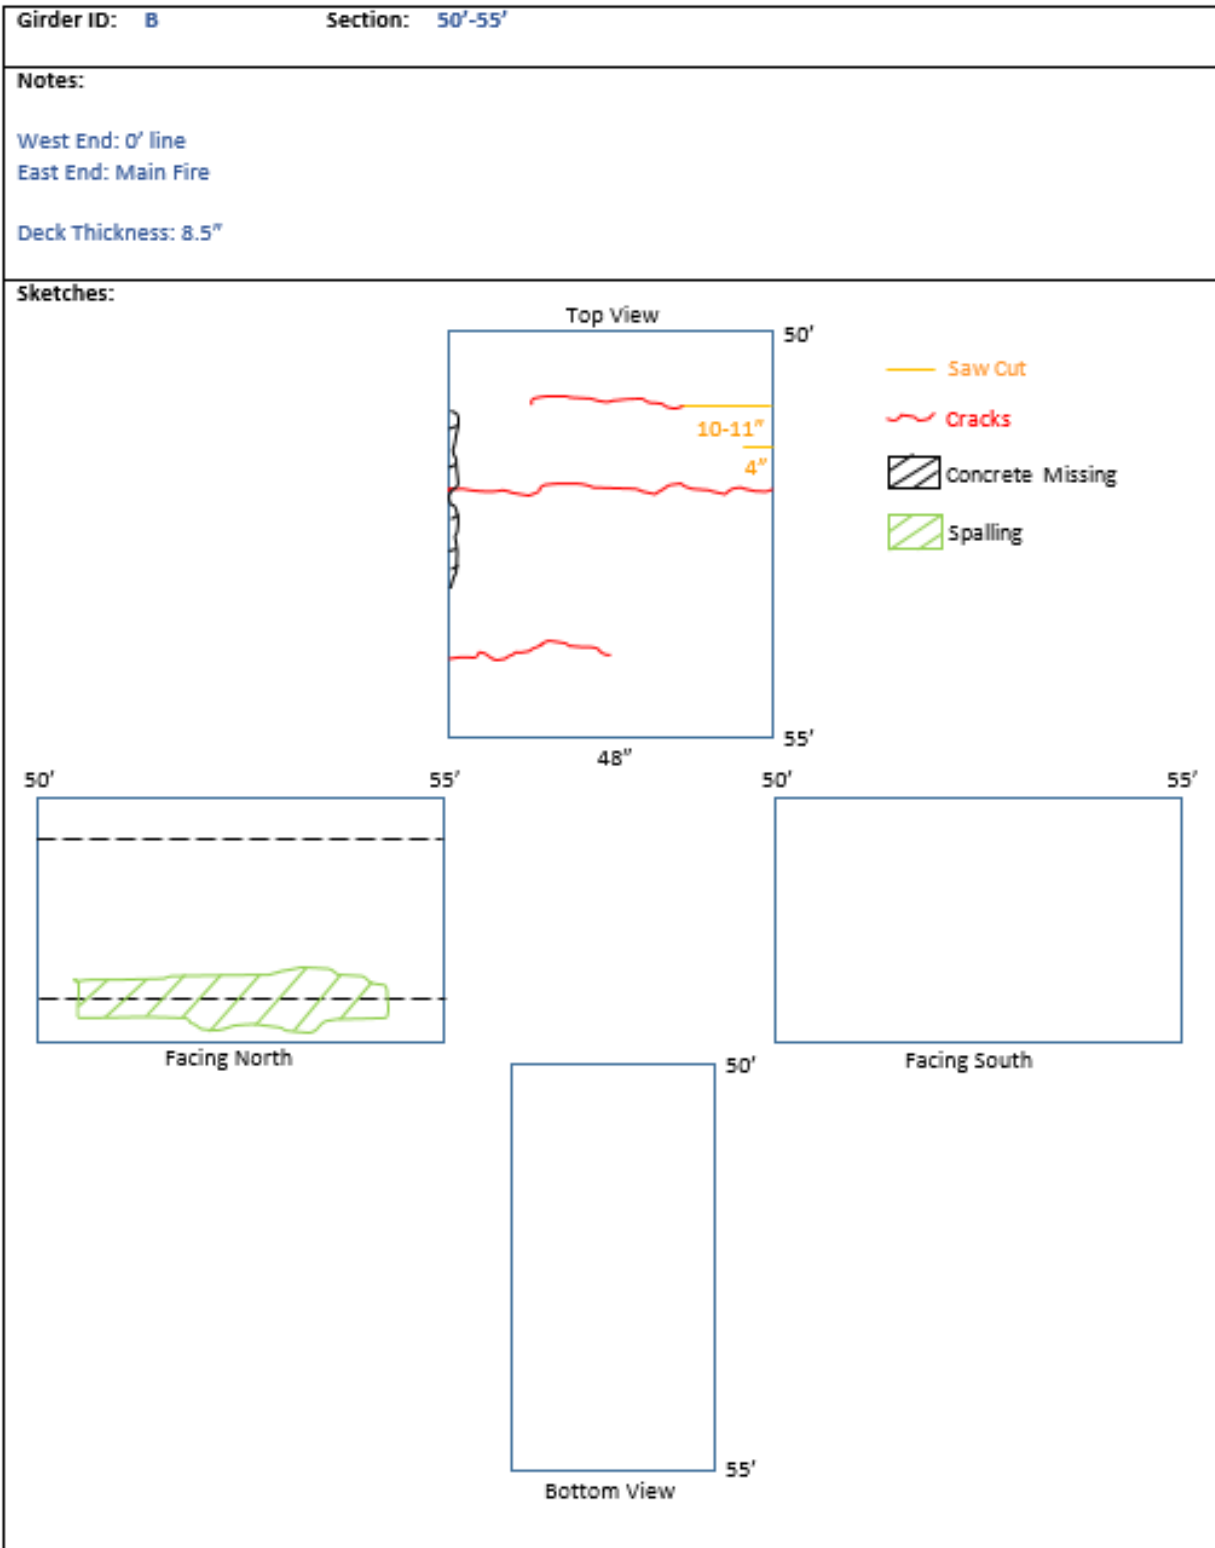
Areas of spalling were present on each side and bottom of the girder although it was in better condition than Girder E or G. An example of spalling near the midspan of Girder B at the bottom flange concrete is shown in Figure 44 and Figure 45 (annotated for clarity).

Figure 44. Example showing digitized condition assessment for Girder B

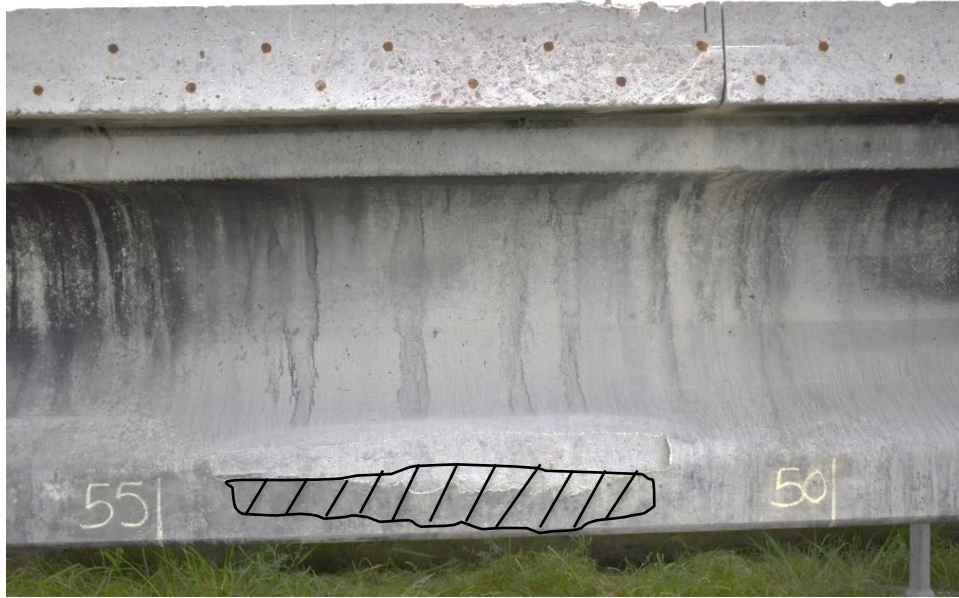
Figure 45. Spalled area on bottom flange near Girder B midspan

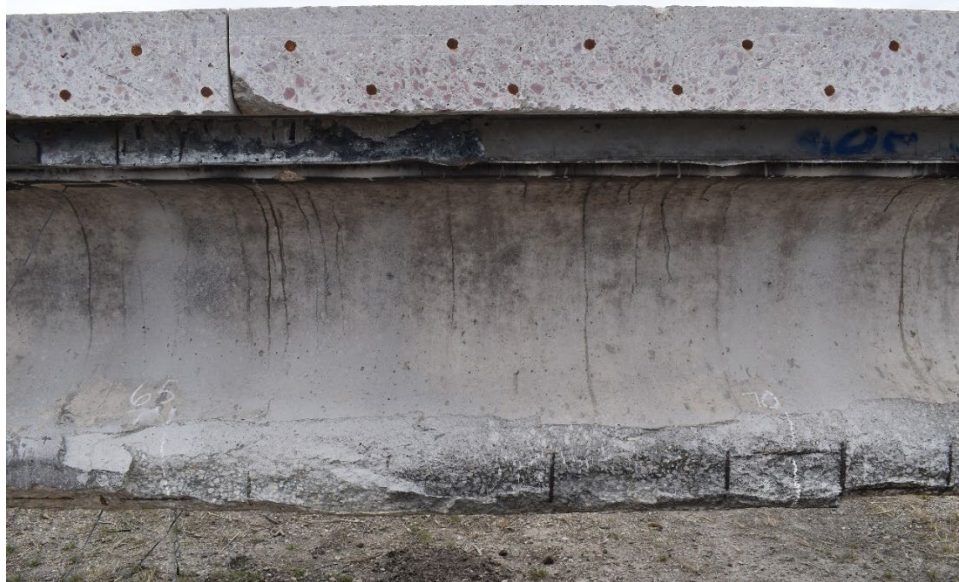
Visual observation of Girder E indicated a greater level of damage than Girder B (see Appendix). An increased area and depth of spalling was present compared to that for Girder B. The spalling occurred throughout the bottom flanges and at several areas on the web. Areas of steel reinforcement were exposed as shown in Figure 46 and Figure 47.

Figure 46. Bottom flange spalling on Girder E

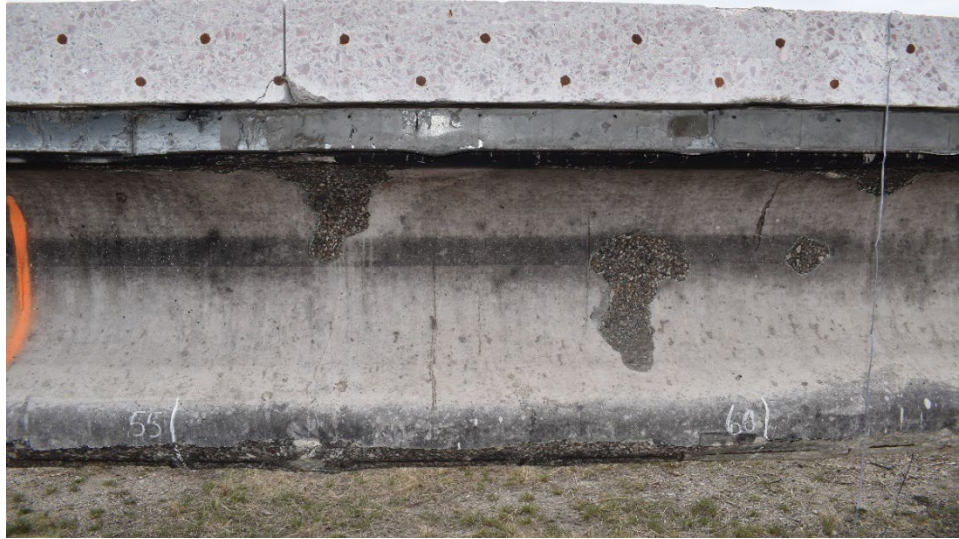
Figure 47. Web spalling on Girder E

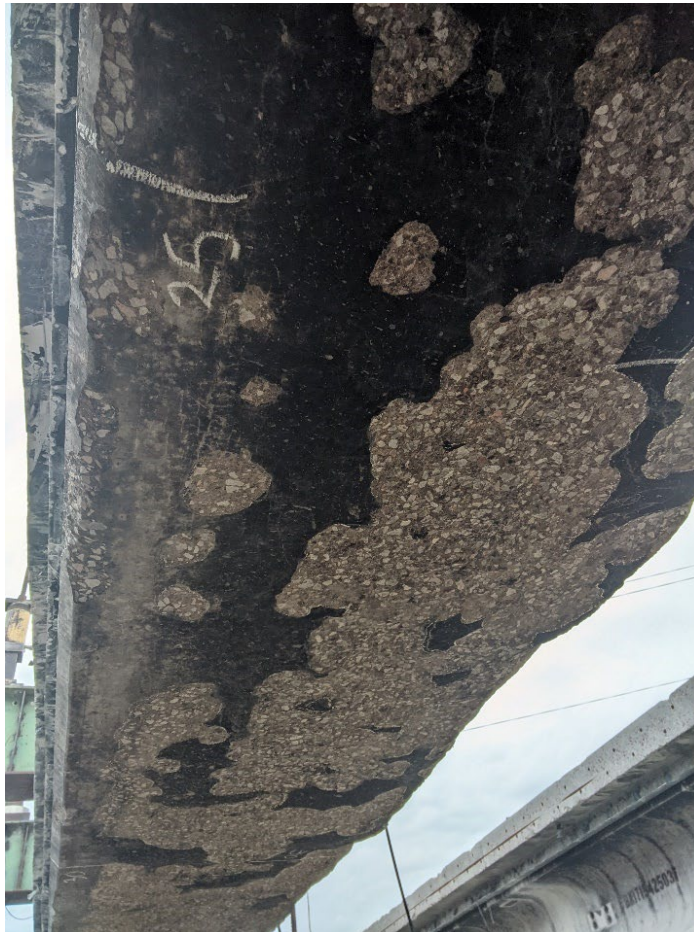
Extensive spalling on the bottom side of the girder is shown in Figure 48.

Figure 48. Bottom side spalling on Girder E

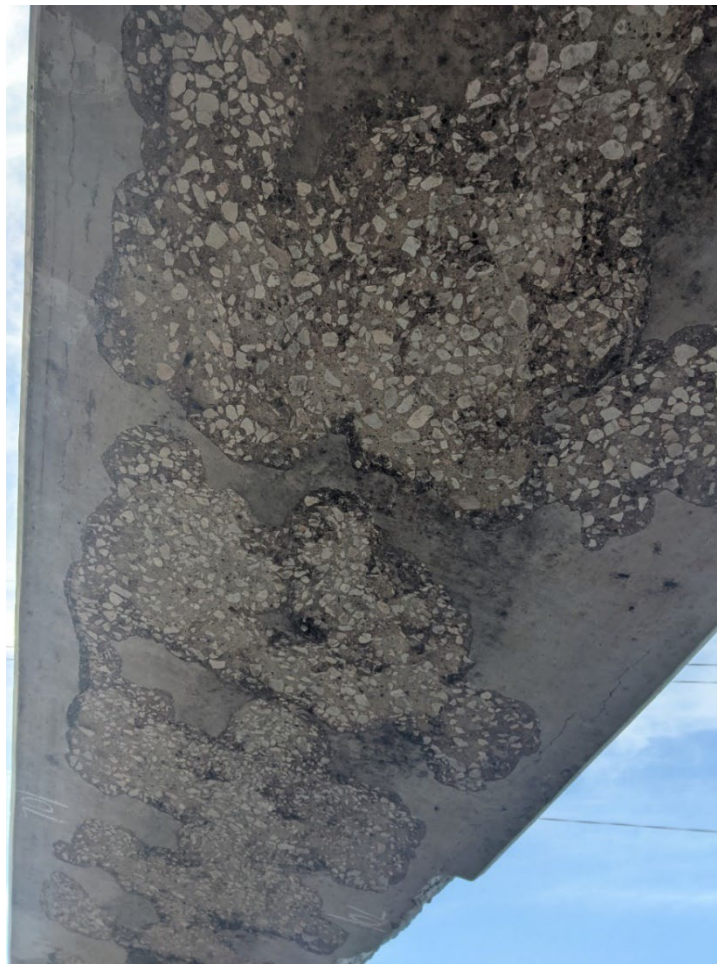
The condition of Girder G was similar to what was observed on Girder E (see Appendix), although the overall area of concrete damage was greater. The bottom flanges and bottom side of the girder had extensive spalling (see Figure 49), which resulted in the exposure of steel strands and shear reinforcement (see Figure 50).

Figure 49. Spalling of concrete on bottom side of Girder G

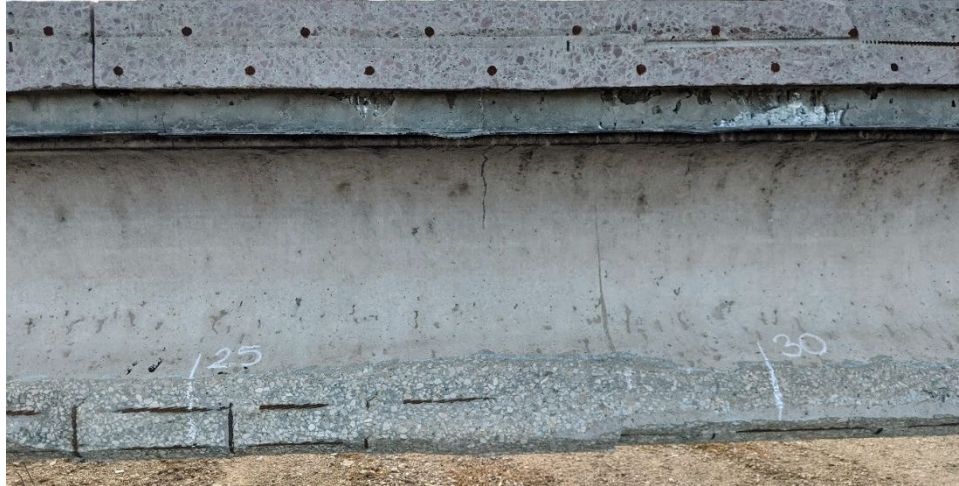
Figure 50. Exposure of steel reinforcement as a result of concrete spalling on Girder G

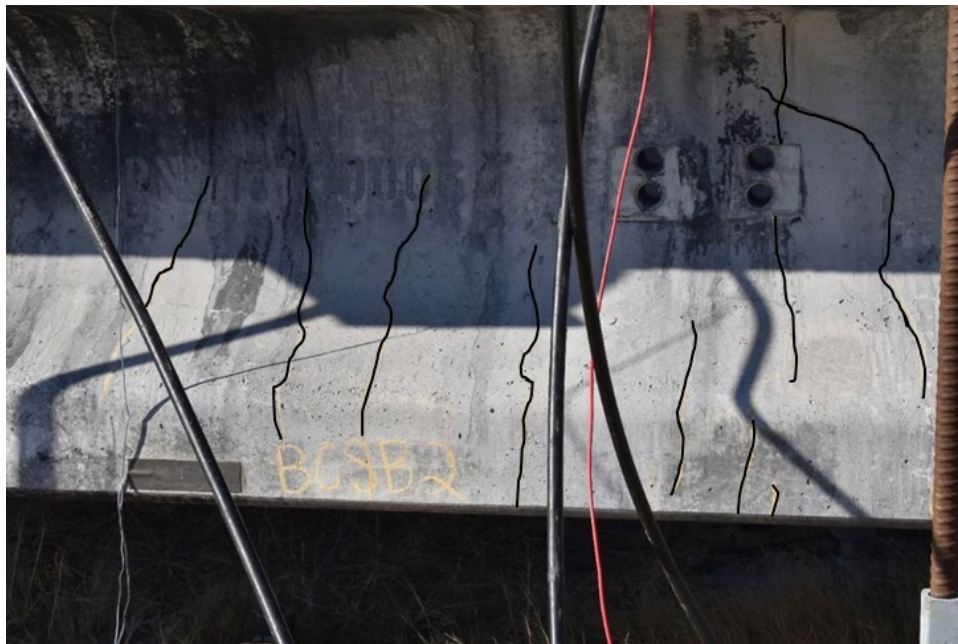
Girder B remained in an elastic state until the load reached about 70 kips at each load point location, or 140 kips total. This resulted in a midspan moment of about 2,700 kip-ft. Once this load magnitude was exceeded, yielding of the tensile reinforcement ensued at the extremities of the midspan, and flexural cracks in the concrete began to form at the bottom flange extending into the web. An example of the crack pattern is shown in Figure 52.

Figure 52. Crack patterns at midspan of Girder B

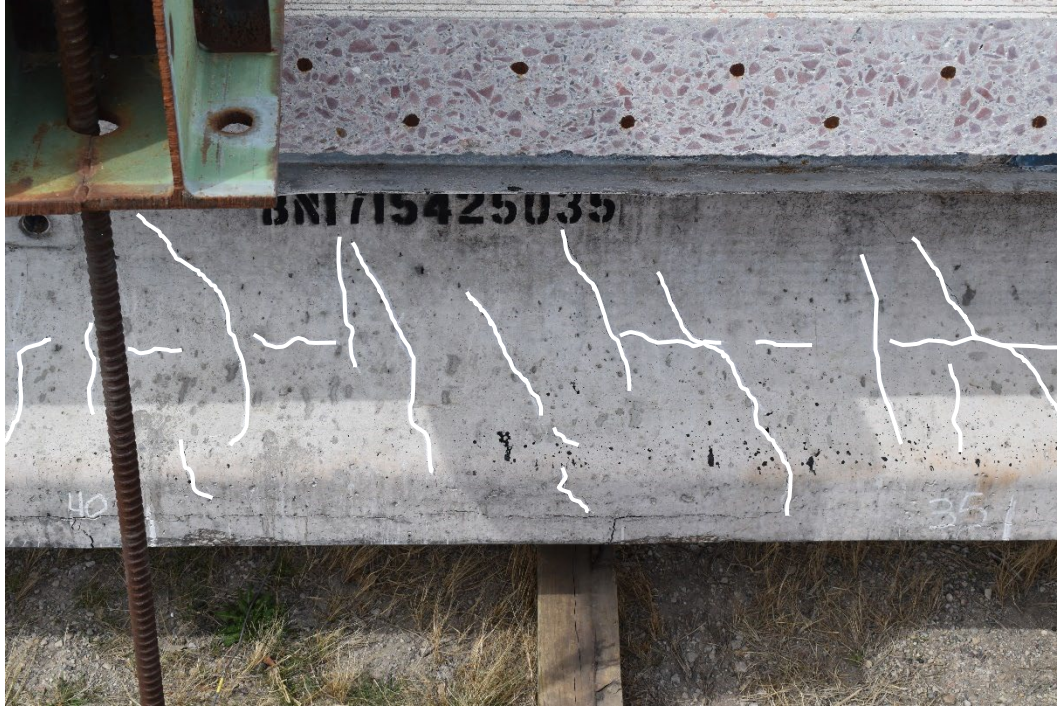
The load test of Girder E differed from that for Girder B in that the load was increased to the point of girder failure. The measured strain and deflection behavior were consistent with what was observed during the Girder B test, despite the evidence of more extensive damage (increased areas and depth of concrete spalling). Figure 57 shows the observed crack pattern near midspan prior to full failure of Girder E.

Figure 57. Cracking of Girder E bottom flange and web

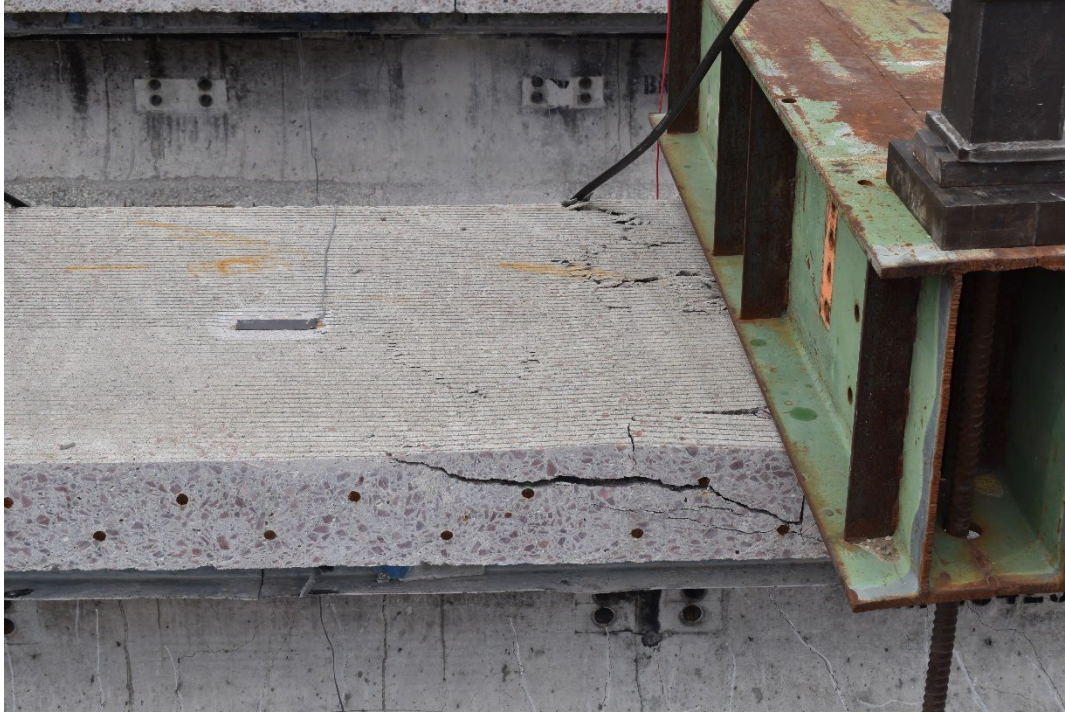
The final failure was a result of deck buckling. Capacity of the deck portion of the composite section was quickly lost upon buckling, resulting in all of the load being directed into the girder and exceeding the girder ultimate capacity. Figure 58 shows the initiation of the deck buckling near one of the points of loading, and Figure 59 shows the girder after failure occurred at a total load of 260 kips or a midspan moment of about 5,000 kip-ft

Figure 58. Initiation of deck cracking at Girder E midspan

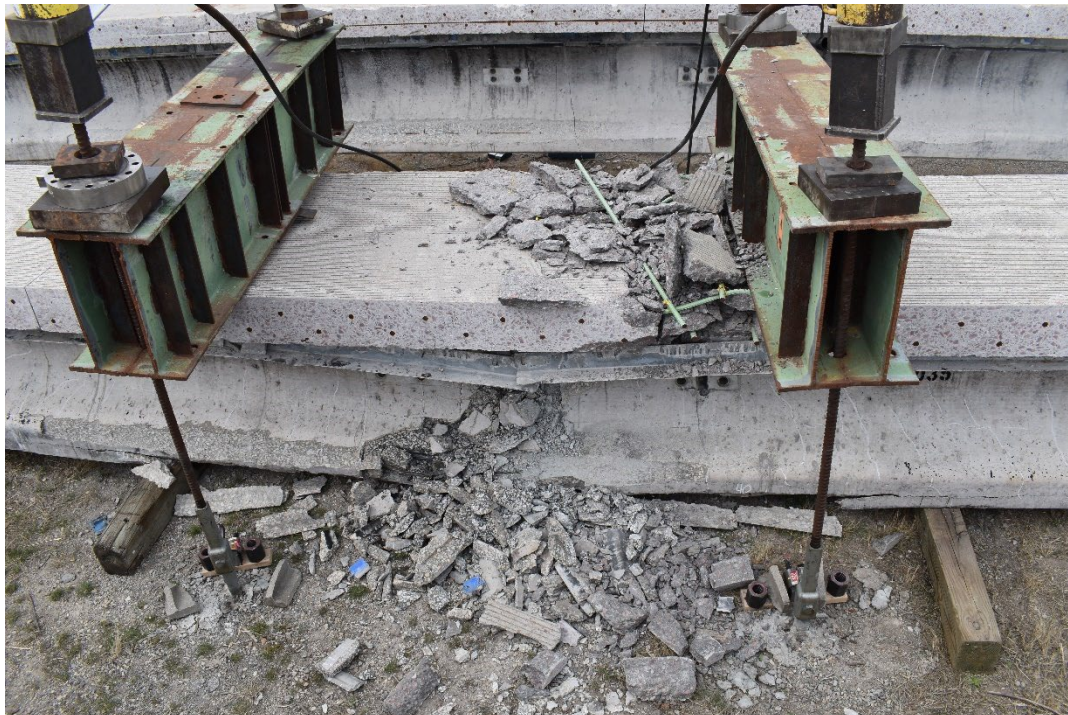
Figure 59. Girder E after failure at midspan

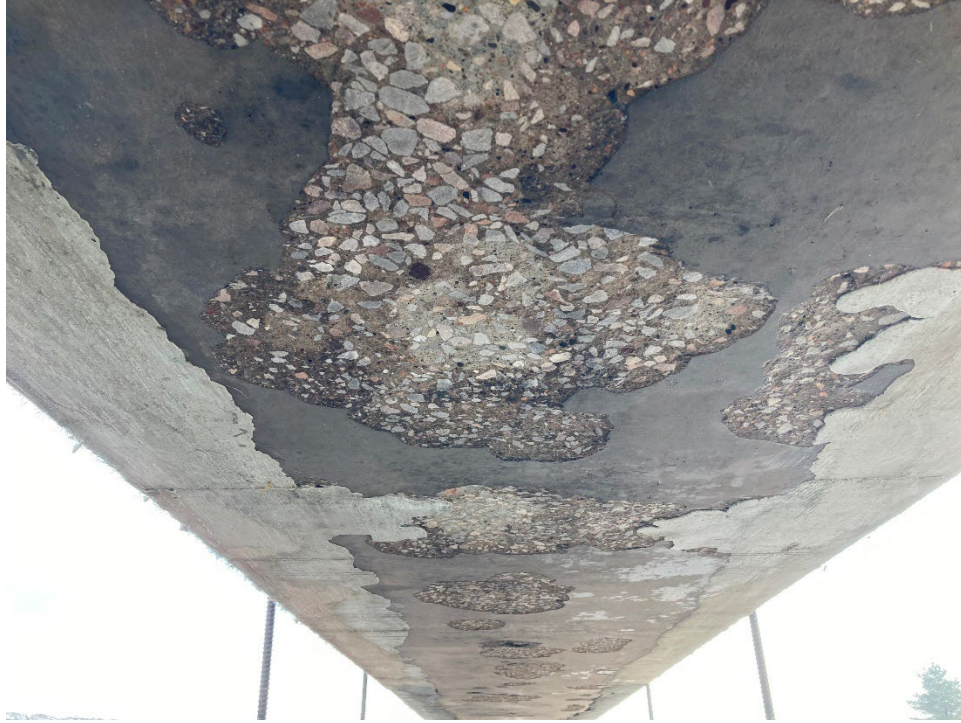
Figure 83. Bottom of girder spalls prior to repair

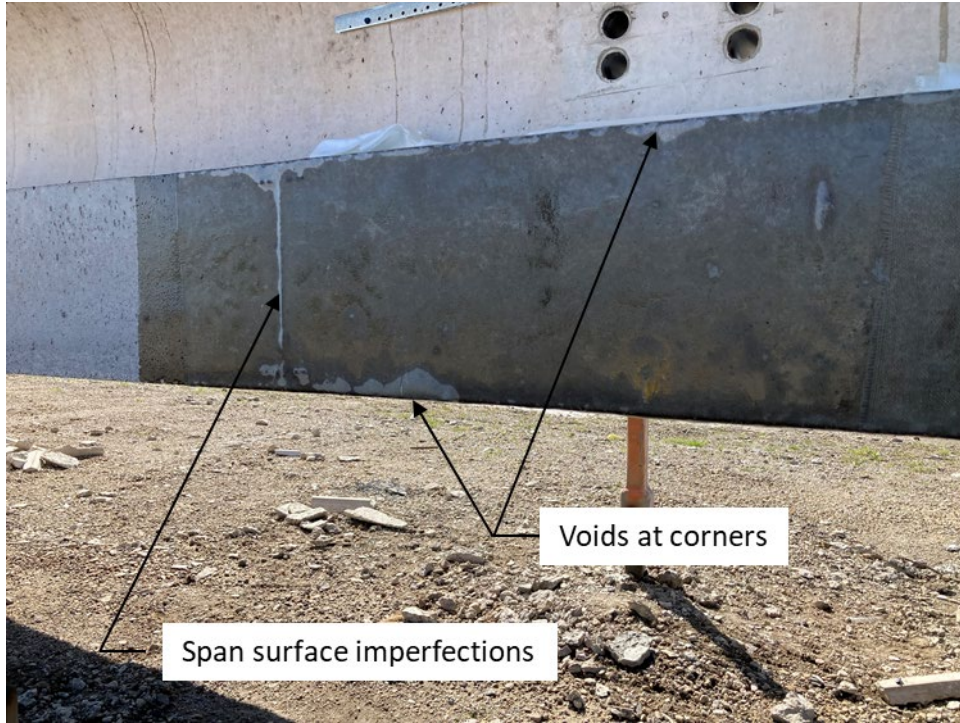
Figure 87. Problematic areas of FRP installation

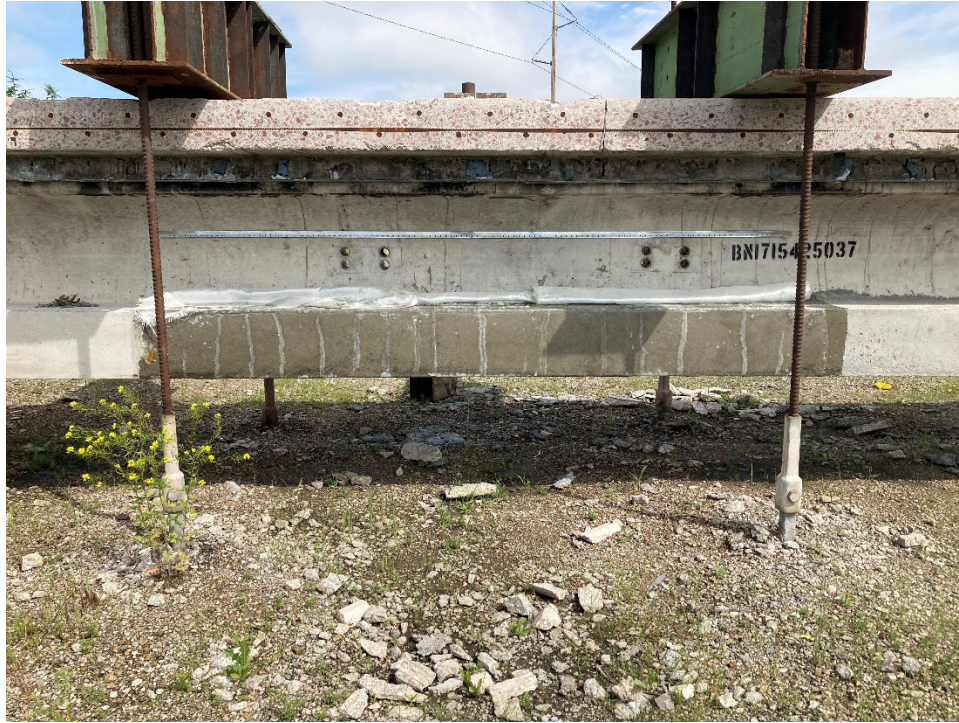
Figure 90. Vertical cracks in SCC/FRP repair section

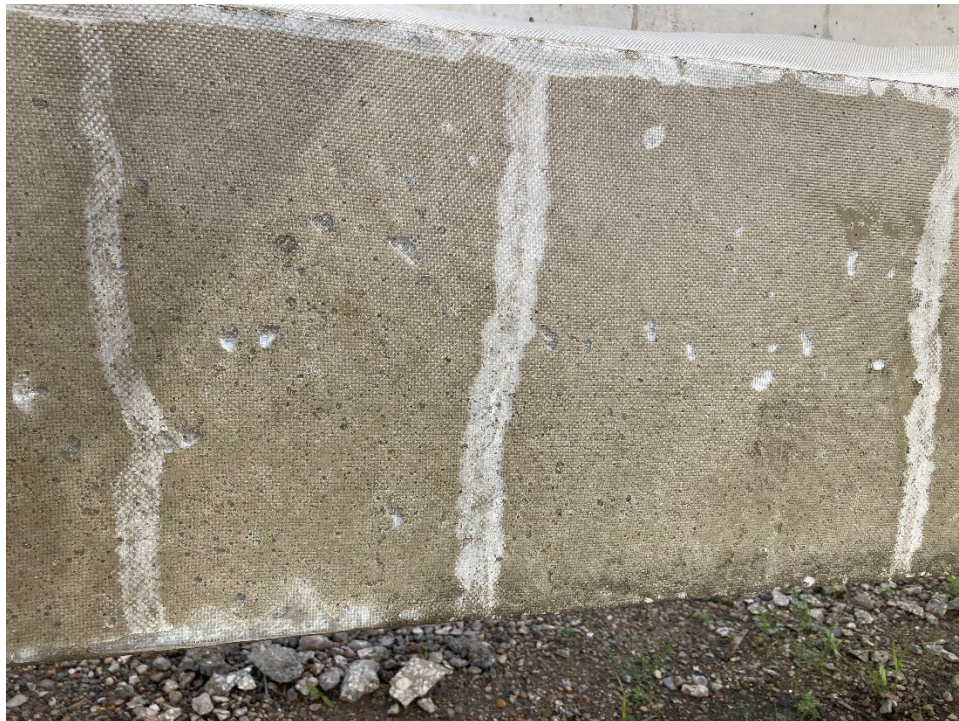
Figure 91. Closeup of vertical cracks in SCC/FRP repair section
