Arlington RAPID

Autonomy Insights Report

March 2021

March 17th, 2021 – April 30th, 2021

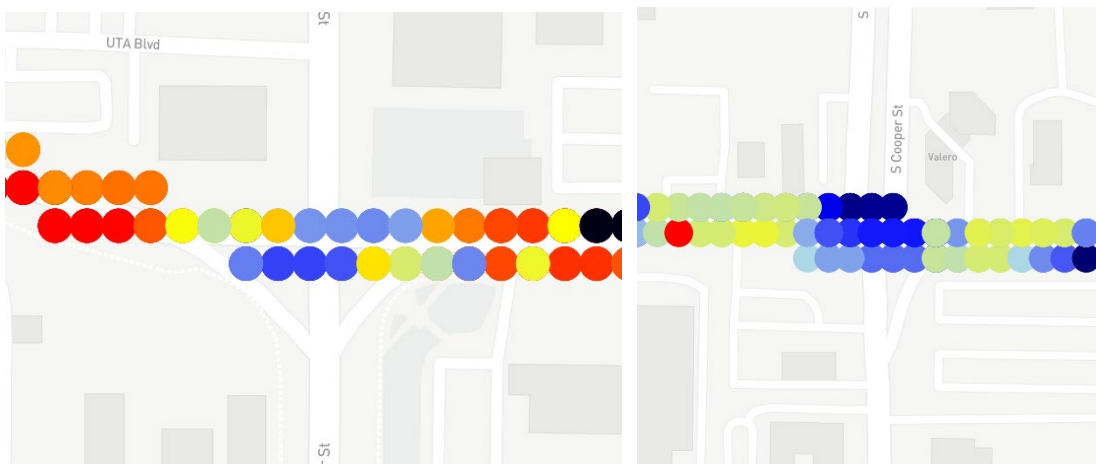
Figure 2: Intersections of UTA and Cooper (Left) Abram and Cooper (Right)

Due to constraints with our new Lexus platform, traffic light detection has been more challenging compared to the GEM. This results in some traffic lights failing to be detected, at which point the autonomy system assumes it is a red light. The Fleet Attendant will have to take over, which can be seen through decreased autonomy utilization near traffic controlled intersections.

This performance degradation has been communicated to the autonomy development team, and a new feature has been created that will practically

eliminate the failed readings we are seeing on the Lexus. This feature will be rolled out to the fleet in our next software release.

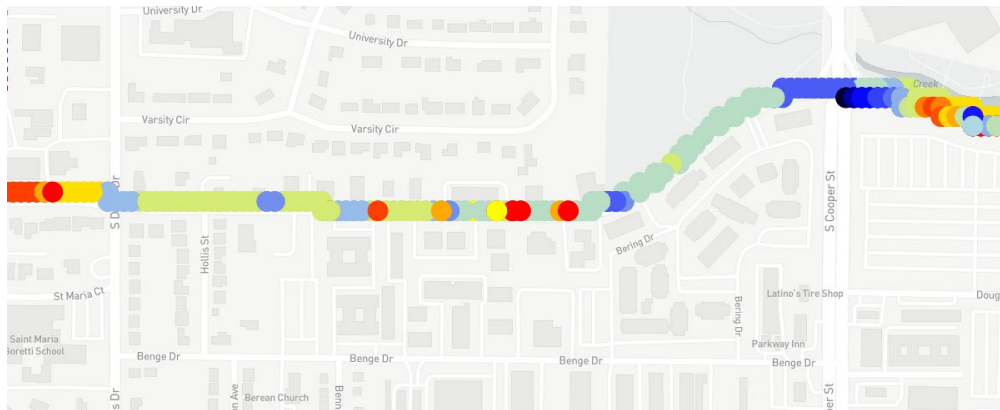
Figure 3: Mitchell Street west of Cooper

Mitchell has relatively low autonomy utilization compared to other areas of the route. This particular section of Mitchell is a challenge for our localization system, as there are many sections characterized by dense foliage and low clear vertical structure. This reduced localization accuracy results in the vehicle driving slightly off center in the lane at which point the Fleet Attendant will take over. The narrow lanes on

Mitchell street combined with the moderate localization explains the lower autonomy utilization in this relatively low complexity area.

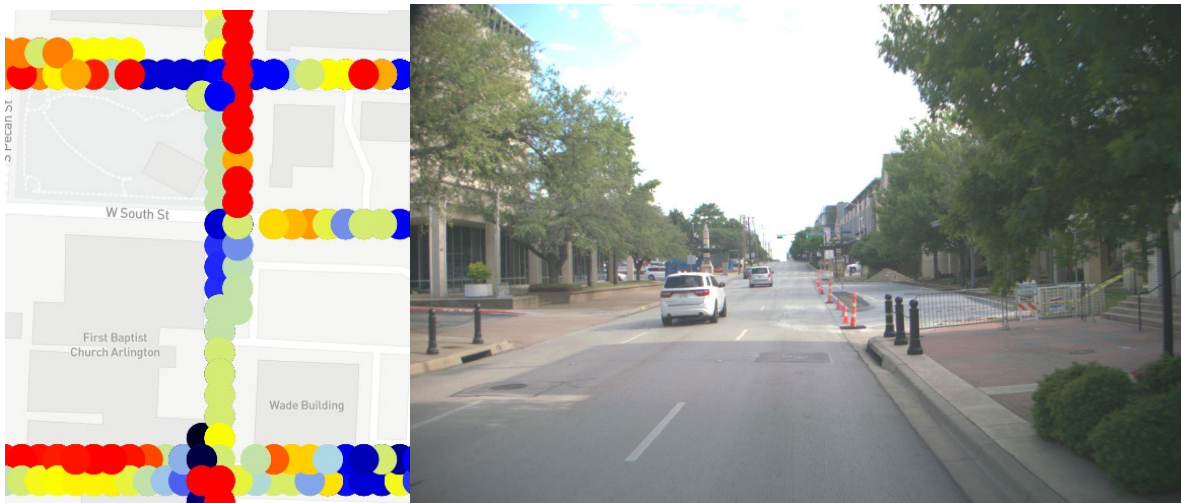
Figure 4: Center Street constructions

Sections of Center street (pictured above) and Abram have seen construction during the month of April. Even if the construction does not change the path the vehicle must take, it can still affect autonomy performance. This is primarily due to retroreflective cones and signs placed close the edge of the lane. Retroreflective objects appear to “bloom” from the Lidar’s perspective. This means that the object can appear larger than it really is, thus the vehicle may not think that it can get around the object while staying in the lane. This Lidar bloom can also be sporadic, causing uncomfortable slowdowns as the vehicle passes. For this reason FAs are trained to take over in these areas to prioritize safety and rider comfort.

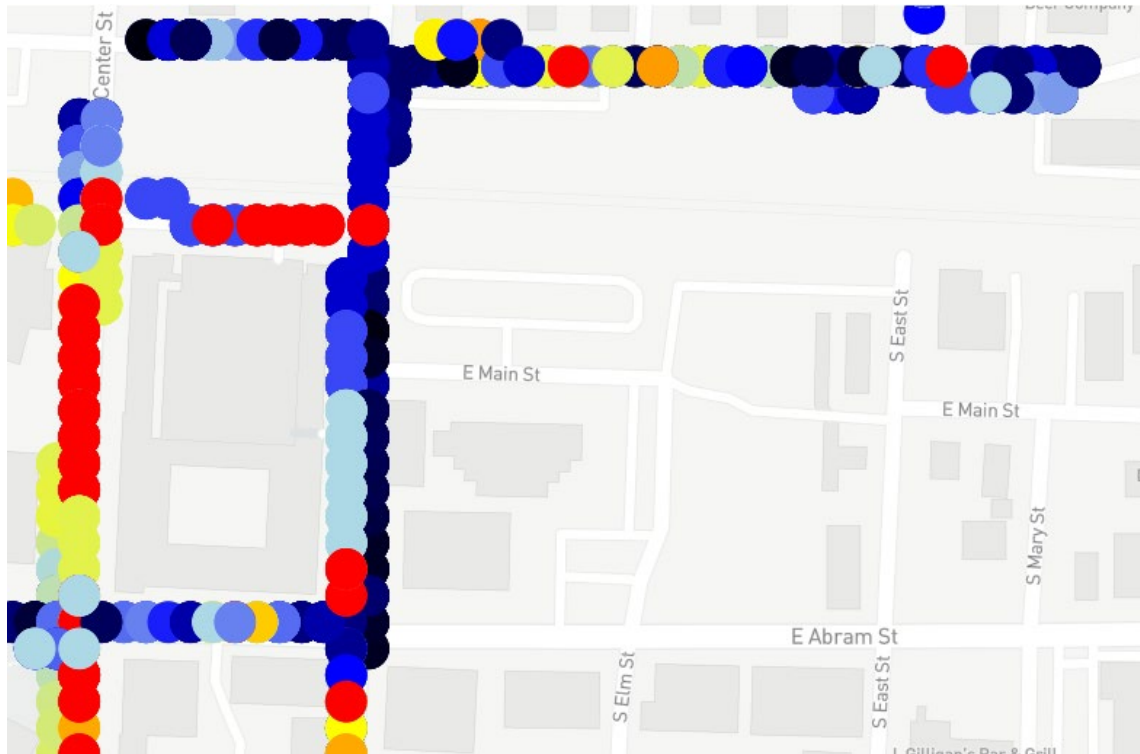
Autonomy utilization is very low along Mesquite from Abram up to and along Front street. This occurs as it is the most common route the FAs follow to get back to our office on Front street at the end of their shift or when taking a break. Since the vehicle can only be “told” to hover between its terminals or drive to a pickup/dropoff, the FAs must take over and manually drive to the office, thus reducing autonomy utilization in this area.

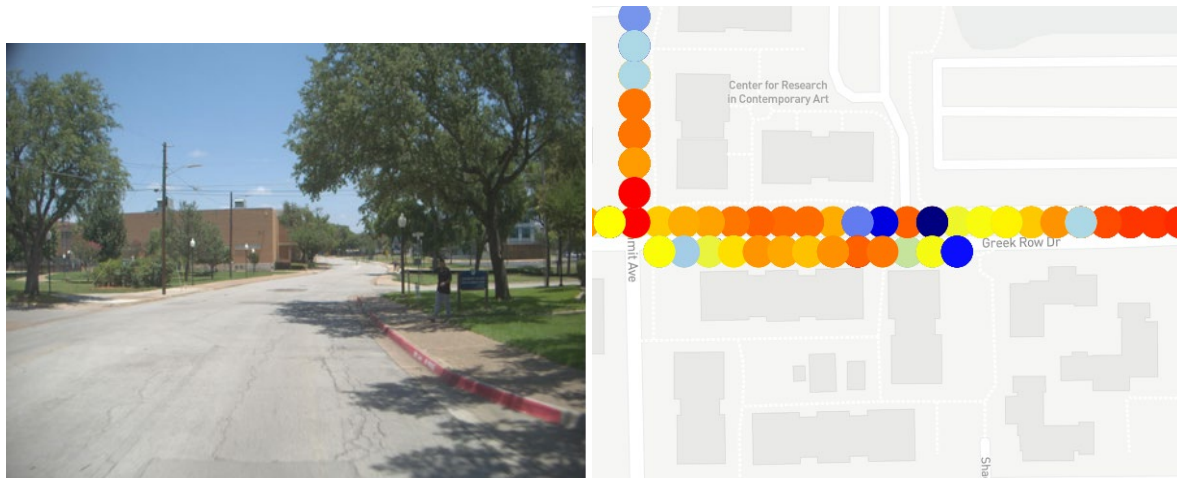
Figure 2: Overhanging Trees (Left) and Autonomy heatmap on Greek Row (Right)

Tree growth particularly on Greek Row has affected autonomy performance toward the end of May. Autonomy utilization is relatively high as seen in the above heatmap, however, FAs have reported the vehicle slowing down while going through this area. The autonomy system is able to go under static objects such as trees or bridges if the vehicle determines there is enough clearance based on its height and a set buffer distance. At a distance, there is additional uncertainty in the exact clearance

between the road and the trees, so the vehicle ops to slow down until it is confident there will be enough space. We are working with UTA to trim these trees to improve autonomy performance.

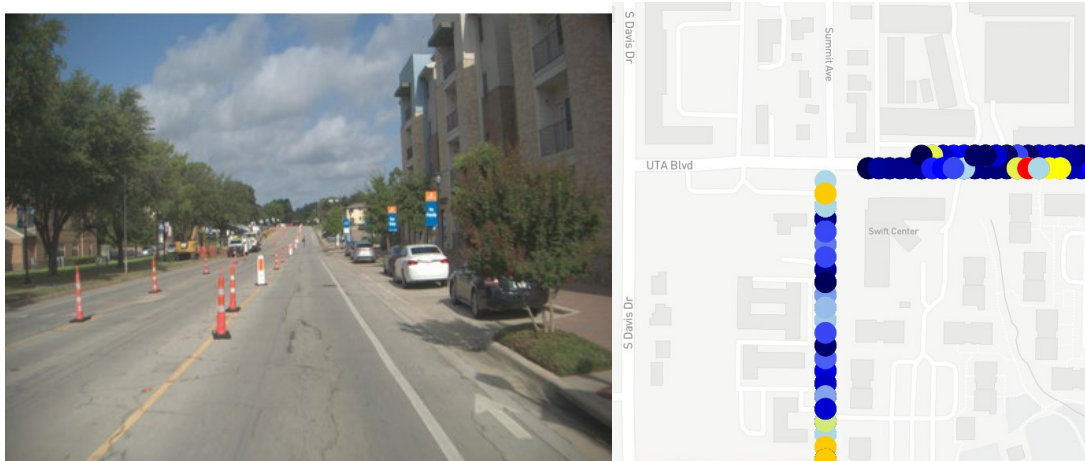
Figure 3: Construction on UTA

Construction on UTA has reduced autonomy utilization along UTA and Summit. The intersection of Summit and UTA was closed to traffic for most of May, thus requiring

the FAs to manually divert when dispatched to stops along the north end of Summit. In addition, the cones shown in the image above, depending on their placement, cause the vehicle to slow down. Prioritizing rider comfort, the FAs will often take over in these areas to ensure a smoother ride.

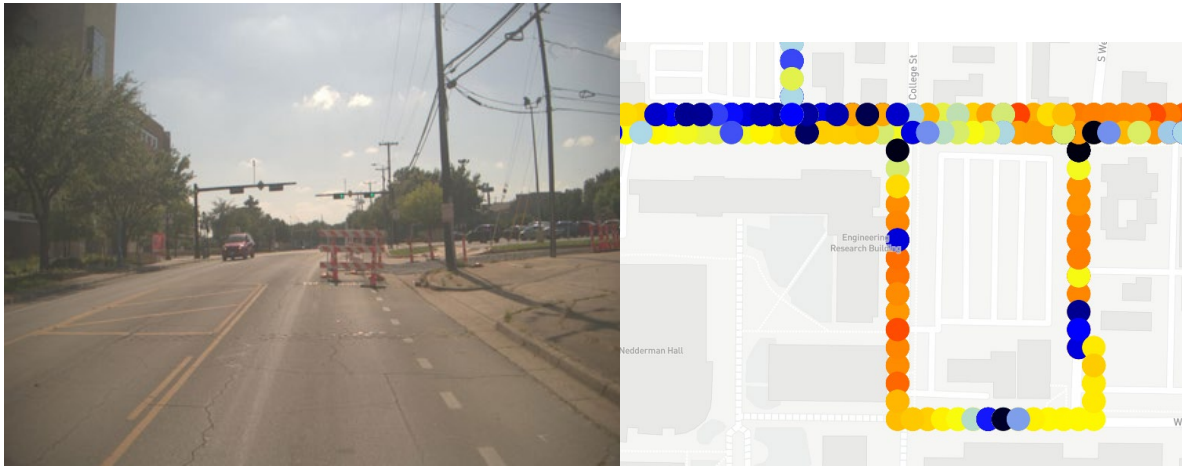
Figure 4: Construction at UTA and Lampe

Additional construction blocking the westbound lane of UTA at Lampe also requires the FAs to take over. Currently, takeovers due to construction cannot be filtered and categorized from our total intervention numbers. This categorization is something we are looking to work on in the coming months.

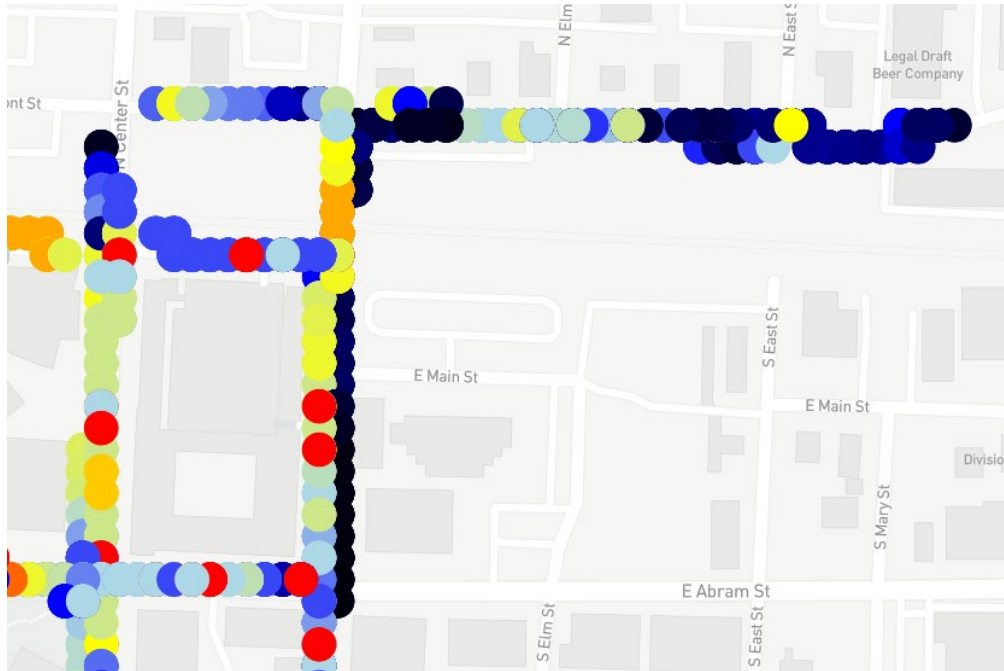
Figure 5:

As mentioned in the previous report, the FAs must manually drive to the office (located at the top right corner of the above image) as the vehicle is dispatched by default to circulate between two stops while awaiting a ride. The fix for this is to dispatch the vehicle to the office on Front street when an FA's Via shift is complete. This feature will be tested and implemented in June.

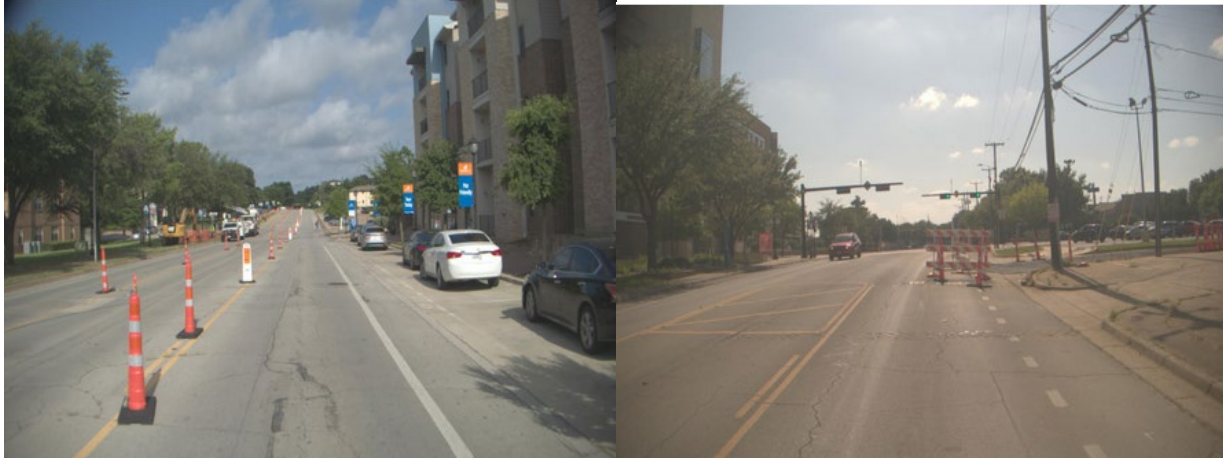
Figure 2: Construction on UTA & Summit (Left), Barrier along UTA & Lampe (Right)

Throughout the month of June, construction has continued on UTA, which is a heavily trafficked area of the route. As seen in the above left image, cones along the westbound direction of UTA cause the vehicle to slow, so FAs will often take over to improve the ride for the passengers.

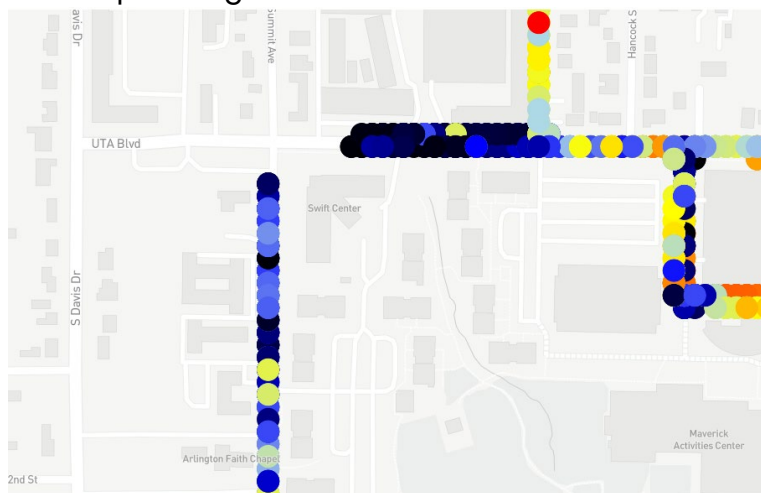
Figure 3: Reduced autonomy utilization along UTA and summit due to construction

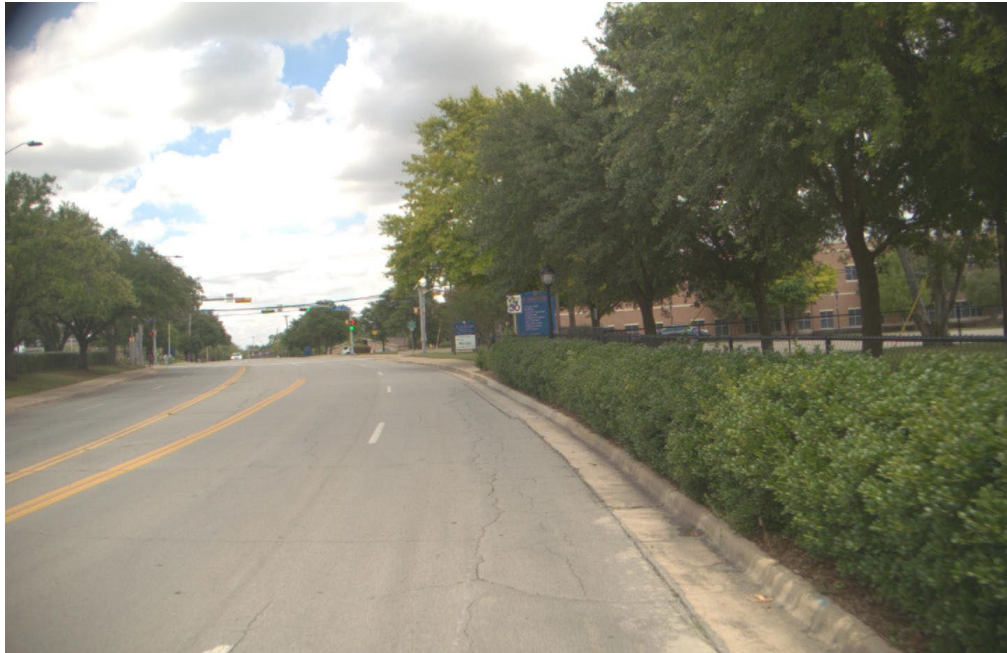
Figure 4: Shrubs on Mitchell EB

As mentioned in previous reports, the vehicle can have difficulties when foliage encroaches into the drive lane. This is especially problematic with large objects near/in the road as our system may momentarily predict that the object will move into our path. This causes the vehicle to behave cautiously and slow down. In anticipation of these slowdowns FAs often preemptively takeover.

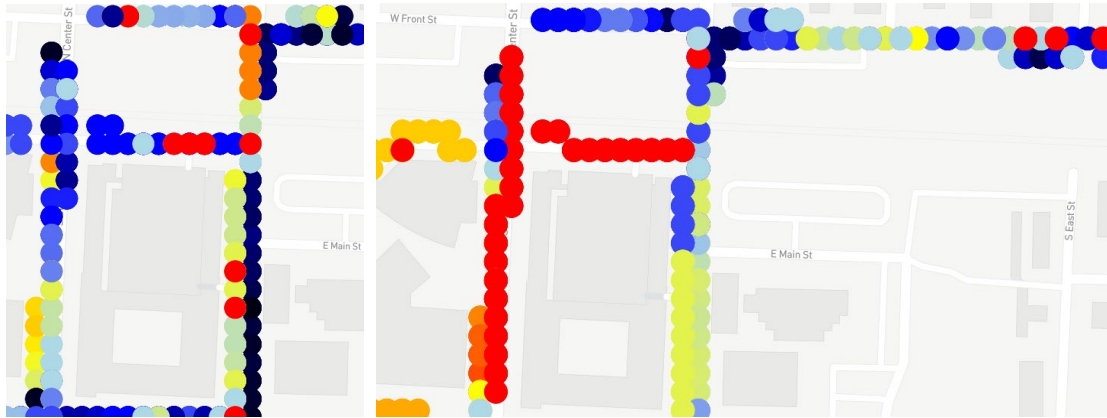
Figure 5: *Autonomy Utilization on Mesquite before June 23rd (left), Autonomy Utilization on Mesquite after June 23rd (right)*

Starting on June 23rd, Via began dispatching the AVs to the office (at the top right corner of the image) at the end of the FA’s shift. FAs most commonly drive north in the right lane of Mesquite up to Front Street at the end of their shift. Before this change, the FA would need to manually drive to the office, since the vehicle’s last command was to continue hovering. Autonomy utilization along mesquite has greatly improved due to this change.

As vehicles began driving this section more often in autonomy, FAs began reporting that overgrown foliage from Mesquite to Front street was causing the vehicle to slow down. This was quickly remedied with route changes that moved the vehicle’s nominal lane placement away from the shrubs.

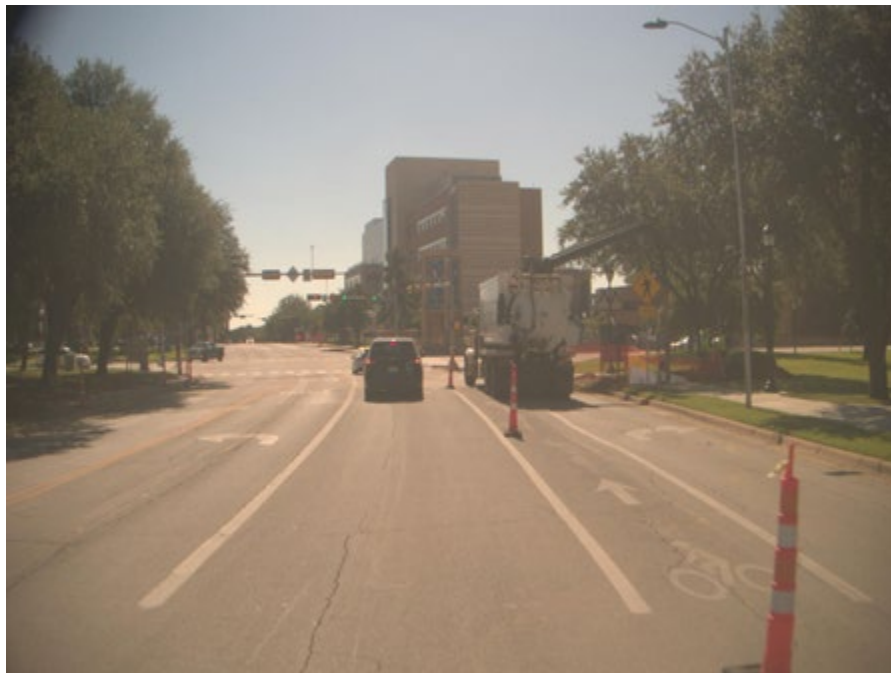
Figure 3: Construction cones along UTA

Continued construction along most of UTA Blvd has reduced autonomy utilization along this section. As mentioned in previous reports, construction cones near our lane often result in the vehicle slowing down unexpectedly; therefore, the AVOs will need to take over. This situation is particularly challenging since, depending on their placement, the traffic cones may or may not cause a slowdown depending on if they encroach on the AV's designated lane. As a result, the AVOs opt to prioritize rider comfort and drive manually in these areas. The May autonomy development team is

currently working on the classification of and reaction to static objects in the AV's lane.

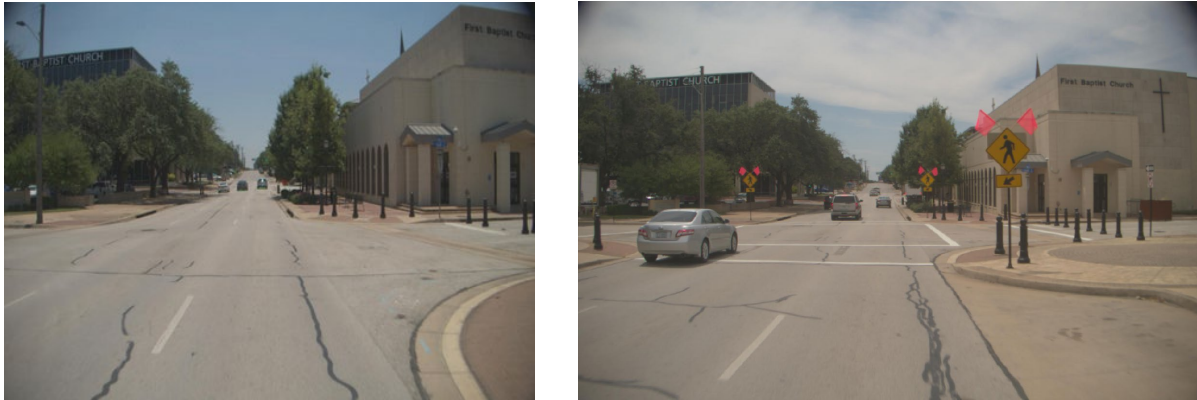
Figure 4: New crosswalks added to Center & E South St

During the Field Engineering trip to Arlington for July, it was noted that crosswalks were added to the intersection of Center and E South St. The geometry of crosswalks are added to the route network which the vehicle uses to inform its decision making. Knowing the locations of crosswalks are particularly important for the AV as it allows the behavior system to better predict what pedestrians along the sides of the road may do. This in turn allows the vehicle to better determine the right of way when pedestrians are crossing this intersection.

For these reasons it's important to update the route network with pertinent information such as crosswalks and lane markings, and it highlights the importance of regular checks for changes in the route. We are also now training the AVOs on changes to look out for in order for the Field Engineering team to make updates as quickly as possible.

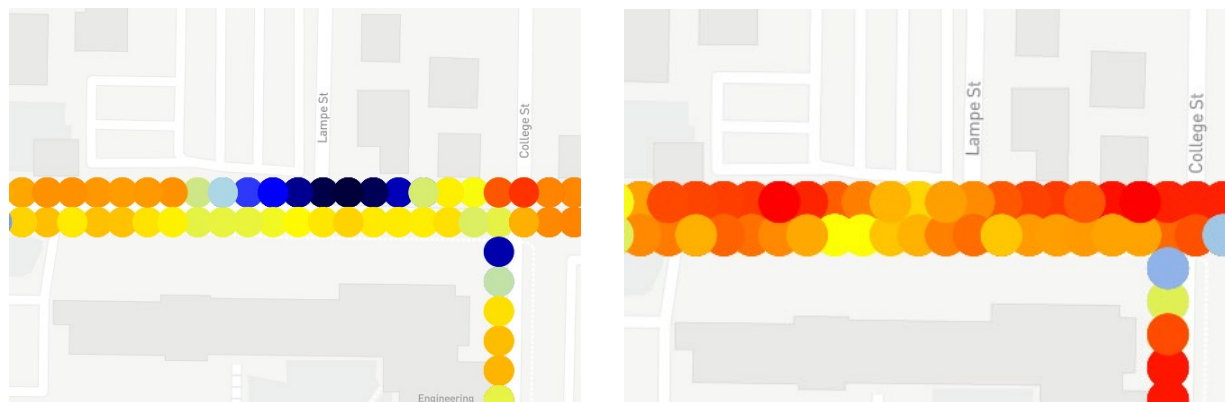
Figure 2: Autonomy utilization on UTA before (left) and after (right) construction on Lampe St cleared

Construction on Lampe Street cleared at the end of August. Before, construction cones and signs blocking UTA Boulevard westbound resulted in the AVOs manually taking over to drive around the obstructions. The above autonomy heat maps show the autonomy utilization on UTA before and after the obstructions at UTA & Lampe

cleared. Small improvements such as this help to improve autonomy utilization through fewer interventions and longer autonomy segments.

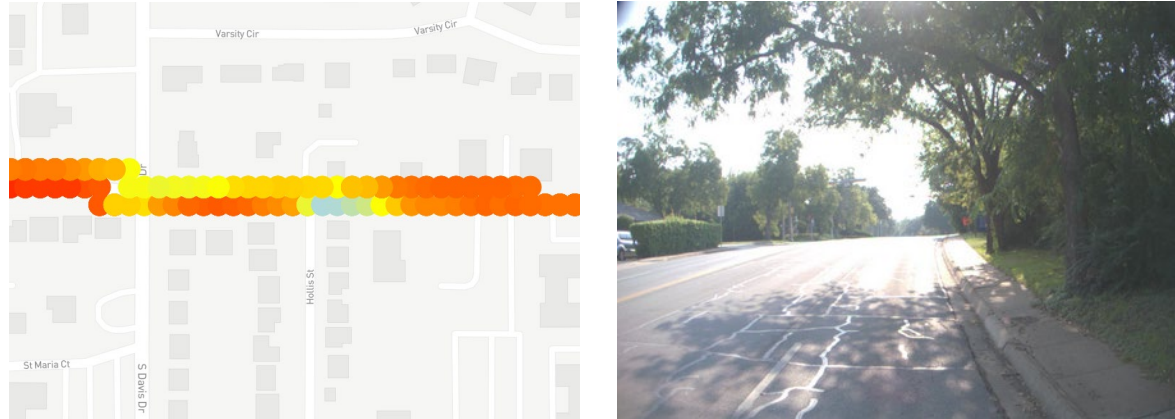
Figure 3: Reduce d autonomy in yellow (left), Overhanging trees on Mitchell & Davis

As mentioned in previous reports, foliage that encroaches on the AV's lane will cause the vehicle to slow or come to a stop as it passes. In this particular case, the overhead trees appear to be too close to the top of the AV when viewed at a distance. Because of this, the AV will slow down until it becomes confident that it can pass safely under the perceived obstacle. AVOs have been taking over recently to improve rider comfort as the slowing has increased due to increased growth. The project team is working with UTA to get these trees trimmed to avoid this problem in the future.

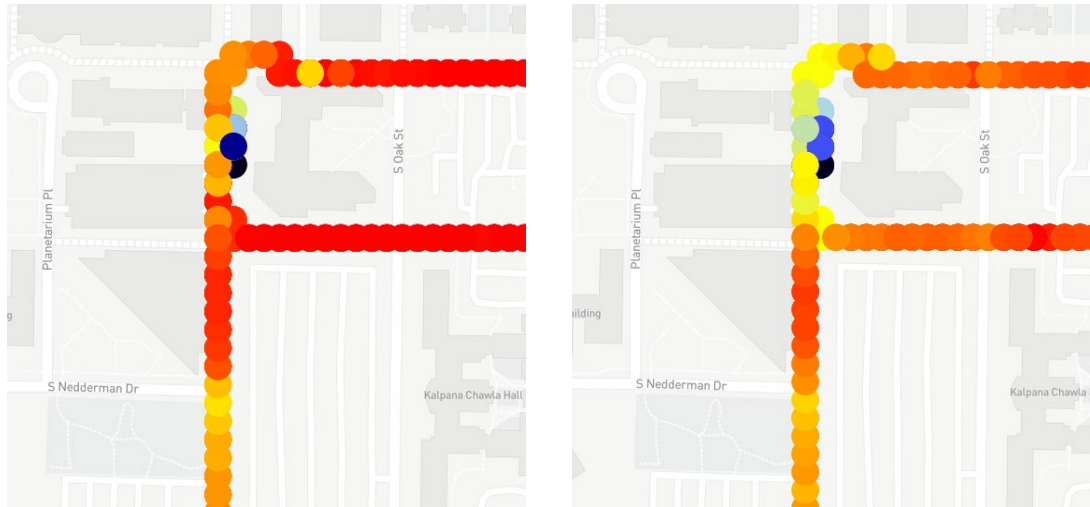
Figure 4: Autonomy utilization near the Business Building terminal

As classes came back into session, pedestrian foot traffic increased near the eastern terminal at the Business Building. With this, vehicle traffic has also increased, often resulting in situations where the AVO needs to take over to get around and parked vehicles. This can be seen with the reduction in autonomy near the AV stop on the top left of the images. This expectation of increased vehicle traffic is one of the reasons we moved the AV terminals to a new location in order to decrease congestion.

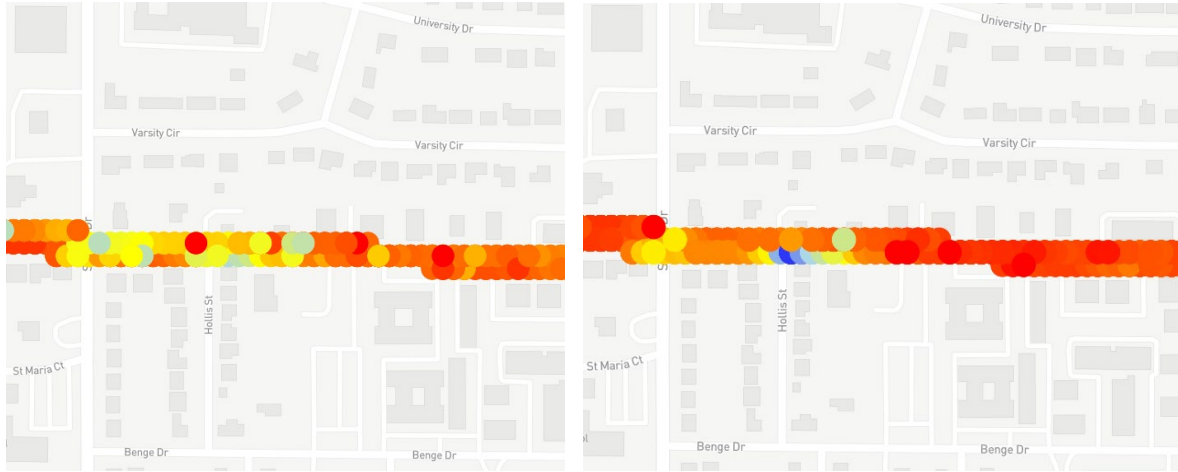
Figure 3:Autonomy utilization on Mitchell in August (left) and September (right)

Mitchell Street has been a challenge for the AV as it is a narrow road with limited buildings to provide precise localization. After fine-tunings to the lane placement in the route map and AVO training, the western section of Mitchell St. has had >90% autonomy on average throughout the month of September.

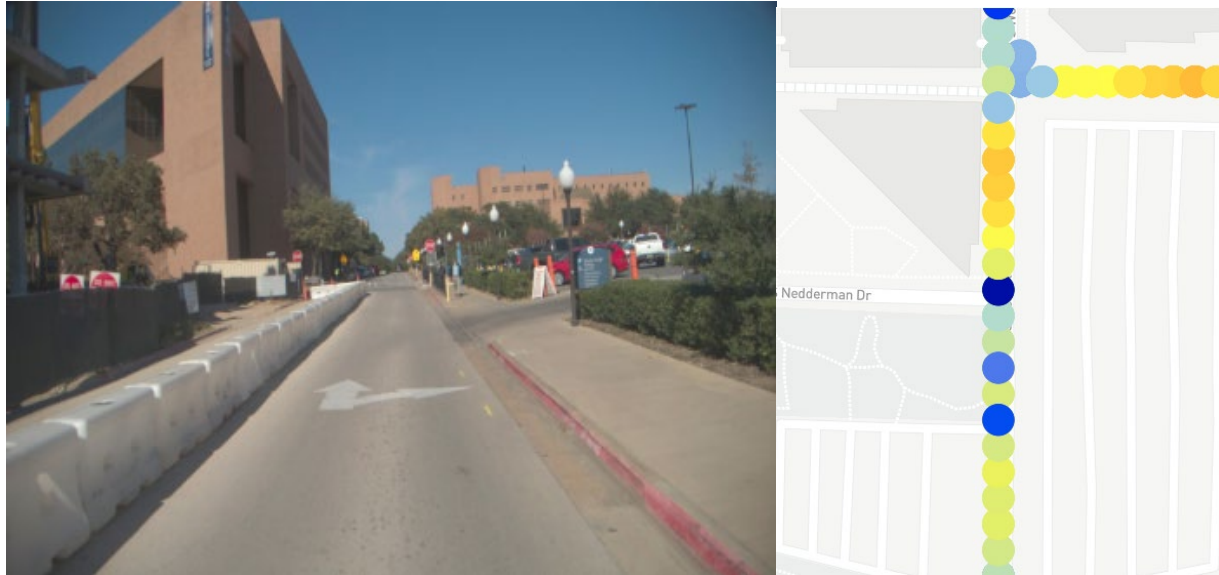
Figure 4: Construction barriers on S West St (Left) and corresponding autonomy heat map (Right)

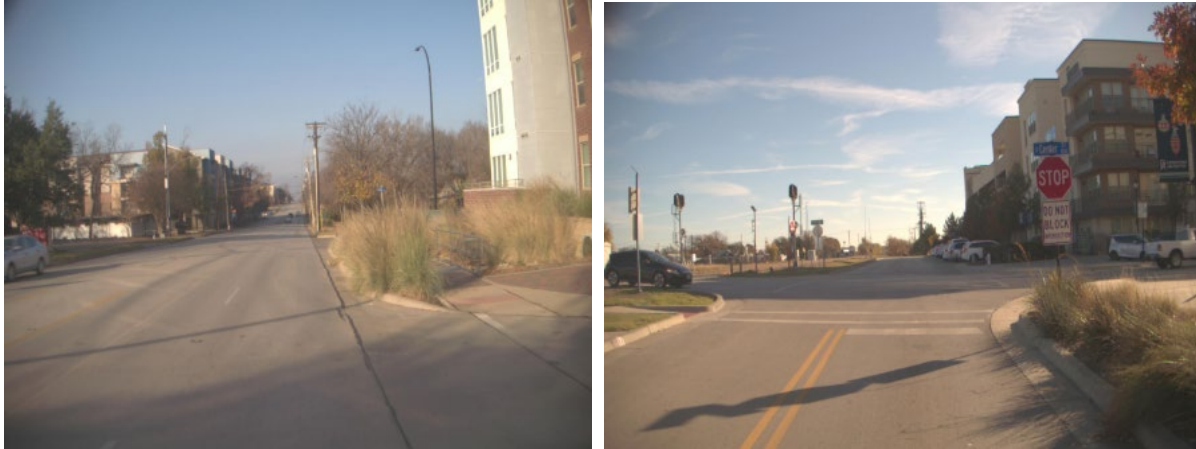
Figure 3: Foliage near roads continues to be a challenge in sections of the route

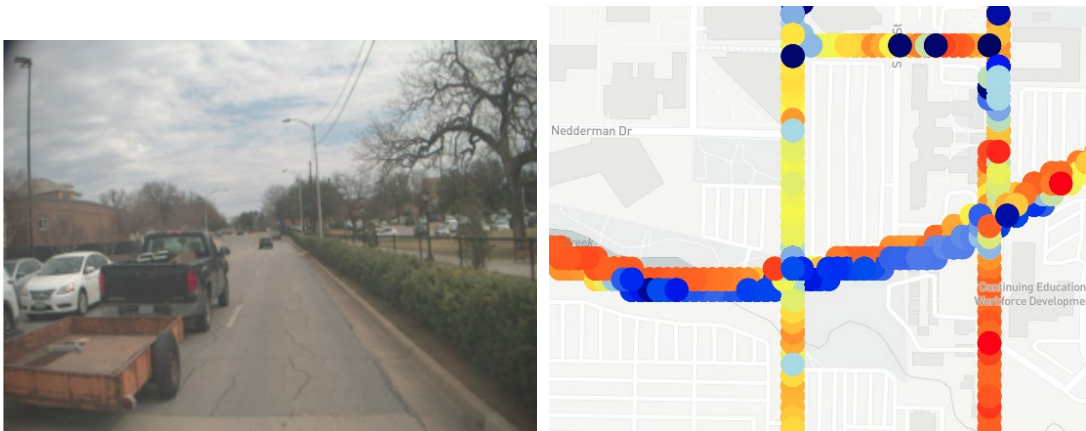
Figure 3: Narrow lanes (left) and autonomy utilization (right) on Mitchell
