# Aerial Infrared Scanning of Bridge Decks on Parks Highway to Map Delaminations

## FINAL REPORT

**Prepared by:**  
Infrasense, Inc.  
Woburn, MA

**Report # FHWA-AK-RD-000S(960)**  
**March 2, 2023**

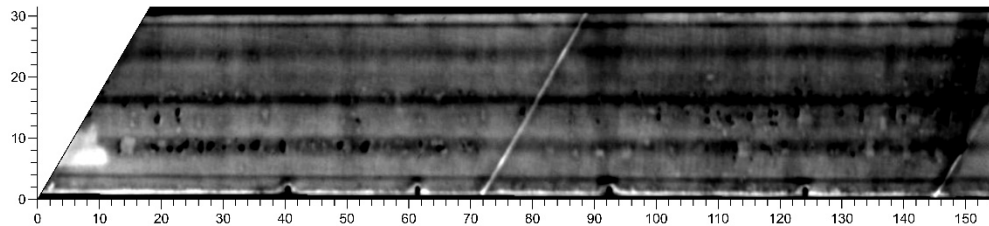
Figure 2. Example of IR Image Enhancement (Structure 1141)

Figures 2a and 2b below demonstrate the effects of the transverse normalization enhancement on the infrared image. Note the increase in contrast, which makes the “hot spots” corresponding with delaminations more distinguishable from patching and spalls. This is especially helpful in identifying smaller and more subtle delaminations. The effects of wheelpaths and structural elements on the IR data are also lessened significantly.

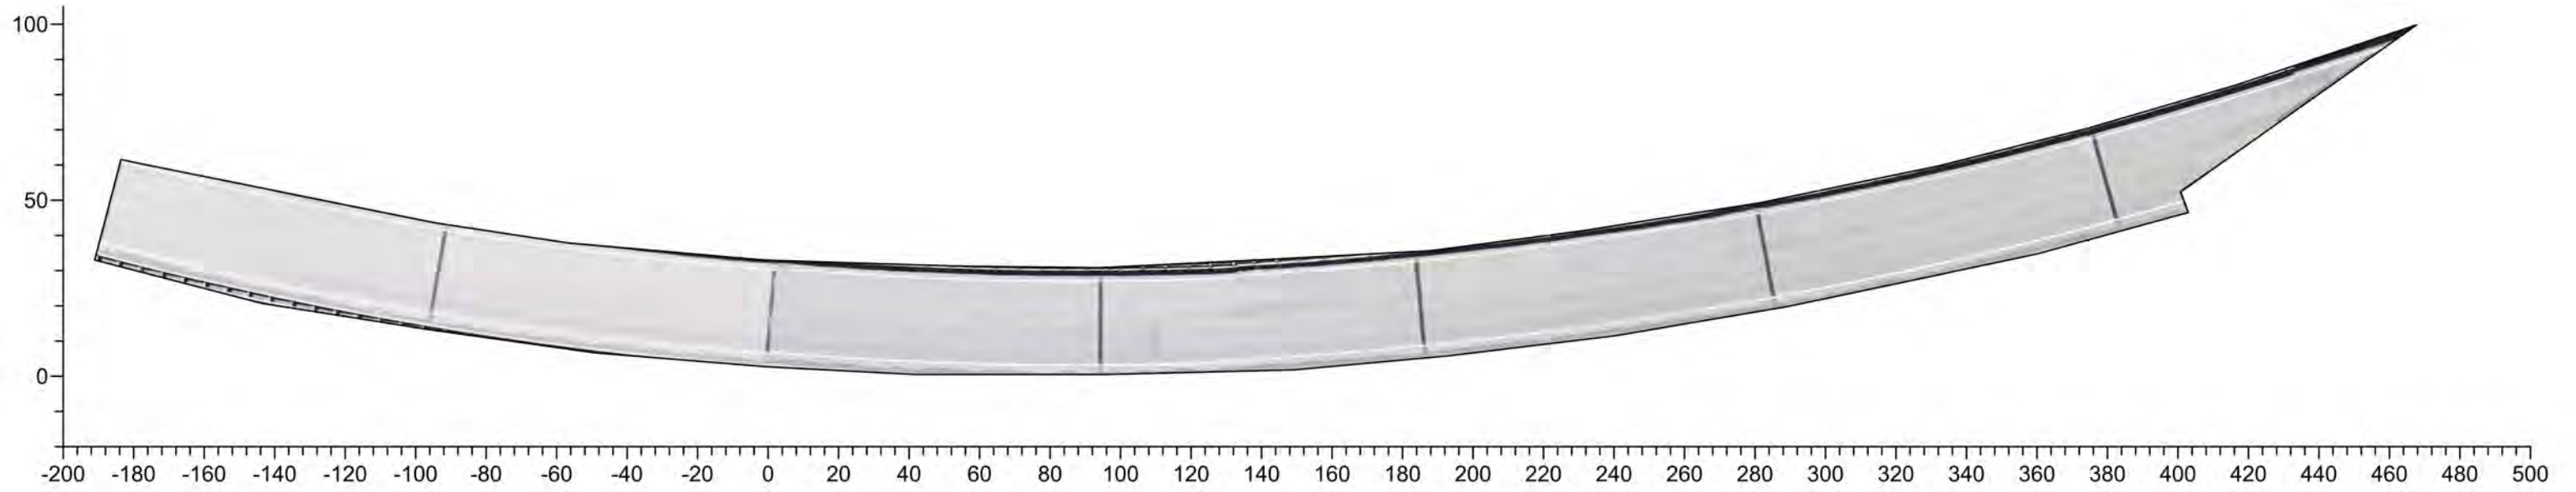
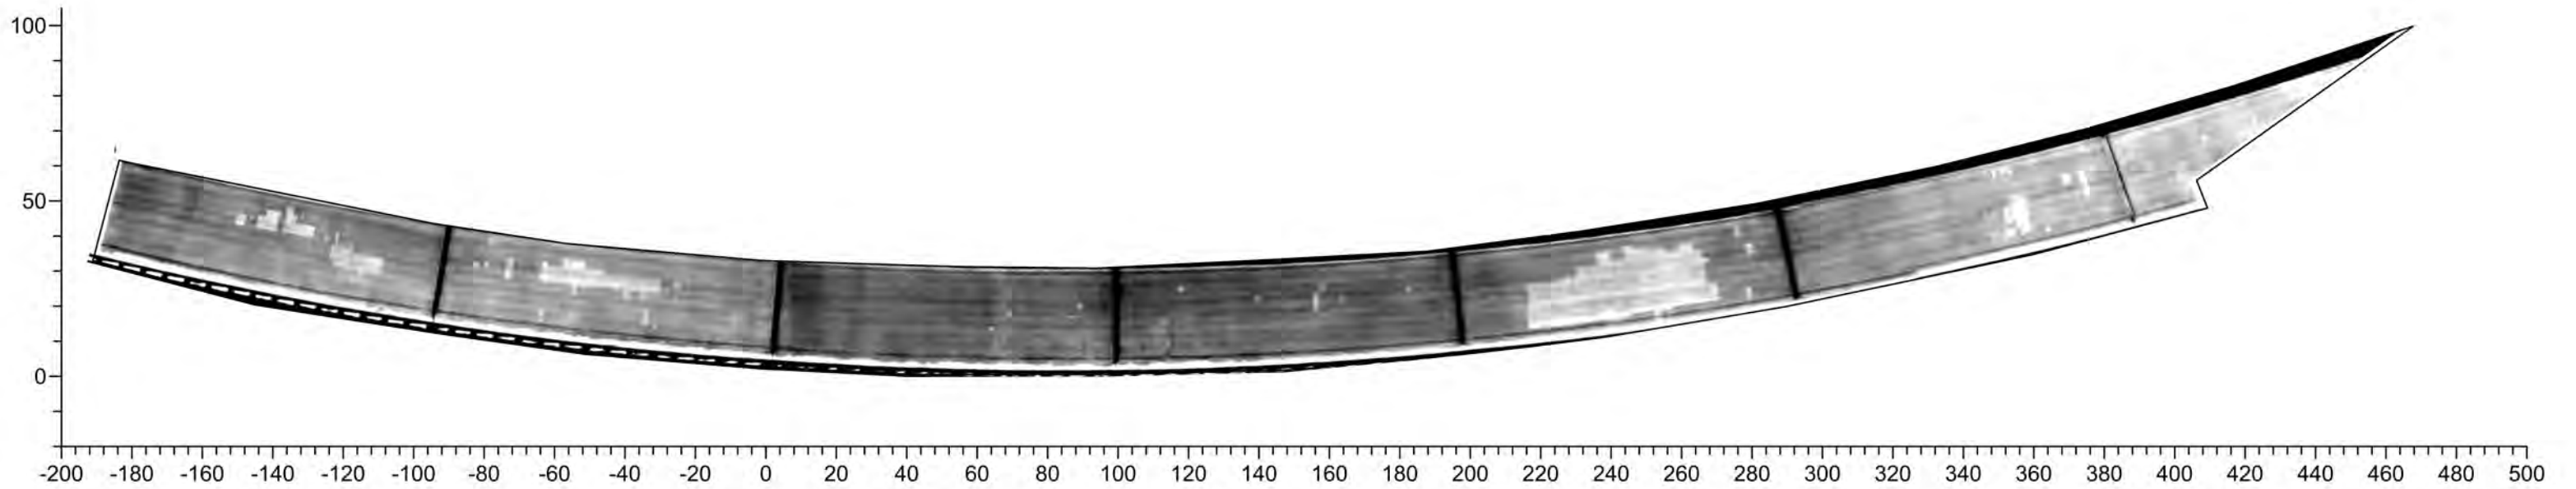
\*Note: 1447 sq. ft. of thermal anomalies not mapped due to being rectilinear in shape and appearing more like subsurface patching or some other structural feature

Note: Delamination locations not shown as quantity is less than 2%.

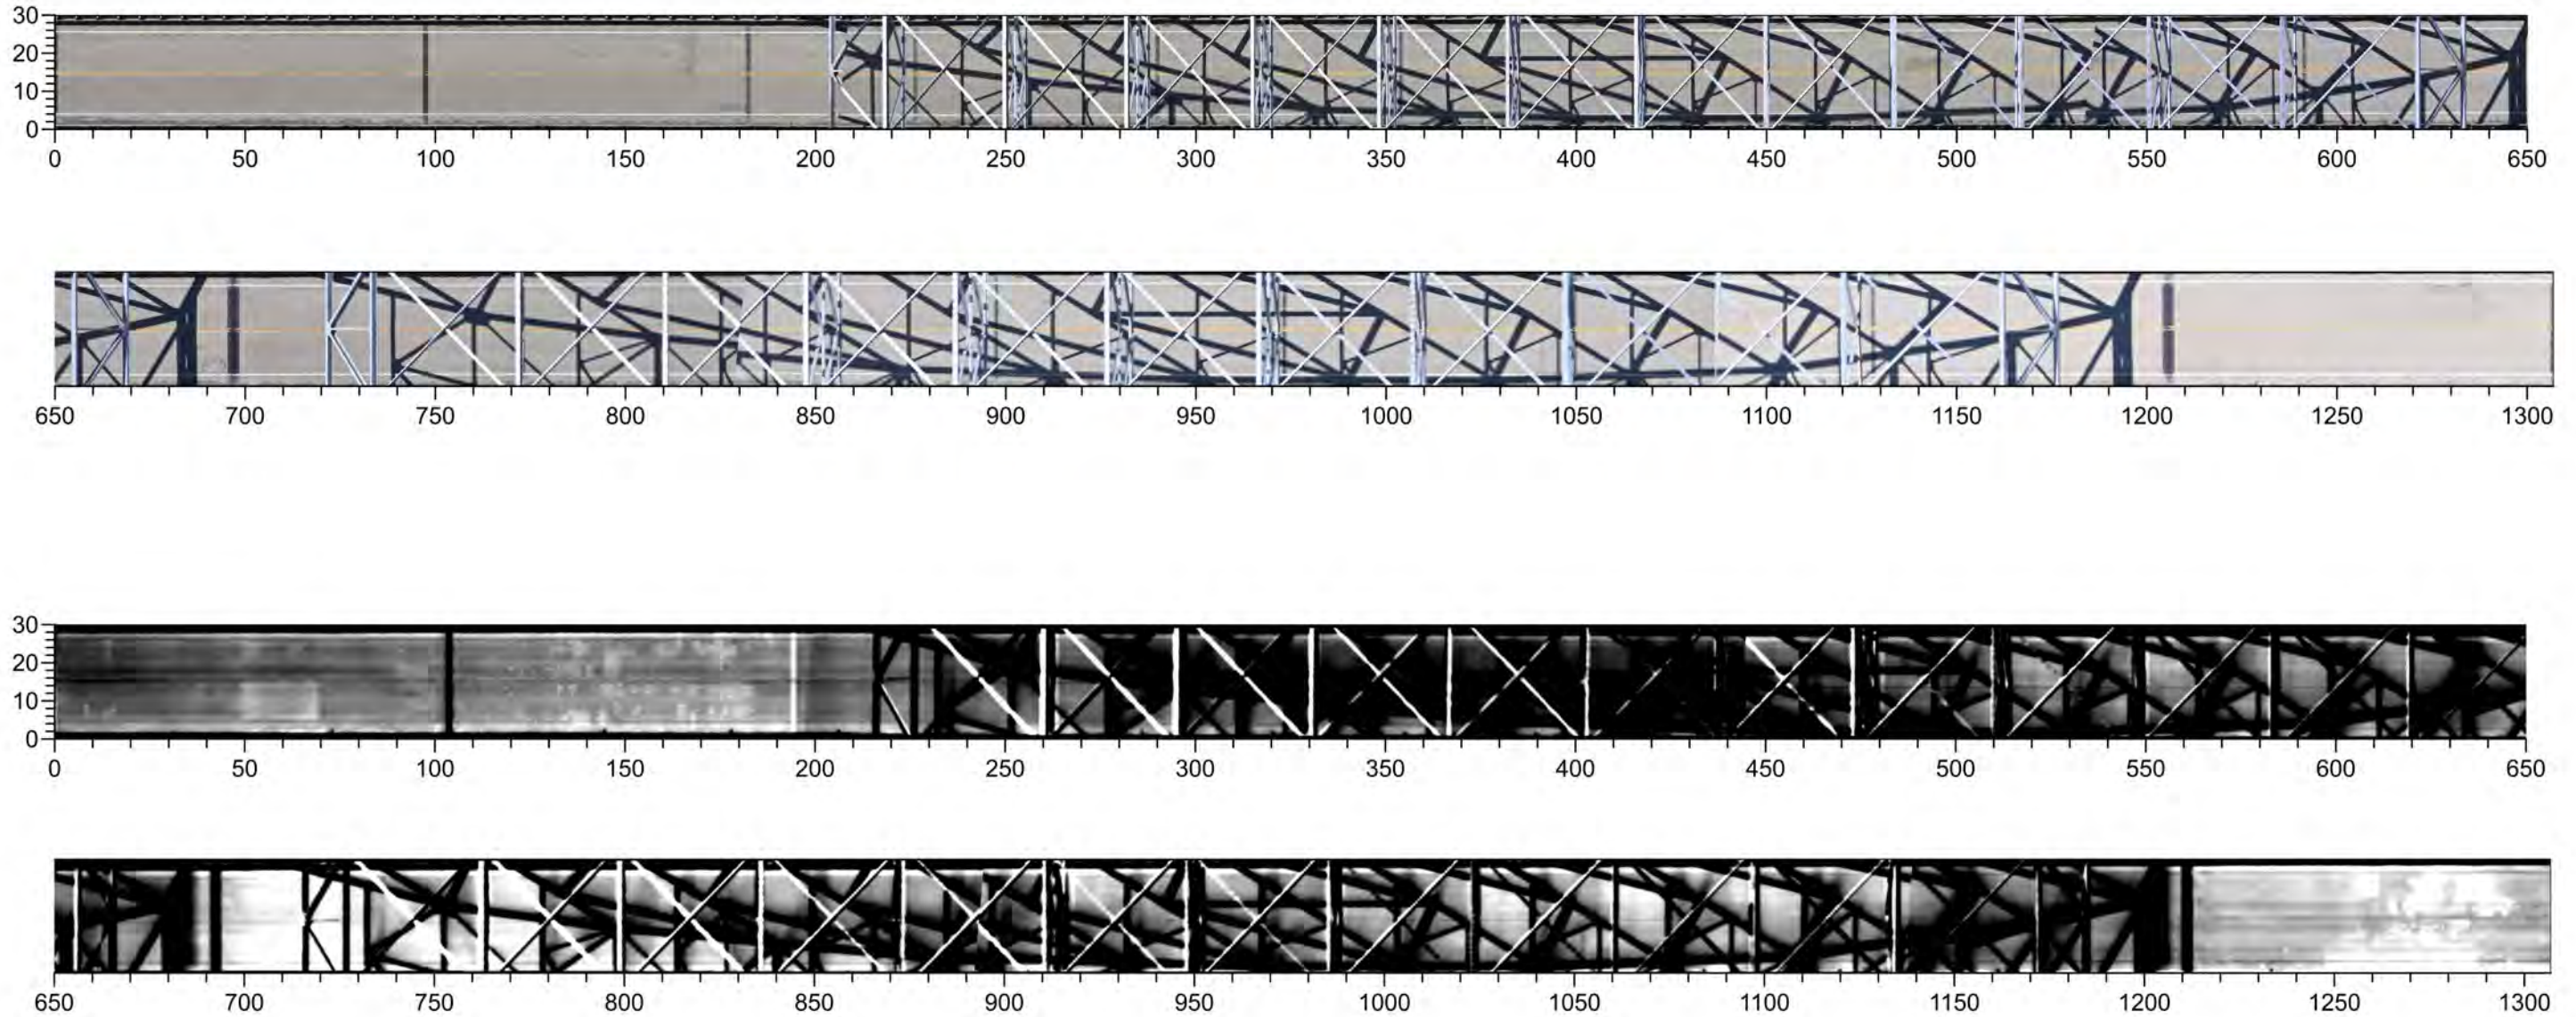
1304 sq. ft. of thermal anomalies not mapped due to being rectilinear in shape and appearing more like subsurface patching or some other structural feature

Note: Delamination locations not shown as quantity is less than 2%.

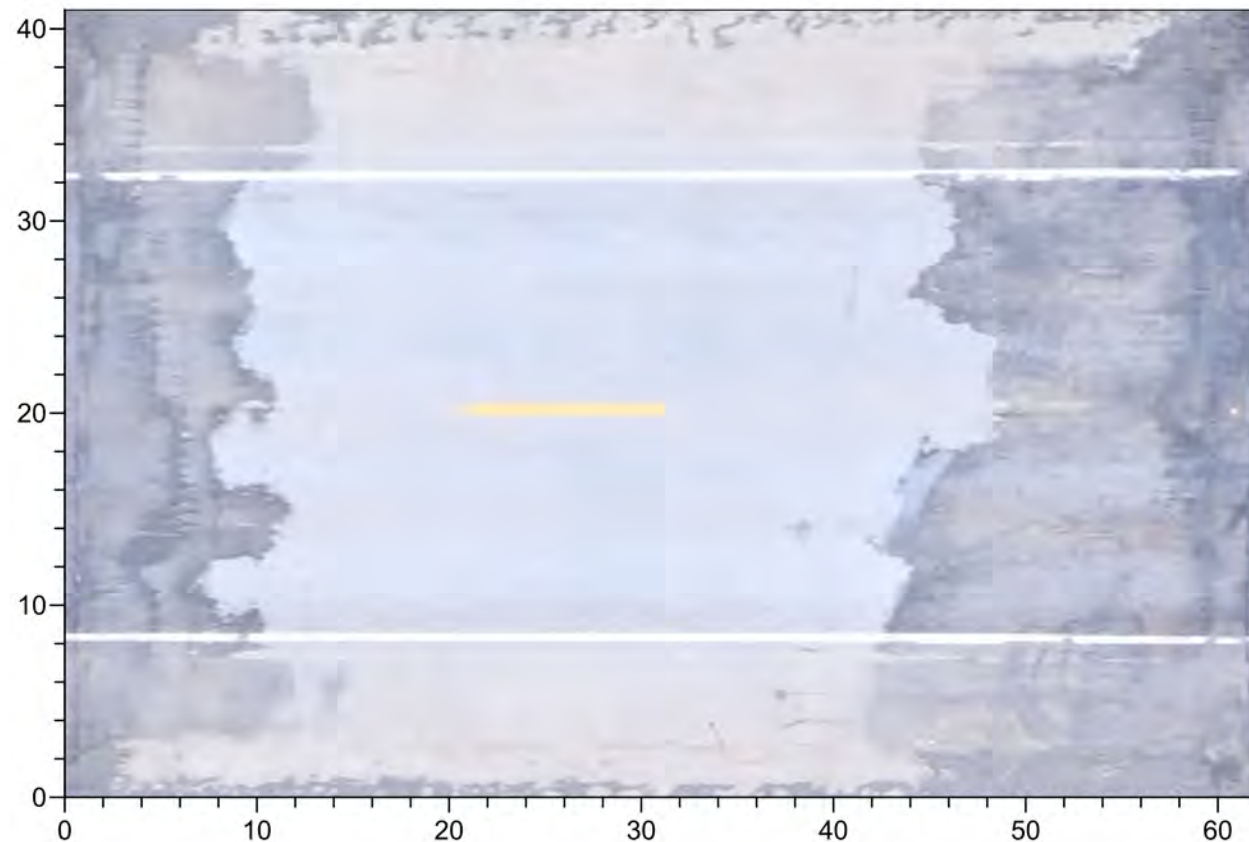
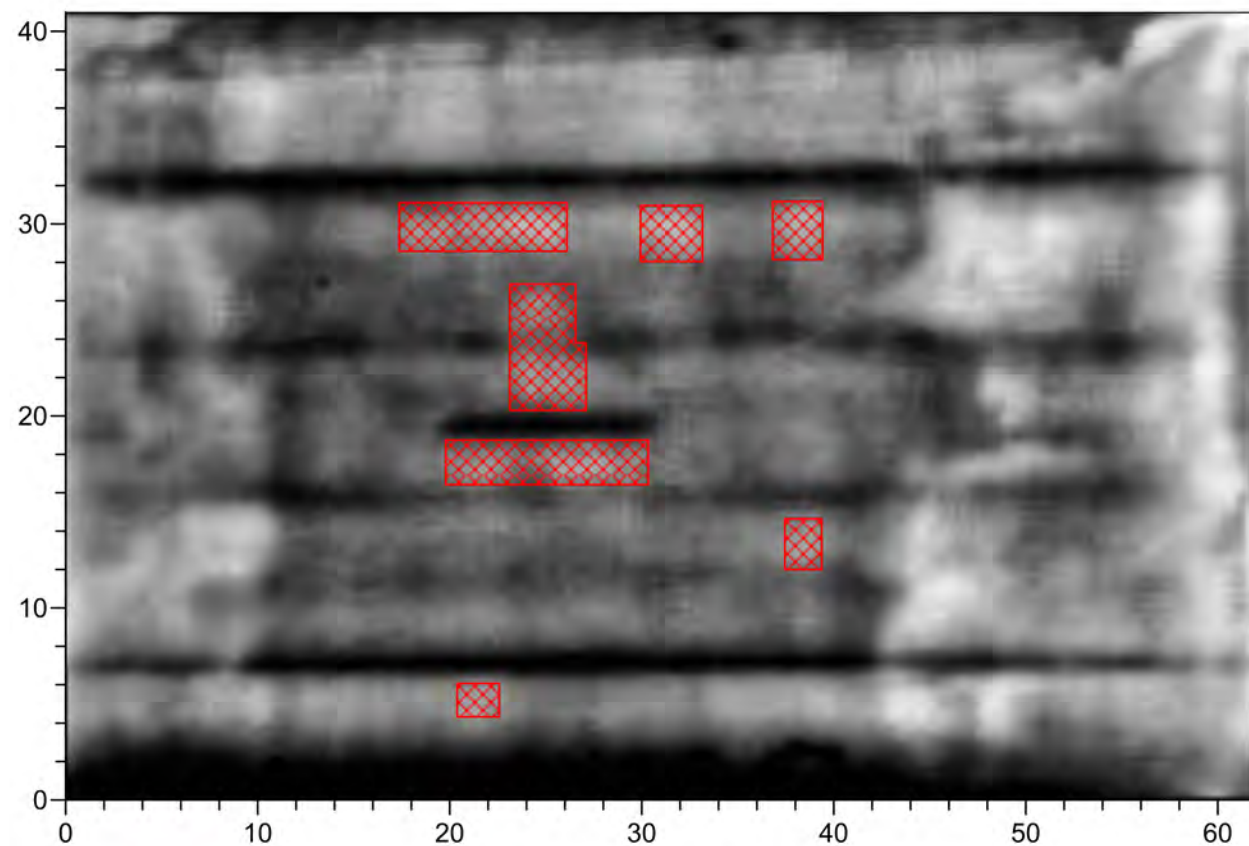
\*Note: Irregular surface conditions at ends of bridge represent 1078 sq. ft.. If this area is removed from the analysis, then the results would show 6.6% of the deck area as delaminated.

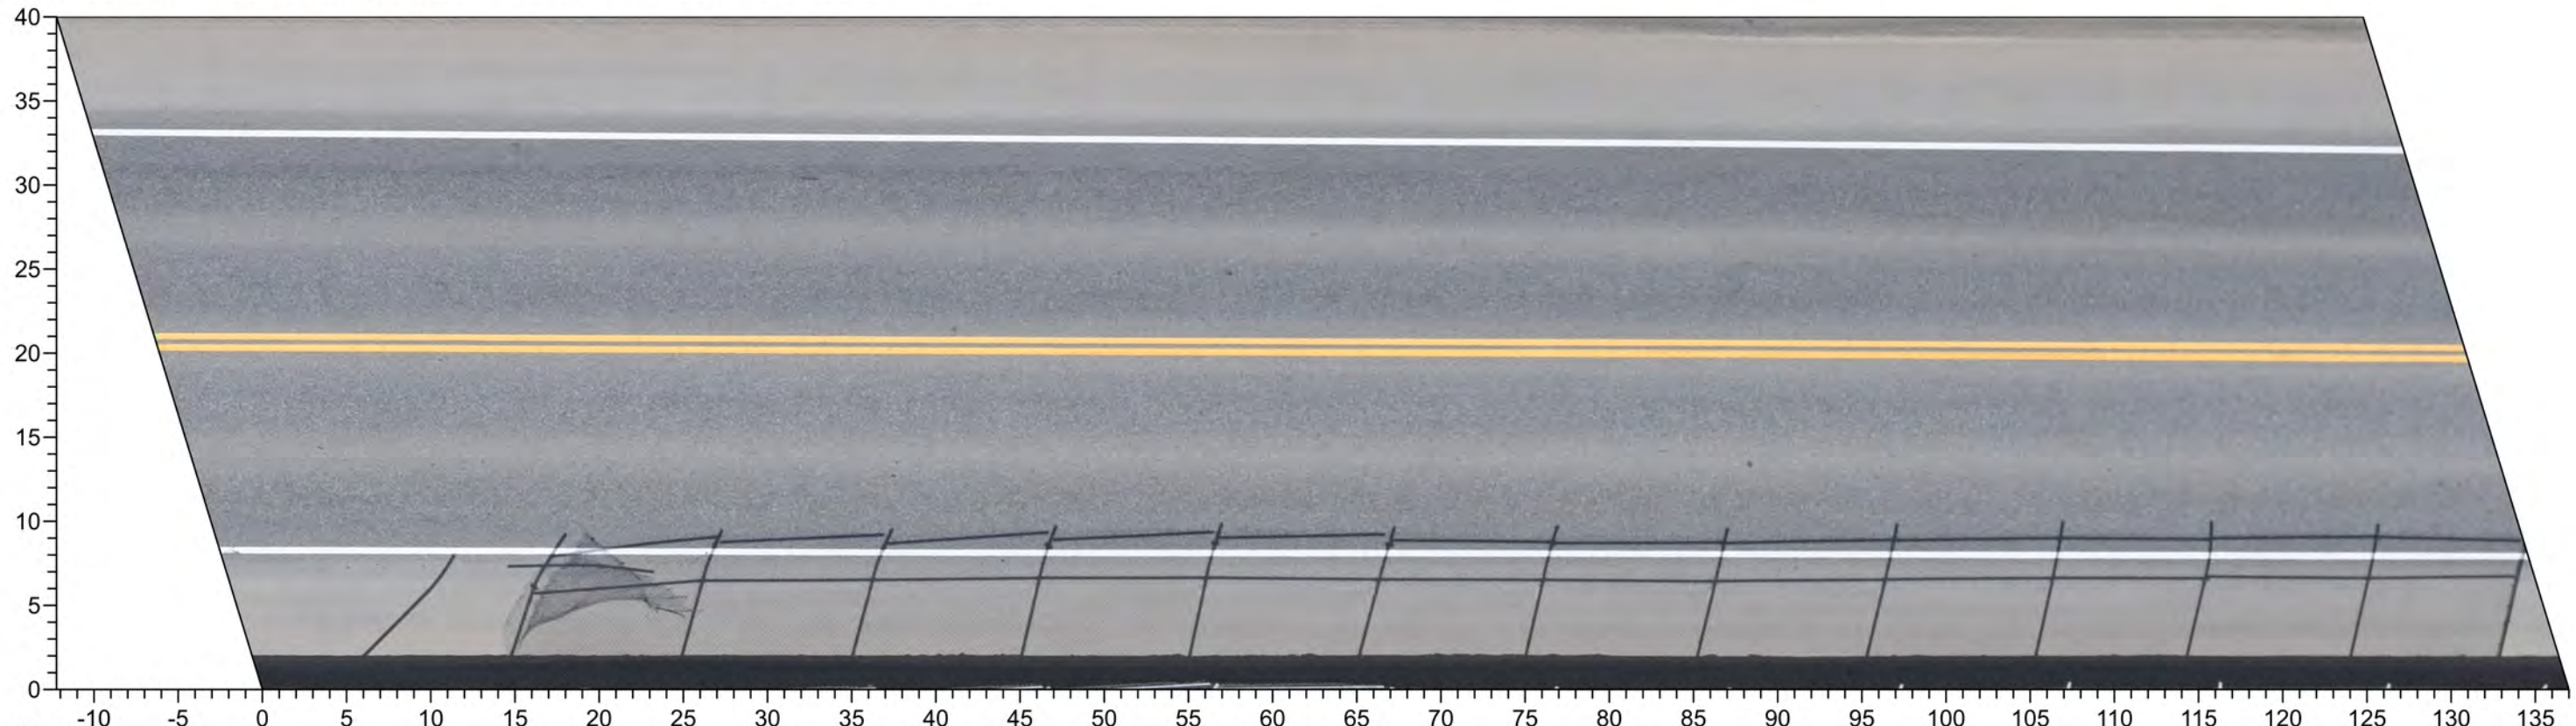
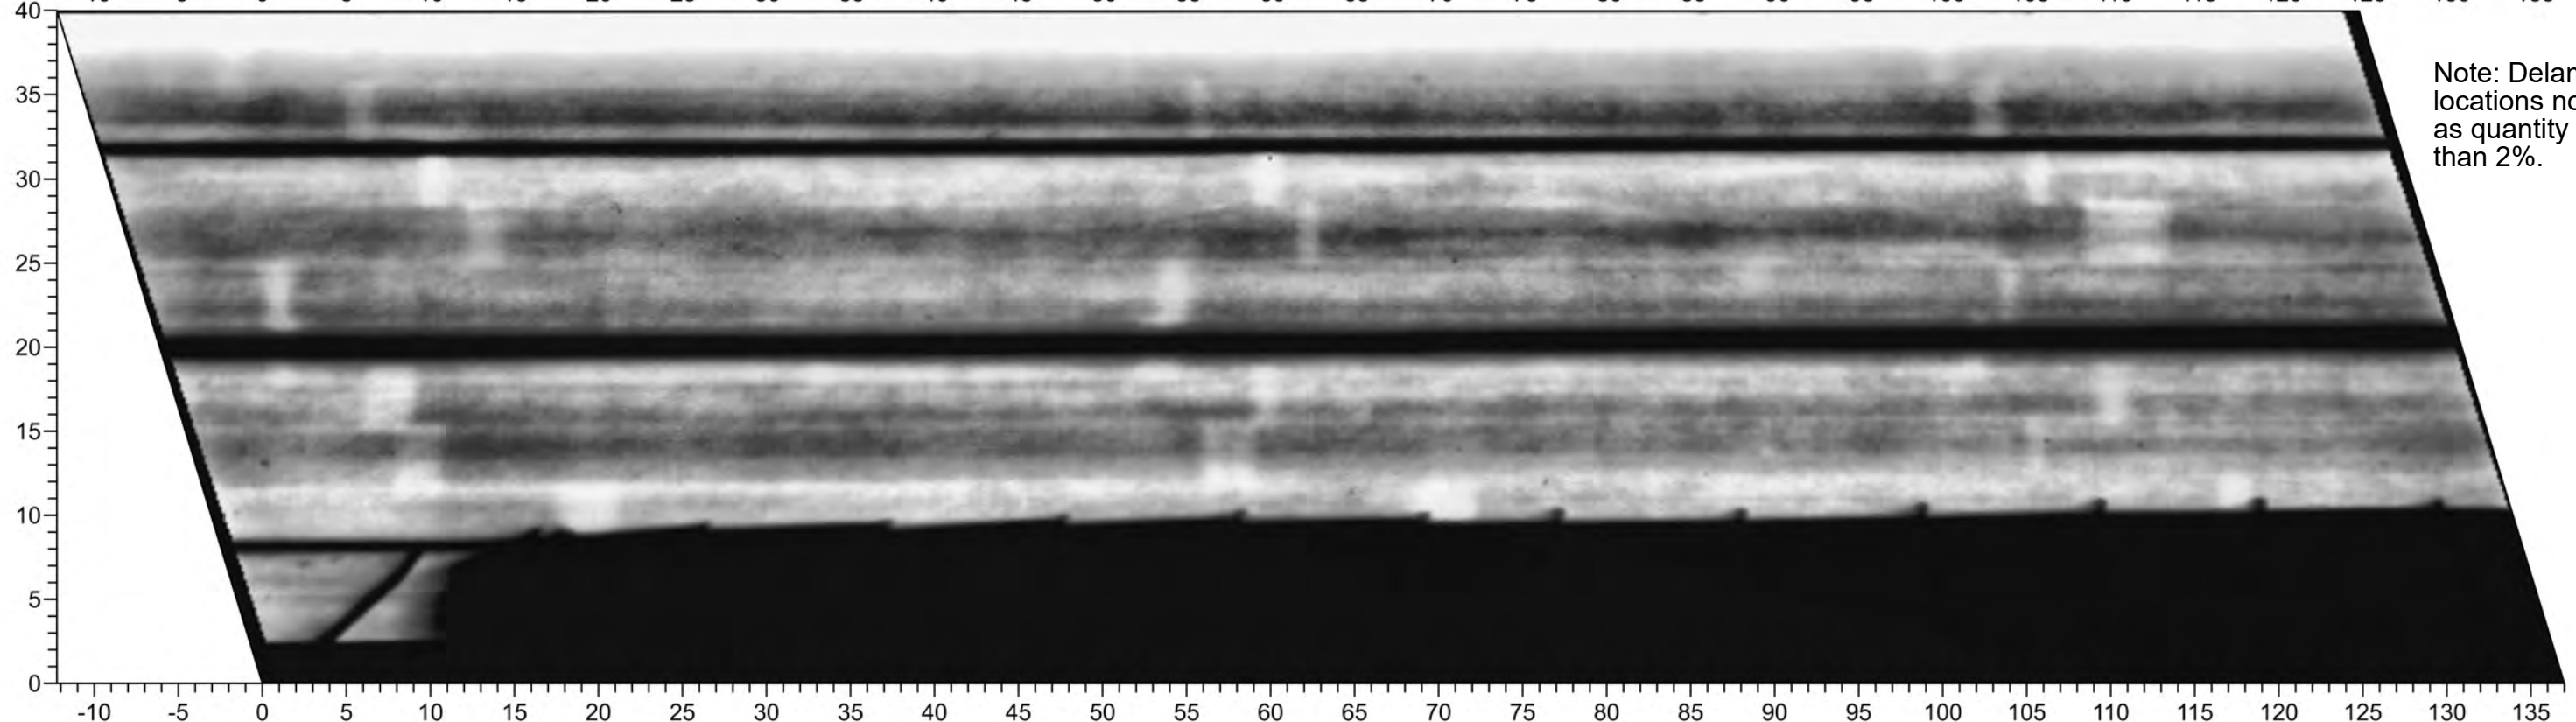
\*Note: Analysis limited by shadow from barrier/chain-link fence

Note: Delamination locations not shown as quantity is less than 2%.

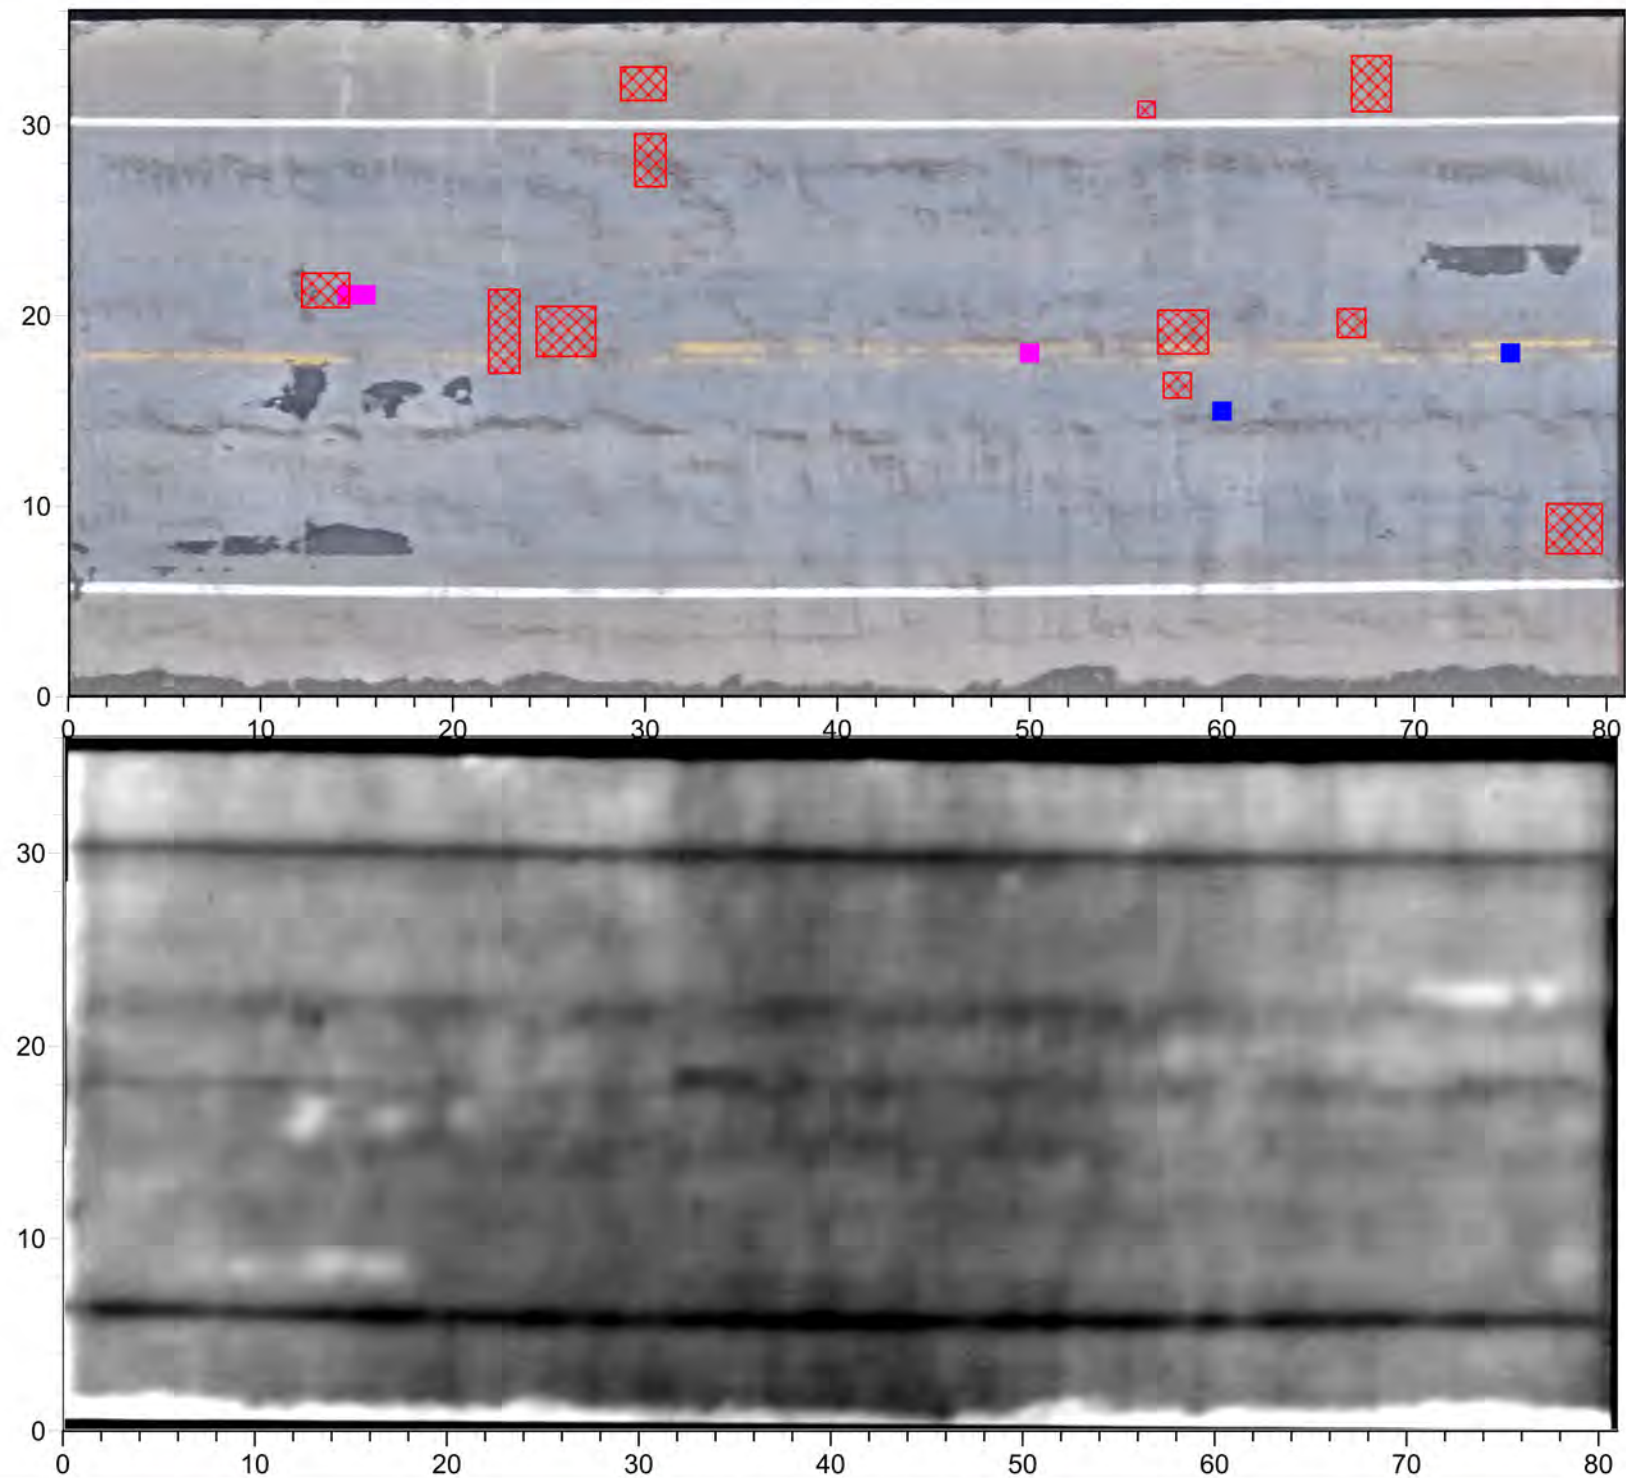
Delaminations Detected by Aerial Infrared		Delamination Quantity (%)    1.1 Delamination Quantity (ft <sup>2</sup> )    65			Imagery Collected: 6/5/22 Analyzed by: EG, SB Reviewed by: AJC Completed: 10/6/22	
0		15

Chain Drag Delamination Quantity (%)	0.2
Chain Drag Delamination Quantity (ft <sup>2</sup> )	5
Chain Drag Delam/Spall Quantity (%)	0.1
Chain Drag Delam/Spall Quantity (ft <sup>2</sup> )	3

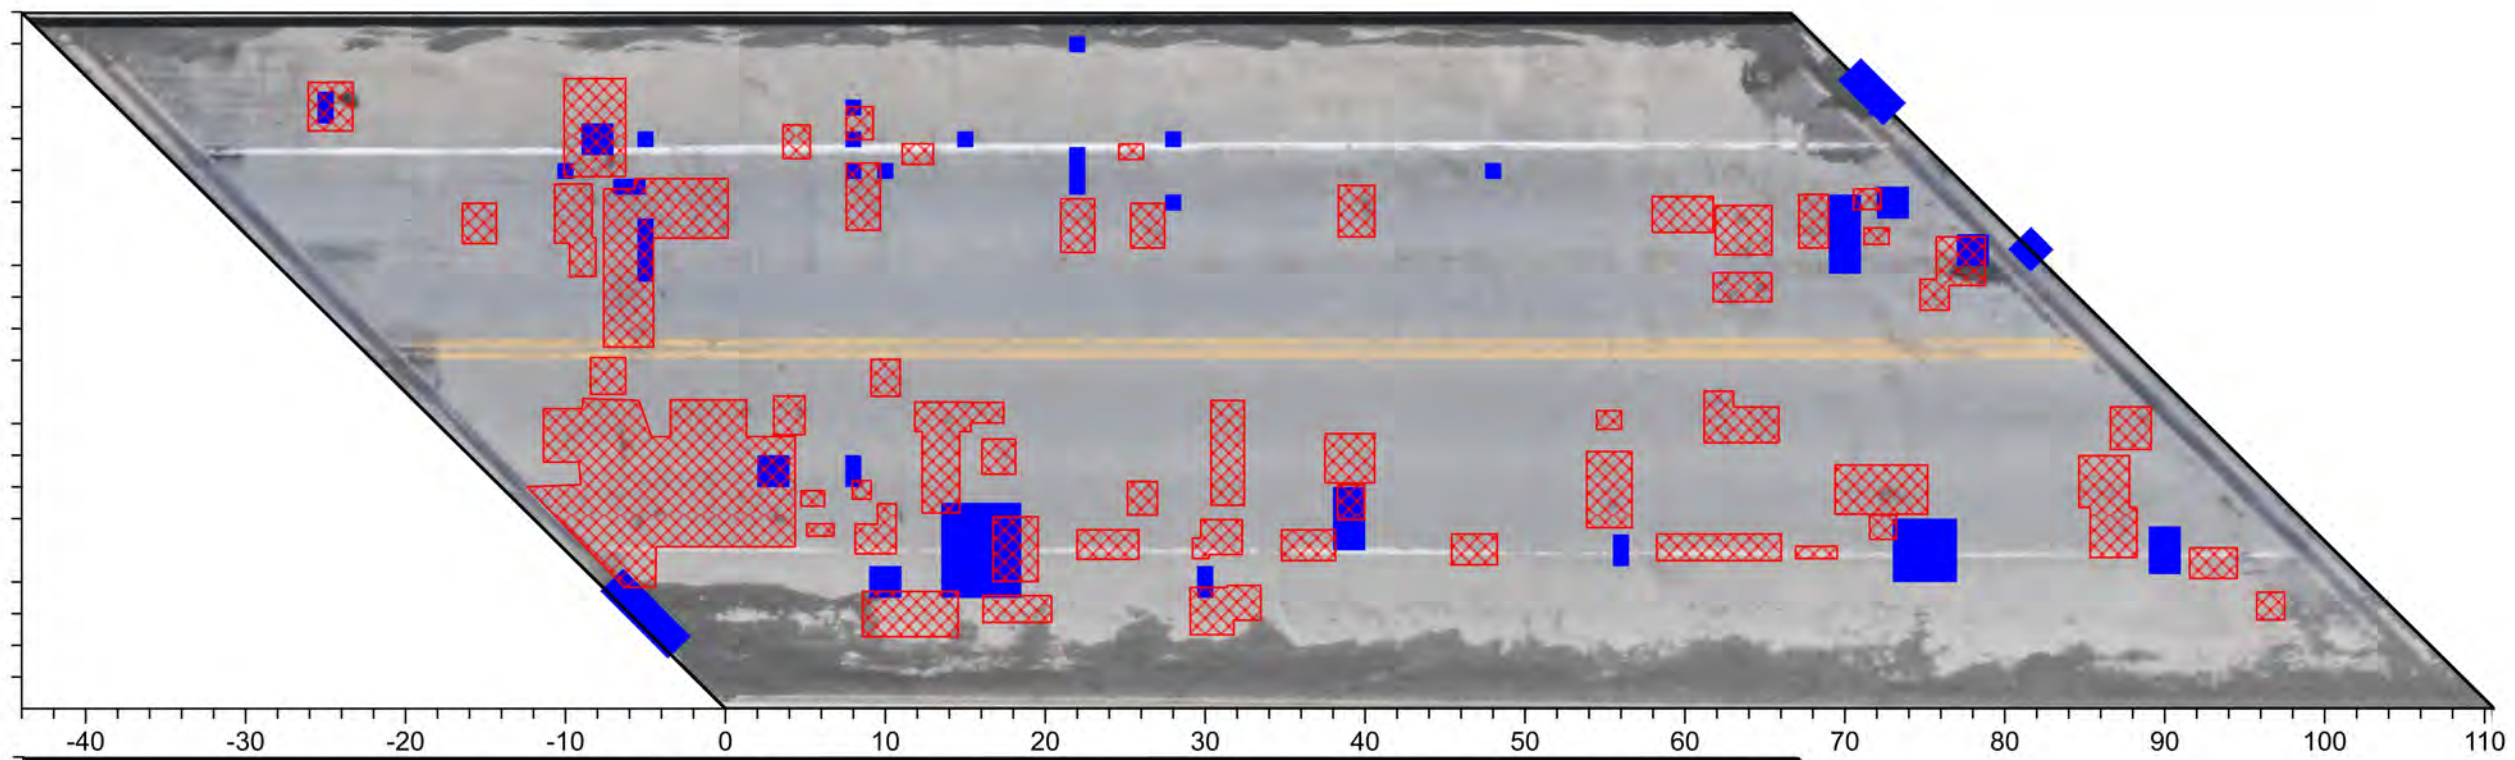
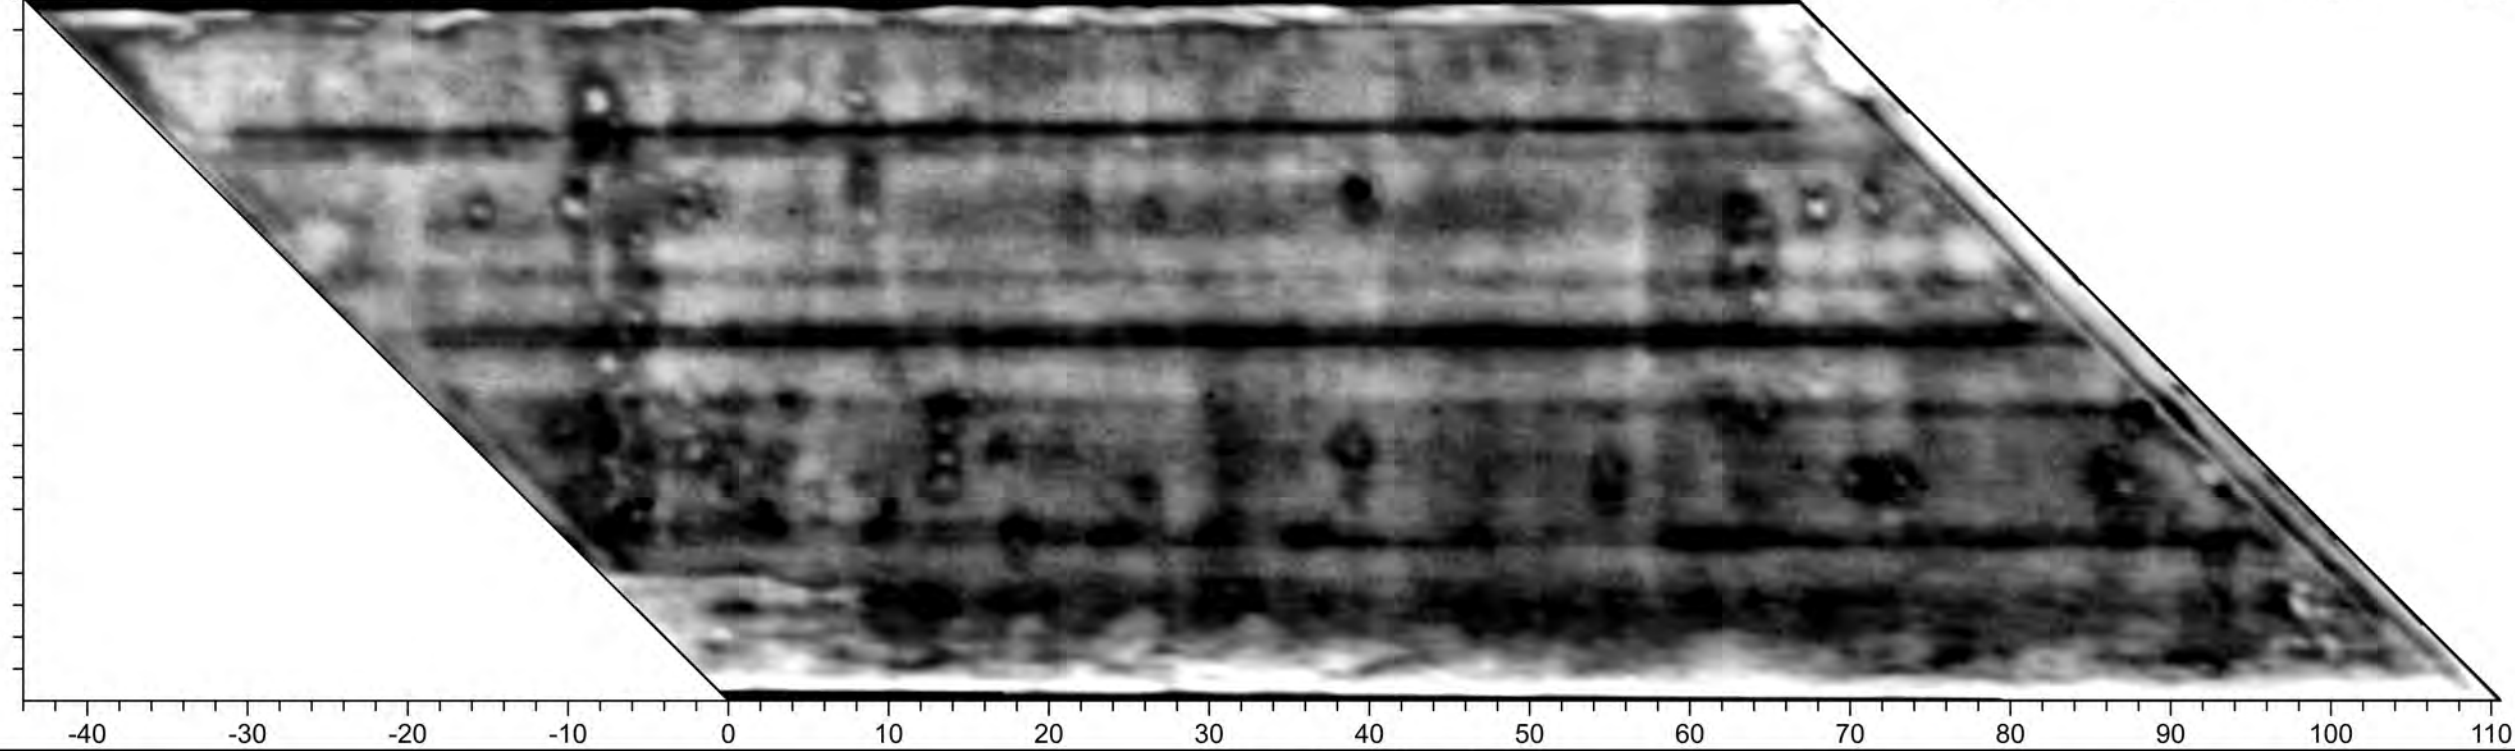
Delaminations Detected by Aerial Infrared	Delamination Quantity (%)    1.8	Imagery Collected: 6/5/22 Analyzed by: EG, SB Reviewed by: AJC Completed: 10/6/22	Bridge No.: 0311 BEAR CREEK PARKS HIGHWAY
			Delamination Quantity (ft <sup>2</sup> )    52.6

Chain Drag Delamination Quantity (%)	3.1
Chain Drag Delamination Quantity (ft <sup>2</sup> )	153

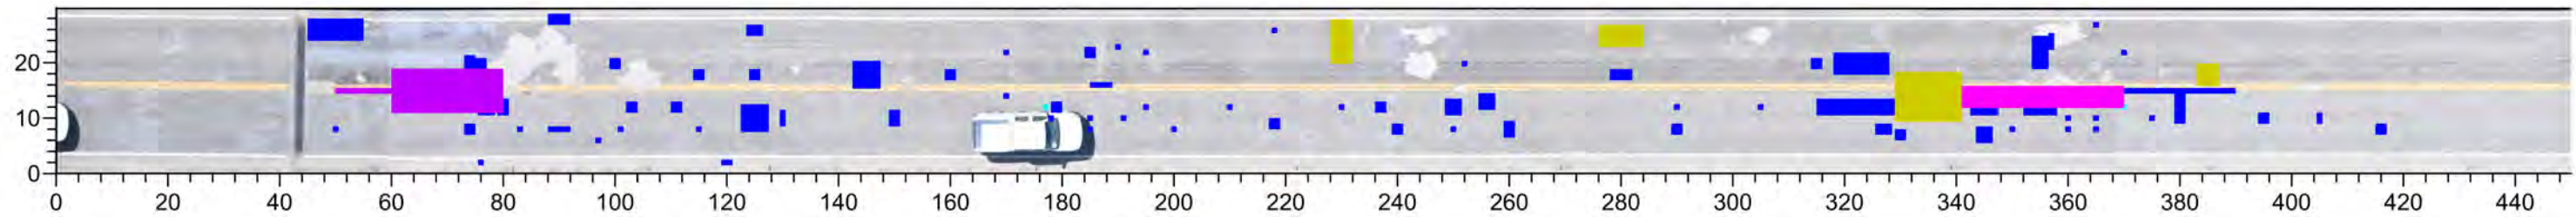
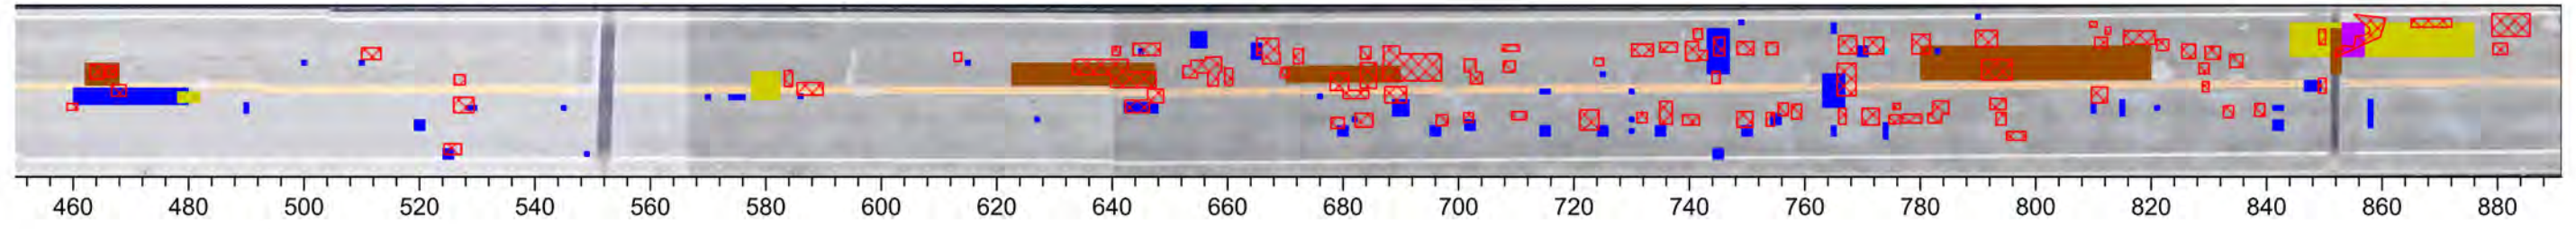
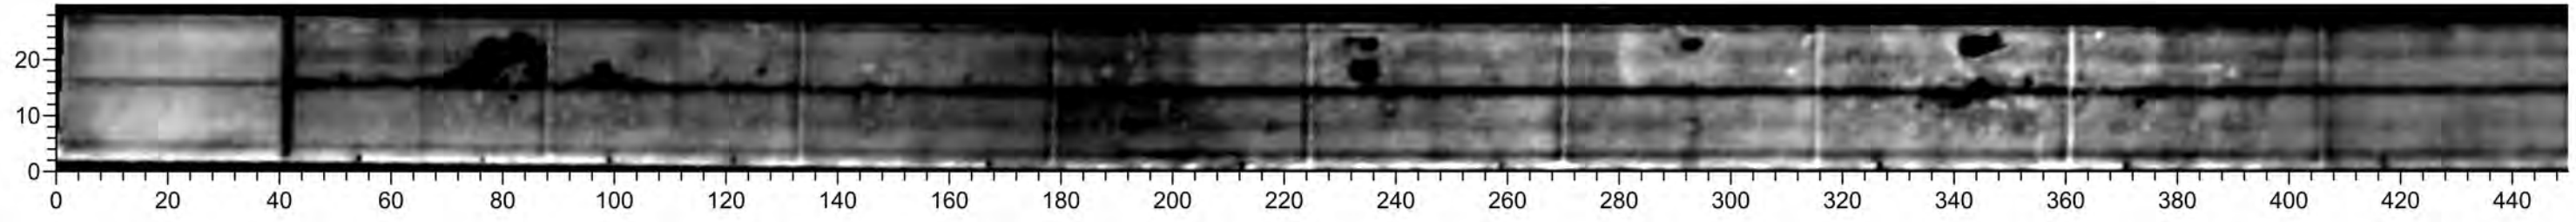
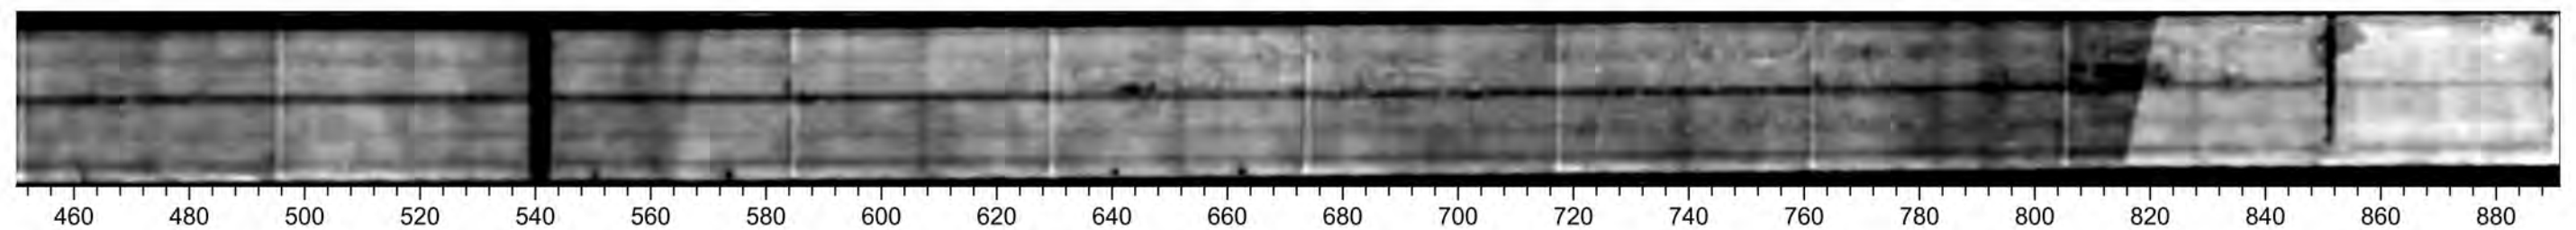
Delaminations Detected by Aerial Infrared	Delamination Quantity (%)    8.5	Imagery Collected: 6/5/22 Analyzed by: EG, SB Reviewed by: AJC Completed: 10/10/22	Bridge No.: 1141 ANTLER CREEK PARKS HIGHWAY
			Delamination Quantity (ft <sup>2</sup> )    591

Chain Drag Delamination Quantity (%)	Chain Drag Delamination Quantity (ft <sup>2</sup> )	Chain Drag Spalling Quantity (%)	Chain Drag Spalling Quantity (ft <sup>2</sup> )	Chain Drag Delam/Spall Quantity (%)	Chain Drag Delam/Spall Quantity (ft <sup>2</sup> )	Chain Drag Failed Overlay Quantity (%)	Chain Drag Failed Overlay Quantity (ft <sup>2</sup> )	Chain Drag Delam/F. Overlay Quantity (%)	Chain Drag Delam/F. Overlay Quantity (ft <sup>2</sup> )	Chain Drag Delam/F. Overlay/Spall Quantity (%)	Chain Drag Delam/F. Overlay/Spall Quantity (ft <sup>2</sup> )
6.8	1811	<0.1	3	0.6	160	0.8	199	1.6	413	1.7	440
