February 2023

Report No. 23-039

Post-Fire Damage Inspection of Concrete Structures - Phase II

University of Massachusetts Amherst

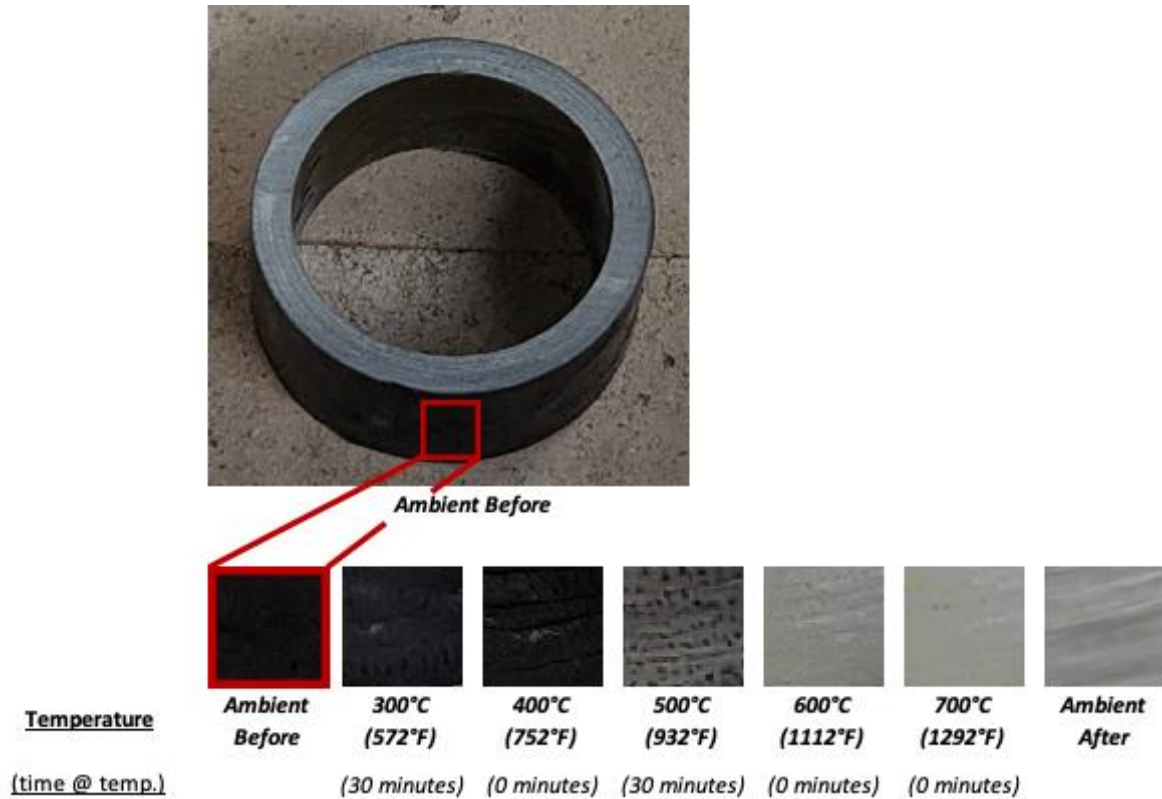
introducing a gray color shift. Temperatures of 600°C (1112°F) and 700°C (1292°F) showed a full transition of the outer surface of the phenolic conduit to a gray/silver color. The gray/silver color was maintained once the conduit returned to ambient temperature conditions.

Figure 5.1: Phenolic conduit visual response to stepped heat loading

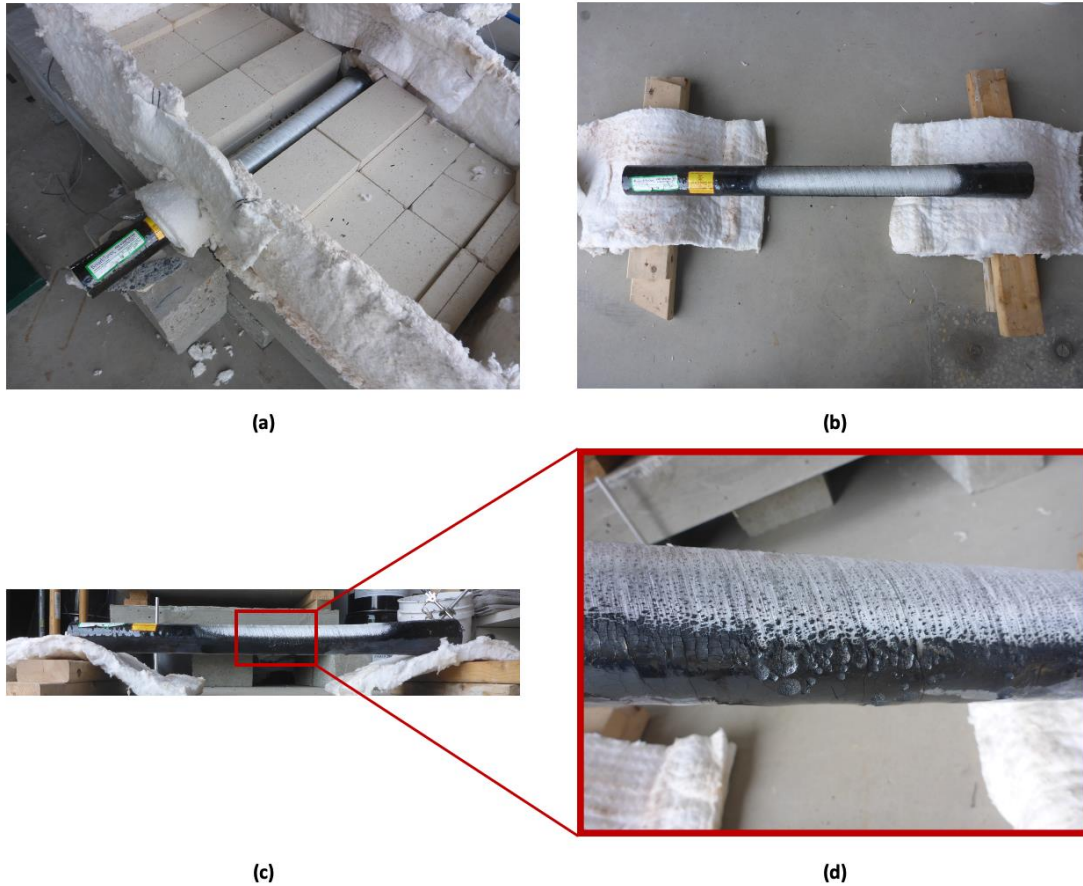
Figure 5.5: Phenolic conduit appearance after heat loading (a) in open heating chamber (b) top view (c) side view (d) close up side view, top exposed to 600°C (1112°F) and bottom exposed to 400°C (752°F)

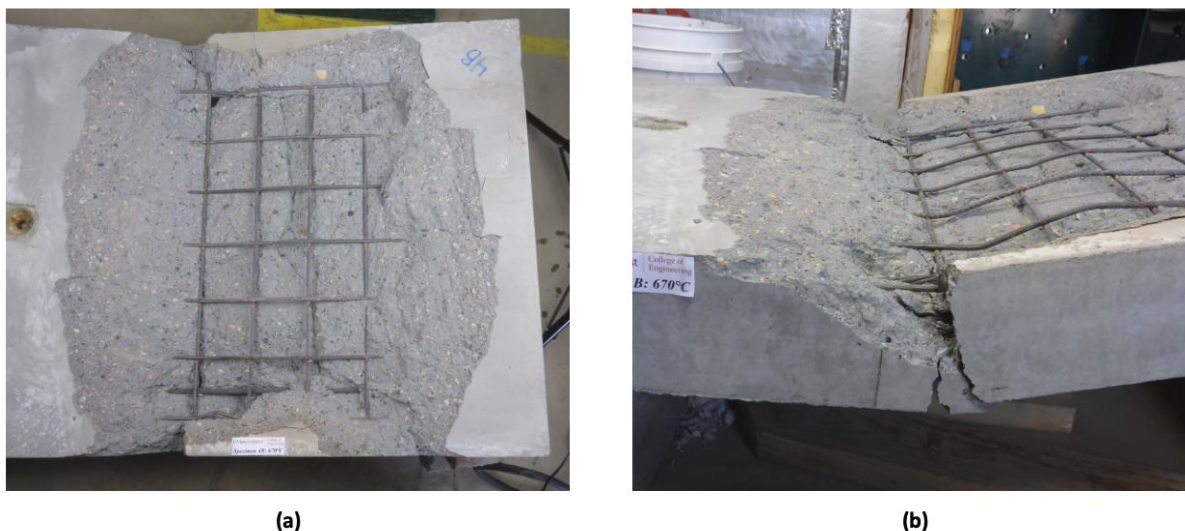
In addition to heating slabs to 300°C (572°F), 400°C (752°F), and 500°C (932°F), the investigators attempted to heat one slab, CS-1F from batch 1, to 700°C (1292°F) to see the concrete slab response at higher temperatures. When this specimen reached 670°C (1238°F), it spalled explosively (Figure 6.10), and the test was stopped.

Figure 6.10: Concrete slab specimen CS-1F explosive spalling at 670°C (1238°F) (a) top view (b) side view)

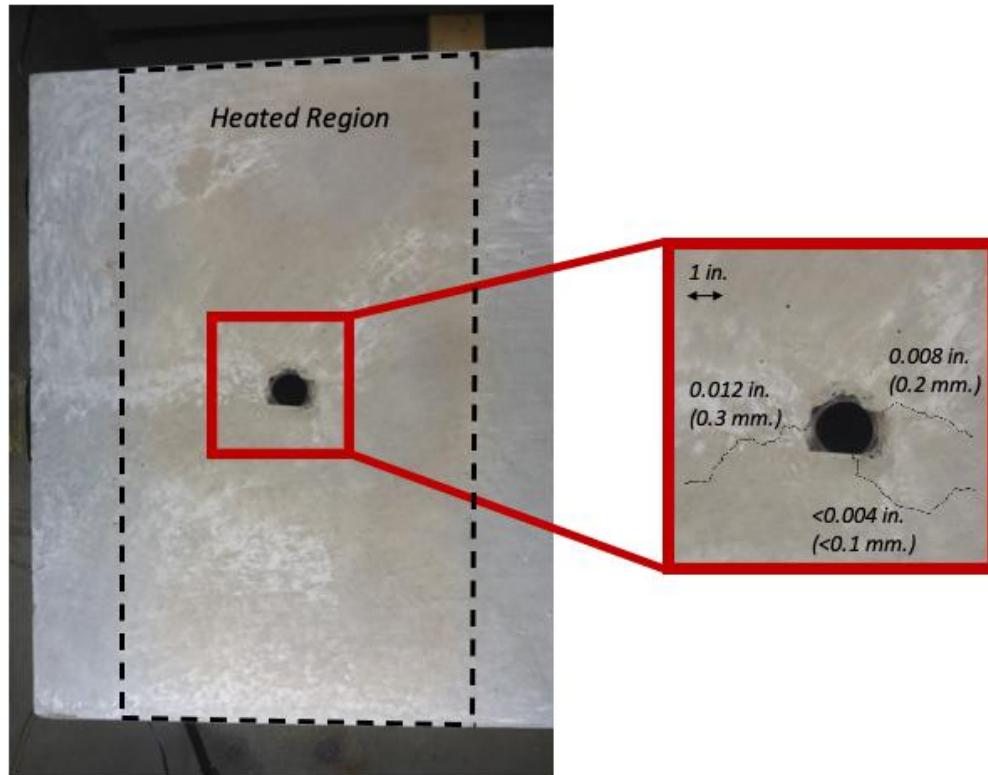
When heating around an insert located 12 in. from the left edge of a specimen from batch 1, it was observed that after the concrete was heated at 500°C (932°F) for three hours, there was some cracking around the metal insert (Figure 6.12). No cracking was observed prior to this. General surface cracking trends were comparable to those in concrete without a metal insert, with exception of the enhanced/highlighted cracks surrounding the insert. Temperature trends of the top surface, bottom surface, and metal insert can be found in Figure 6.13. The sharp drops and spikes in the temperature-time curves (Figures 6.13 and 6.15) after the top of the slab reached approximately 300°C (572°F), 400°C (752°F), and 500°C (932°F) can be explained by the opening of the heat chamber to visually investigate the specimen at these temperatures. When the heat chamber was opened, the heat chamber would be exposed to ambient laboratory conditions briefly, influencing the temperature-time curves. There was no mild reinforcement around this insert.

Figure 6.12: Cracking around metal insert, batch 1, 12in from left edge, after 500°C (932°F) for 3 hours with cracks enhanced (picture taken once cooled to ambient conditions)

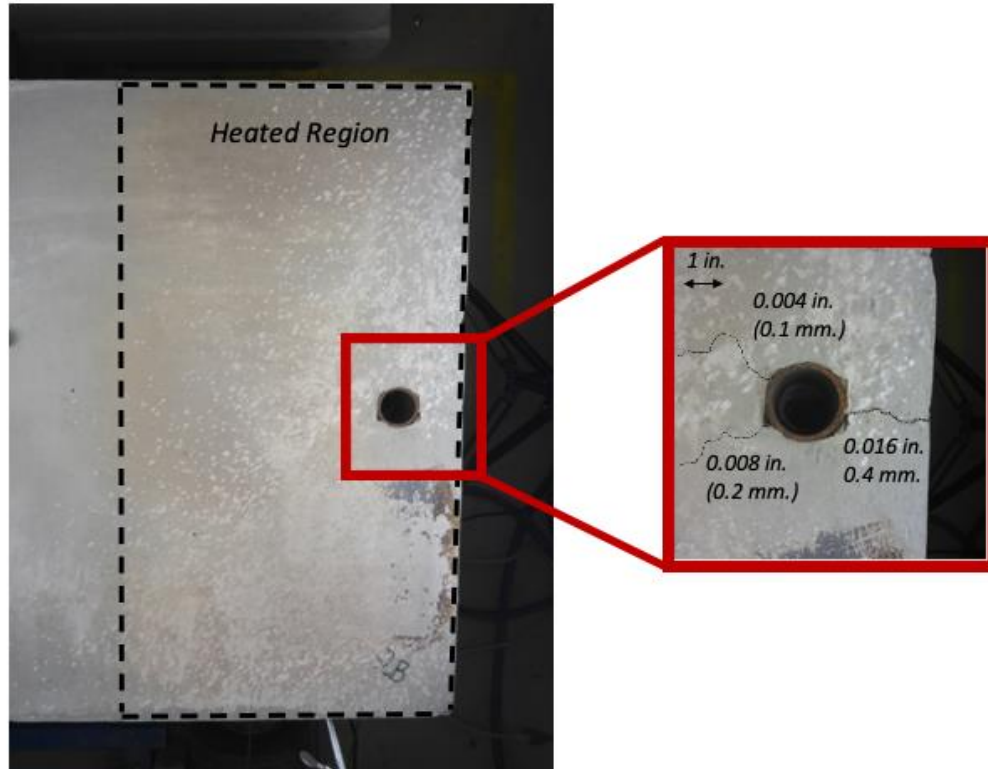
An insert 2 in. from the right edge of a slab from batch 1 was also investigated to understand how boundary conditions influence test results. This test had results identical to the previous test except that a crack formed that ran from the insert to the edge boundary beginning at 300°C (572°F) (Figure 6.14). As seen in Figure 6.15, the temperature-time data show that the metal insert maintained a cooler temperature when it was 2 in. from the edge than when it was 12 in. due to the change in proximity of the insert to the boundary edge. Notably, the bottom surface temperature of the concrete surpassed the insert temperature toward the end of the testing period. There was mild reinforcement around this insert.

Figure 6.14: Cracking around metal insert, batch 1, 2in from left edge, after 500°C (932°F) for 3 hours with cracks enhanced (picture taken once cooled to ambient conditions)

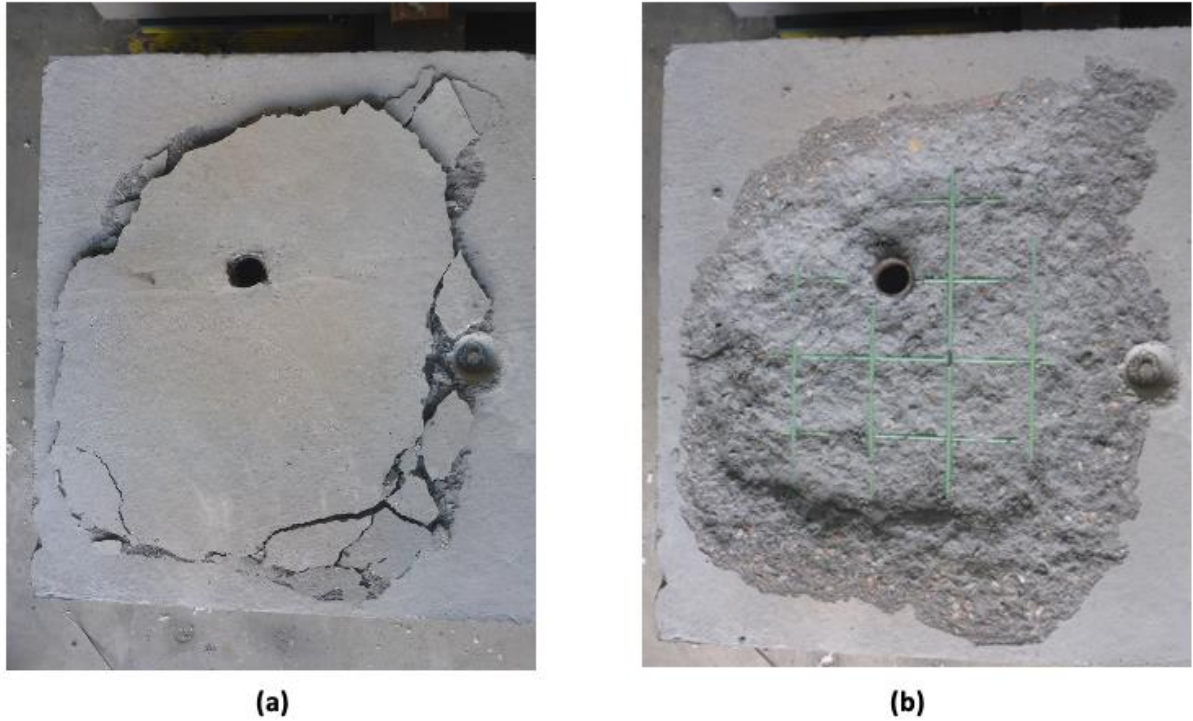
An insert 12 in. from the left edge of a slab from batch 2 was tested. This specimen explosively spalled after the top surface concrete temperatures were held at 500°C (932°F) for four minutes (Figure 6.16). The spalled concrete surrounded the metal insert. No cracking was observed on the piece of spalled concrete that was touching the metal insert. All spalled concrete did not extend to edge boundaries of the slab. The spall was approximately 1.75 in. in depth and did not exceed the depth of the reinforcing wire mesh. The test was concluded after spalling occurred. A replica of this test was conducted to further investigate the spalling phenomenon. It was found that the replica test did not induce spalling and showed normal surface cracking trends. Notably, there was no cracking around the insert during the replica test. There was no mild reinforcement around the insert in either test.

Figure 6.16: Spalling around metal insert, batch 2, 12in from left edge, 4 minutes after being at 500°C (932°F) (a) spalled concrete in place on specimen (b) after removal of spalled concrete

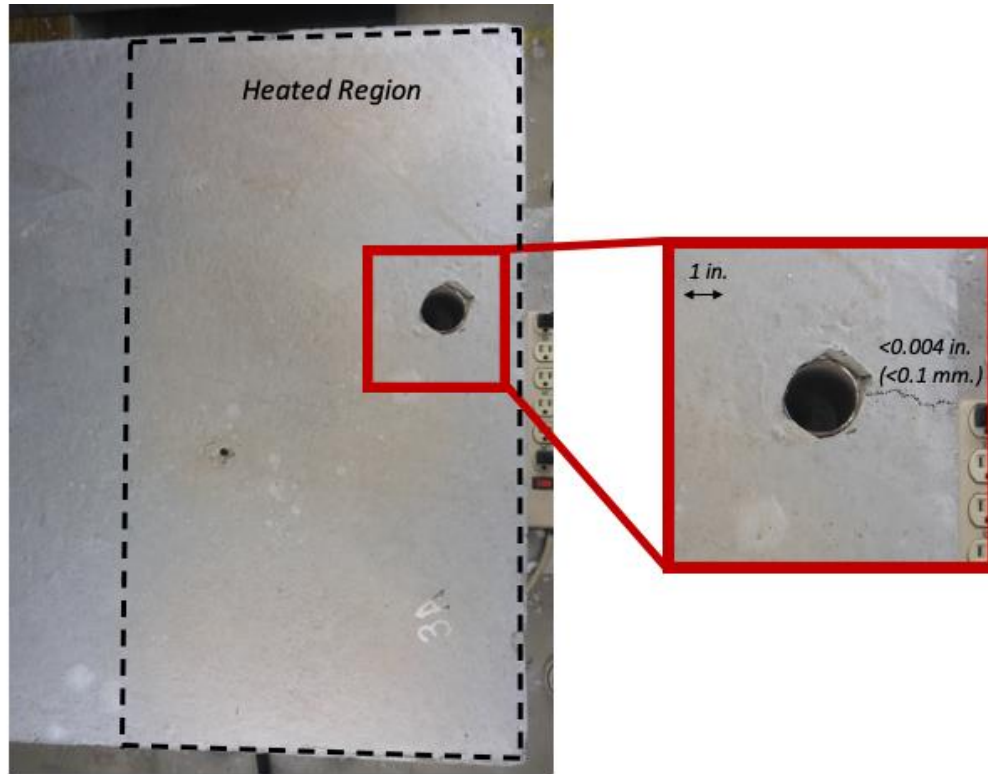
An insert 2 in. from the right edge of a batch 2 specimen was tested and found to show general surface cracking trends that were comparable to concrete without a metal insert with the exception of the enhanced/highlighted cracks surrounding the insert, which formed at 400°C (752°F) and ran from the insert to the edge boundary (Figure 6.17). There was mild reinforcement around this insert.

Figure 6.17: Cracking around metal insert, batch 2, 2in from left edge, after 500°C (932°F) for 3 hours with cracks enhanced (picture taken once cooled to ambient conditions)

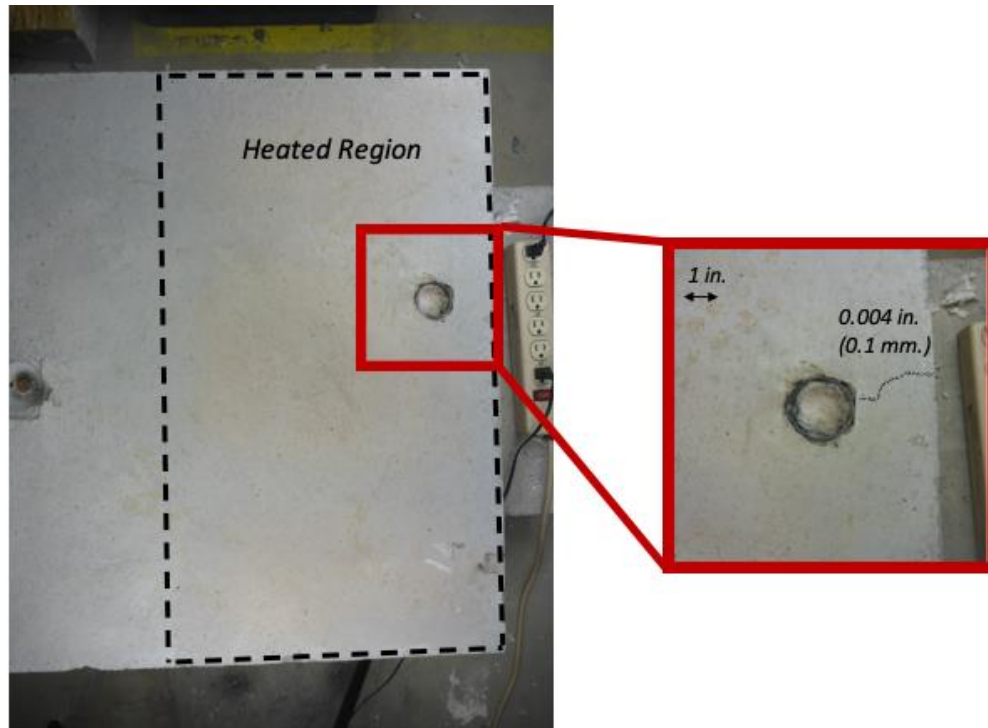
Metal inserts are used so that supporting metal angles can be physically attached to the slab by fitting a metal cylinder into the insert. This causes restricted airflow through the insert, so to imitate this, an insert was filled with insulation. This test showed general surface cracking trends that were comparable to concrete without a metal insert with exception of the enhanced/highlighted cracks surrounding the insert, which formed at 400°C (752°F) and ran from the insert to the edge boundary (Figure 6.18). There was mild reinforcement around this insert.

Figure 6.18: Cracking around metal insert, batch 2, 2in from right edge, after 500°C (932°F) for 3 hours with cracks enhanced (picture taken once cooled to ambient conditions)

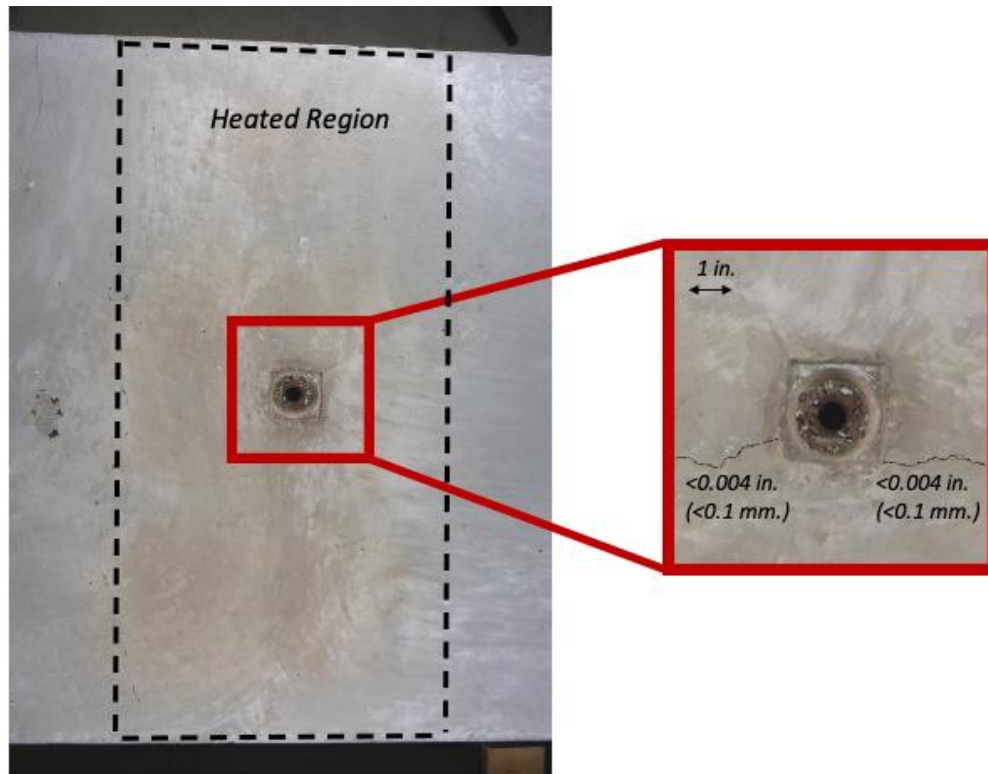
An anchor 36 in. from the edge of a batch 1 specimen was tested and found to show general surface cracking trends that were comparable to concrete without lifting anchors with the exception of the enhanced/highlighted cracks surrounding the anchor, which were observed after the slab top surface was maintained at 500°C (932°F) for three hours (Figure 6.19). A replica test was conducted and found identical results.

Figure 6.19: Cracking around F63B-B lifting anchor, batch 1, 36in from edge, after 500°C (932°F) for 3 hours with cracks enhanced (picture taken once cooled to ambient conditions)

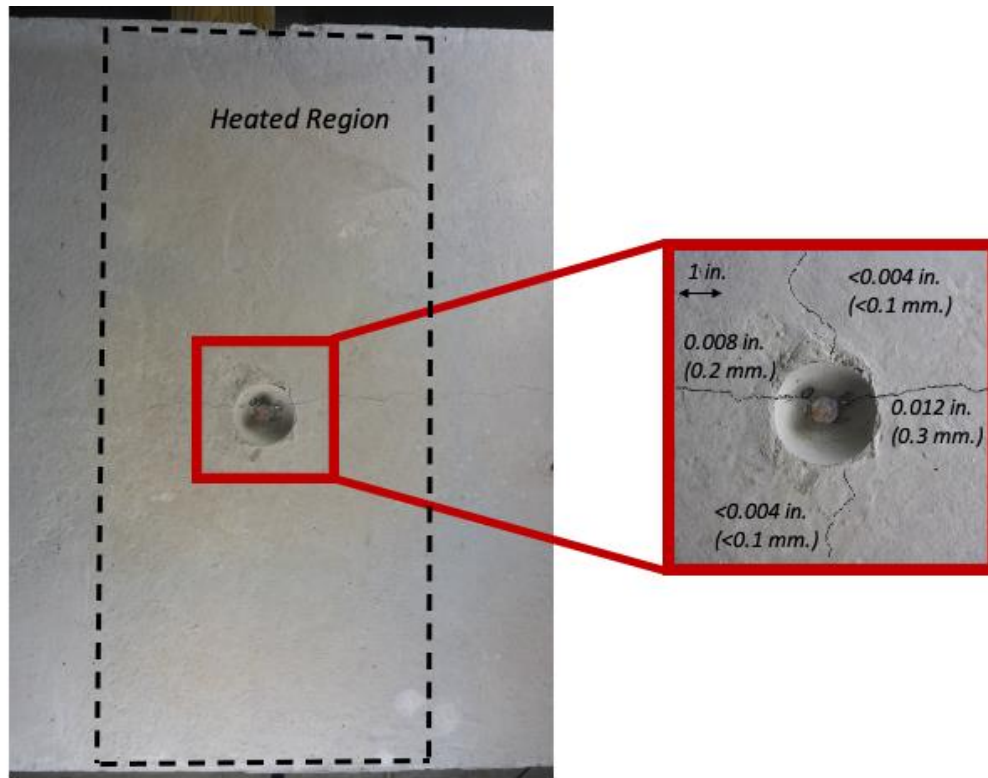
An anchor 24 in. from the edge of a batch 2 specimen was tested and found to show general surface cracking trends that were comparable to concrete without a lifting anchor with the exception of the enhanced/highlighted cracks surrounding the anchor, which were observed after the slab surface was at 500°C (932°F) for three hours. (Figure 6.20).

Figure 6.20: Cracking around P-52 lifting anchor, batch 2, 24in from edge, after 500°C (932°F) for 3 hours with cracks enhanced (picture taken once cooled to ambient conditions)

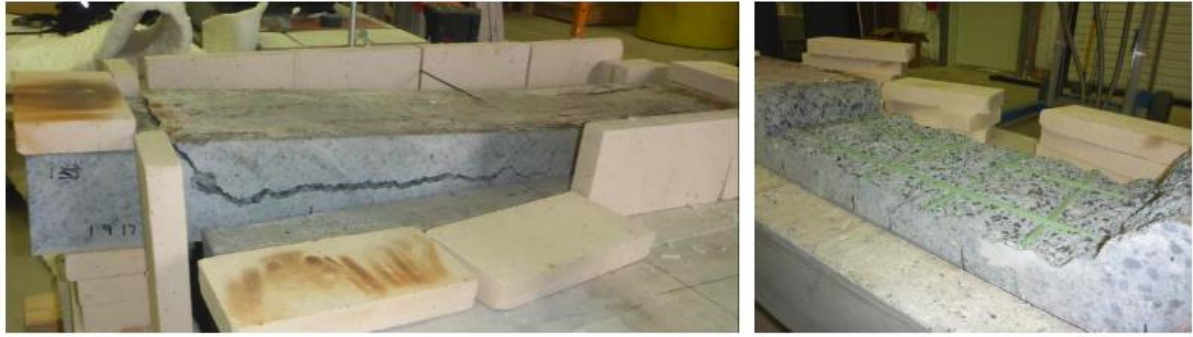
Figure 6.23: First spalled wall panel specimen from Phase I experimental testing (1)

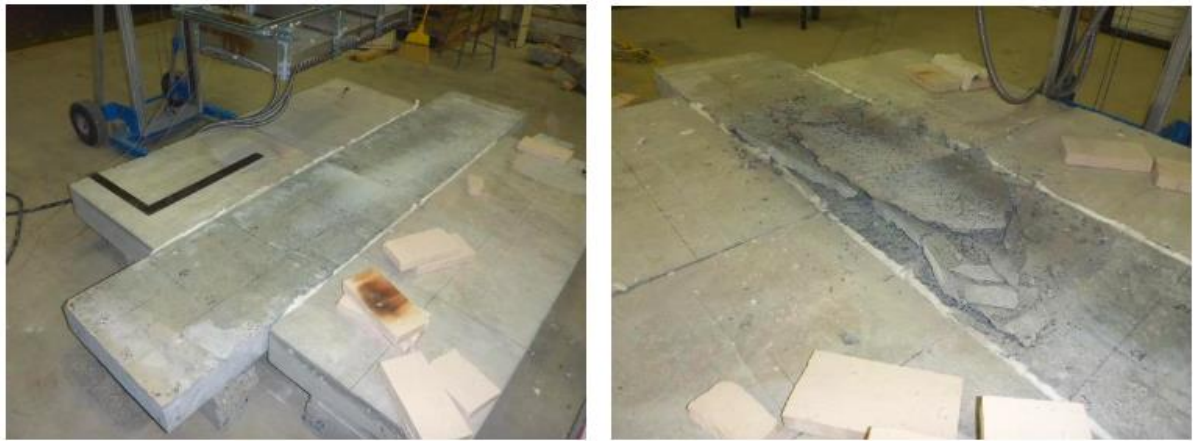
Figure 6.24: Second spalled wall panel specimen from Phase I experimental testing (1)

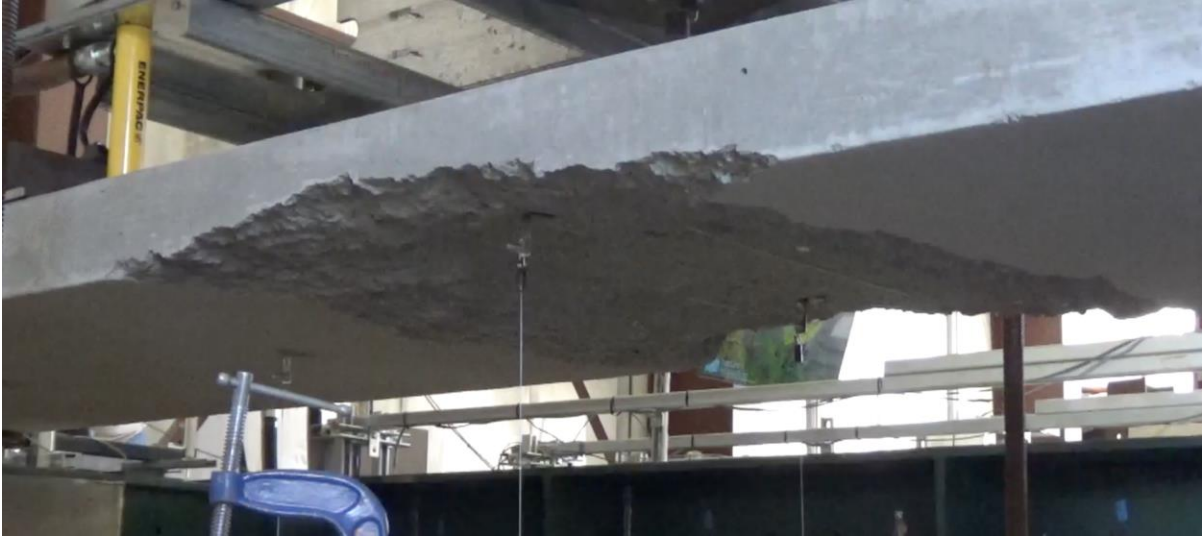
Figure 6.39: Specimen CS-2D spalled tensile face

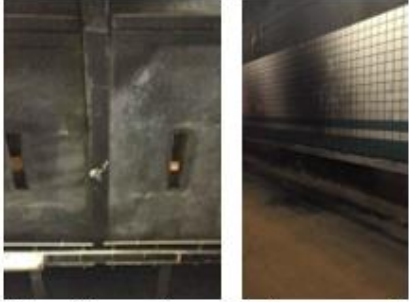
Example Condition State 1 Left: ceiling panels post-fire, bottom-up view; right: wall panel post-fire

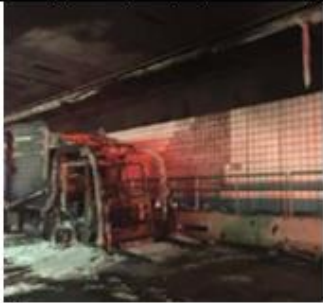
Example Condition State 2 Wall panel post garbage truck fire

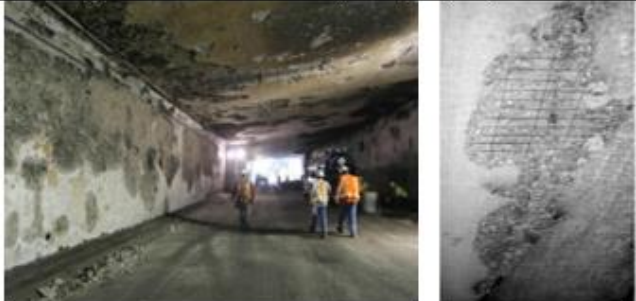
Example Condition State 3 Left: tunnel section with spalling post-fire, right: concrete spalling post-fire (67)

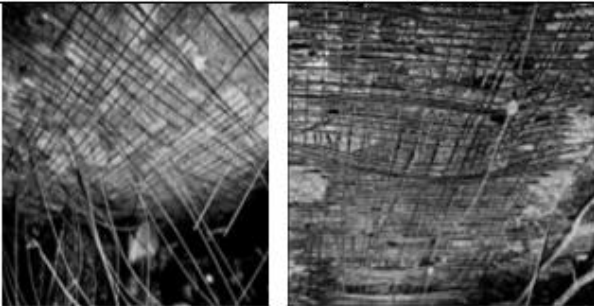
Example Condition State 4 Severe concrete spalling post-fire with damage reinforcement
