U.S. Department
of Transportation
**Federal Highway
Administration**

Publication No. FHWA-RD-95-032
November 1995

Cathodic Protection Field Trials on Prestressed Concrete Components

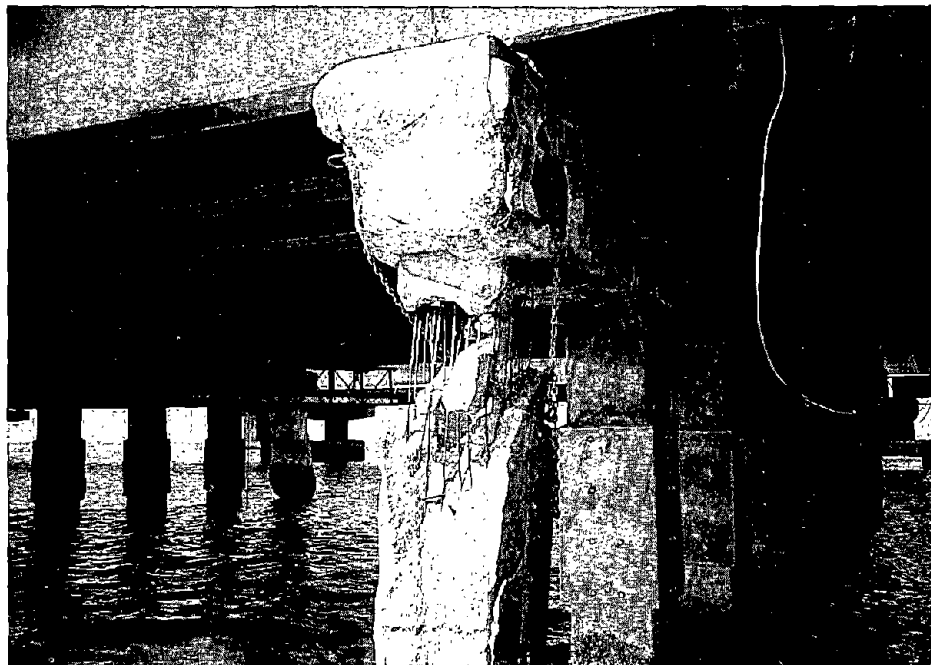
Figure 24. Barge damage to bridge structure.

below the mud line. The titanium mesh jacket on this pile was destroyed, with only part of it remaining on the other sides of the pile. Part of the concrete on the eastern side of the face of the pile cap was knocked off, leaving exposed bar. Several cracks were also present on the cap.

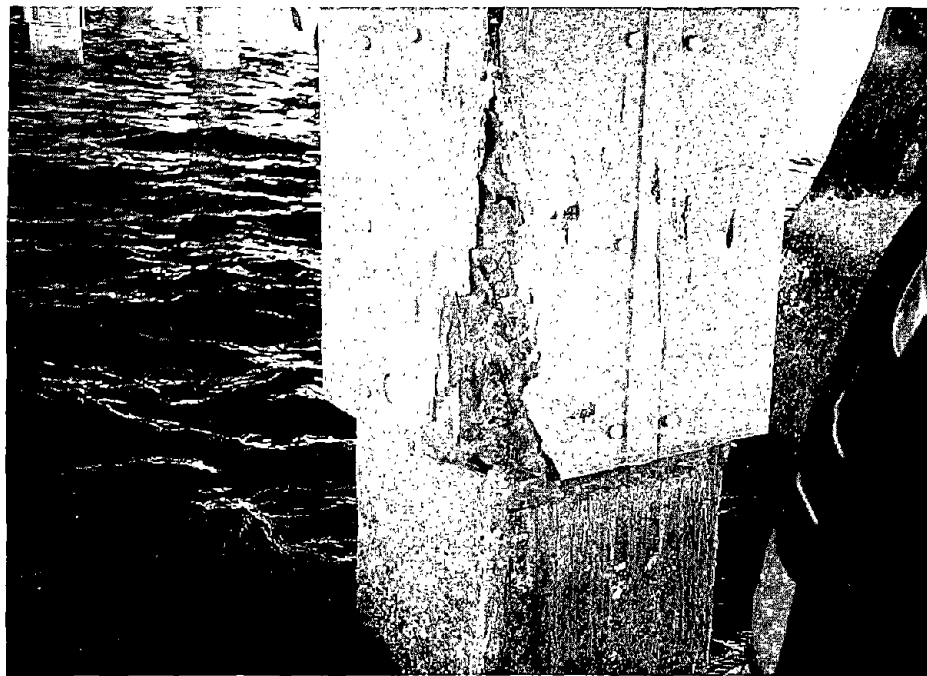
Figure 25. Barge damage to pile jacket.

The southernmost pile of bent 212 sustained only minor damage, as shown in figure 25. The lower half of the fiberglass jacket was broken off, but the titanium mesh was still in place. The concrete on both the pile and cap was abraded. No cracks were observed by Florida DOT divers.

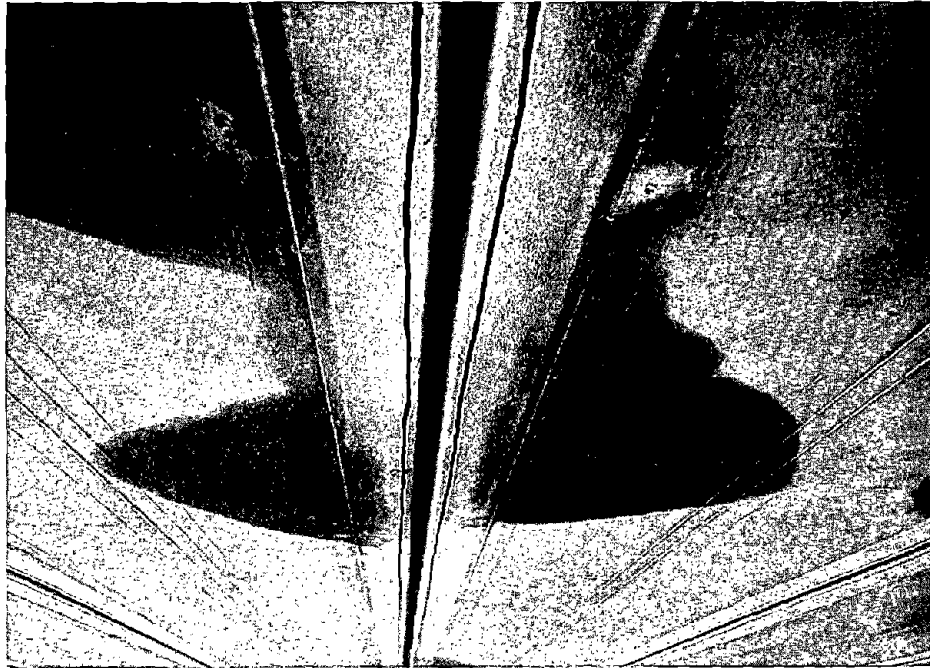
Figure 27. Finished grooves on each side of the joint between adjacent box beams.

Melting snow leaked through at several joints between the box beams and, because of the superelevation of the bridge, ran across the underside of the beams. Several attempts to dry the underside of the bridge were unsuccessful. A number of options were then tested to prevent the water from wetting the soffit side of the beams. These included caulking along the edges of the joints to form a dike to stop water movement, placing geotextile fabric in the joints to keep water confined to the joints and to act as a drip edge, and sawcutting a drip line along the edges of each box beam. The last option, sawcutting a drip edge, proved to be the most effective, and this is shown in figure 27.

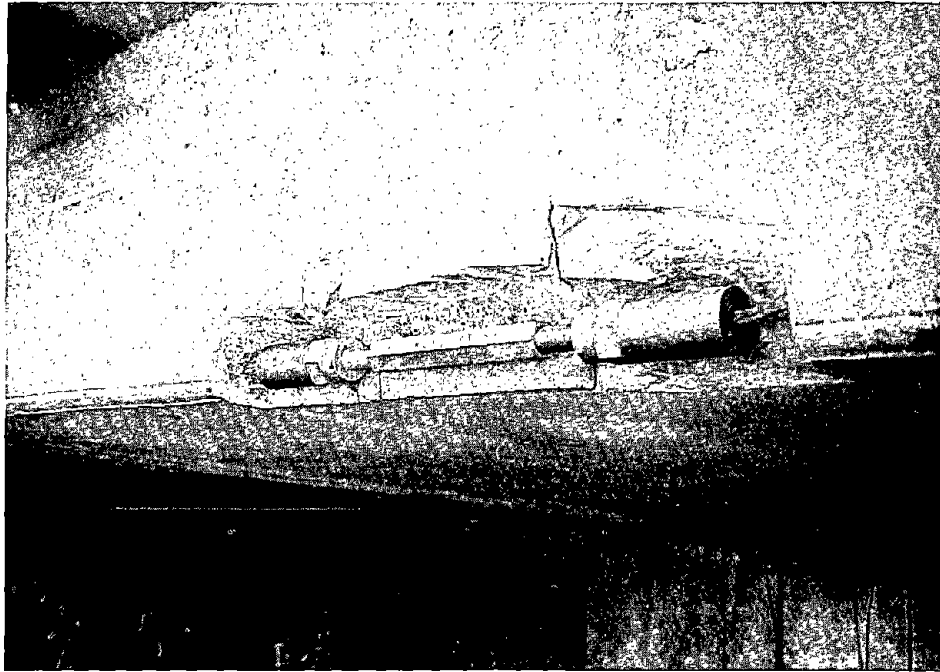
Figure 33. Grab-it splice connector installed at site where a prestressing strand sample was removed.

confirmed that there was no loose or delaminated concrete to repair. A sample of prestressing strand was removed from beam 15 for petrographic analysis. The strand in the beam was repaired with a Grabb-it splice.

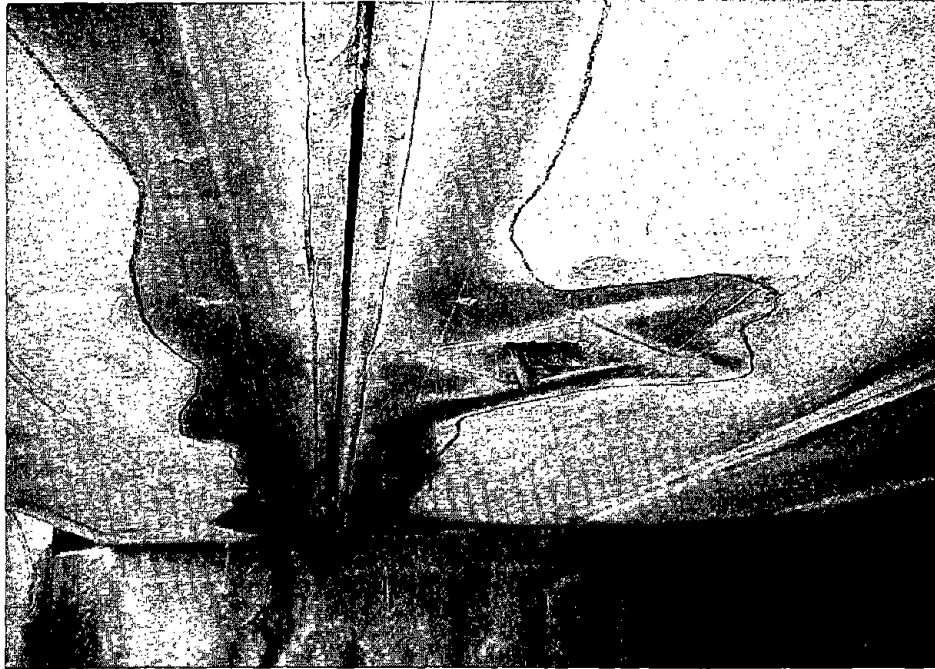
Figure 35. Drying of soffit 2 days after a storm.

As with the Abbey Road bridge, the cold temperatures and leaking of water through joints between the box beams presented major problems. The leaking joints were of particular concern since a conductive paint was selected for application to the soffit of this bridge. The manufacturer of the conductive coating indicated that the coating could be successfully applied only if the soffit was dry prior to and during the coating application and curing. The soffit was therefore prepared with sawcut drip edges, as described for the Abbey Road bridge, in an effort to keep the concrete dry during conductive coating application and for several consecutive days afterward for curing. Drying of the soffit 2 days after a storm is shown in figure 35. Even with these measures, it was not possible to adequately dry the concrete during the winter months, and the work was stopped from mid-January until April 1994. Application of the conductive coating then proceeded without difficulty.
