Performance of Concrete Pavements

Volume I: Field Investigation

PUBLICATION NO. FHWA-RD-94-177

JULY 1997

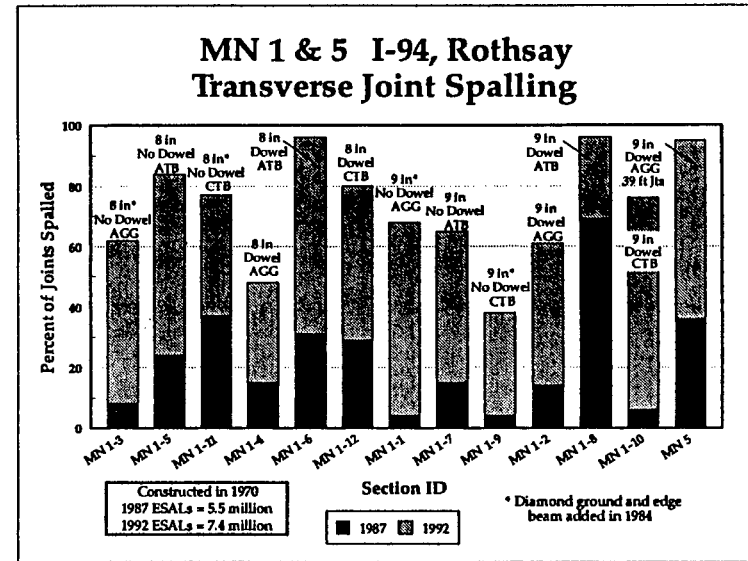
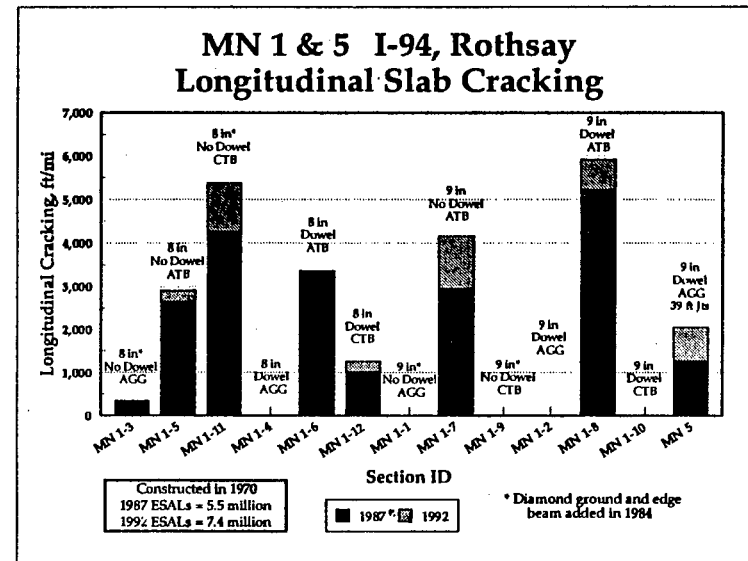
Figure 9. Performance summary for MN 1 & 5.

The 1992 data indicate, as did the 1987 data, that the sections constructed on the ATB developed a significant amount of longitudinal cracking, while the sections constructed on the AGG base display very little longitudinal cracking. This finding is confirmed by the replicate sections surveyed in the eastbound direction in 1992. In addition, nearly 90 percent of the joints on the sections constructed on the ATB exhibit joint spalling, whereas less than 50 percent of the joints on the CTB or on the AGG sections exhibit joint spalling. However, for a given method of load transfer, there are no discernible differences in joint faulting between the sections constructed on the different base types.

- The pavement sections placed on treated bases exhibit substantially more longitudinal cracking than the pavement sections constructed on aggregate bases. However, the levels of transverse cracking for each base type are about the same.
- The doweled pavement sections had less faulting than the nondoweled sections, although the small dowel bars (1 in [25 mm]) did allow significant levels of faulting.

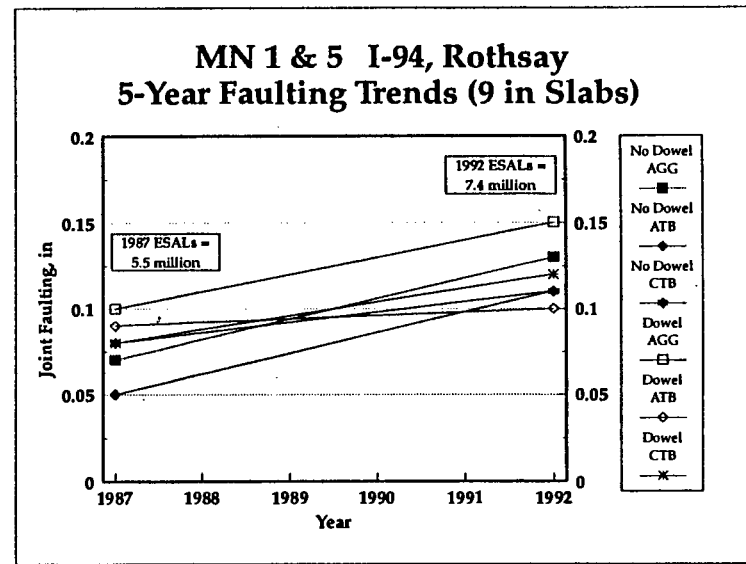
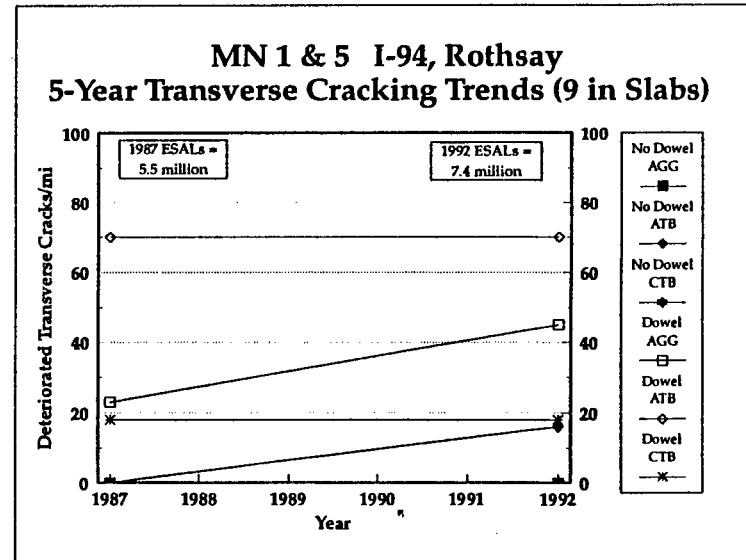
Figure 11. Faulting and transverse cracking 5-year performance trends for MN 1 & 5.

- The doweled sections often had more spalling and transverse cracking than the nondoweled sections, suggesting that the noncoated dowels had corroded and locked up many of the joints. The small amount of reinforcing steel (0.09 and 0.08 percent) may also be partially responsible for the deterioration of the transverse cracks.
- Increased slab thickness (from 8 in [203 mm] to 9 in [229 mm]) reduced faulting and cracking for the nondoweled sections but not for the doweled sections. Again, this result is probably related to the dowel bars locking up the joints and causing mid-slab cracks to open and deteriorate.
- The section with 27-ft (8.2-m) joint spacing displayed less transverse cracking and spalling than the longer 39-ft (12.2-m) pavement.

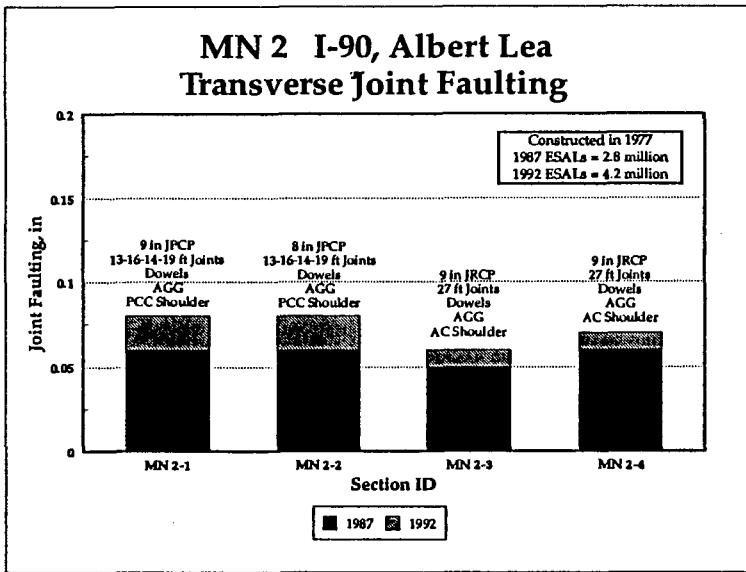
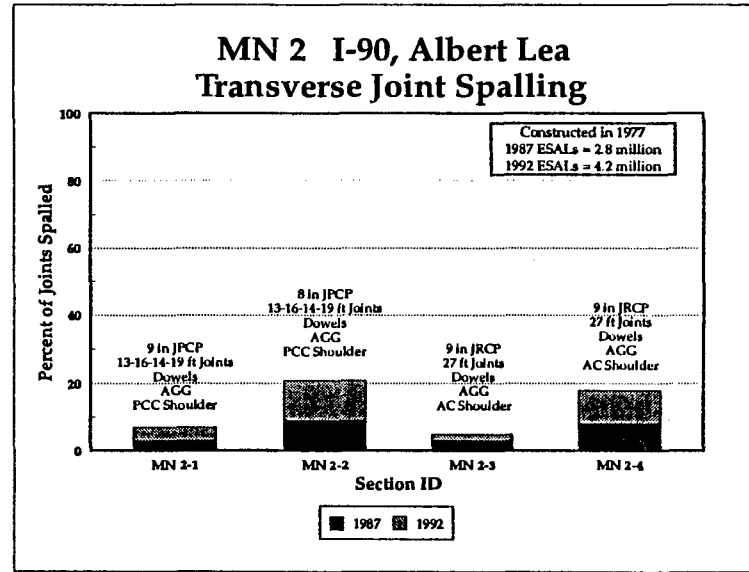
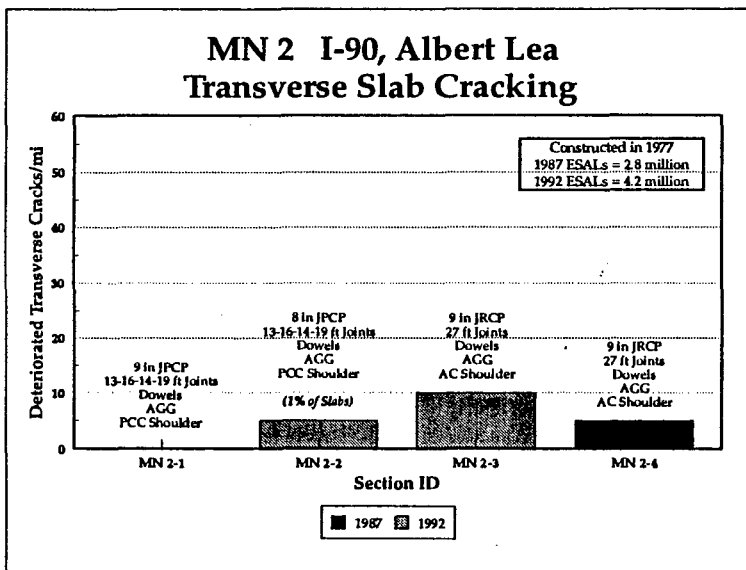
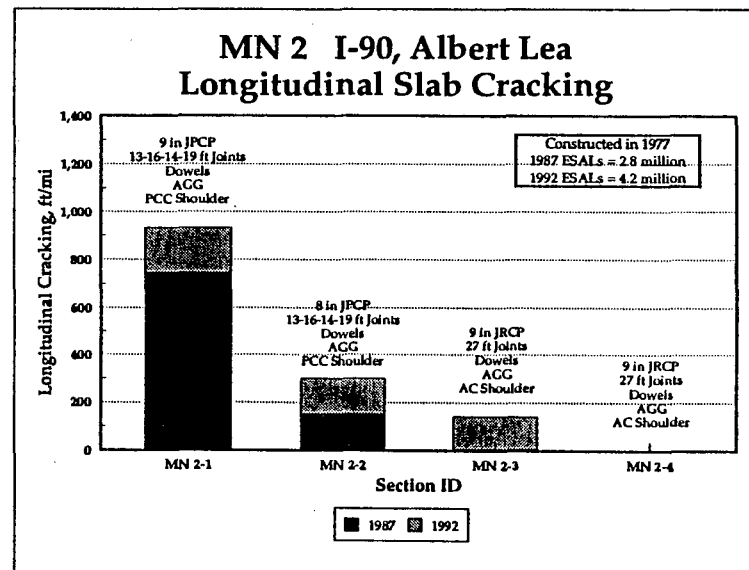
Figure 12. Performance summary for MN 2.

In assessing the performance of the different pavement types, the JRCP sections appear to be performing slightly better than the JPCP sections. The JRCP sections have slightly less faulting, less joint deterioration, and less longitudinal cracking.

However, these differences are not appreciable and the overall rideability of both JRCP and JPCP sections is similar.

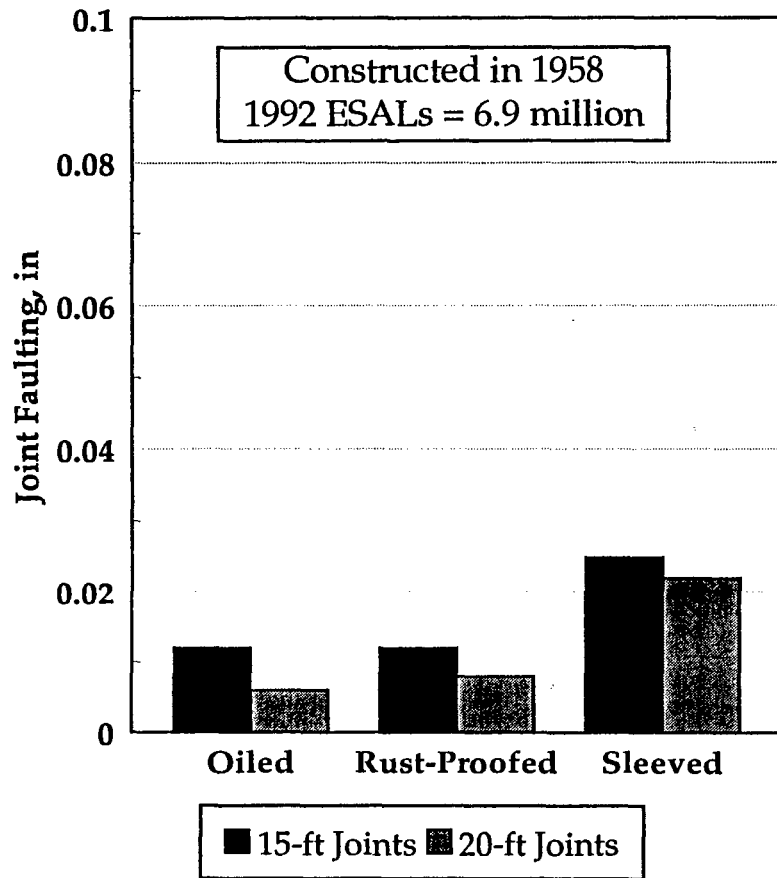
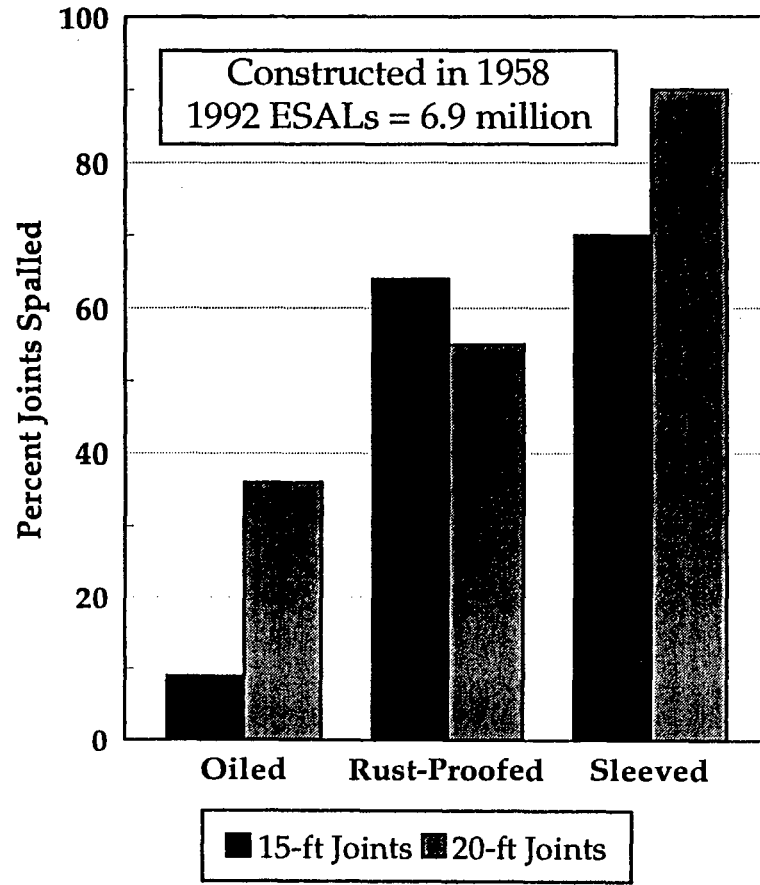
Figure 16. Performance of dowel coatings for MN 7.

affected. The joints with oiled dowels exhibited much less medium- and high-severity joint spalling than those joints with rust-proofed or sleeved dowels. The joints containing the sleeved dowels were badly deteriorated, and several had received full- and partial-depth repairs. It should be recalled that the different dowel types were placed at alternating joints.

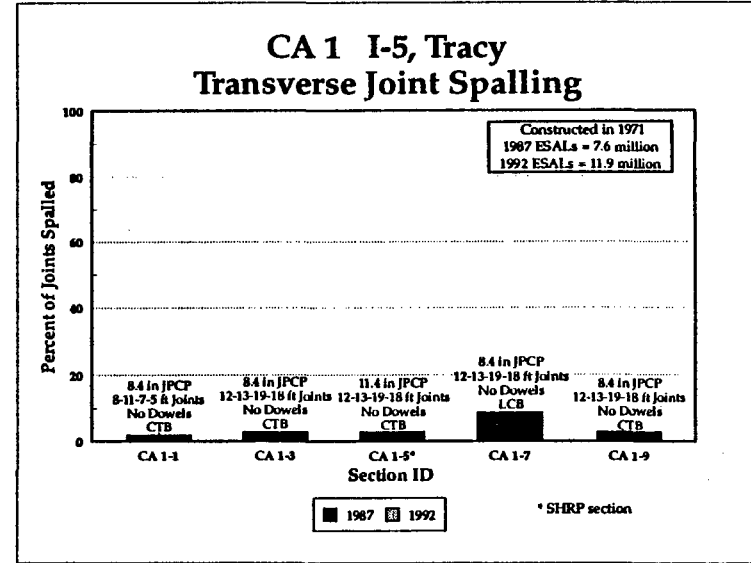
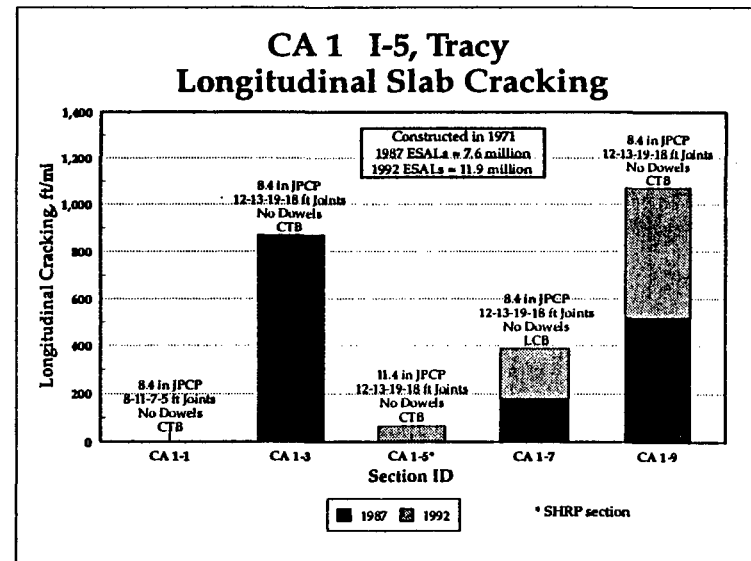
Figure 21. Performance summary for CA 1.

cracking. The high-strength replicate section (CA 1-10) had higher levels of faulting, transverse cracking, and longitudinal cracking, as well a lower PSR and higher IRI than the corresponding section (CA 1-4).

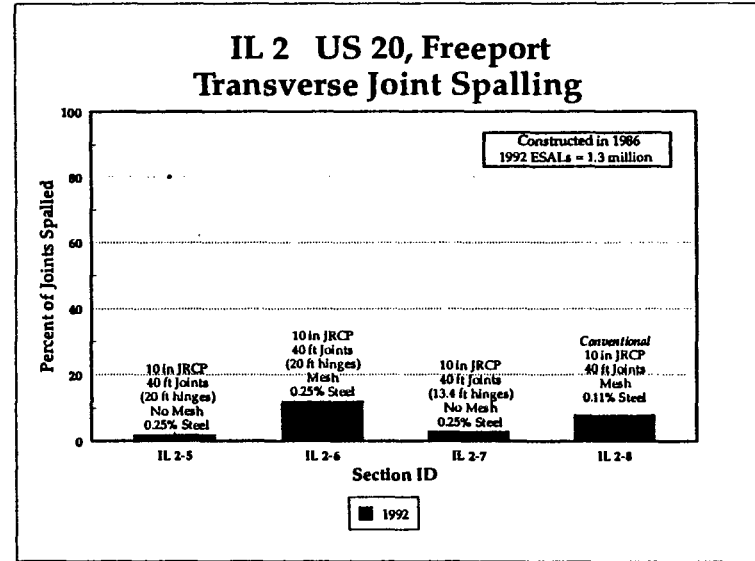
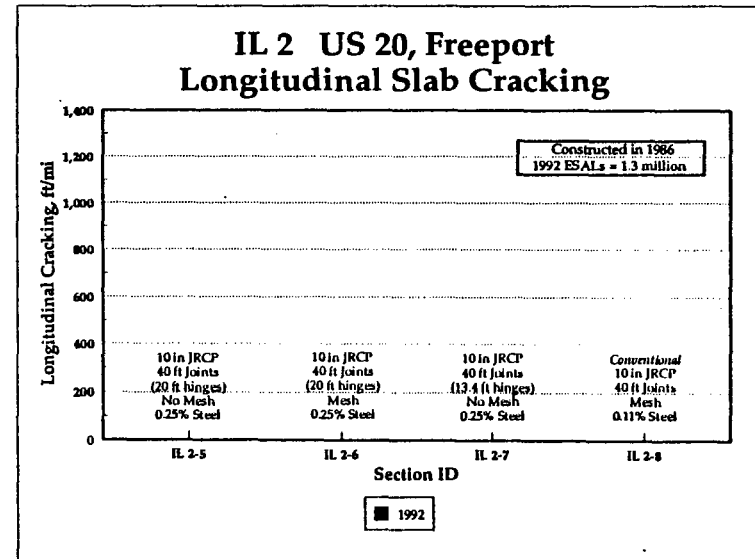
Figure 26. Performance summary for IL 2.

- The sections containing the hinge joint design are performing better than the conventional design in terms of the amount of deteriorated transverse cracking. However, there are no other significant differences in performance.
- No differences in performance exist between the different hinge joint designs.
- Roughness levels for each of the sections are not significantly different.

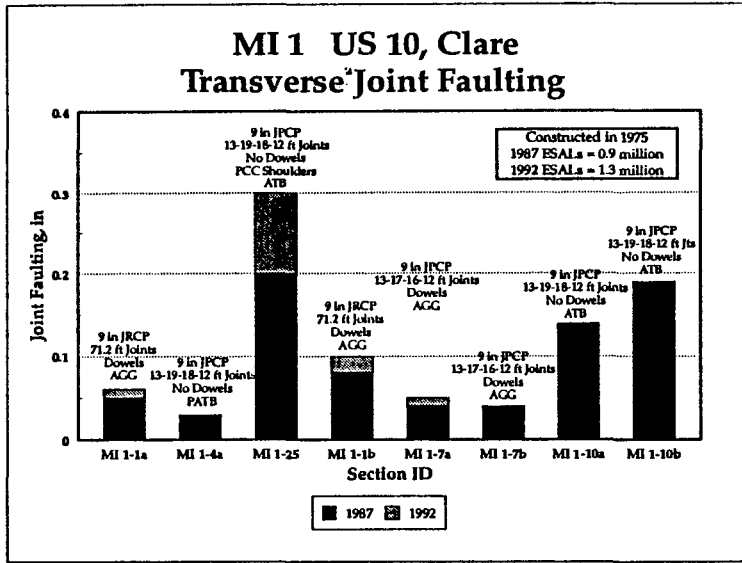
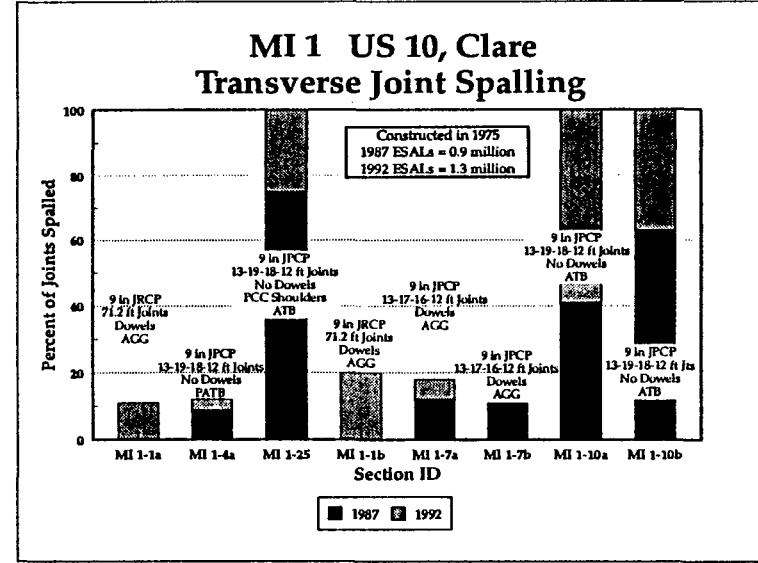
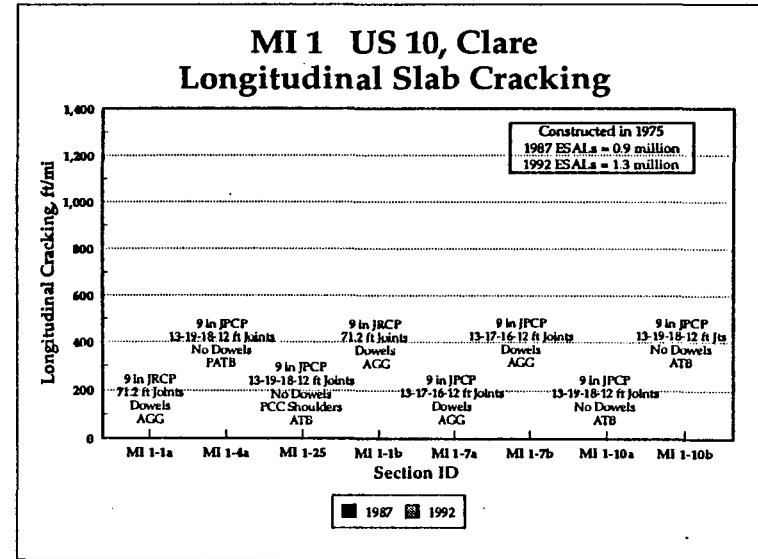
Figure 28. Performance summary for MI 1.

spalling. These ATB sections were constructed as a "bathtub" design with full-depth AC shoulders, which served to retain excess moisture within the pavement structure and resulted in the accelerated development of pavement distress.

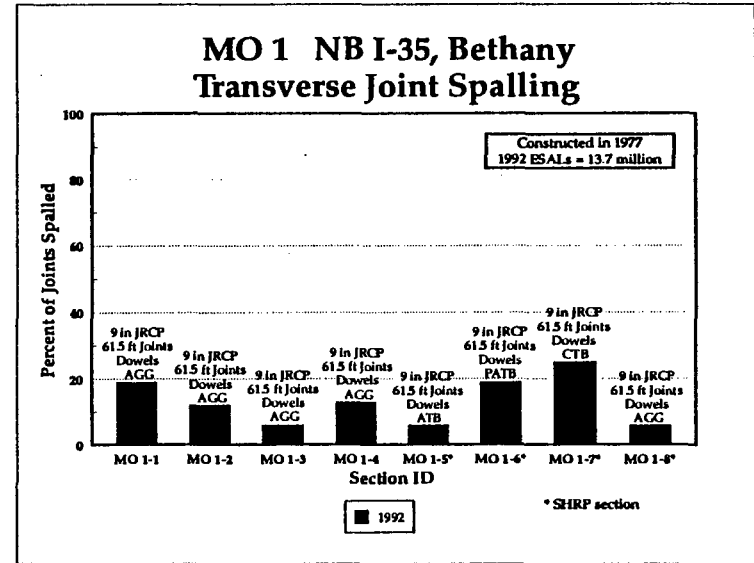
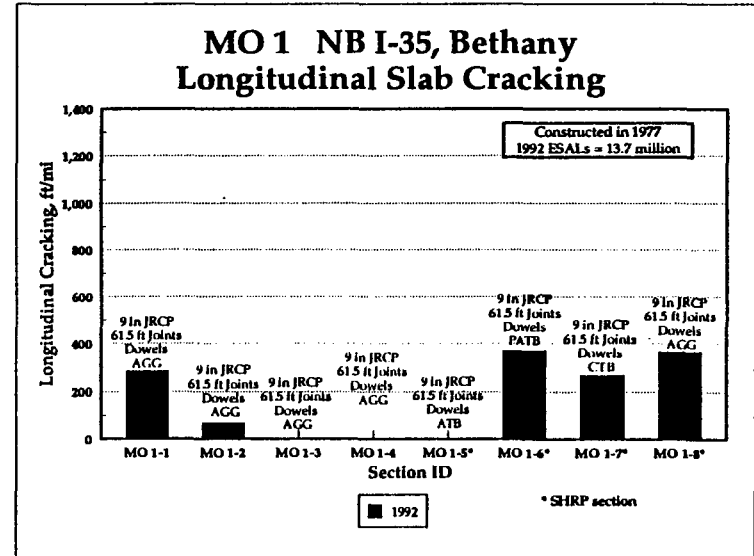
Figure 31. Performance summary for MO 1.

- No significant difference is observed between the performance of the pavement sections constructed on various base types. Levels of faulting, spalling, and transverse cracking are comparable for all sections, although pumping was

only observed on the AGG sections. The section constructed on PATB did exhibit less transverse cracking than the other sections, suggesting that a reduction in transverse crack deterioration is related to the removal of excess water from the pavement structure.

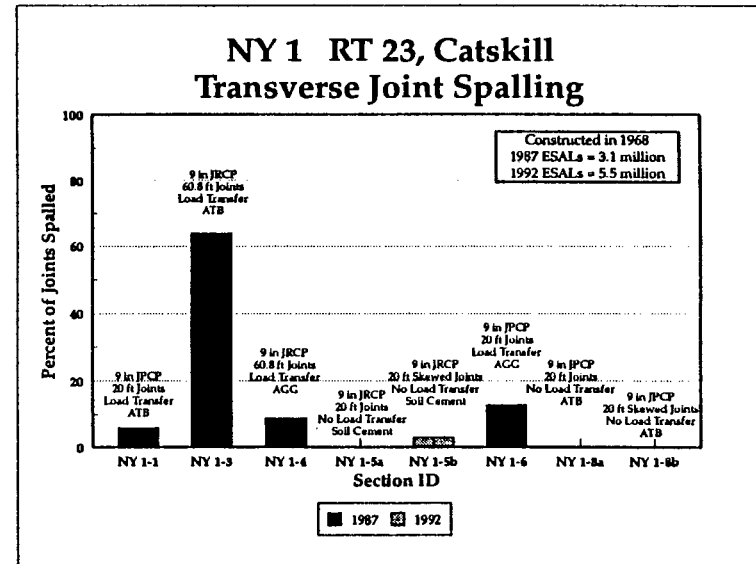
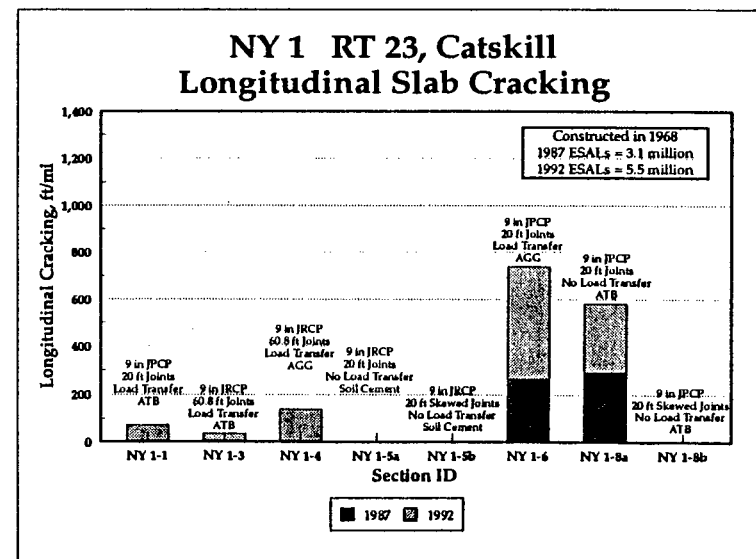
Figure 33. Performance summary for NY 1.

The effect of the ACME load transfer devices in reducing faulting can be observed by comparing the performance of NY 1-1 and 1-8a. The distress data indicate no significant difference in the performance of these sections, suggesting that the light traffic to which this project is exposed may not be a true test of the load transfer devices. Other studies conducted in New York have indicated that these devices corroded and could not be relied upon to provide positive, long-term load transfer, often failing within 5 years.⁽²⁹⁾

No definitive conclusions can be drawn regarding the effectiveness of skewed transverse joints. The section with the skewed joints displays more faulting than the corresponding section with perpendicular joints, although this difference is not significant. The section with perpendicular joints, however, displays more transverse slab cracking than the section with skewed joints.

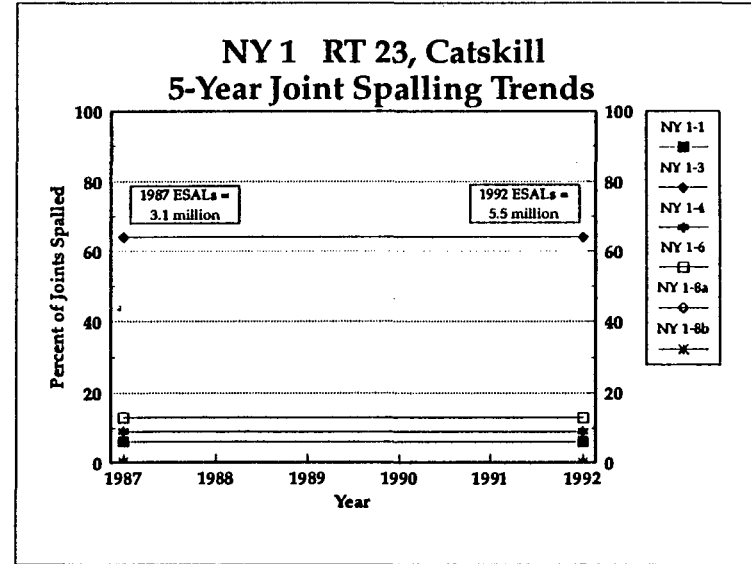
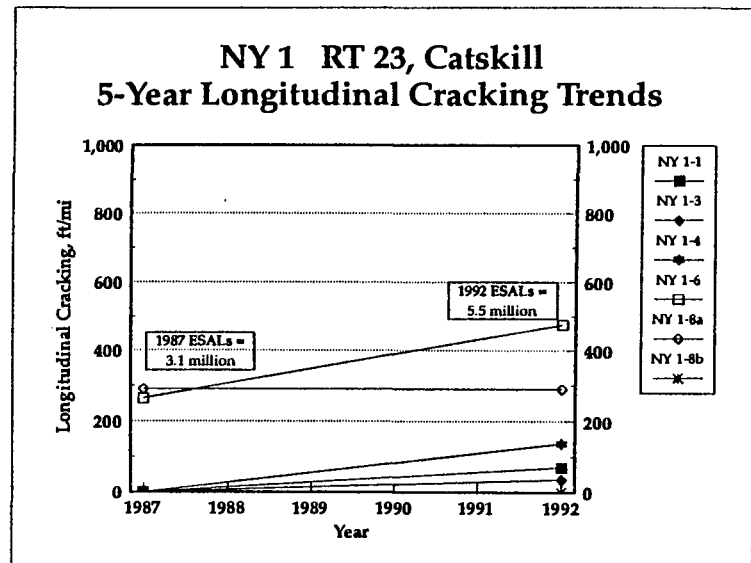
Figure 35. 5-year performance trends for NY 1.

- At this time, no performance benefits are apparent for the sections constructed with the ACME load transfer device. The faulting levels for sections with and without the load transfer device are about the same. This may be partially attributed to the low level of traffic present on the pavement.
- No definitive conclusions could be drawn regarding the effectiveness of joint skewing. The skewed section had slightly more faulting than its nonskewed counterpart, although it also had fewer deteriorated cracks.
- With the exception of the long-jointed JRCP, the pavement sections are providing satisfactory rideability. The long-jointed pavements are the roughest sections, probably due to the severe faulting that has developed.
- With the exception of transverse cracking, no significant changes in pavement condition have occurred for these sections over the last 5 years.

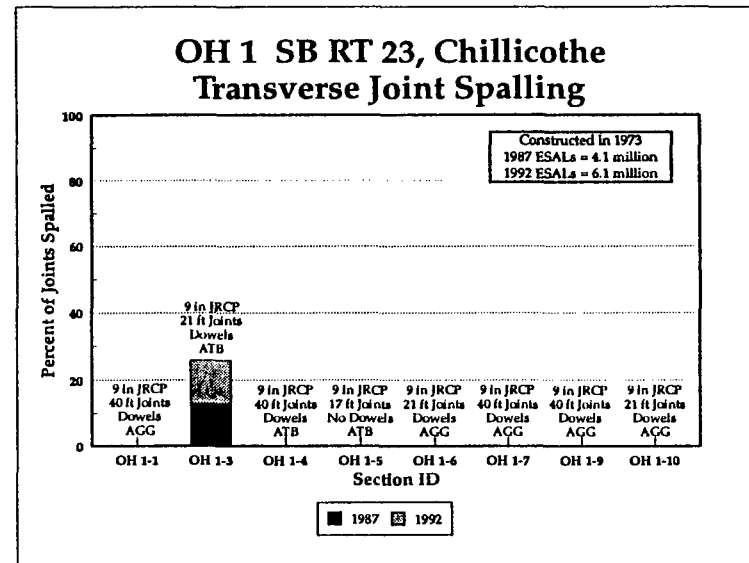
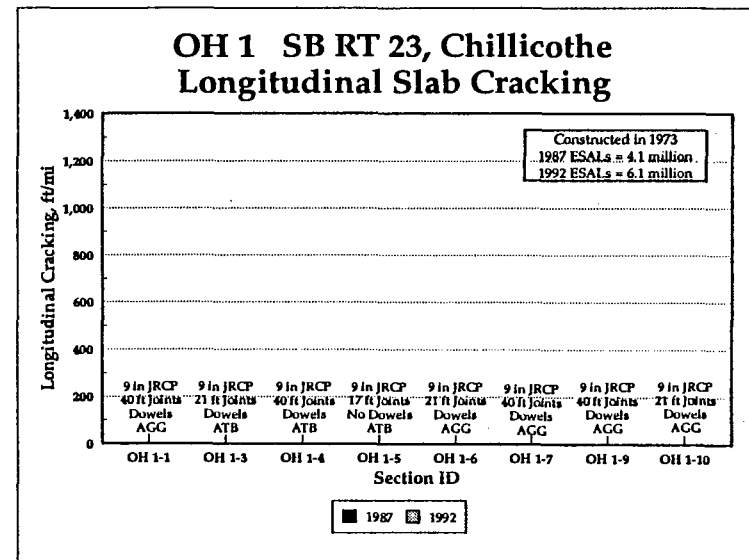
Figure 39. Performance summary for OH 1.

The sections constructed on ATB show fewer deteriorated transverse cracks and slightly less faulting than the sections constructed on aggregate base. This may speak to the ATB's greater resistance to moisture and erosion. Although one ATB section

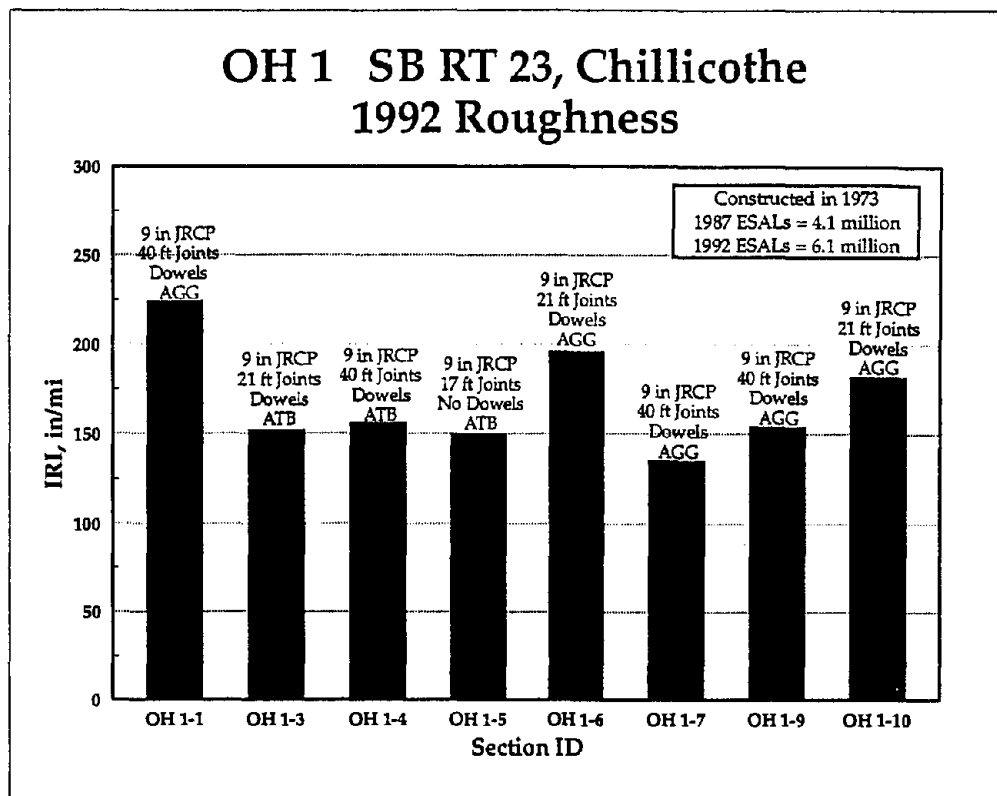
Figure 40. Roughness measurements for OH 1.

Figure 40 shows the roughness measurements recorded for the OH 1 sections. Overall, most of the sections are fairly smooth, with the sections constructed on ATB providing the smoothest riding surfaces. Three sections stand out as being particularly rough (OH 1-1, OH 1-6, OH 1-10), all of which show a significant amount of deteriorated transverse cracking. Because these sections are extremely short (typically less than 200 ft [61.0 m]), serviceability ratings were not recorded.

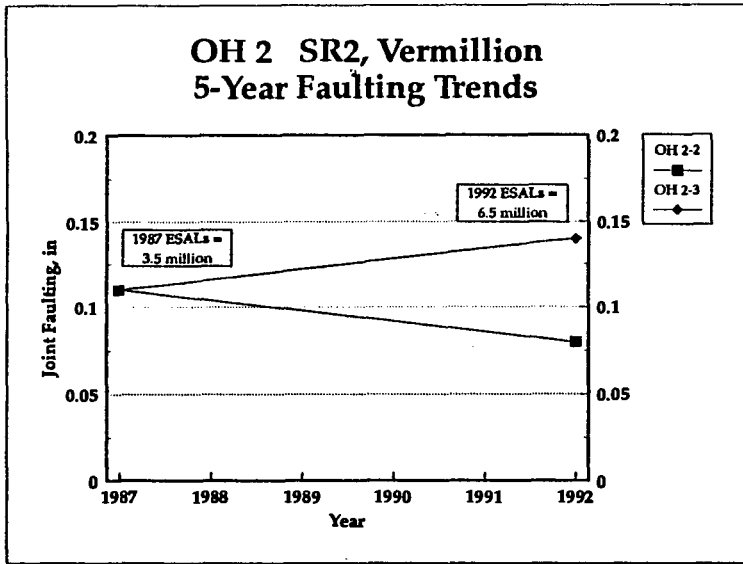
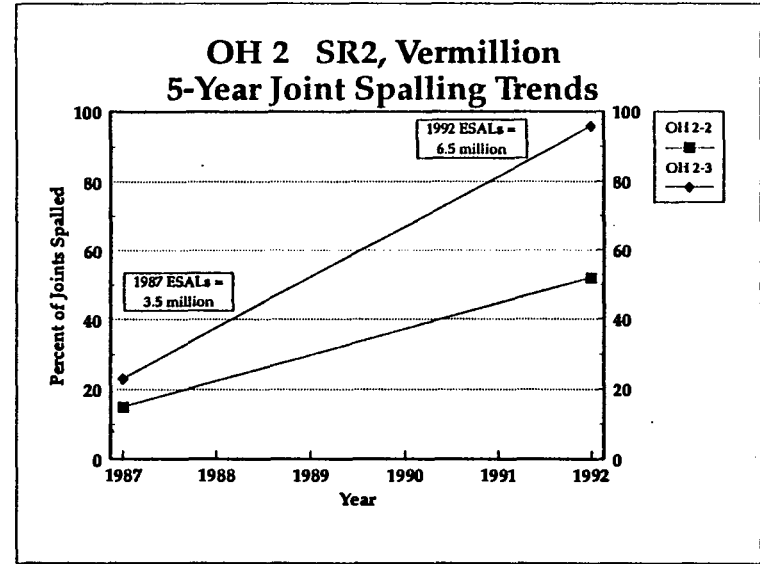
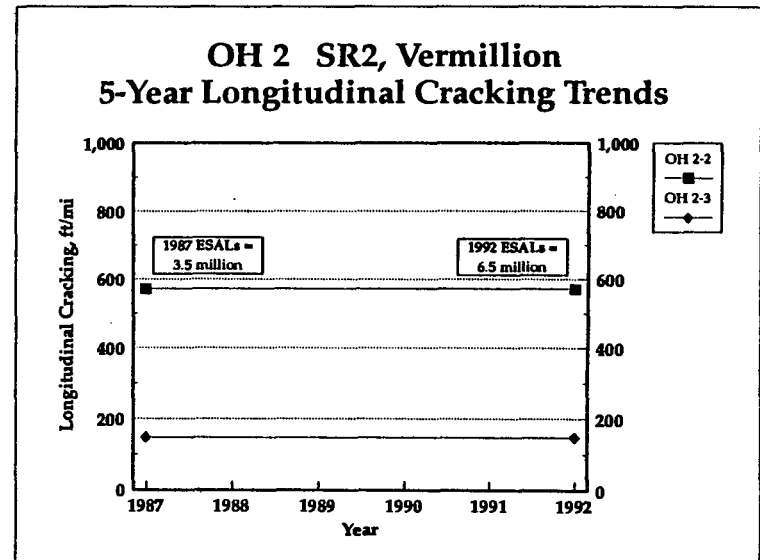
Figure 45. 5-year performance trends for OH 2 sections.

- Faulting is more severe at deteriorated cracks than at the joints. Faulting of 0.20 to 0.25 in (5 to 6 mm) is common on deteriorated cracks in this project.
- The best performers are the 40-ft (12.2-m) JRCP sections with large aggregates and edge drains constructed on ATB. These sections have very little faulting and deteriorated cracks.
- On stabilized base sections, deterioration of transverse cracks is much more severe on sections constructed with 0.5-in (13-mm) maximum-size aggregate than on the ones constructed with 1.5-in (38-mm) maximum-size aggregate.
- On aggregate base sections, the maximum aggregate size does not appear to affect deterioration of transverse cracks in JRCP.

- The 60-ft (18.3-m) JRCF sections constructed with 1.5-in (38-mm) maximum size aggregate (OH 2-9 and OH 2-11) contain the most joint spalling.
- Pumping is a severe problem in the sections placed without a subbase.

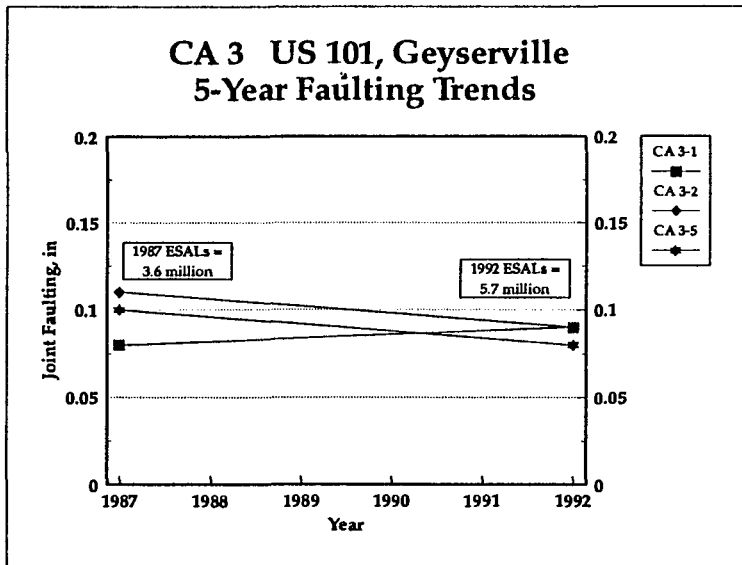
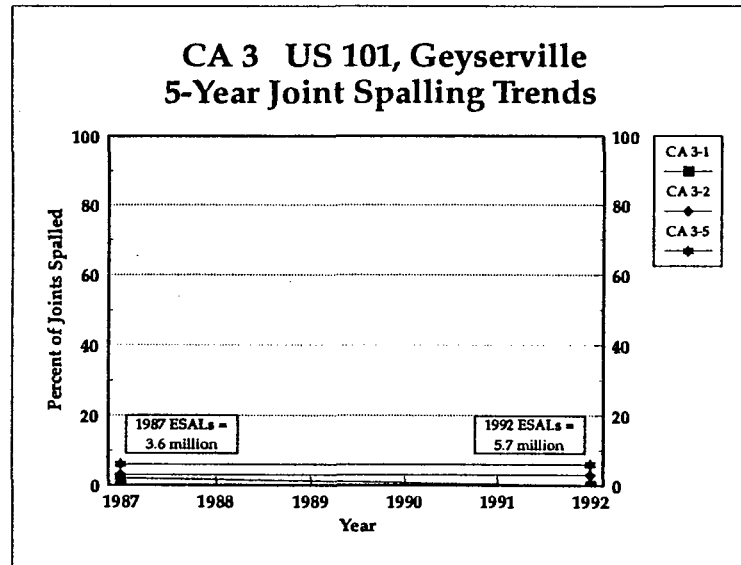
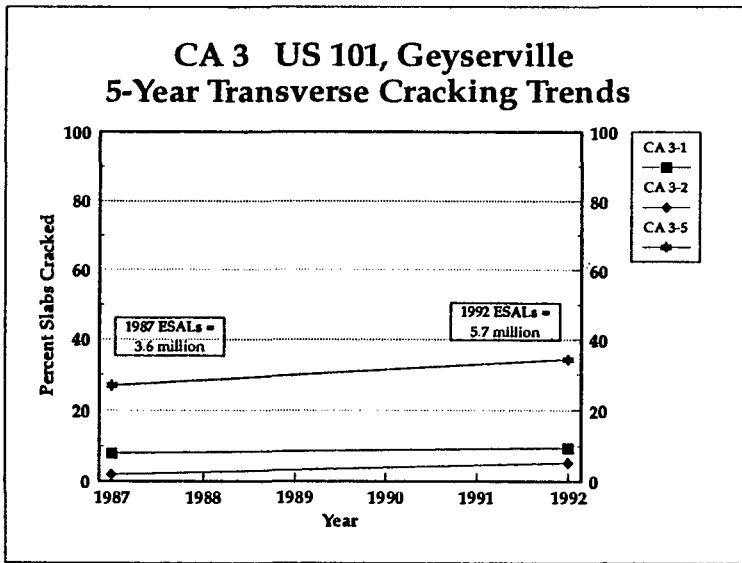
Figure 68. 5-year performance trends for CA 3.

- Overall, the roughest pavement sections were those constructed with AC shoulders. The smoothest pavement section was CA 3-6, which contained sealed transverse joints and a tied PCC shoulder. However, several sections with nontied PCC shoulders are also providing a smooth-riding surface.
- A decrease in serviceability was observed for the three sections that were surveyed in 1987 (CA 3-1, 3-2, and 3-5). The biggest decrease occurred in section 3-2, which contained a tied PCC shoulder and no joint sealant.
- An examination of the 5-year performance trends indicate virtually no changes in pavement distress since the 1987 survey. The biggest change was observed in section CA 3-5, which showed an increase in transverse cracking from 27 to 34 percent of the slabs.

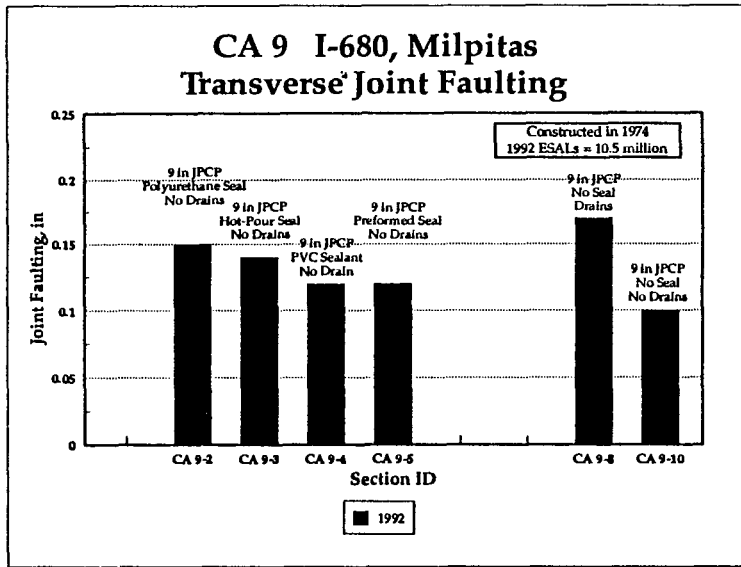
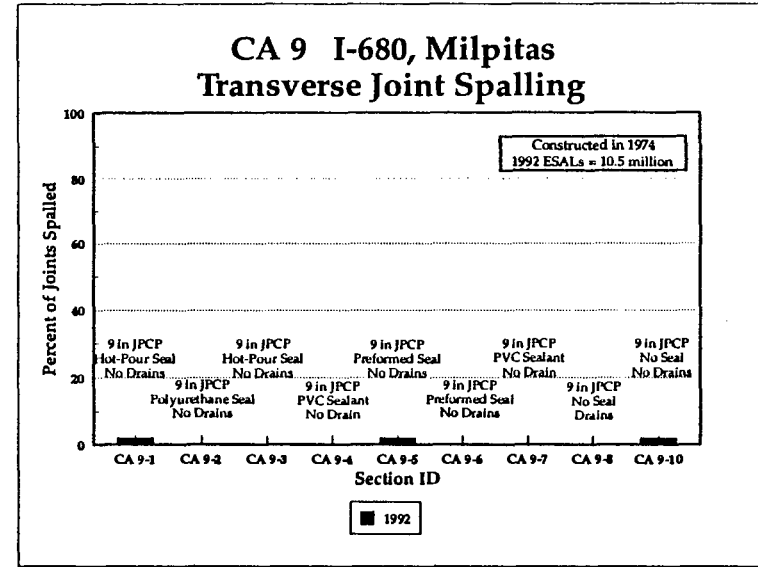
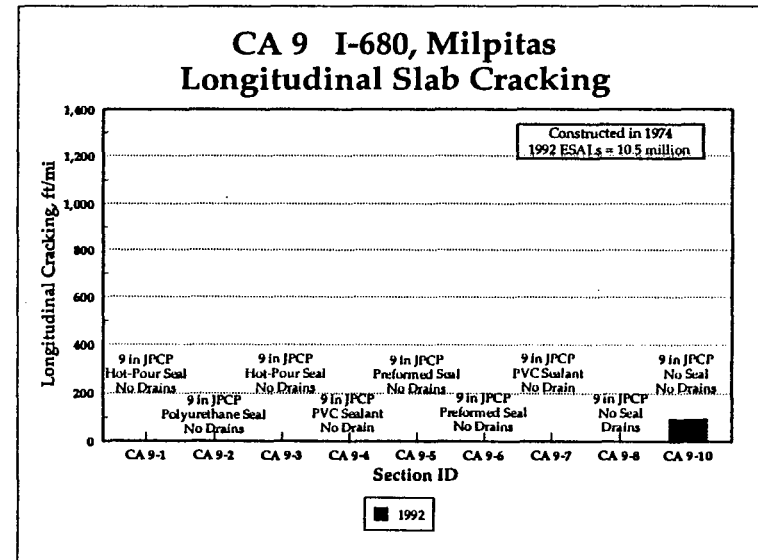
Figure 69. Performance summary for CA 9.

Overall, some of the sealed sections are performing better than the control section, particularly in terms of transverse cracking. However, even after 18 years, it remains to be seen what effects the sealants will have on joint spalling.

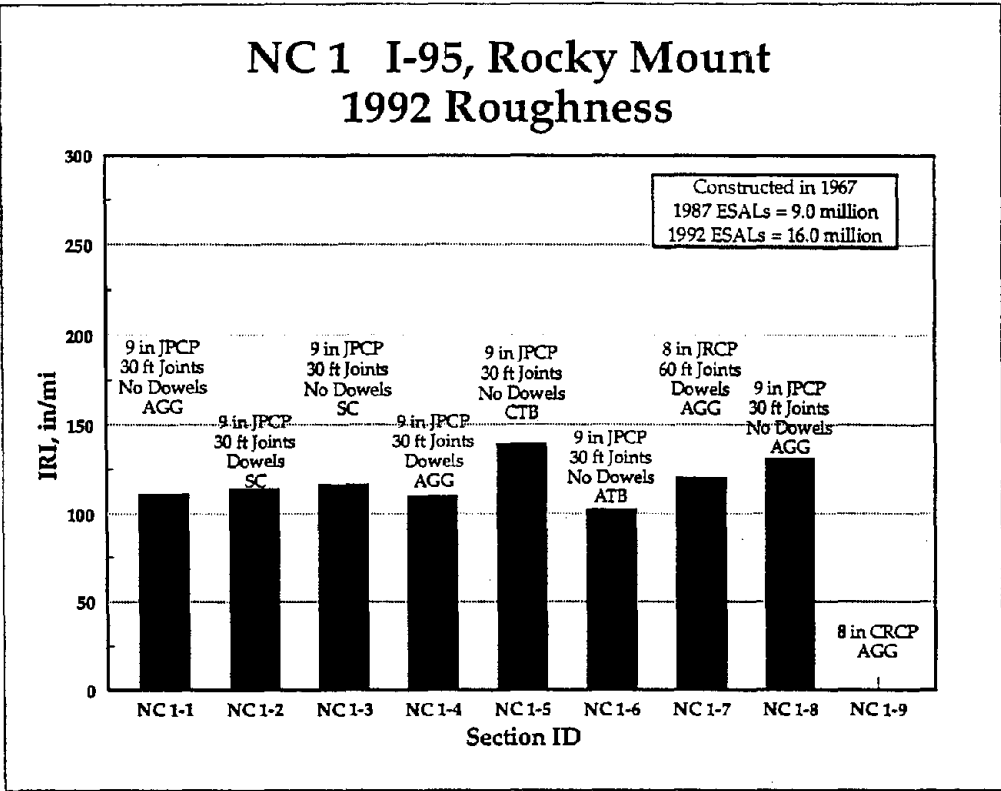
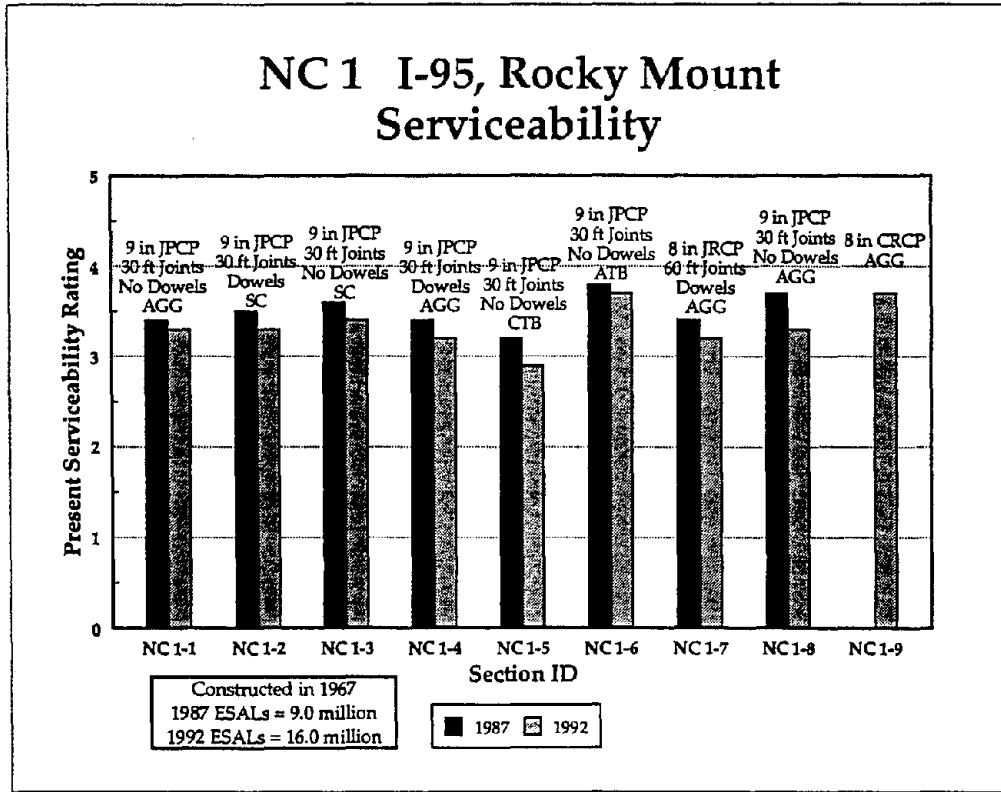
Figure 77. Roughness and serviceability for NC 1.

All sections are noted to have decreased in serviceability from 1987. Sections 1-5 and 1-8 have low serviceabilities, ones that have reached or are approaching "trigger" values for rehabilitation. Section 1-6 and section 1-9 (the CRCP design) have the highest serviceabilities. The high serviceability of the CRCP section confirms its excellent performance.

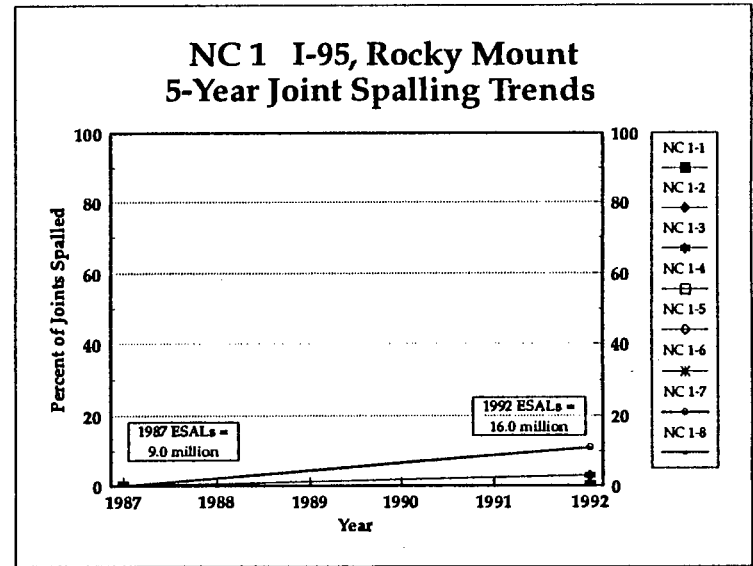
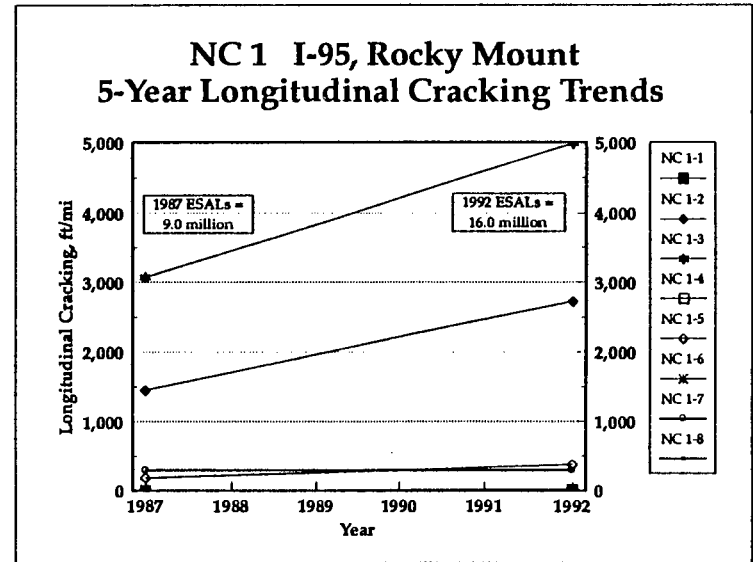
Figure 78. 5-year performance trends for NC 1.

- The 8-in (203-mm) JRCP is showing fair to good performance, certainly comparable to several of the 9-in (229-mm) JPCP sections.

- The JRCF section, with the longer joint spacing, displayed more joint spalling than any of the other sections. However, the amount of joint spalling for all sections is extremely low for a 25-year-old pavement.
