**Publication No. FHWA-RD-89-119
April 1989**

TEST AND EVALUATION OF TRAFFIC BARRIERS

14. Sponsoring Agency Code	
15. Supplementary Notes FHWA Contract Manager: L. Meczkowski (HSR-20)					
16. Abstract A series of crash tests were conducted to evaluate several types of guardrails and bridge rails. Two bridge rail designs were tested and showed acceptable performance when evaluated in accordance with NCHRP 230. A three-cable guardrail was modified, and an end terminal was re-designed to obtain good performance. The guardrail safely redirected a large and small vehicle traveling at 60 mi/h and impacting at 25 and 20 degrees, respectively. The terminal design was tested for snagging by directly impacting the downstream end. Although the device released, the vehicle rolled over. A new PL3 median barrier was designed and tested in accordance with the new AASHTO bridge rail test criteria. A 50,000-lb tractor-trailer impacted the median barrier at 50 mi/h and 15 degrees. The truck was redirected and contained, but rolled over producing undesirable occupant compartment intrusion. An 18,000-lb truck test was conducted on the modified thrie beam median barrier. The results indicated good p

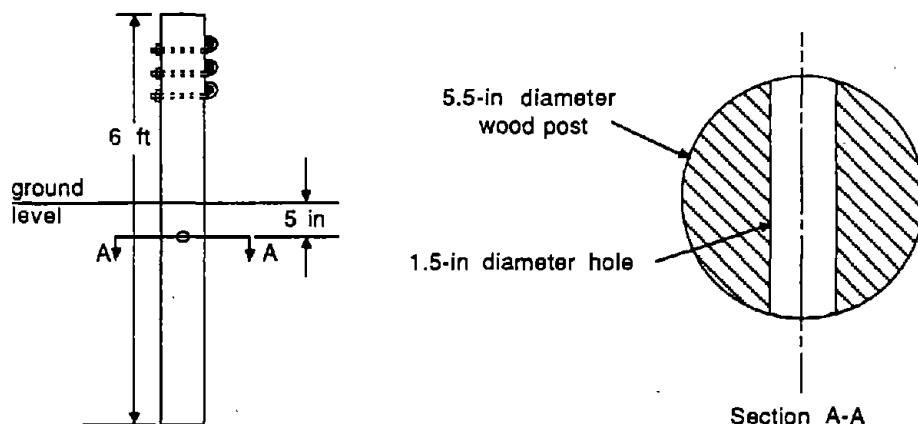
Figure 1. Hole modification for Minnesota three-cable guardrail posts.

A post modification developed for the controlled releasing terminal (CRT) was adapted for this contract.⁽²⁾ This modification consists of a hole drilled through the post to make the post break more easily in the direction of vehicle travel, while maintaining nearly all of the post's strength in the lateral direction. The hole and typical post section is shown in figure 1.

results and the validation of the post/soil model, the single hole located 5 in below grade was selected as the design for testing. This post design was depicted in figure 1, shown previously. This post was used in the full scale tests. Its performance was validated in that it did not cause the 1800-lb vehicle to roll over during the NCHRP Report 230 test type S13.⁽³⁾ This test uses an 1800-lb vehicle impacting at 60 mi/h and 20 degrees. The vehicle was redirected smoothly. See full-scale tests of Minnesota three-cable guardrail for details.

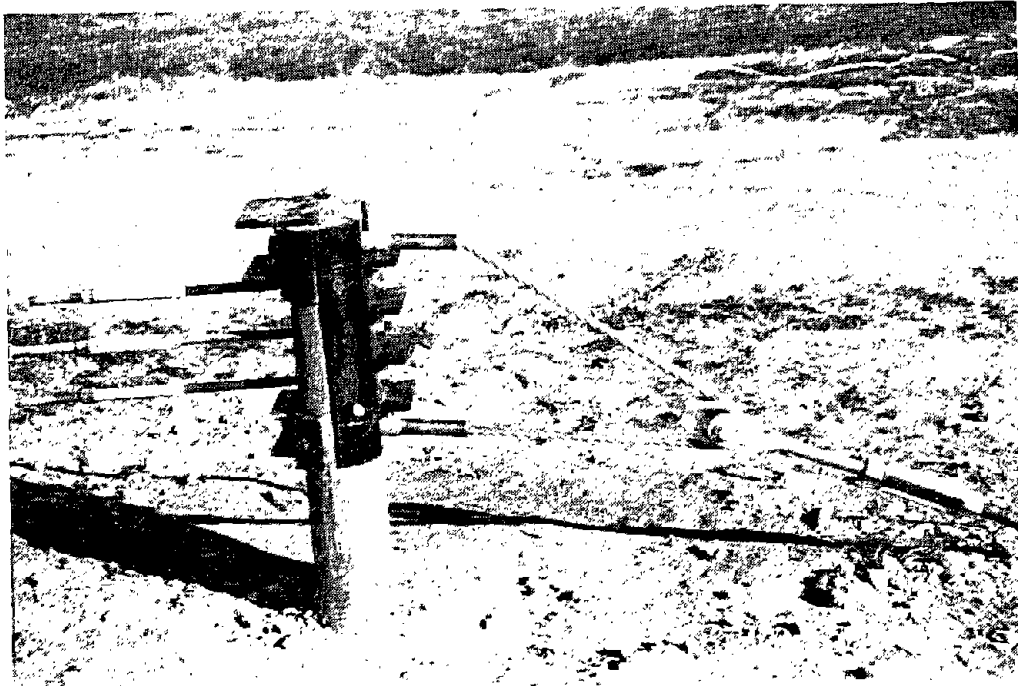
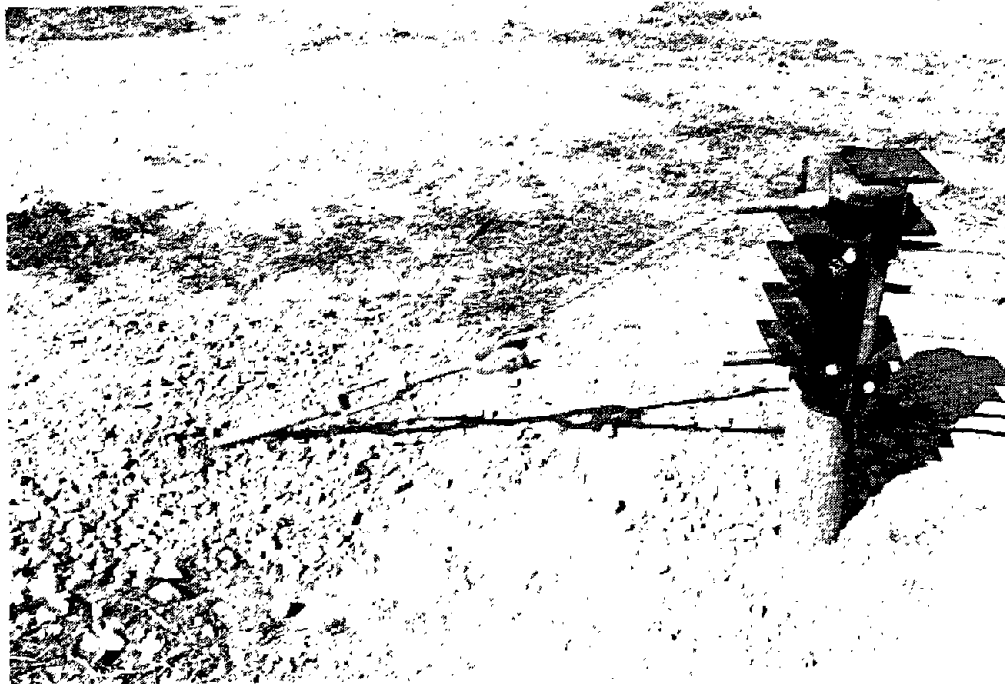
Figure 12. Final modification to Minnesota 3-cable terminal.

Based on these tests, the original plates attached to a single post may work, but the vertical post strength is not adequate. The redesign, which uses two posts, improves this but adds three large steel brackets to the design to span between the posts. During the final test, the improved design caused the vehicle to roll over, the same results as the original design.

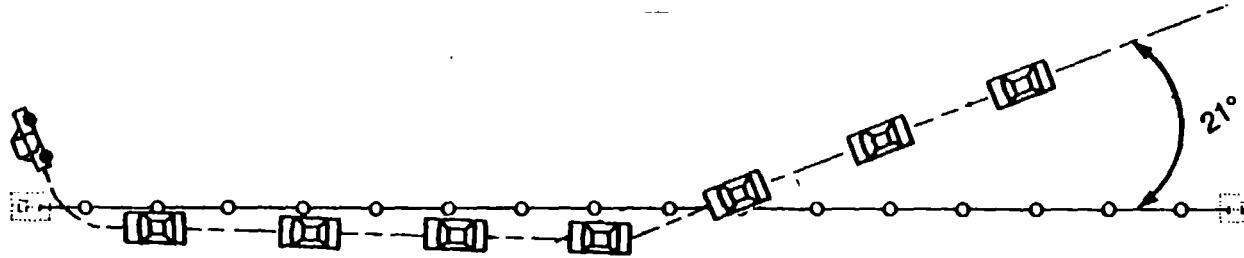
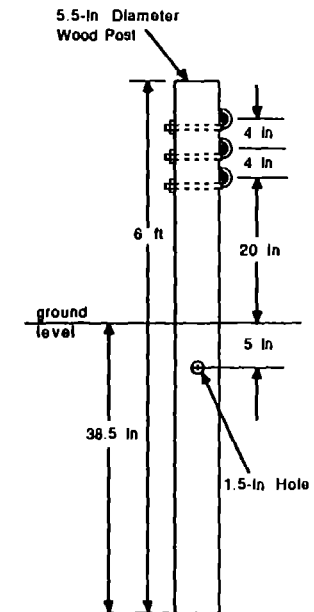
Figure 22. Test summary, test 1769-C-1-87.

The vehicle penetrated into the rail approximately 66 in. The posts near the impact area were snapped off, breaking through the hole located below ground, due to the loads caused by cable deflection. The downstream end post began to break and

the foundation began to move 0.25 seconds after impact. The vehicle continued downstream, rubbing along the cable and breaking off posts. Approximately 30 ft from the end post, the vehicle ran over the broken off post sections, causing the vehicle to steer to the left. The car contacted the end post 1.5 seconds after impact. The tie rod and turnbuckle assembly slid over the bumper, with the lower sections of the tie rod catching the bumper, which caused the vehicle to yaw counter-clockwise after which it rolled. The car came to rest on the passenger side perpendicular to the rail. A summary of the test conditions and results are given in figure 22.

14. Test Results Conclusion: Smooth redirection over length of need section. However, test fails due to vehicle rollover.

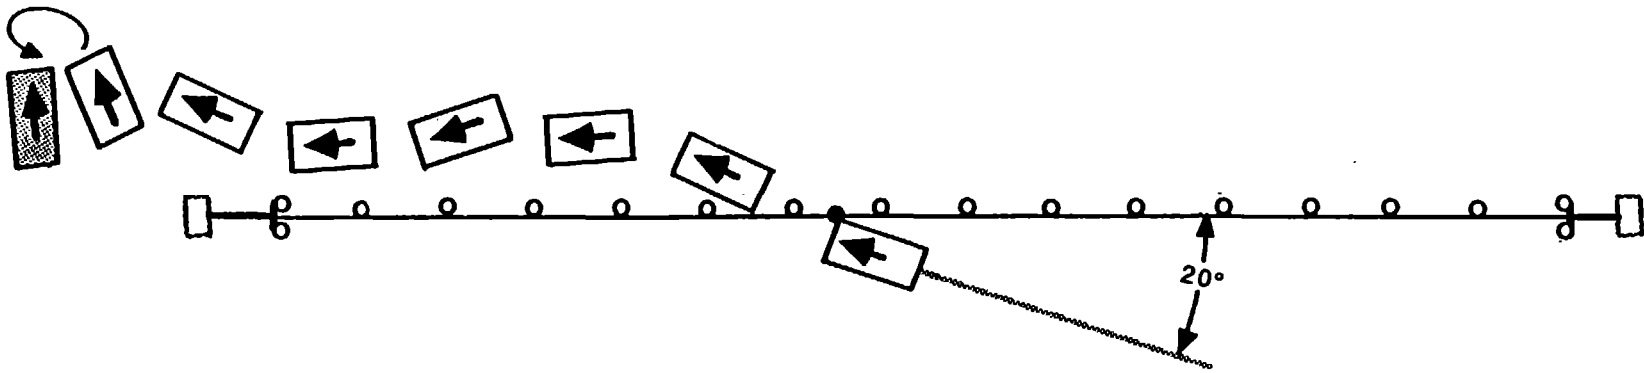
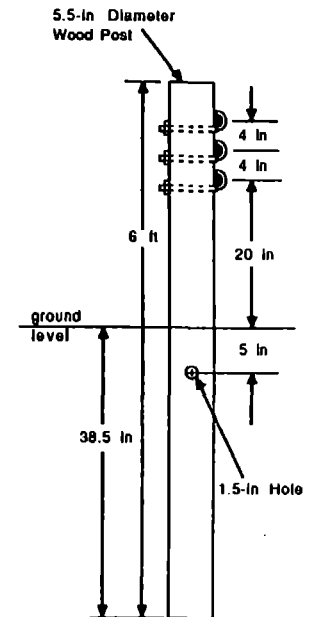
Figure 29. Test summary, test 1769-C-2-87.

As the vehicle penetrated into the rail it began to redirect slightly. At approximately 0.220 s, the upstream end post broke allowing the cable rail to become detached from the anchor block. With the loss of rail tension, there was no capability for the rail to redirect the test vehicle. The vehicle continued in almost a straight line through the rail system into the field side. Some of the cables were tangled with the vehicle causing it to be captured with a final result of the vehicle rolling over approximately 200 ft past the impact point. A summary of the test conditions and results are given in figure 29.

Review of the high-speed photography of the upstream end post indicate the post assembly failed due to the top bracket breaking away. This bracket attaches the anchor rod to the post. Failure seemed to occur when the bracket rotated up and over the top of the post.

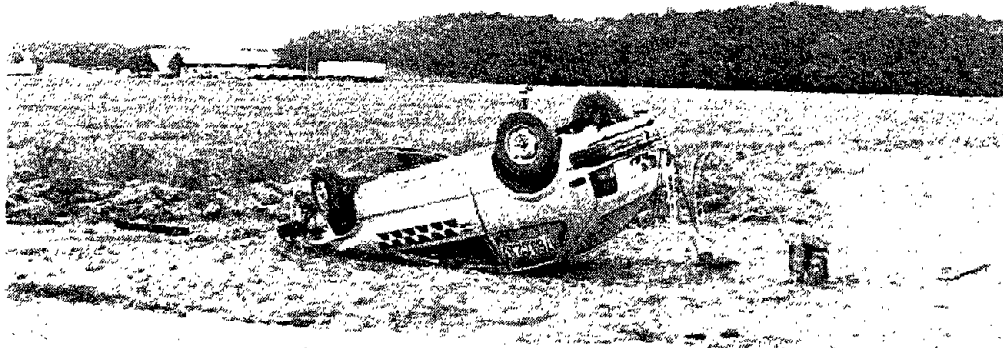
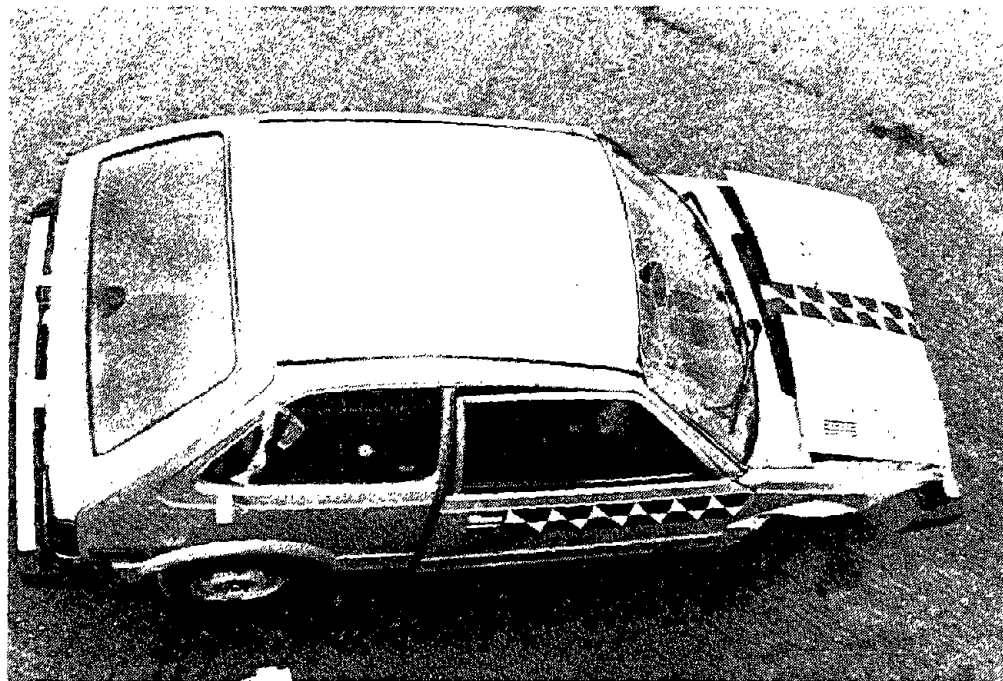
Figure 31. Posttest photographs of test vehicle,
test 1769-C-2-87.

Almost all of the right side of the vehicle was damaged, but damage occurred mainly to the right front fender, grill and bumper. Some top damage occurred after the vehicle rolled on its roof. Posttest photographs of the vehicle are shown in figure 31.

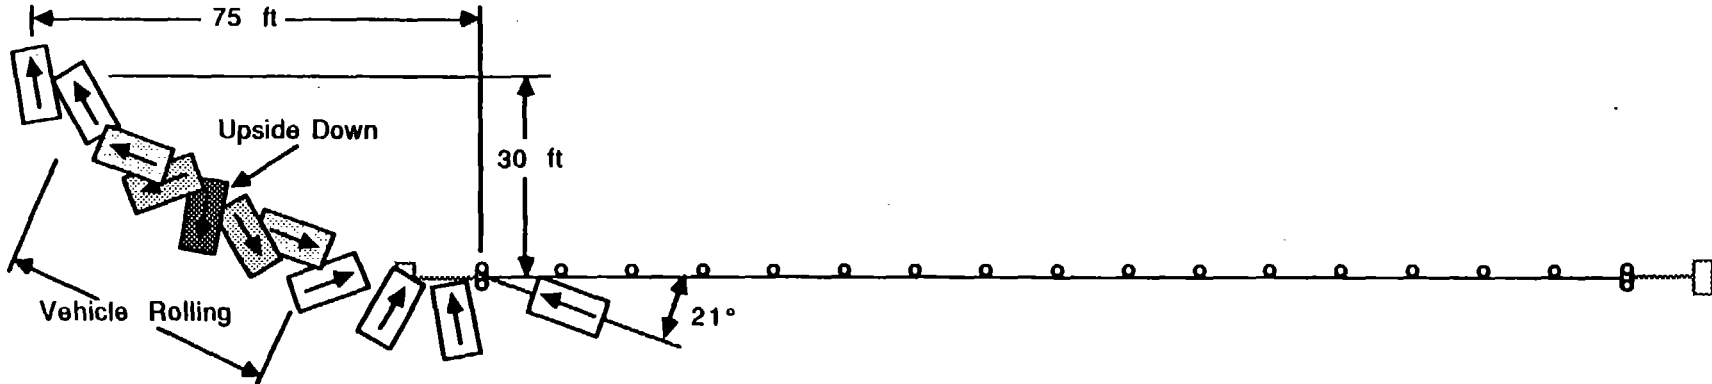
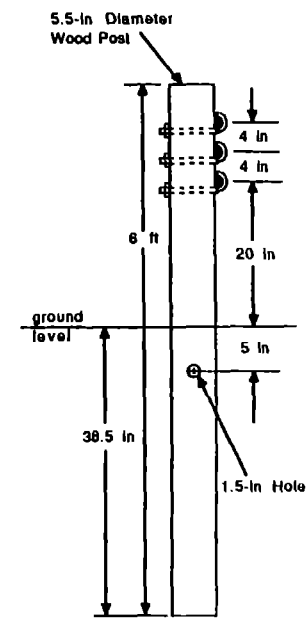
Figure 50. Test summary, test 1769-C-5-88.

14. Test Results Conclusion: (evaluated for NCHRP 230 test S13)
 Vehicle rolled over after yawing. Integrity of the passenger compartment was not maintained due to rollover. Detached elements showed potential for penetrating passenger compartment.
