**Federal Highway  
Administration**

Publication No. FHWA-RD-88-269

July 1989

# SALT PENETRATION AND CORROSION IN PRESTRESSED CONCRETE MEMBERS

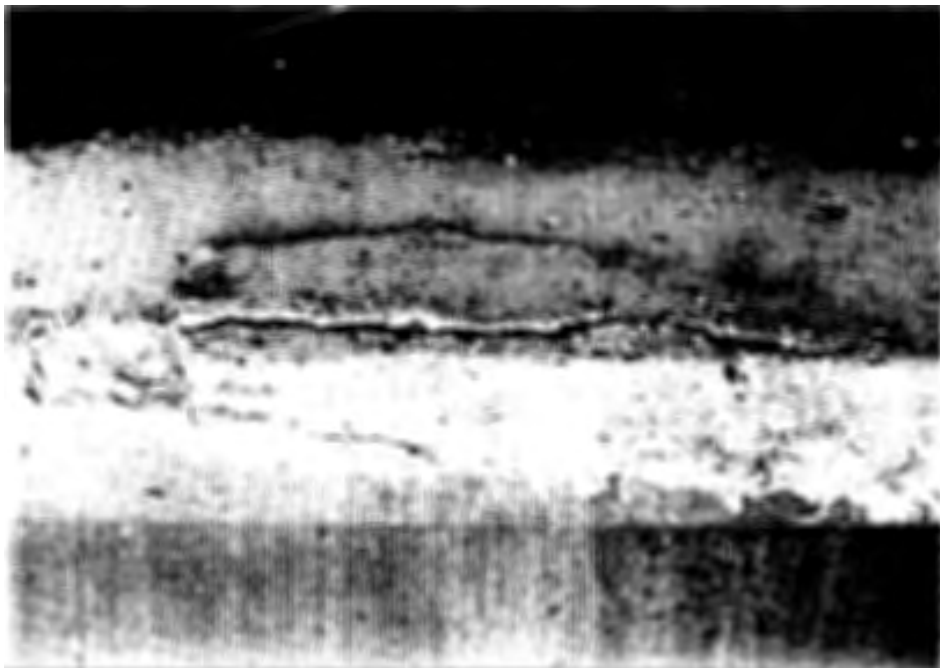
Figure 5. Severe cracking of concrete cover in Girder 3, Span 4.

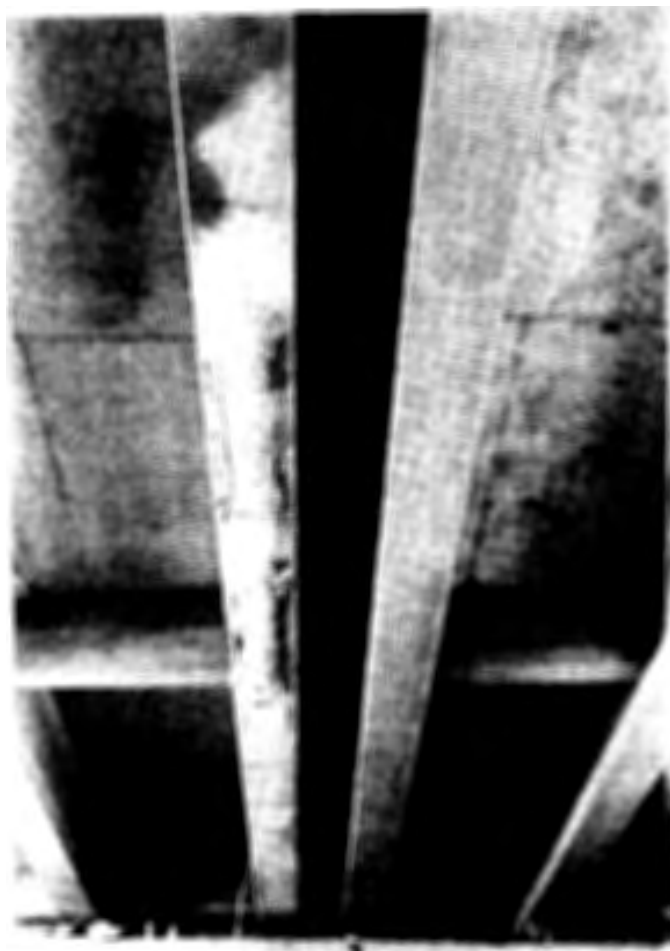
Figure 6. Spalling of concrete cover in Girder 3, Span 4.

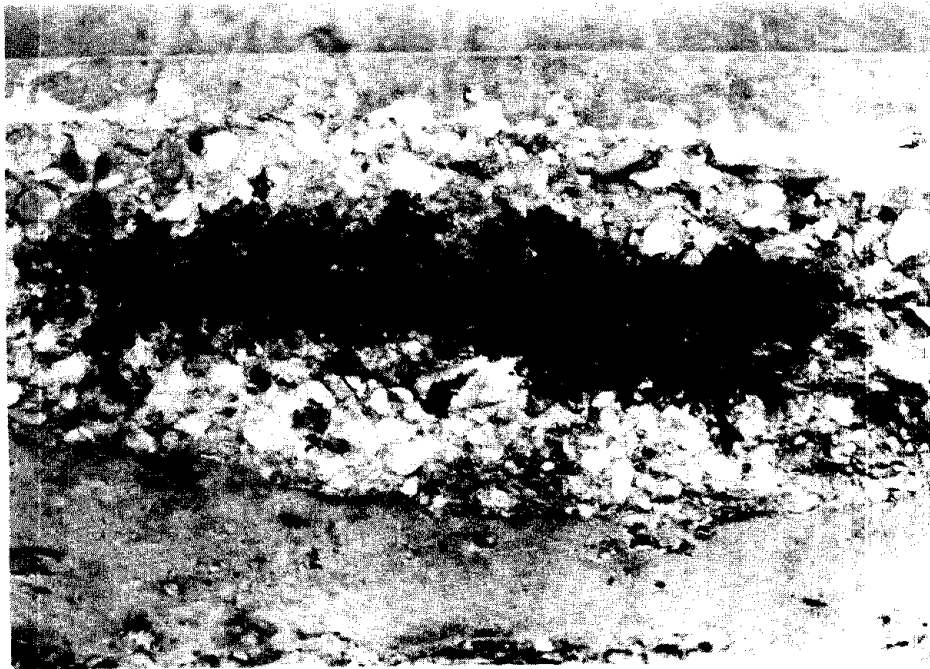
Figure 8. Severely corroded strand on the north side of Girder 3, Span 4.

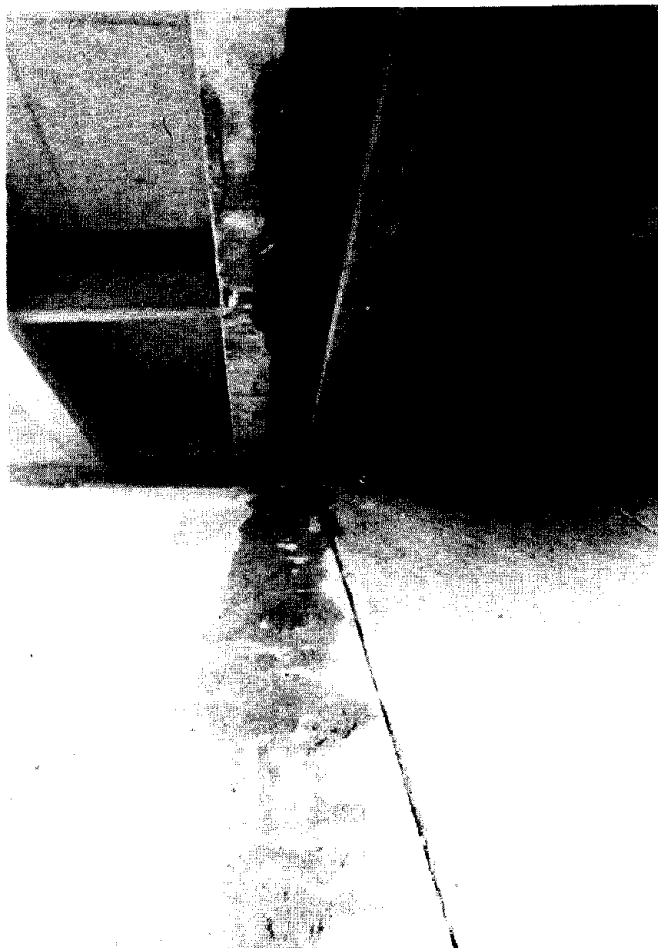
Figure 11. Wet spots under  
the bridge in Span 4.

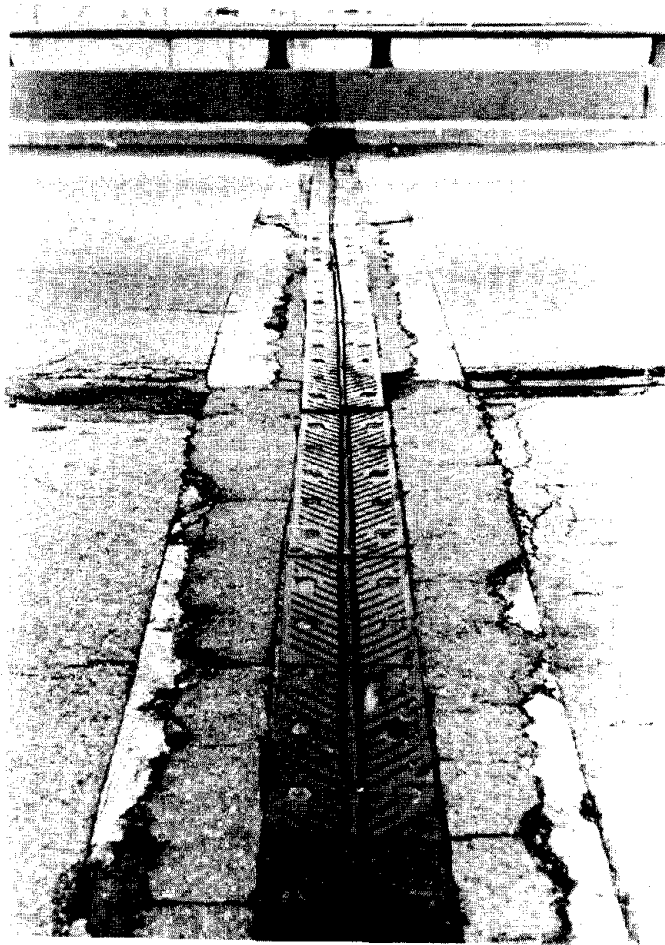
Figure 13. Badly deteriorated  
transverse expansion joint.

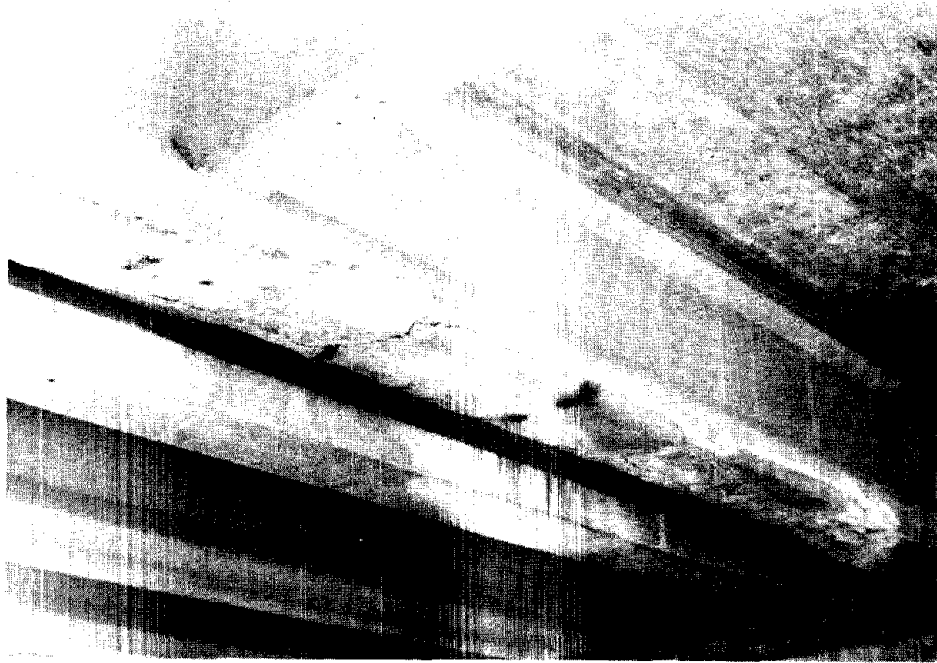
the presence of cracks, and rust stains of rust (figure 14), apparently caused by corrosion of prestressing strands due to chloride-laden water penetrating through the loose bond between the patch and the beam and also through the shotcrete. The patterns of deterioration in this girder resembled those in Girder 3 of Span 4, in the bridge carrying westbound traffic. It is believed that the cause of deteriorations in both cases was the same.

Figure 14. Cracks and stains of rust in the shotcrete patch.

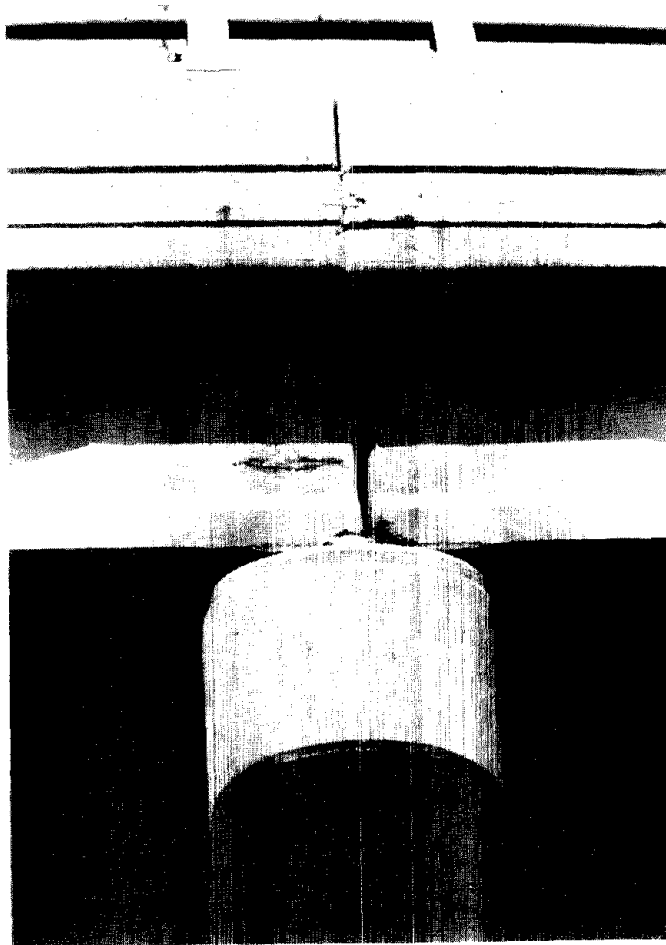
Figure 16. Spalling of concrete cover over corroded stirrups.

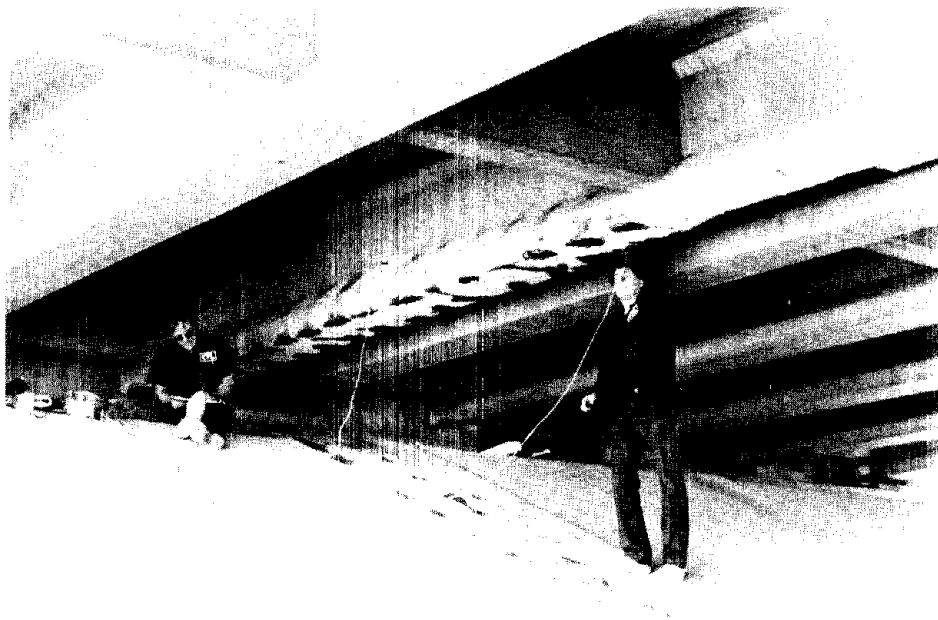
The amount of readings more negative than -0.35 V in Girder 4 is very low, only about 3 percent. The presence of these readings in Girder 4 is not unusual, since it is also adjacent to the leaking longitudinal joint. Therefore, there may be a 90 percent probability that corrosion activity had occurred in this Girder, but on a very limited scale. The approximate location of corrosion activity is on the north side of the girder (adjacent to the leaking joint) at about 27 to 29 ft (8.2 to 8.8 m) from the east end of the girder, where some delamination of concrete cover due to corrosion of stirrups was reported.

Figure 22. Potential survey of  
Girder 3 in Span 4.

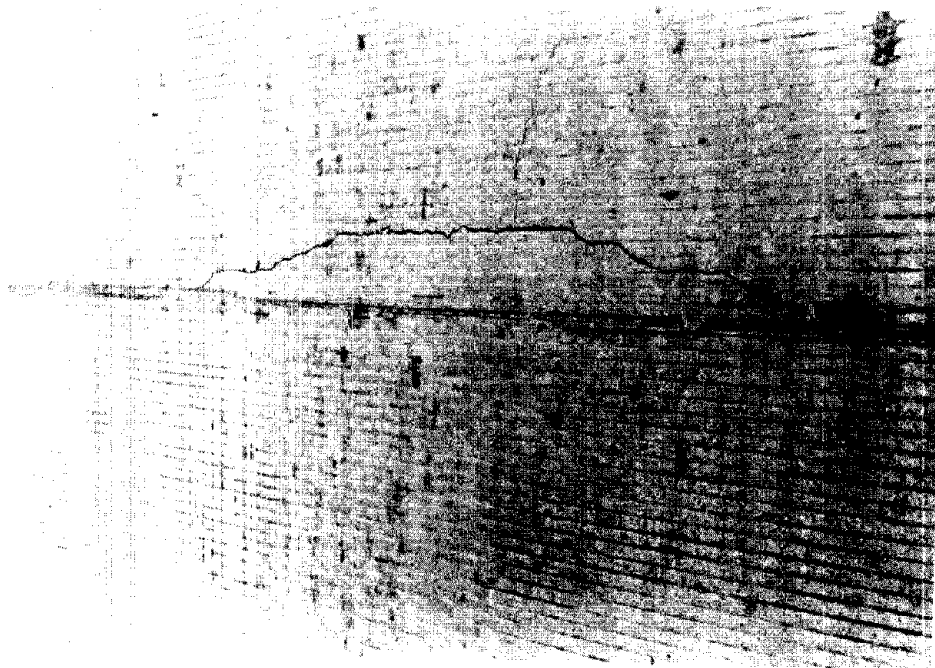
Figure 31. Cracking of concrete overlay in areas adjacent to expansion/contraction joints.

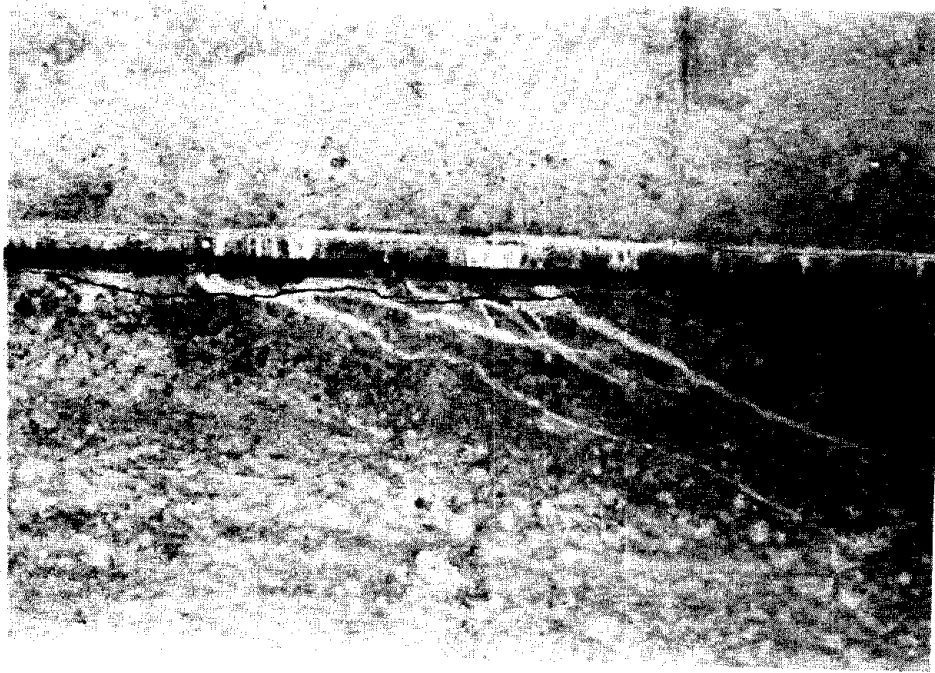
Figure 32. Typical crack caused by corrosion of a prestressing strand.

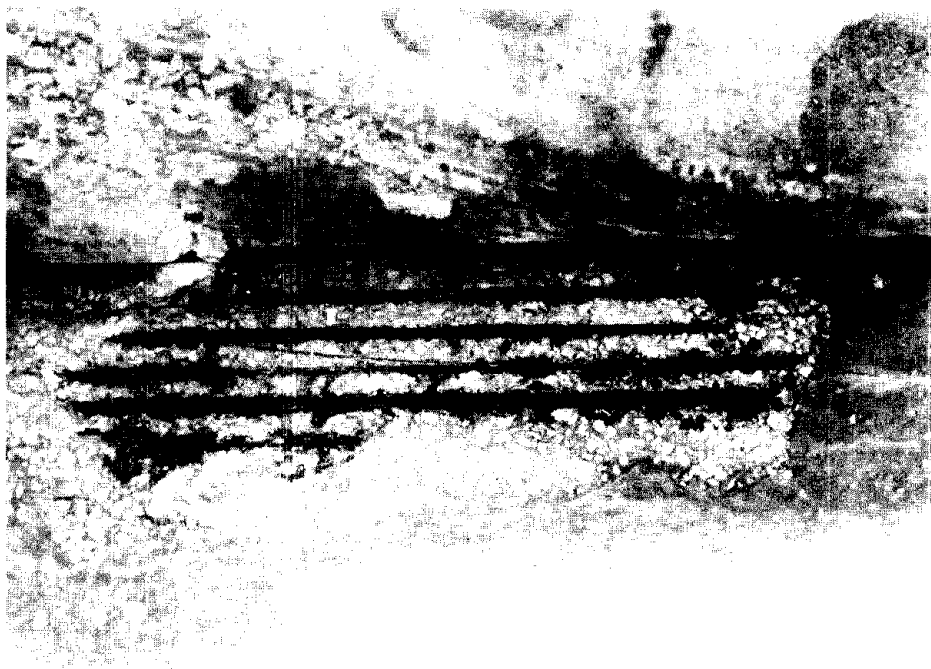
Figure 34. Very severe spalling of concrete cover over several prestressing strands.

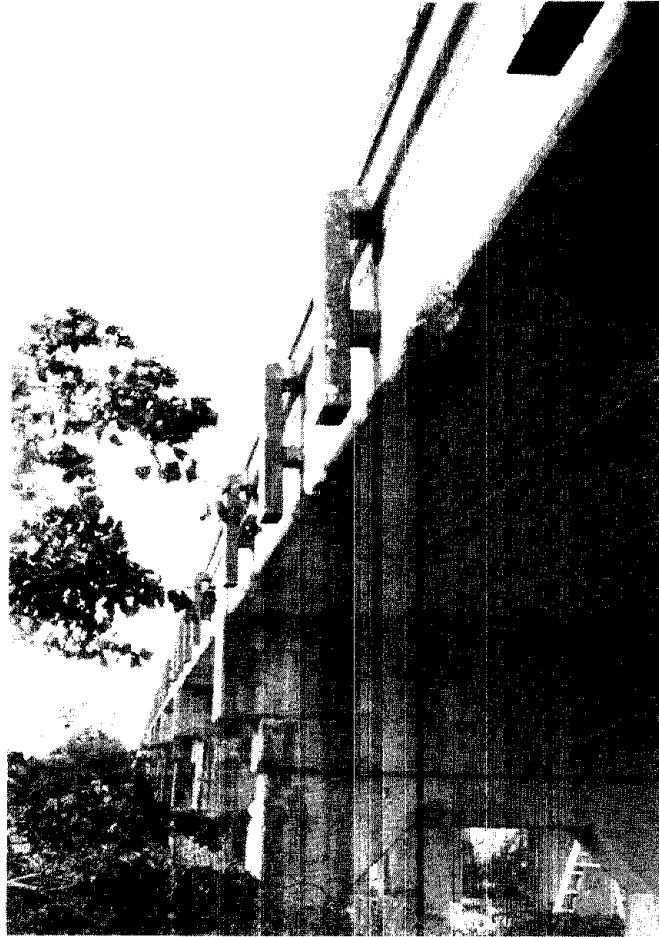
Figure 36. Corrosion related spalling of concrete cover due to water running along the side of a girder.

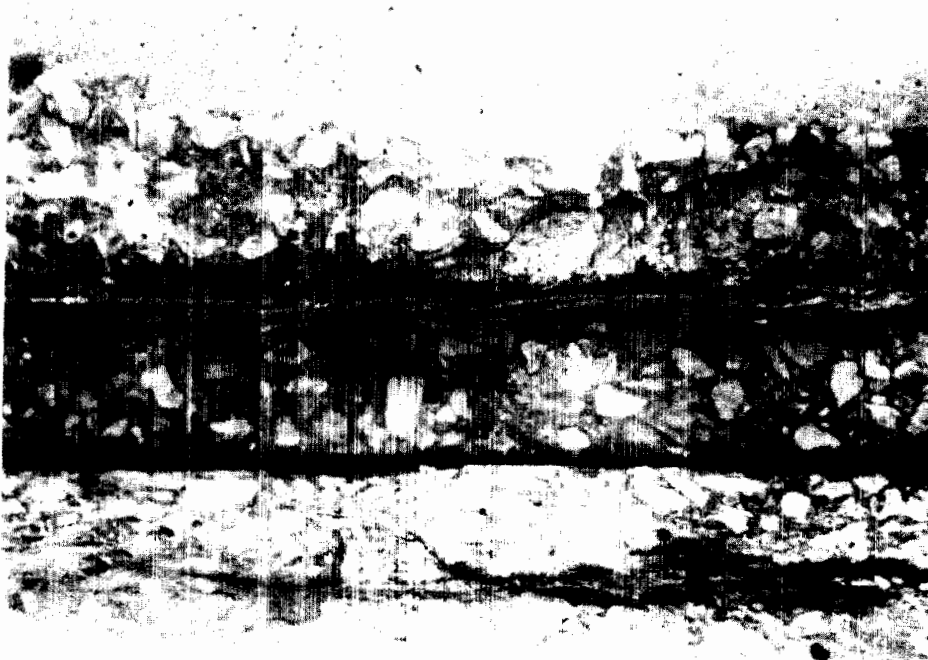
Figure 38. Failure in all six wires surrounding a central wire.

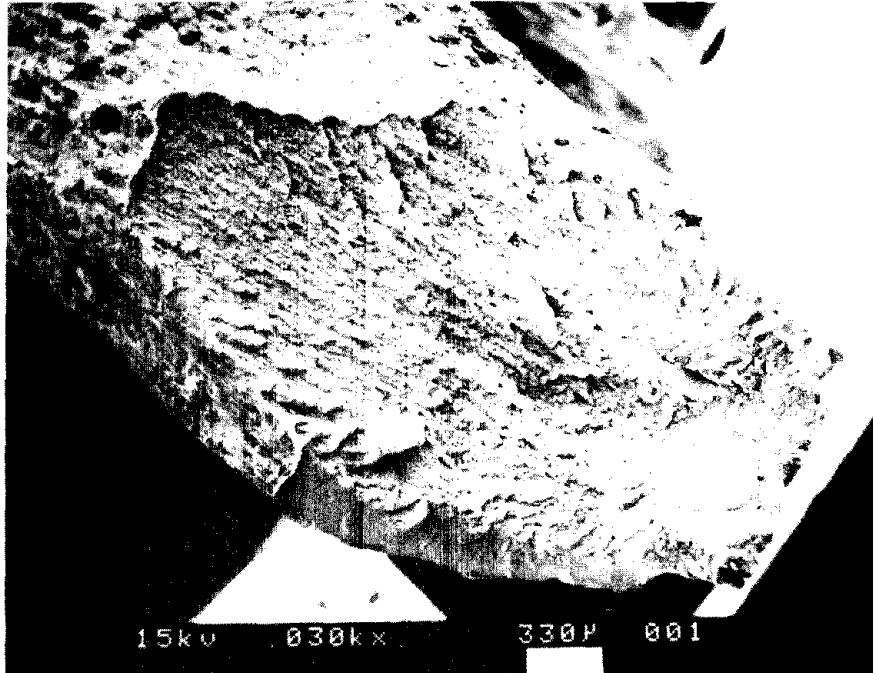
Figure 51. The fractured end of one of the sample wires. (Magnification: 30X.)

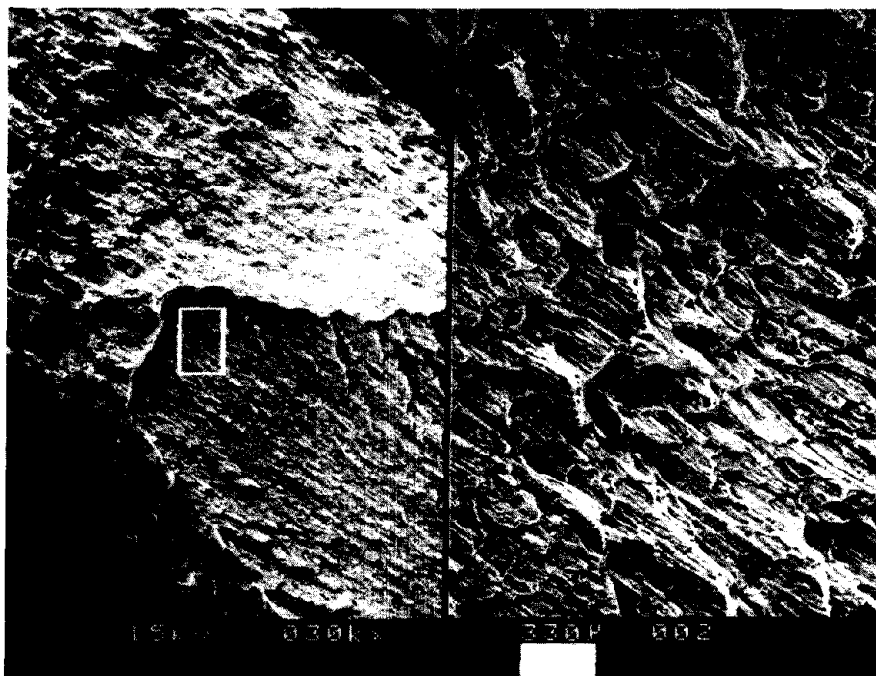
Figure 52. Fractured area of a wire at a magnification of 30X (left) and 300X (right).

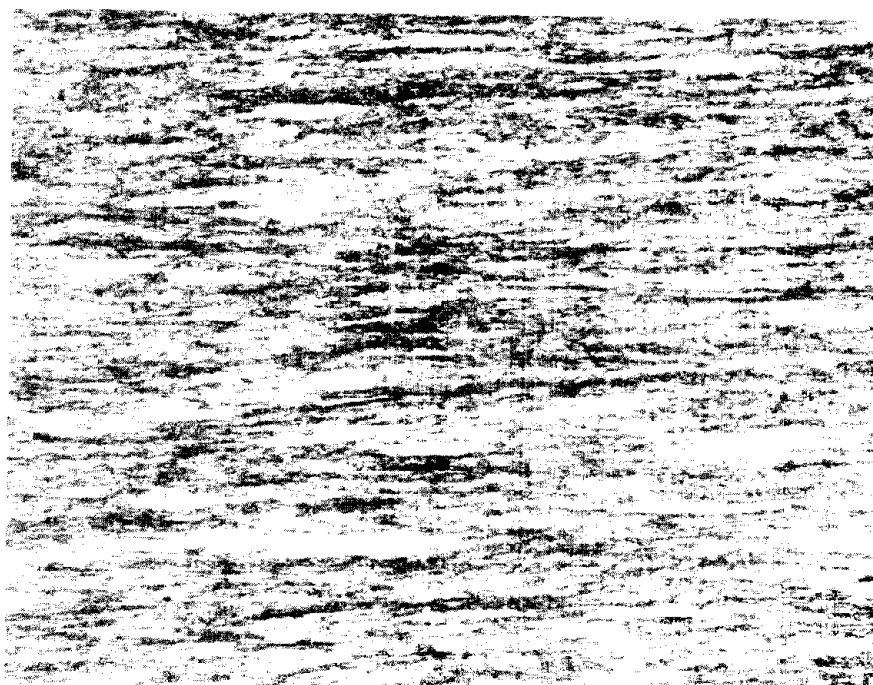
Figure 53. A typical example of the heavily cold-worked microstructure exhibited near the cut end of a wire.  
(Magnification: 200X. Etchant: 1% Nital.)

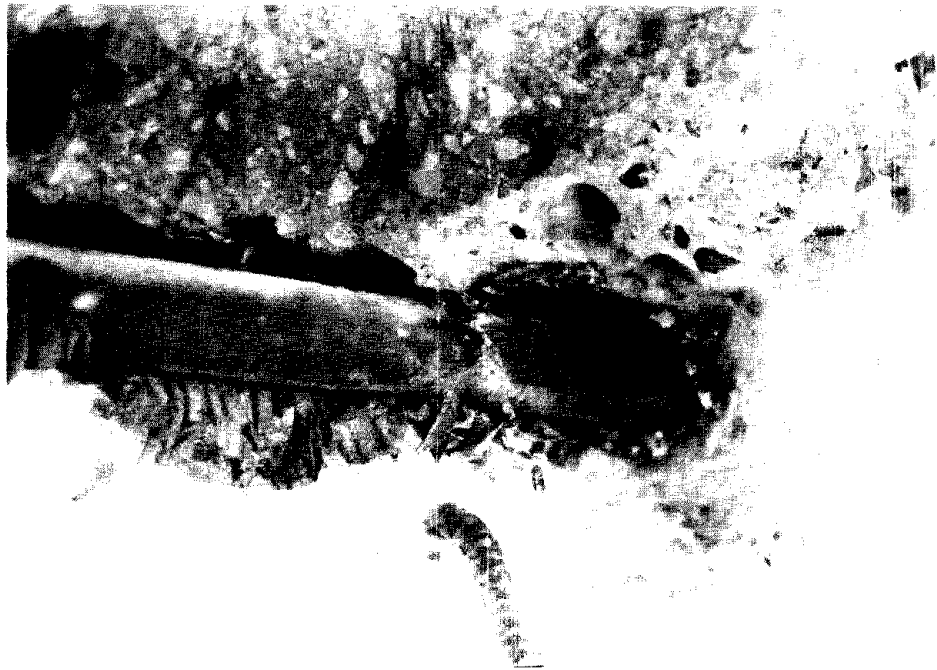
Figure 61. Extent of corrosion on the newly exposed surface of the rod in Girder 3.

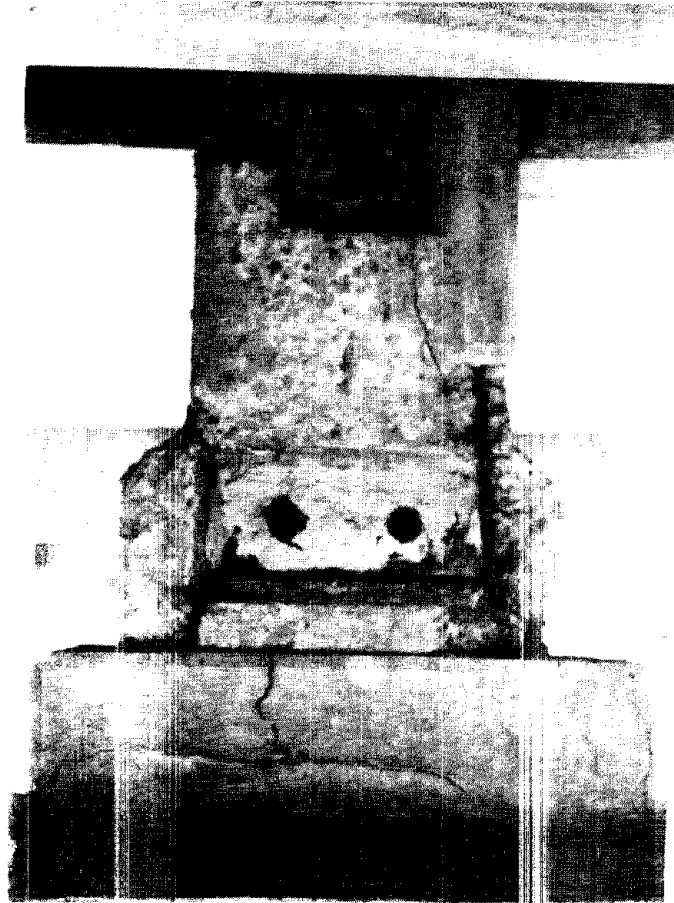
Figure 68. Spalling of the mortar cover over anchor steel plates.

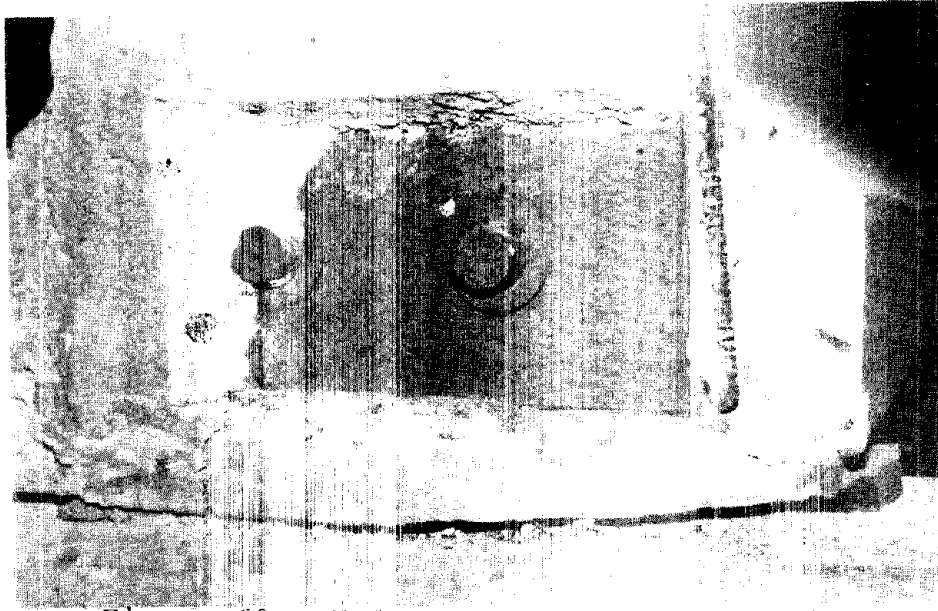
Figure 69. Moderate to severe corrosion of a steel plate.

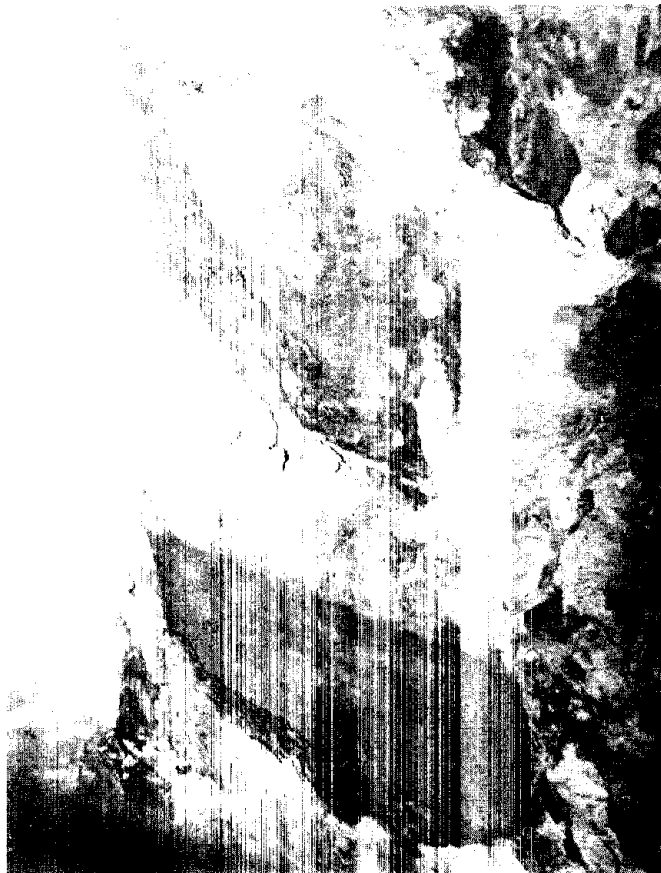
Figure 70. Very severe corrosion of an anchor plate.

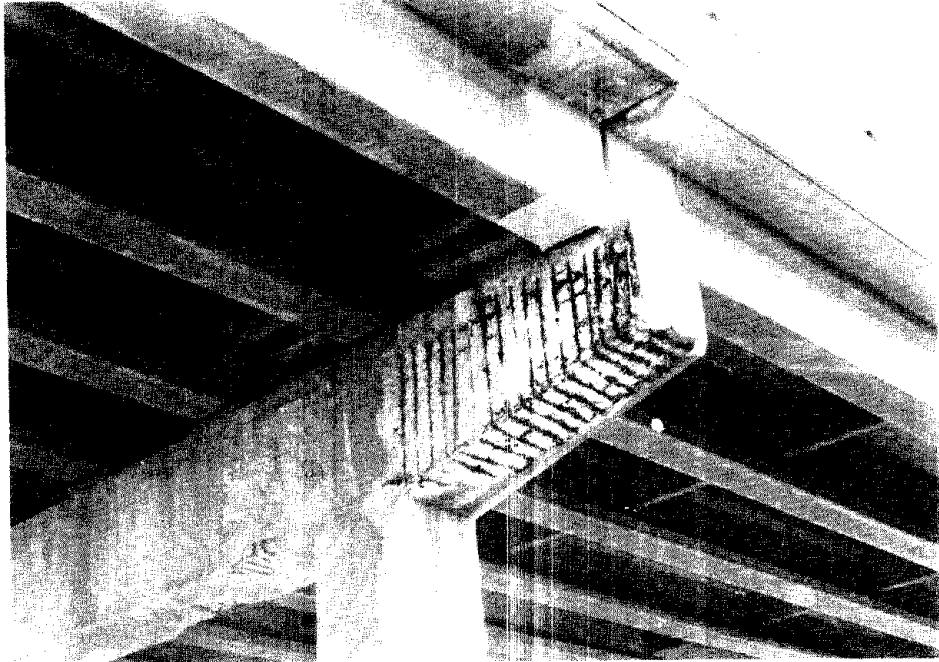
Figure 75. Corrosion-related deterioration of concrete in a pier cap.

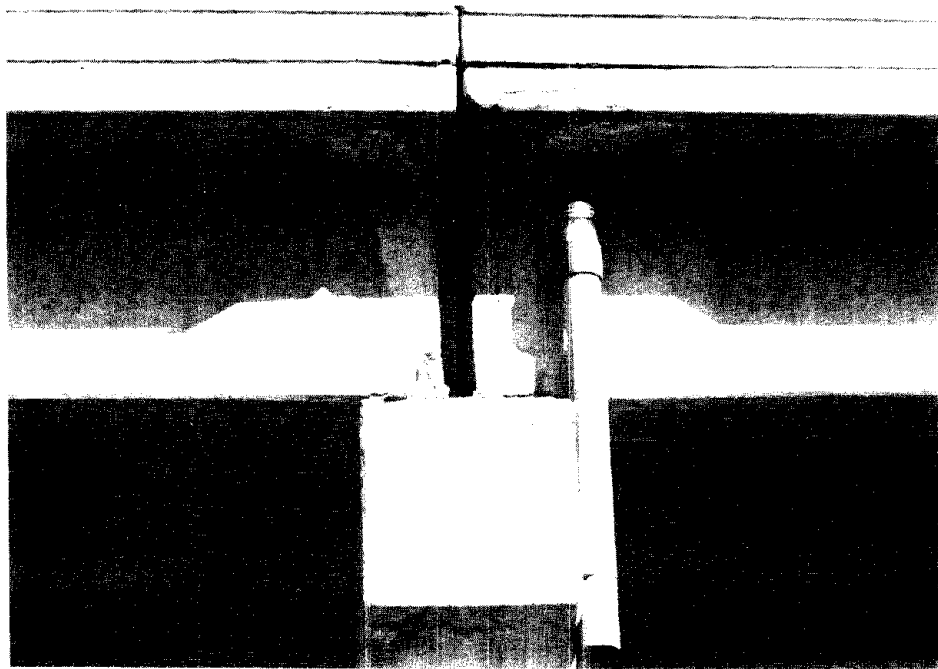
Figure 76. Remaining short vertical portion of a drain pipe.

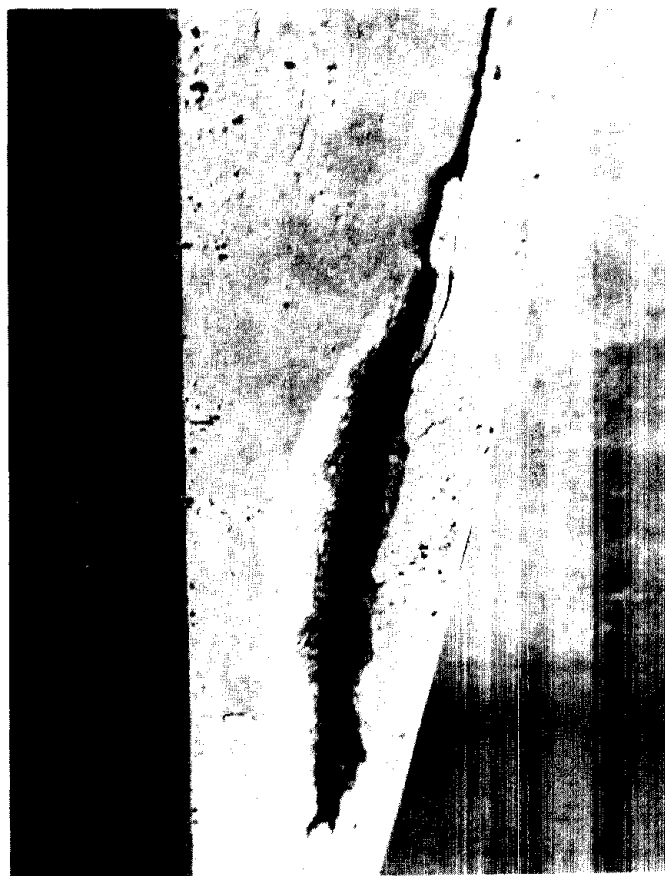
Figure 88. Spalling of concrete cover over the bottom tendon.

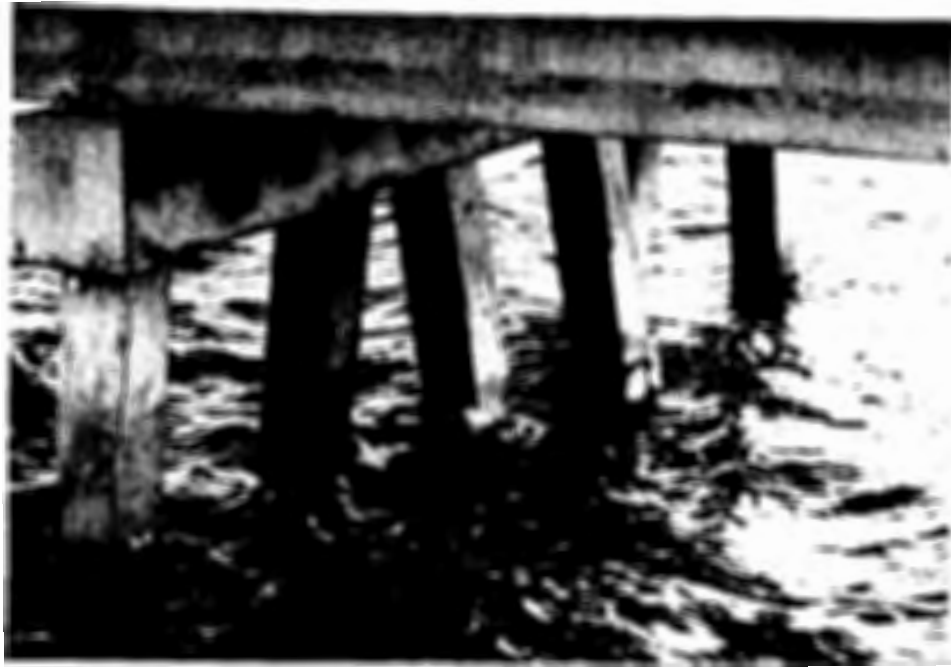
Figure 91. Cracks in prestressed piles of out-of-service Sunshine Skyway Bridge

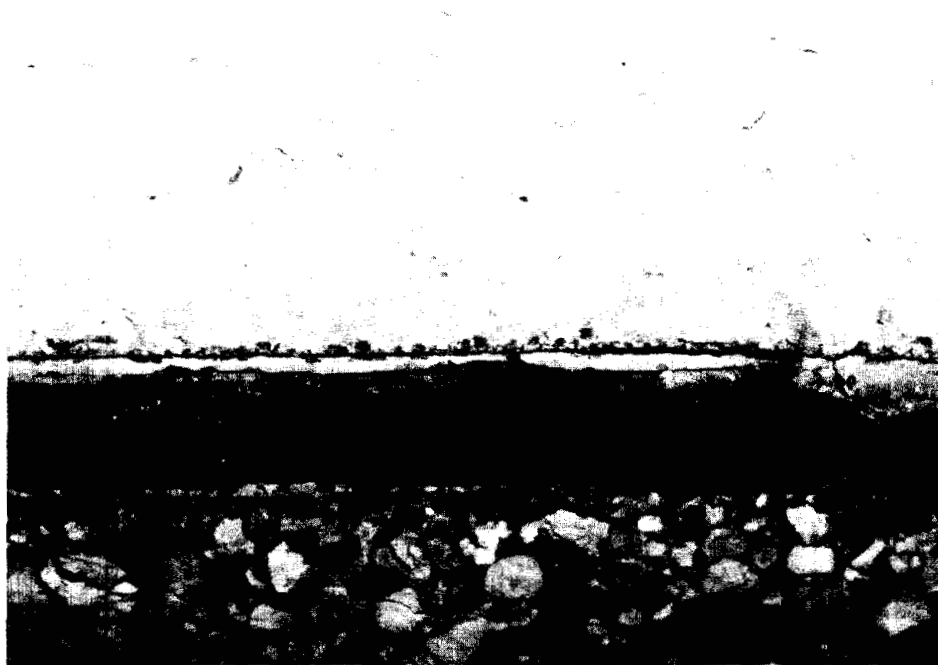
Figure 92. Moderate surface type corrosion.

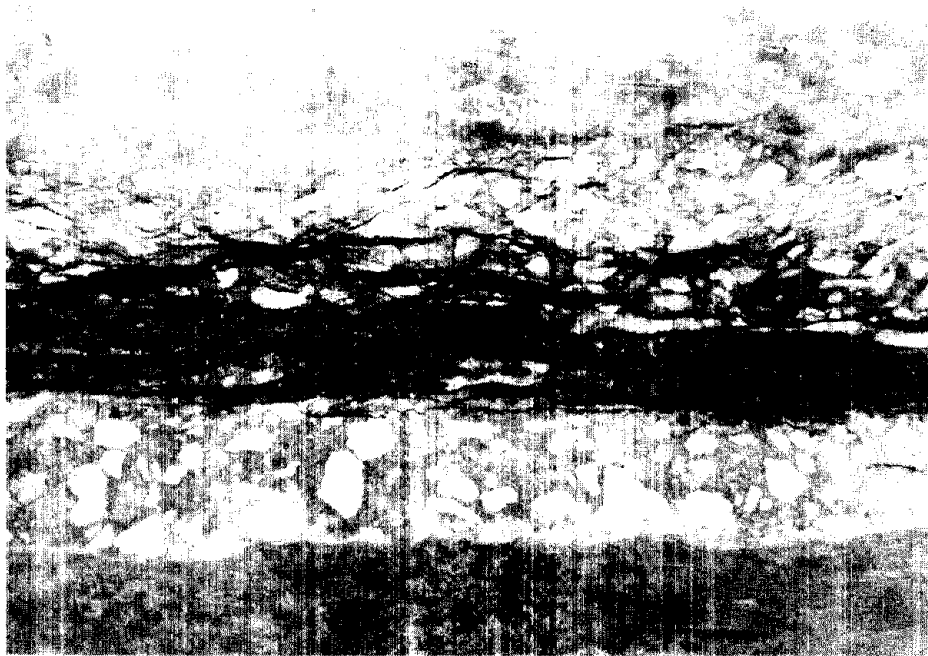
Figure 93. Very severe extent of corrosion of the prestressing rod.

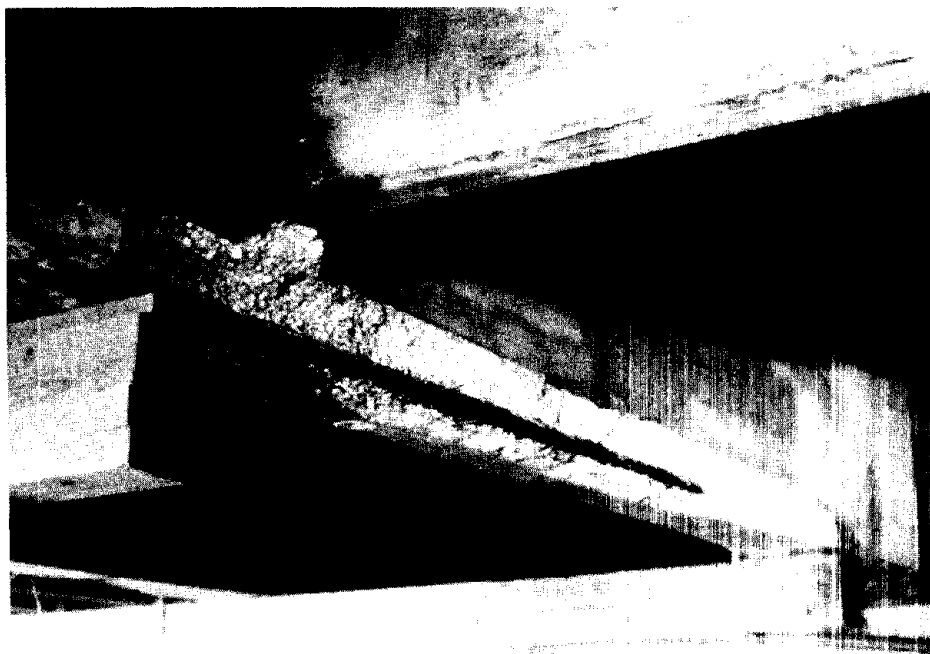
Figure 94. Severe corrosion of the prestressing rod in Beam 2, Span 274.

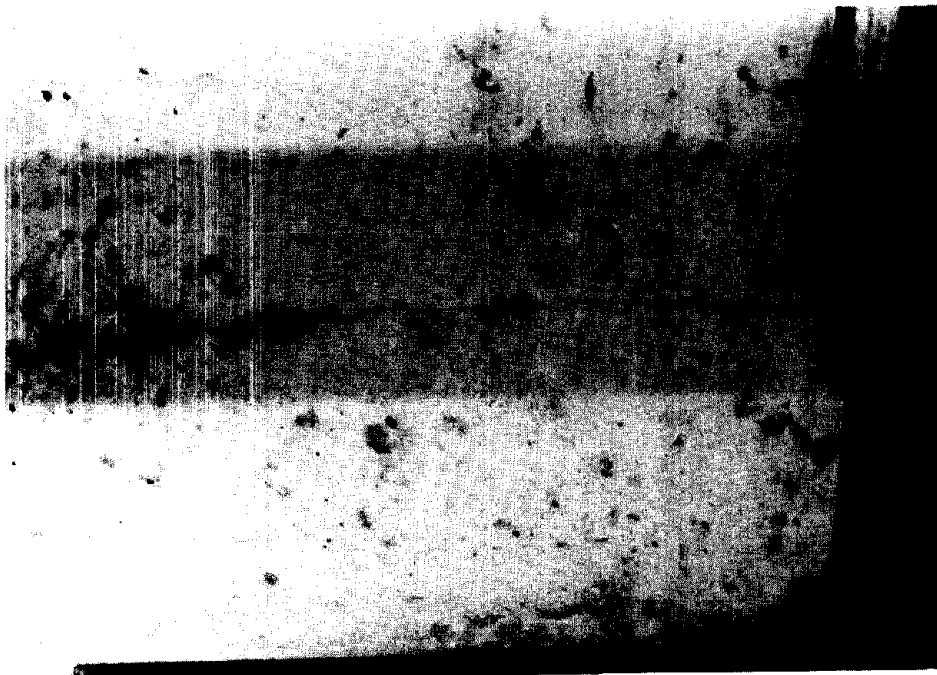
Figure 105. Crack in concrete cover above  
a top row of prestressing strands.

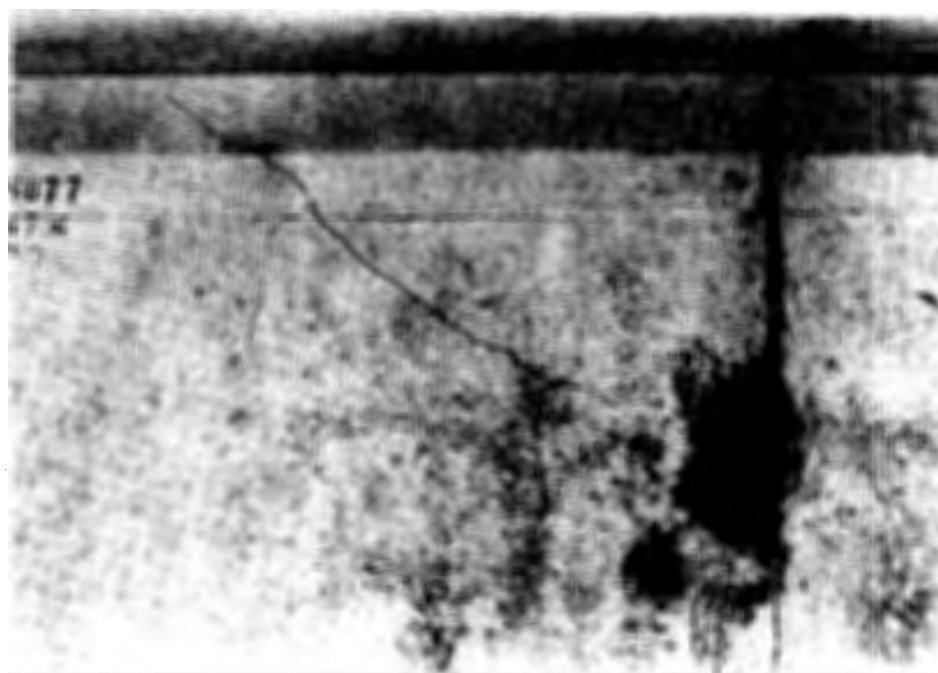
Figure 107. Severe concrete cracking inside segmental boxes.

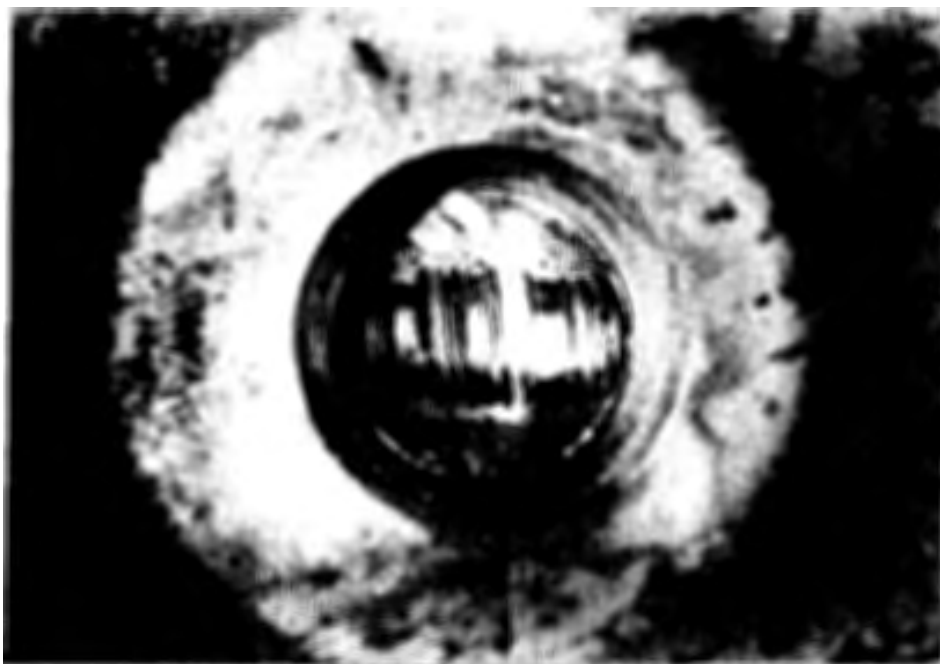
Figure 112. Condition of the sheathing  
in the bottom ducts.

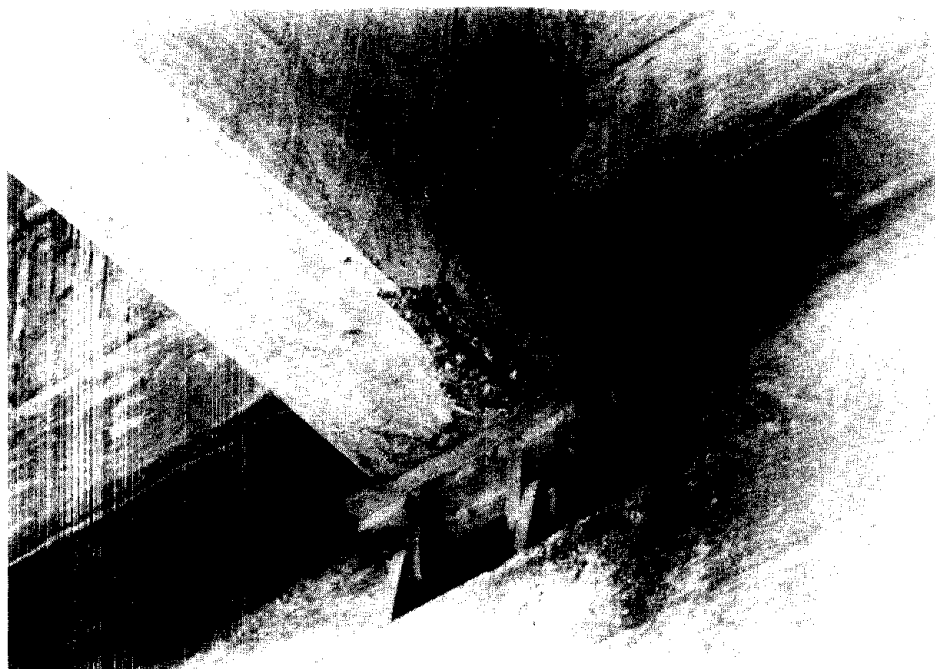
Concrete cover over conventional steel bars at the end of a girder, determined on three sides of the girder varied from 0.75 to 1.5 in (19.1 to 38.1 mm). Concrete cover over prestressed tendons was in the range of 2.25 to 3.5 in (57.2 to 88.9 mm). There was no delamination of concrete over conventional steel bars or over prestressing tendons. In general, concrete cover in prestressed girders appeared to be adequate.

Figure 118. Spalling of concrete cover over conventional reinforcing steel bars.
