RETROFIT RAILINGS FOR NARROW THROUGH TRUSS AND OTHER OBSOLETE BRIDGE

Research, Development,
and Technology

Report No.
FHWA/RD-82/099

Final Report
November 1986

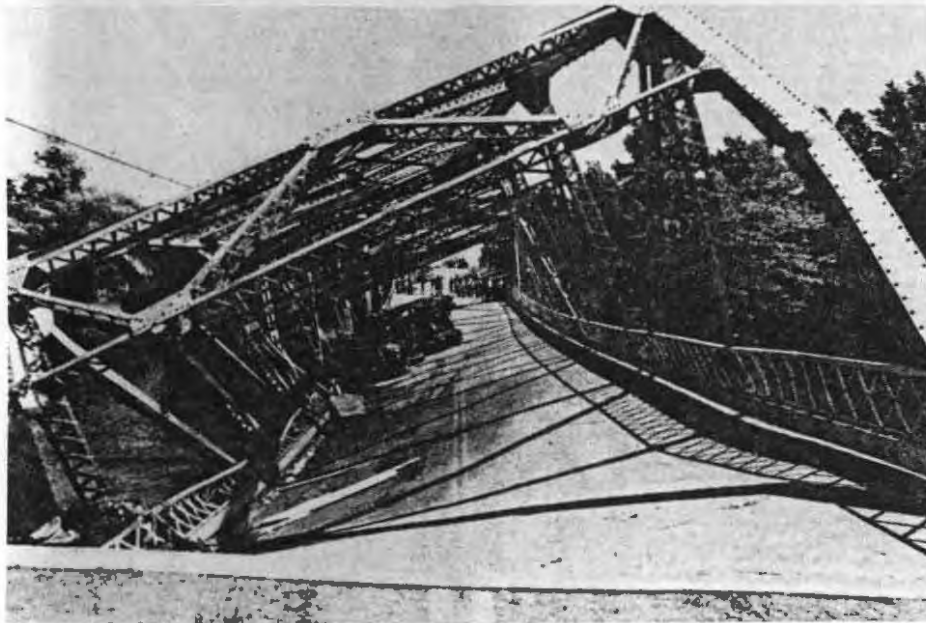
(a) Truck Collision in West Virginia

Truck ramming downs bridge

Truss bridge damaged beyond repair by truck accident will be replaced with new crossing.

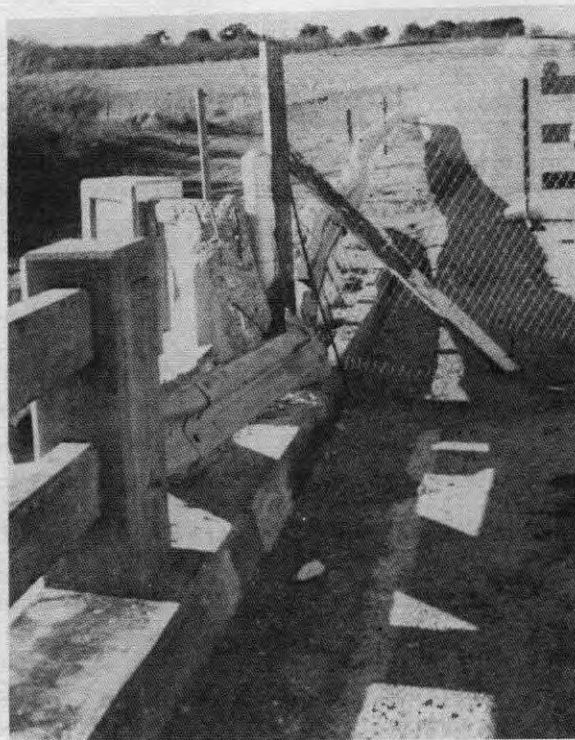
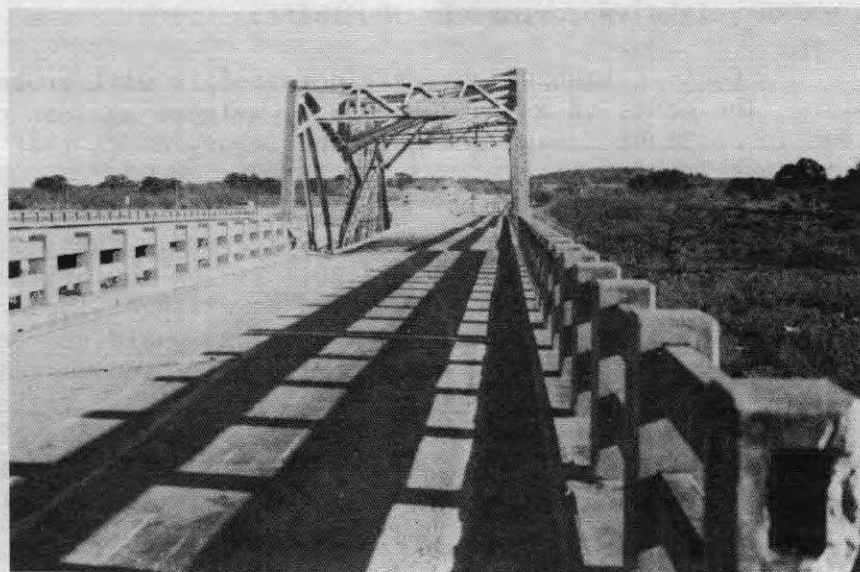
FIGURE 3. BEAVER CREEK BRIDGE (TX)

Limited Space. The clear horizontal widths on most of these bridges are substandard. For example, Figures 3, 4, and 5 show the Beaver Creek Bridge in Texas and the Yadkin River Bridge in North Carolina, both of which were irreparably damaged by vehicle impacts. Flanges of the steel channel bridge rails of Figures 3 and 4 were notched and meshed with the truss end posts and hangers for attachment. With a clear width of only 11'-2" (3.4m), the wooden railings in Figure 3 were actually butted up against the end posts for attachment.

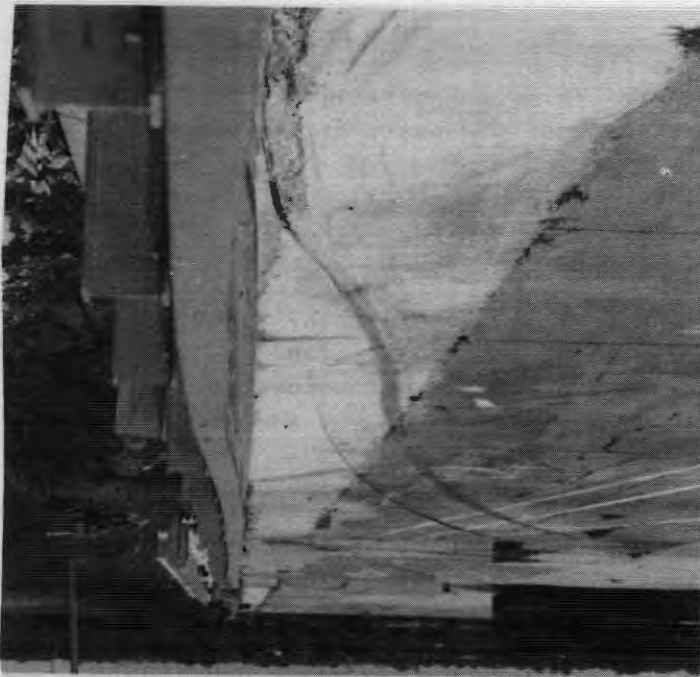
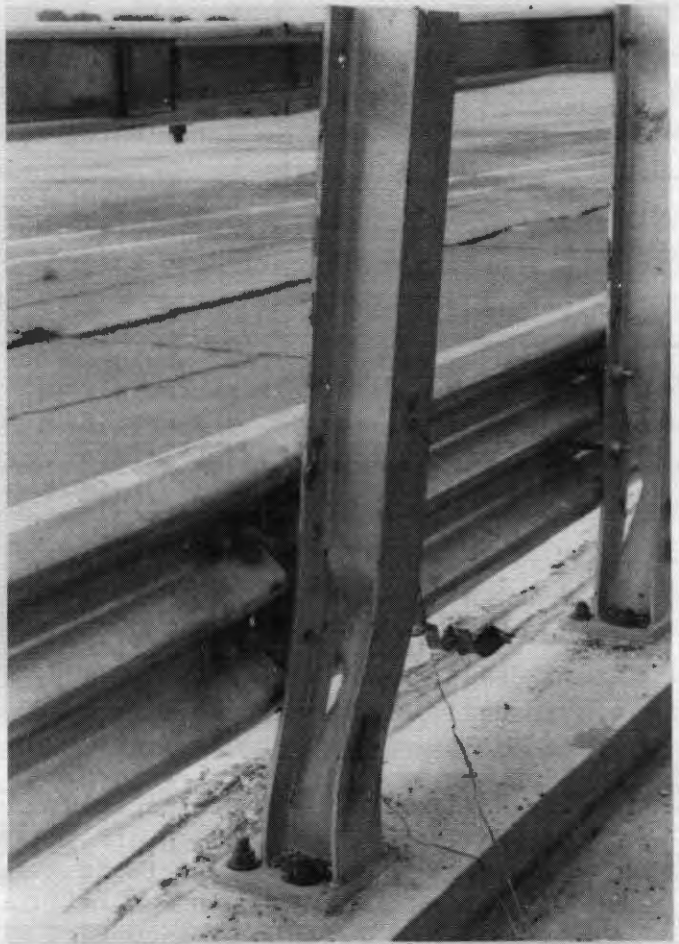
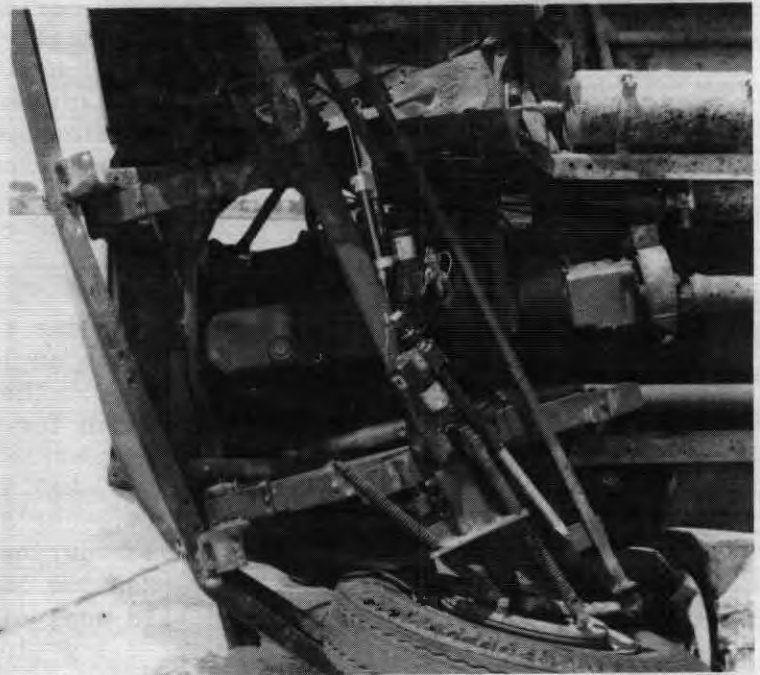
FIGURE 27. PHOTOGRAPHS AFTER TEST TTR-2

Test TTR-2. Notched posts as described in Figure 25 were installed in the impact area for this test; all other details were the same as TTR-1. The 20,000-lb (9070-kg), 72-passenger bus impacted the installation at 56.1 mph (90.3 kmph) and a 17.8-deg angle. As shown in Figure 26, the bus rolled toward the barrier after impact as it was redirected with a maximum roll angle of 12.5 deg. After losing contact with the barrier, the bus began a hard steer to the left due to suspension and linkage failure. The steer angle was too great for the speed and the bus subsequently rolled on the right side.

Post-test examination revealed that the rivets which attach the front spring hanger brackets to the frame were sheared on both sides. This allowed the front axle and springs to rotate (about a vertical axis) as the right front wheel was pushed rearward by the lower rail. This, in turn, caused the steering pitman arm/wheel link connection to fail and the bus front wheels to be turned and locked into a hard left turn position.

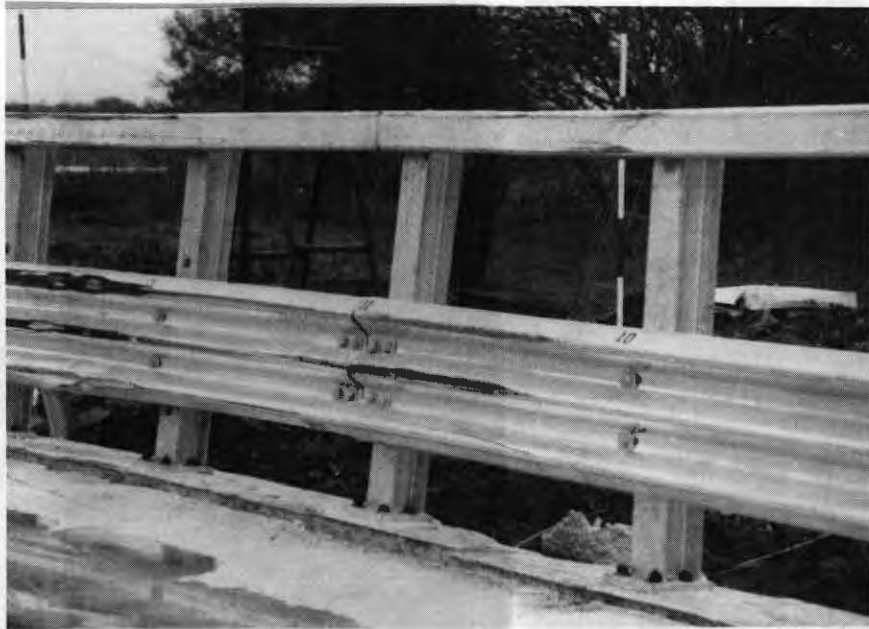
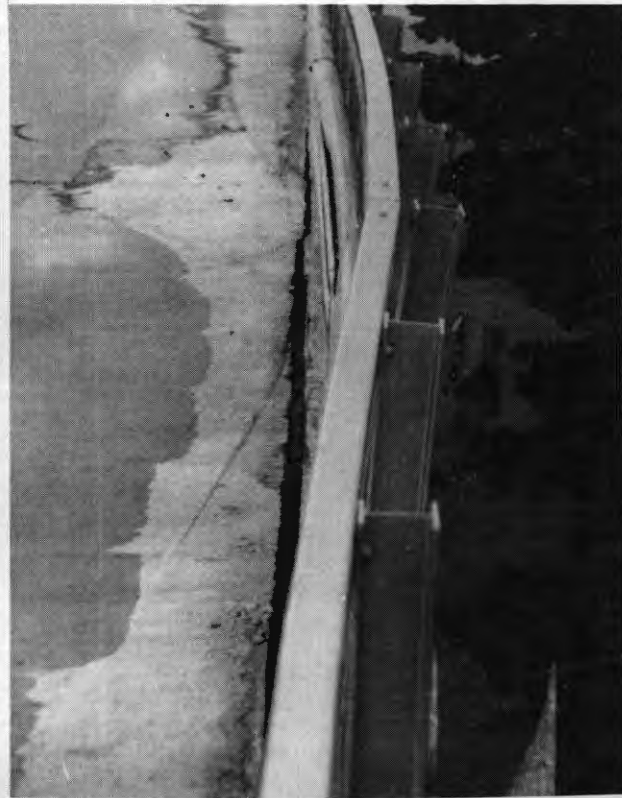
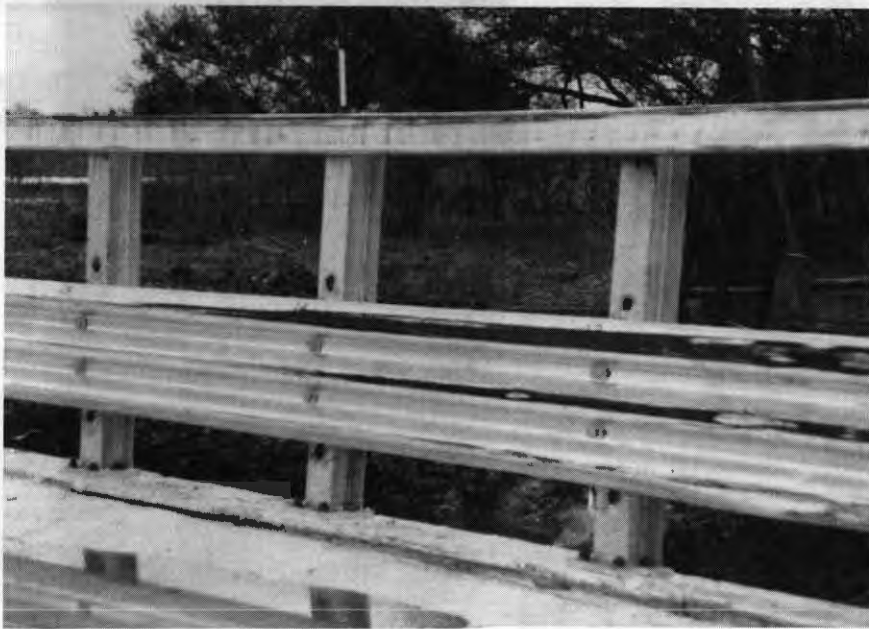
FIGURE 66. TEST TTR-1 BARRIER DAMAGE

ment. However, the concrete foundation on which the posts were mounted proved to be inadequate. Drilled shaft footings proved to be inadequate due to flooding of the soil at the test site; multiple failures were noted in the concrete beam connecting the footings between Posts 8 through 16. Also, these foundation failures permitted more post leaning and barrier deflection than is considered allowable. Reconstruction/strengthening of the foundation was required prior to further testing. Barrier deflections are contained in Table 8, and barrier damage photographs are shown in Figure 66.

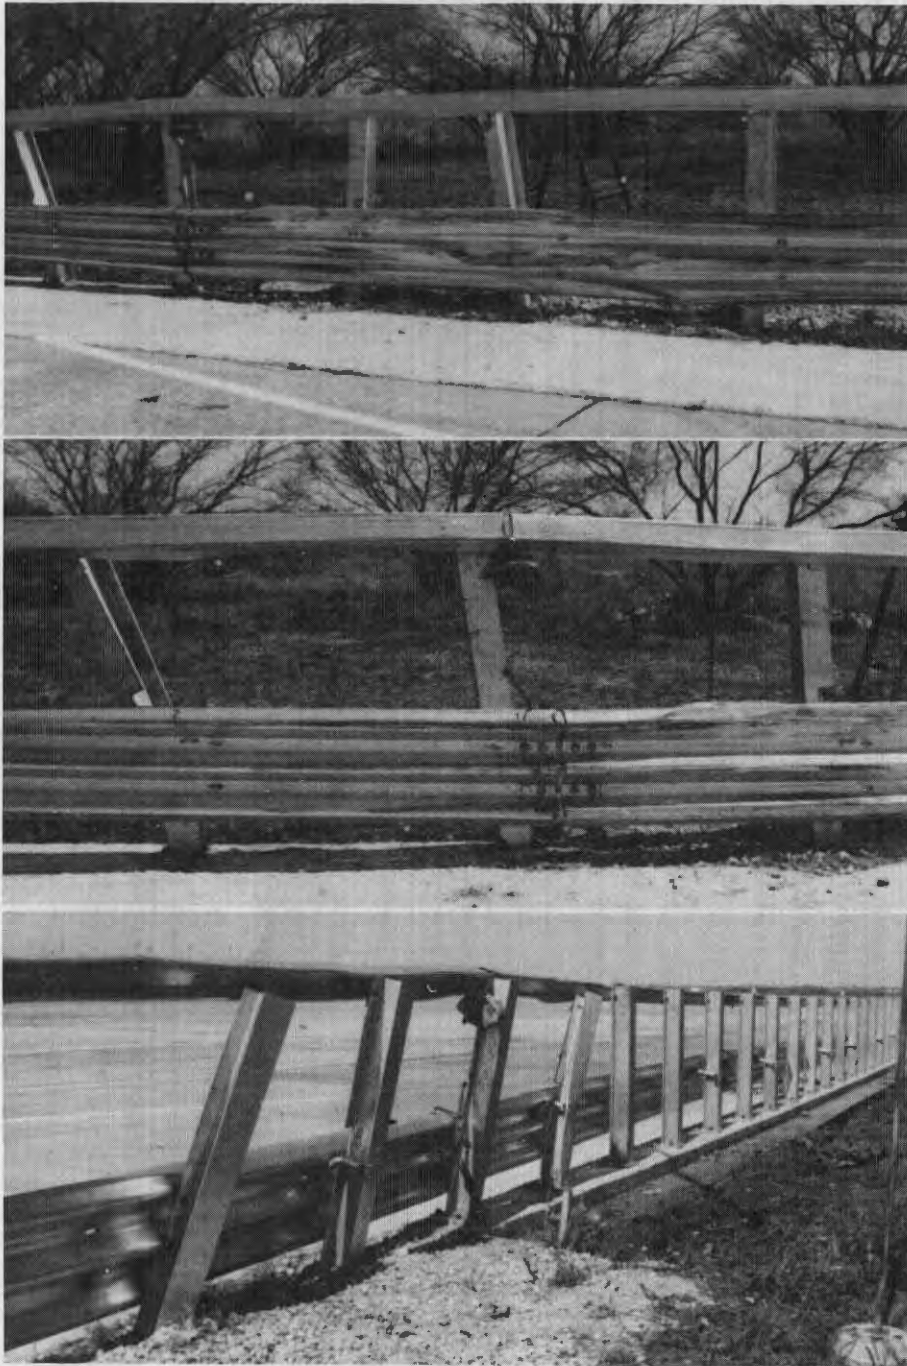
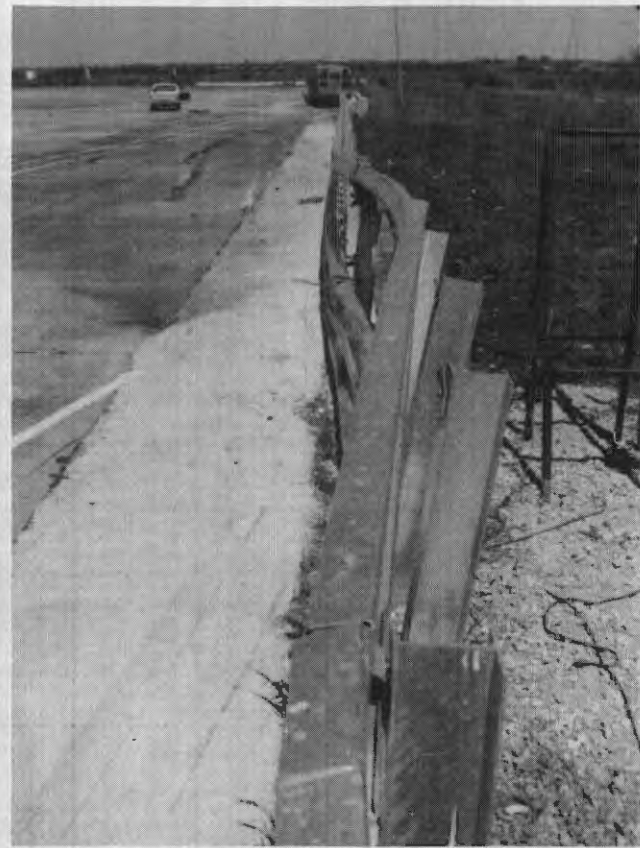
FIGURE 85. BARRIER AND VEHICLE DAMAGE, TEST TTR-5

Barrier Damage: As shown in Figure 85, barrier damage consisted of two bent tubular thrie beam sections, two bent upper rail sections, two bent bridge posts, and one bent soil-mounted post. The remaining transition posts were pushed back in the soil, but were undamaged. In addition, some concrete failure around bridge Posts 1 and 2 was observed. Permanent barrier deflections are given in Table 16.

Vehicle Damage: As described previously, the bus sustained front suspension and steering linkage damage sufficient enough to totally dislodge the front axle from its mounting. In addition, the

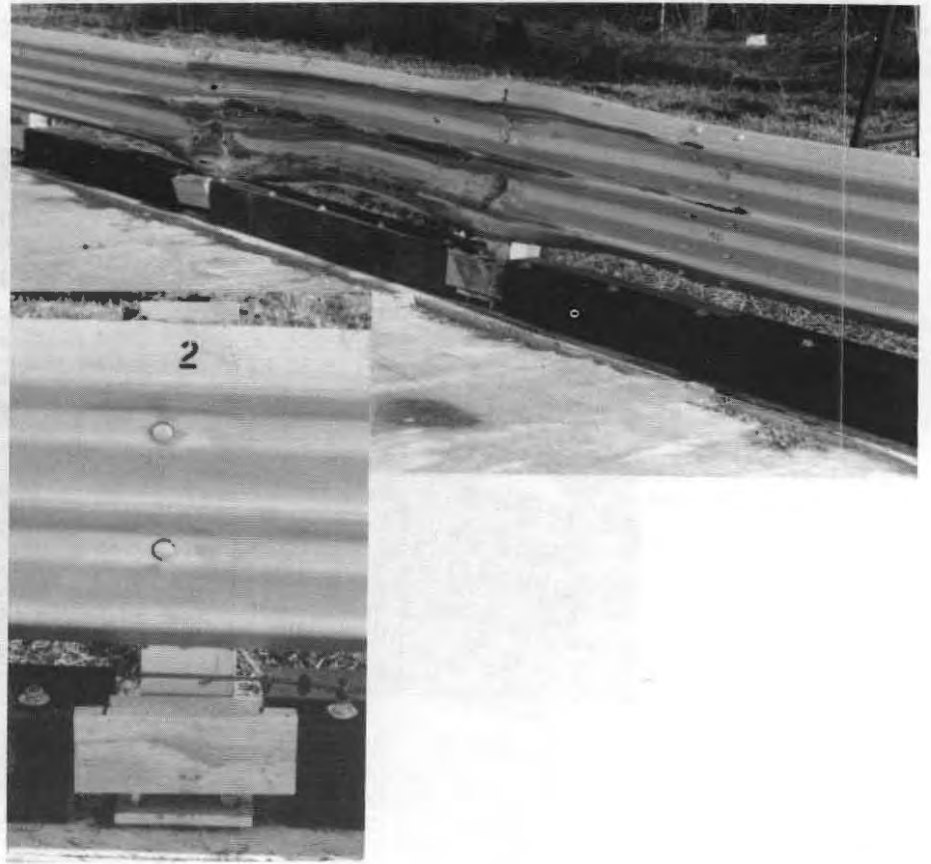
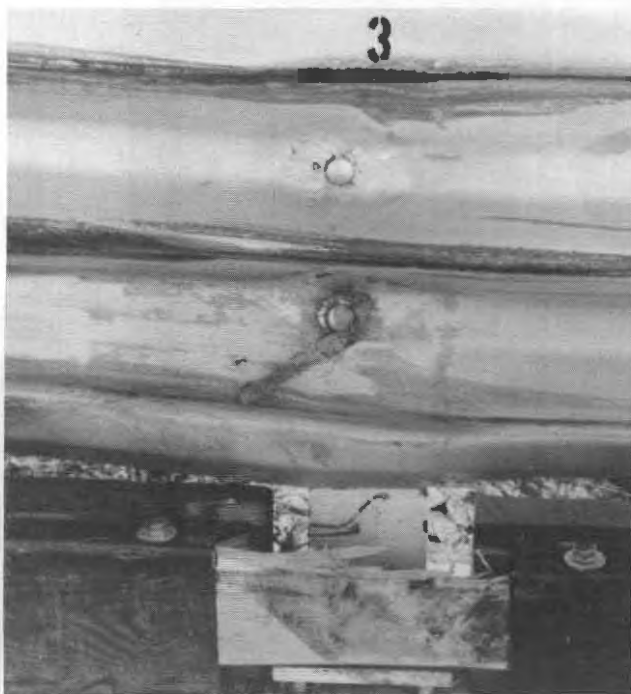
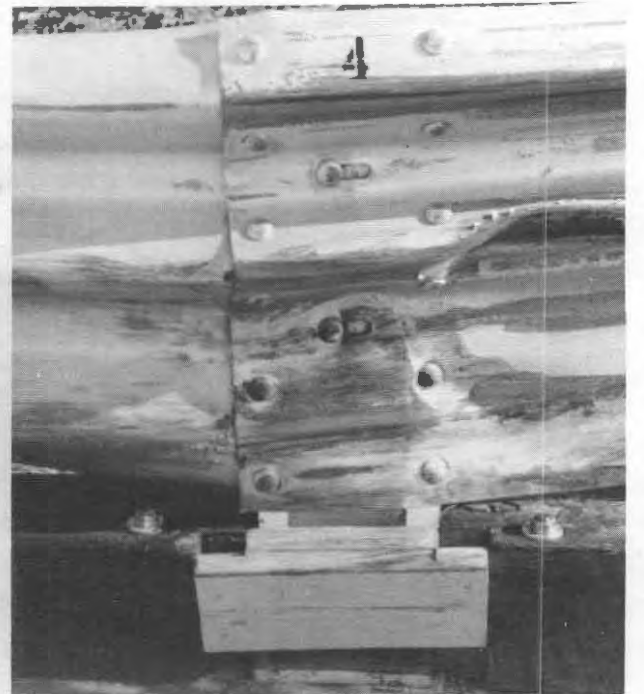
FIGURE 104. TTR-11 BARRIER DAMAGE

**Max defl 7.25 in. located 50 in. downstream of Post 3.

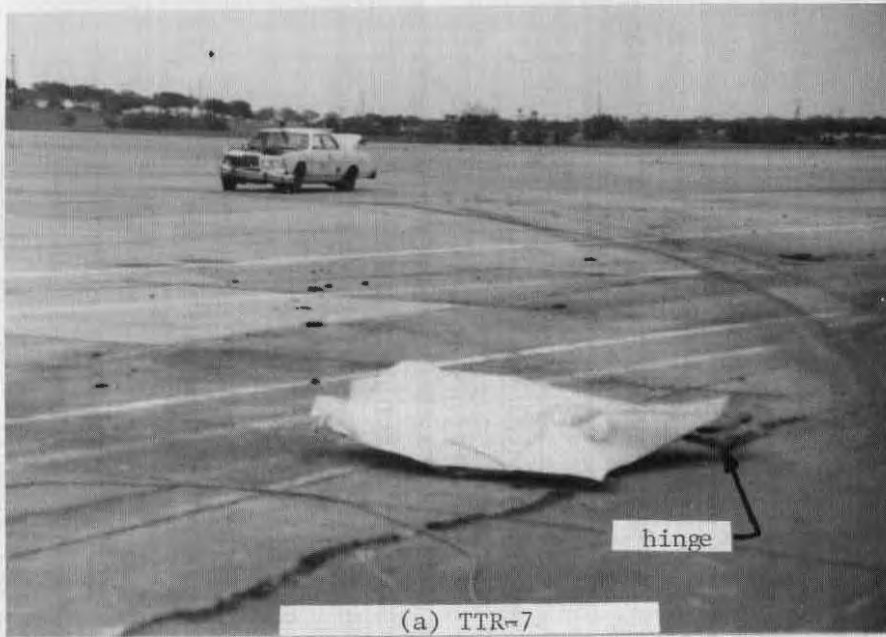
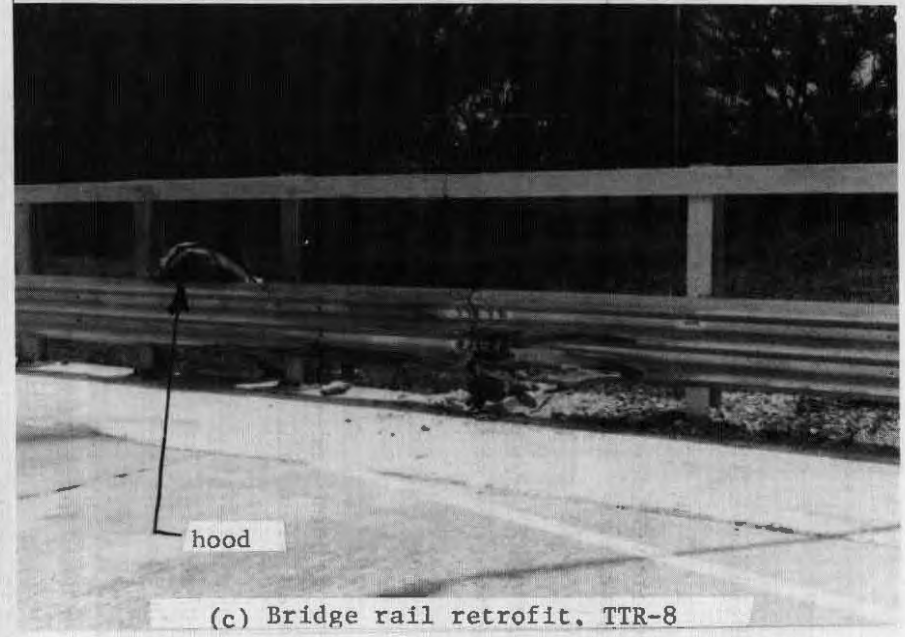
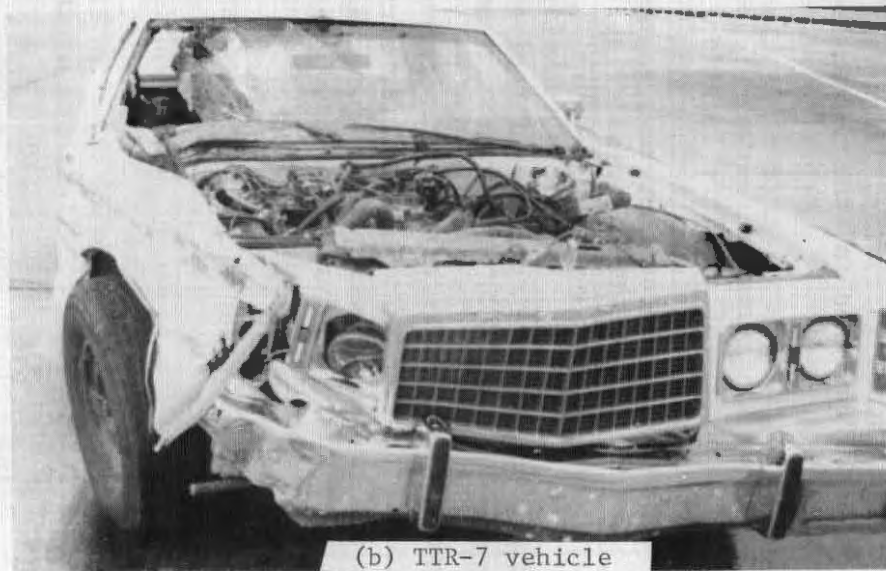
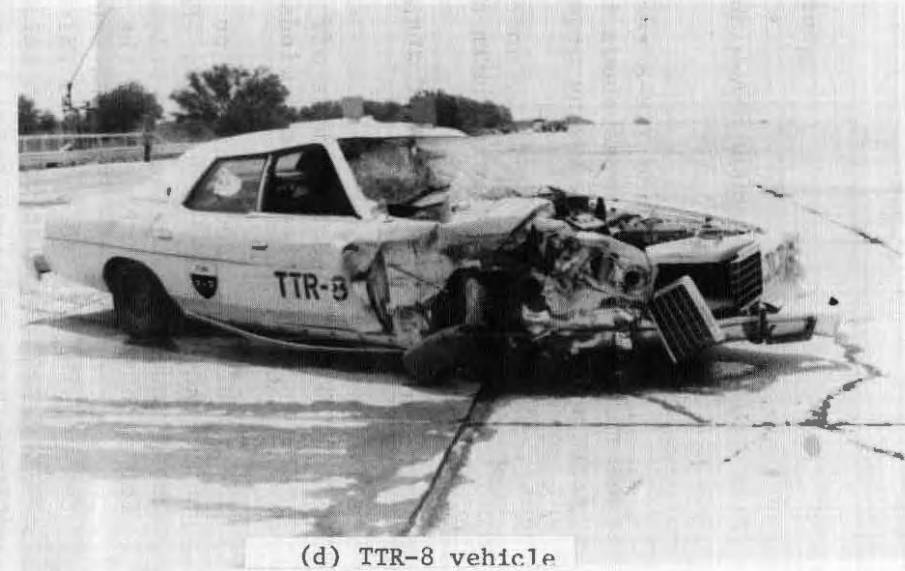
FIGURE 131. PHOTOGRAPHS AFTER TESTS TTR-7 AND TTR-8

In a limited survey of late model cars made by the Big 3, these controlled hinge locations are designed by locally weakening of the hood structural members as illustrated in Figure 133. Ford and GM employ a stud that engages the hood (Ford) or hinge (GM) to prevent rearward hood translation (Figure 133). In the case of the 1978 Ford LTD used in TTR-7 and TTR-8, it appears that hinge attachment to the quarter panel is the weak link; i.e., the hinges remain with the hood. The rather loose fit of the hood sheet metal with the stud [Figure 133(a)] appears to defeat the purpose of the detail. The local crimping of the hood structure shown in Figure 133(b) is much less significant than that employed by GM and Chrysler as shown in Figures 133(d), (f) and (h). Of the cars surveyed, the Ford designed hood fold points seemed to be minimally weakened in comparison with the others. Folding of the hood as shown in Figure 132(a) could have prevented the undesirable windshield penetration problem.

A ready solution to the hood snagging problem would be to raise the height of the lower beam to prevent the hood from going over the beam. The 33-in. (0.8-m) mounting height appears to be an upper bound, however, when considering the bumper interfaced with the tubular thrie beam as shown in Figure 134. By raising the beam only 2 in. (50 mm) the likelihood of the Honda Civic bumper sliding under the beam and snagging on the posts appears to be probable. This 2-in. (50-mm) increase in height would not be sufficient to engage the bumper.
