Sawmill Creek Road Transportation Corridor Assessment

AK NPS SITK 2015(2)

SAWMILL CREEK ROAD TRANSPORTATION CORRIDOR ASSESSMENT

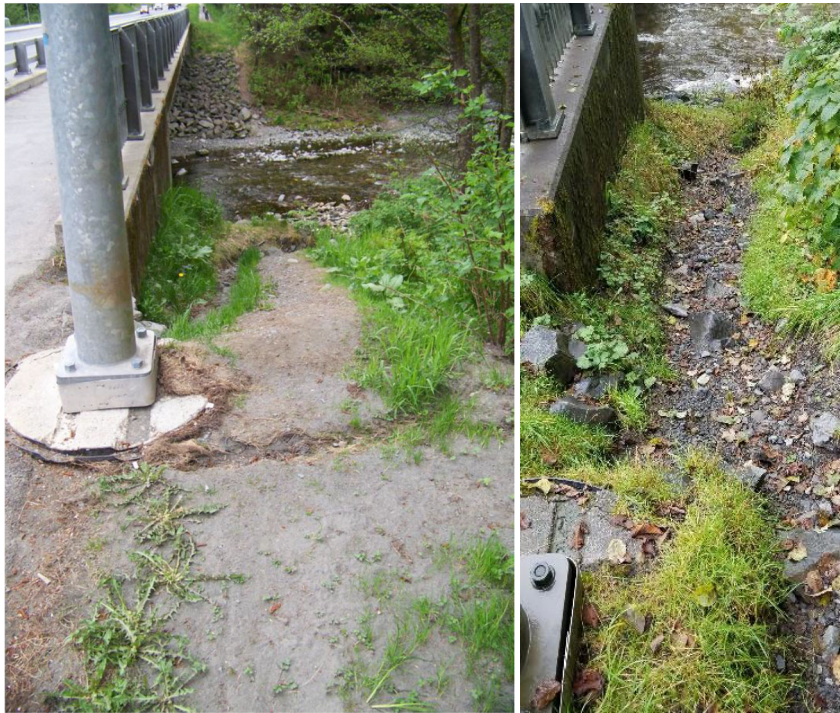
**Figure 8 - (L) Trail connection in 2014. Water started to wear channels into the soil.
Figure 9 - (R) Trail connection in 2018. Trail surface has continued to deteriorate and large rocks are starting to show through. The surface is very loose with uneven footing.**

1. Connection to multi-use trail at Indian River Bridge – An existing walking trail borders the Indian River and provides a connection between the Sitka National Historical Park visitor center and the base of the Indian River bridge. A formal access connection, such as stairs or other hardscaped improvements, between Sawmill Creek Road and the trail below has not been established. The trail connecting to the visitor center is visible at the bottom of the slope adjacent to

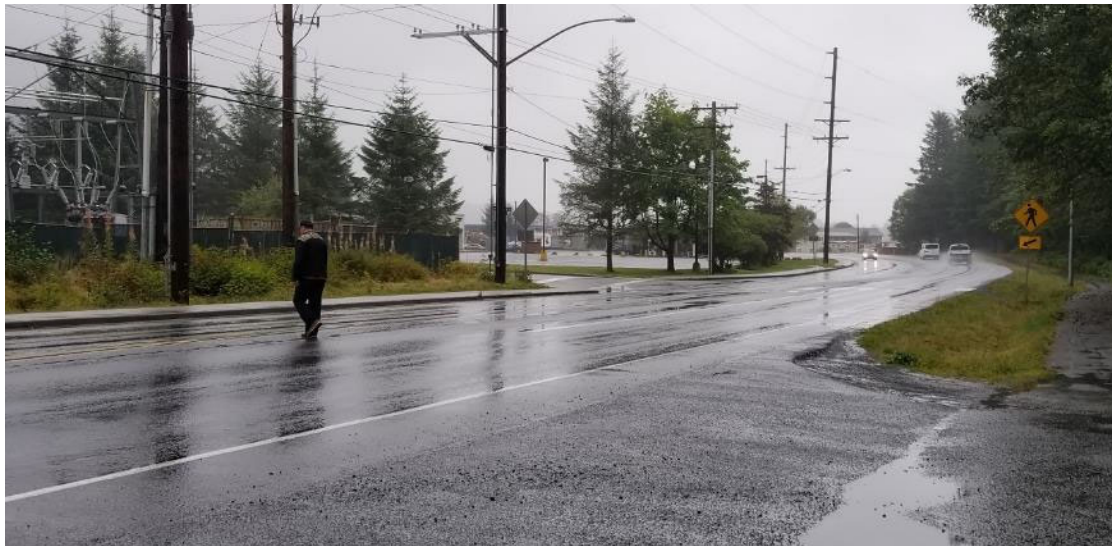
Figure 13 – A pedestrian crossing Sawmill Creek Road at the entrance to the national park SMC parking lot.

3. Entrance to national park parking lot along SMC Road – The entry driveway to the national park lot is offset from the Jarvis Street intersection by approximately 150'. The paved portion of the driveway is approximately 30' in width, but the current driveway opening including gravel shoulder is approximately 60' wide. The driveway opening has been widened inadvertently by traffic entering and exiting the parking and not utilizing the pavement. There are no curbs at the limits of the driveway which may allow faster turns into the parking lot than desired. The ditches on either side of the driveway are not very deep, and the culvert extends well beyond the edges of the pavement. There is a possibility that the culvert has sustained some damage from the vehicle activity as well.

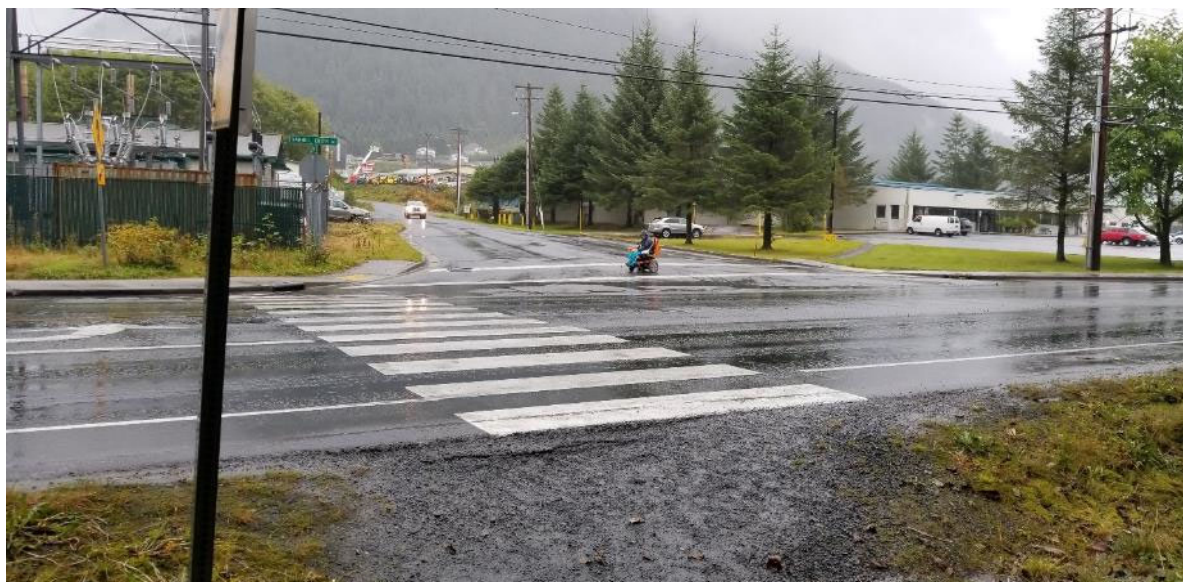
Figure 12 - A wheelchair user can be seen crossing Jarvis Street. The sidewalk on Jarvis Street includes ramps. The crossing on Sawmill Creek Road connects to a gravel and dirt connection.

4. Marked crossings at Jarvis Street – Pedestrians who use the crosswalk on SMC Road must connect to the road by a gravel connection worn into the grass. There is no paved connection between the multi-use path and the roadway. The crosswalk is marked with white pavement markings and is located at the intersection. The crosswalk is in the form of continental stripes and the existing markings are in good condition. The crosswalk on Jarvis Street is a simple design of two parallel white markings. There are ramps on the sidewalk on either side of the intersection.

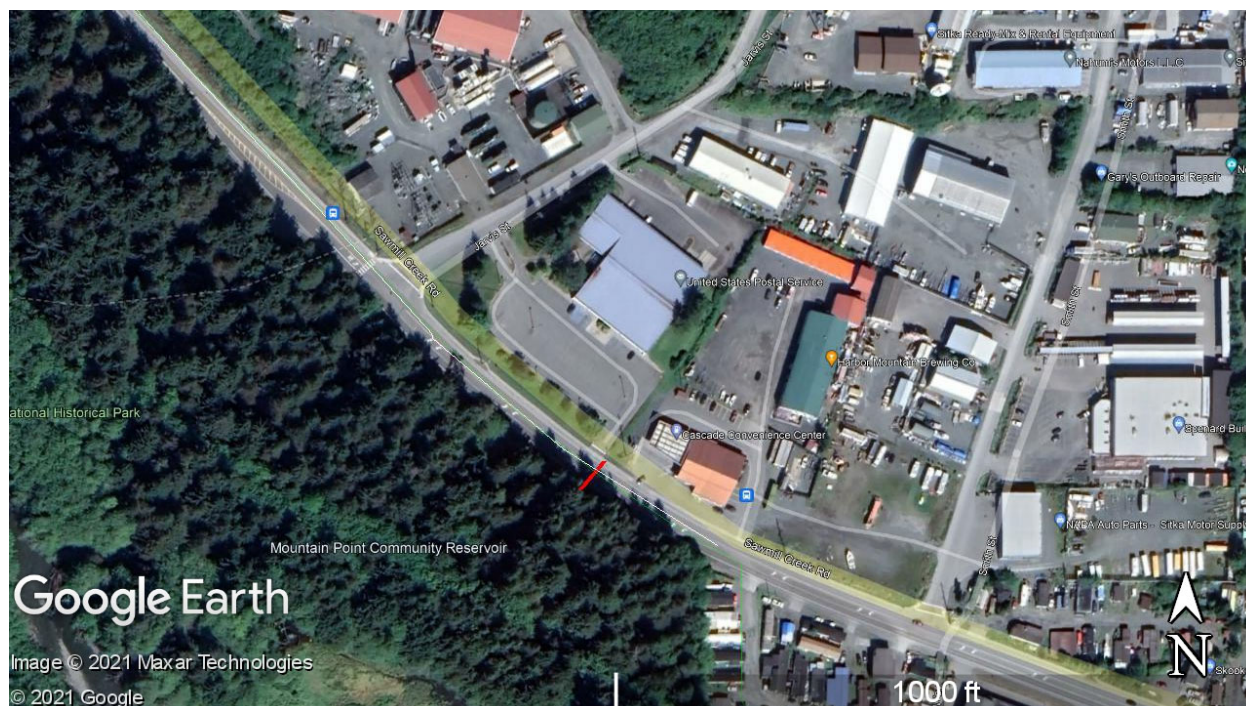
5. Unmarked crossing to convenience store – The SMC Road crossing at the convenience store is another situation of an unmarked crossing located at the midblock instead of at an intersection. The convenience store is located about 600 feet from the Jarvis Street intersection and marked crosswalk.

Figure 14 - Unmarked Crossing at Convenience Store (Approximate Location Marked in Red)

An informal path has been worn into the ditch between the multi-use path and SMC Road immediately adjacent to the convenience store. On the opposing side of the multi-use path, a trail is worn into the woods where people familiar with the area take a shortcut through the national park. It is thought that this occurs because passing through the park is a more enjoyable walk than if near a roadway. The informal path provides the shortest connection between the trail in the park and the convenience store across the road. The connector trail crosses the multi-use path, takes advantage of a culvert in the ditch, and crosses the road in a location with no crosswalk. The culvert at this location facilitates the crossing of the ditch during the often wet conditions. It is not known exactly why the culvert exists in this location, other than to help with crossing of the ditch.

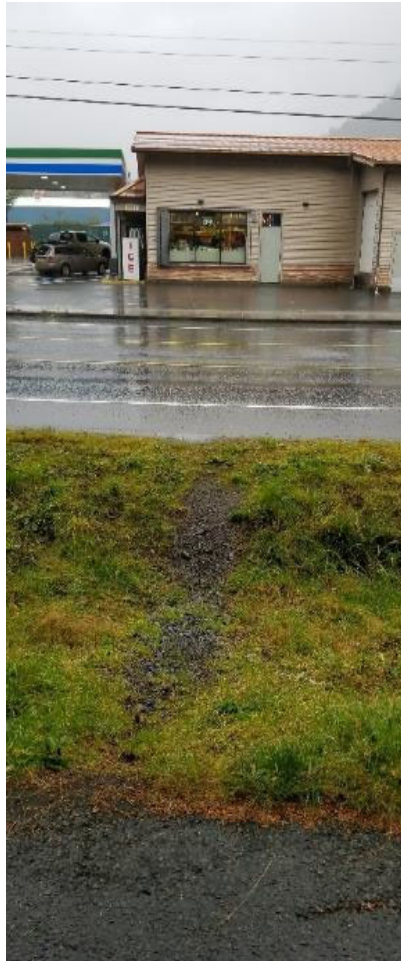
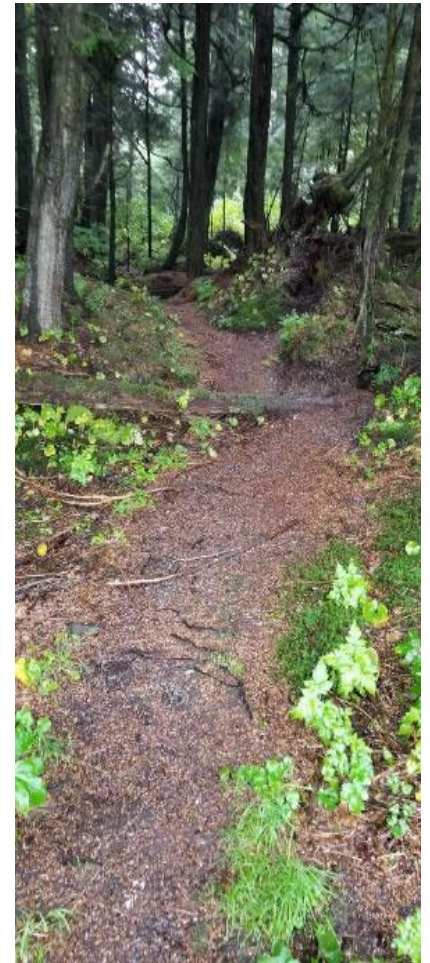
Figure 15 - (L) Crossing area worn into the grass. A culvert in this location facilitates the crossing. Figure 16 - (R) Picture of the path worn into the woods leading to the park trail network.

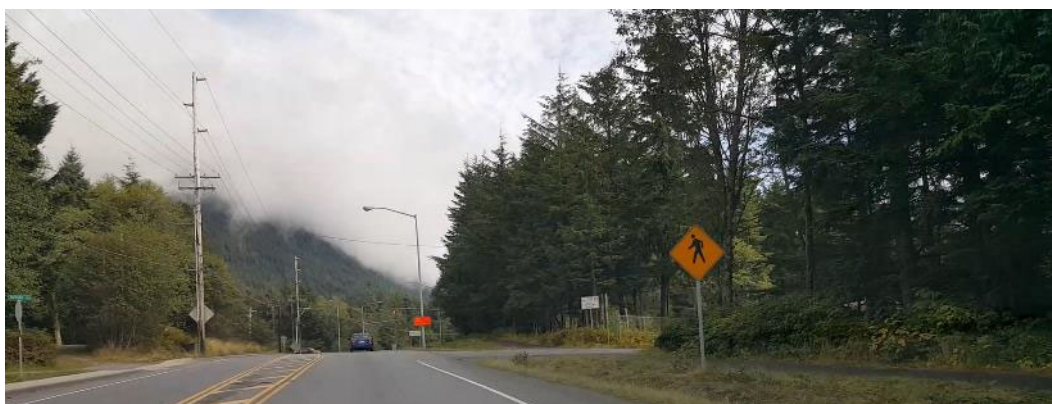
Figure 17 - EB SMC Road approaching Sisters Lane

Observations:	<ul style="list-style-type: none"> - Pedestrian signs in both directions approaching the crosswalk appear to be outdated and are not optionally a fluorescent color; - Signs do not include supplemental “AHEAD” plates.
Improvement Options:	<ul style="list-style-type: none"> - Replace signs with updated fluorescent yellow signs; <ul style="list-style-type: none"> o <i>December, 2021 Update – 2020 project replaced these, unknown if fluorescent or standard yellow.</i> - Add supplemental “AHEAD” plates. <ul style="list-style-type: none"> o <i>December, 2021 Update – 2020 project added this for the eastbound approach but not westbound.</i>

1. Replace the eastbound pedestrian warning sign with a new fluorescent sign and “AHEAD” supplemental plaque or “NEXT ½ MILE” (MUTCD W11-2 with W16-9P or W16-4P). Replace the westbound pedestrian warning sign as well with an “AHEAD” plaque.
December, 2021 Update – completed for eastbound but not westbound. Consider fluorescent yellow for higher visibility against grey skies for future updates.

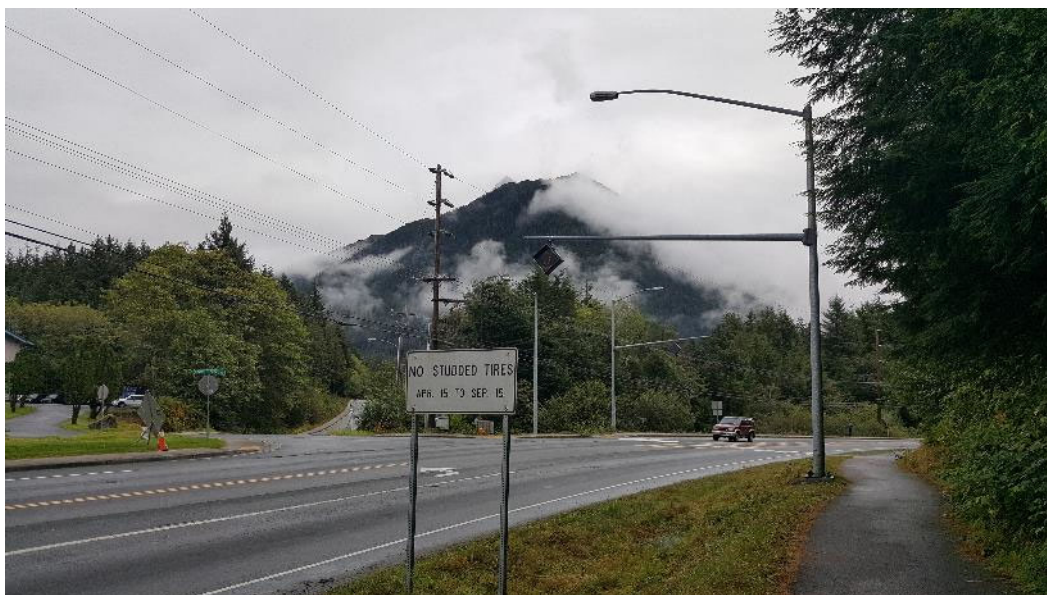
Figure 18 - EB Sawmill Creek Road approaching Indian River Road

<p>EB Observations:</p>	<ul style="list-style-type: none"> - Overhead pedestrian warning sign is outdated and is not visible enough to be effective; - Existing “NO STUDDER TIRES” sign is deteriorated; - Shared use path has vegetation overgrowth along outer parameter; - Lighting is present near the sign and crosswalk
<p>Improvement Options:</p>	<ul style="list-style-type: none"> - Reevaluate the overhead sign with recommendations from Table 1 of the FHWA Federal Lands Highway Action Plan for Implementing Pedestrian Crossing Countermeasures at Uncontrolled Locations. Options could include one or several of the following: <ul style="list-style-type: none"> o High-visibility crosswalk markings and signing o Advance Yield Here To (Stop Here For) Pedestrian sign and yield (stop) line (depending on state law) o Pedestrian refuge island o Rectangular Rapid-Flashing Beacon (RRFB) or Pedestrian Hybrid Beacon (PHB)

WFLHD recommends the installation of either Option 1 or Option 2. If more traffic data is collected, Option 3 may become viable as well, but is likely to be more expensive than RRFBs, without much difference in safety performance. Furthermore, the City of Sitka has installed some RRFBs, so motorists and pedestrians may be familiar with these systems already.

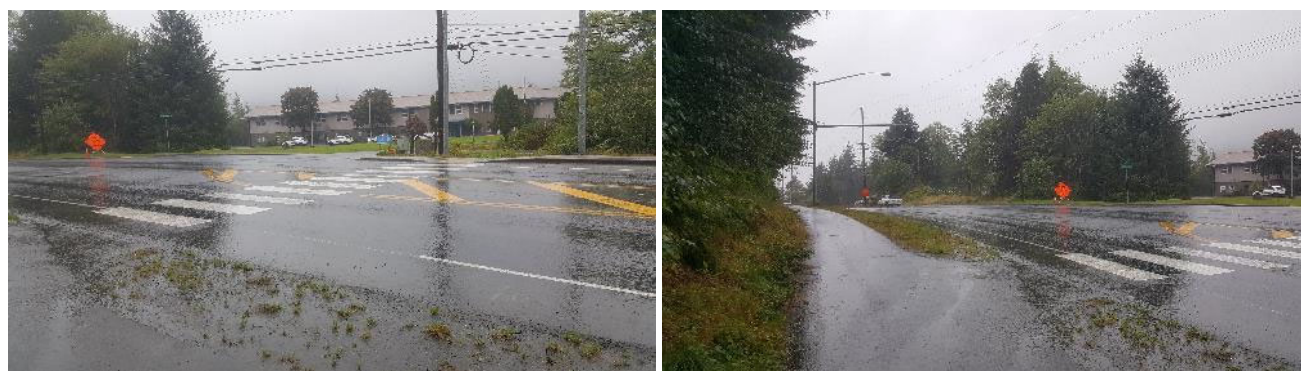
Figure 19 & 20 - EB Sawmill Creek Road facing Indian River Road intersection

<ul style="list-style-type: none"> ○ <i>December, 2021 Update – pedestrian warning signs, with push-button activated LED border lights, and down arrows were added for the crosswalk to replace the overhead signs.</i> - Replace fading “NO STUDDED TIRES” sign; <ul style="list-style-type: none"> ○ <i>December, 2021 Update – sign was replaced.</i> - Perform basic maintenance along the path to better delineate the path.
Crosswalk Observations:	<ul style="list-style-type: none"> - Crosswalk is highly visible and centerline markings are visible even when pavement is wet; - Appear to be drainage issues where crosswalk ties into shared use path; - Not able to visibly determine if overhead lighting is operational.
Improvement Options:	<ul style="list-style-type: none"> - For ADA compliance, install a clear separation between crosswalk and shared use path; <ul style="list-style-type: none"> ○ <i>December, 2021 Update – ADA crossing added on each side of crosswalk.</i> - Address the drainage issue along path to prevent pooling water. <ul style="list-style-type: none"> ○ <i>December, 2021 Update – may have addressed some drainage issues with new ADA ramp.</i>

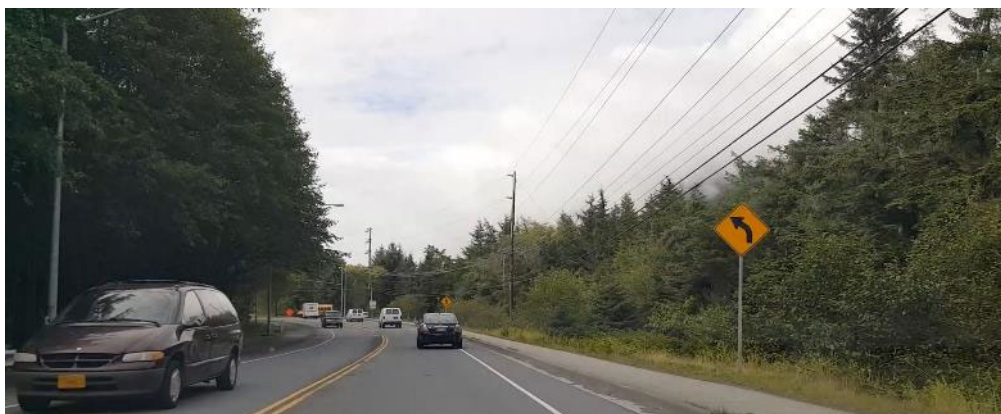
Figure 21 - WB Sawmill Creek Road approaching Indian River Road

WB Observations:	<ul style="list-style-type: none"> - Curve warning sign visibly old and not retroreflective on initial inspection; - Pavement in poor condition near centerline and roadway edges; - Centerline striping was faded in some locations.
Improvement Options:	<ul style="list-style-type: none"> - Evaluate the need for the curve warning sign. Even near the upper range of the assumed prevailing speed (35-45 mph), this sign may not be warranted per the 2009 Manual for Uniform Traffic Control Devices (MUTCD). Removing this sign can improve motorist adherence to more critical traffic control devices such as pedestrian warning signs; <ul style="list-style-type: none"> ○ <i>December, 2021 Update – sign was replaced in-kind.</i> - Resurface roadway and replace all pavement markings. <ul style="list-style-type: none"> ○ <i>December, 2021 Update – the resurfacing was completed. It is assumed that all pavement markings were reinstalled in their</i>

existing configuration. Durable MMA markings used at crosswalks; painted markings for others.
--	---

For the westbound direction, it is recommended to remove the advanced curve warning sign. The curve radius is approximately 1,000 ft and there is superelevation on the roadway. Assuming the roadway is superelevated at 3.0%, and using the AASHTO minimum radii table for an max superelevation rate of 4.0% (for urban areas), the curve design speed meets the posted speed of 35 mph and therefore does not need a curve warning sign per the MUTCD. Furthermore, given the more urban context, the sign is not as effective as a rural setting.

The curve warning sign was replaced in-kind.

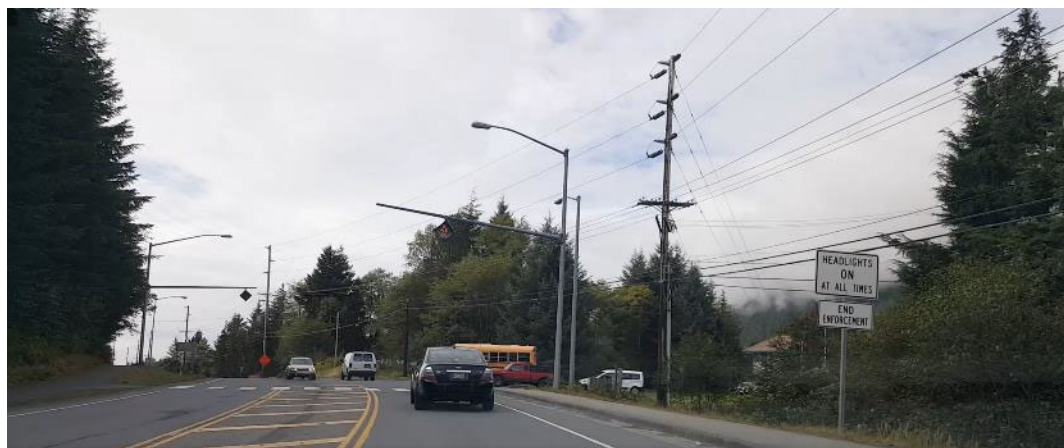
Figure 22 - WB Sawmill Creek Road at Indian River Road

Westbound Observations closer to intersection:	<ul style="list-style-type: none"> - Overhead pedestrian warning light is ineffective. The sign is lit at all times, but is difficult to see during the daytime, and is quite small; - "HEADLIGHTS ON" with supplemental sign was visible and was visibly in good condition. - Center line pavement marking were somewhat worn.
Improvement Options:	<ul style="list-style-type: none"> - Upgrade overhead pedestrian warning traffic control device; <ul style="list-style-type: none"> o Pedestrian hybrid beacon; o Rectangular rapid flashing beacon; o Pedestrian activated signal. o <i>December, 2021 Update – pedestrian warning signs, with push-button activated LED border lights, and down arrows were added for the crosswalk to replace the overhead signs.</i> - Repaint pavement markings <ul style="list-style-type: none"> o <i>December, 2021 Update – pavement markings were reinstalled.</i>

The upcoming DOT&PF project should address other roadway and pavement marking deficiencies noted near this area.

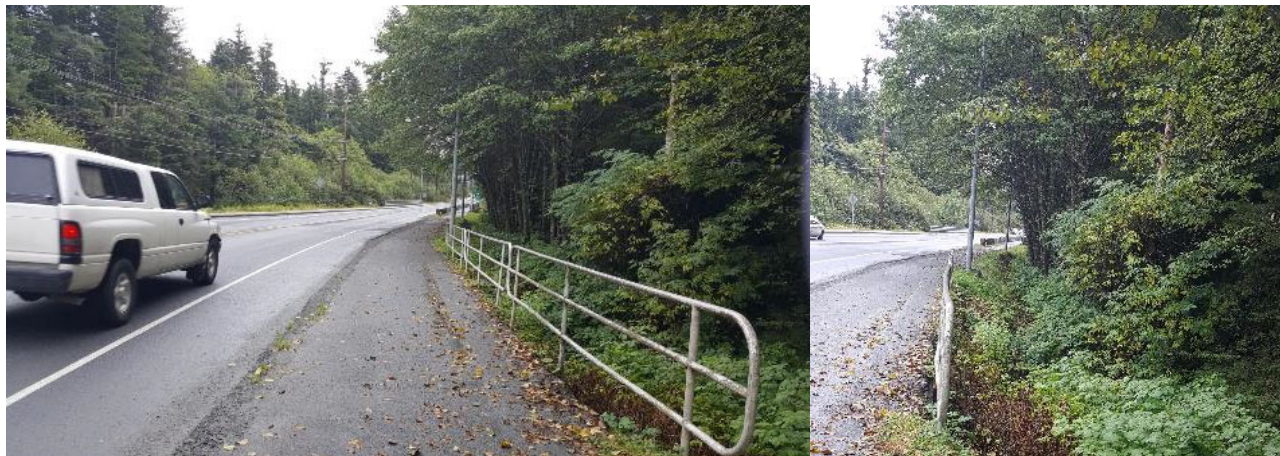
Figure 23 & 24 - EB Sawmill Creek Road approaching Indian River bridge

<p>Observations Approaching Indian River Bridge:</p>	<ul style="list-style-type: none"> - Roadway runoff drains directly onto the shared use path; - No separation between pedestrian and roadway; - Pavement was visibly in poor condition; - Ponding on path causing debris deposits. - Handrail provides delineation and some protection for bicyclists and pedestrians along steep drop-off.
<p>Improvement Options:</p>	<ul style="list-style-type: none"> - Add curb and gutter to Sawmill Creek Road to alleviate the drainage issues on shared use path; - Resurface roadway and replace all pavement markings; - Provide a clear separation between roadway and shared use path by constructing curb and gutter along SMC Road. <ul style="list-style-type: none"> o <i>December, 2021 Update – a recently crash-tested aluminum 42” pedestrian rail/fence may be a good option for shared use path delineation and pedestrian fall accommodations along any steep areas. The existing handrail may or may not be considered crashworthy. For reference, see pg. 181: https://onlinepubs.trb.org/onlinepubs/circulars/ec220.pdf</i> o <i>The 2020 project replaced this handrail with a galvanized steel 42” rail. Unlikely to be cost effective to replace this with the new crash-tested Manual for Assessing Safety Hardware (MASH) Test Level-2 barrier.</i>

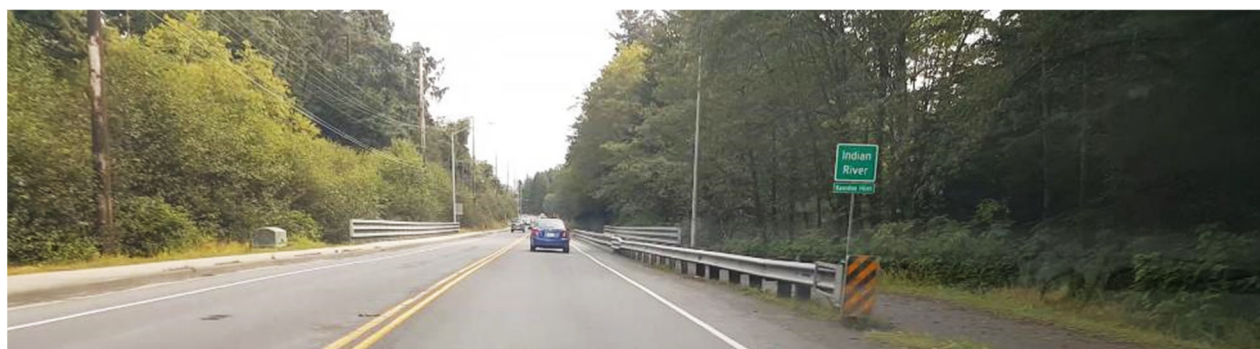
Figure 26 - EB multi-use path at Indian River bridge

<p>Bridge Rail and Guardrail Observations:</p>	<ul style="list-style-type: none"> - The purpose of the guardrail appears to be to shield the river hazard and provide a transition to the interior bridge rail along the path; - The purpose of the interior bridge rail appears to be to shield pedestrians and trail-users along the bridge. However, the opposite side does not have a similar treatment and much of the shared-use trail is similarly exposed to vehicular traffic.
<p>Improvement Options:</p>	<ul style="list-style-type: none"> - Evaluate guardrail and bridge railing to determine if the existing treatment is appropriate for the location. <ul style="list-style-type: none"> o <i>December, 2021 Update – guardrail height of 28” was maintained. The downstream/opposite side transition rail was modified to match the downstream guardrail height. The terminal grading may have been improved.</i>

WFLHD has no specific short-term improvement recommendations at this location at this time. It is recommended to evaluate the interior bridge rail and guardrail to verify that this is the desired treatment here, given that the opposite side has no interior bridge rail or guardrail.

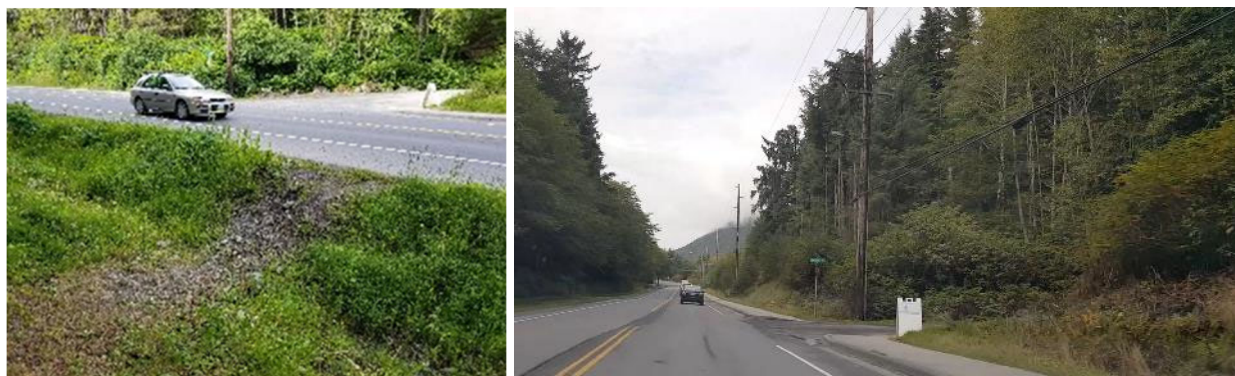
Figure 27 & 28 - WB Sawmill Creek Road at Raptor Way

<p>Observations:</p>	<ul style="list-style-type: none"> - Pedestrians were observed crossing midblock to access the Raptor Center; there is an informal path indicating that this is a high crossing location for pedestrians; - The gravel roadway along Raptor Way is visibly in poor condition; - Gravel is tracked out by vehicles onto the SMC roadway, including the SMC Rd. bike lane - Water observed flowing from the informal path onto the shared use path.
<p>Improvement Options:</p>	<ul style="list-style-type: none"> - Surface roadway along Raptor Way; - Evaluate the uncontrolled crossing on SMC Rd. with Table 1 of the FHWA Federal Lands Highway Action Plan for Implementing Pedestrian Crossing Countermeasures at Uncontrolled Locations. Options could include one or several of the following: <ul style="list-style-type: none"> o High-visibility crosswalk markings and signing o Advance Yield Here To (Stop Here For) Pedestrian sign and yield (stop) line (check state law) o Rectangular Rapid-Flashing Beacon (RRFB) or Pedestrian Hybrid Beacon (PHB) o <i>December, 2021 Update – Pedestrian warning signs with “300 FT AHEAD” plaques were installed in advance of Raptor Way.</i> - Instead, provide delineation such as guardrail to prevent pedestrians from crossing at this location; <ul style="list-style-type: none"> o <i>December, 2021 Update – consider the crash-tested aluminum pedestrian rail/fence. Note, this is considered a channelizer and not a redirective barrier like guardrail, though guardrail also deflects and may not prevent vehicle-pedestrian crashes.</i> - Provide guide signage that directs pedestrians to marked crosswalks in order to access Raptor Way. - Provide SMC Road MUTCD highway guide signage for road users to guide them to the Raptor Center (currently no wayfinding signage on SMC Road for the Raptor Center).

Therefore, WFLHD recommends a similar treatment at Raptor Way if the revised crossing in the DOT&PF project (relocated from Jarvis to just west of the NPS parking lot) does not have the intended effect of encouraging pedestrians to cross within the crosswalk rather than the uncontrolled crossing at Raptor Way. Either Option 1 or Option 2 from 5.2.2.

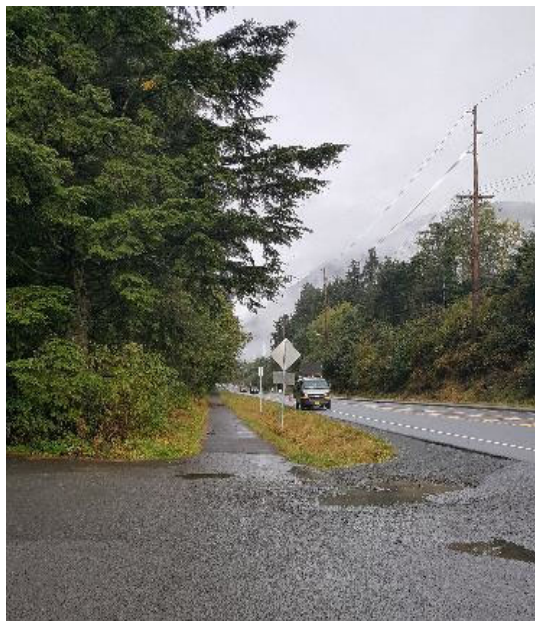
Figure 29 - Sawmill Creek Road at Sitka National Park Lot

<p>Observations at Parking Lot:</p>	<ul style="list-style-type: none"> - Driveway apron into Sitka National Historical Park has drainage issues (ponding and erosion); - The shared use path asphalt is visibly in poor condition; - Water observed pooling in various sections of the path and parking lot; - The parking lot driveway is not delineated with curb, allowing vehicles entering the parking lot to carry higher speeds when making the turn, and endangering pedestrians in the area; - The Ride uses the driveway as a stop on the city bus route; - During the field visit pedestrians were observed walking west along this path to reach the Raptor Center; - Pedestrians were observed crossing midblock without a designated crossing; - The preferred crossing maneuver is to walk east to Jarvis Street, cross at the marked crosswalk, then walk west to reach the Raptor Center; - There is no visible signage directing pedestrians to the preferred route to the Raptor Center. This may contribute to the safety issues as noted by the City of Sitka and NPS Staff; - The pooling water can cause additional safety issues during extreme weather conditions especially freezing rain/snow events; - Several vehicles were observed spinning gravel in an effort to accelerate quickly into traffic.

If speeds turning into the parking lot continue to be higher than desired, it is recommended to install curb from the edge of pavement along mainline near the entrance around the turn to the sidewalk. The ends could be tapered down to eliminate an abrupt edge facing SMC traffic. The radii should be kept smaller (15-20') to help reduce motorists' speeds when making the turn into the parking lot. A slotted drain can be installed to help drain the low, ponding areas to the ditch. In the long term, storm sewer could be installed.

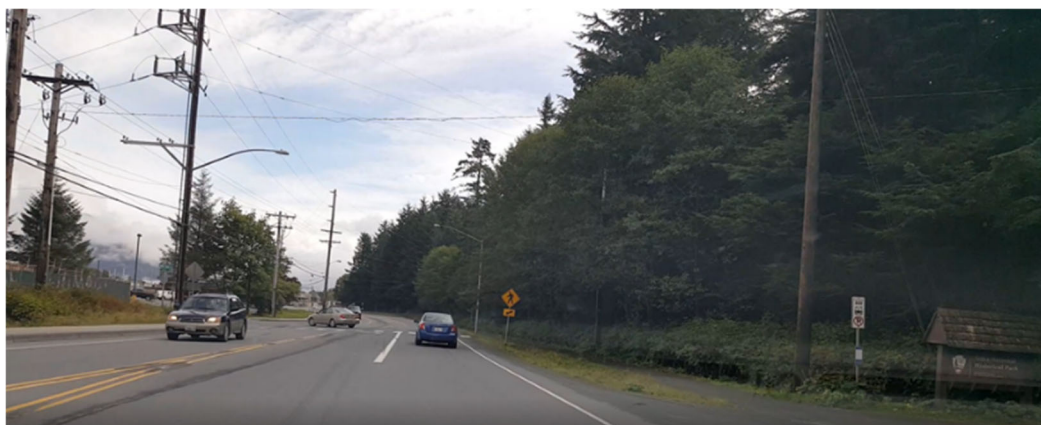
Figure 30 - Sawmill Creek Road EB approaching Jarvis Street

Observations Approaching Jarvis Street Crossing:	<ul style="list-style-type: none"> - Pavement markings approaching intersection are visibly faded; - Pedestrian crossing signing seems old and is not very reflective.
Improvement Options:	<ul style="list-style-type: none"> - Restripe pavement markings; <ul style="list-style-type: none"> o <i>December, 2021 Update – Pavement markings were reinstalled with the paving project.</i> - Check retroreflectivity of existing signs and replace if needed. <ul style="list-style-type: none"> o <i>December, 2021 Update – the pedestrian warning signs were replaced in advance of the crosswalk with “AHEAD” plaques for each direction. The pedestrian warning signs at the crosswalk were replaced, however, the required down arrow plaques may have not been reinstalled. They were not called out specifically in the plans.</i>

Depending on the effects of the proposed DOT&PF project on moving the Jarvis St. crosswalk, follow the recommendations for 5.2.2 for either Option 1 or Option 2. Even if the relocated crosswalk is successful with pedestrians using the crossing, enhancements in Option 1 and Option 2 are believed to be viable based on the understood use by pedestrians accessing the Raptor Way. Again, more traffic, bicycle and pedestrian data would be beneficial.

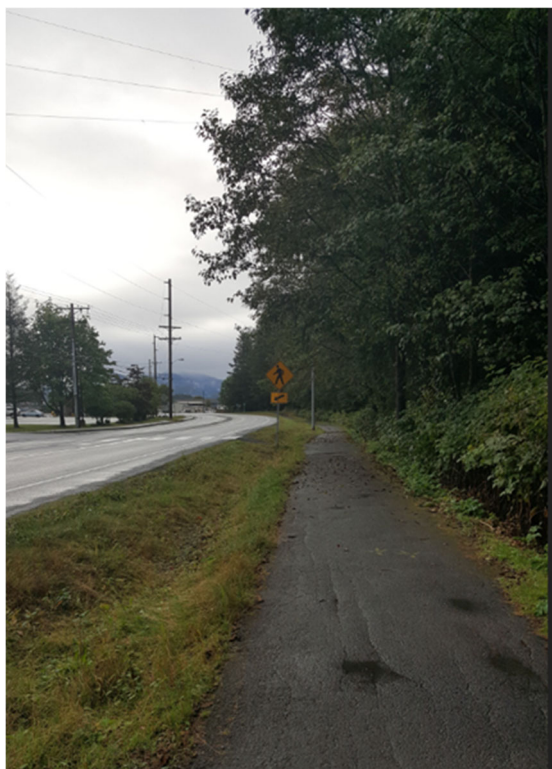
Figure 31 - EB Sawmill Creek path at Jarvis Street

<p>Observations Along Path Near Jarvis Street:</p>	<ul style="list-style-type: none"> - Shared used path is in poor condition; - Pooling water observed along path; - Pavement rutting present along shared use path; - Vegetation along path overgrown; - Drainage issues along ditch line. - No ADA facilities on west side (from path)
<p>Improvement Options:</p>	<ul style="list-style-type: none"> - Repave shared use path; <ul style="list-style-type: none"> o <i>December, 2021 Update – a portion of this path was repaved, likely to facilitate the ADA crossing.</i> - Evaluate existing drainage issues along the road edge and shared use path; <ul style="list-style-type: none"> o <i>December, 2021 Update – some improvements to this condition may have been made.</i> - Address issues with vegetation and evaluate the condition of asphalt in shared use path. <ul style="list-style-type: none"> o <i>December, 2021 Update – some improvements to this condition may have been made.</i>

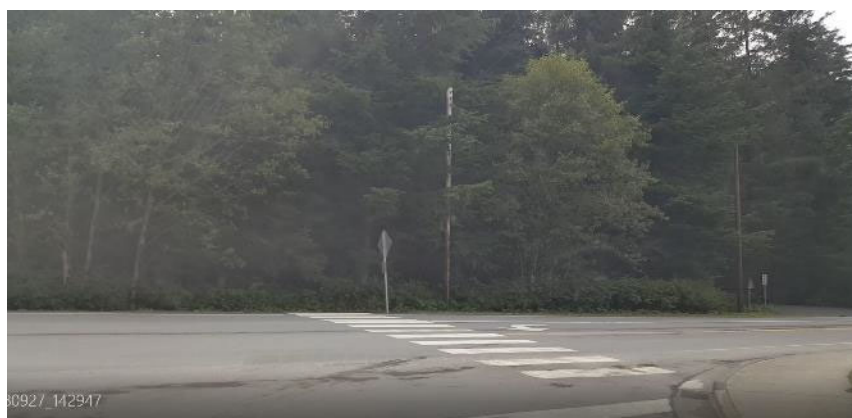
Figure 34 – Jarvis Street facing Sawmill Creek Road pedestrian crossing

<p>Observations from Jarvis Street</p>	<ul style="list-style-type: none"> - Crosswalk pavement markings in poor condition; - Pavement markings are not consistent with one another;
--	--

<p>Looking toward SMC Rd.:</p>	<ul style="list-style-type: none"> - Pavement visibly in poor condition; - Existing curb ramps were not perpendicular to the crosswalks at Jarvis Street and Sawmill Creek Road.
<p>Improvement Options:</p>	<ul style="list-style-type: none"> - Resurface roadway; <ul style="list-style-type: none"> o <i>December, 2021 Update – the resurfacing was completed along SMC and through the return along Jarvis St.</i> - Restripe pavement markings, and ensure markings are consistent with pavement marking plans; <ul style="list-style-type: none"> o <i>December, 2021 Update – pavement markings were reinstalled with the project. The same crosswalk types were used and are likely adequate.</i> - Provide separated curb ramps that are perpendicular to the crosswalk for ADA compliance. <ul style="list-style-type: none"> o <i>December, 2021 Update – new ADA facilities were constructed at Jarvis St. for the crossing across Jarvis St. as well as the crossing across SMC Rd.</i>
