FINAL REPORT (Project BDV25-977-69)

**Identification of the Mechanisms that Produce Hydrogen Embrittlement on
Post-Tensioning Members and the Effects of Galvanic Coupling on Bridge
Tendons**

Final Report to Florida Department of Transportation

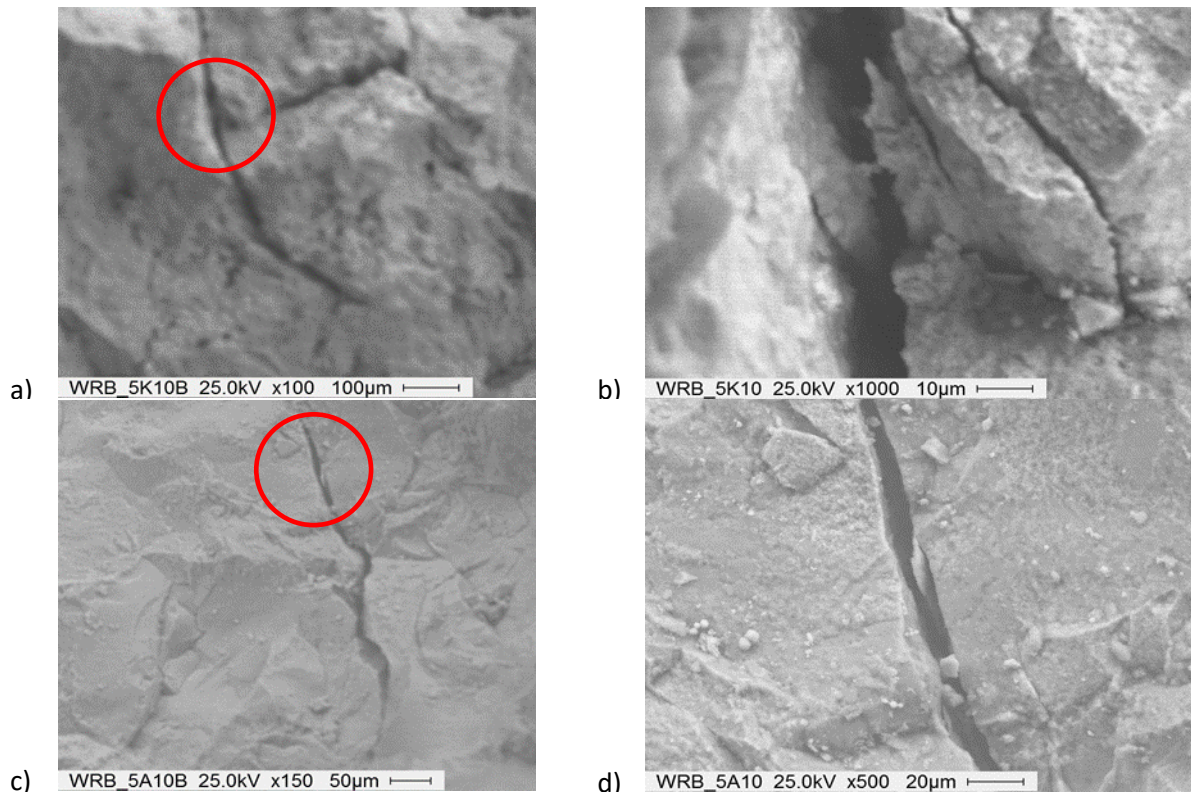
Another visible feature associated with some of the brittle failures was the presence of cracks at the fracture surface progressing longitudinally into the fracture plane and along the length of the wire. An example may be observed in the micrograph presented in Figure 3-6. These microcracks were viewed on the fracture surface of the wires however, other microcracks were also found on the side of some wires. According to [44], as the hydrogen content within the wires increases, the extent of longitudinal splitting increases and the fracture surface becomes more tortuous. Therefore, the microcracks observed are a good indication of hydrogen embrittlement.

Figure 3-6. SEM images of a microcrack on a brittle wire. Images (B) and (D) are taken at higher magnifications at the circled areas of the cracks seen on images (A) and (C), respectively.

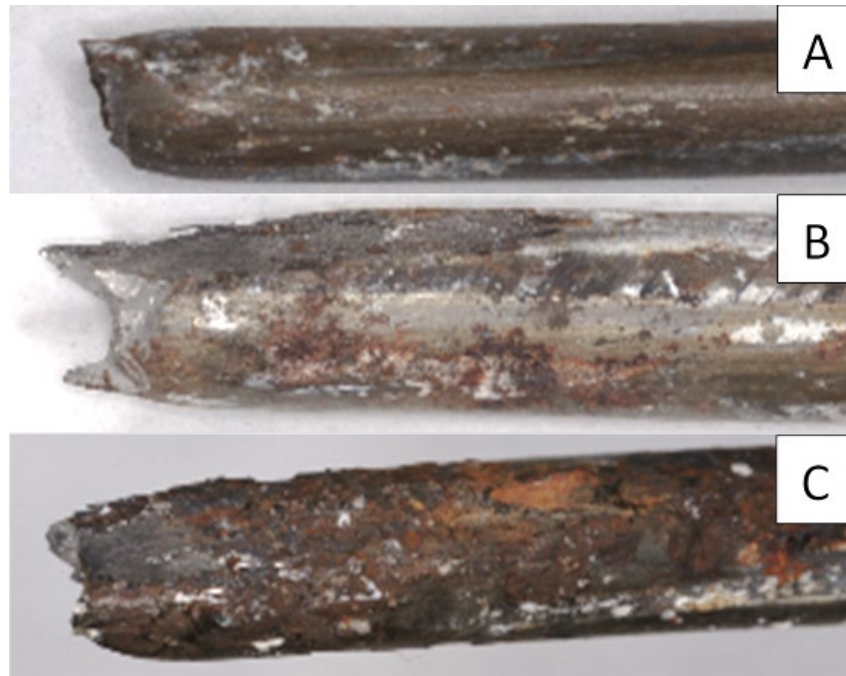
While the fracture patterns clearly show indications of embrittlement, they do not necessarily reveal their cause. Embrittlement can occur under excessive cathodic polarization or it can be induced by corrosion. Based on the results provided in Table 1, 97.1% (99/102) of wires examined showed some signs of corrosion, whether it be mild or moderate, leaving only 2.9% (3/102) of wires showing no signs of corrosion. An example of each degree of corrosion can be seen in Figure 3-7. In general, most of the wires observed experienced mild uniform surface (Figure 7b) corrosion near the fractured end of the strand. In some cases, moderate corrosion was observed in more localized areas in the form of significant metal loss. Only a few of the wires did not have visible signs of corrosion near the fractured end.

Figure 3-7. Example of (A) strands that have no corrosion, (B) mild corrosion, and (C) moderate corrosion.

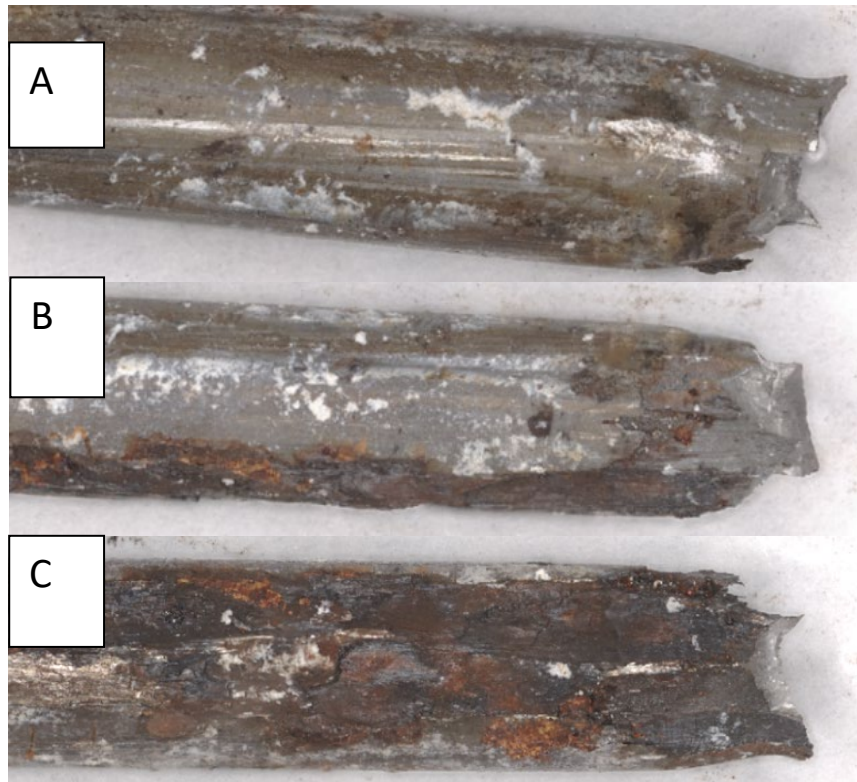
The corrosion observed in most cases was concentrated on the outer surface of the steel strands. After unwinding and observing the individual wires in each strand, it was evident that some of the wires experienced mild to moderate corrosion on the outer surface of the wire, while virtually no corrosion was found on the inside surface of the same wire facing the king strand wire. An example of this is shown in Figure 3-8. In these cases, the king strand wire showed considerably less corrosion than compared to the outer wires.

Figure 3-8. Different sides of the same wire showing: (A) inner surface of the wire without corrosion; (B) surface that contacts the neighboring wire with mild corrosion; (C) outer surface of the wire with moderate corrosion.

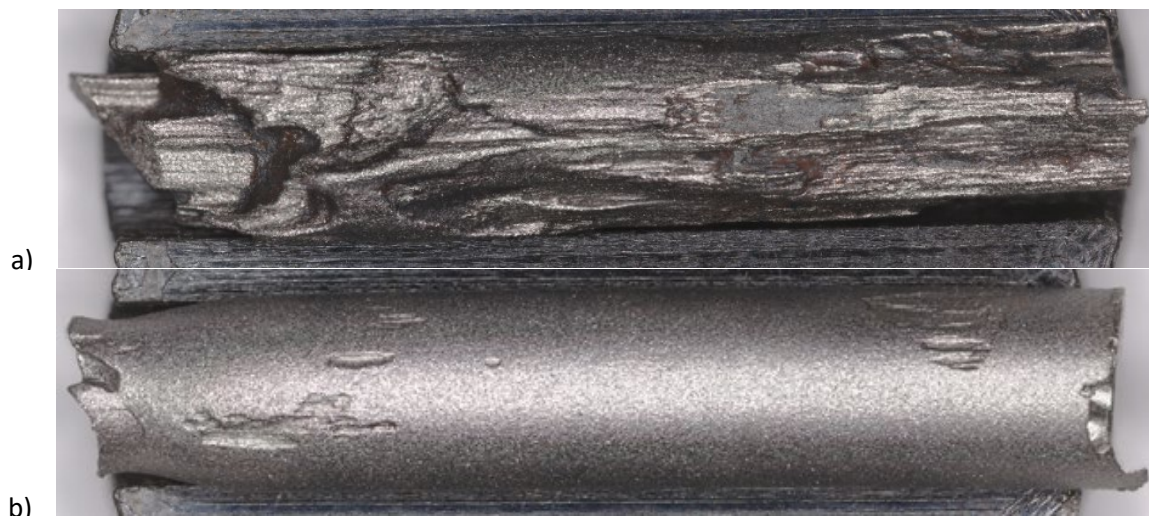
An example of significant and minimal corrosion pits on the surface of the sandblasted samples can be seen in Figure 3-9. Figure 3-9a shows a moderately corroded wire after removal of the surface corrosion products. Figure 3-9b shows a wire with minimal corrosion pits on the surface. Interestingly, the moderately corroding wires show no sign of necking while the mildly corroded ones show extensive necking.

Figure 3-9. 3D surface images of corroded wire sections near the fracture location; (A) extensive corrosion with brittle fracture; (B) mild corrosion with ductile fracture.

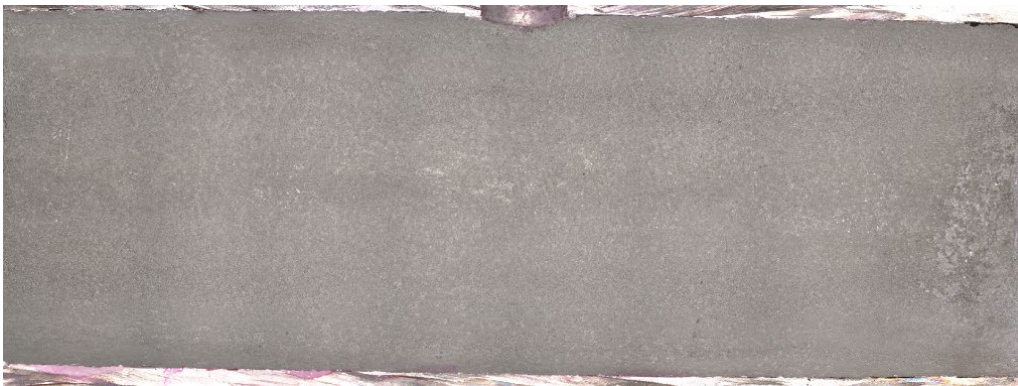
Figure 5-3. Inside view of the galvanized duct from Tendon 1 with good grout ($w/c = 0.28$).

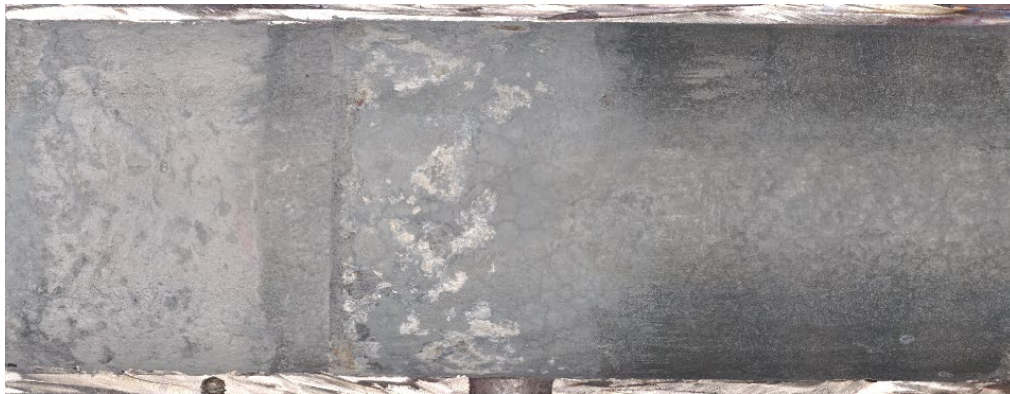
Figure 5-5 shows the inside view of the galvanized duct from Tendon 5. Three distinct zones were observed along the inner surface of the galvanized duct. On the right side of Figure 5-5 (bottom of tendon), the duct wall appeared darker in color corresponding with the size of the high alkaline grout band. The center zone of the duct was lighter in color and white zinc corrosion products can be seen along with minimal amounts of orange iron oxide. The left side of Figure 5-5 (top of tendon) shows a lighter color similar to the center zone but without the zinc and iron oxide products. From this it is clear that the low alkalinity region of the grout resulted in corrosion of the galvanized duct. The maximum corrosion penetration was measured using a 3D profilometer and was $\sim 76 \mu\text{m}$ which corresponds to an approximate corrosion rate of $100 \mu\text{m}/\text{yr}$. If it is assumed that such a high corrosion rate persists over time, corrosion through the thickness of the duct would occur in $\sim 40\text{-}50$ years. Further analysis of the grout in this region should provide more understanding of the potential cause of the corrosion.

Figure 5-5. Inside view of the galvanized duct from Tendon 5 with very soft grout ($w/c = 0.5$).
