Summary of Case Studies and Observations on Airport Experience with Pavement Surface Treatments

August 2023

DOT/FAA/TC-TN23/49

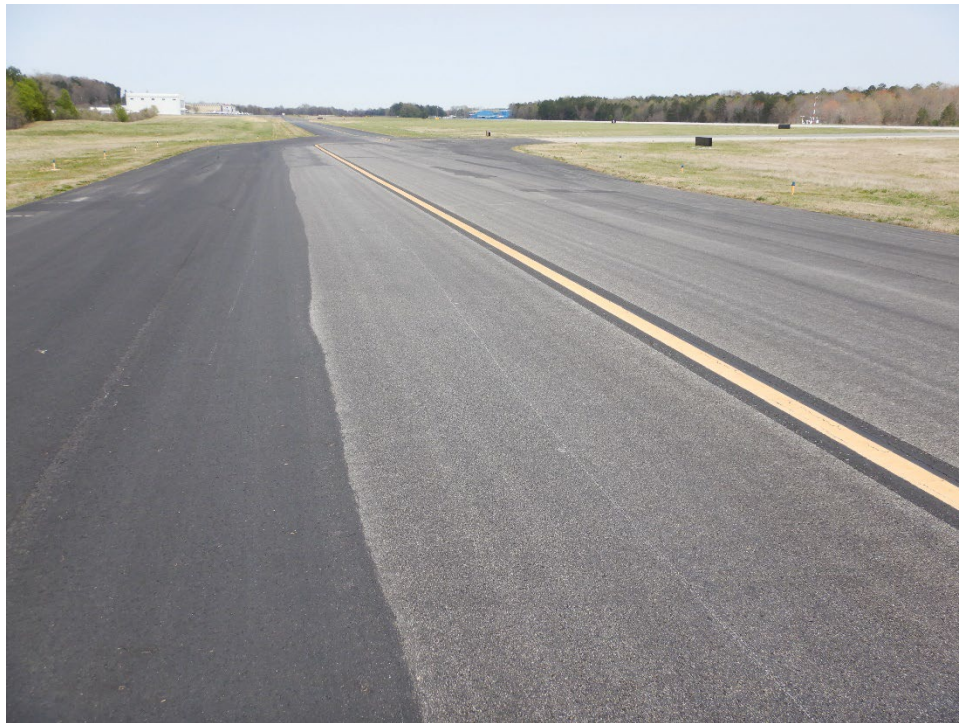
Figure 4. P-632 Coverage Variation

EQY applied P-632 on the taxiways in 2018. This project was carried out through the North Carolina Department of Transportation Pavement Maintenance Project. EQY taxiways consist of pavements that ranged from 5 to 20 years at the time of application. All taxiways had predominantly climate-related distresses and PCIs above 74 in 2019. A cursory visual inspection in 2022 indicates that P-632 coverage was still good across all the applied surfaces with approximately 5% coarse aggregate exposure. P-632 uniformity within an application lane was also good, although some areas received less coverage during application of P-632 as shown in Figure 4. Additionally, P-632 was apparently not able to reduce the loss of fine aggregate as the performance of the P-632-treated pavement was approximately the same as the untreated pavements. Minor spalls were also observed that could lead to FOD generation.

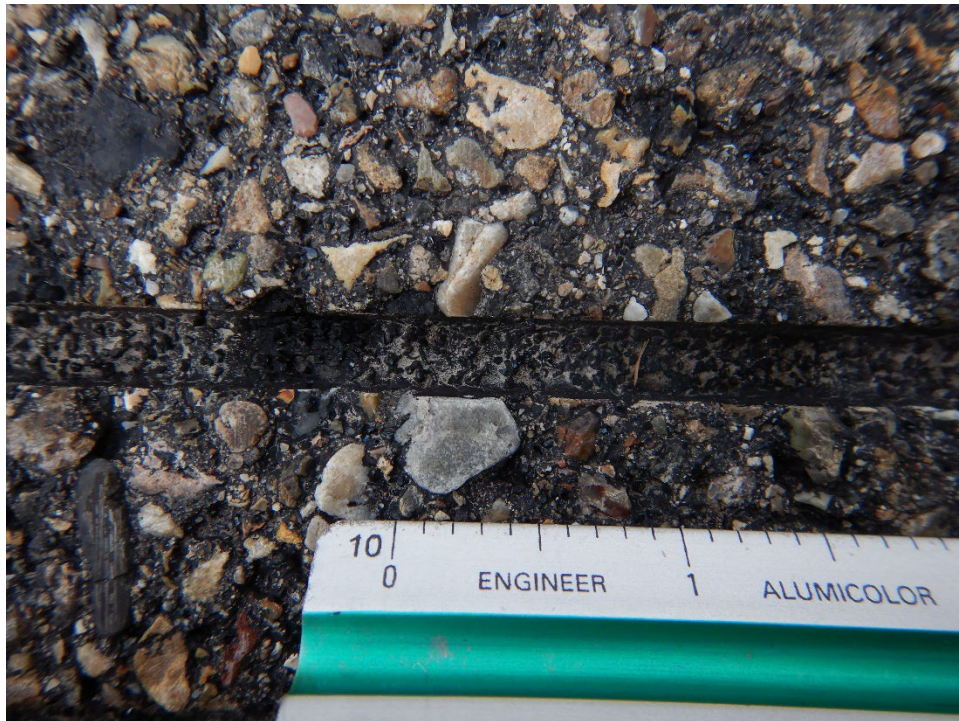
Figure 5. P-608 Material Visible in EKO Runway 06/24 Groove

Immediately after application, EKO reported that P-608 was successful and the visual delineation with the newly applied pavement markings was very good. However, the P-608 material started fading within 1 year of application, possibly accelerated by snow-removal operations. A cursory visual inspection in 2022 revealed very little of the P-608 remaining on the surface of the grooved primary runway but P-608 was present within grooves, as shown in Figure 5. P-608 had no service life remaining at the time of inspection. The primary taxiway and apron had better P-608 coverage than the primary runway, but still between 40% and 80% of the coarse aggregate was exposed. Overall, EKO reports the P-608 did not fully meet its intended objective for these pavements based on the surface coverage.

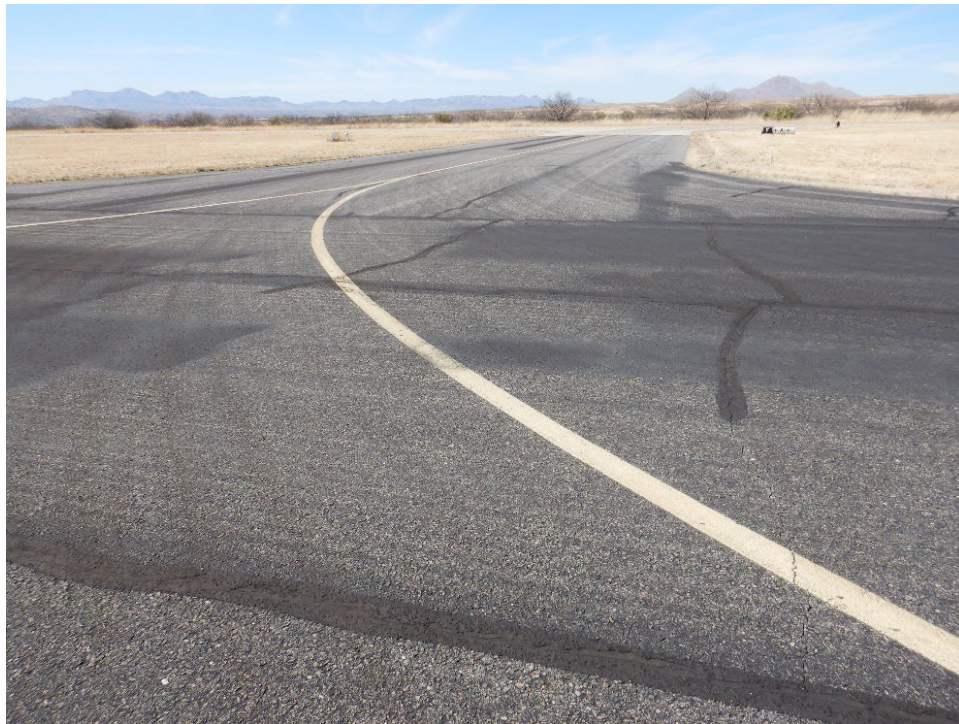
Figure 6. P-608 Coverage Along Taxi Line at OLS

Immediately after application in 2021, OLS reported that P-608 was successful in improving pavement conditions and the visual delineation with the newly applied pavement markings was very good. A cursory visual inspection in 2022 revealed that coverage over the surface was still adequate in most locations; however, coverage was noticeably lighter in high traffic areas as shown in Figure 6. Tire marks were apparent in all areas of application. The P-608 did not prevent the formation of new cracks or prevent existing cracks from widening. There were no general FOD concerns in the treated areas. Overall, OLS views the P-608 as meeting its intended objective by shielding the pavement from high UV exposure.

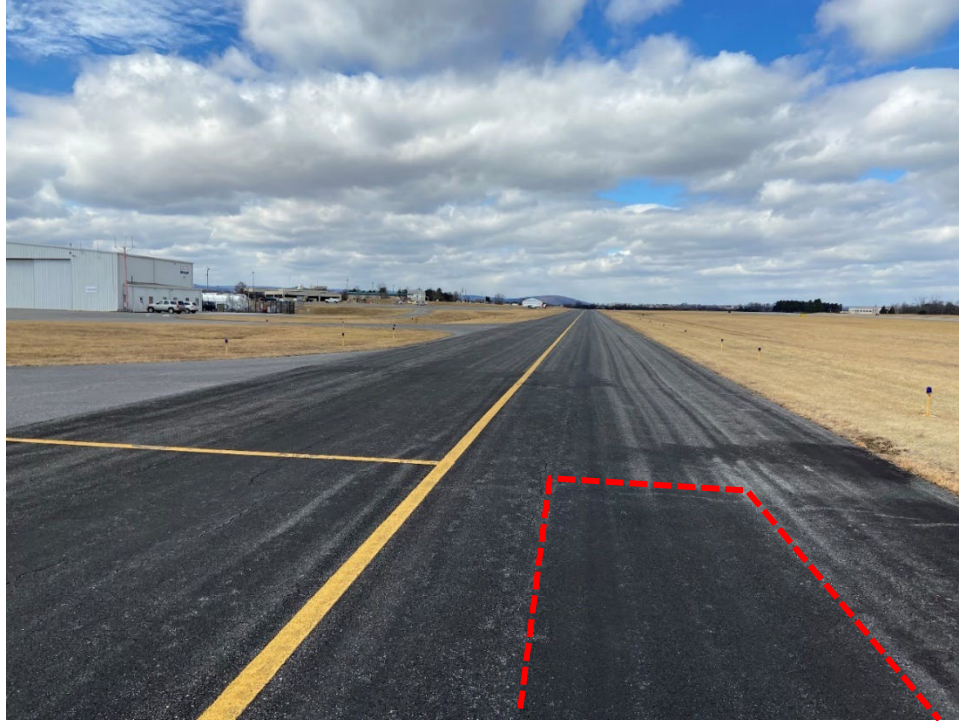
Figure 8. Typical P-608 Application and Overlap on Taxiway A

The P-608 application occurred in 2020, and immediately after application, OKV reported that the P-608 was successful in improving the pavement condition. Also, with its dark color, the visual delineation with the newly applied pavement markings was very good. Some areas received double treatment due to overlap of the spray distributor, and those areas were easily visible in early 2022, as seen in Figure 8. No FOD concern was apparent at the airport. It has yet to be determined if the surface treatment has extended the life of the pavement.

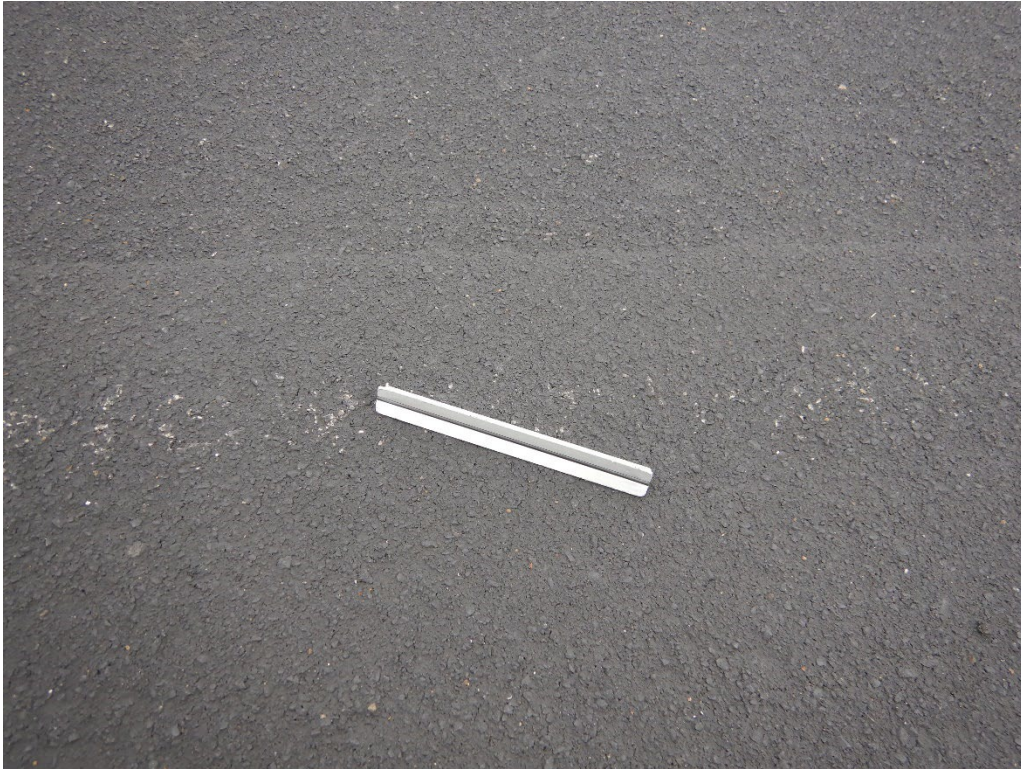
Figure 9. P-629 Texture on M17 Taxiway

coverage on all pavements. The surface is highly textured as shown in Figure 9. The treatment maintained its black color except for certain locations compromised by fuel spillage. Cracks were appearing at some locations and the cracking pattern indicates that the underlying pavement is continuing to develop new cracks and older cracks continue to widen. Sealant was also failing in some crack locations.

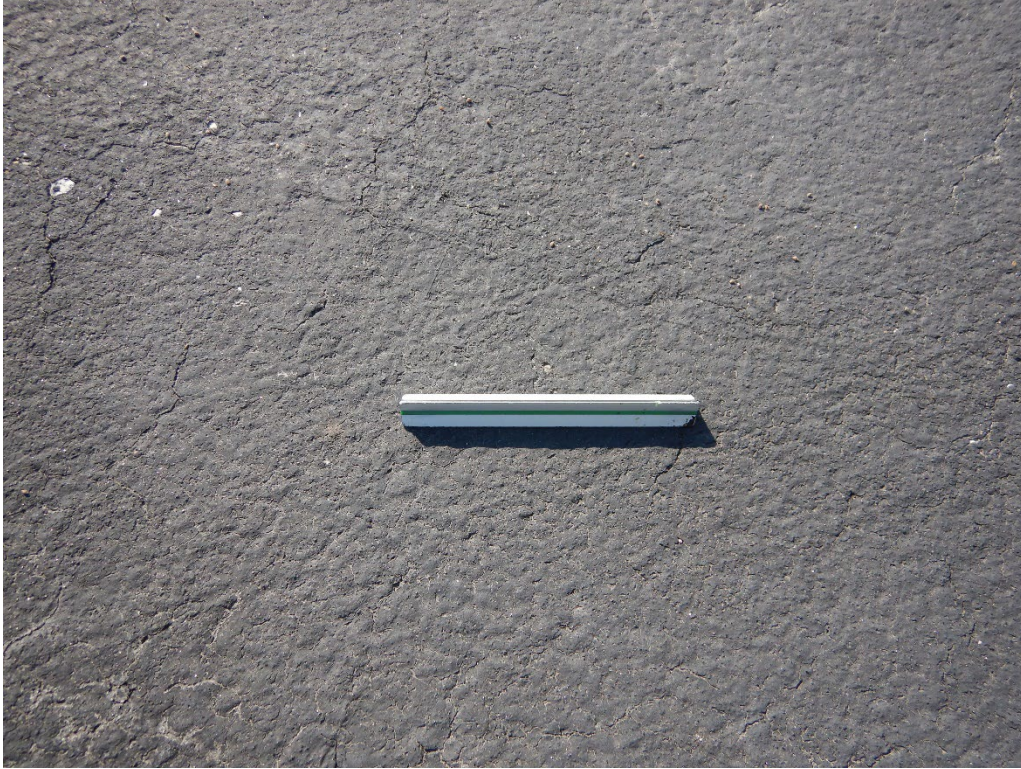
Figure 10. MO-623 Texture on LLU Apron

An MO-623 Pavement Friction Seal Coat Surface Treatment was applied at Lamar Municipal Airport (LLU) in 2016 on runway, taxiway, and apron pavements constructed between 2002 and 2005. At the time of application, this material met FAA AC 150-5370-10G specifications. A cursory visual inspection in 2022 revealed that the MO-623 coverage had deteriorated over the 6 years since application, with exposed coarse aggregate present in almost half the taxiway and apron areas and a quarter of the runway area. The pavement markings placed in 2016 were very worn but the surface treatment still appeared to be black. Cracks were appearing at some locations and the cracking pattern indicated that the underlying pavement was continuing to develop new cracks and older cracks continued to widen.

Overall, MO-623 was successful in extending the pavement life. MoDOT reported that based on their experience, MO-623 is a cost-effective and longer lasting treatment than P-608. The treatment provides good visual delineation due to its black color, as shown in Figure 10. The sourcing of “Black Beauty” sand used in MO-623 is very limited. Due to this and the lack of inclusion within the FAA specifications for NPIAS airports, MoDOT is currently promoting use of P-608 or P-631 instead of MO-623. LLU believes MO-623 should be given preference as its advantages far exceed the difficulty in acquiring specialized aggregate.

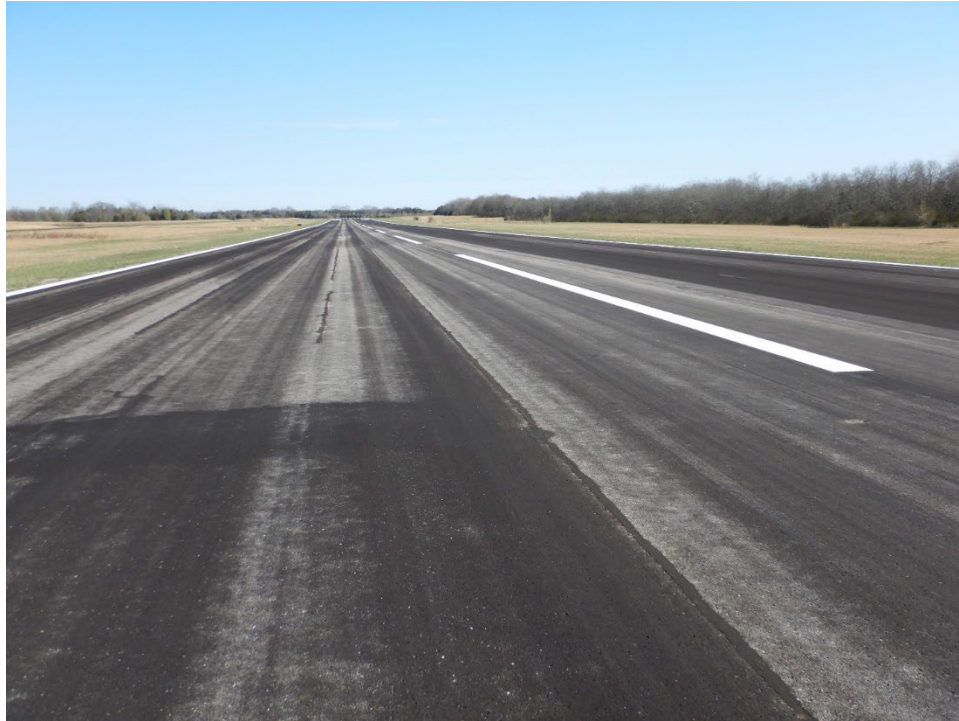
Figure 11. Ellington Airport Runway 02/20

Immediately after application in 2021, LUG reported that P-608 was successful in improving pavement conditions. Since application, the treatment has faded and gives the appearance of deteriorating pavement. From a cursory visual inspection in 2022, the P-608 application was likely non-uniform as shown in Figure 11. Between 50% and 60% of the coarse aggregate was exposed throughout much of the application area. However, P-608 was applied on the apron over a previously applied P-631, which made it difficult to assess the current condition of the P-608. The P-608 application itself appears uniform and there is only 5% exposed coarse aggregate. Some

white precipitates had formed within the cracks. The majority of the crack sealant was in good condition on all pavements. There is no FOD concern related to these surface treatments. Overall, however, LUG reports the P-608 failed to meet their objectives due to its early fading. TDOT, in general, has been satisfied with their approach of widespread application of P-608 across the state and its use in extending pavement life.

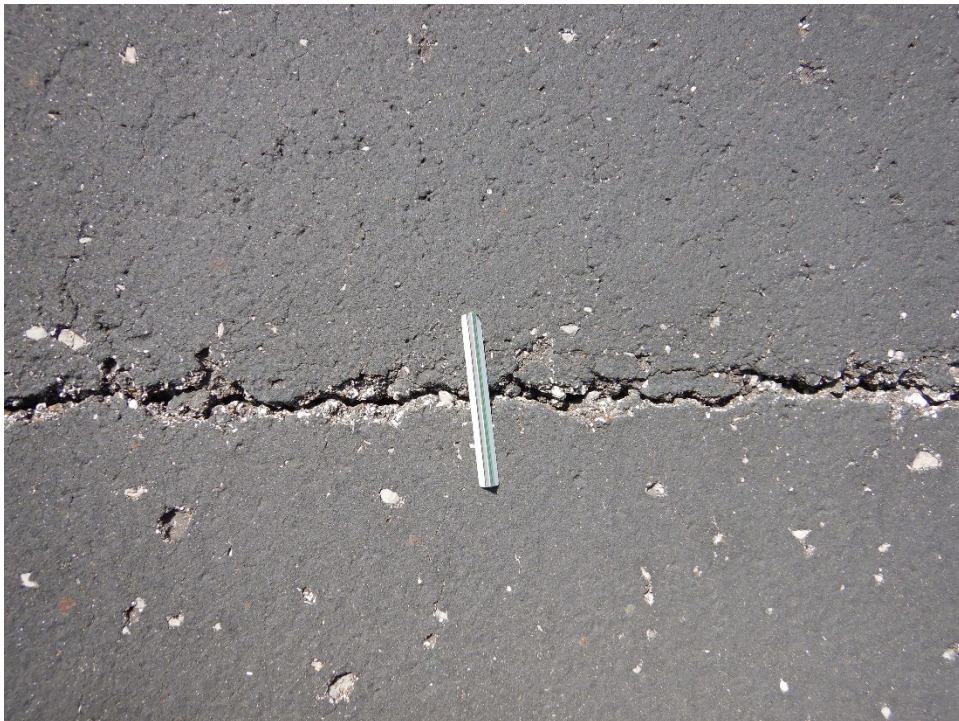
Figure GZS-5. Cracking on Runway 16/34

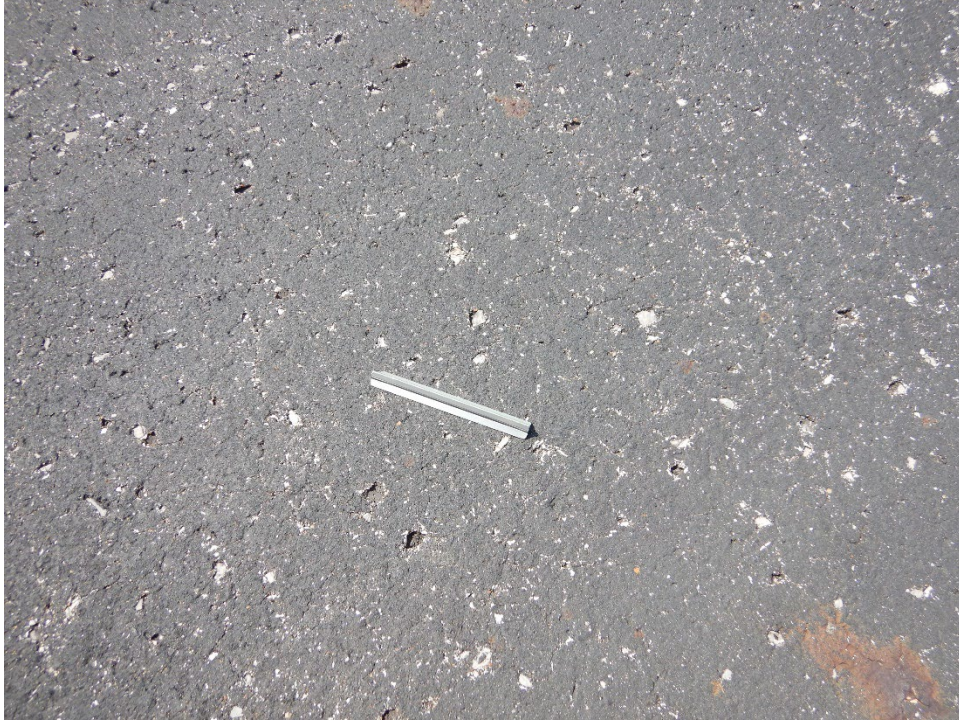
Figure GZS-6. Raveling on Runway 16/34

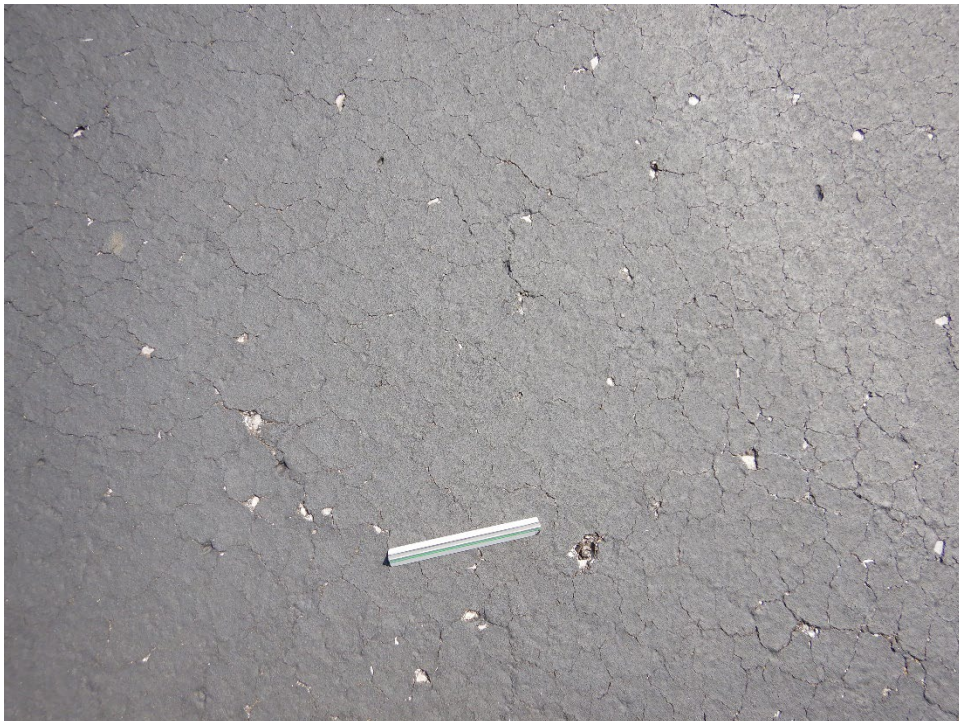
Figure GZS-11. Map Cracking on Apron

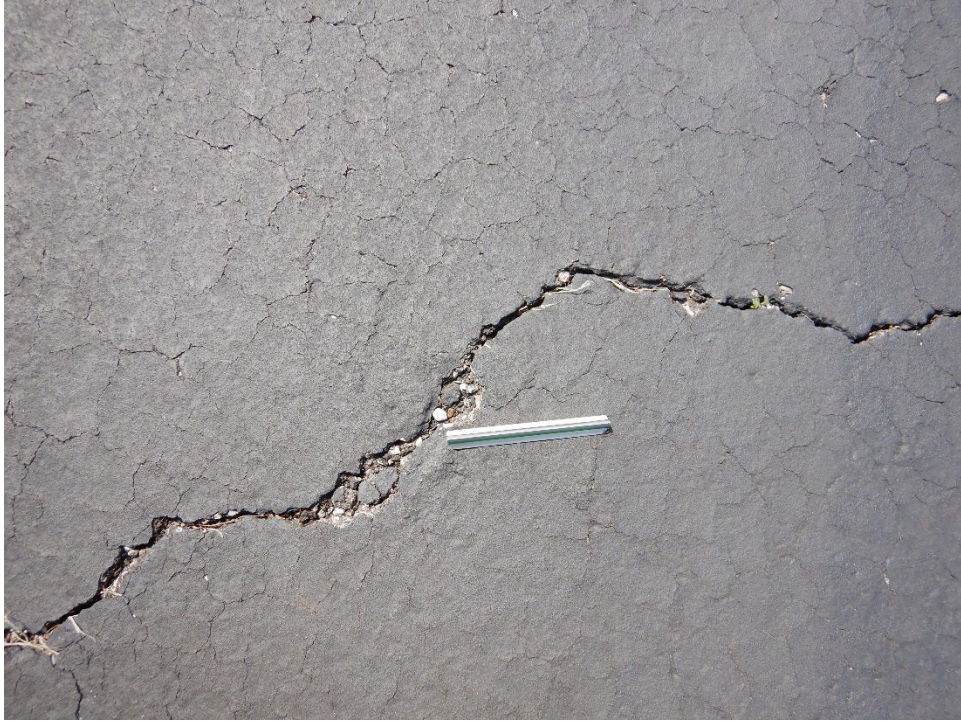
Figure GZS-12. Cracking on Apron

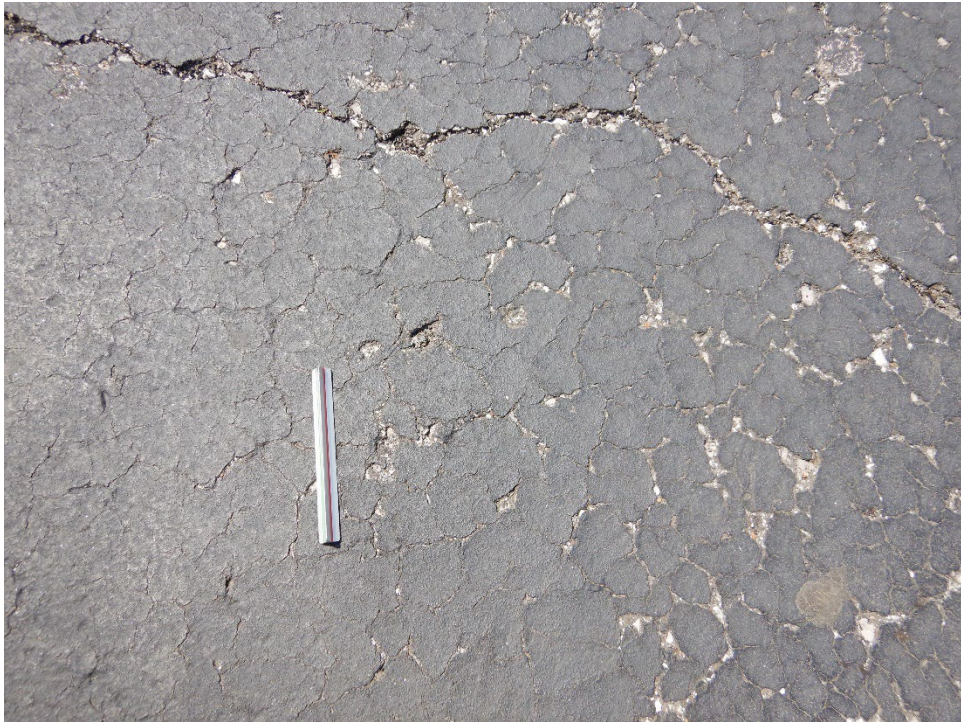
Figure GZS-13. Raveling on Apron

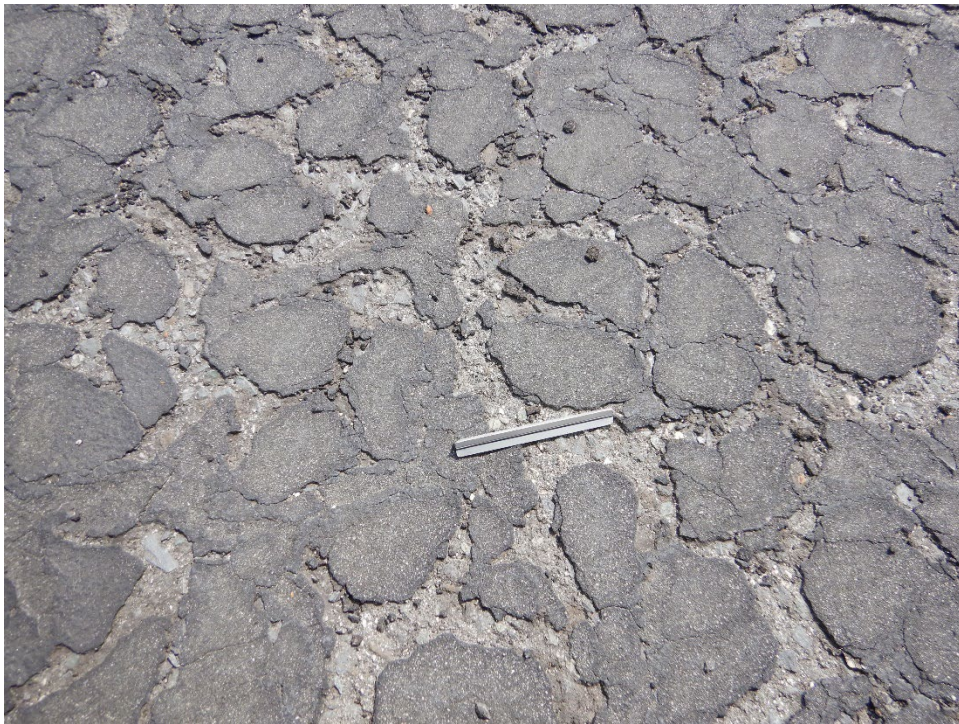
Figure EQY-4. Severe Map Cracking with Coal Tar Slurry

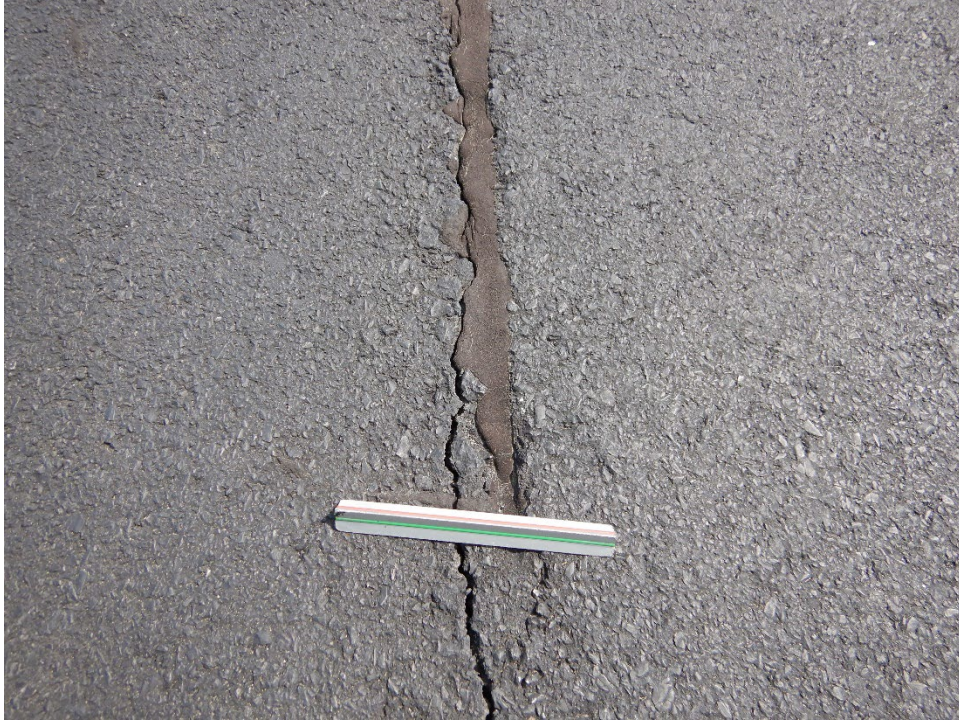
Figure EQY-14. Cracking on Medium Age Taxiway

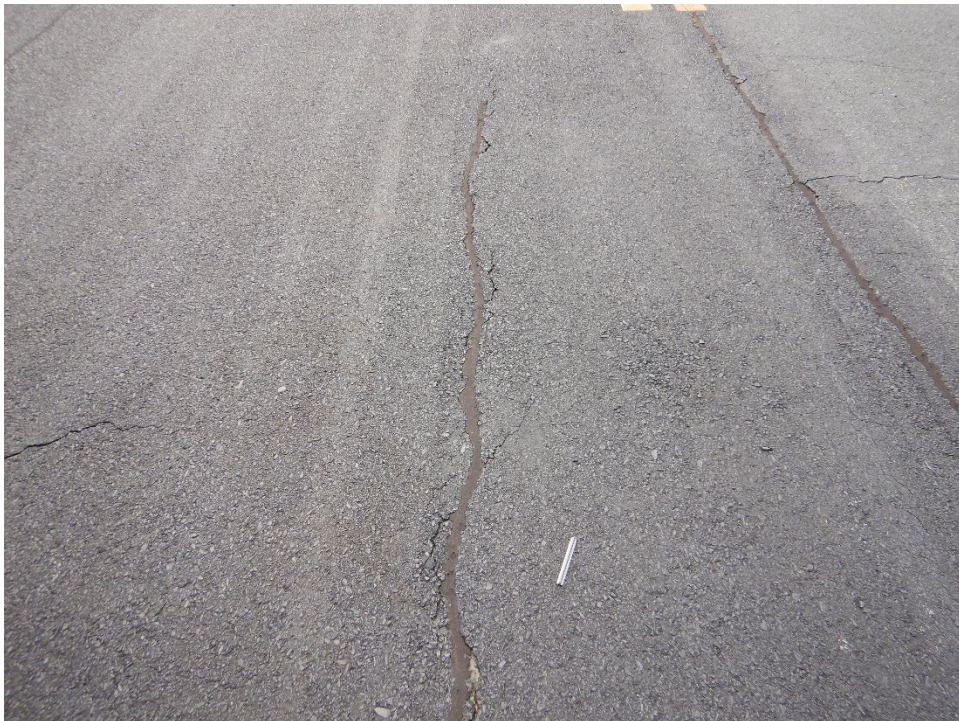
Figure EQY-21. Cracking on High Age Taxiway

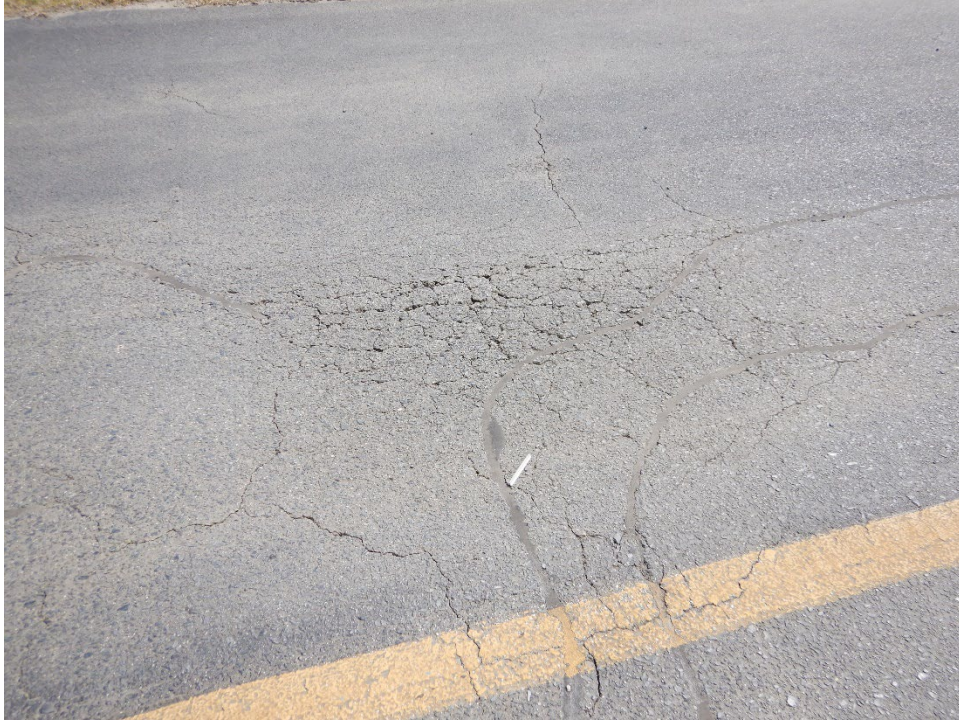
Figure EQY-22. Depression and Fatigue Cracking on High Age Taxiway

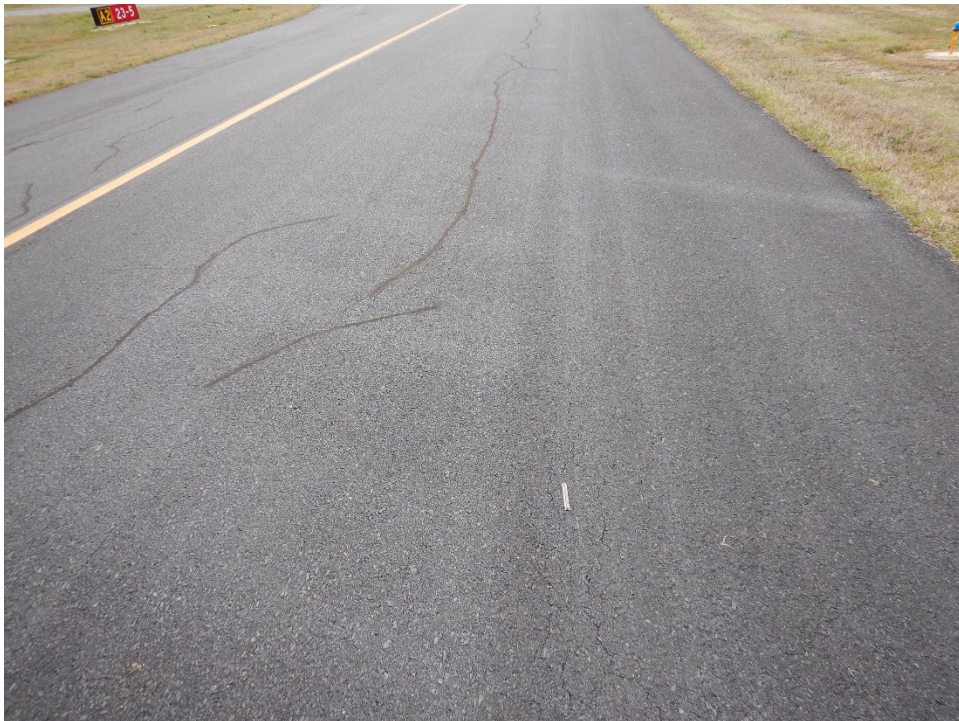
Figure EQY-23. Fatigue Cracking on High Age Taxiway

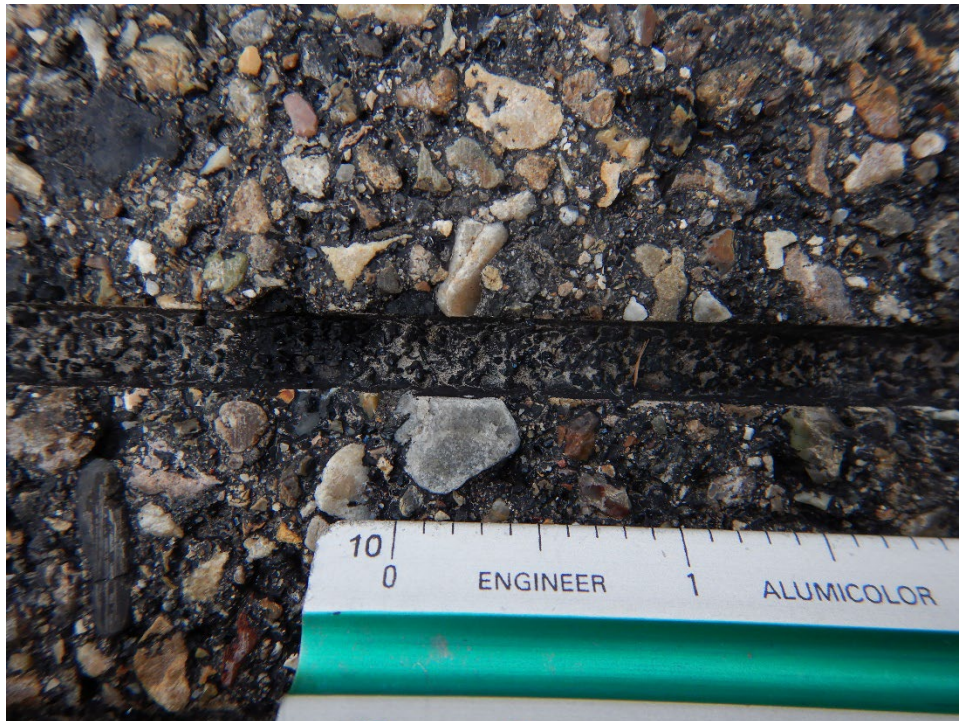
At the current condition, the P-608 surface treatment on Runway 06/24 has no remaining service life. The P-608 material visible within the runway grooves does not help to preserve the pavement. The city commented that the rapid fading of P-608 may have been accelerated by snow removal operations. Figures EKO-1 through EKO-7 showcase the condition of the runway.

Figure EKO-4. P-608 Material Within Runway 06/24 Grooves

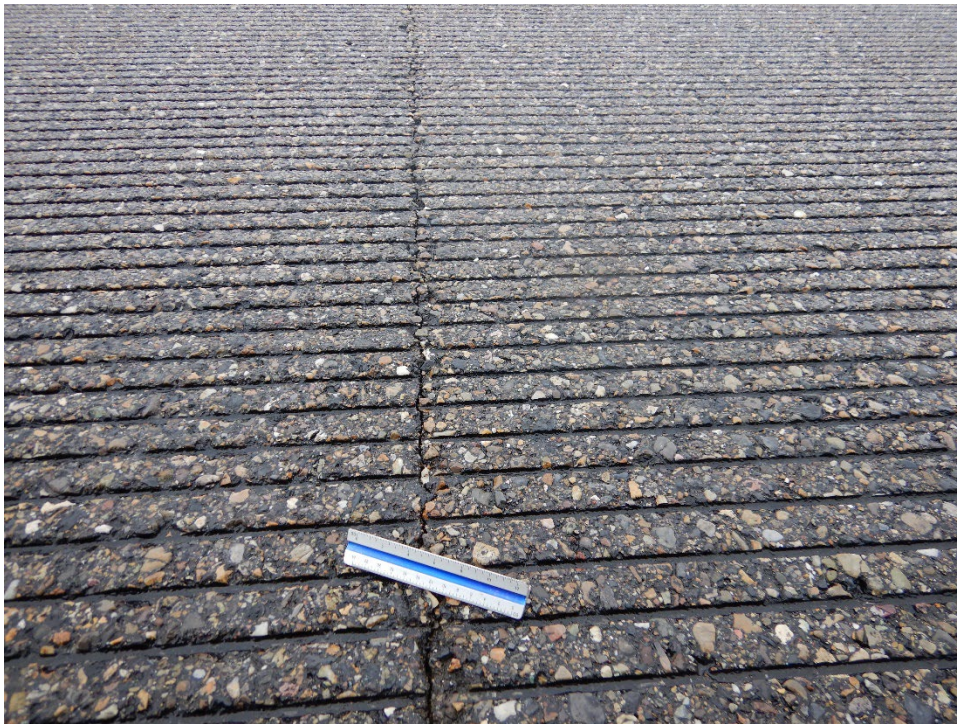
Figure EKO-6. Cracked Longitudinal Paving Joint on Runway 06/24

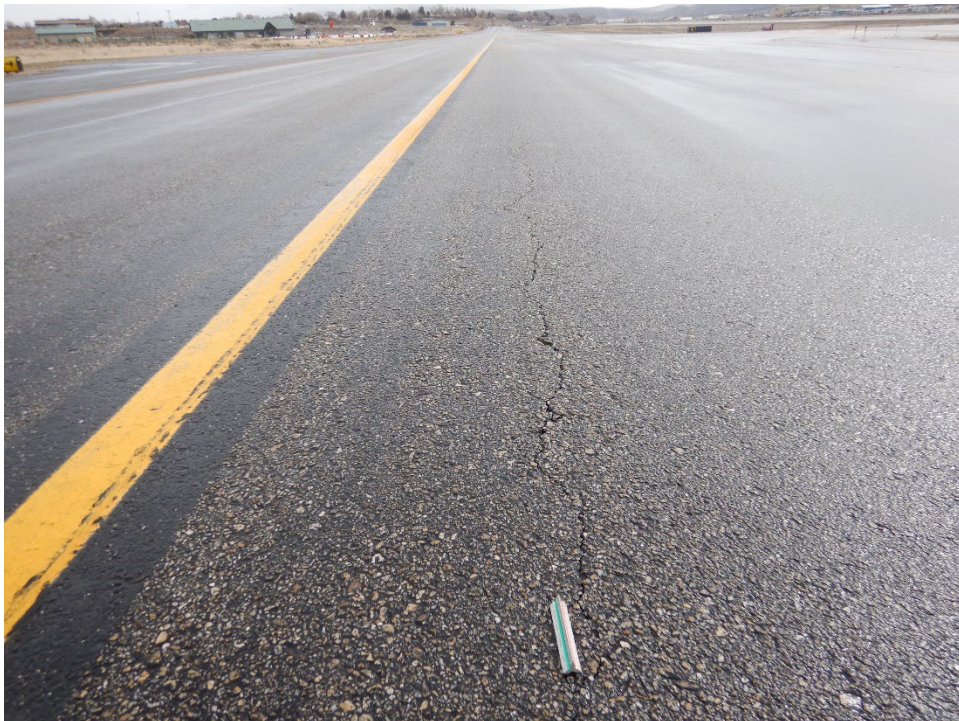
Figure EKO-11. Wheelpath Cracking on Taxiway A

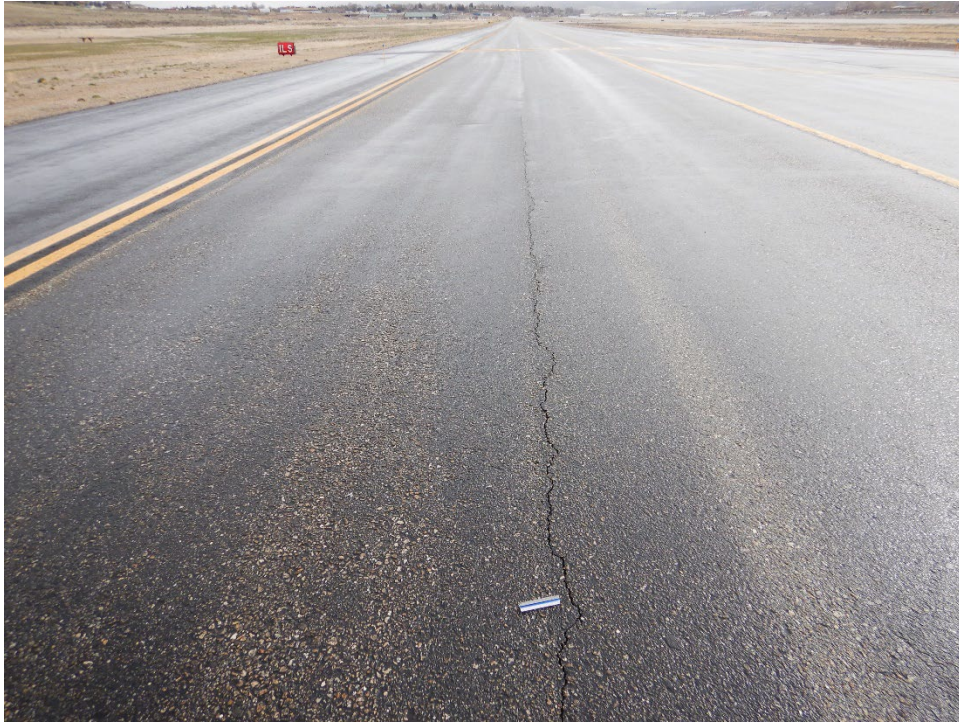
Figure EKO-12. Opened Longitudinal Joint on Taxiway A

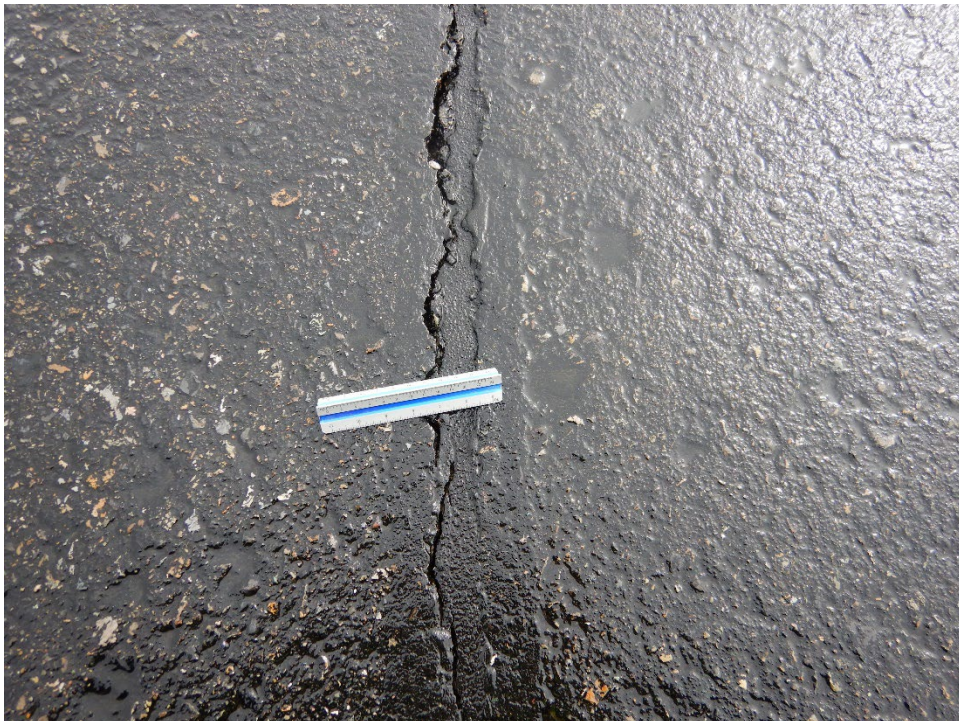
Figure EKO-13. Failed Crack Sealant on Taxiway A

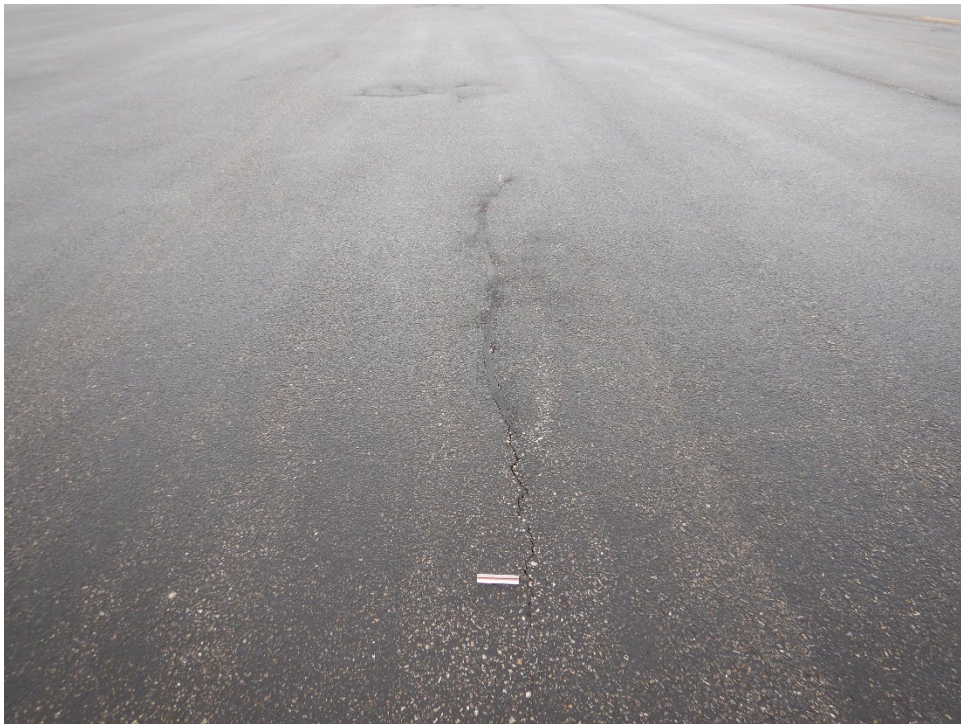
Figure EKO-17. Cracking Development on Apron

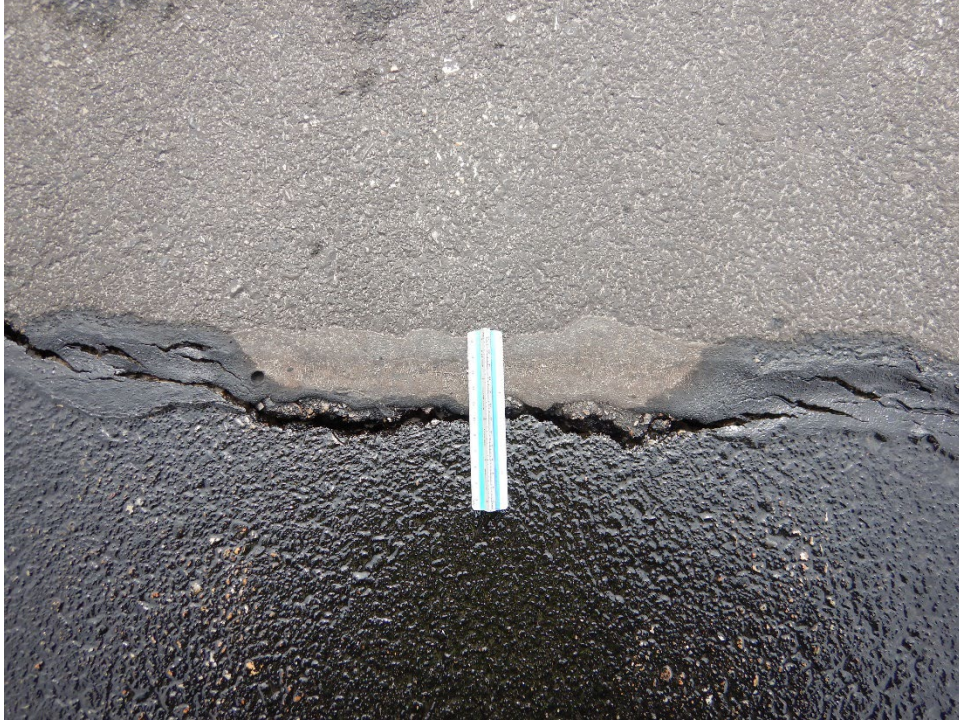
Figure EKO-24. Failed Crack Sealant on Runway 12/30

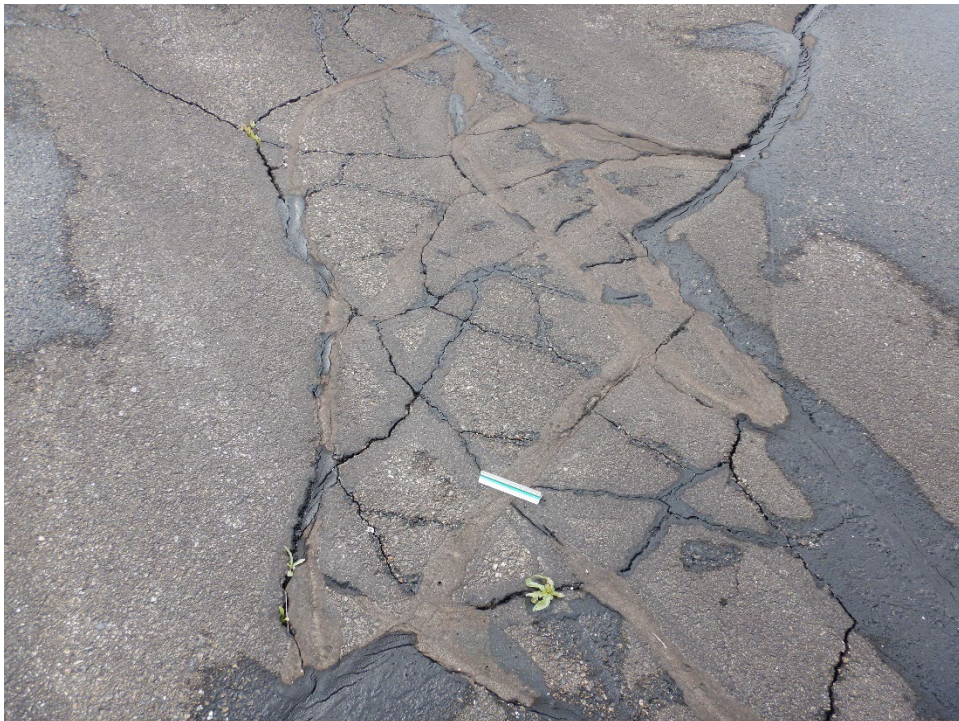
Figure EKO-25. Fatigue Cracking on Runway 12/30

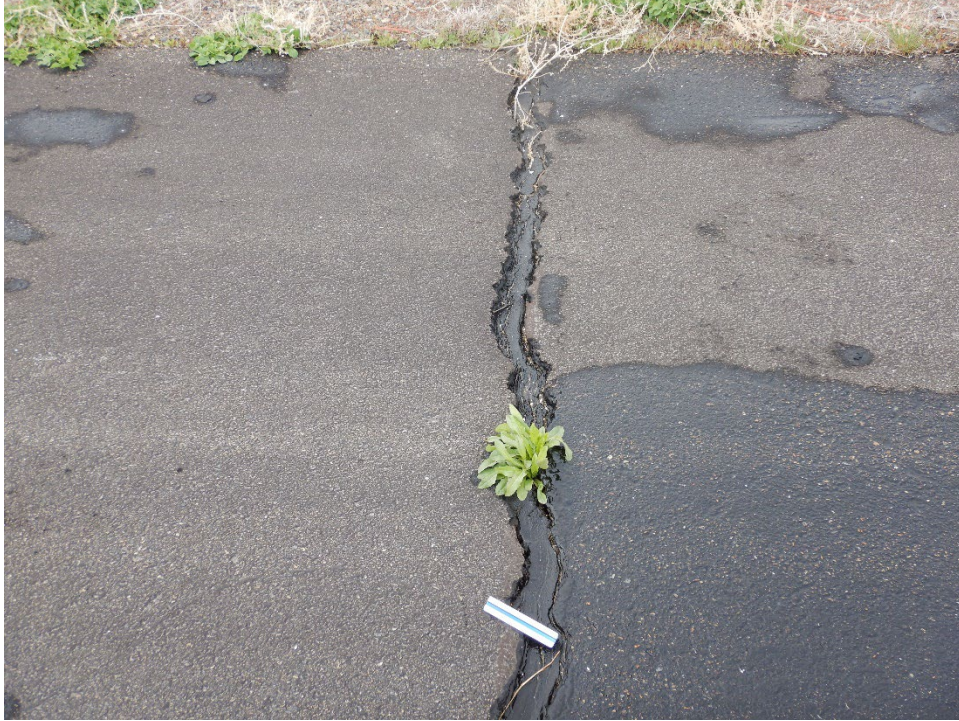
Figure EKO-26. Vegetation on Runway 12/30

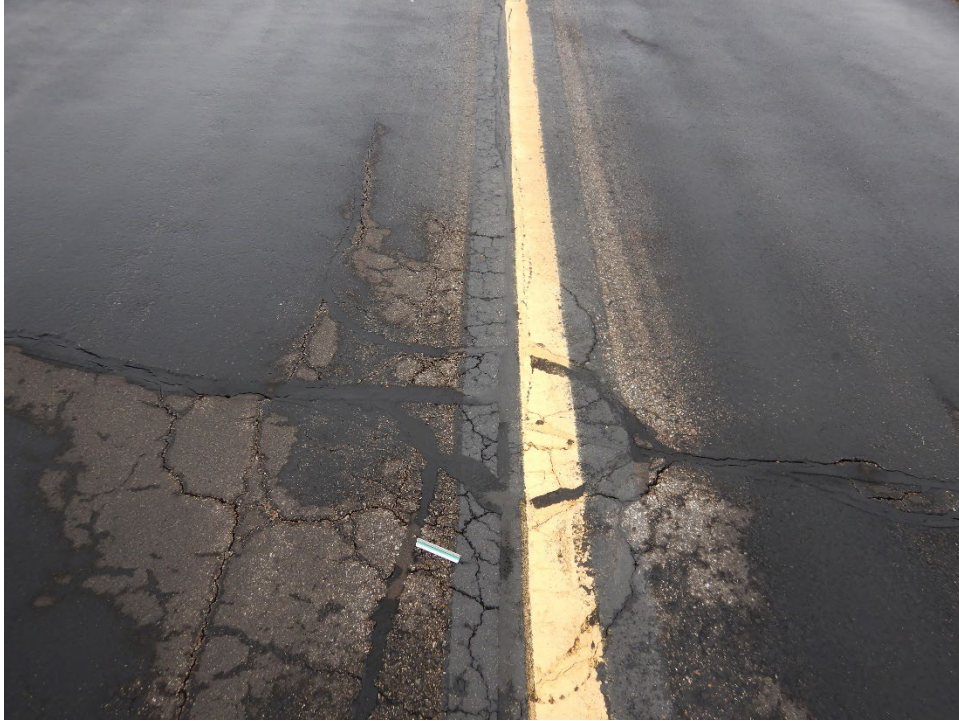
Figure EKO-30. Fatigue Cracking on Taxiway B

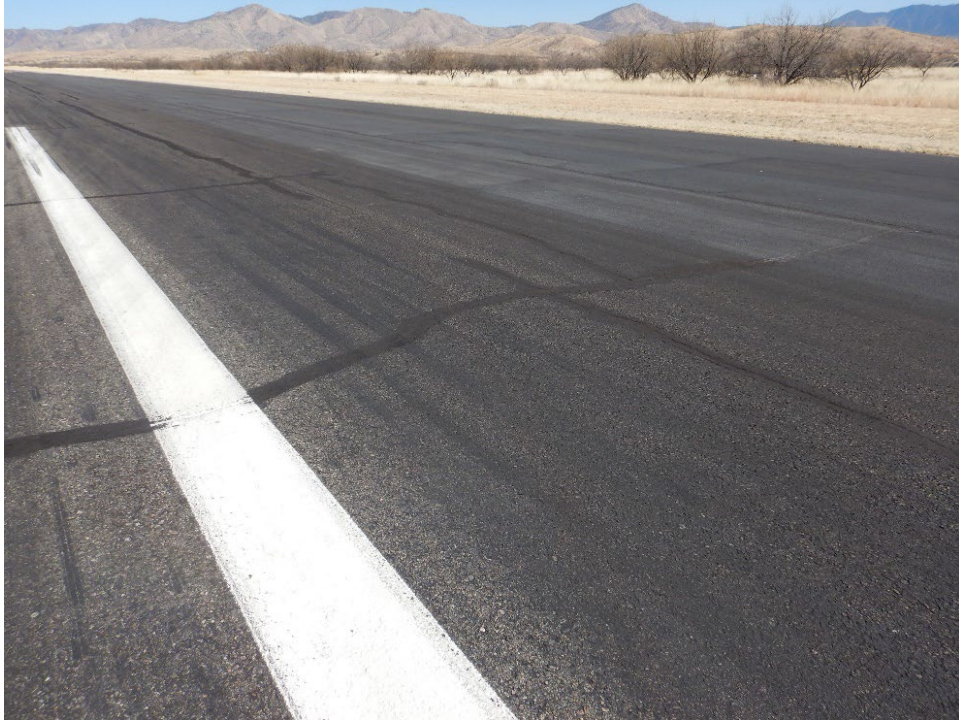
Figure OLS-2. Wearing Pattern on Runway 04/22

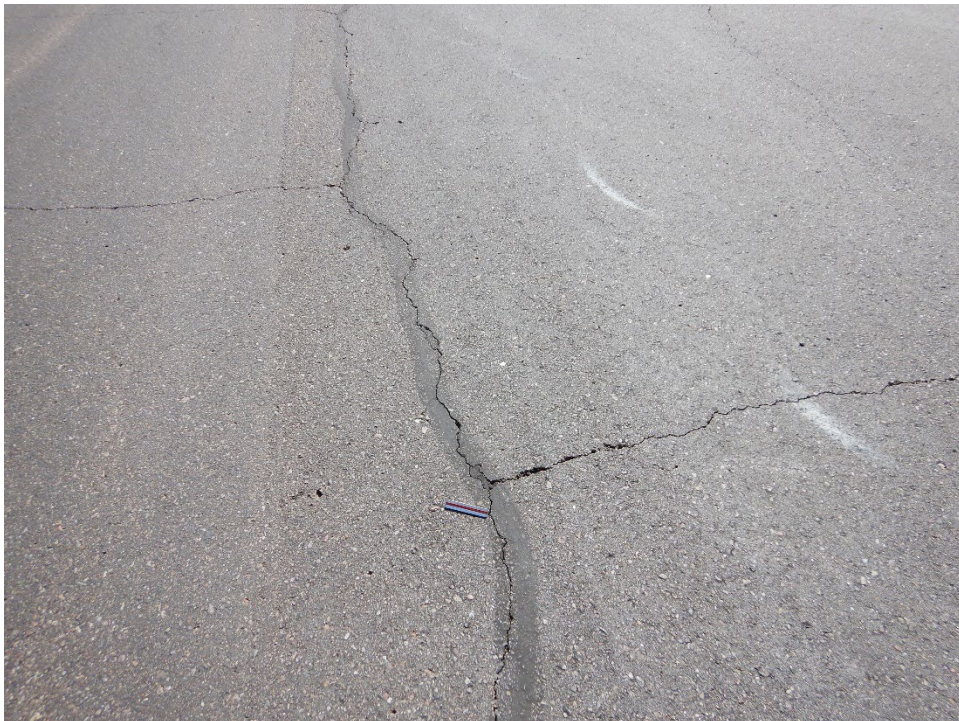
Figure PHX-4. New Crack Formation on West Cargo Apron

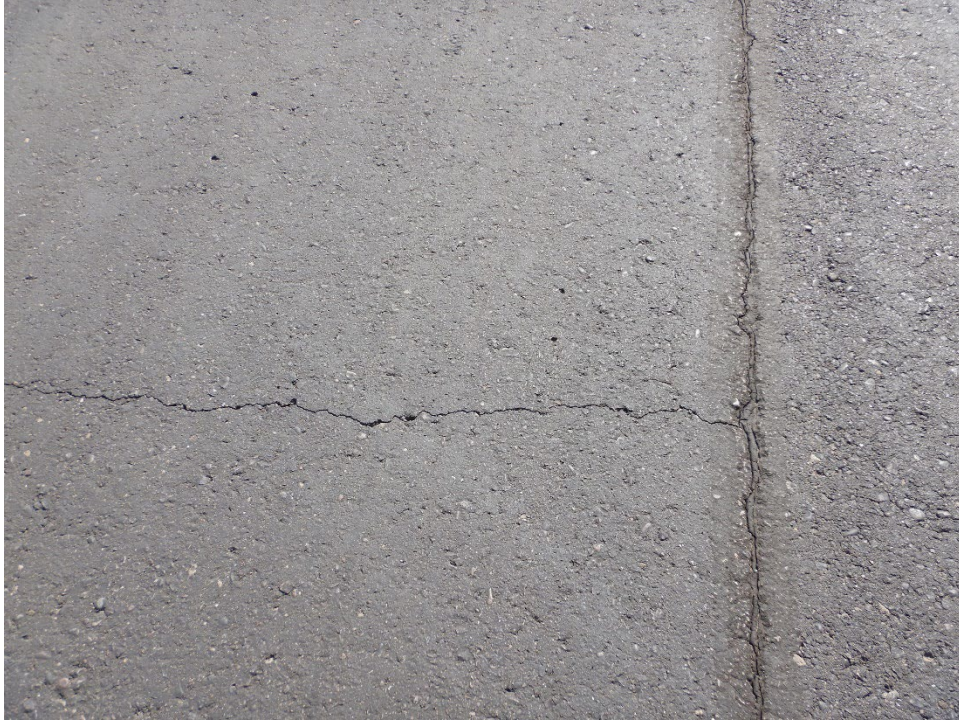
Figure PHX-8. New Cracking on Taxiway A
