Summary of Case Studies and Observations on Airport Experience with Pavement Surface Treatments

August 2023

DOT/FAA/TC-TN23/49

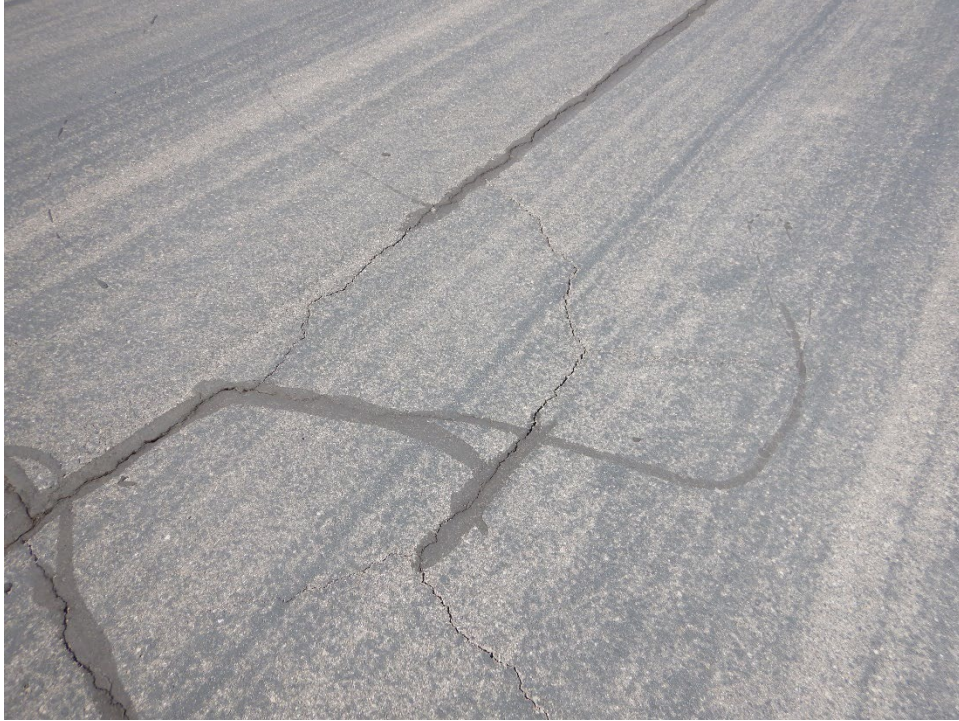
Figure PHX-12. Crack Development on East Cargo Apron

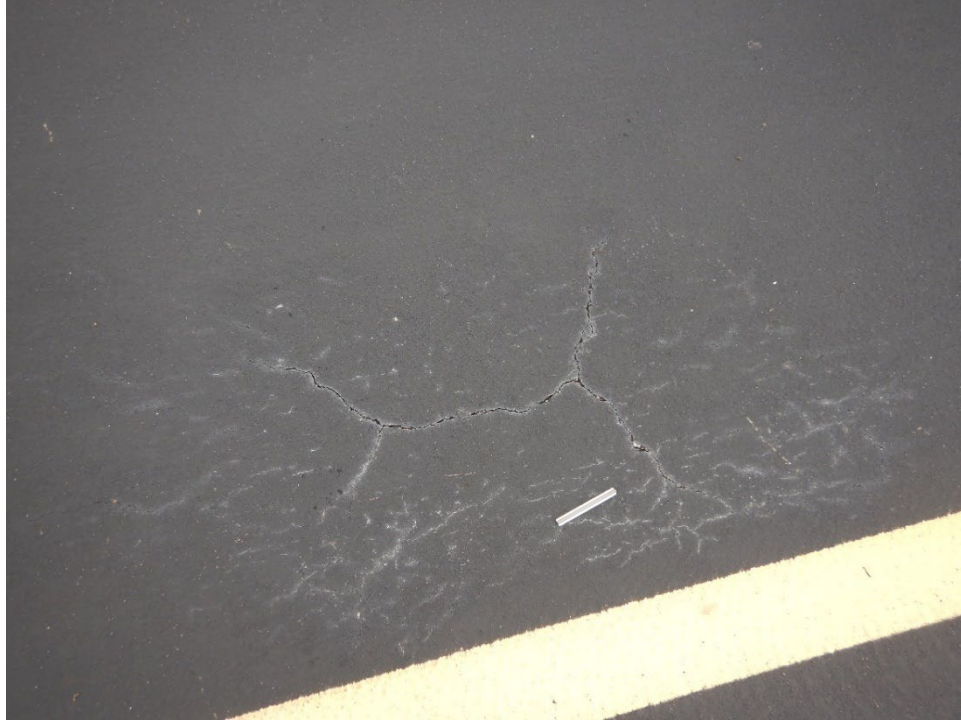
Figure MoDOT-9. Possible Fatigue Cracking on P-629

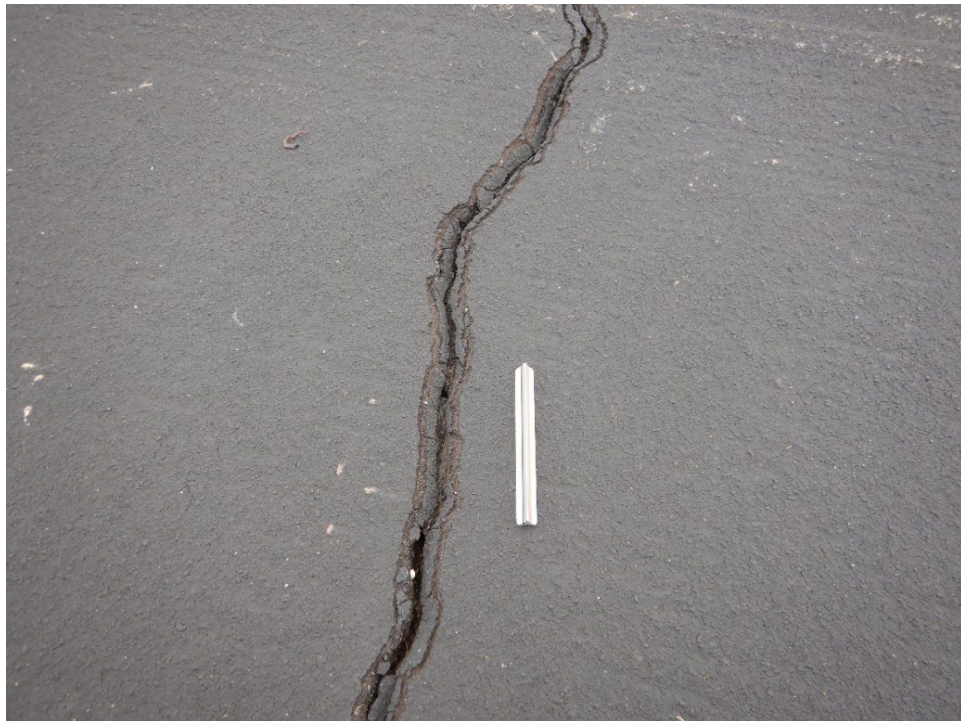
Figure MoDOT-10. M17 Taxiway Cracking With Failed Sealant

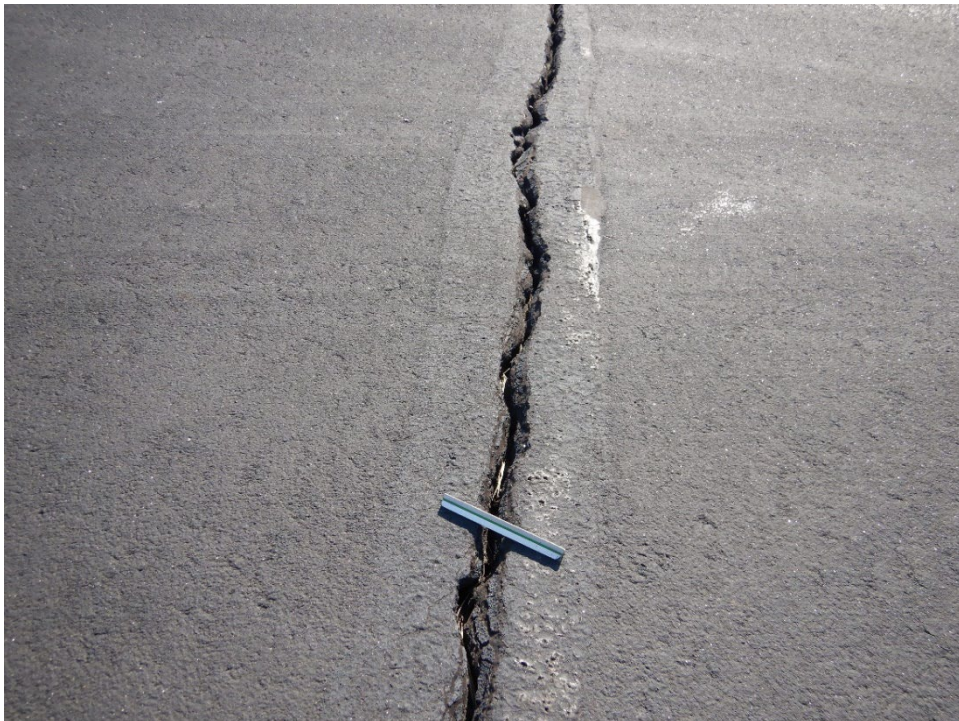
Figure MoDOT-18. LLU Runway 03/21 Cracking With Failed Sealant

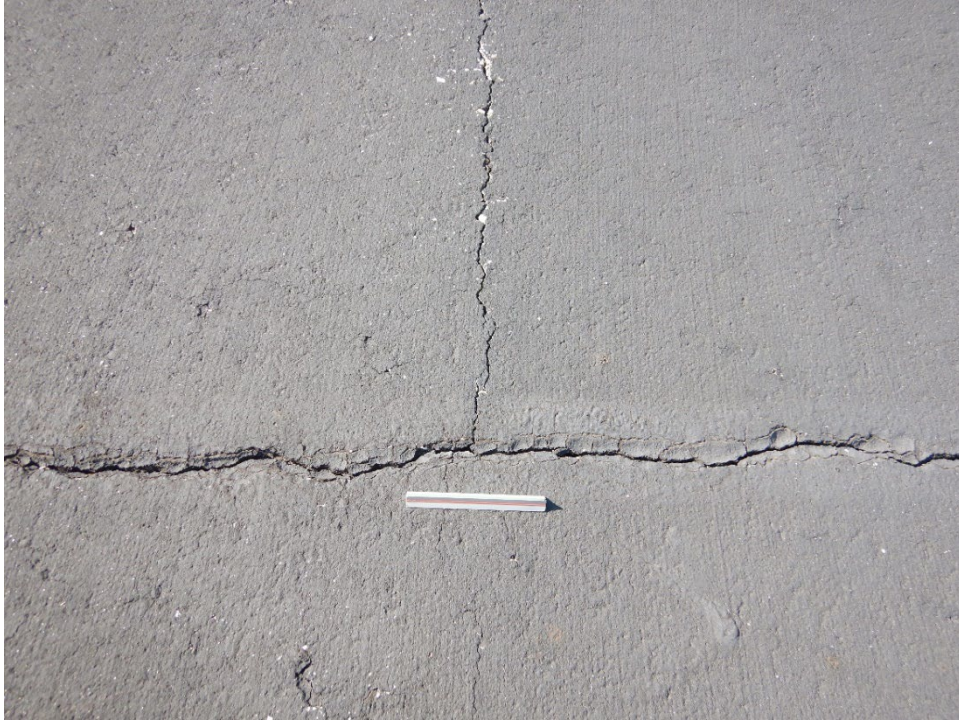
Figure MoDOT-19. LLU Runway 03/21 Cracking

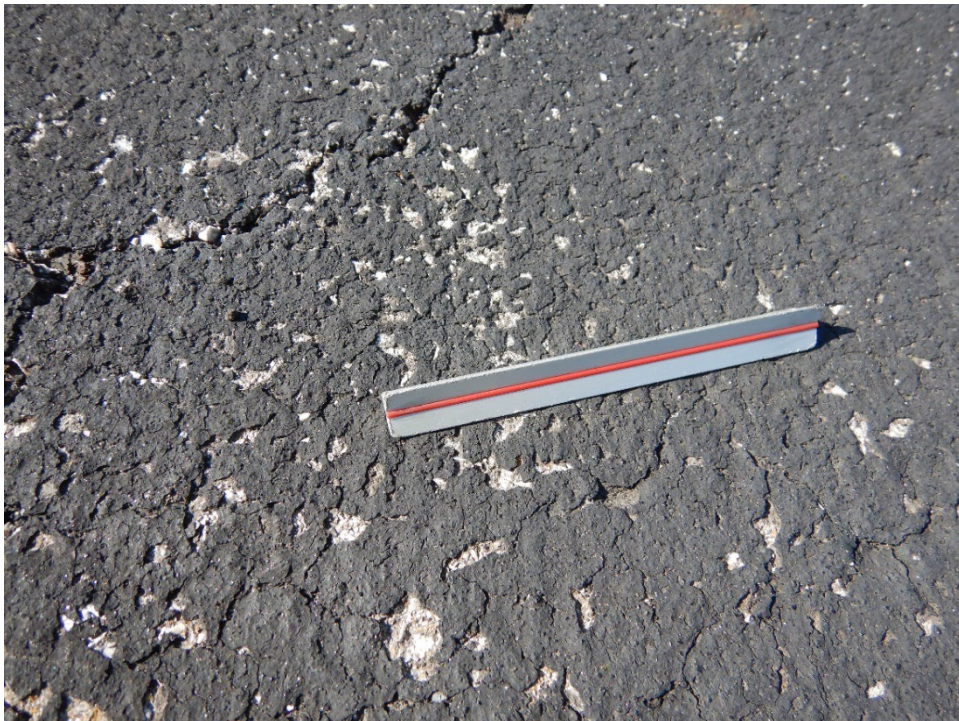
Figure MoDOT-20. LLU Runway 03/21 Raveling

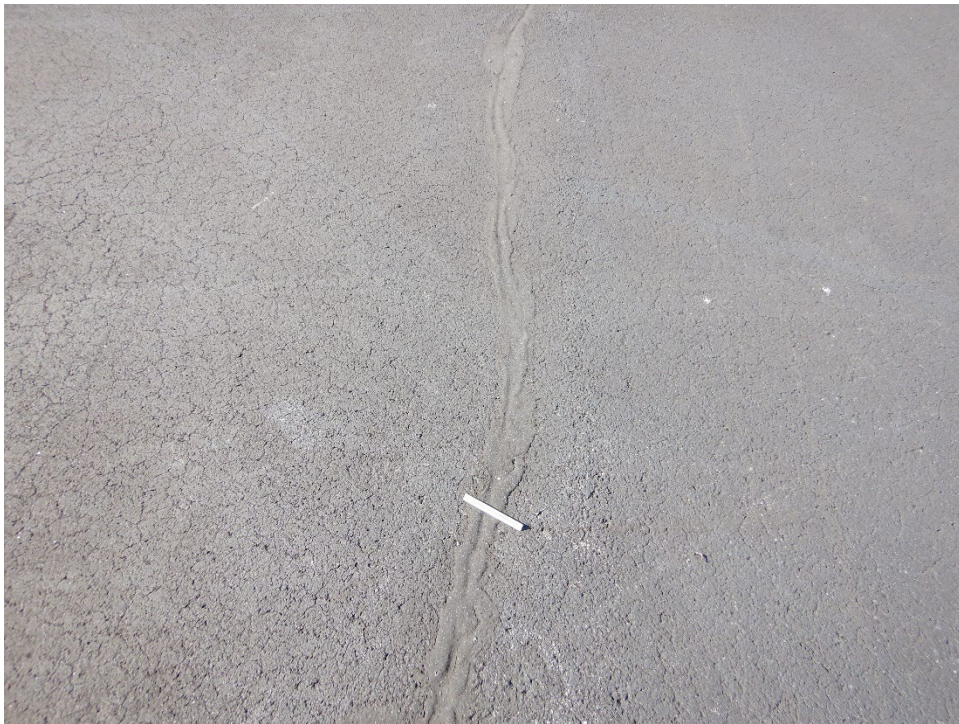
Figure LUG-16. Crack Sealant on Apron

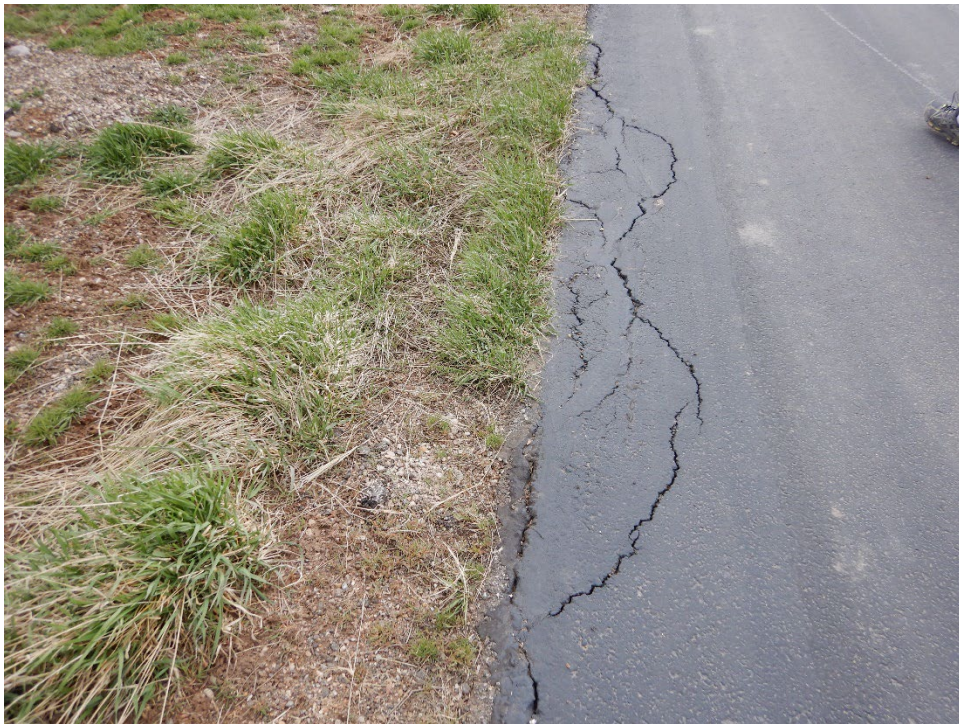
Figure UDOT-26. Edge Cracking on 42U Taxiway

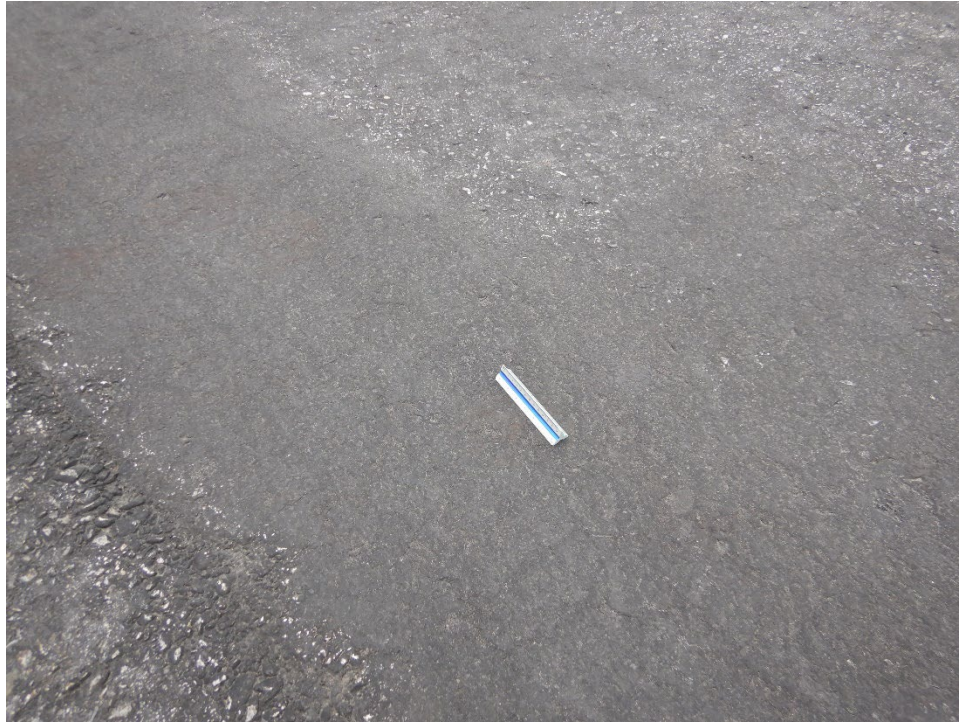
Figure UDOT-39. Thick Coal Tar Fog Seal Application on BMC Taxiway
(Rehabilitated in 2006)
