AC NO: AC 20-52

MAINTENANCE INSPECTION NOTES FOR
DOUGLAS DC-6/7 SERIES AIRCRAFT

AUGUST 24, 1967

DEPARTMENT OF TRANSPORTATION
Federal Aviation Administration

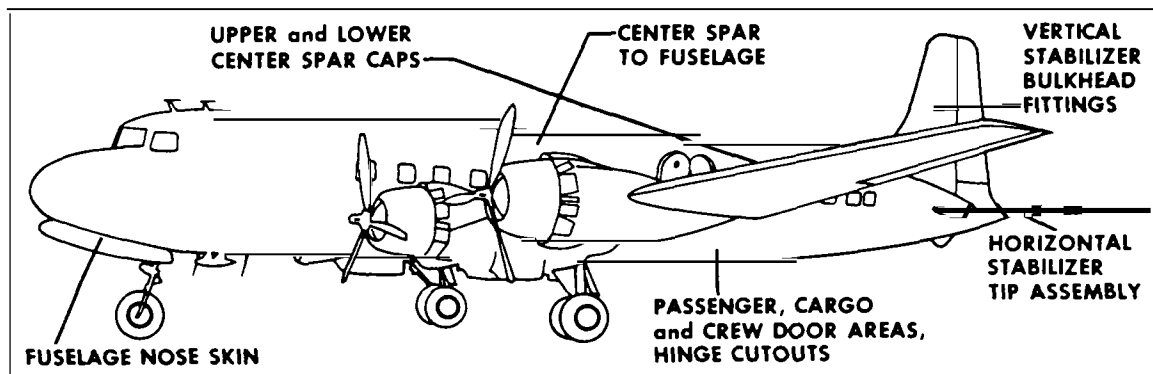
FIGURE 1 - AREAS SUBJECT TO FATIGUE CRACKS

- (1) Wing to fuselage attach fittings at center spar.
 - (2) Horizontal stabilizer and tail stub front spar attach fittings.
 - (3) Fuselage nose skin plating.
 - (4) Main crew/cargo entrance door latch plates.
 - (5) Rear fuselage frame and transverse floor beams.
- c. Corrosion Prone Areas. Figure 2 refers to some of the corrosion prone areas in the aircraft. Manufacturer's service bulletins and manuals have been issued to provide detailed repair instructions.

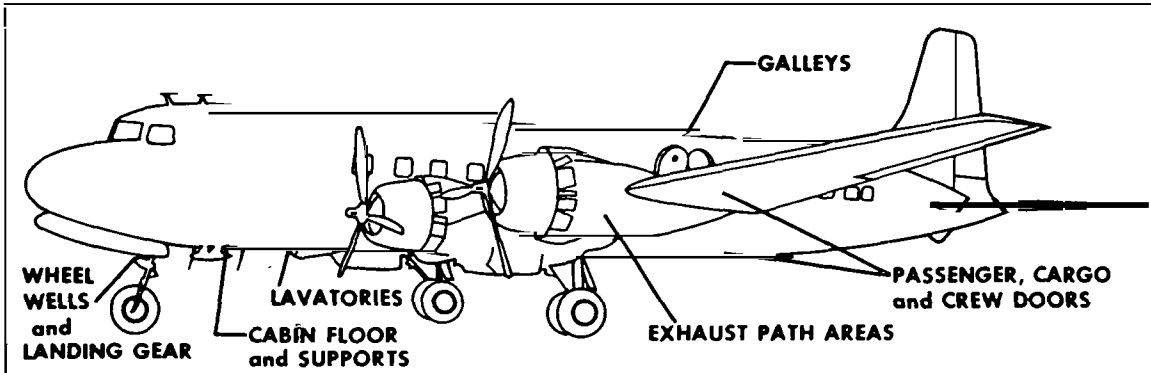
FIGURE 2 - AREAS SUBJECT TO CORROSION DAMAGE

- (1) Exhaust path areas.
- (2) Battery areas and vents.
- (3) Lavatories, galleys, and cabin floors.
- (4) Wheel wells and landing gear.
- (5) Joints between extruded aluminum sections and laminations.

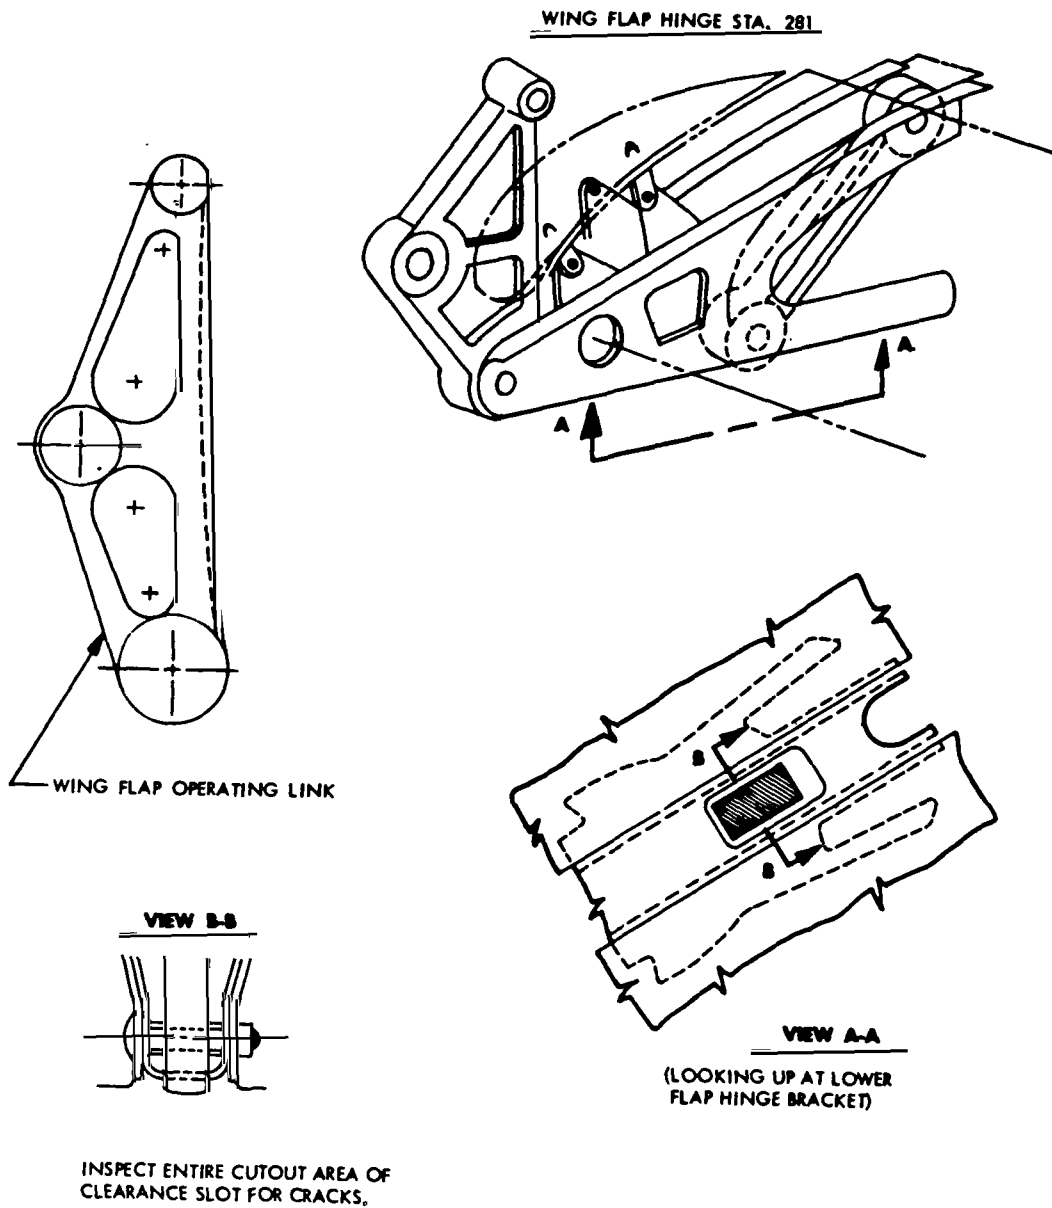
FIGURE C-4
FLAP HINGE BRACKET AND
LINKAGE WING STATION 281 (SHEET 4 OF 5)

- (4) During landing, the left wing flap was damaged. Investigation revealed that the left outboard hinge bracket assembly, P/N 3365189, was broken. The bracket was replaced.

- (6) During inspection, the right and left flap hinge fittings were found cracked in the inboard web at the radius of the hinge hanger cutout at W.S. 167. Hinge fittings, P/N 5492213-13 and -14 were replaced. Aircraft total time was 19,783 hours.

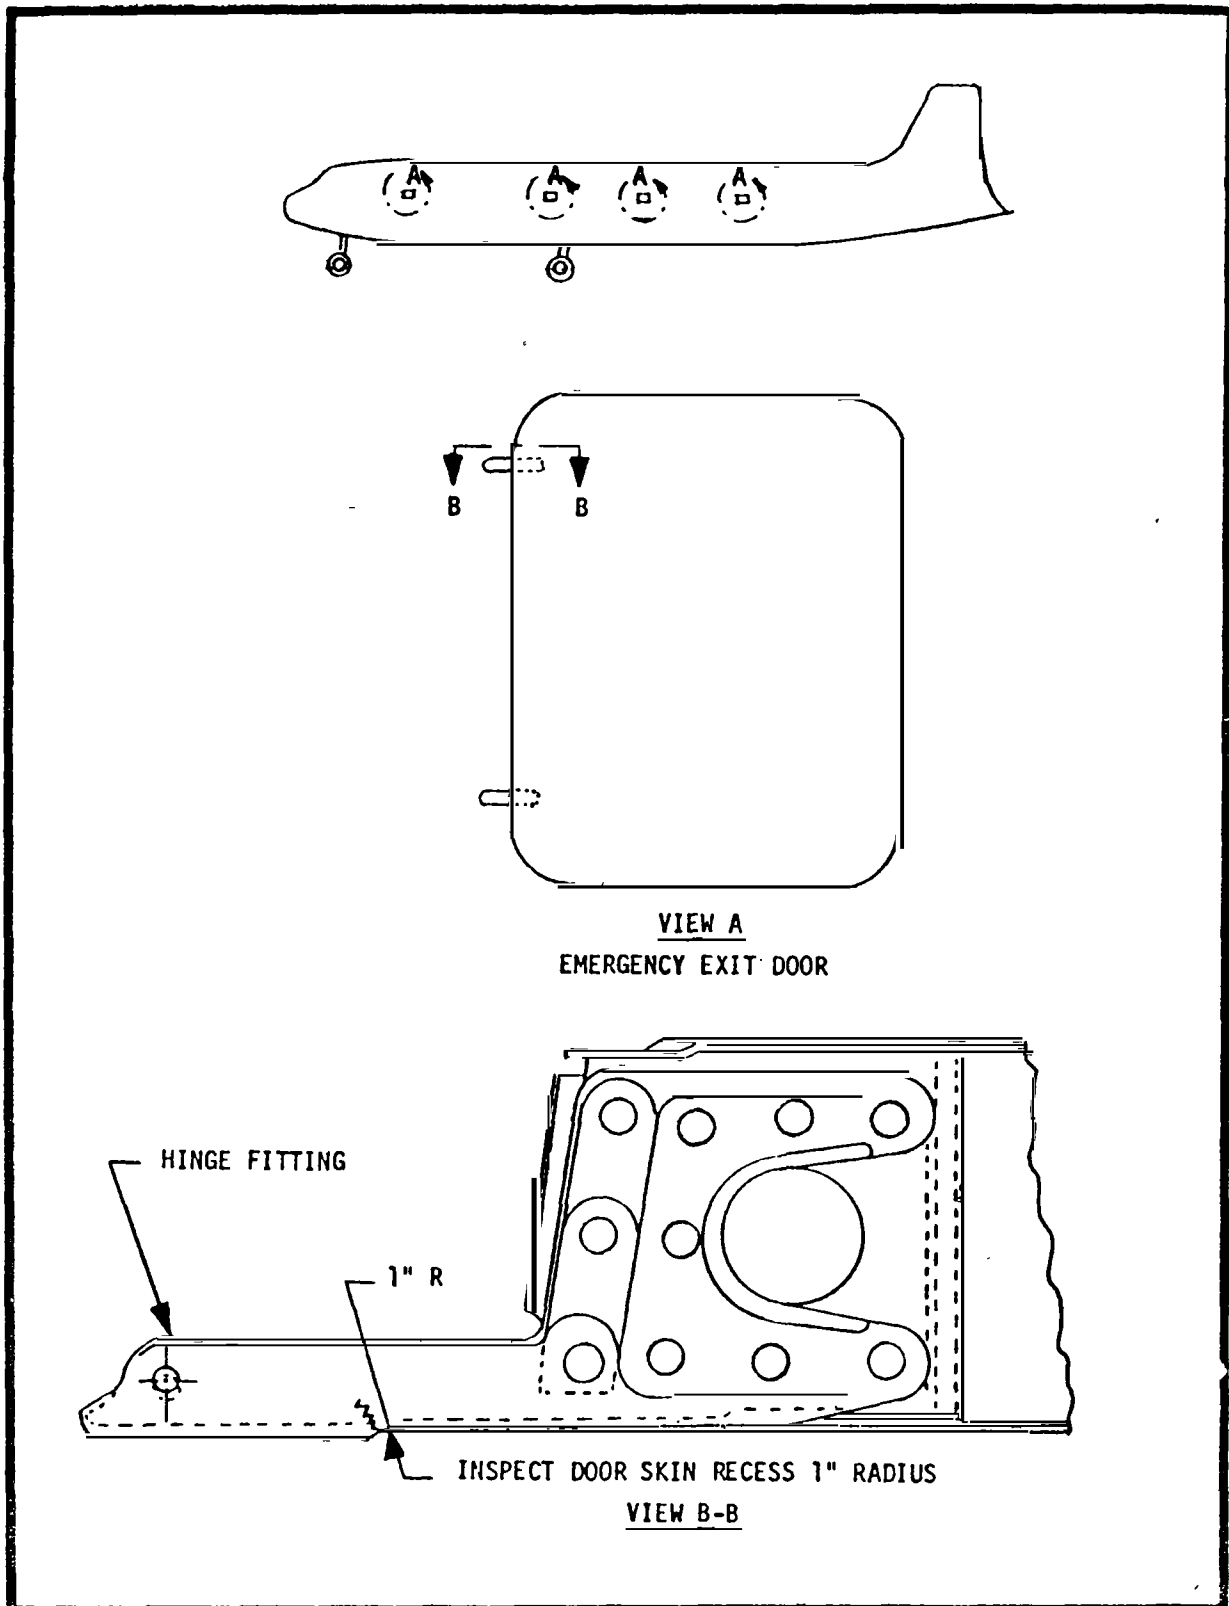
FIGURE G-3. EMERGENCY EXIT DOOR HINGES

FUSELAGE STATION	DESCRIPTION	INSPECT FOR	COMMENTS	INSPECTION TOOLS	REMARKS
F.S. 500 to 600	Emergency exit doors	Cracks	None	Visual	(1) Cracks are located in the intercostal located immediately under the window. Cracks normally start in the angles.
F.S. 661 to 1194	Passenger entrance door frames, skin, floor, and buffet area	Cracks/ Corrosion	(Ref: DSBs 407 & 858) Removal of buffet required for thorough inspection	Visual Dye Penetrant X-ray	(1) Moderate to heavy corrosion in the door sill panel. (2) Corrosion in the buffet floor area can be severe. (3) Frequent and close inspection of these areas recommended.
F.S. 661 to 1194	Passenger entrance door hinge case	Cracks/ Corrosion	(Ref: DSBs 407 & 858)	Visual Dye Penetrant	(1) Cracks are located at the front of the door frame. (2) Fuselage skin cracks at the upper forward corner of the door hinge cutouts and both upper and lower hinges.
NOTE: Refer to the manufacturer's manual for repairs and modifications.

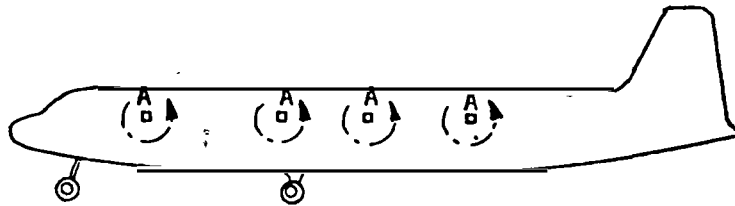
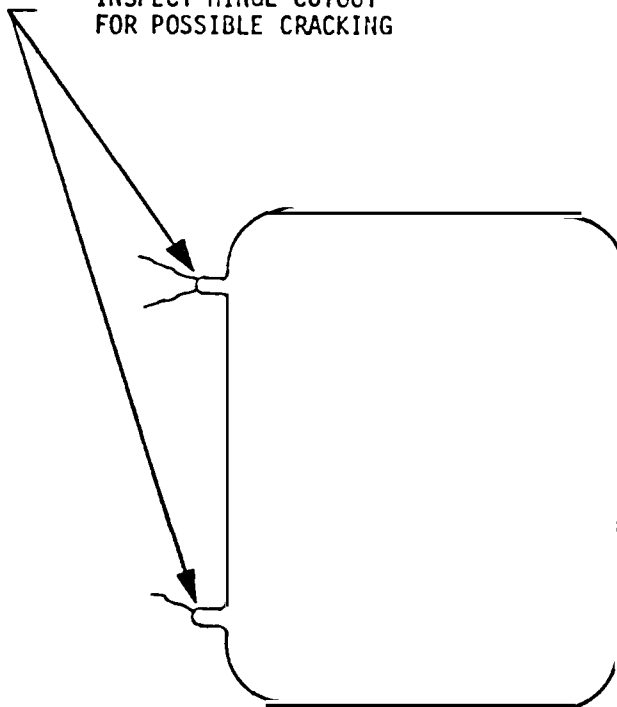
FIGURE G-4. EMERGENCY EXIT HINGE CUTOUTS

INSPECT HINGE CUTOUT
FOR POSSIBLE CRACKING
