AC NO: 20-78

ADVISORY CIRCULAR

DEPARTMENT OF TRANSPORTATION FEDERAL AVIATION ADMINISTRATION

SUBJECT: MAINTENANCE INSPECTION NOTES FOR McDONNELL DOUGLAS DC-8
SERIES AIRCRAFT

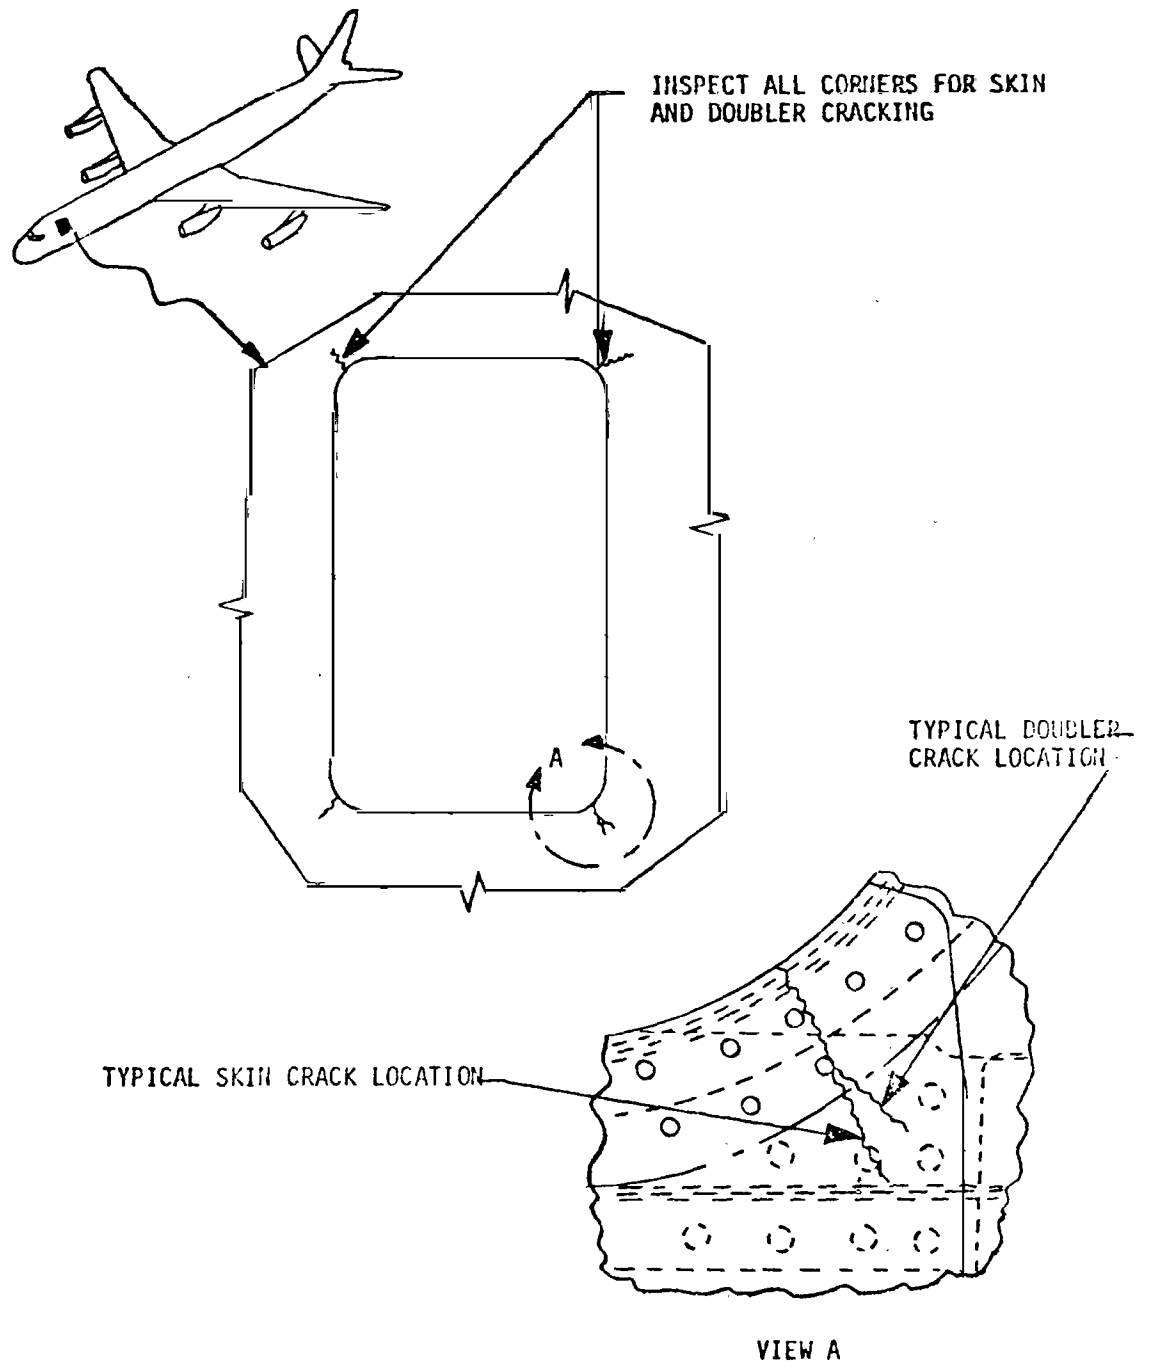
Fig. 10 Forward Passenger Door Areas

- (1) Location. Forward fuselage, left hand side (See Figure 10, Appendix 3).
- (2) Applicable Airworthiness Directive. None.
- (3) Other Reference Data. None

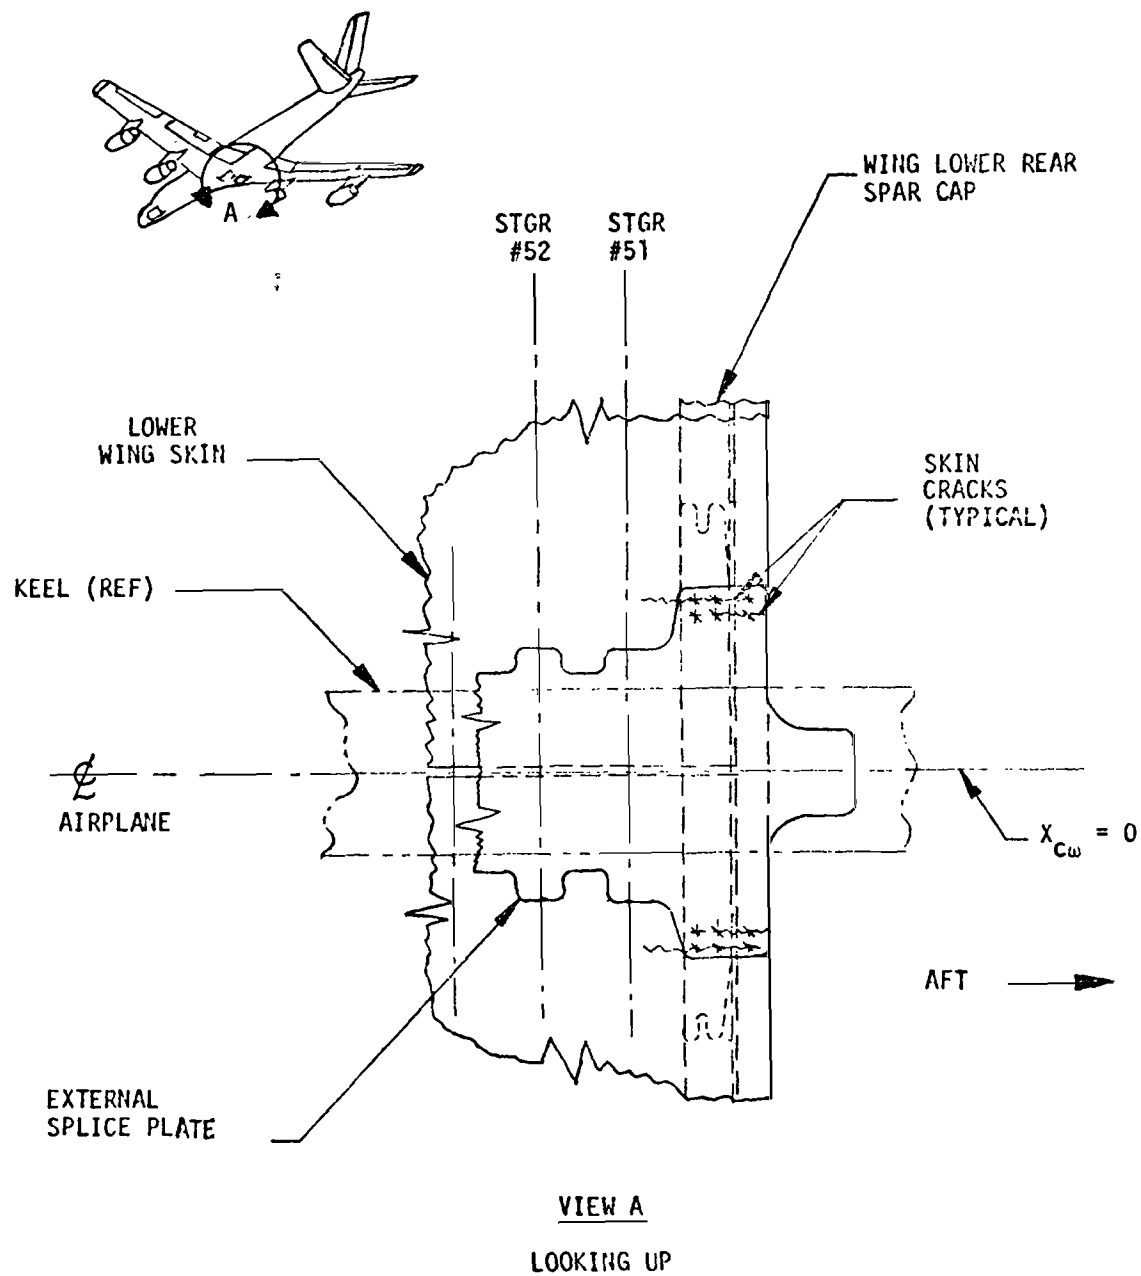
Fig. 12. Aft Lower Skin at Centerline Splice

e. Aft Lower Wing Skin at Centerline Splice.

- (1) Location. Aft lower wing skin at the centerline splice plate attach to the rear spar cap. (See Figure 12, Appendix 3)
- (2) Applicable Airworthiness Directive. None
- (3) Other Reference Documents. None
- (4) Probable Consequences. Crack extension in other area can significantly reduce the structural integrity of the wing.
- (5) Recommendation.
 - (a) Periodically inspect to assure continued structural integrity.
 - (b) Perform preventive rework in this area equivalent to Service Bulletin 57-70 at an appropriate later date depending on the airplane model.
