AC NO. 20-7N

# GENERAL AVIATION INSPECTION AID

# MARTIN MODEL 404 AIRCRAFT - CORROSION INSPECTION

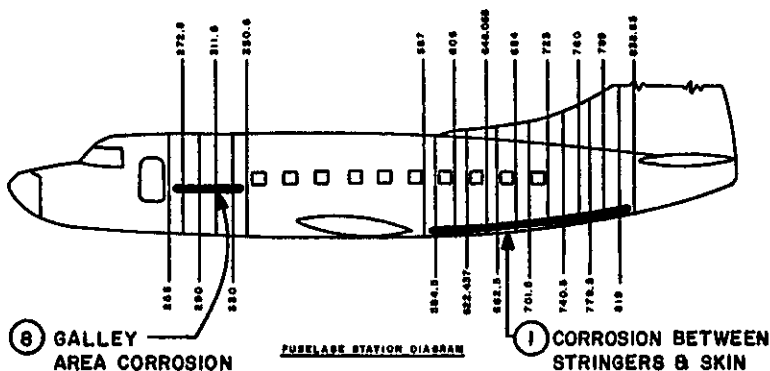
Reports have been received which indicate numerous areas where corrosion has occurred within a Martin Model 404 aircraft. It is recommended that these areas be periodically inspected to keep the corrosion under control. The following listed items correspond numerically with the shaded areas in the diagram and point out locations where corrosion has been found.

1. Fuselage in the area of the lavatory service door. Fuselage skin surface corrosion is detected by visual inspection. Corrosion between skin, stringers, and formers is detected by a slight bulging and pulled or sheared rivet heads.

2. Lower side of center wing between engine nacelle and fuselage. This is detected by blisters or bulges, usually at rivet holes.
3. Engine exhaust contributes to corrosion, especially on rear spar area, wing flap hinge brackets, and stringers inside the nacelle.

4. Top outer wing panel. Usually detected by a bulge on top surface of wing panel. This corrosion starts between top wing skin and corrugated panel inside wing. Wing scarf splices should also be checked for corrosion due to engine exhaust. Experience has shown that the lower left rear wing splice is more prone to excessive corrosion. AD 75-26-08 concerns inspection for corrosion at wing spar chord splice joints at wing station 187.

5. Fuel cell area. Look for bulges in the same area as outside, particularly in the production splice areas. Also, in the cell area, check the top spar cap vertical leg and radius areas.

6. Center section-to-fuselage attach area at the doubler between front and rear spar wing station 55. Check with the fairing removed.
7. Rudder upper hinge bracket and the spar cap top hinge attach area. Remove the cover inspection plate and look forward on the under side.

8. Galley and radio rack area along stringers and floor panels.
9. Horizontal stabilizer on the front spar caps station 22-27 and the bottom rear spar cap. Experience has shown that the top spar cap area is more susceptible to corrosion. Corrosion is usually detected by slight bulging of the adjacent skin.

10. Front and rear face of the rear wing spar web and spar caps between center wing station 55 and outer wing station 221.
