GENERAL AVIATION
inspection

SUPPLEMENT NO. 1

SEPTEMBER 1976

U.S. DEPARTMENT OF TRANSPORTATION
FEDERAL AVIATION ADMINISTRATION

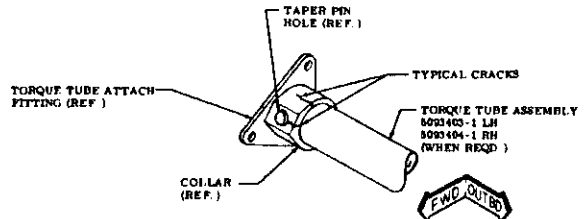
There have been several reports of cracks found in the torque tube fittings, especially at the taper pinholes. Cracking at these holes is believed to be caused by overtightening the taper pins. The recommended torque value for these pins is 50 ± 10 inch-pounds.

It is suggested that these fittings be checked for cracks and corrosion at each annual or 100-hour inspection, or whenever the tail cone is removed for any reason. Cessna Service Letter No. ME71-8 provides additional information on this subject.

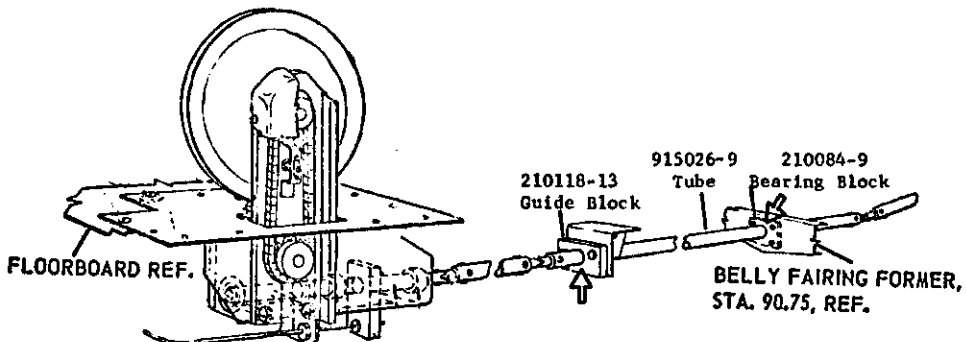
The elevator trim tab control tube was found to be severely worn at both ends where it rubs on the guide blocks.

Mooney Service Bulletin No. M20-185 provides information for inspection in this area and describes a kit which protects the trim tube from wear.

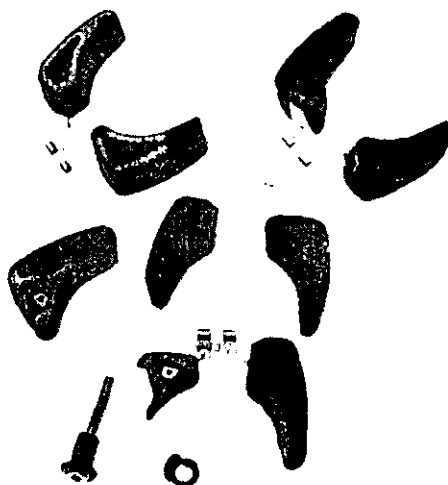
EXAMPLES OF DAMAGED NON METAL CARBURETOR PARTS WHICH HAVE BEEN EXPOSED TO CARBURETOR CLEANER

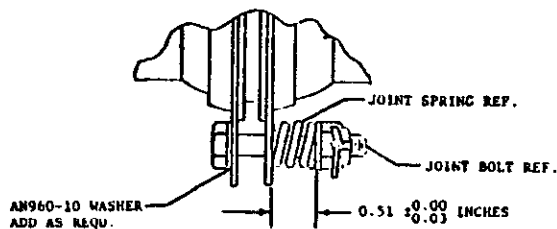
Typical Exhaust Joint Spring Installation

The exhaust joint spring tension relaxed permitting the ball socket to separate approximately 1/8-inch. The escaping exhaust damaged the right engine compartment, hoses, and wiring. AD 75-23-08 relates to this subject.

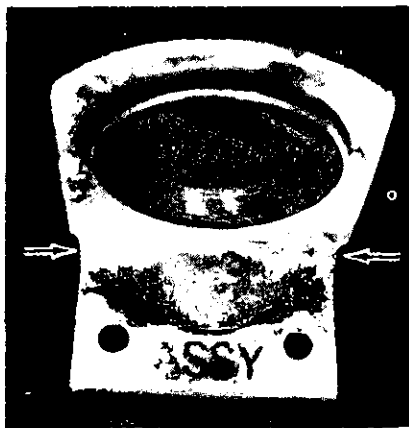
During inspection, the right aileron outboard hinge bearing support bracket was found to be cracked in the bend radius. These cracks were not visible until the bracket was removed from the aircraft.

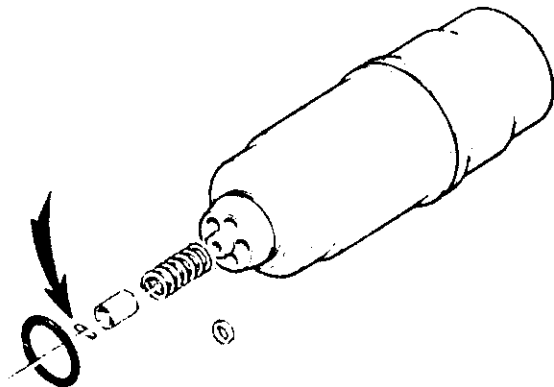
In-flight oil pressure fluctuation was reported. Investigation revealed that the dowel pin which secures the oil filter check valve spring retainer collar to the valve stem had broken. A piece of the broken dowel pin lodged under the valve. The valve face was galled and the retainer collar had worn a groove into the oil filter housing.

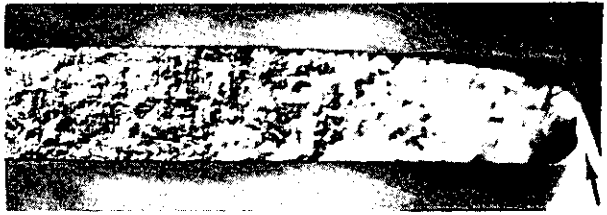
The propeller blade failed 8-inches from the tip. Failures of this type are usually due to previous damage to the blade leading edge, such as a stone nick. It is suggested that the propeller blades be examined prior to each flight and if any damage is found, it should be repaired immediately.

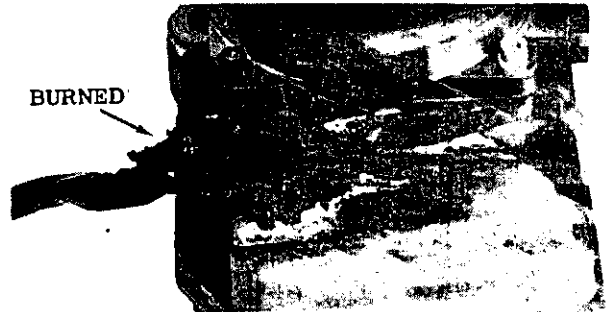
The right main fuel boost pump failed. Investigation revealed that the wiring was severely burned at the pump.

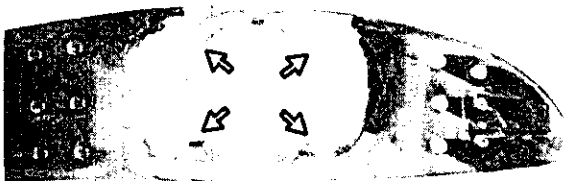
During inspection, the right horizontal stabilizer inboard rib was found to be cracked. Total time in service - 590 hours. A doubler had been installed in compliance with AD 76-05-01, however, the doubler was cracked also.

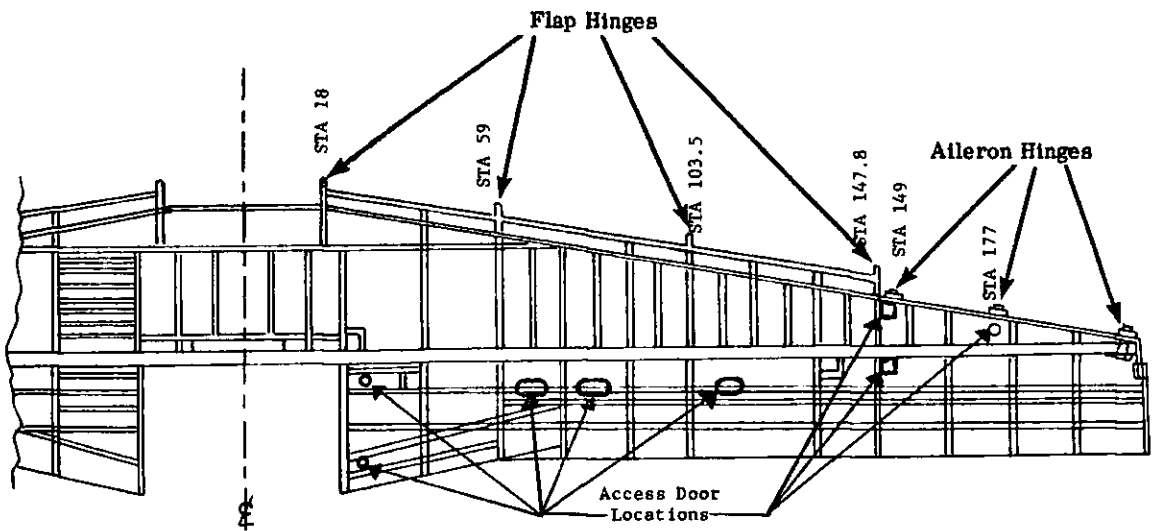
FIG. 1 WING STRUCTURE BOTTOM VIEW

During an accident investigation, extensive wood rot, weathering, and glue joint separation were found in the wing structure. Airworthiness Directive 76-15-01 and Service Bulletin No. M20-170A require inspections of the wing wood structure as well as the empennage wood structure. When required inspections are made, particular attention should be directed to the wing areas shown in Figures 1 and 2. The areas marked R_E can be visually inspected externally without removing access plates. The areas marked R_I require removal of access plates for inspections. The flap support ribs of Stations 18, 59, 103.5, and 147.8 can all be inspected externally. The flap support ribs should be gently flexed during visual inspections for evidence of rot near the flap hinge and for glue joint separation. If evidence of wood deterioration is observed (such as wood discoloration or weather cracks) the fabric (and skin as necessary) should be removed until the extent of wood deterioration is determined. All wood and wood-joint deterioration should be repaired in accordance with the provisions of AD 76-15-01. Malfunction or defect report (FAA Form 8330-2) should be submitted for each instance of wood deterioration requiring repair.

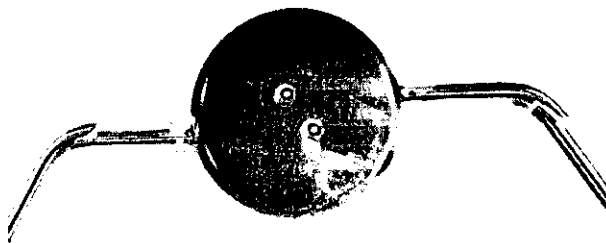
During inspection, cracks were noted in the bend radius of both elements of the nav antenna installed on the aircraft vertical stabilizer. Identical conditions were found during inspection of six other aircraft.

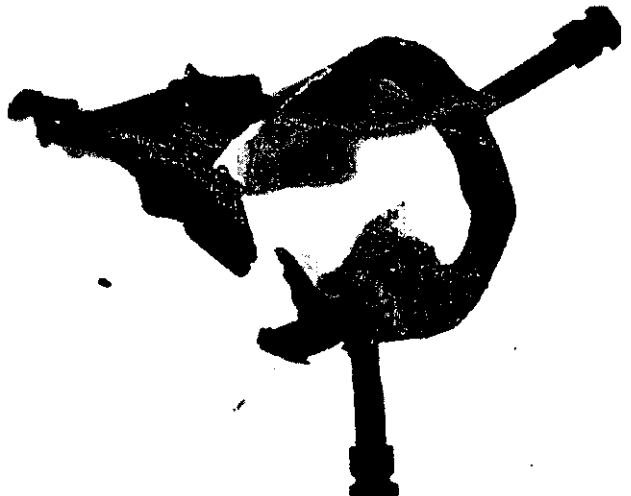
Inspection to determine the cause for reported intermittent engine roughness during level flight revealed the carburetor venturi was severely distorted. Examination revealed that heat from a previous induction system fire evidently caused the venturi to burn and melt. Further checks revealed a worn and leaking carburetor needle valve and evidence of carburetor flooding.

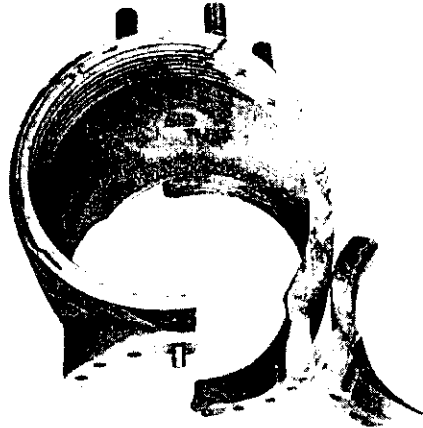
The propeller hub failed at the blade retention sockets permitting the blades to separate from the hub.

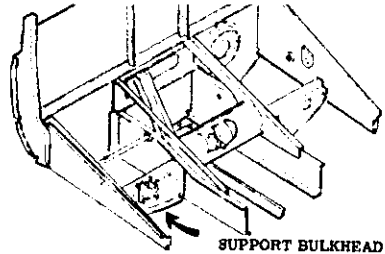
SUPPORT BULKHEAD

The bulkhead, located on the left side of the fuselage at Station 49.0, has been found cracked or broken. When this bulkhead fails, partial loss of rudder travel may occur as the rudder bellcrank support, P/N 35-424136, is mounted on this bulkhead. These failures are believed to be attributable to ground handling of the aircraft using a tow bar and tow tractor when the aircraft gust locks are installed.

Beech Class II Service Instructions No. 0869-154 announced the availability of two kits which were developed to provide more durable cast-type supports. Kit No. 55-4029-1S pertains to Model 95-B55, S/N's TC-502 through TC-1944. Kit No. 55-4029-3S affects Model 95-C55, S/N's TE-1 through TE-300.

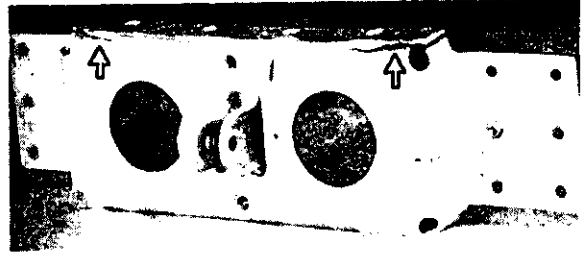
The elevator bellcrank bracket assembly was found to be cracked. Total time in service - 6275 hours. A second aircraft was inspected and the same condition was found.

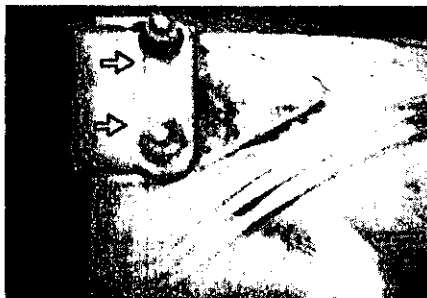
A tail rotor blade grip was found to be cracked. The crack extended from a retaining bolt hole.

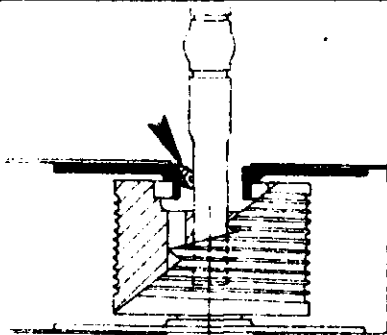
The elevator trim tab system jammed in the neutral position shortly after takeoff. After landing, an inspection disclosed that a nut, washer and rivet were jamming the trim cable shaft under the cockpit floor at the control pedestal. Further checks disclosed that an opening in the cockpit floor at the control pedestal, permitted debris to fall through. Grumman Alert Customer Bulletin No. 13, Amendment 1, dated January 1977 relates to this subject.

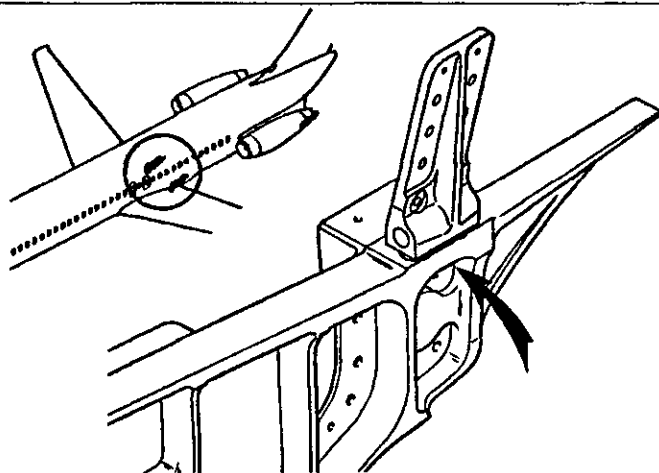
The right trapezoidal panel was found to be cracked at its attach point to the fuselage fitting, P/N 5911366-1. The crack extended from bolthole-to-bolthole. Total time in service - 21824 hours.

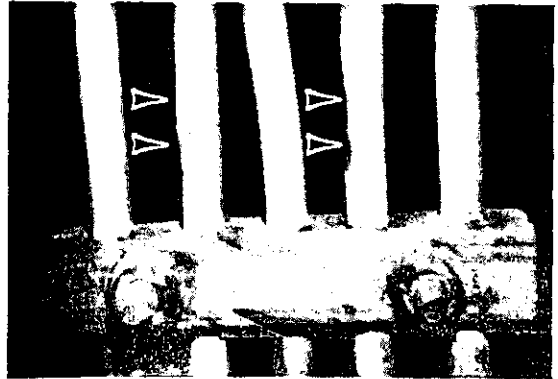
Five metal hydraulic lines are secured by a wood clamp block aft of the nose wheel well. A leak developed from corrosion damage that formed at the wood clamp block. This clamp should be removed for proper inspection of the hydraulic lines.

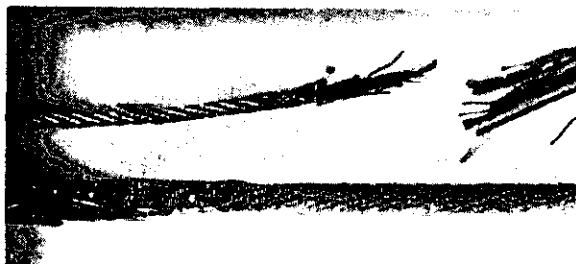
Two instances have been reported whereby the left aileron balance cable and the rudder interconnect cable have short circuited against the wing flap motor solenoid, P/N 26898-04, terminal at fuselage station 174 under the cabin floor. The rubber insulator boot did not completely cover the terminal and contact resulted in complete burn-through of the interconnect cable and approximately 50 percent burn-through of the balance cable. This condition was found when the pilot reported sloppy control action. In one instance, the wing flap circuit breaker tripped as a result of the short circuit.

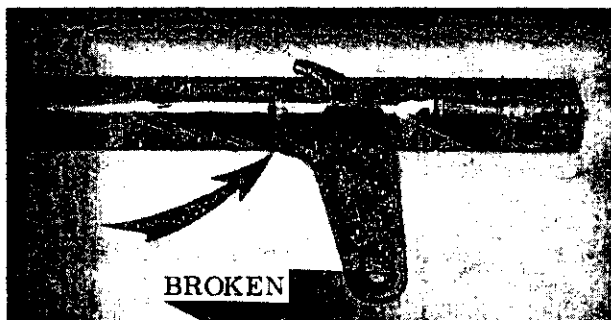
The right rudder bar cable bracket separated in flight. Examination of the rudder bar disclosed that the failure occurred in the weld attaching the cable bracket to the bar.
