TAD-494.4
AC NO. 20-7N

GENERAL AVIATION
inspection
AIDS

SUPPLEMENT NO. 5

JANUARY 1977

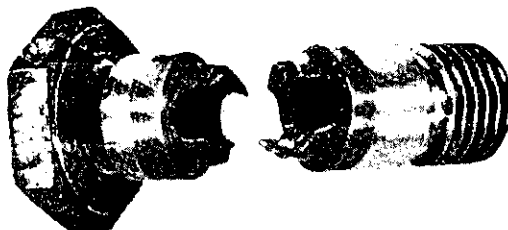
Bell
Model 47G-2

Boost Cylinder
Bolt, P/N 47-691093-5

The pilot reported fore and aft cyclic control feedback. Inspection disclosed that the boost cylinder bolt was broken.

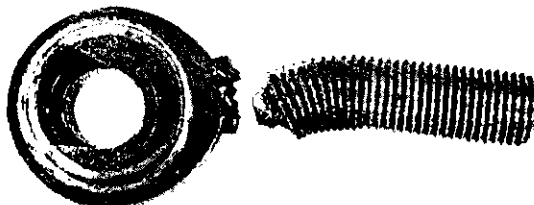
Bellanca
Model 17-30A

Nose Gear Actuator
Rod End

The nose gear actuator rod end failed during gear extension. Inspection disclosed that the ball joint was seized due to the lack of lubrication.

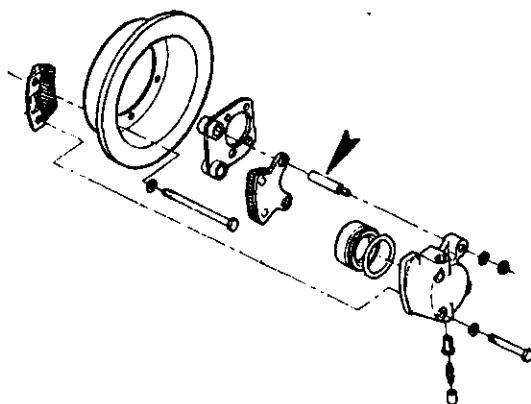
Brake Guide Pin,
P/N A30023
(McCauley Brakes)

The guide pins in the brake cylinder are reported to be corroding and seizing in the torque plate. This condition is more likely to exist if the aircraft has been inactive for an extended period. The brake manufacturer advises that the plating on later guide pins has been improved which reduces this problem.

It is suggested that these brake assembly guide pins be inspected each 50 hours of operation. Aircraft affected are: Model 150, S/N's 15072004 and on; Model A150, S/N's 1500227 and on; and Model 172, S/N's 17260835 and on.

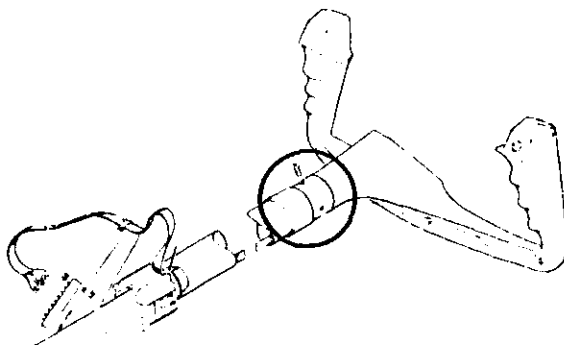
Control Wheel
Attach Screws

Several reports have been received which describe loose or missing screws which attach the control wheel adapter to the tube assembly.

It is recommended that the control wheel adapter cover be pulled back and the attaching screws periodically checked for tightness. The screws should be tightened to 20-25 inch pounds torque or as an alternate method, a thread locking material such as "Loc-tite" can be used.

The use of screws for this application was discontinued on the Model 210, beginning with the 1972 model year and on; Models 182, 206 and 207 at the beginning of the 1976 model year. These newer model airplanes use AN3 bolts instead of screws. The proper torque value for these bolts is 30 inch pounds.

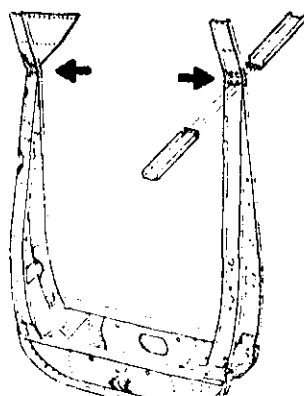
Fuselage
Door Frames

Inspections have revealed cracks emanating from the door post bulkhead (fuselage frame) upper attach rivets. The cracks have been found in the front and rear door posts on both the left and right sides of the aircraft. The area involved is adjacent to the location described in AD No. 63-20-2. Any previous involvement in a ground loop or other operational damage to the wing tip could have transmitted excessive loads to this area. Cessna Service Letter SE 73-15 dated June 22, 1973 outlines an inspection procedure.

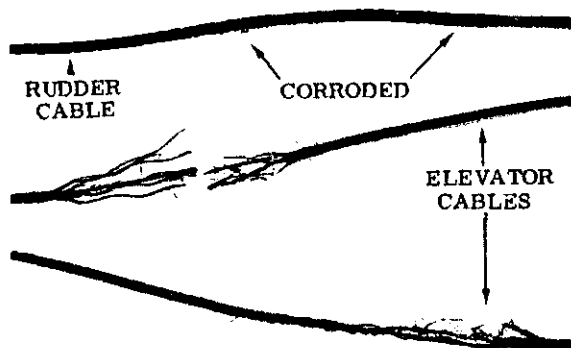
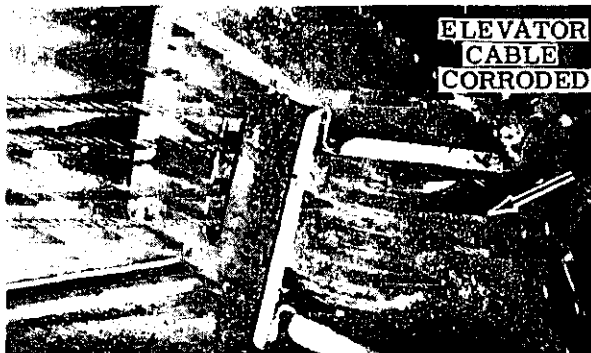
Elevator and Rudder
Control Cables

A pilot reported loss of elevator control during takeoff roll. Investigation revealed separation of the elevator control cable and severe corrosion of both the elevator and rudder cables between fuselage stations 353 and 377. The aircraft time in service was 9300 hours. Inspection of another aircraft with 8400 hours time in service disclosed control cable corrosion in the same area, but not as severe.

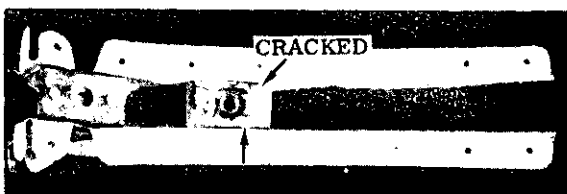
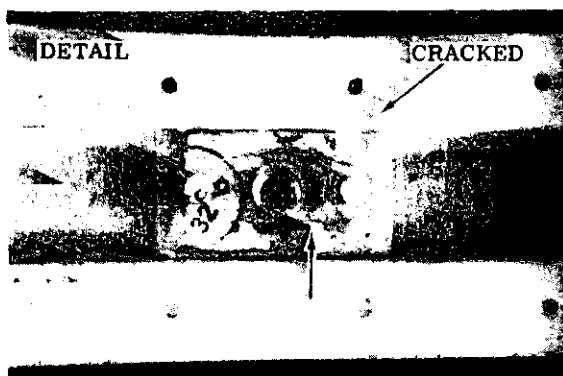
Helio Wing Leading Edge Rib Model H-391B

The wing leading edge rib assemblies were found to be cracked and corroded.

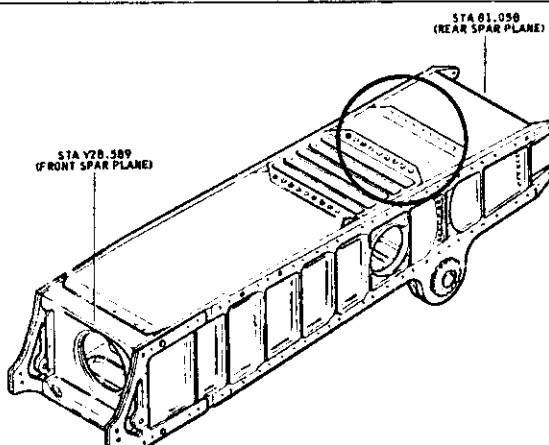
McDonnell Douglas Fitting, P/N 5918098 Model DC-9

During inspection, the horizontal stabilizer center section fitting was found to be cracked. The crack extended 6-3/4 inches.

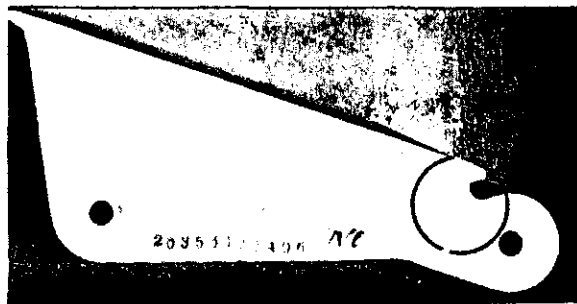
Rockwell International Aileron Hinge Bracket,
Model S-2R P/N's 20354T-1, -2, -3,
and -4

Several aileron hinge brackets were found to be cracked.
Total time in service range from 342 hours to 1004 hours.

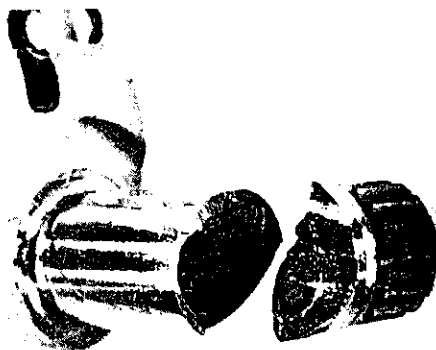
Rockwell International Nosewheel Steering
Model NA-265-60 Bellcrank, P/N 3010812-5

The nosewheel steering bellcrank was found to be shear-
ed at the serrated end. Also, a radial crack was found
which extended two-thirds of the way around the shaft
and into the machined radius. Total time in service -
1337 hours.

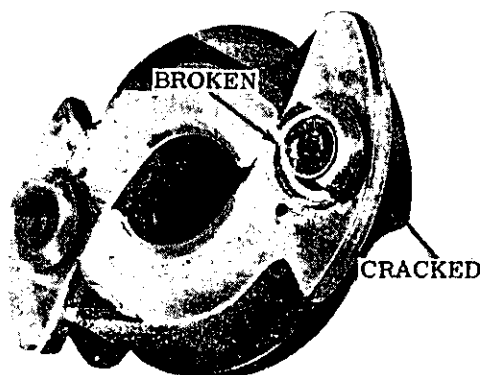
The inattention and mishandling many magneto impulse couplings receive is substantiated by service difficulty reports. In some instances, when magnetos are removed for maintenance/overhaul the couplings are not disassembled for inspection and receive no more attention than a "wash down." They are then reinstalled in an "as is" condition. This situation is further magnified by the abuse the unit receives through various unorthodox removal methods. Quite often this results in hidden damage which if not detected can lead to in-flight engine failure.

Sometimes impulse couplings are found broken and cracked as shown in the accompanying picture. In this instance, the damage is believed to have resulted from the use of gear pullers. Careful attachment of pullers used to remove the impulse coupling must be exercised to avoid damage.

To help all persons to better understand the purpose, operation, and care of aircraft magneto impulse couplings, the Bendix Corporation has prepared a booklet related to this subject. The title of the publication is "I Am Your Impulse Coupling." The caption on the booklet face is "Nobody Pays Any Attention to Me." Copies of the publication may be procured free from: The Bendix Corporation, Electrical Components Division, Product Support Department, Sidney, New York 13838.

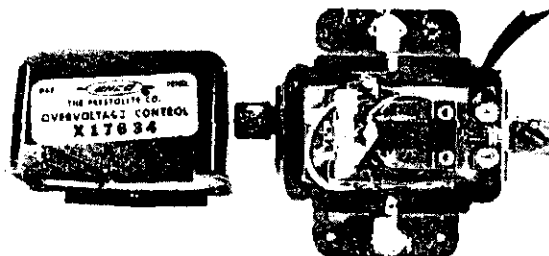
Contact Plate

The overvoltage control failed. Investigation disclosed that the contact plate was broken.
