AC NO. 20-7P

GENERAL AVIATION
inspection
AIDS

SUMMARY

AUGUST 1977

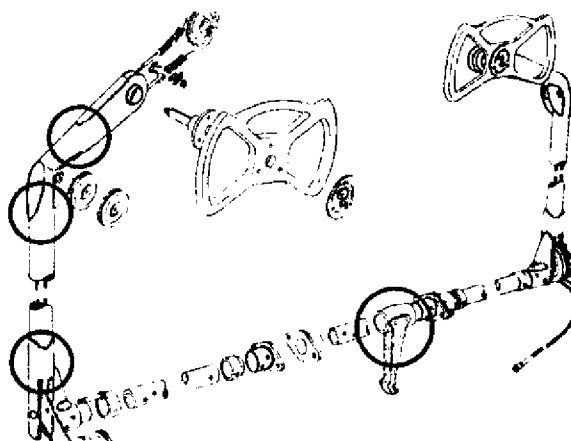
Beech
Model E18S

There have been several reports of the control columns being found either cracked or broken. The manufacturer believes these cracks may have been caused by stress exerted by the elevator during gusty wind conditions when the control locks were in place.

Beech has issued Class I Service Instructions No. 0889-155 which provides procedures to be used to detect and repair cracks found in the control column or elevator control arms.

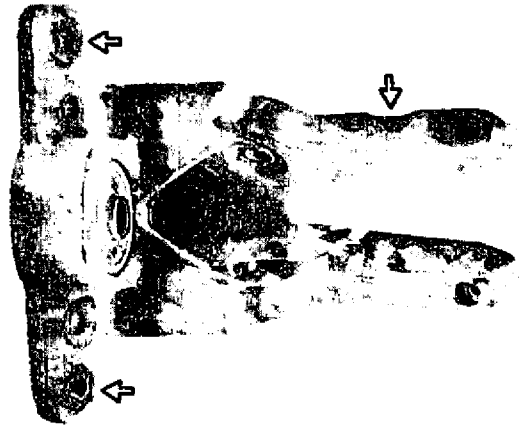
An annual inspection of a Beech M35 Bonanza revealed severe corrosion (pitting) of the elevator support located on the fuselage aft bulkhead. The area affected the most was around the attach boltholes. The corrosion is believed to have been caused by inadequate removal or neutralizing of a paint stripper used during preparation for repainting the aircraft.

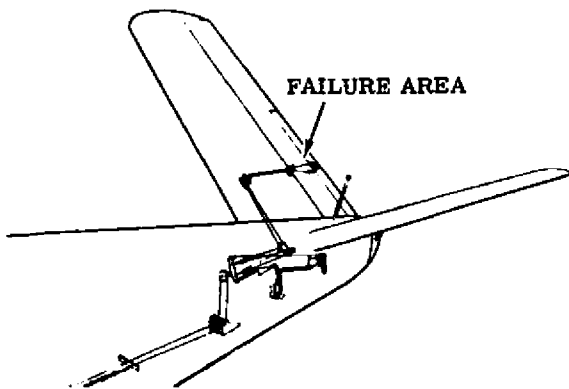
Beech
Model 35 Series

There have been a number of reports which indicate that the trim tab cables were found rusted, corroded, frayed, and broken at the end which is attached to the tab.

Rust and corrosion are believed to be the result of paint strippers or other caustic materials coming in contact with the trim tab cables. Cable fraying and breakage at the swaged clevis fitting are caused by overtorque of the bolt used to secure the clevis end to the trim tab horn. When the bolt is overtorqued, the clevis will not move on the horn so all movement occurs at the cable end of the clevis which causes the strands of the cable to fray and break. It is suggested these cables be inspected frequently for conditions of impending failure.

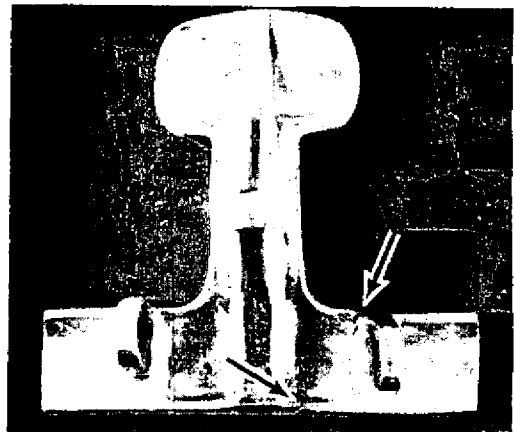
The left brake and rudder pedal was found to be cracked and bent during inspection. Total time in service - 979 hours.

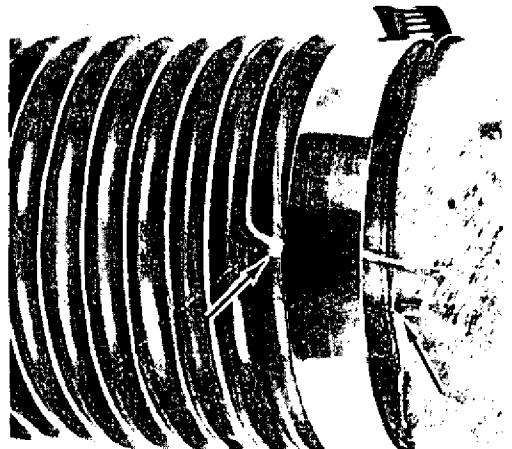
The Cessna Aircraft Company provided this photograph to illustrate how they recommend the flexible ducts be clamped. Please note that the ends of the inner reinforcing wire and the outer cord are turned 45 degrees to normal and are secured by the clamp.

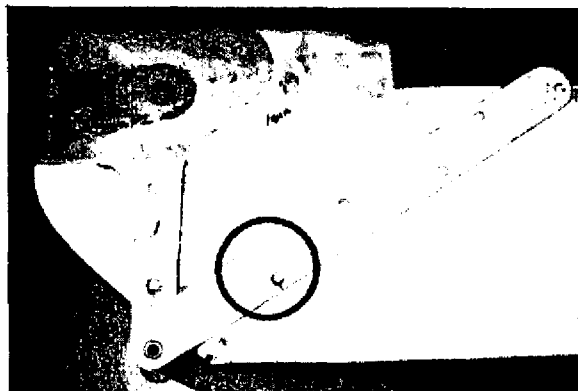
During preflight inspection, a main rotor blade upper retention strap was found to be cracked. Total time in service - 644 hours.

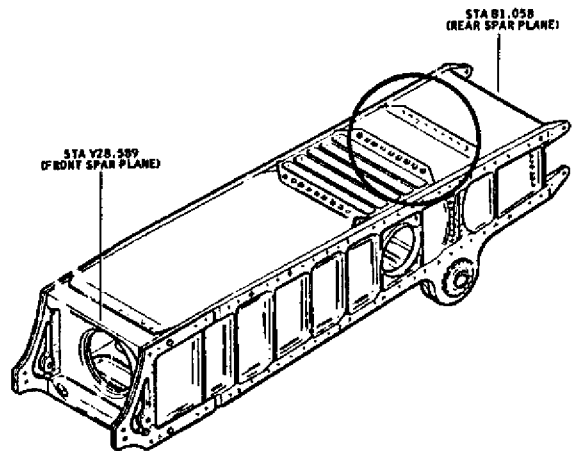
McDonnell Douglas Fitting, P/N 5918098
Model DC-9

During inspection, the horizontal stabilizer center section fitting was found to be cracked. The crack extended 8-3/4 inches.

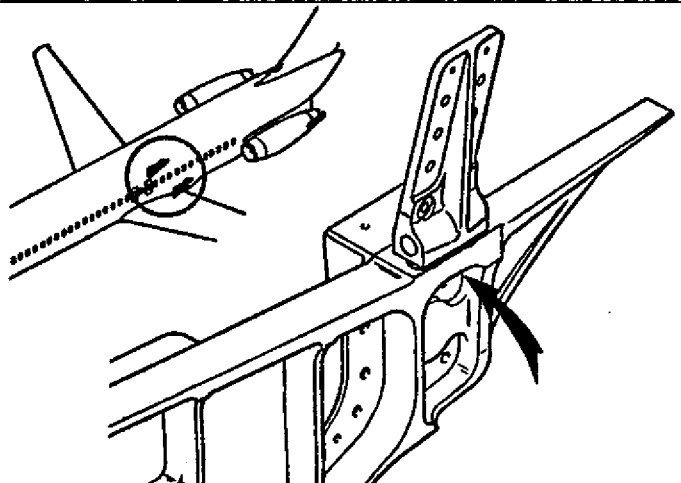
McDonnell Douglas Trapezoidal Panel,
Model DC-8-31 P/N 8919402-2

The right trapezoidal panel was found to be cracked at its attach point to the fuselage fitting, P/N 5911366-1. The crack extended from bolthole-to-bolthole. Total time in service - 21824 hours.

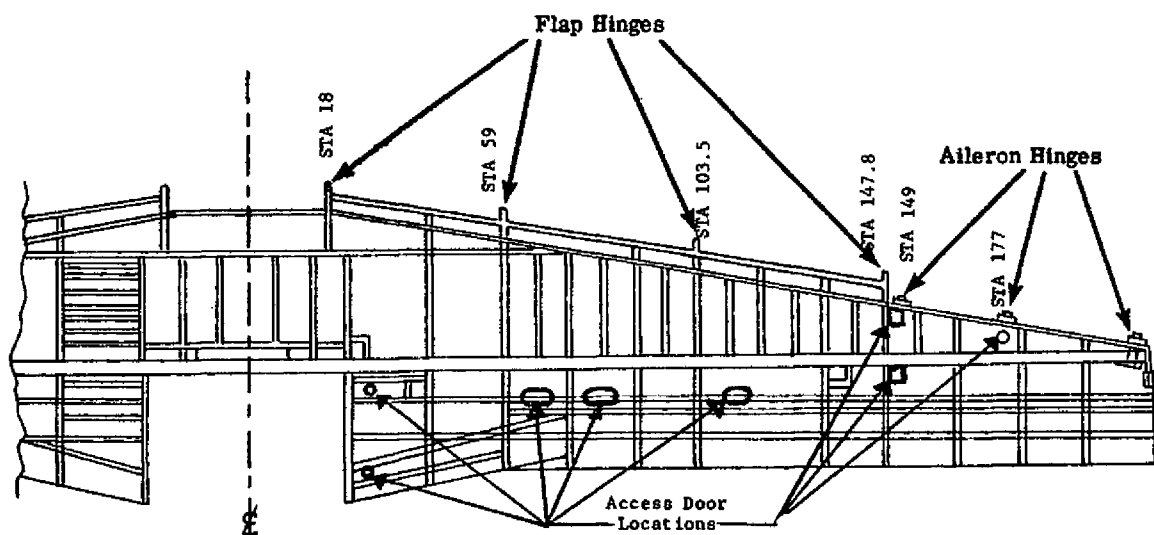
FIG. 1 WING STRUCTURE BOTTOM VIEW

During an accident investigation, extensive wood rot, weathering, and glue joint separation were found in the wing structure. Airworthiness Directive 76-15-01 and Service Bulletin No. M20-170A require inspections of the wing wood structure as well as the empennage wood structure. When required inspections are made, particular attention should be directed to the wing areas shown in Figures 1 and 2. The areas marked R_E can be visually inspected externally without removing access plates. The areas marked R_I require removal of access plates for inspections. The flap support ribs of Stations 18, 59, 103.5, and 147.8 can all be inspected externally. The flap support ribs should be gently flexed during visual inspections for evidence of rot near the flap hinge and for glue joint separation. If evidence of wood deterioration is observed (such as wood discoloration or weather cracks) the fabric (and skin as necessary) should be removed until the extent of wood deterioration is determined. All wood and wood-joint deterioration should be repaired in accordance with the provisions of AD 76-15-01. Malfunction or defect report (FAA Form 8330-2) should be submitted for each instance of wood deterioration requiring repair.

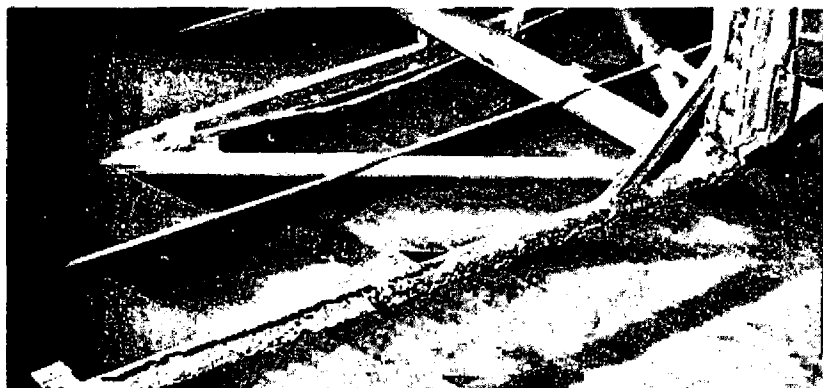
Piper Model PA-18S	Elevator Cable Turnbuckle Terminal	Elevator control was lost immediately following takeoff, requiring the pilot to execute a straight-in emergency landing maintaining altitude control by use of the throttle. Investigation revealed the upper elevator cable turnbuckle terminal had failed adjacent to its bellcrank attachment. The terminal fork to bellcrank attachment was rusted causing the terminal to bend rather than swivel during elevator control actuation, resulting in eventual failure. The aircraft had been operated 97 hours and 12 months since last inspection.
Piper Model PA-22	Fuselage Tubular Member	At 1500 hours aircraft time in service, the fuselage tubular member at the baggage compartment doorsill was found to be severely rusted. This tube is normally covered with fabric, making it difficult to detect deterioration until it has progressed to an advanced stage.

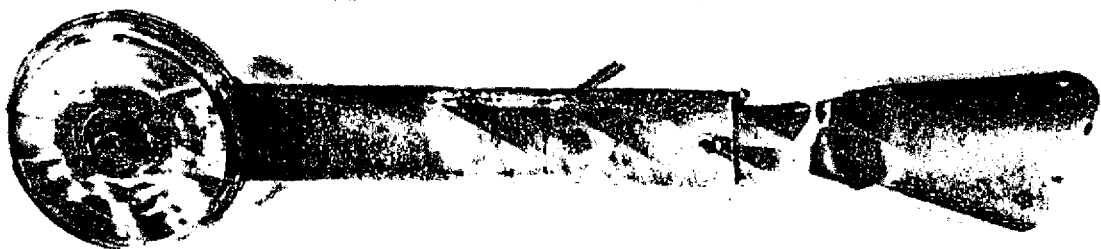
Several instances have been reported where the landing gear control lever has failed when attempting to retract the landing gear. If these failures had occurred after the landing gear had retracted, a serious accident may have resulted. Reports indicate the failures occur at the first bend radius forward of the control lever knob. Close examination of this area of the control lever for evidence of cracks is recommended at each aircraft inspection period.

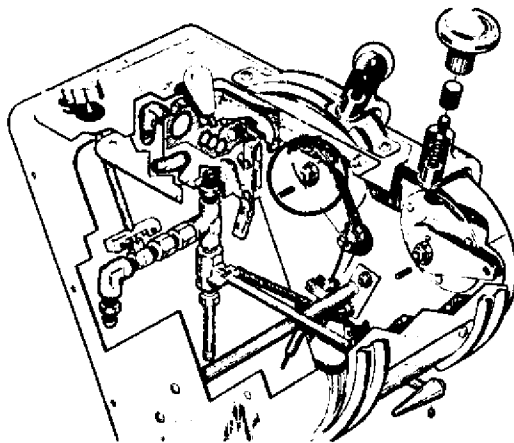
Investigation to determine the cause of reported play in the fuel valve control system revealed that the screw which retains the control lever arm was loose. Further inspection inside the fuel system control box disclosed one of the roll-pins, P/N 480700, which secures the lever arm in position had fallen out, and the other was loose.

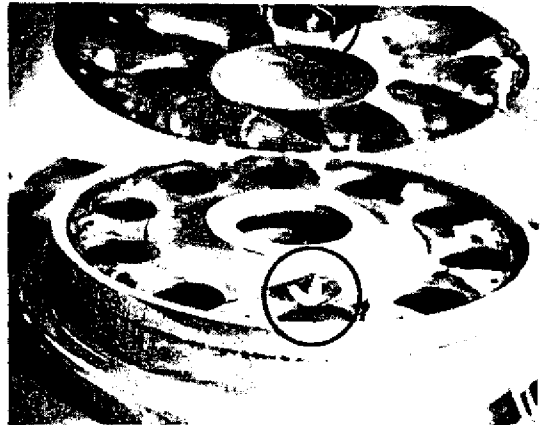
The Goodyear manual states that each wheel half is individually balanced at the factory and may be assembled in any position relative to each other. However, if two wheel halves are assembled so that the balance weights are together, the weight attach screws and nuts contact each other, preventing the wheel halves from seating properly. The wheel shown in the photo was assembled so that the screws contacted. Both screws were bent and loose, and both balance weights were bent.

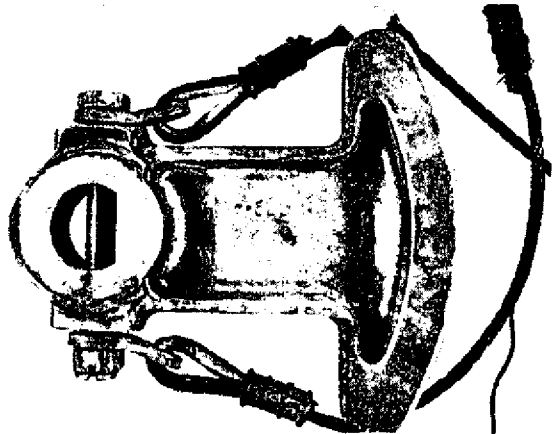
An investigation to determine the cause for loss of aileron control revealed that the aileron cable was broken in the control column assembly where it wraps around the control quadrant, P/N 415-52130. AD 54-28-2 relates to this subject.

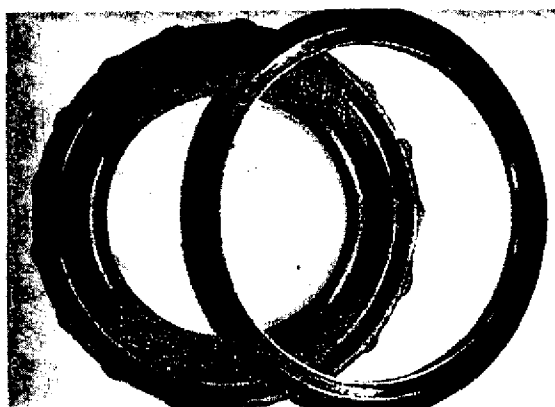
The grease seal, P/N 5B, which is pressed onto the main wheel, P/N 9543991, bearing, would not remain on the bearing. When this condition occurred, the grease was lost from the bearing. Total time in service - 1153 hours.

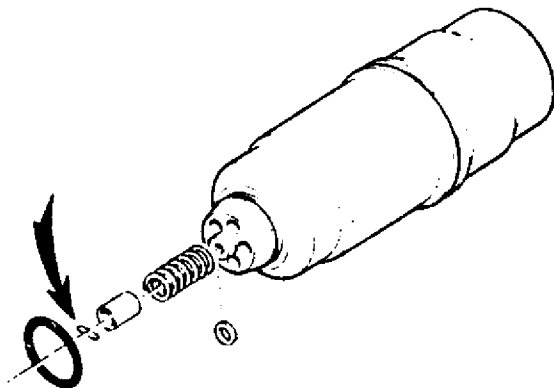
United Aircraft
of Canada
Model PT6A-20

In-flight oil pressure fluctuation was reported. Investigation revealed that the dowel pin which secures the oil filter check valve spring retainer collar to the valve stem had broken. A piece of the broken dowel pin lodged under the valve. The valve face was galled and the retainer collar had worn a groove into the oil filter housing.

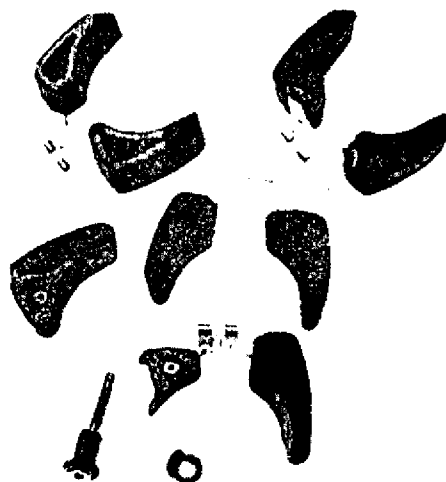
EXAMPLES OF DAMAGED NON METAL
CARBURETOR PARTS WHICH HAVE BEEN
EXPOSED TO CARBURETOR CLEANER

Marvel-Schebler/Tillotson Service Bulletin No. A1-76 and Aircraft Carburetor Overhaul Procedures Manual relate to this subject.

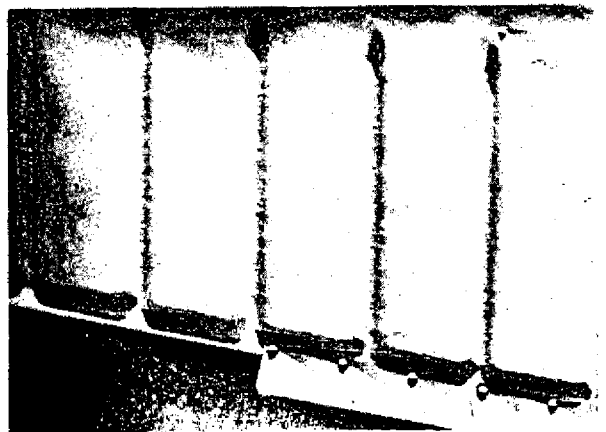
The control surfaces on some aircraft have been 100 percent statically balanced. After each repair or repainting of the control surfaces, they must be rebalanced. In addition, entries must be made in the aircraft log book to reflect the fact that the control surfaces were repaired, repainted, and balanced. This control surface would not balance in accordance with the manufacturer's prescribed procedures and had to be stripped and repainted. It had five coats of paint plus heavy surface corrosion.

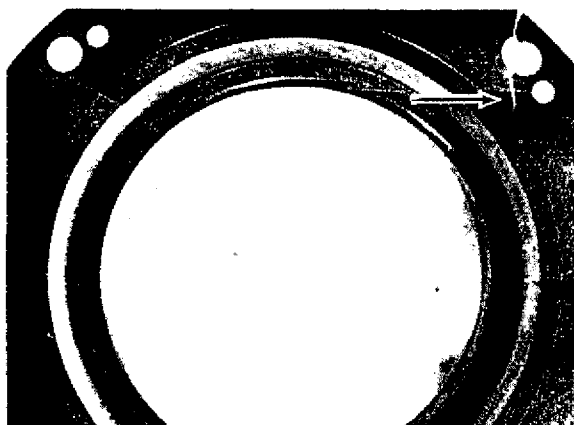
United Aircraft
of Canada
Model PT6A-28

Excessive bearing noise was reported during engine run-down. Inspection revealed that the engine No. 4 bearing outer race was cracked.

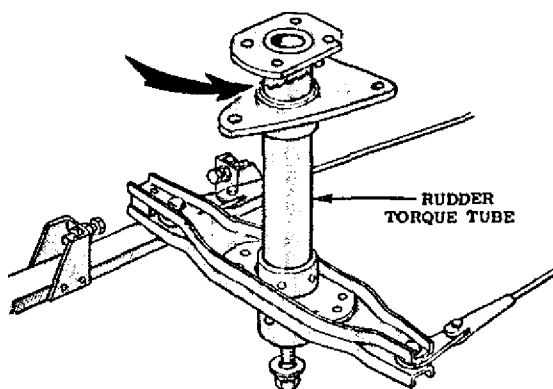
Rockwell International Rudder Torque Tube Fitting,
Model 690

During preflight engine run, the rudder torque tube assembly separated between the adapter plate and the rudder horn. Investigation disclosed that the interior of the tube was severely corroded. Total time in service - 3978 hours. The rudder must be removed for inspection of the interior of the tube. Further checks disclosed that this tube has no provision for drainage.

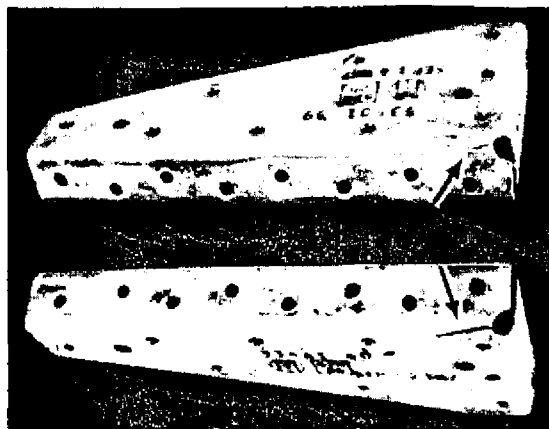
The left and right aileron horn flanges were found cracked. The cracks extended along the horizontal radius. Total time in service - 1229 hours.
