**GENERAL AVIATION**  
**inspection**  
**AIDS**

**SUPPLEMENT NO. 11**

**JULY 1978**

**U.S. DEPARTMENT OF TRANSPORTATION**  
**FEDERAL AVIATION ADMINISTRATION**

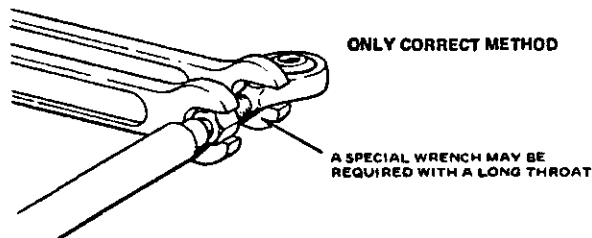
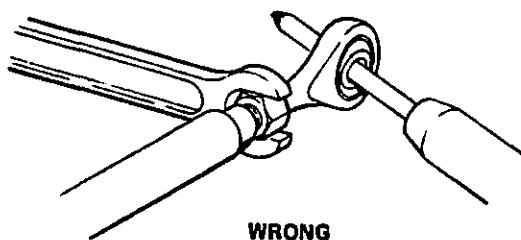
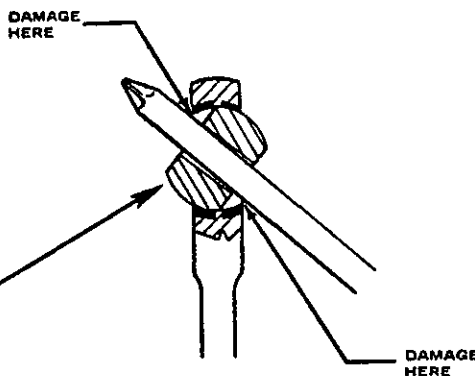
Piper  
Model PA-31 Series

Landing Gear Lock  
Rod End Fittings

The aircraft manufacturer has advised that the rod end fittings for the landing gear downlock actuator rod assemblies can be damaged if the proper tools are not used when tightening the fitting jam nuts. The end fitting must be supported with one wrench while the jam nut is tightened with another wrench. Inserting a tool through the end fitting bearing ball can damage the race and result in stiff operation and subsequent malfunction of the landing gear downlocks.

IMPROPER TOOL (RESULTING IN LOCKED BALL)

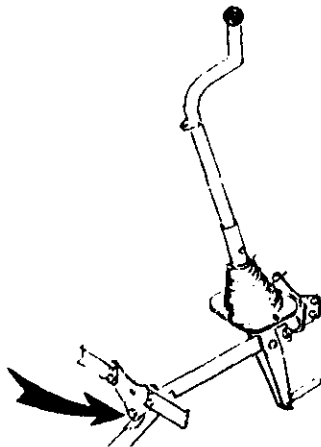
Piper  
Model PA-36-285

Control Stick Torque  
Tube Bolt, P/N AN4-13A

A pilot reported partial loss of elevator control during flight. Investigation revealed the forward control stick torque tube-to-bearing plate bolt had backed out. The bolt was the proper length, and the barrel nut was found inside the torque tube. Airworthiness Directive 75-20-07, which pertains to the subject, did not apply by serial number to this aircraft.

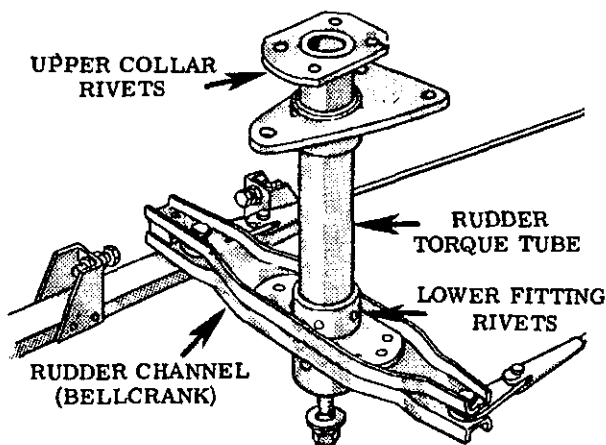
## Rockwell International Rudder Control System

There have been instances of rudder channel (bellcrank) failure, as well as shearing of the rivets which attach the lower fitting and the upper collar to the rudder torque tube. Some of the reported failures have occurred shortly after take-off. These failures are attributed to rudder buffeting during high wind conditions while the aircraft is parked without gust locks installed, and in some cases, even when gust locks have been installed.

It is suggested that rudder control systems be periodically inspected, particularly after high wind conditions have existed, even if gust locks were installed. It is recommended that walkaround preflight inspections be conducted with a control lock on the rudder pedals and the rudder gust lock removed. If significant rudder movement is apparent when pushed from side to side by hand, the rivets may be sheared, and need for further, more detailed inspection is indicated.

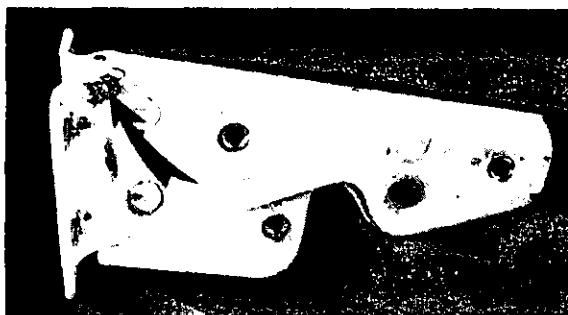
Varga (Morrissey) Elevator Horn  
Model 2150A

During preflight inspection, a crack was found in the radius of the elevator horn flange at attachment to the elevator.

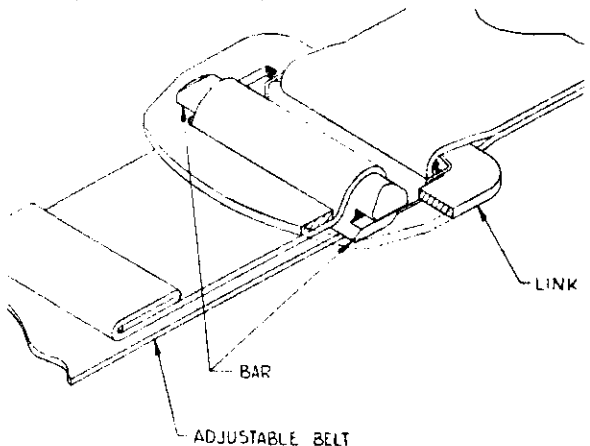
Pacific Scientific      Adjustment Take-up  
1101 Series Lap Belt      Devices  
and 1101 and 0101  
Series Shoulder  
Harnesses

A routine inspection of two helicopters showed that the seat belts and shoulder harnesses were improperly assembled. The improper assembly reduces the strength of the belt to a point well below its intended strength. This condition is not readily discernable unless a study of the fitting and cross-bar is made. This problem appears to be brought on by removal and reassembly of the belt for maintenance purposes, and is believed to be quite prevalent. Pacific Scientific Company Service Bulletin No. 042, dated January 11, 1972, covers this subject, and was published as follows:

**"RECOMMENDED ACTION:** Visually examine in-service lap belts and shoulder harnesses using this adjustment design to determine that BAR is correctly installed. Visually examine same items for correct BAR installation if, for any reason, disassembly and maintenance and reassembly has taken place. Insert this bulletin in applicable maintenance and overhaul instructions."

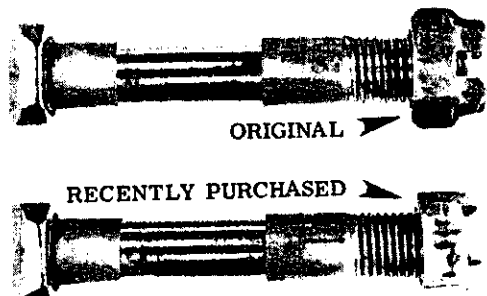
Continental      Connecting Rod  
Model A-65      Nut, P/N 24804

It has been reported that when attempting to torque the connecting rod bolt nut to the manufacturer's specified requirements, the nut distorts and damages the threads on both the nut and the bolt. These nuts were purchased from a parts distributor in California, and were advertised as genuine Continental parts. The accompanying photograph shows a comparison of the original nut (steel), and the recently purchased nut.

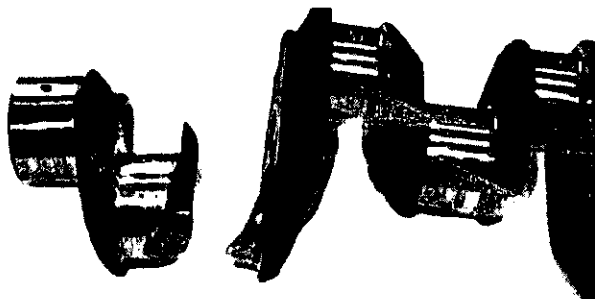
Crankshaft,  
P/N 74708

Investigation following a reported partial engine power loss revealed zero compression for No. 4 cylinder. Further inspection disclosed the crankshaft had failed at the No. 4 connecting rod journal through the rear crank cheek radius. The engine had been in service approximately 959 hours since factory remanufacture.
