With Change 1
AC NO: 20-82

MAINTENANCE INSPECTION NOTES FOR FAIRCHILD HILLER F-27/FH-227 SERIES AIRCRAFT

AC NO: 20-82 CHG 1

SUBJECT: MAINTENANCE INSPECTION NOTES FOR FAIRCHILD HILLER F-27/FH-227
SERIES AIRCRAFT

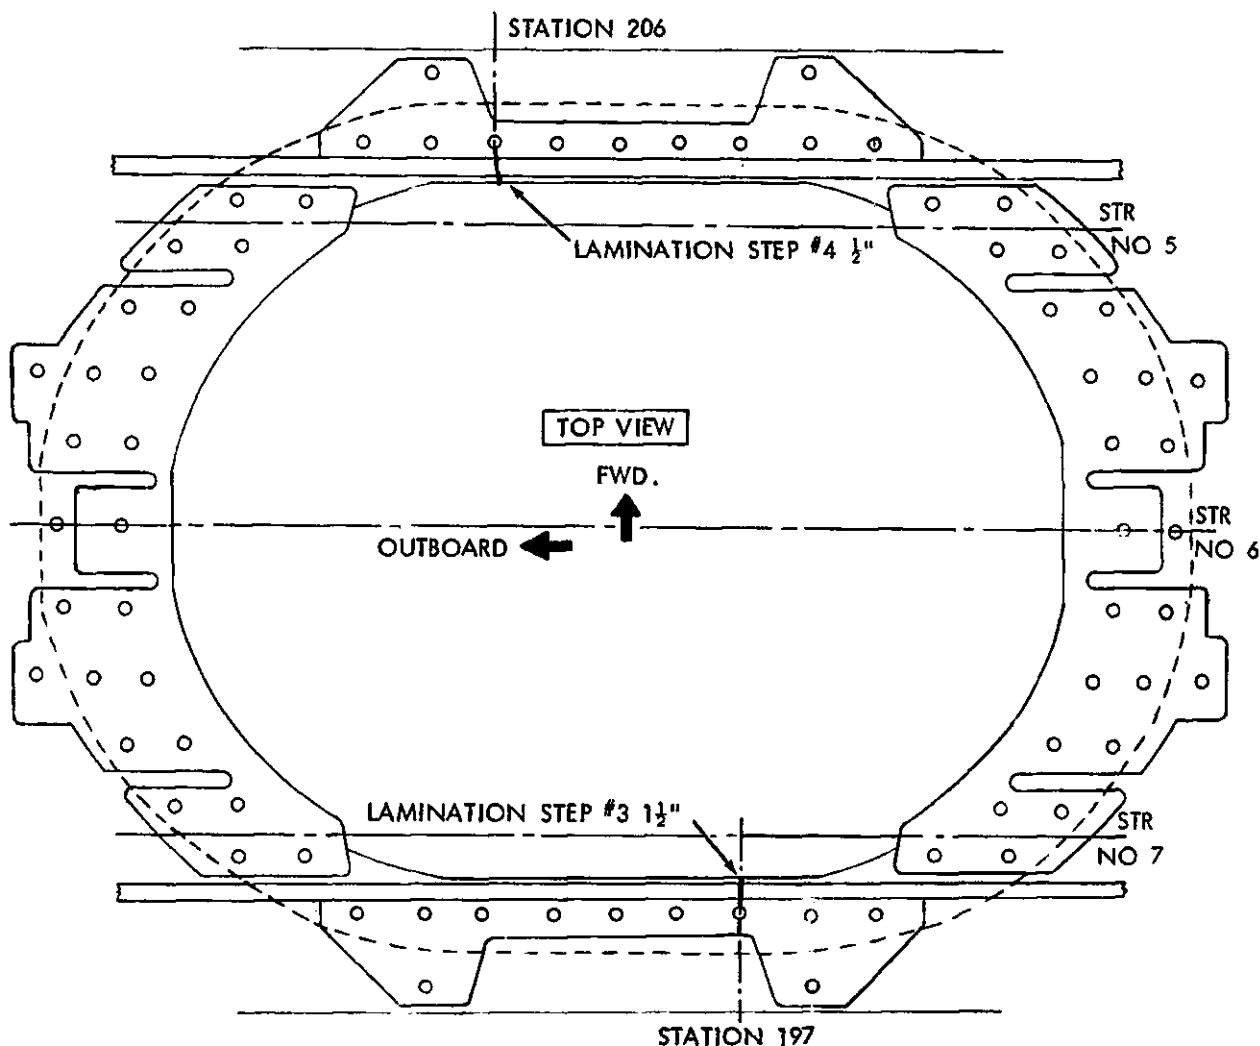
FIGURE 1. CRACKS IN WING FUEL ACCESS DOOR LAND AT WS 197 AND WS 206.

On a routine inspection of an FH-227 series aircraft, two cracks, $\frac{1}{2}$ -inch long each, were found in the No. 1 fuel access door land screw-holes (Ref. Fairchild Hiller Service Bulletin FH 227-51-1). Total aircraft time 12,830 hours. Time since inspection 150 hours. Time since last X-ray 465 hours.

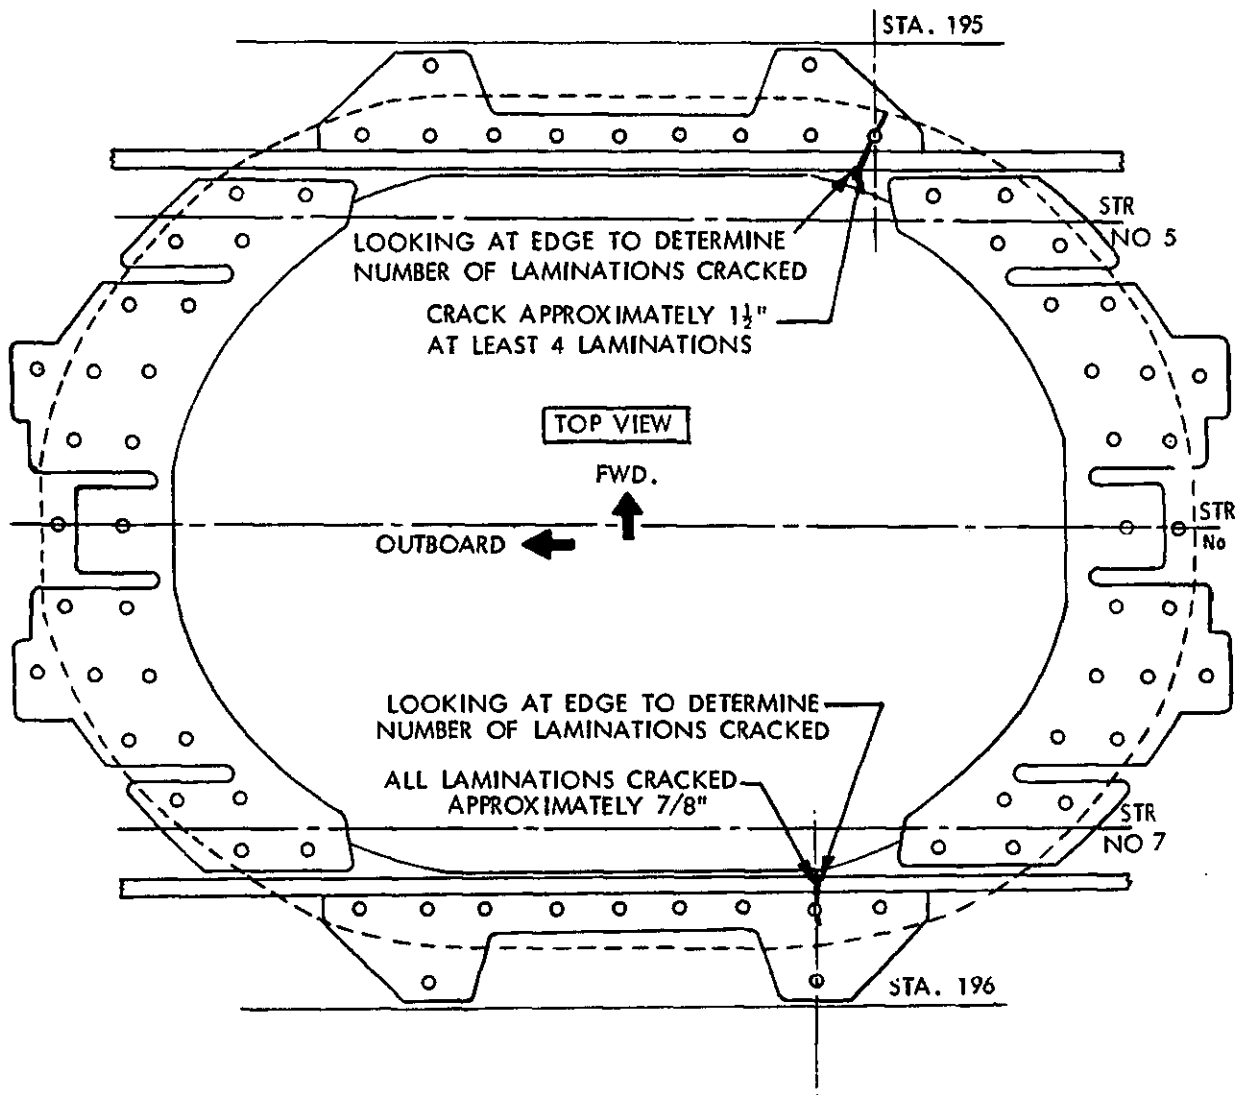
FIGURE 2. CRACKS IN WING FUEL ACCESS DOOR LAND AT WS 195 AND WS 196.

On a routine inspection of an FH-227 series aircraft, two cracks, 1/2-inch and 7/8-inch long, were found in the left outer wing panel at the screw-holes in the No. 1 fuel access door land. (Ref. Fairchild Hiller Service Bulletin FH-227-51-1). Total aircraft time 12,257 hours. Time since inspection 132 hours. Time since last X-ray 1,143 hours.
