# **General Aviation Airworthiness Alerts**

**AC No. 43-16**

**Alert No. 64  
November 1983**

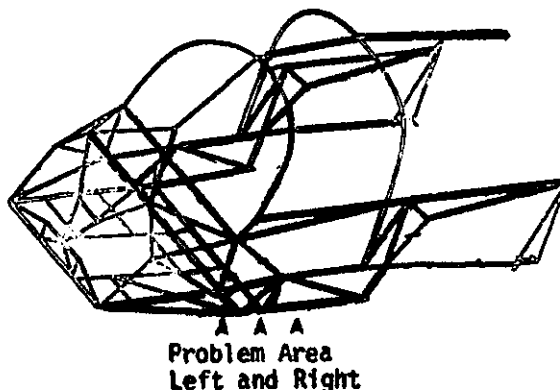
Rusted Longeron

The left lower longeron was found rusted from the inside out in several places. This was the second rusted longeron the submitting repair station has recently found. Mooney Service Bulletin M20-208 pertains to the problem.

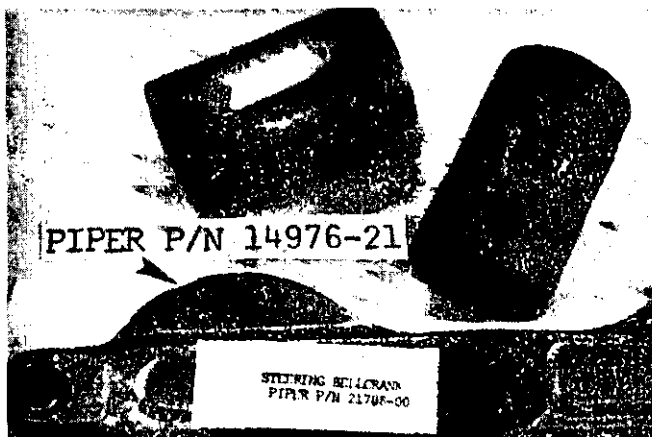
Nose Steering  
Bellcrank

The nose gear steering bellcrank indicated excessive wear on the cam faces. Investigation disclosed peening resulting from excessive clearance between the steering bellcrank and the steering arm bushings. Both steering arm bushings were worn to hourglass shapes, and one showed indications of not turning. The submitter advised this condition could be prevented by maintaining gap clearances between the bushings and bellcrank in accordance with Piper Comanche Service Manual, Chapter 6-16(a). The submitter also advised these parts are common to PA-30 and PA-39 aircraft.

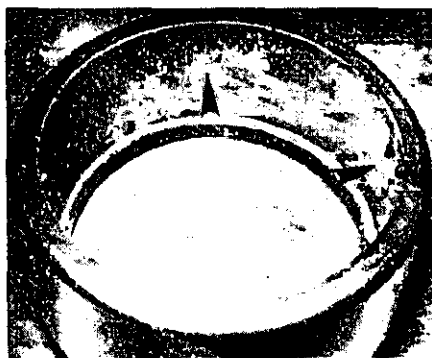
**Sheared Bearing  
Retainer Pins**

A torque link broke during takeoff. Disassembly of the right main gear strut assembly revealed that three of the pins had sheared and one was missing. This allowed the piston to extend and be held only by the torque links until one broke.

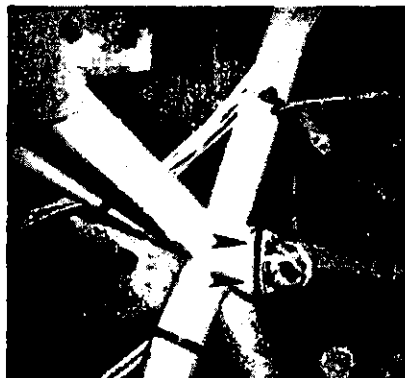
**Cracked Fittings**

The left and right forward spar fuselage-to-wing attach fittings were found cracked. This area was inspected because the pilot reported he could hear a "thump" sound on landing.

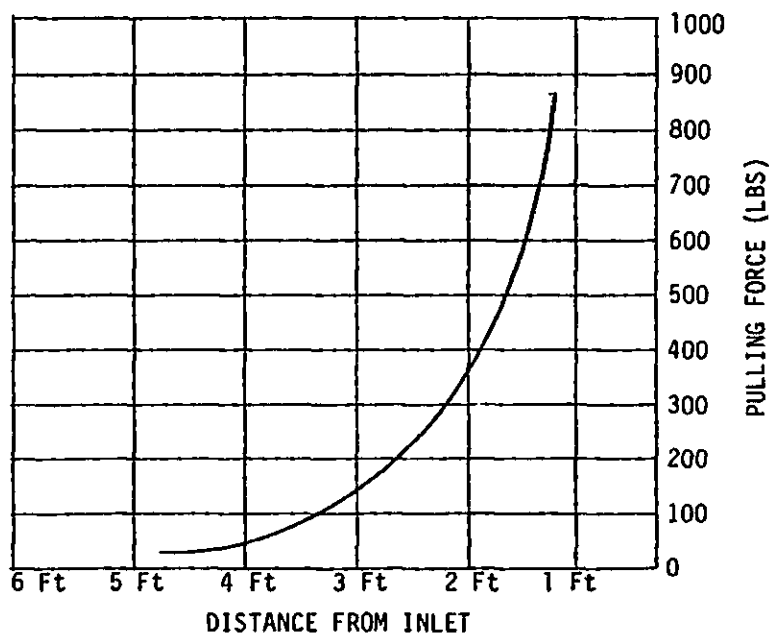
The accompanying figure illustrates the typical strength of the pulling force near the inlet of a wing-mounted jet engine operating near takeoff thrust. The pulling force felt over the body is the same force felt in a strong wind, except that a wind of 25 mph exerts a force of only 20 pounds on an average-size person. By comparison, a force of about 1,000 pounds is exerted on a person standing within a step in front of an engine operating at takeoff thrust. Even with an engine at idle, the pulling force is greater than 300 pounds. With nothing to hold on to, a person can offer only about 95 pounds of resistance by skidding on the bottom of his shoes. This means that the pulling force generated by an engine just at idle is enough to drag almost anyone into the spinning compressor and certainly, it is enough to pull in loose articles of clothing, rags, and loose objects from shirt pockets.

The graph also helps to illustrate the deceptive nature of the suction force. The suction generated by an engine operates in the same manner as the suction generated by a vacuum cleaner.
