Rapid Pothole Repair in Concrete Bridge Decks

Report Number: KTC-23-02/SPR21-607-1F

Research Report

November 2022

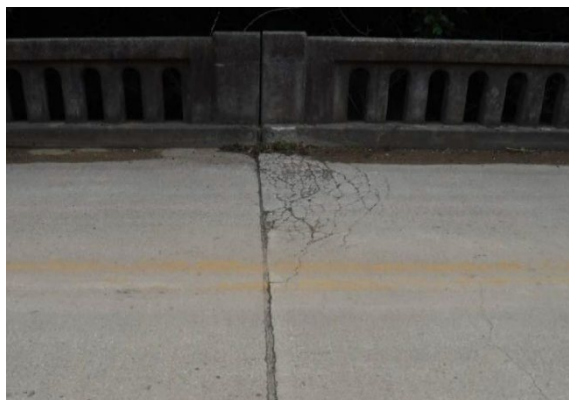
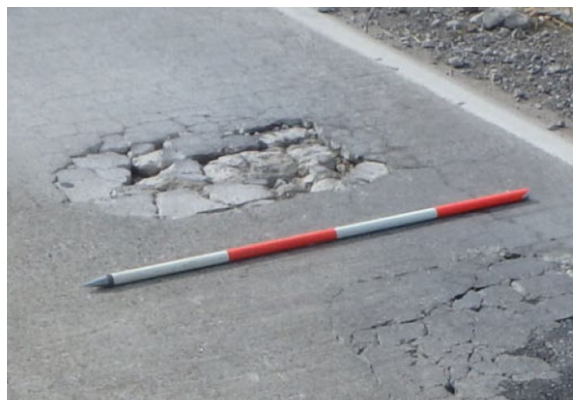
Figure 1.1 Cracking and Spalling Damage Observed on Bridge Decks

Figure 1.1 illustrates the types of cracking and related damage to a bridge deck expected to be repaired using epoxy, including initial cracking prior to concrete spalling (Figure 1.1a) and spalled concrete that results from cracks and the loosening of the deck concrete (Figure 1.1b).

(a) Cracking on bridge decks

(b) Concrete spalled off from deck

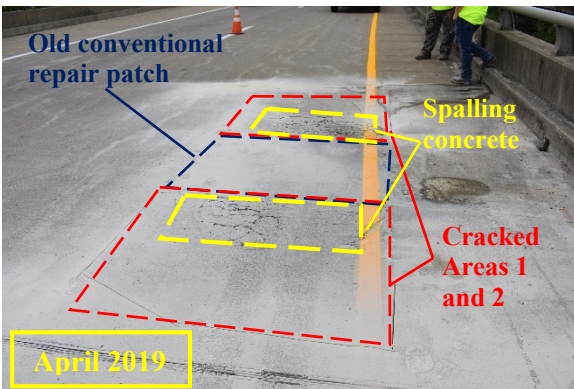
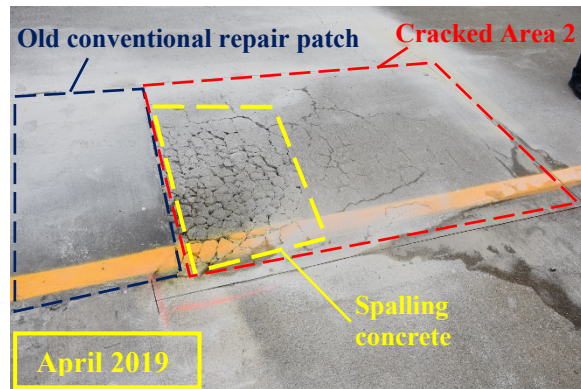
The deck's westbound lanes were damaged on this three-span prestressed concrete I-girder bridge built in 1971. Average daily traffic (ADT) on the bridge is 6,294 vehicles (8% truck traffic). The deck had cracked regions, and potholes opened up on either side of a partial-depth patch on the northbound slow lane previously repaired using conventional methods, resulting in spalling concrete. A KYTC District 07 bridge crew repaired the deck on April 18, 2019. The ambient temperature was 70°F and rising during the repair period. Cracked areas are shown in Figure 4.1, which also depicts the saw cuts around the crumbling patch made when the bridge crew mistakenly assumed a conventional concrete type of repair. Saw cuts were later filled with epoxy in a similar fashion to the cracks. Cracked areas on each side (to the west and east) of the patch were approximately 60" wide, the same width as the previous patch. The degree of damage was severe near the repaired patch, with concrete spalling only visible up to approximately 24" from the edge of the existing patch in both directions. Beyond this point (Figure 4.1b) cracking was visible for an additional 36" but spalling of concrete was not observed.

(a) Damage on either side of previously and conventionally repaired patch

(b) Cracking seen on one of the damaged areas

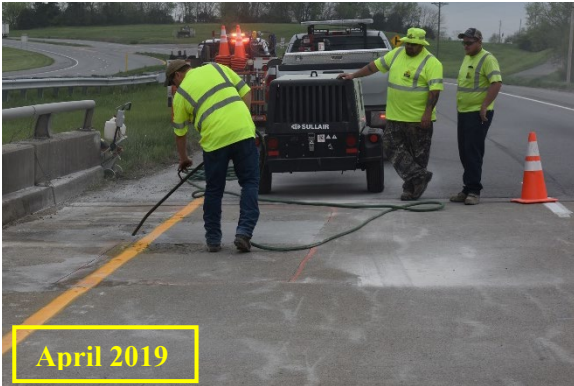
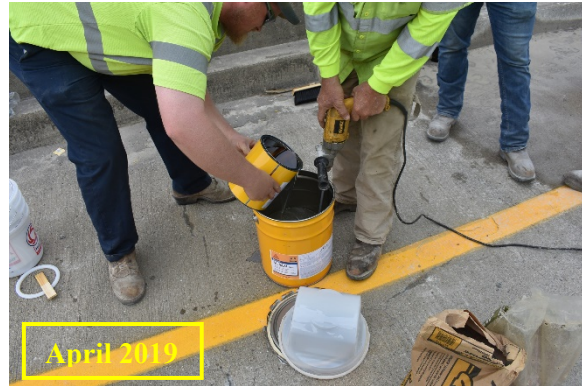
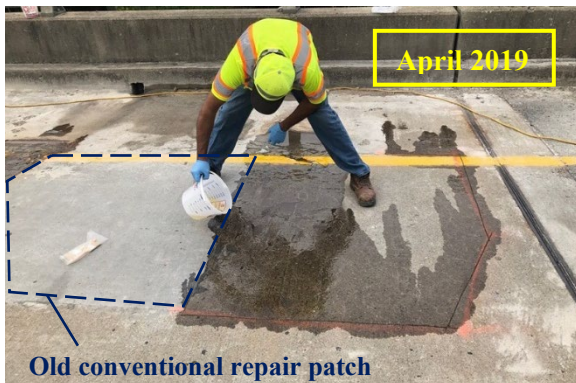
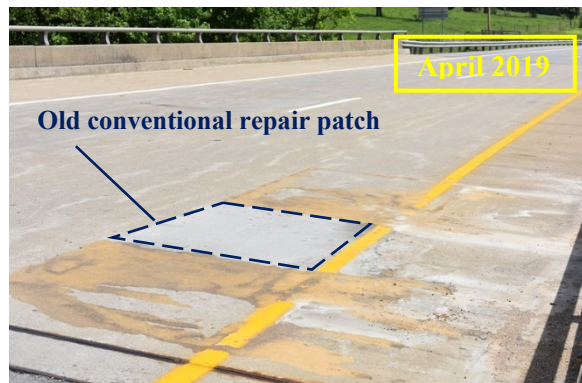
(a) Cleaning of repair area using compressed air

(b) Mixing of the two-part epoxy

(c) Application of epoxy over cracked Area 1, west of old repair patch

(d) Sand spread over the epoxy

was removed using a shovel. Prior to the epoxy achieving initial set, sand was spread over the top of the epoxy to provide a roughened driving surface (Figure 4.2d). The repair — from cleaning to epoxy application — took approximately 30 minutes. Sand was periodically spread for an additional 45 minutes until the epoxy started to set. At this point excess sand was swept off using a broom. While it was possible to drive over the repair at this point, lane closure was maintained for an additional hour to allow more time for the epoxy to cure.

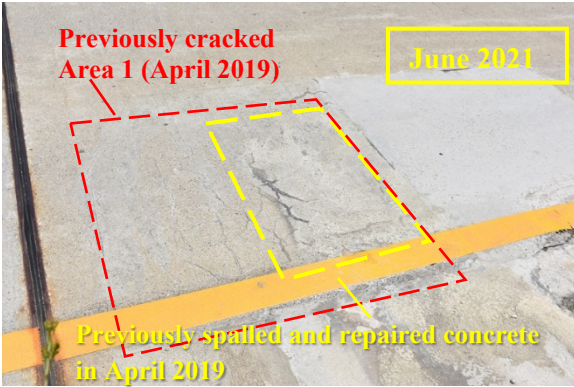
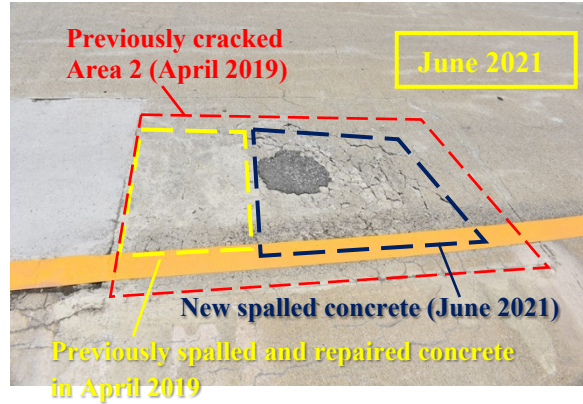
The previously spalled area to the east of the concrete patch (Area 2 in Figure 4.1b) also looked well-bonded by the epoxy with no observed cracking (Figure 4.3b). Beyond the previously spalled and repaired area, new cracks formed resulting in spalled concrete. The epoxy was successful in repairing the two spalled areas in April 2019. However, similar to a conventional concrete repair patch, new cracking formed adjacent to the repaired area (Figure 4.3b).

(a) Area 1, west of old concrete patch

(b) Area 2, east of old concrete patch

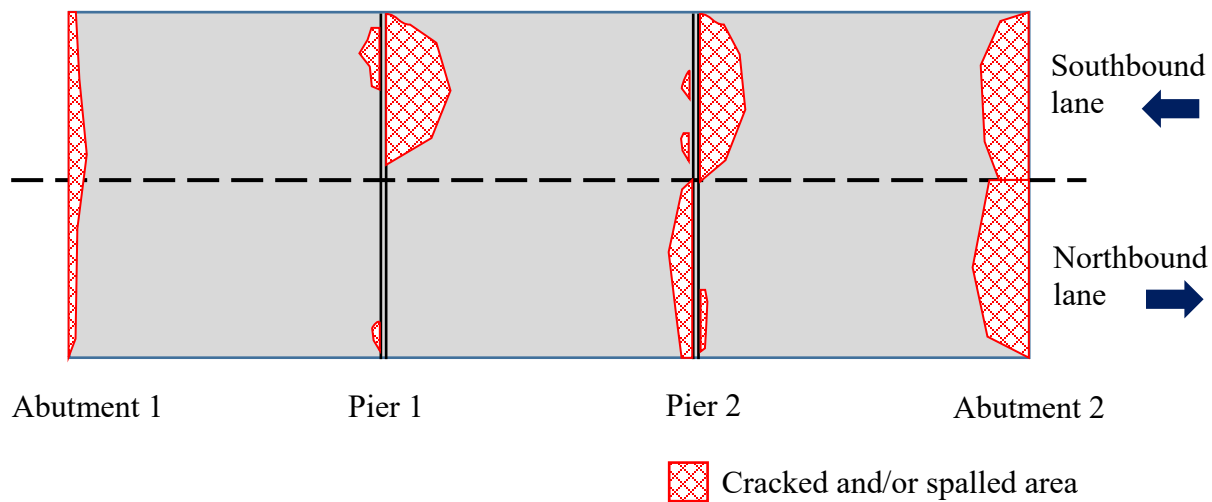
Figure 4.4 Damaged Areas on 023B00040N Bridge Deck

As seen in Figure 4.5, cracked areas contained moisture. This provided the opportunity to evaluate the use of a portable propane blow torch to dry damaged areas. For cracked areas, heat was applied to the concrete with the torch head held approximately 6" – 12" from the surface. For areas where the concrete had spalled, heat was applied directly over standing water as well as the exposed concrete surfaces. All aggregate and concrete fill material was also dried using the blow torch prior to placement within the patch area.

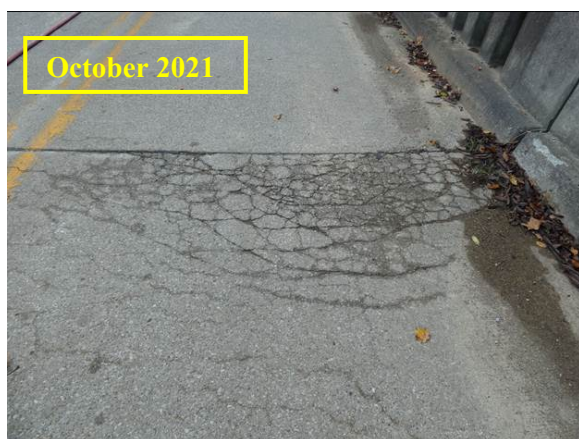
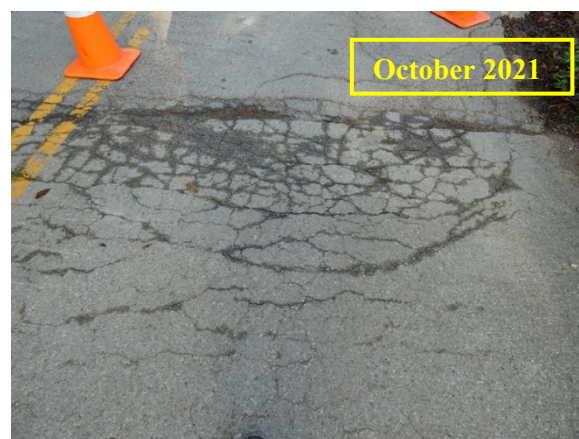
(a) Southbound lane over joint at Pier 1

(b) Northbound lane over joint at Abutment 2

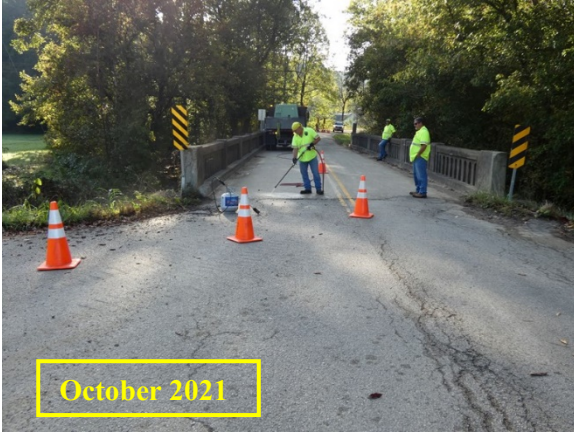
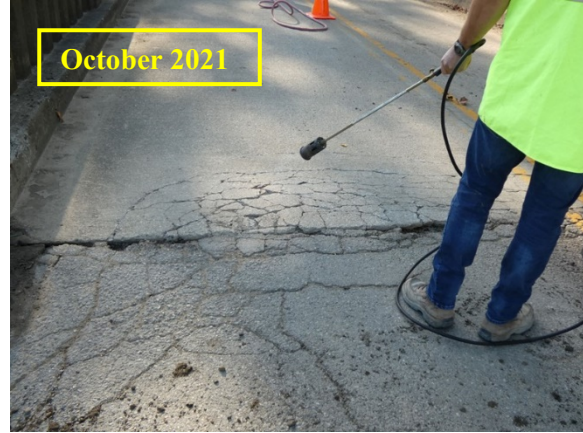
Figure 4.6 Cleaning and preparing cracked area over Abutment 2

(a) Cleaning using compressed air

(b) Drying using blowtorch

Figure 4.6 shows preparation of the damaged area on the northbound lane over Abutment 2. All crack locations were cleaned using compressed air (Figure 4.6a). Due to moisture within damaged areas (Figure 4.5), all cracks were dried using a blow torch (Figure 4.6b), followed by detailed inspection to evaluate the type of repair to be carried out. For several cracked locations, only the application of epoxy and subsequent spreading of sand was required. The crew used Class I sand (which has particle sizes from 3/16" down to dust) as it was readily available. In case of the concrete spalling on the northbound lane at Abutment 2 and several other locations, voids were present within the spalled concrete area. The repair process (Figure 4.7) involved filling voids with pea gravel and spreading the mixed Sikadur 52 epoxy over the area (Figure 4.7a). Class I sand was then spread over the repair area periodically prior to initial set (Figure 4.7b).

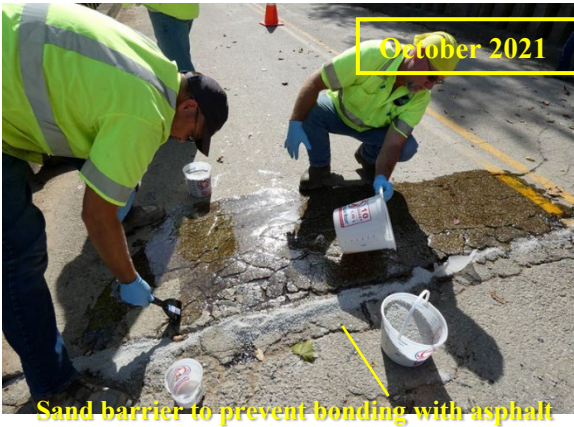
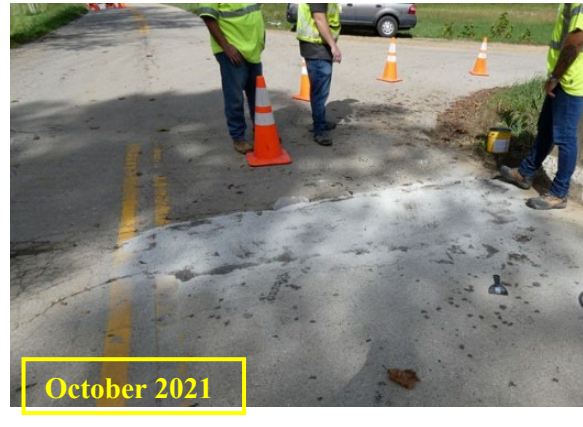
(a) Spreading of epoxy over cracked area

(b) Class I sand spread over epoxy

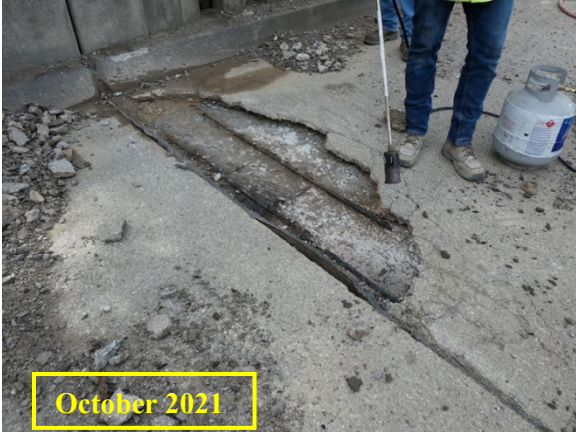
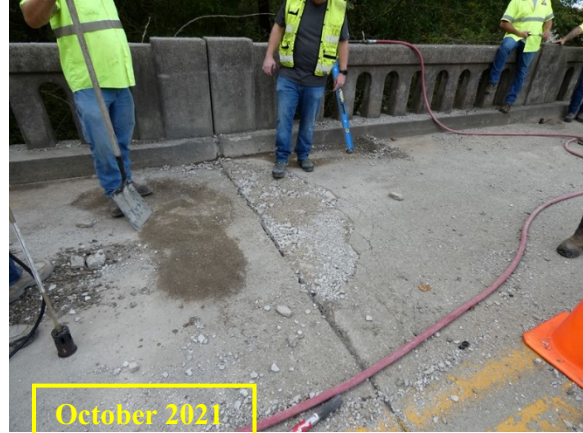
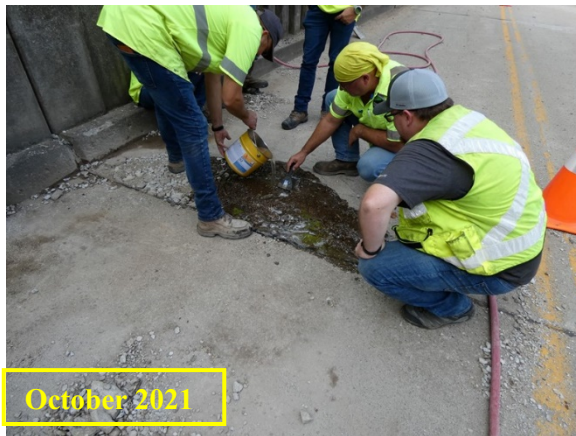
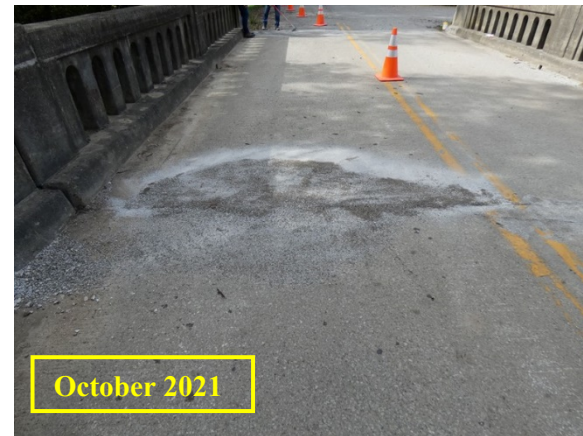
(a) Drying area after removing loose concrete

(b) Packing back removed concrete

(c) Application of epoxy

(d) Class I sand spread over epoxy

When cleaning the damaged area on the southbound lane at Pier 1, spalled concrete came loose under the force of compressed air. All loose concrete was removed, and the area dried using a blowtorch (Figure 4.8a). Exposed steel was cleaned using a wire brush. Removed concrete pieces were also dried using a blowtorch, following which, concrete was repacked into the void, along with a mix of pea gravel, to completely fill the pothole (Figure 4.8b). The concrete and pea gravel aggregate mix was tamped by hand to establish a level surface prior to application of epoxy (Figure 4.8c). Epoxy was poured at regular intervals until it began to pond atop the aggregate. At which point the application was stopped. Similar to the other areas, Class I sand was spread over the repair area prior to initial set (Figure 4.8d).

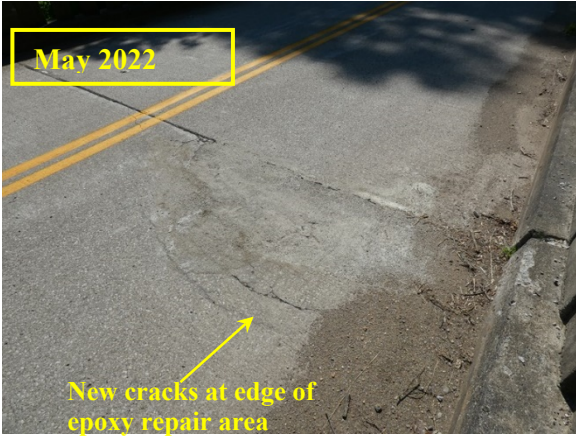
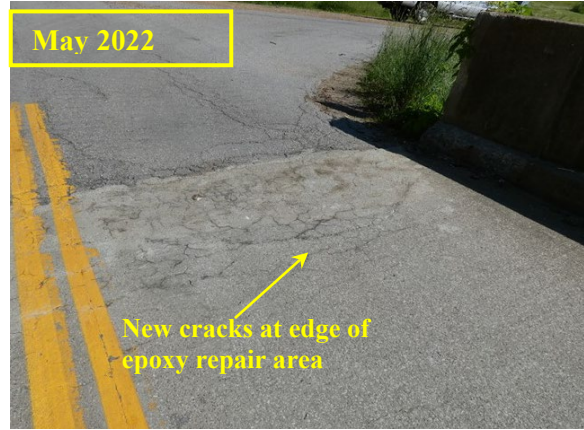
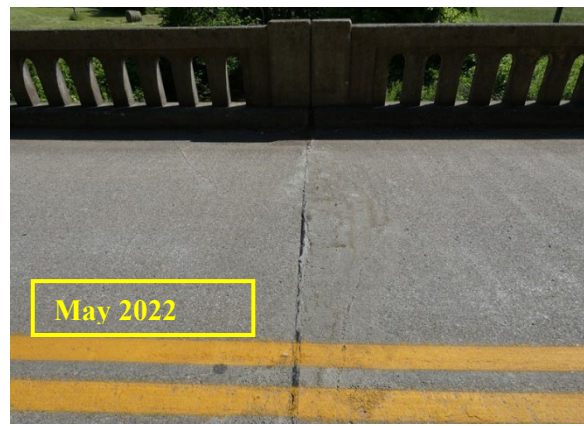
The deck was inspected on May 31, 2022 (eight months after the repair). The condition of the two locations that had the most damage (Figure 4.4) is shown in Figures 4.9a and 4.9b. At both locations, the previously cracked/spalled concrete was well bonded with the epoxy. At both locations, new cracks were visible along the perimeter of the epoxy repair patch within the concrete deck and slightly away from the patch. At all other repair locations, no new cracking/damage was observed. The condition of the repairs at these locations was similar to the northbound and southbound lanes over Pier 2 (Figure 4.9c and 4.9d).

(a) Southbound lane over joint at Pier 1

(b) Northbound lane at Abutment 2

(d) Northbound lane over joint at Pier 2

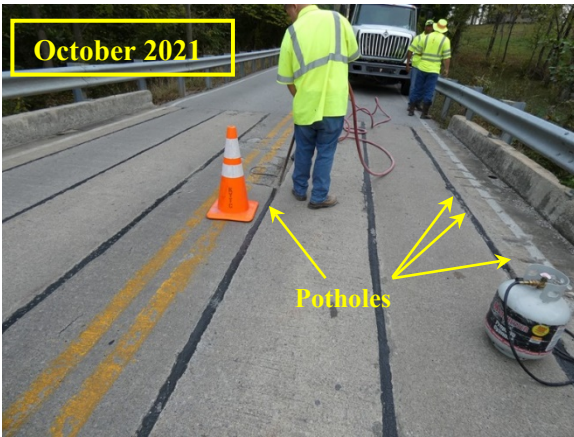
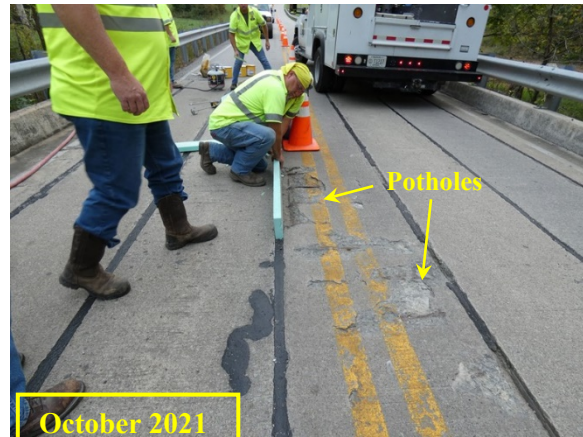
This is a single span side-by-side prestressed concrete (PC) box beam bridge built in 1980. ADT is 1,144 vehicles. A section of the center PC beam (Beam 4) had spalled concrete, which exposed steel rebar (Figure 4.10a). The edge beam on the eastbound lane (Beam 7) had multiple sections where the concrete had spalled off, leaving potholes. As the driving surface was the top of the seven PC beams, the traditional method of removing concrete was not an option. Therefore, using epoxy mortar to fill the potholes was thought to be suitable application. As the median divides the center PC beam, damage was over both the eastbound and westbound traffic lanes (Figure 4.10b). Minor spalls were also observed in Beams 2 and 3. A KYTC District 08 bridge crew undertook the repair on October 12, 2021. The ambient temperature was 70°F and rising during the repair period. Based on the narrow bridge width (20 ft curb-to-curb), the center PC beam could not be repaired in a single application, and the repair was carried out in two phases. During the first phase the eastbound lane was closed, and the repair work carried out, following which the crew took a break and let the epoxy cure for an additional hour. Then the eastbound lane was opened to traffic and the westbound lane closed for repair.

(a) Damage to beam 4 and 7 (looking east)

(b) Damage to beam 4 (looking west)

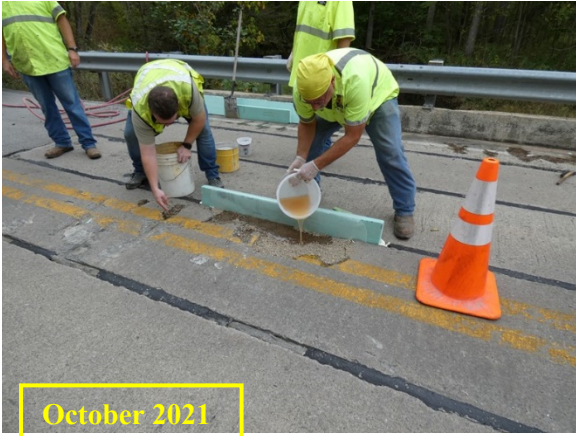
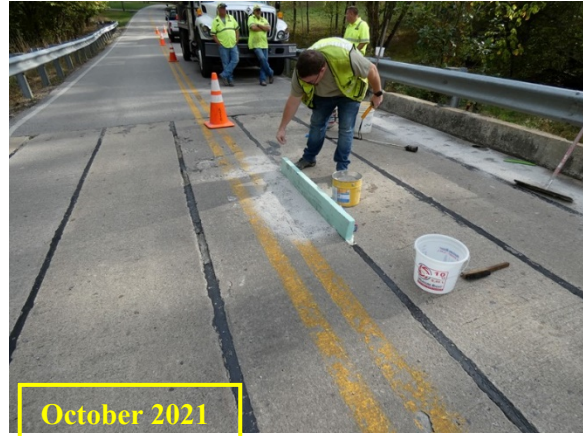
(a) Application of epoxy over pea gravel

(b) Spreading Class I sand over repair area

Preparation of the damaged area proceeded in a manner similar to the other bridge deck repairs. Potholes were cleaned using compressed air (Figure 4.10a) and dried using a blowtorch. Pea gravel was used as the aggregate and also dried with a blowtorch. Joint material between the beams was damaged, and a section of form board was used as a backer rod to prevent epoxy from seeping and bonding with the adjoining beam (Figure 4.10b). Initially potholes were wetted using the Sikadur 52 epoxy, after which they were filled with pea gravel. The epoxy was then evenly poured over the section (Figure 4.11a). Prior to the epoxy achieving initial set, Class I sand was spread over the entire repair area (Figure 4.11b). The same procedure was used to fill all potholes on the edge girder and repeated on the westbound lane once the lane closure was switched. Repairing each side took approximately 90 minutes; epoxy was allowed to cure for one hour before lanes reopened to traffic. Preheating the potholes and aggregate accelerated epoxy set times.

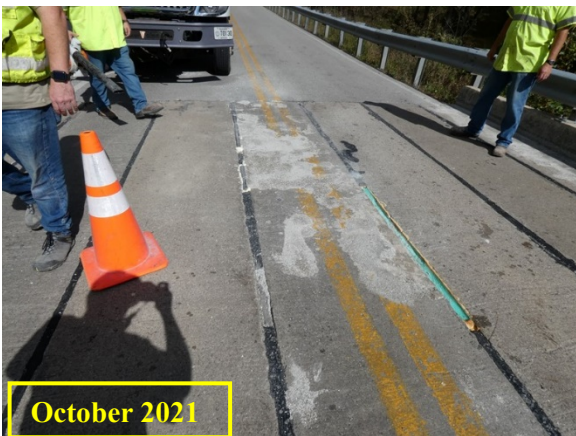
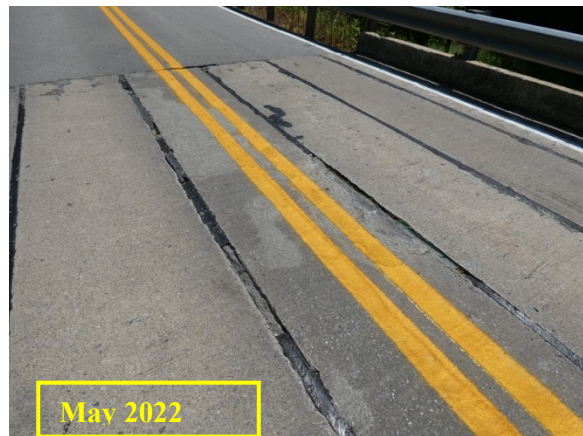
Figure 4.12a shows the repaired area over eastbound and westbound lanes on the center PC beam just before the bridge opened to all traffic. Repaired areas on the top of the PC beams were inspected eight months after the repairs on May 31, 2022. Figure 4.12b shows the same area as observed during inspection. No cracking or damage to the repairs was found at any repaired location.

(a) Center PC beam soon after repair

(b) Center PC beam after 8 months

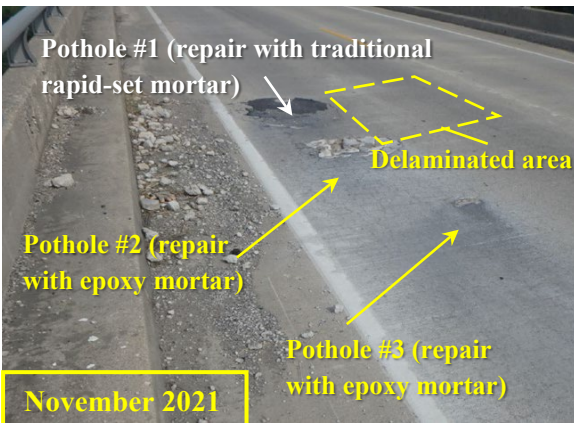
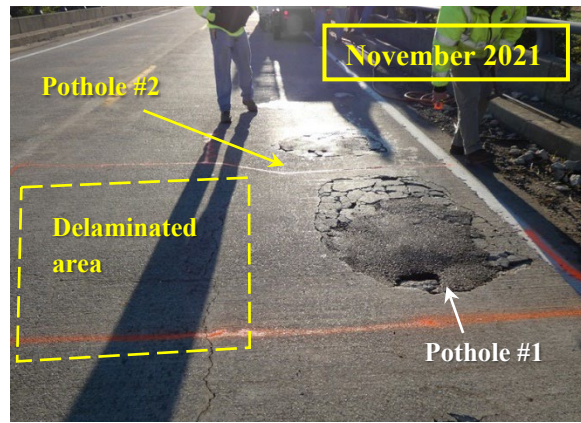
(a) Damage to deck (looking west)

(b) Damage area (looking east)

A KYTC District 06 bridge crew undertook the repair on November 01, 2021. The ambient temperature was 43°F and rising during the repair period. Based on the size of the damaged area, and both potholes being located on the same wheel path, the larger pothole (Pothole #1) was repaired using traditional methods while the smaller one (Pothole #2) was repaired using epoxy mortar. As seen in Figure 4.13a, a much smaller pothole was visible away from the two large potholes (Pothole #3). It was also repaired using epoxy mortar. The eastbound lane was closed during the repair period.

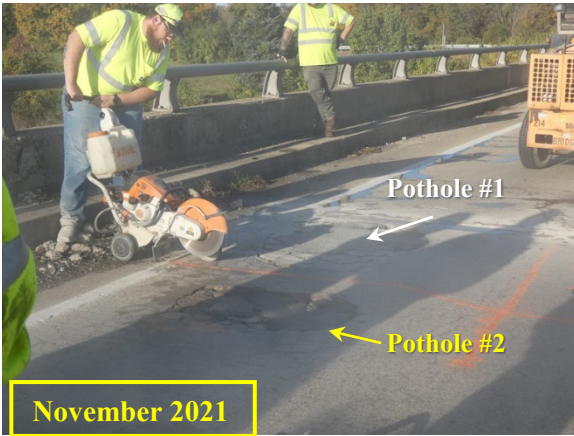
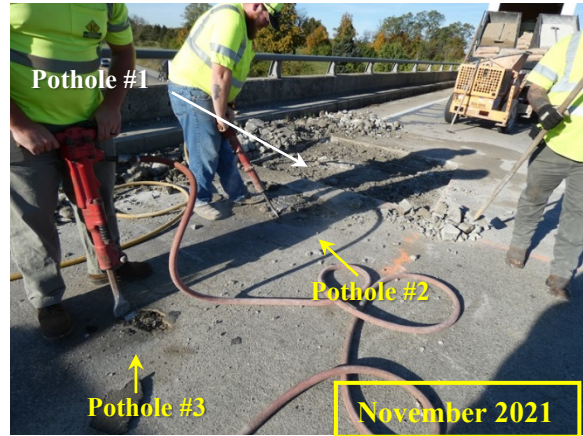
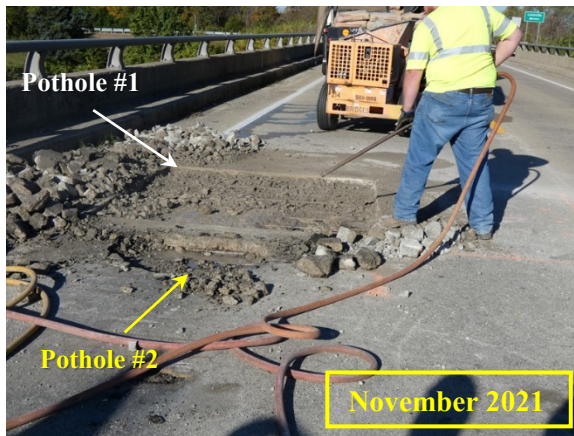
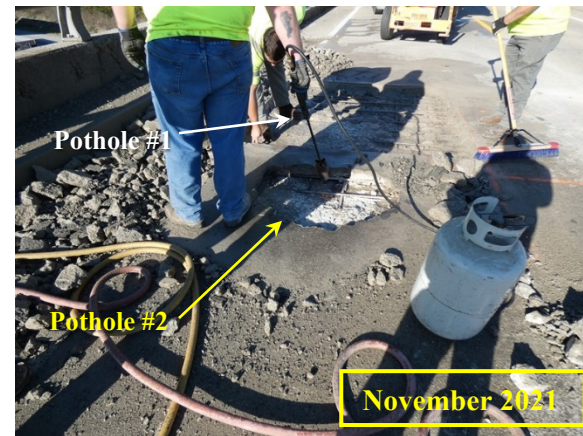
(a) Saw cutting around Pothole #1

(b) Removal of damaged concrete in Pothole #2 and #3

(c) Removal of standing water using compressed air

(d) Drying of potholes using blowtorch

Because standing water was observed in potholes, all loose concrete was removed in Potholes #2 and #3 (Figure 4.14b). Standing water was blown off using compressed air (Figure 4.14c). Following this a blowtorch was used to dry the repair area (Figure 4.14d). The crew decided to remove existing concrete from Potholes #2 and #3 based on the observed moisture as well as the asphalt material used to patch Pothole #2. A #8 aggregate (graded with a maximum size of 1/2") was used to fill Potholes #2 and #3. After spreading epoxy on the bottom of the pothole, it was filled with #8 aggregate (Figure 4.15a). After which, epoxy was slowly added until it started to pond (Figure 4.15b). Sand was spread over the epoxy prior before it achieved initial set. Due to the low temperature it took approximately 80 minutes for the epoxy to reach initial set.

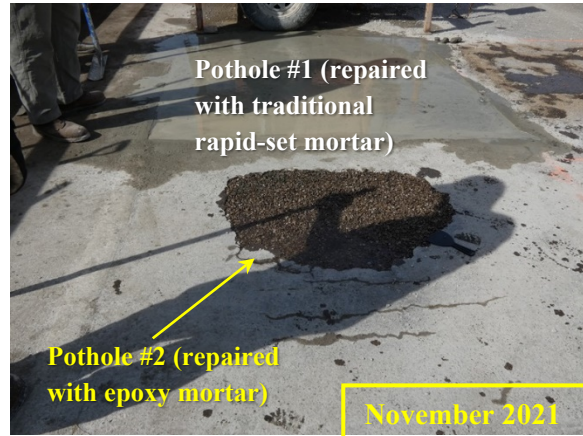
(b) Pothole following application of epoxy

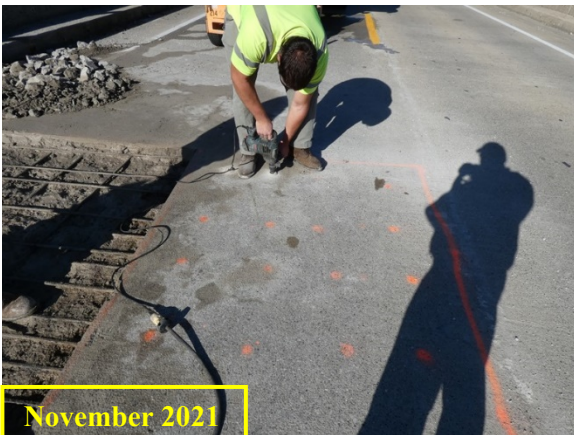
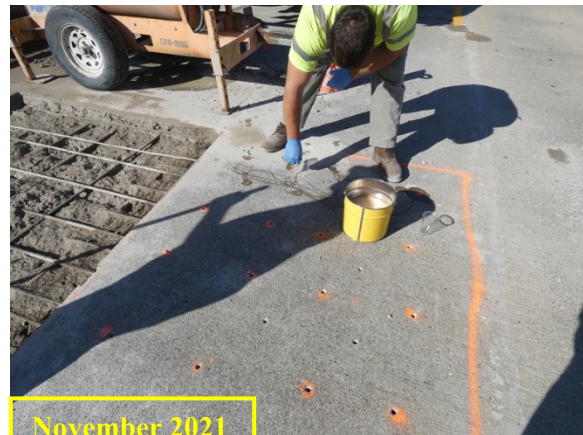
Figure 4.16 Repair of Delaminated Concrete

While sounding the deck concrete, some delamination was found in the concrete deck between Pothole #1 and the median. It was thought this could be remedied by applying epoxy to the deck to bond delaminated areas. Six holes (0.5" diameter x 6" deep) were drilled into the deck on an approximately 12-inch grid (Figure 4.16a). Additional holes were drilled at the center of these grid points later (Figure 4.16b). The mixed Sikadur 52 epoxy was poured into each hole (Figure 4.16b). Over time the epoxy level dropped in several holes. These were topped off periodically until no drop was observed. At this point, sand was spread over the epoxy periodically until initial set was achieved. Due to the multiple locations and different repair methods used, the repair took over 4.5 hours. The low ambient temperature also extended the lane closure time. The lane was opened to traffic after an additional 3 hours. The repaired areas just prior to opening the bridge to traffic are shown in Figure 4.17a.

(a) Drilling of holes

(b) Gravity feeding of epoxy

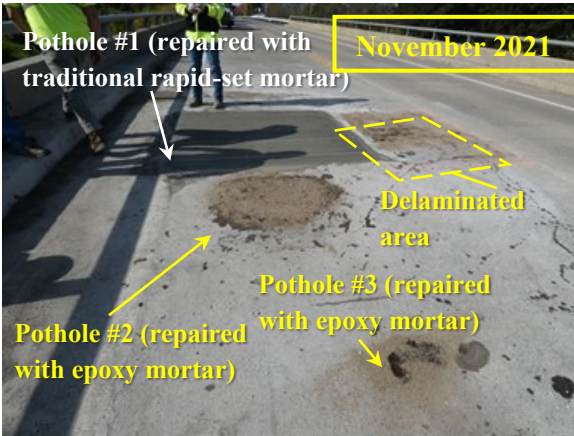
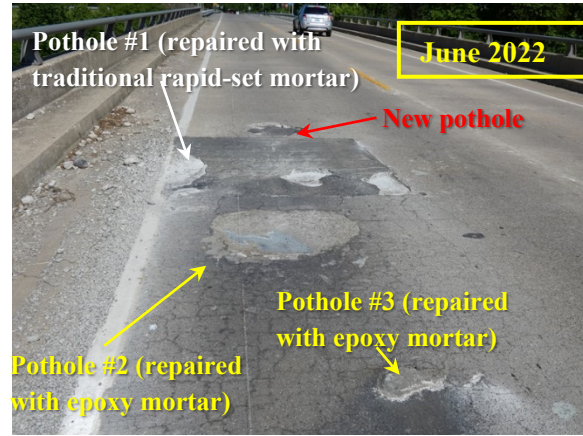
(a) Area soon after repair

(b) Area 7 months after repair
(ADT of 43,403 vehicles)
