AC NO: 91-18

# ADVISORY CIRCULAR

**SUBJECT:** COURSE NEEDLE OSCILLATIONS ON VHF OMNIDIRECTIONAL  
RANGE (VOR) RECEIVERS

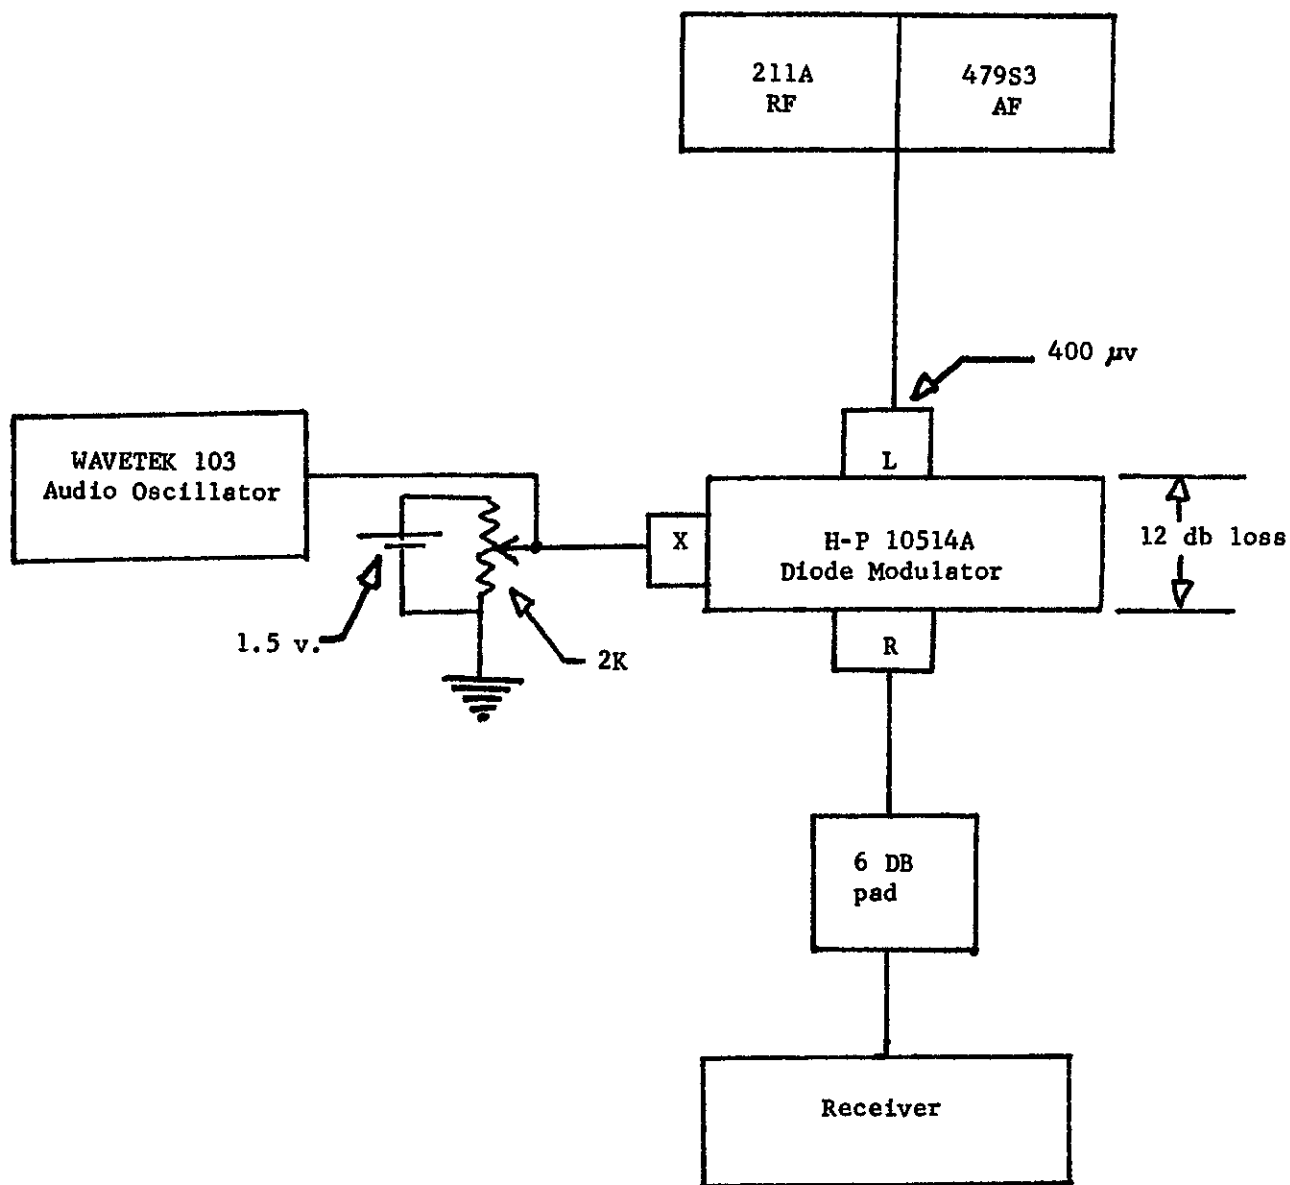
Figure 1

- (1) Set up test equipment as shown in Figure 1.
- (2) Insert a standard VOR signal, and set 211A attenuator to 400  $\mu$ v output.
- (3) Adjust battery bias to obtain 12 db loss through H-P 10514A mixer. 0.75 m.a. current was necessary in FAA testing.
- (4) Using VTVM, measure the level of the 30 Hz variable AM modulation in the 30 Hz channel of the VOR receiver (primary of output transformer).
- (5) Turn off 30 Hz variable AM modulation from VOR audio source.
- (6) Set audio oscillator output to 1/3 of the value measured in Step (4) to obtain 10 percent modulation. Restore 30 Hz AM.
