Test Report No. 440822-01

**EVALUATION OF ATTACHMENTS TO CONCRETE BARRIER
SYSTEMS TO DETER PEDESTRIANS**

Texas Department of Transportation
<https://tti.tamu.edu/documents/0-7082-R1-Vol2.pdf>

| 4. Title and Subtitle EVALUATION OF ATTACHMENTS TO CONCRETE BARRIER SYSTEMS TO DETER PEDESTRIANS—VOLUME 2: CRASH REPORT | | | | 5. Report Date Published: August 2023 | |

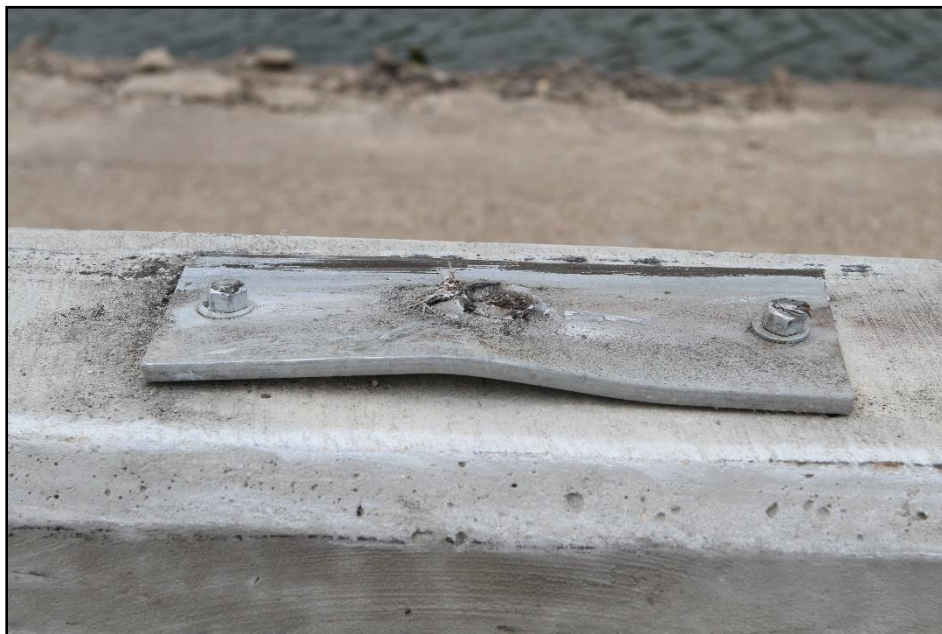
There was some scuffing and gouging at impact on the concrete barrier. Panels 6–20 were removed from the parapet. Panels 6 and 7 landed behind the parapet, and the others landed from 195 to 240 ft downstream. The pipe-to-plate connection failed at panels 7, 11, 15, and 16. The anchor bolts failed on the others.

Figure 5.8. Armorcast® Gawk Screen on Single-Slope Barrier after Test at Base Plate with Missing Post, Test 440822-01-1.

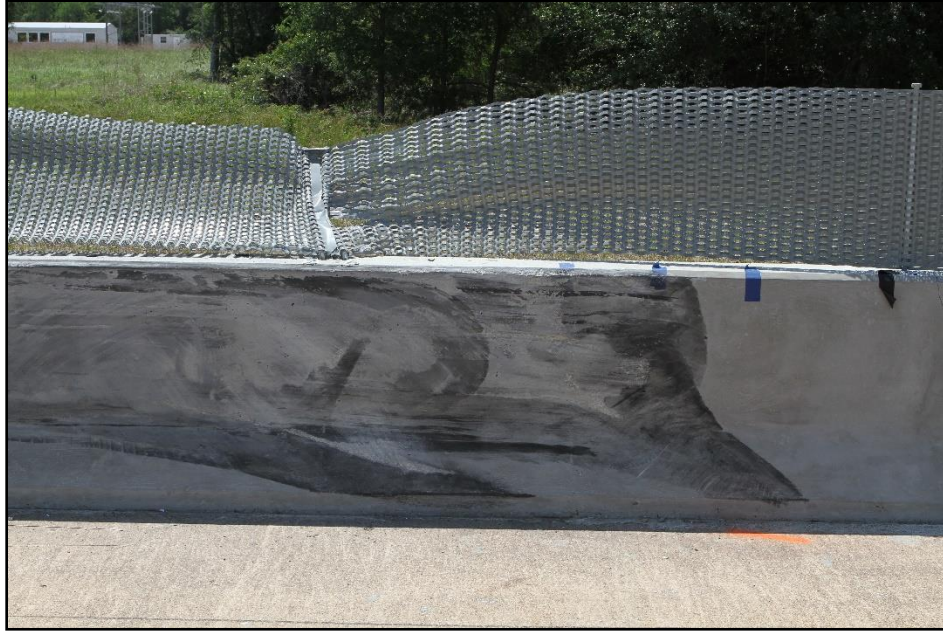
Figure 8.7. Screen-Safe® Glare Screen on F-Shape Barrier after Test at the Joint of Posts 6 and 7, Test 440822-01-4.
