Methodology for Load Rating Double-Tee Bridges

Study SD2016-01

Final Report

**Department of Civil & Environmental Engineering
South Dakota State University
Brookings, SD 57007**

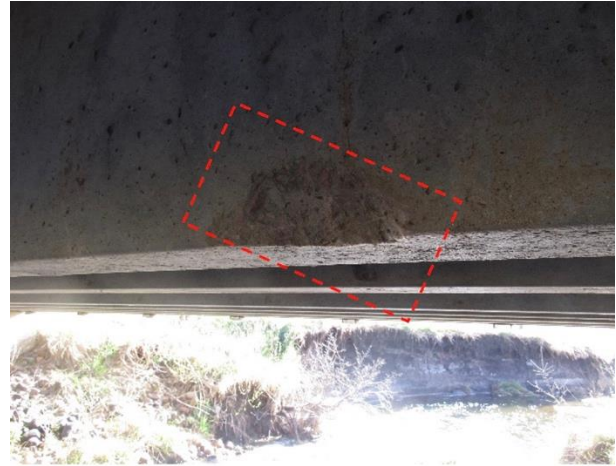
(b) Spalling at bottom of Stem, G4

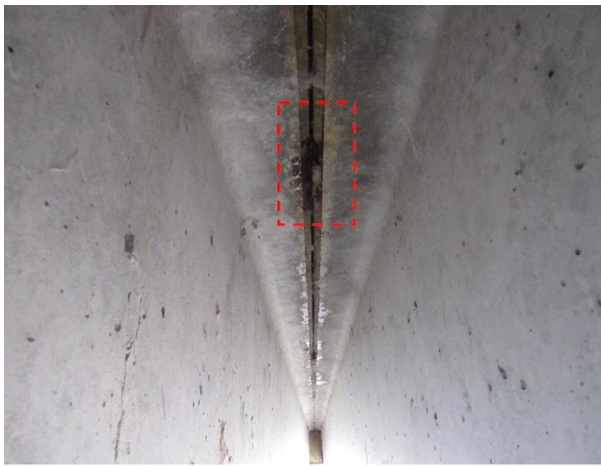
(c) Corrosion of Steel Plate

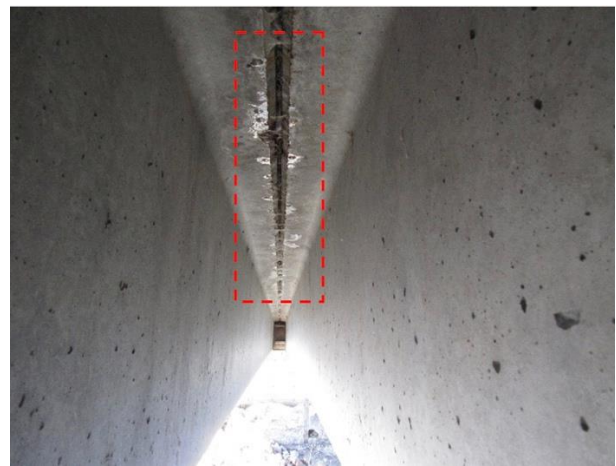
(d) Leakage in Joint

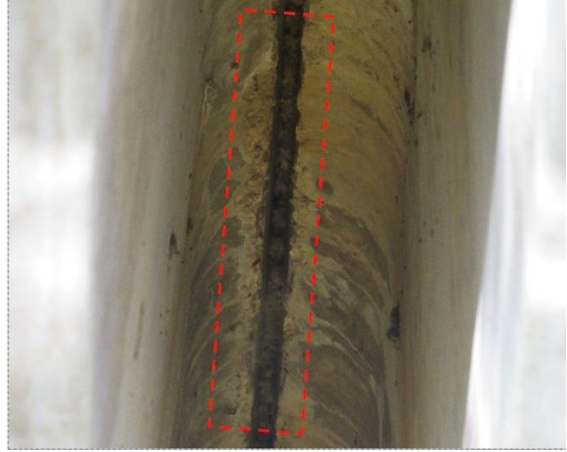
(b) Stains from Minor Corrosion of Steel Plates

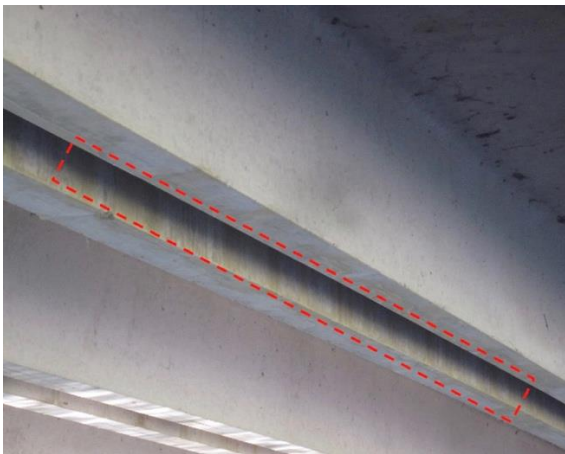
(c) Sign of Water Leak b/w Deck Units

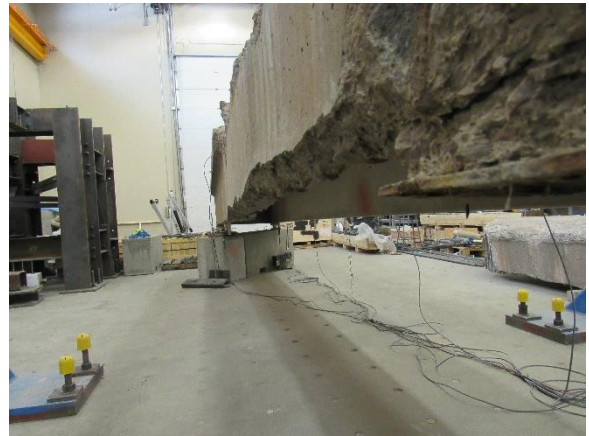
(b) Stem Cover Deterioration for 50-ft (15.24-m) Girder

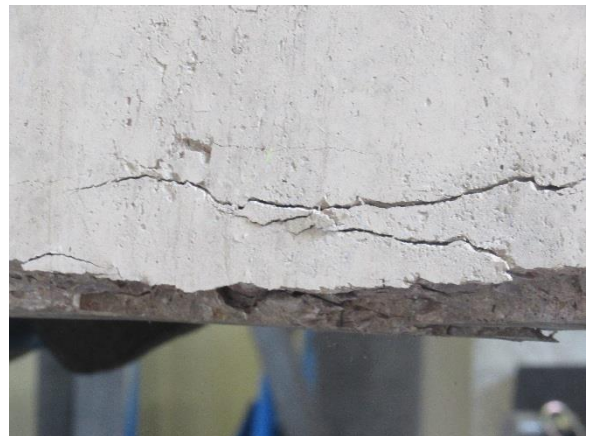
(d) Damage of 50-ft (15.24-m) Girder during Unloading

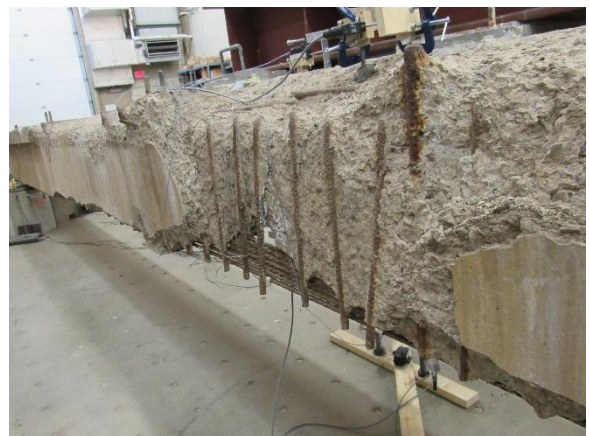
(f) Exposure of Strands and Transverse Bars on Stem of 50-ft (15.24-m) Girder

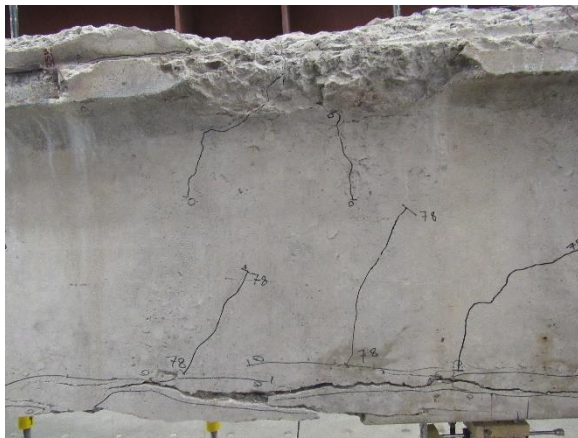
(a) First Flexural Crack at Midspan

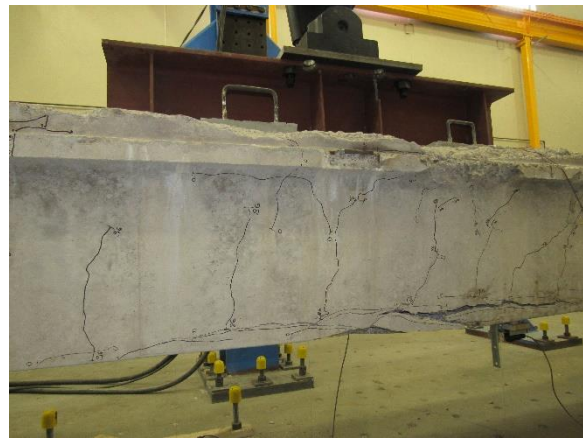
(b) Extension of Flexural cracks

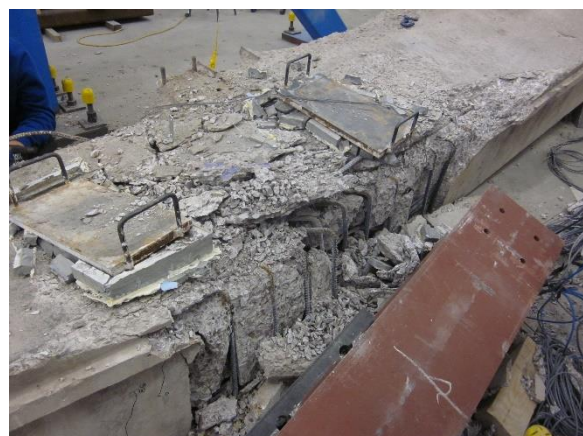
The 45-year old girder had several damages prior to testing (Fig. 8.4). As was mentioned in Sec. 8.1, this girder was cracked at the midspan during unloading from the delivery truck. The first flexural crack was observed at the midspan at a 24.9-kip (110.7-kN) load as shown in Fig. 8.26 (marked as Run No. 78). New flexural cracks developed at the midspan at higher loads (Fig. 8.26b) and the concrete spalled at the north support (Fig. 8.26c). Finally, the girder failed at the midspan in a brittle manner (Fig. 8.26d). It was concluded from the analytical study (Sec. 8.7) that the girder failure was due to the failure of the flange concrete.

(d) Brittle Failure at Midspan

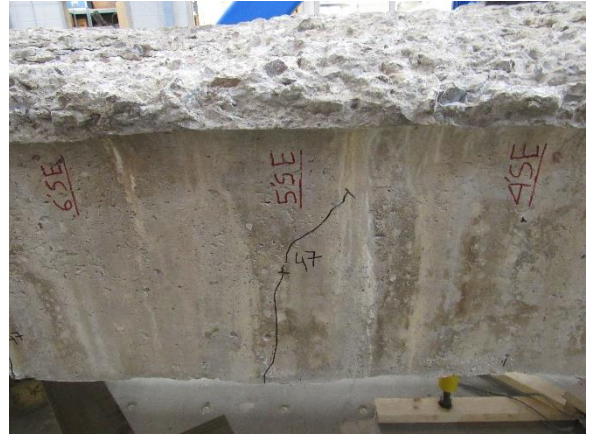
(b) Flexural Crack Near to Midspan

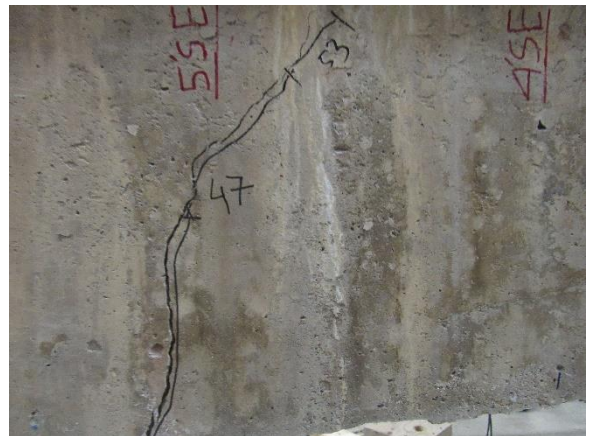
(d) Extension of Crack Width

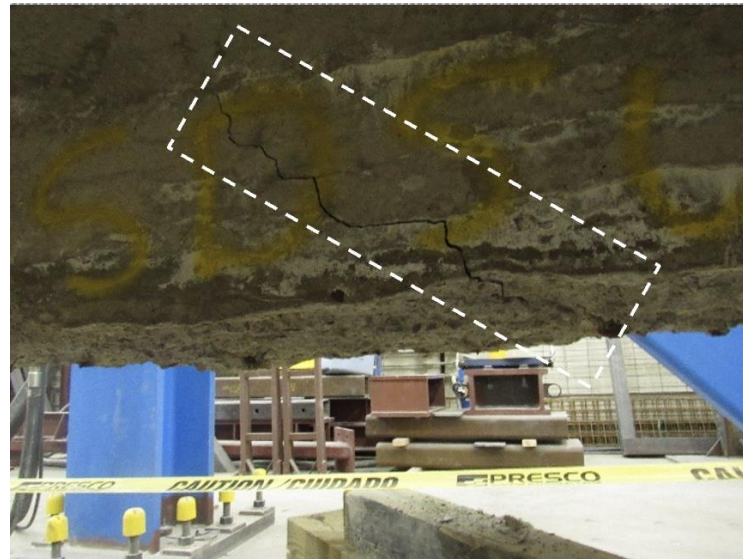
(e) A Major Flexural Crack at Midspan– Stem inside View

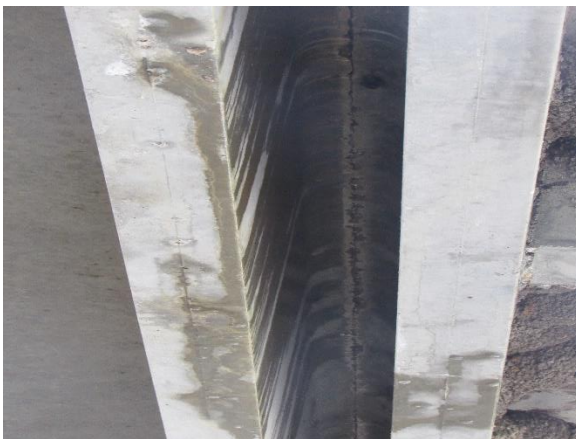
(c) Leakage from joint

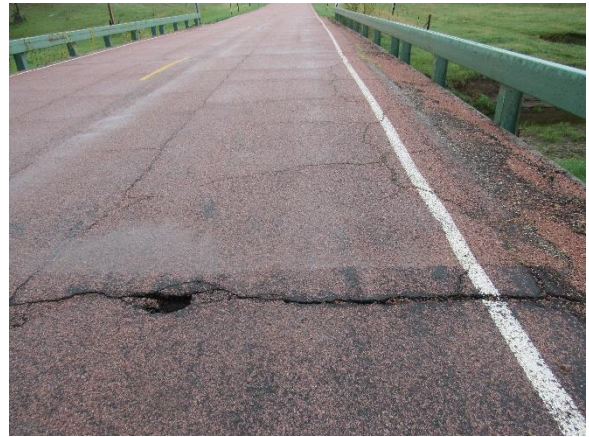
(b) Cracking on pavement over the bridge

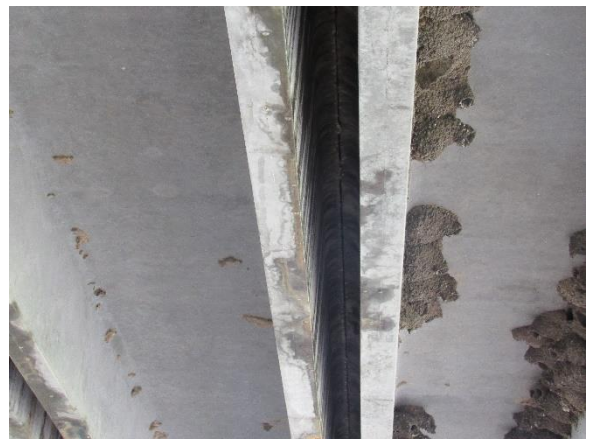
(d) Leakage from joint

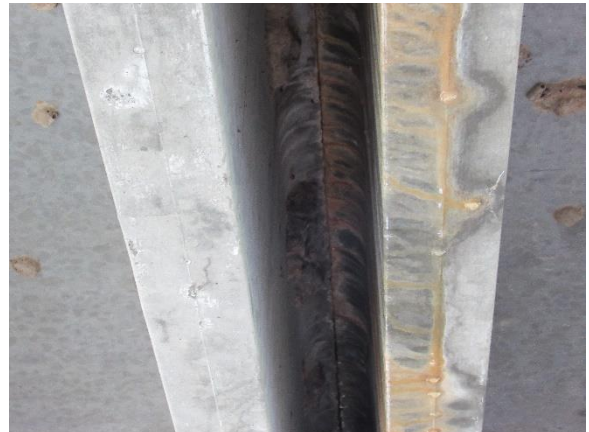
(f) Sign of corrosion

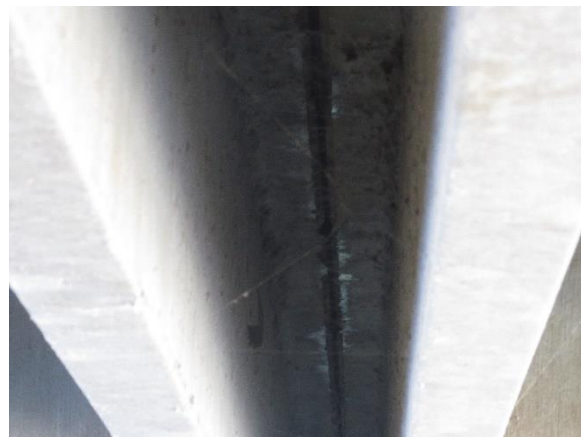
(d) Efflorescence in joint

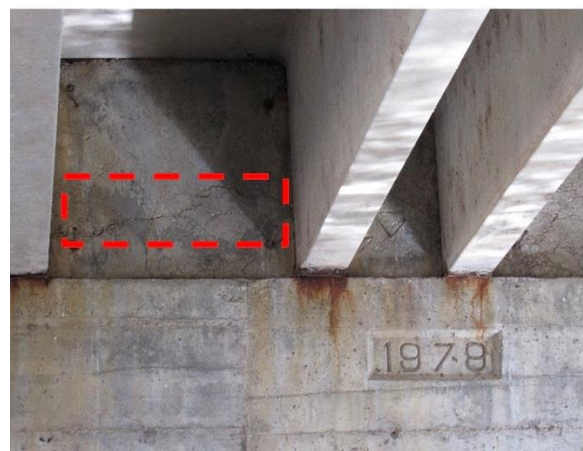
(d) Cracking in diaphragm

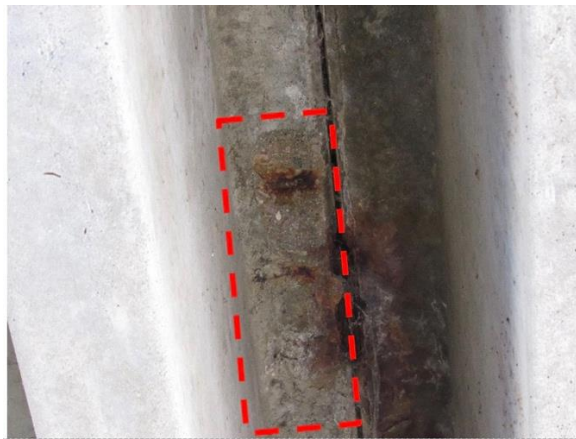
(e) Deterioration in Joint

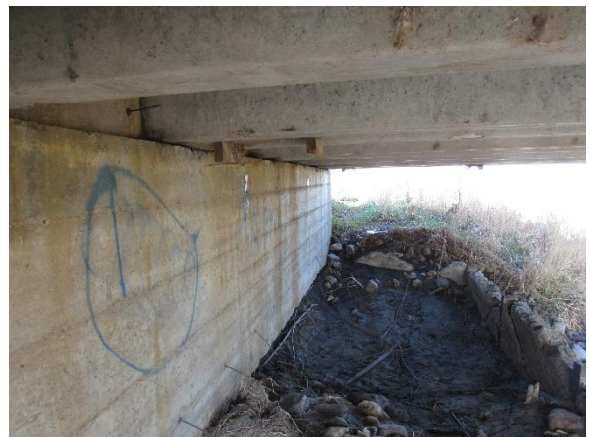
(d) Scouring at abutment of bridge

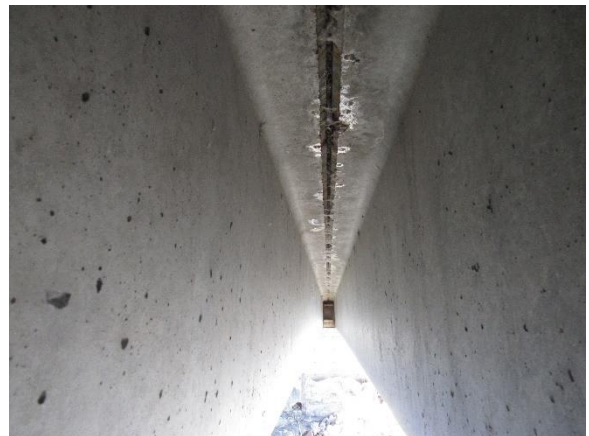
(f) Leakage from joint

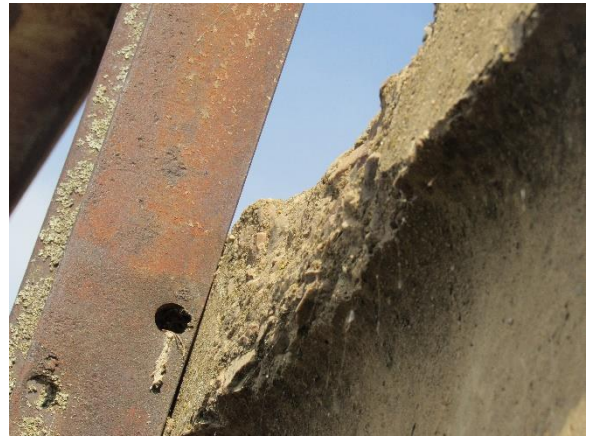
(b) Deterioration at side of bridge

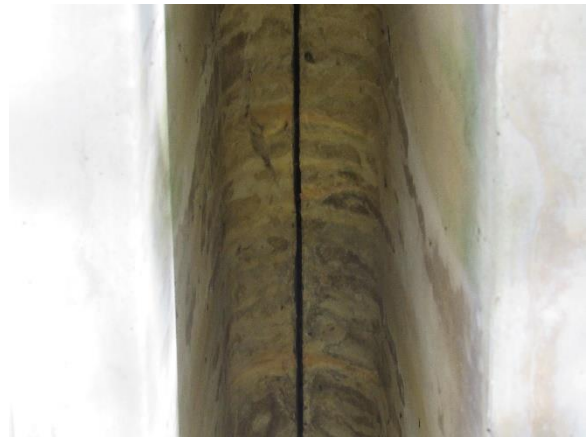
(d) Leakage from joint

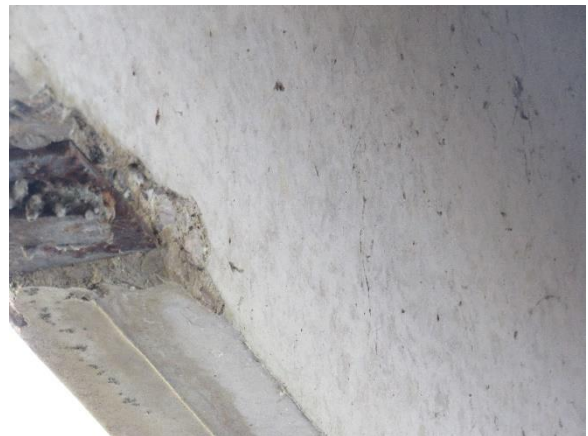
(f) Deterioration at bottom of stem

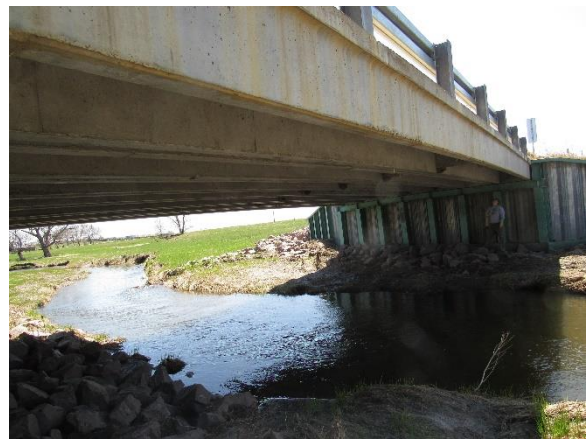
(c) Sign of leakage

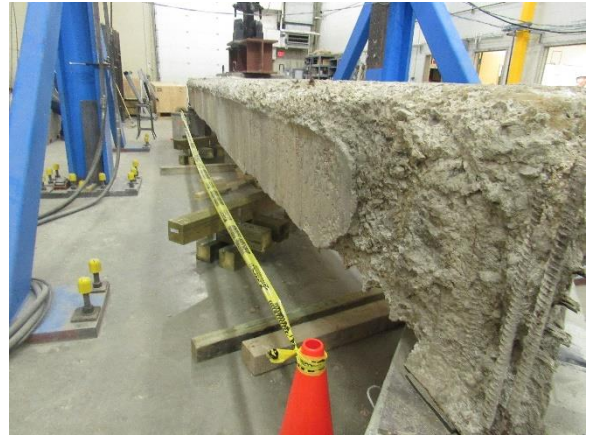
(b) Stem Cover Deterioration

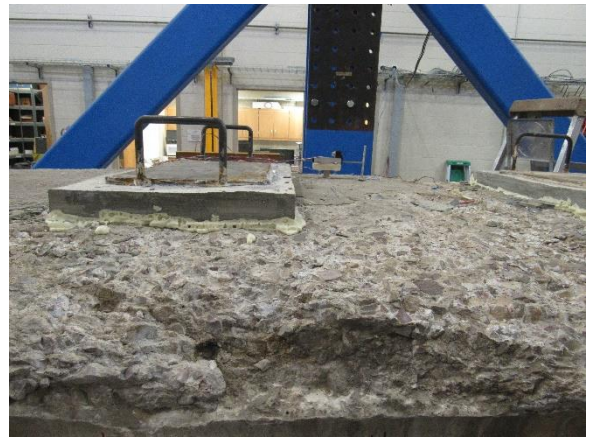
(d) Flange Cover Deterioration

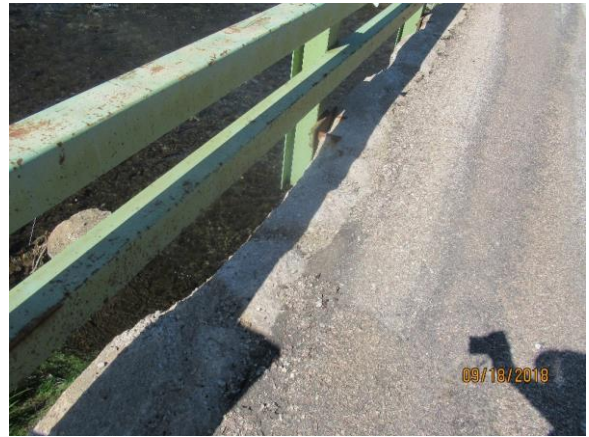
(b) Deterioration of Concrete on Top of West Deck Unit

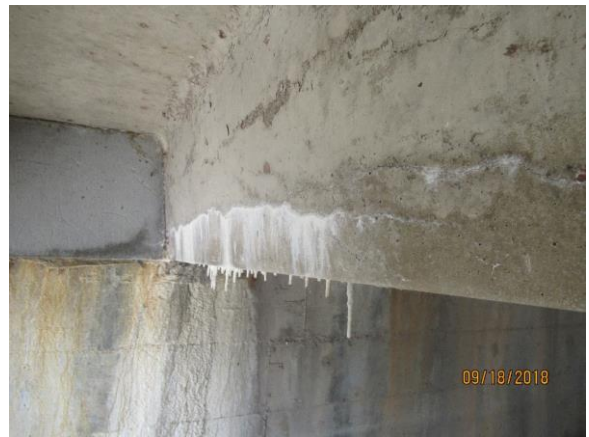
(d) Longitudinal Cracking and Severe Efflorescence- North End of Deck Unit 1

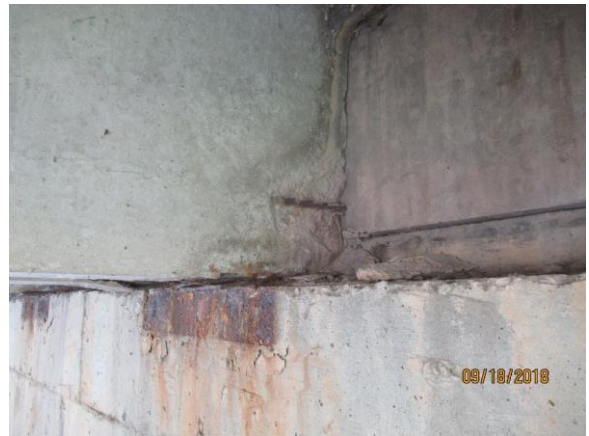
(e) Spall with Prestressing Strand Exposed – South End of East Stem of Deck Unit 3

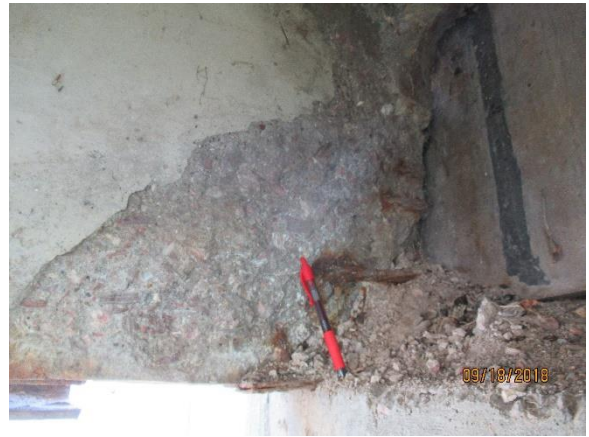
(g) Spall with Prestressing Strand Exposed – South End of East Stem of Deck Unit 7

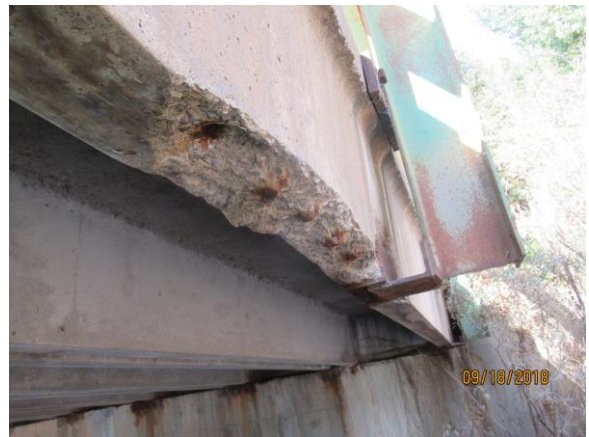
(i) Spall Near Rail Post 5 – Deck Unit 7
