Uncoated Weathering Steel Components

July 19, 2023 FHWA Memorandum

**Federal Highway
Administration**

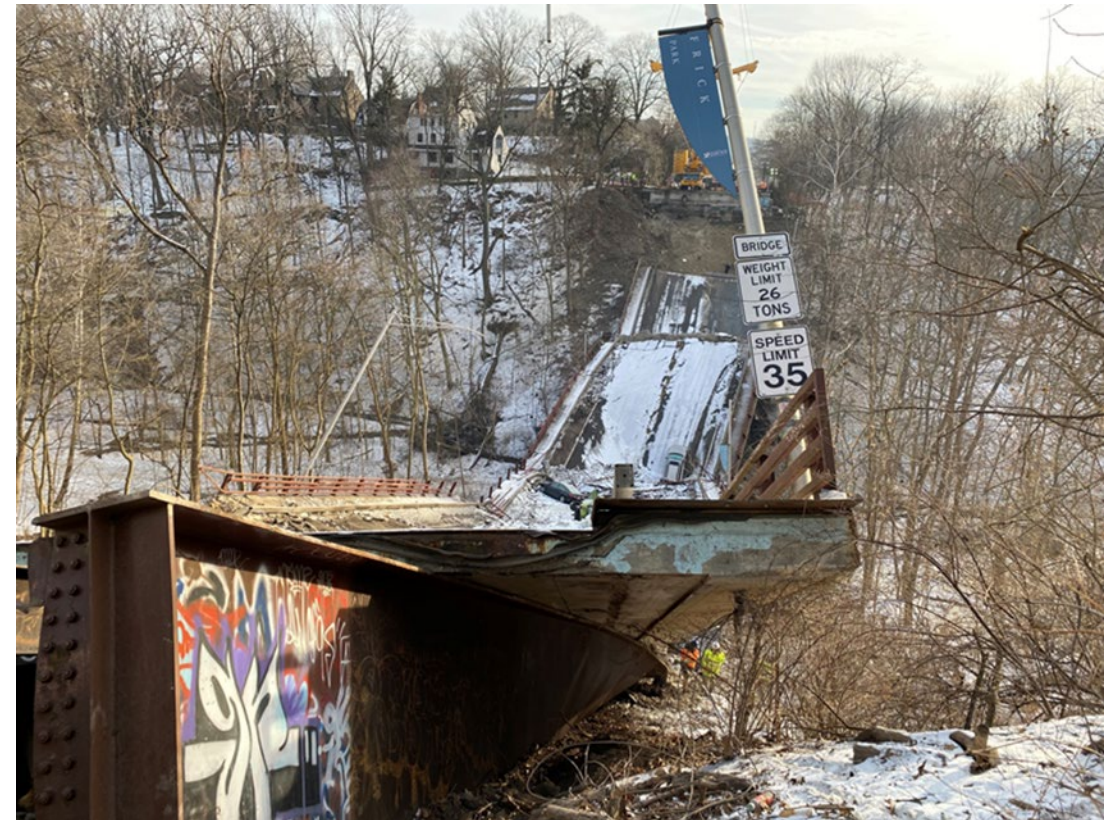
Fern Hollow Bridge Collapse

- January 28, 2022
- Pittsburgh, Pennsylvania
 - Forbes Avenue over Nine Mile Run in Frick Park
- 6 minor injuries
- 3-span rigid (K) frame 442'-8" in length
 - Constructed 1972-1973
- Fracture Critical (NSTM) Bridge
- Poor Condition (annual inspections)
- Posted at 26 tons

1. The legs of the Fern Hollow Bridge experienced significant deterioration and section loss that were documented in inspection reports. The **deterioration and section loss resulted from the continual accumulation of water and debris**, which prevented the development of the protective patina that would resist such corrosion on uncoated weathering steel.
2. The limited examinations of other Pennsylvania bridges revealed that the problem of incomplete maintenance—**where maintenance was identified as needed in inspection reports but not completed**—was not unique to the Fern Hollow Bridge.
3. Because of the potential for corrosion and deterioration associated with lack of proper maintenance, **it is critical that bridge owners nationwide ensure that follow-up actions addressing the accumulation of water and debris on bridges** with weathering steel components have been completed.

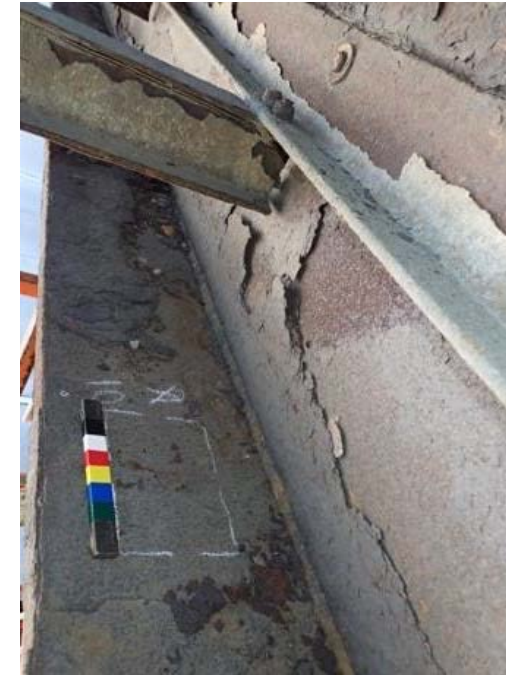
Steel components exhibiting impacted crevice corrosion (pack rust) or corrosive delamination require chipping with a hammer or other means to remove corrosion down to the base metal in order to measure the remaining section of sound metal.

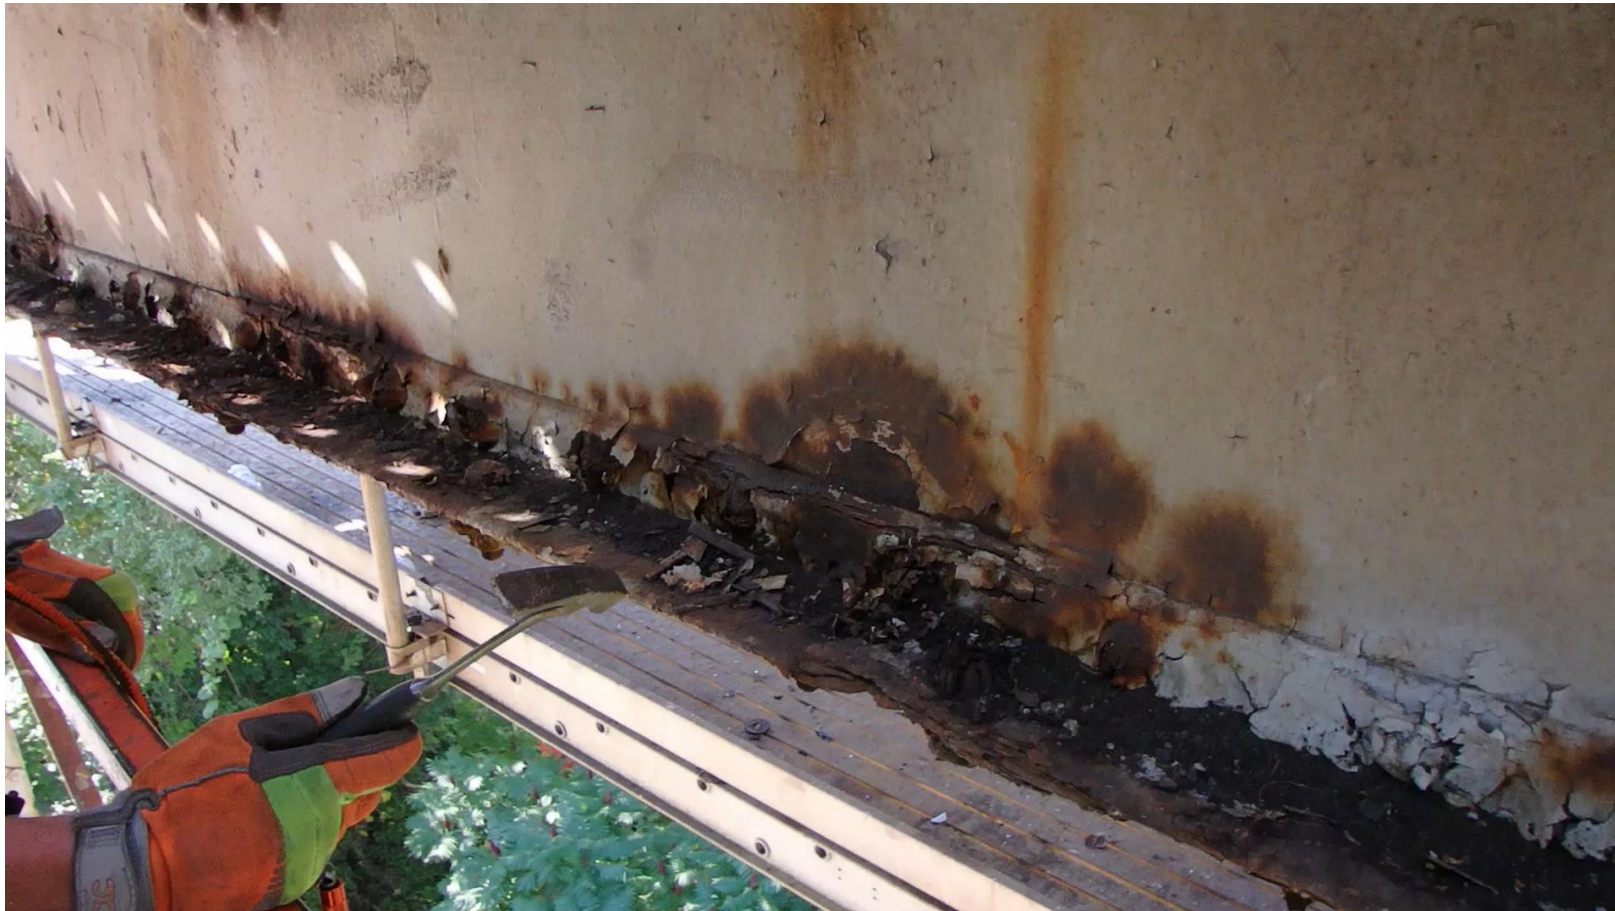
Steel Cleaning

Closed captioned video with narration available: [Inspector removing debris and laminar rust from a floorbeam](#)

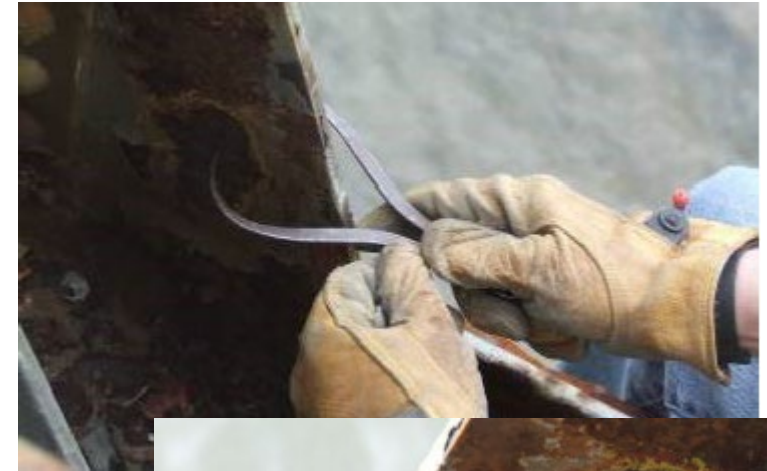
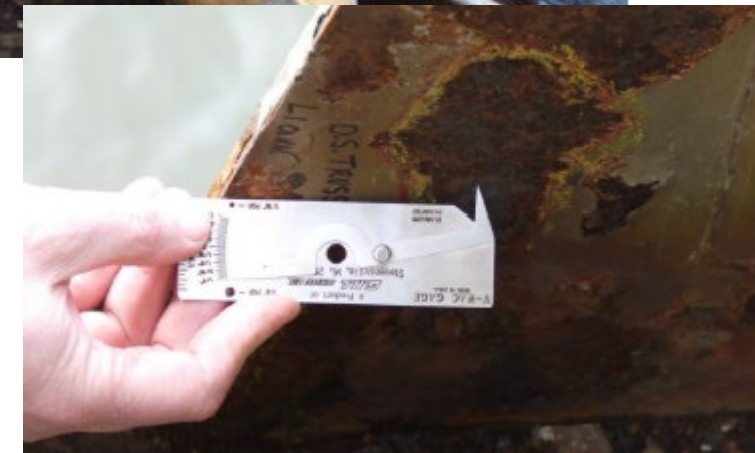
Inspect structural steel members for loss of section due to corrosion. Where a build-up of rust scale is present, a visual observation is usually not sufficient to evaluate section loss. Hand scrape areas of rust scale to base metal and measure the remaining section using calipers, ultrasonic thickness meters, or other appropriate method. Take sufficient measurements to allow the evaluation of the effect of the losses on member capacity.
