DOT/FAA/TC-22/20

Post Small-Flame Forensic Analysis of Aerospace Composites

January 2024

Final report

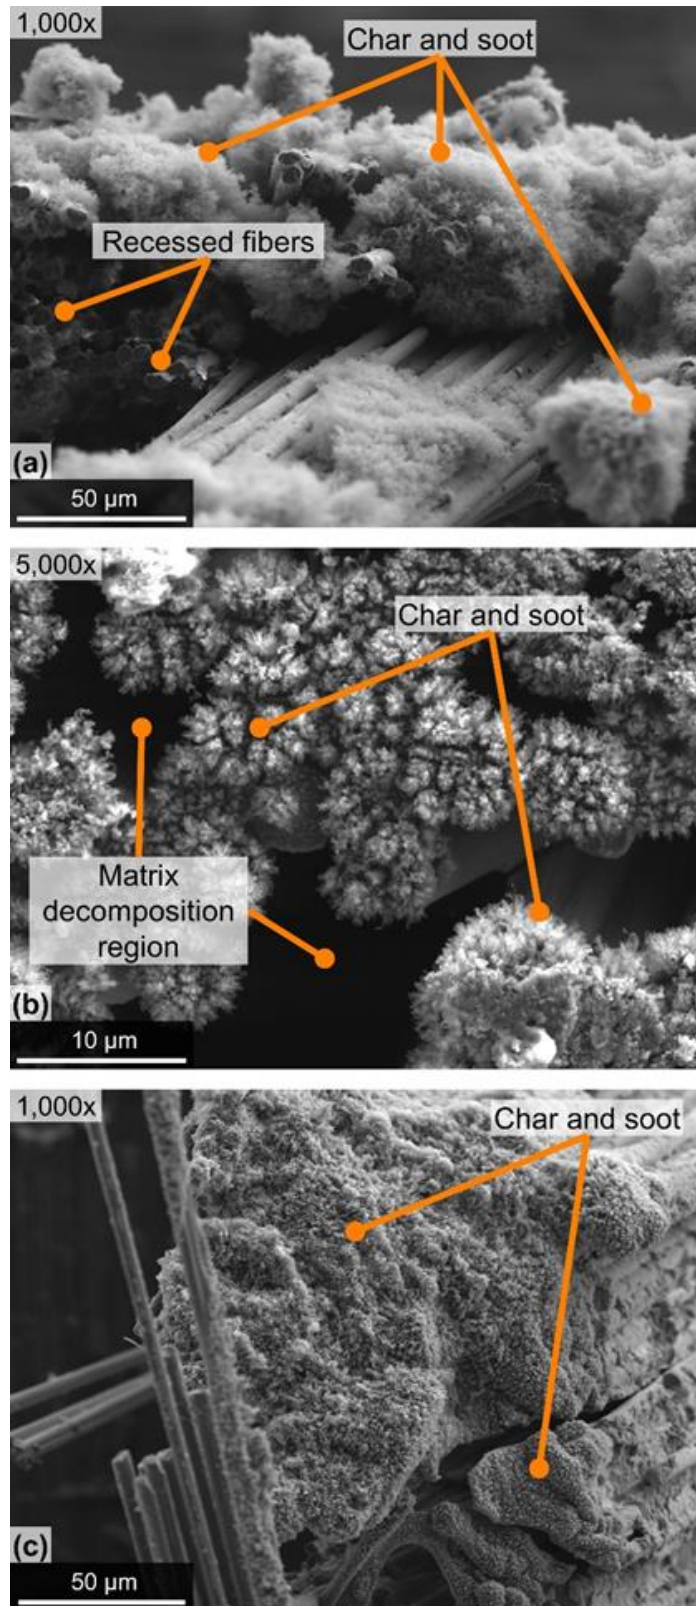
Figure 36. Char and soot on fracture surface of 21-ply cross-ply Cytec UNC0 specimens burned vertically for (a) 12 s (b) 36 s and (c) 60 s

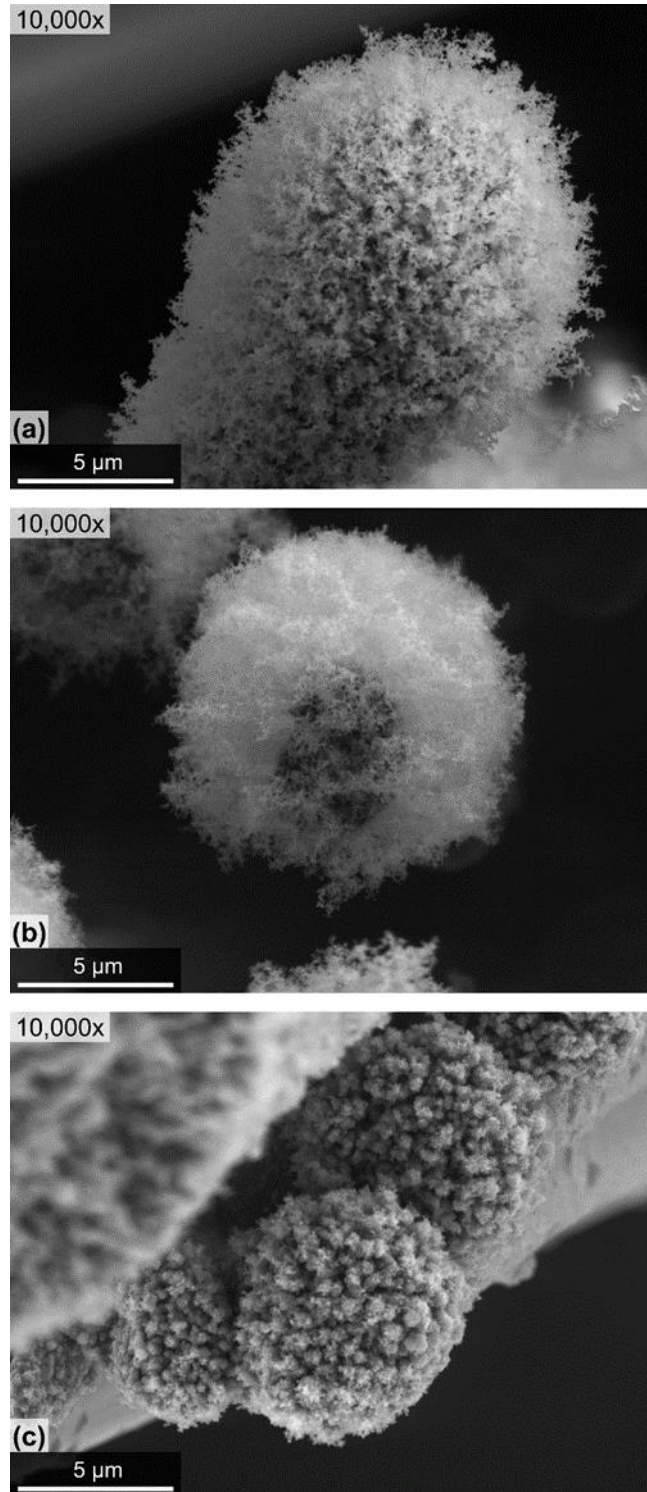
Figure 37. Fuzzy char on single fibers in 21-ply cross-ply Cytec UNC0 specimen burned vertically for (a) 12 s (b) 36 s (c) 60 s

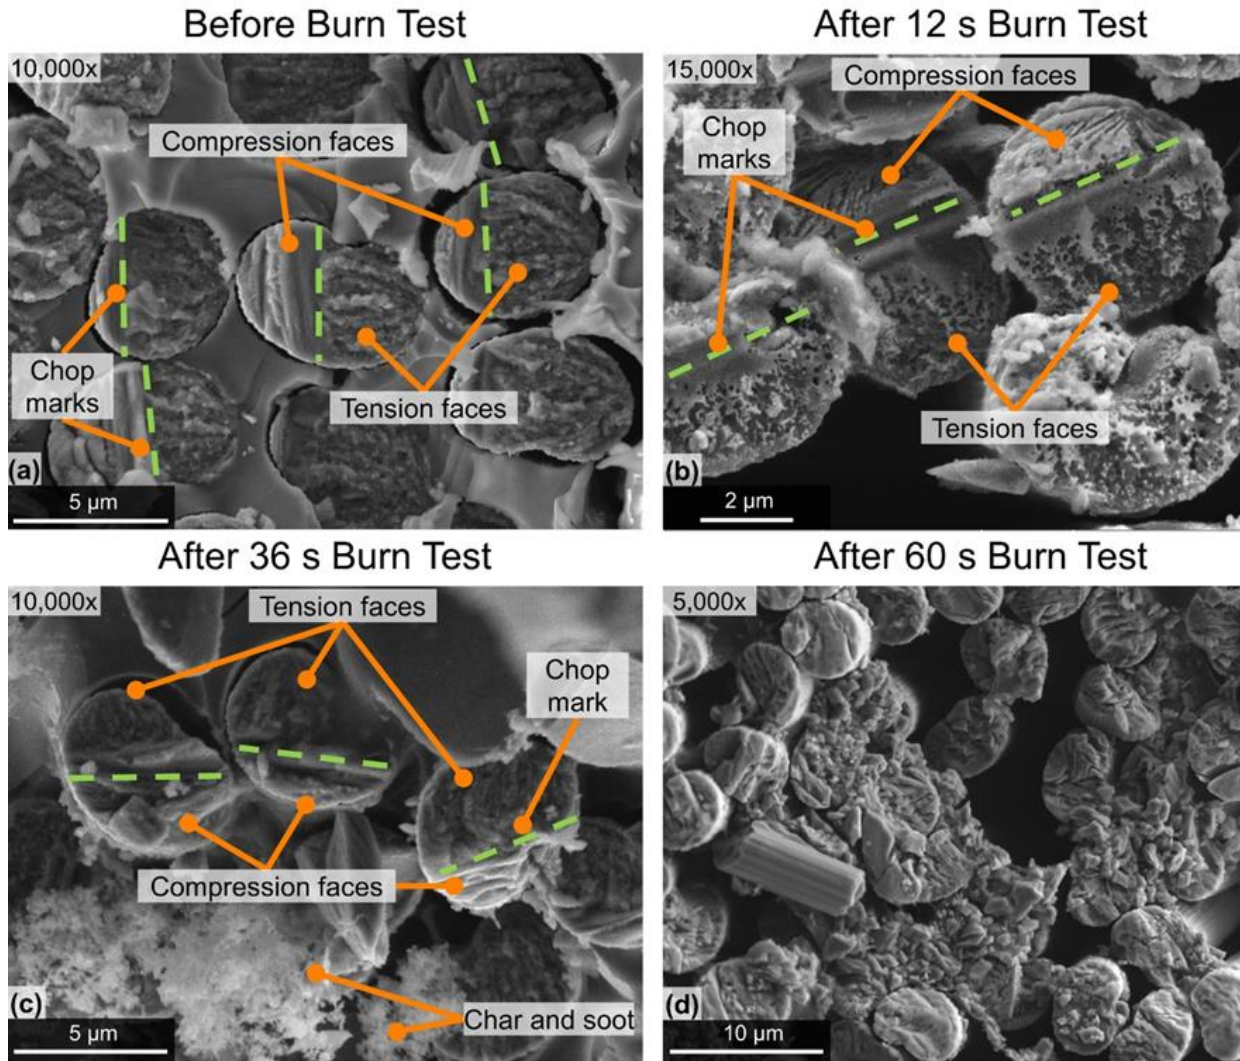
Figure 38. Fracture characteristics on (a) 21-ply cross-ply Cytec UNC0 specimen showing recessed fibers after vertical burning

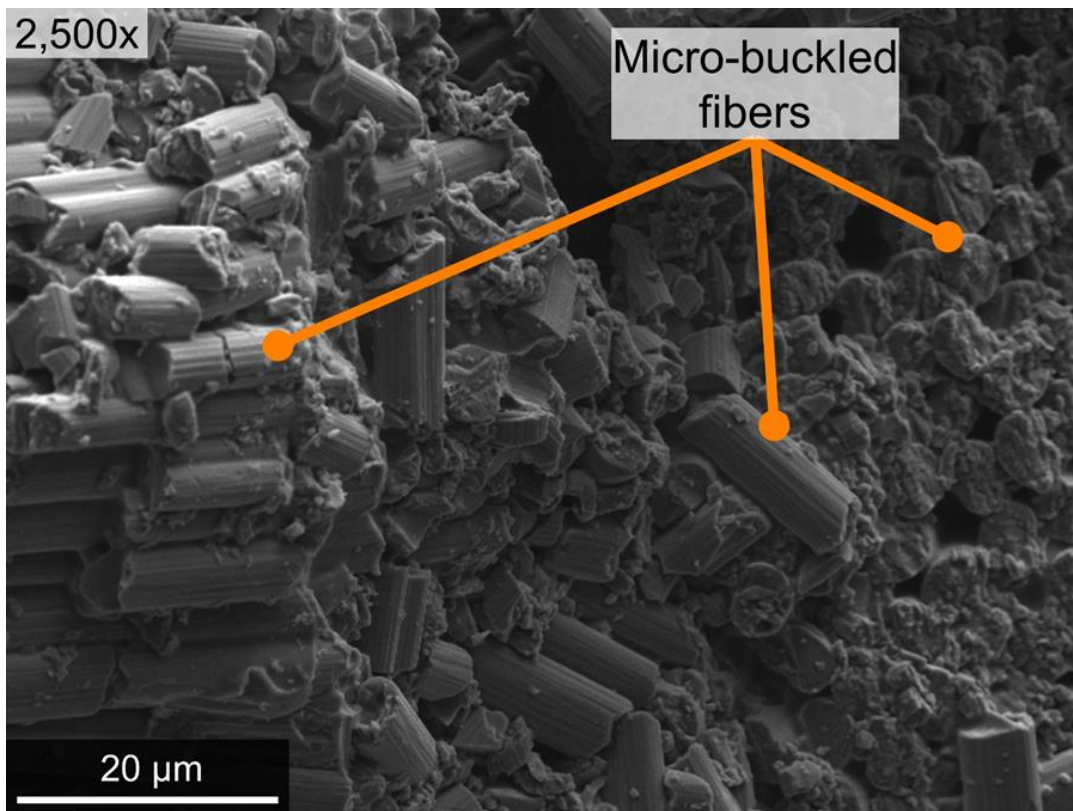
Figure 40. SEM image of micro-buckled fibers in a 21-ply cross-ply Cytec UNCO specimen burned vertically for 60 s

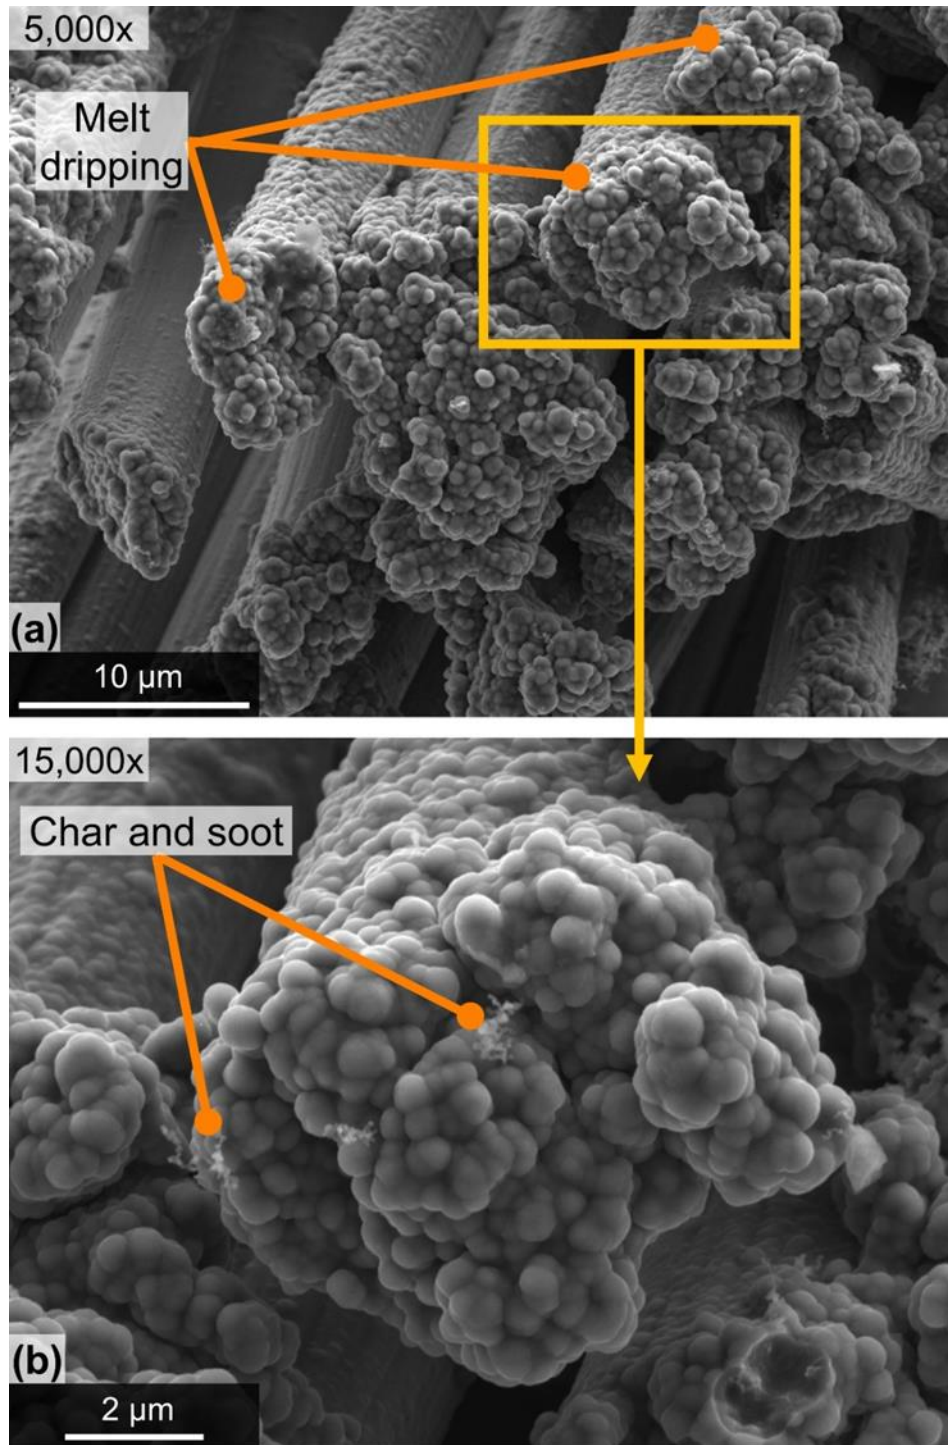
Figure 41. (a) Melt dripping on fracture fiber ends of 21-ply cross-ply Cytec UNC0 specimen burned vertically for 36 s (b) filaments with melt dripping

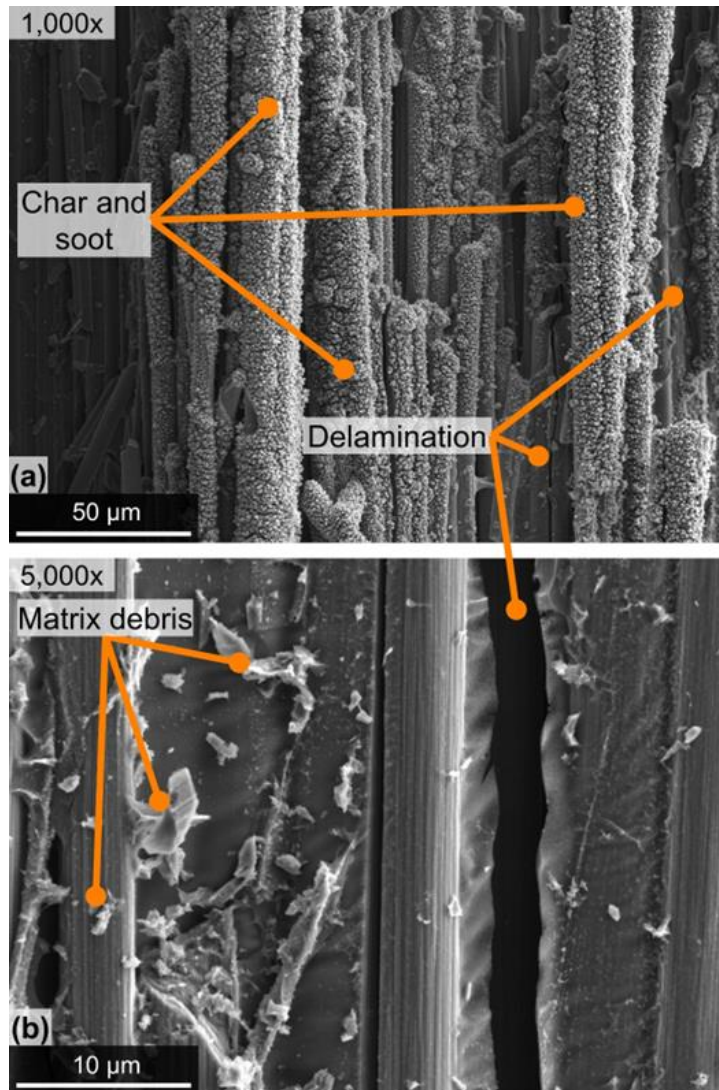
Figure 42. Delamination in 21-ply cross-ply Cyttec UNCO specimen burned vertically for 60 s

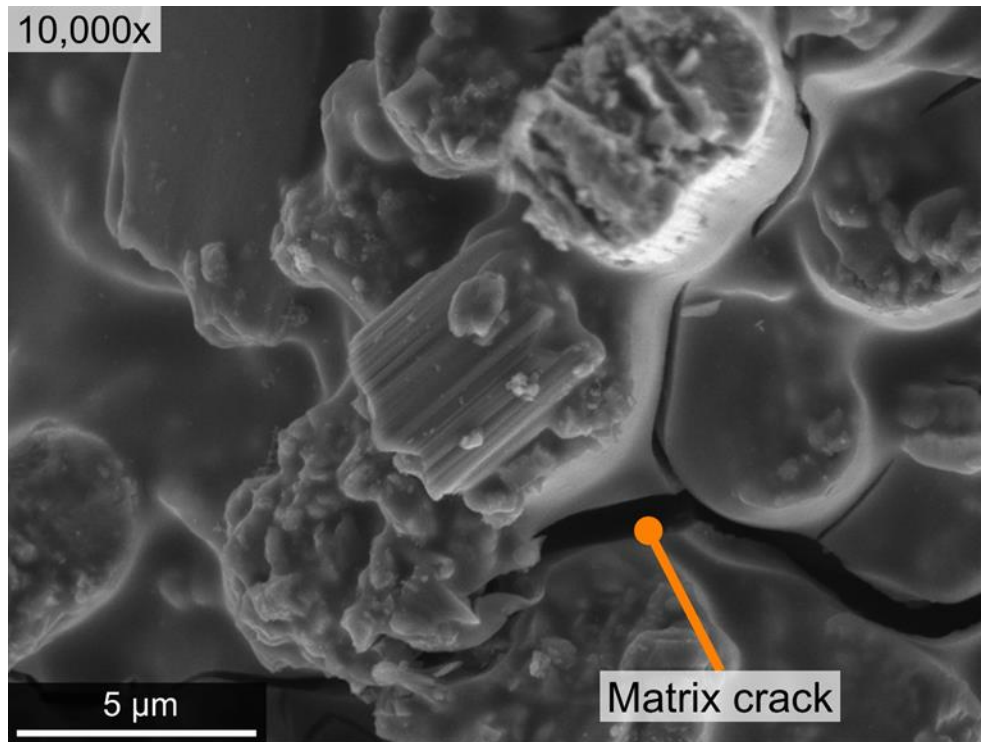
Figure 43. Matrix cracking in 21-ply cross-ply Cytec UNCO specimen burned vertically for 60 s

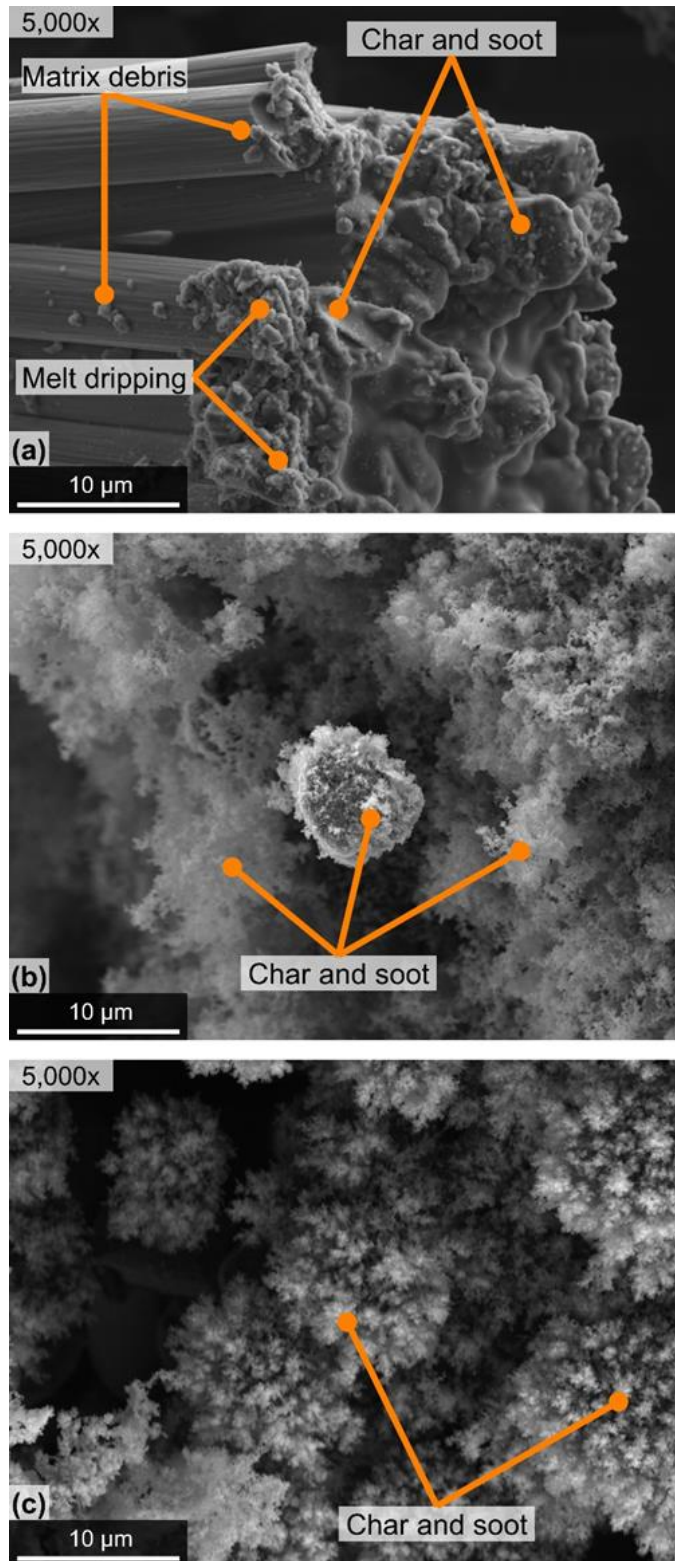
Figure 45. Char and soot on fracture surface of 45-ply unidirectional Cytec SBS specimens after vertical burning for (a) 12 s (b) 36 s and (c) 60 s

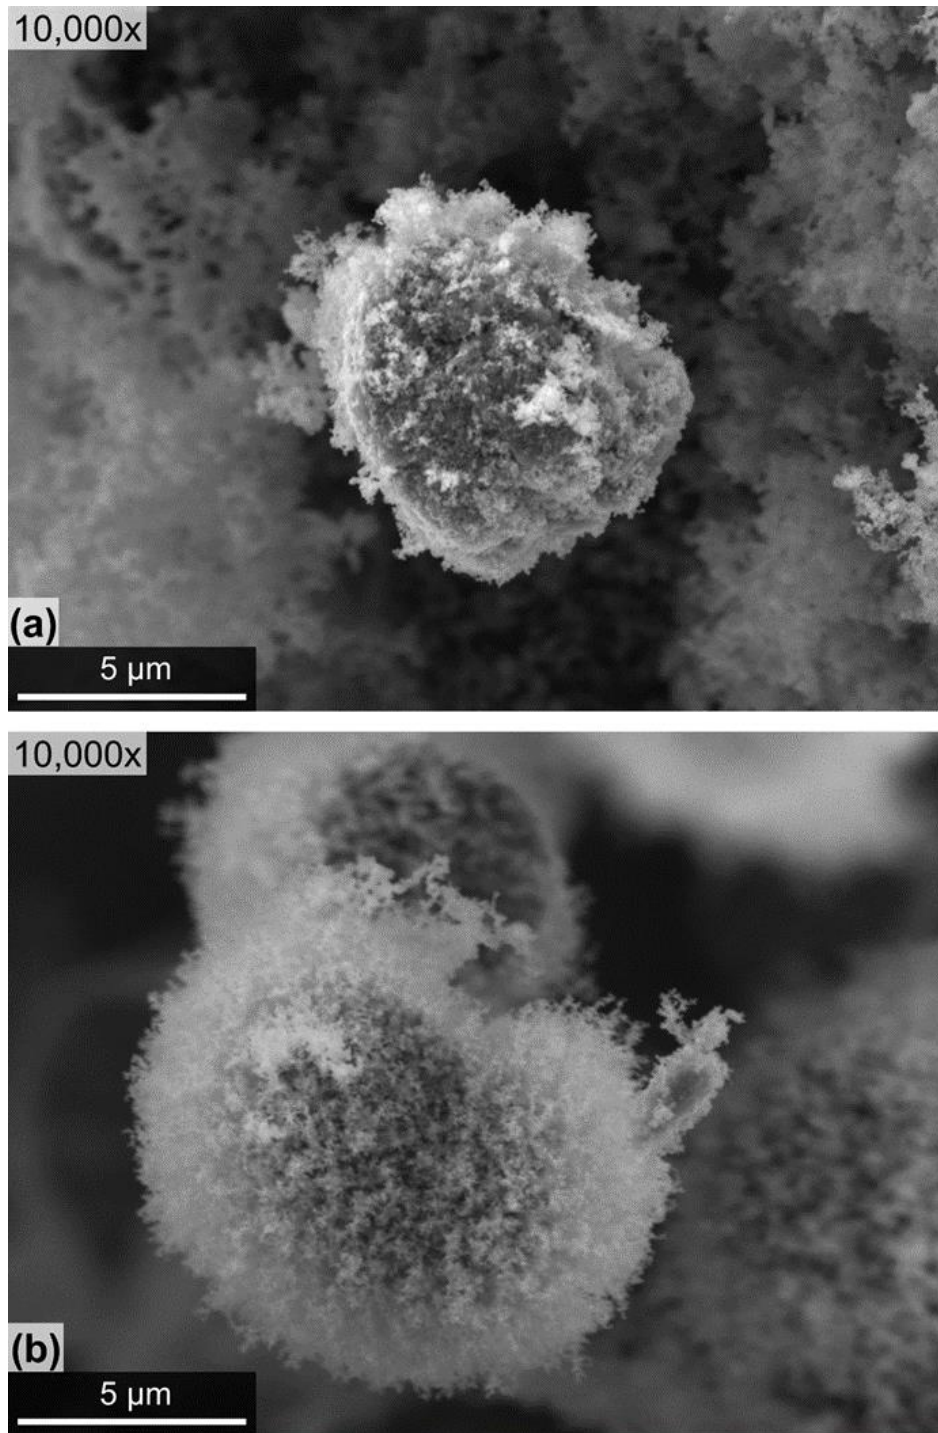
Figure 46. Fuzzy char around single fibers in 45-ply unidirectional Cytac SBS specimens burned vertically for (a) 36 s and (b) 60 s

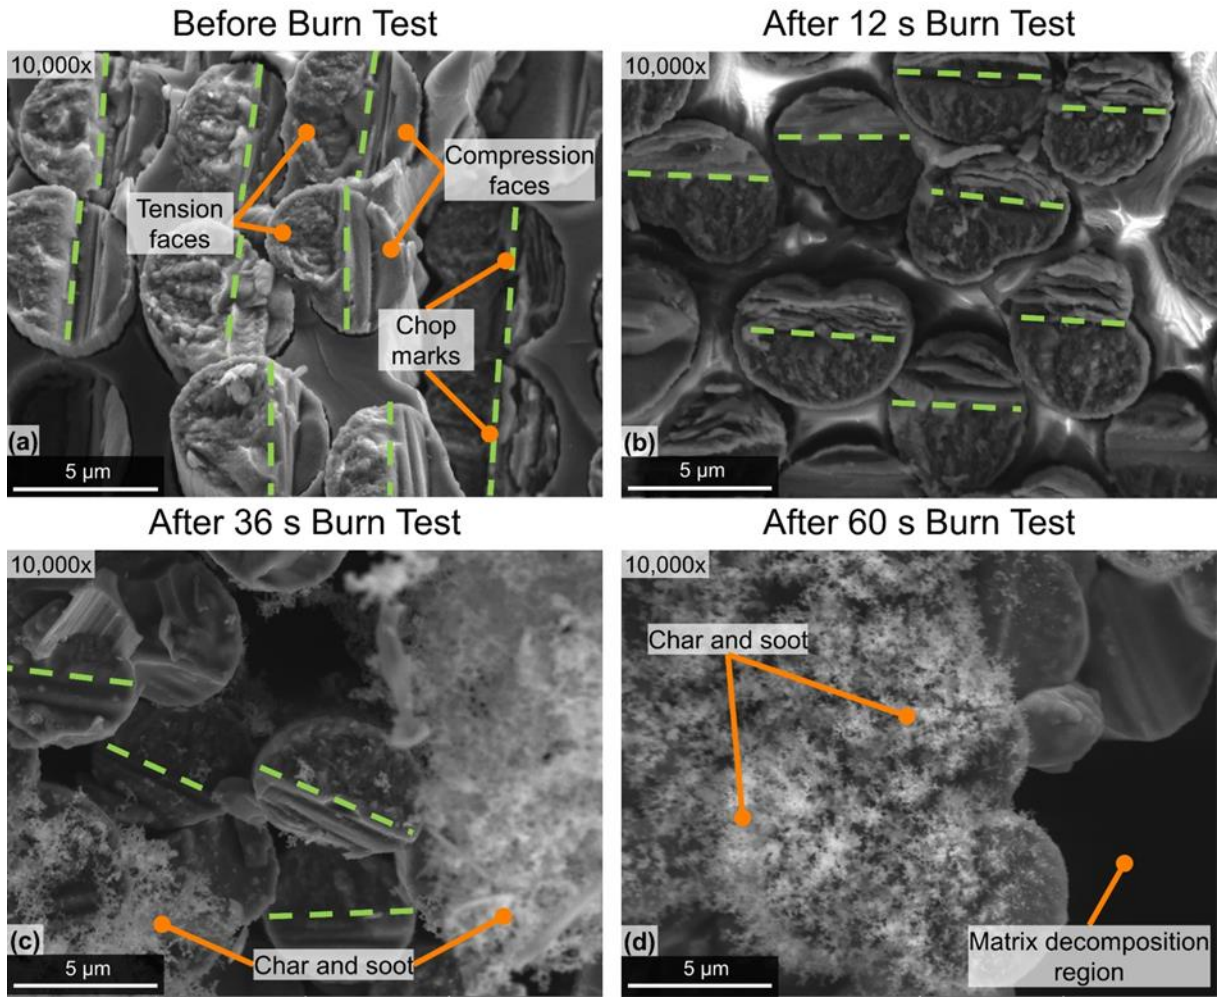
Figure 47. Fracture characteristics on (a) 45-ply unidirectional SBS Cytec specimen showing recessed fibers after (b) 12s, (c) 36s, and (d) 60 s vertical burning

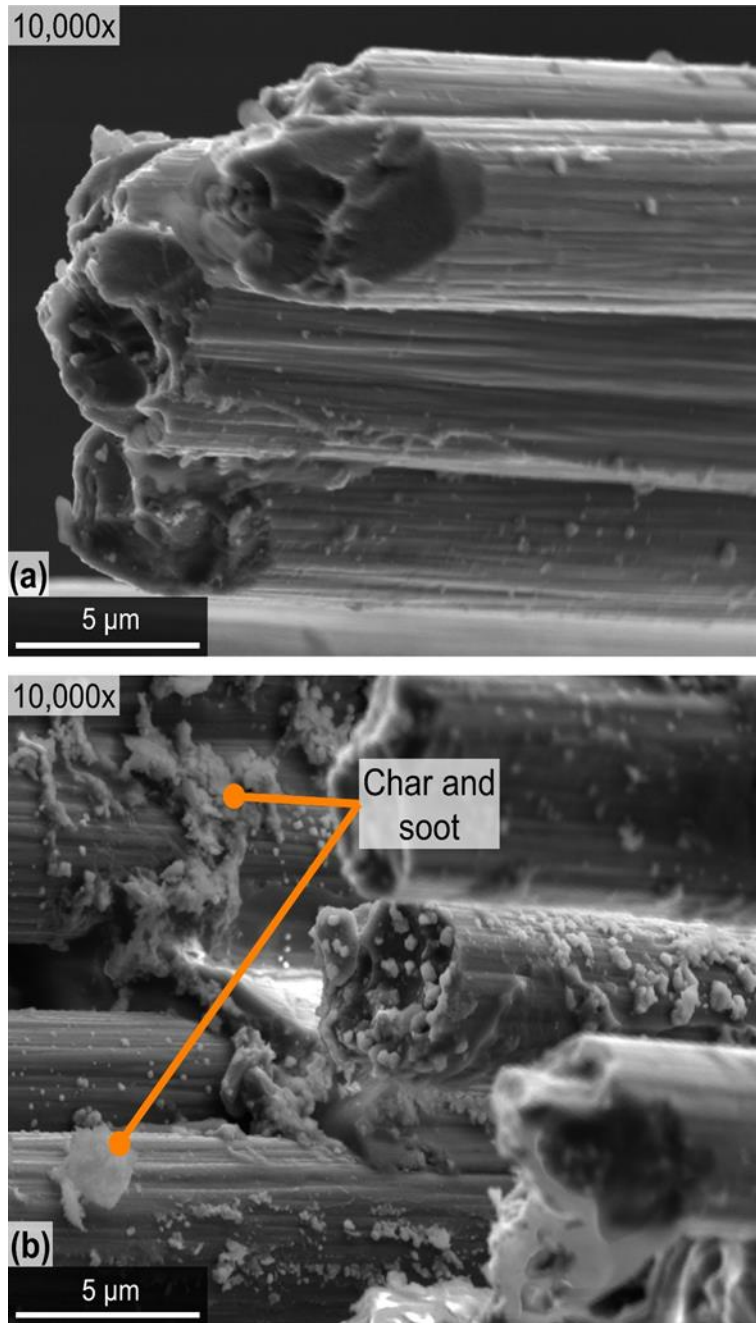
Figure 53. Char formation on (a) longest and (b) shortest lateral edges of 16-ply Cytec IPS specimens burned vertically for 12 s

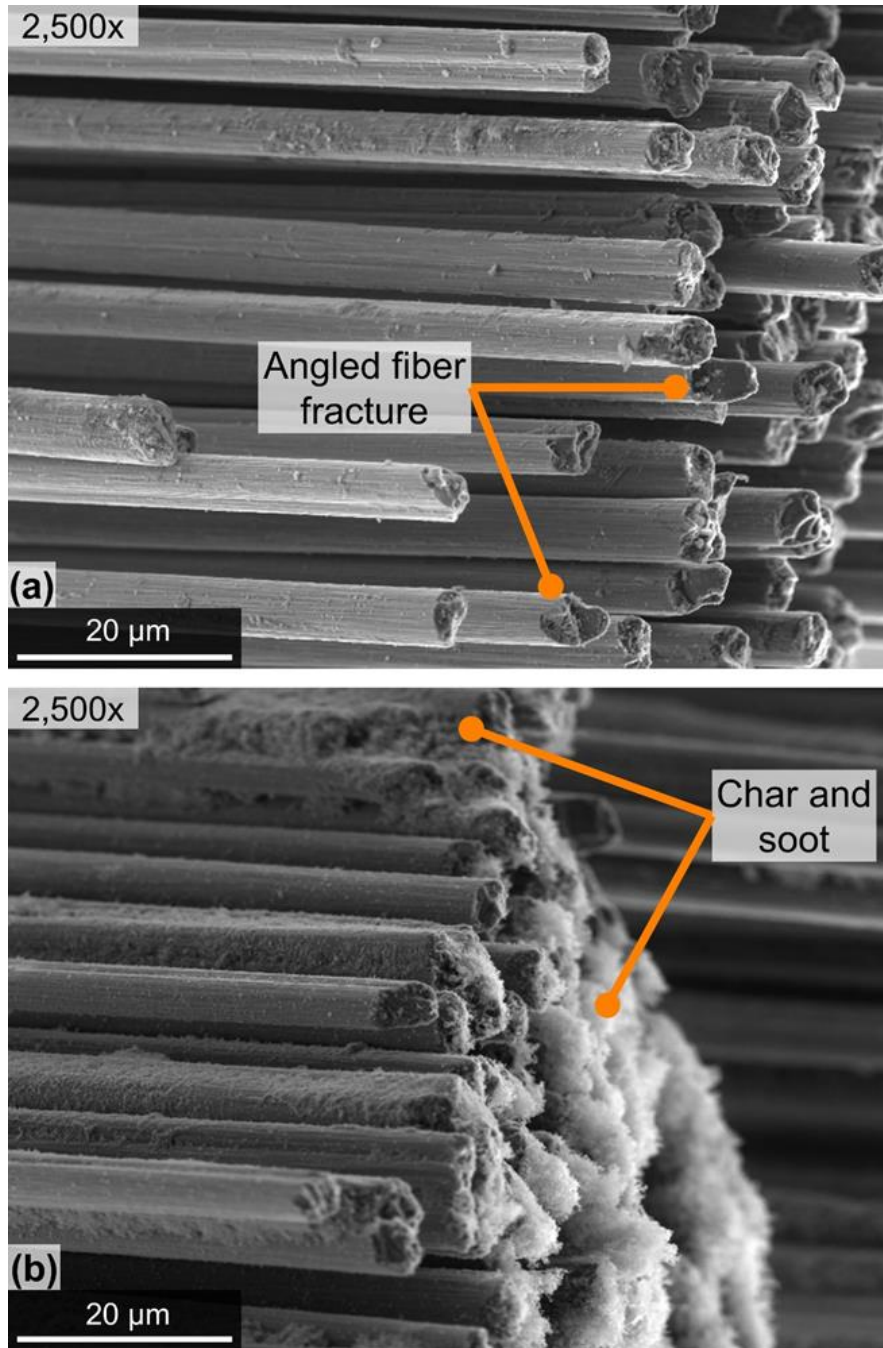
Figure 54. Char formation on (a) longest and (b) shortest lateral edges of 16-ply Cytec IPS specimens burned vertically for 36 s

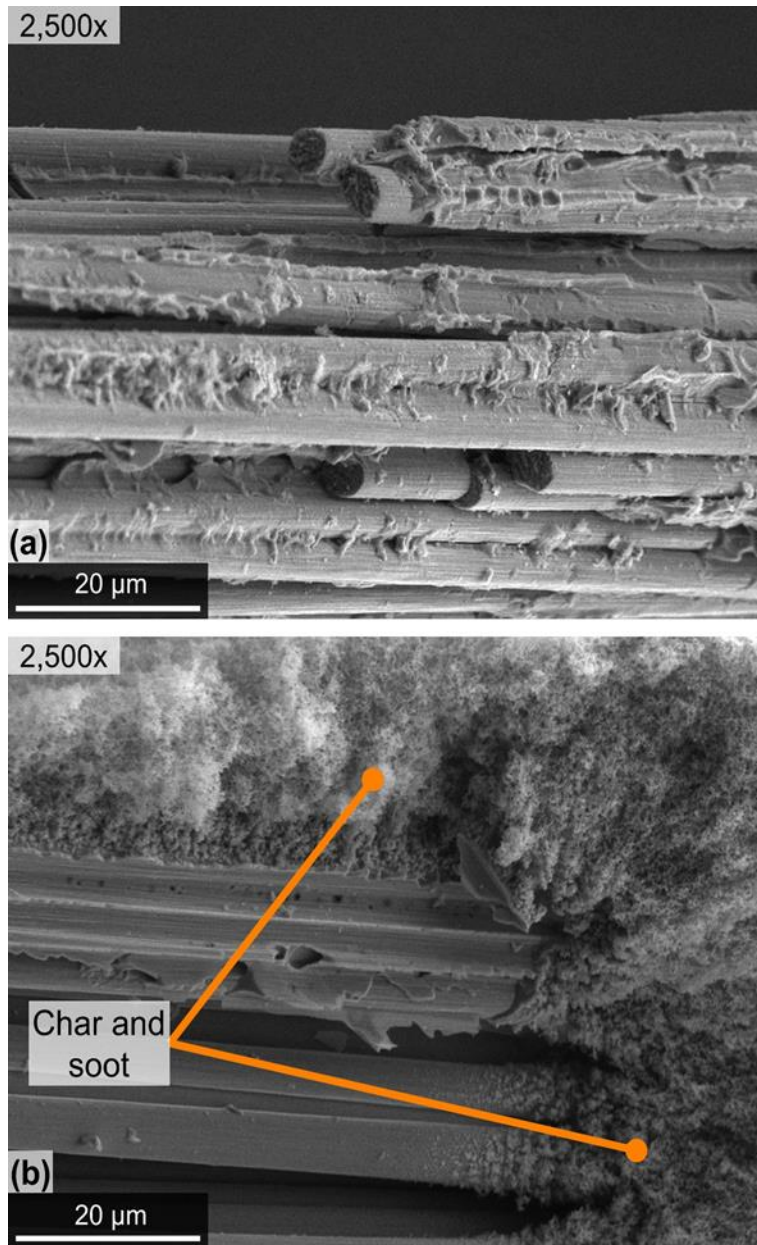
Figure 55. Char formation on (a) longest and (b) shortest lateral edges of 16-ply Cyttec IPS specimens burned vertically for 60 s

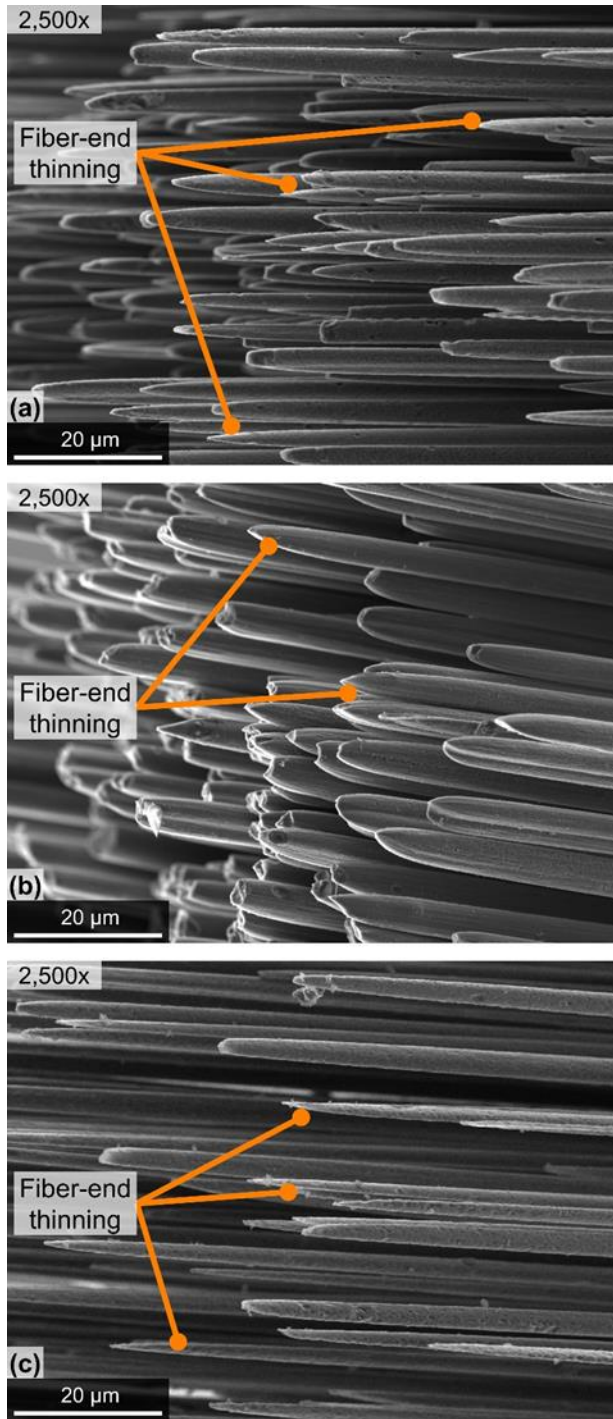
Figure 56. Fiber-end thinning of filaments at mid-plane of 16-ply Cytec IPS specimens burned vertically for (a) 12 (b) 36 and (c) 60 s

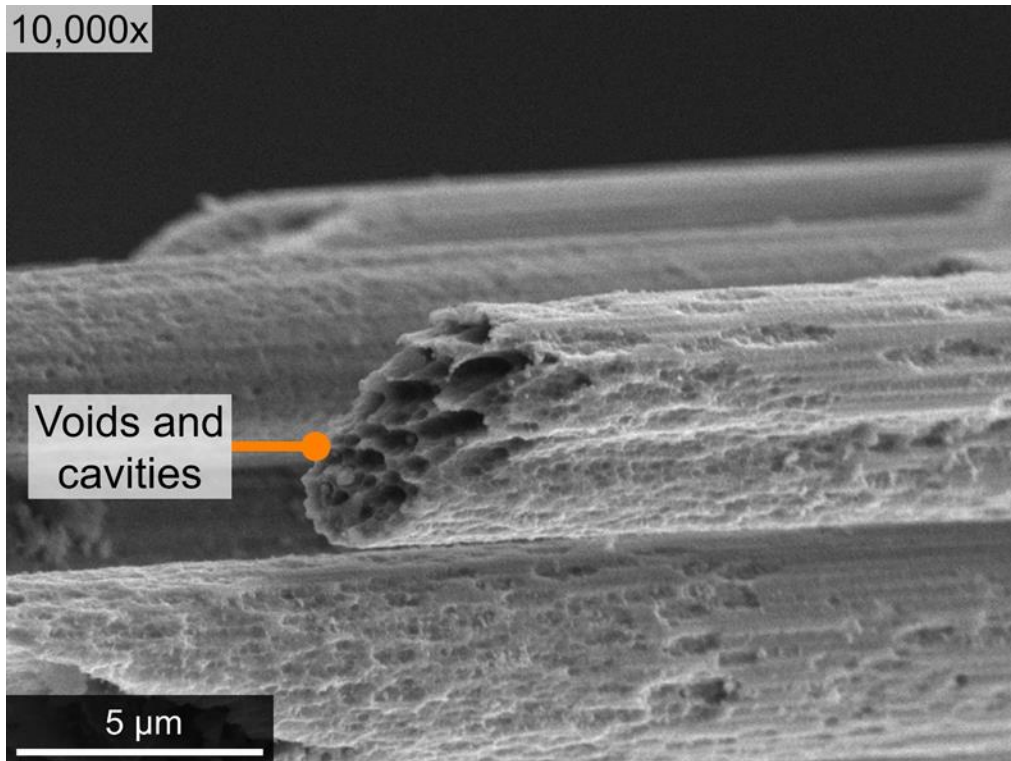
Figure 57. Void and cavities on fiber of 16-ply Cytec IPS specimen burned vertically for 60 s

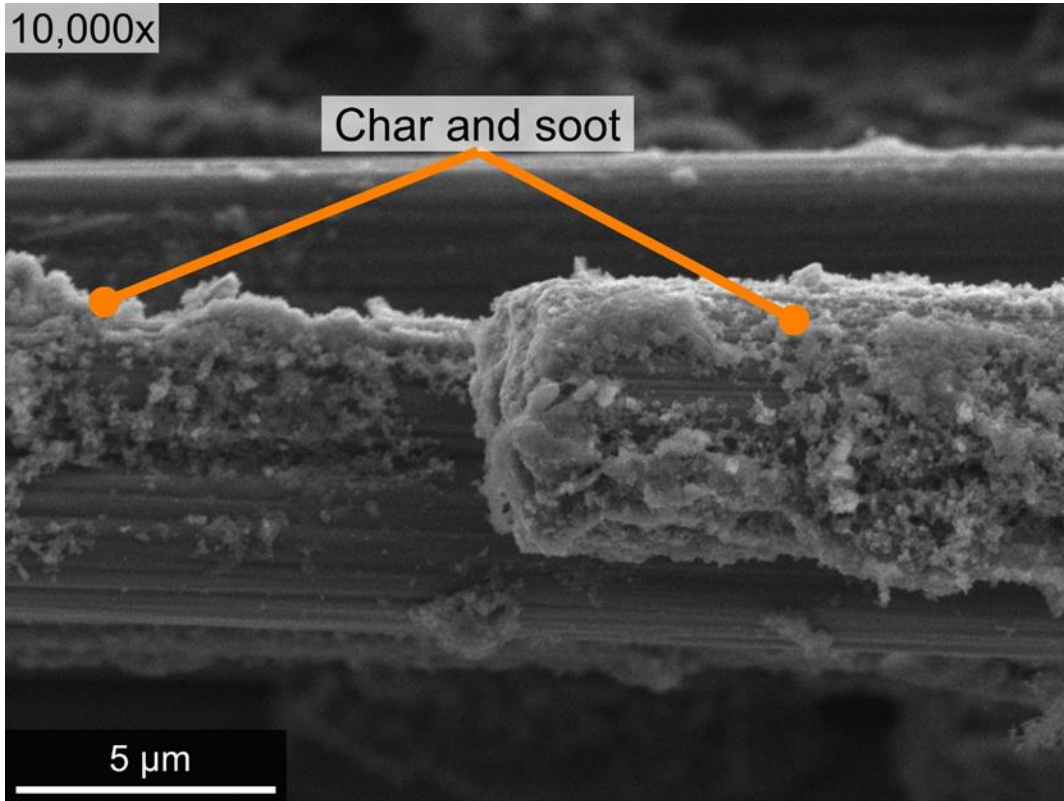
Figure 59. Char and soot at fracture surface of 21-ply cross-ply Cytec UNCO specimen used on 15 s horizontal fire test

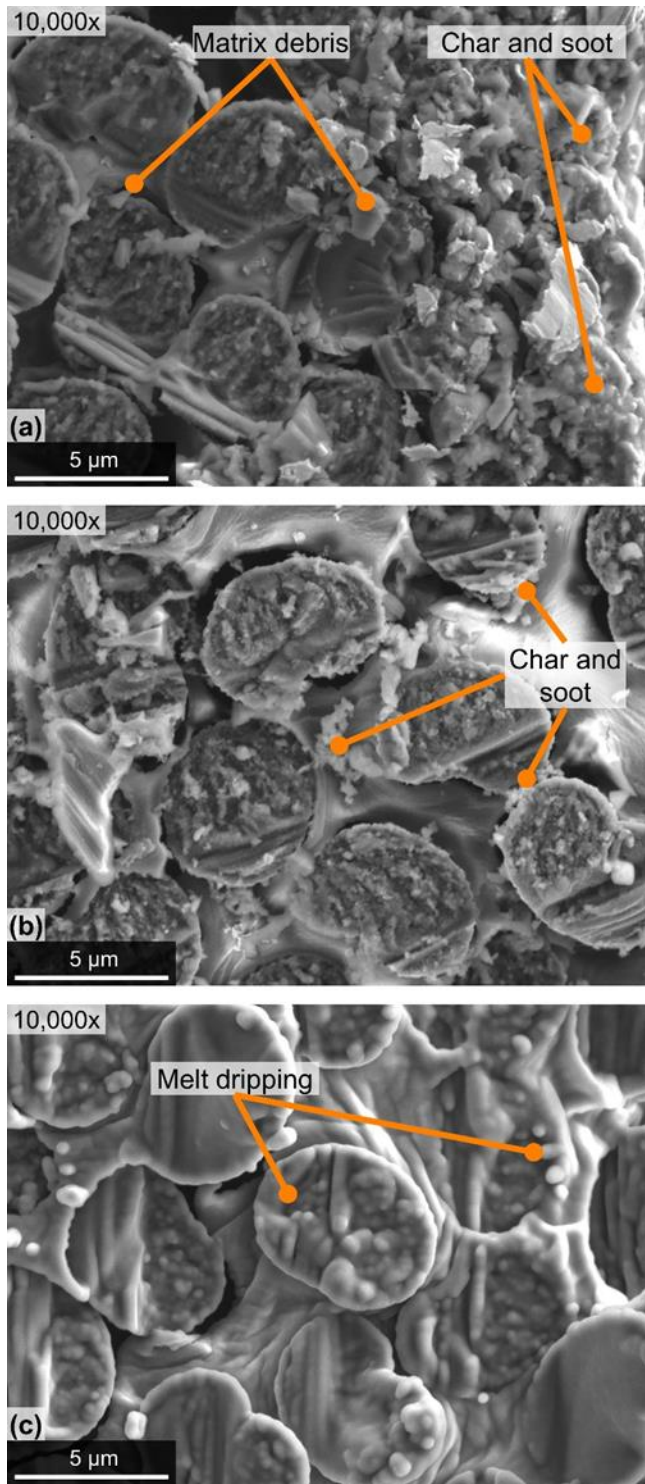
Figure 61. Fracture surface of 45-ply unidirectional Cytec SBS specimens used for (a) 15 s (b) 45 s and (c) 75 s horizontal burning

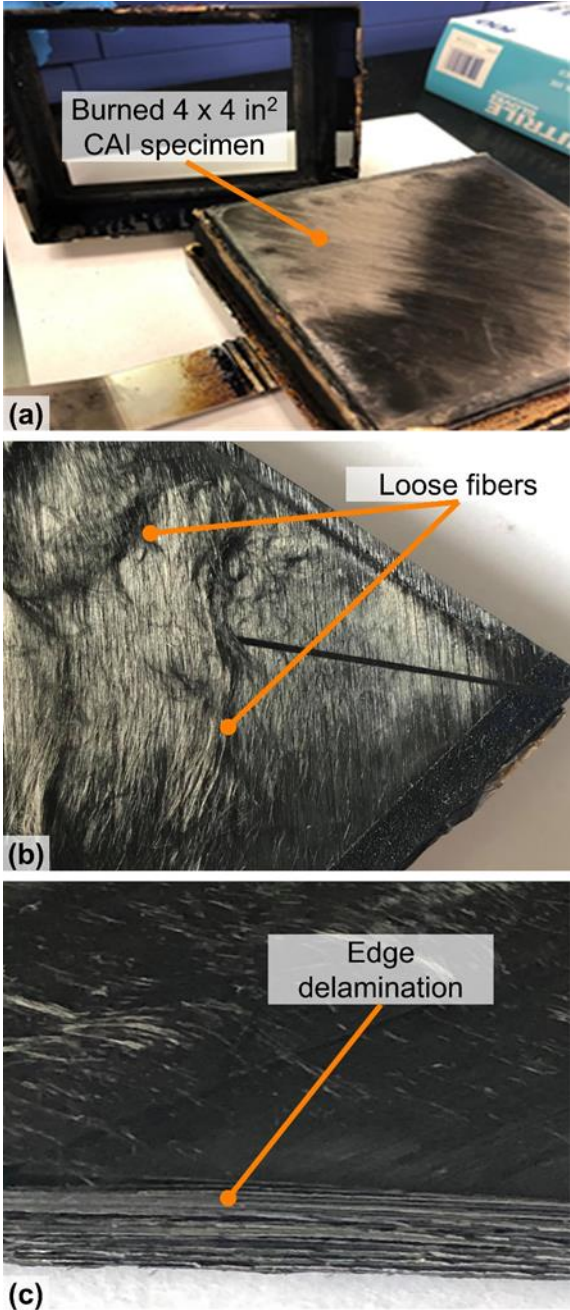
Figure 65. (a) 4 x 4 in² 32-ply CAI specimen after cone calorimeter fire testing with heat flux of 50 kW/ m² (b) loose fibers (c) edge delamination

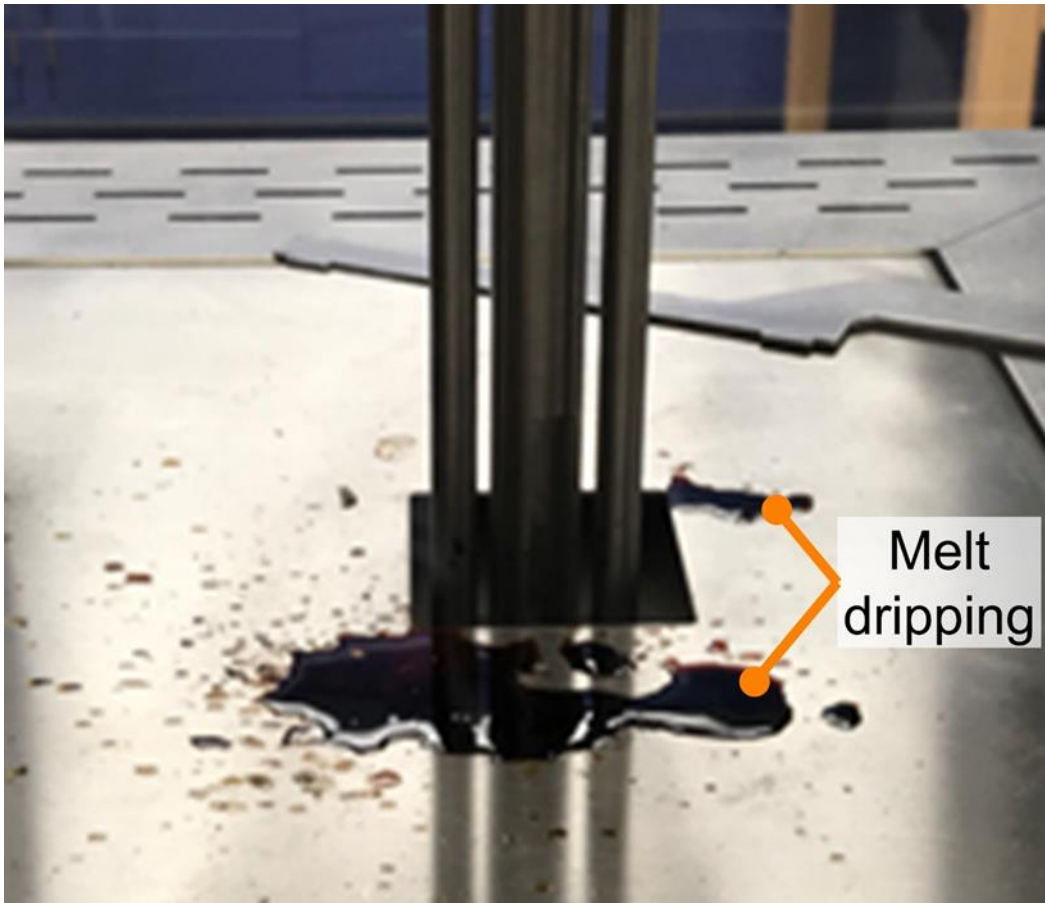
Figure 66. Melt dripping from 4 x 4 in² 32-ply Cytec CAI specimen

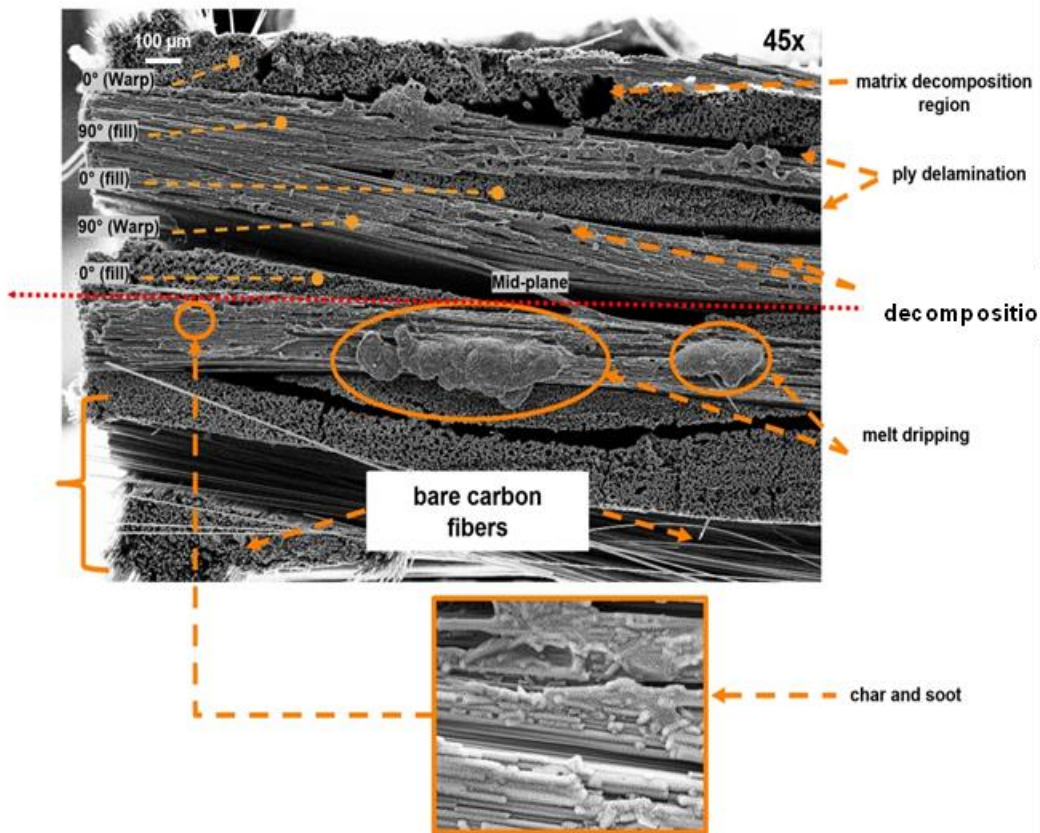
Figure B - 10. Fire damage on 12 s vertically burned 4-ply cross-ply [0/90/90/0] Hexcel specimens
