Mechanistic Investigation of Timber Crosstie Spike Fastener Failures – Phase I: The Magnitude of the Spike Failure Challenge

1. AGENCY USE ONLY (Leave blank)		2. REPORT DATE March 2021		3. REPORT TYPE AND DATES COVERED Technical Report
4. TITLE AND SUBTITLE Mechanistic Investigation of Timber Crosstie Spike Fastener Failures – Phase I: The Magnitude of the Spike Failure Challenge			5. FUNDING NUMBERS 6993JJ6-18-C-000005

6. AUTHOR(S) Tom Roadcap (0000-0001-5591-7922), Marcus S. Dersch P.E. (0000-0001-9262-3480), and J. Riley Edwards, P.E. (0000-0001-7112-0956)				
7. PERFORMING ORGANIZATION NAME(S) AND ADDRESS(ES) University of Illinois at Urbana-Champaign 205 North Mathews Avenue Urbana, Illinois 61801			8. PERFORMING ORGANIZATION REPORT NUMBER

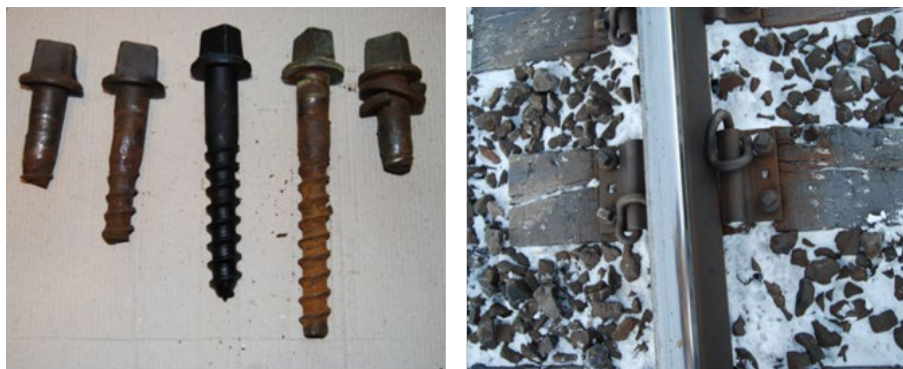
Figure 4. Broken screw spikes (left) and rolled plates (right) [3]

Plate cutting of the ties suggested wide gauge as a possible cause of the derailment. Track geometry car reports from the previous summer and fall showed that the curve had registered several “near-urgent” defects for wide gauge up to 1.125 inches (below the Canadian regulatory requirement for Class 3 track), thus indicating that gage widening had been an ongoing issue in the curve. Further, the high rail rolled over in the derailment, and in some places the plates had pulled screw spikes out of the crossties as the rail rolled over.

The curve was found to have many broken screw spikes. The report does not give the exact number of broken spikes but does mention that 74 were retained for investigation. These screws had two threads per inch and were either 7.5 or 8.5 inches long. They originated in four different batches from three different manufacturers. CN used multiple spike manufacturers because of ongoing problems with spikes breaking in service. The screw spikes met all relevant specifications.

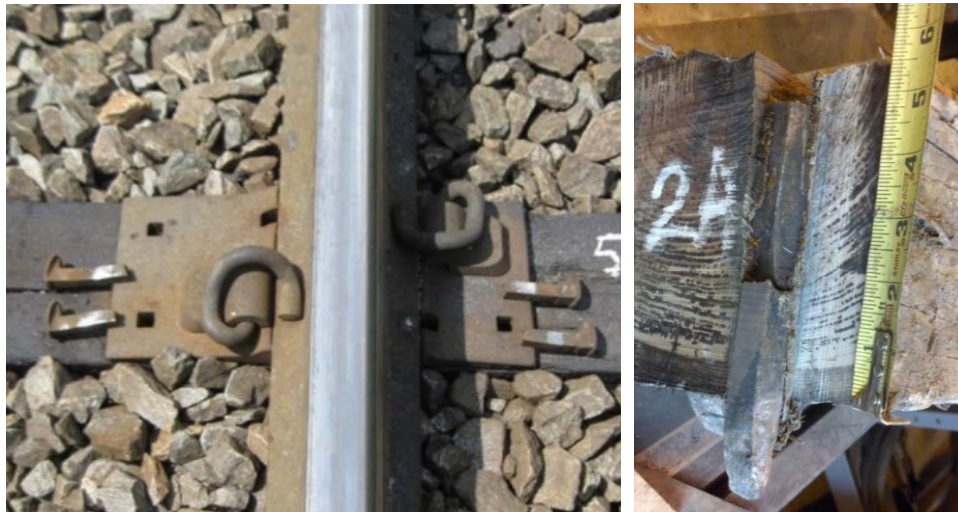
Figure 5. Broken spikes (left) and rail seat cross-section (right) [4]

Some of the crossties had experienced multiple broken spikes in the same location, as shown in [Figure 5](#). In this example, a broken spike had been located by engineering personnel and the top half removed. Because the bottom half of the spike cannot easily be removed while the crosstie is still in track, a new spike was driven above it, pushing the bottom half of the original spike through the bottom of the crosstie. This indicated that the location saw repeated broken spikes. As the journal article states, the investigation “found numerous broken spikes, including multiple broken spikes on top of older broken spikes – indicating a long-term, systematic issue.”

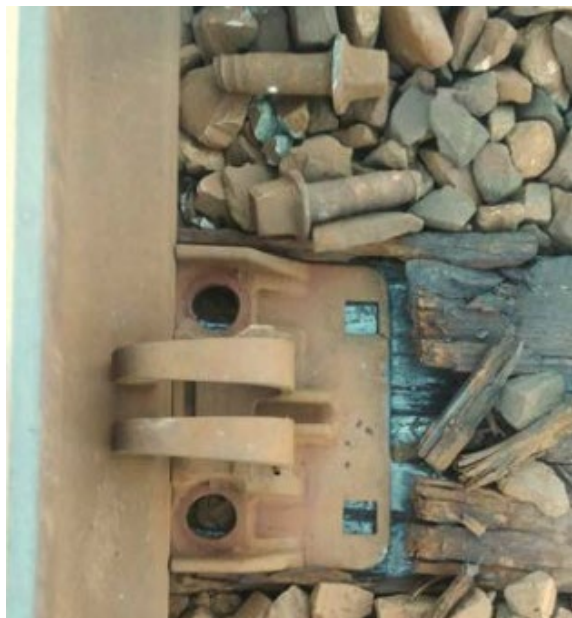
Figure 6. Broken lag bolts at the Mosier derailment site [6]

In the afternoon of June 3, 2016, a Union Pacific (UP) crude oil train derailed at Mosier, OR as it travelled down the Columbia River Gorge. In the FRA Preliminary Factual Findings Report [6], the investigation found that “multiple lag bolts in this section of Union Pacific track were broken and sheared, leading to tie plates loosening from ties. The loosened tie plates allowed for the rails to be pushed outwards as trains moved across them, eventually resulting in an area of wide gauge, leading to the derailment.” An example of the broken lag bolts can be seen in [Figure 6](#).

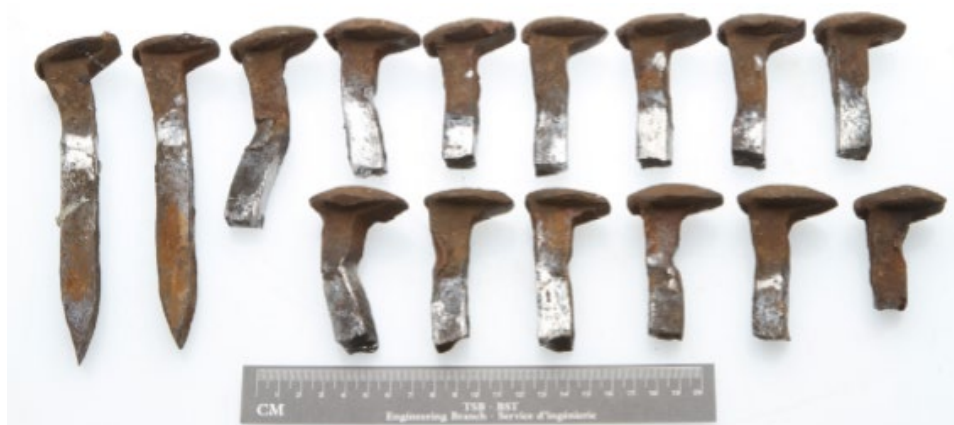
Figure 8. Spikes found in Track 21 of Montreal Central Station [8]

- the spikes did not break at the same height;
- the broken spikes failed in fatigue;
- the fatigue cracks varied by their age; and
- the shiny surfaces of the spikes, deformation, and fatigue cracks suggest that there was some significant relative movement of the spikes and tie plates.”

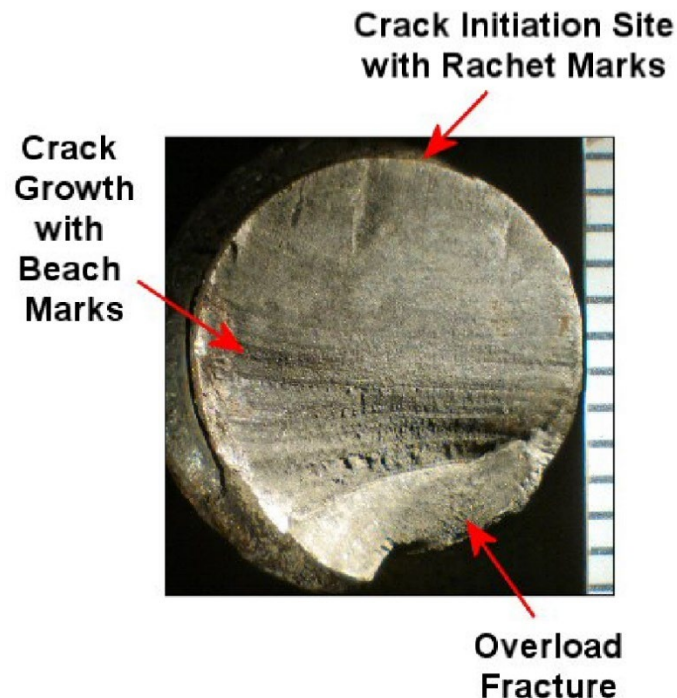
Figure 9. Screw spike fracture surface with notes from Dick et al. [10]

The authors first examined the fractures of the screw spikes, concluding that the “crack growth portion of the fracture indicated a high cycle – low stress condition that allowed the fatigue crack to grow to approximately 80 percent of the cross section. Failed screw spikes are most frequently found in high-degree curves where rail vehicles have their highest lateral wheel loads.” An example of a fractured screw spike is seen in Figure 9. Spike metallurgy is also briefly examined.

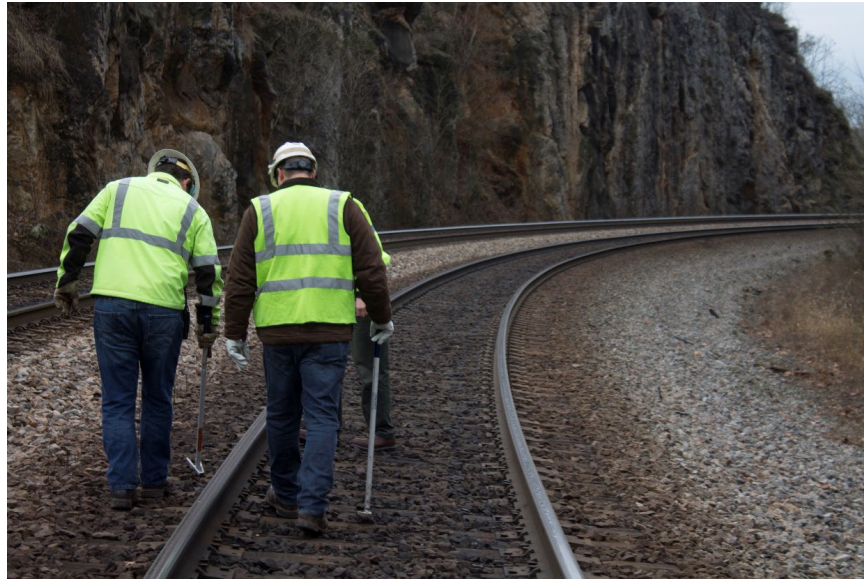
The researchers walked the curves in a manner typical of NS's usual broken spike inspection method (Figure 23). NS has seen broken spikes primarily in the high rail, and the standard method of inspection included one person walking in the gauge and one person walking on the high rail, field side, each tapping every spike as they walked. The group split into two teams to inspect the seven curves more efficiently. The walking inspections and subsequent spike failure repairs proved time-consuming, requiring the entire morning to complete.

Figure 22. Walking inspection for broken spikes near Shawsville, VA

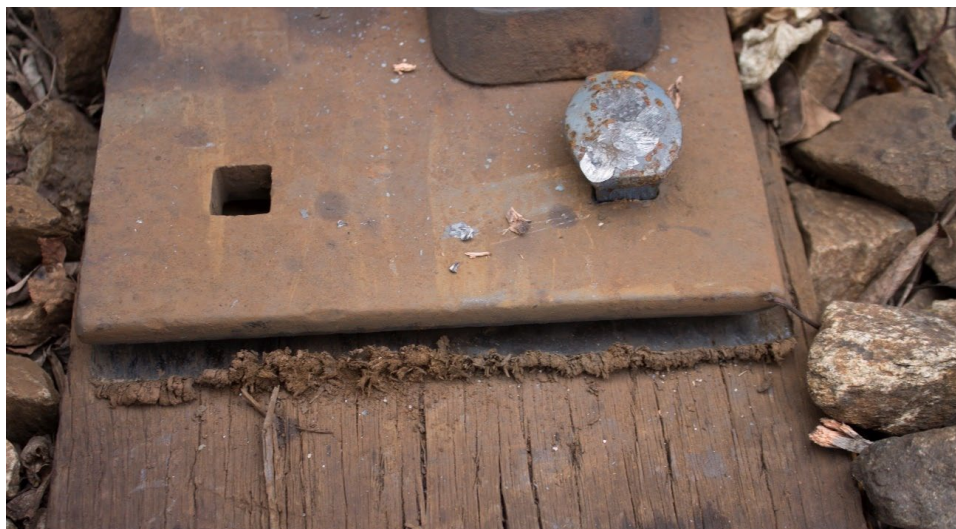
Local field personnel said that one way they can identify plates with broken spikes is by looking for plate cutting (Figure 24).

Figure 23. Plate cut/shove suggesting possible broken spikes

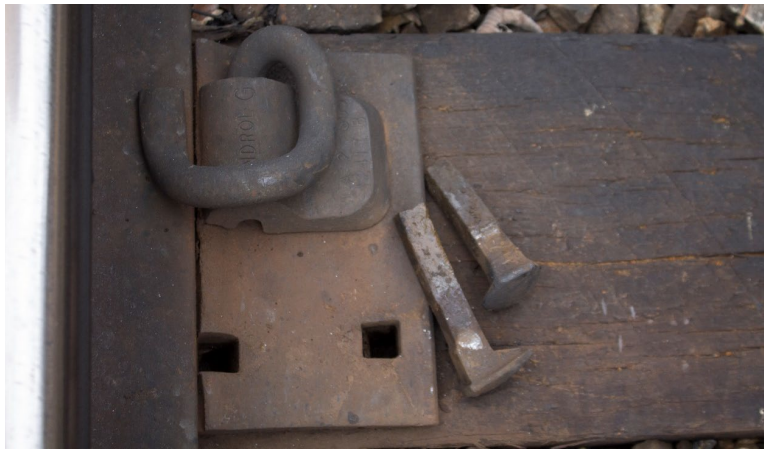
[Figure 25](#) shows some typical broken spikes after removal. The left spike in the photograph is the rail hold down spike, and the right one is the field spike. The rail hold down spike broke lower down the shank because the tie plate is thicker at the rail location. Both spikes failed at approximately the same depth beneath the top of the crosstie, roughly 1.5 inches.

Figure 24. Typical broken spikes after removal

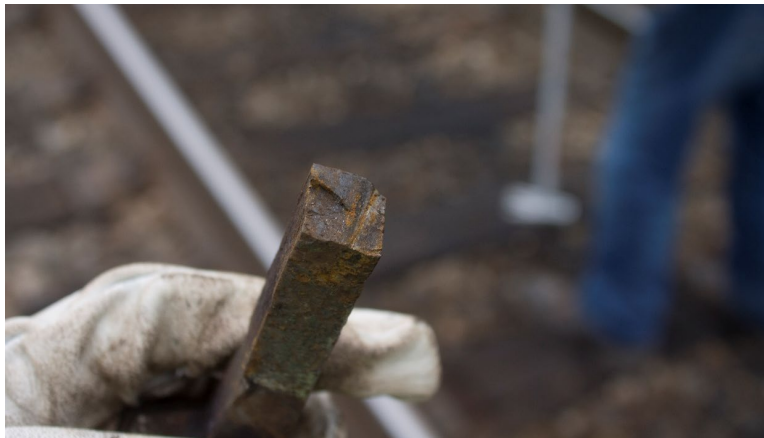
The spikes exhibit similar fracture patterns, suggesting a fatigue failure caused by both lateral and longitudinal loading from the tie plate, as shown in [Figure 26](#). Most spikes had fracture surfaces that had degraded considerably, likely due to the two broken halves rubbing against each other in the spike hole after failing.

Figure 25. Common spike fracture pattern

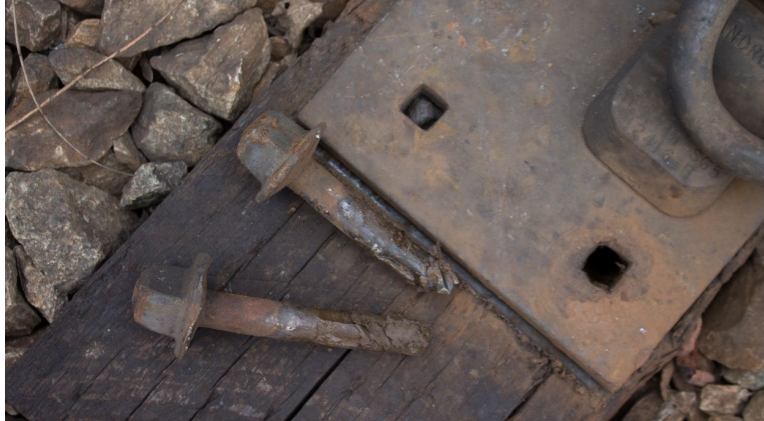
NS has installed drive spikes in the Victor plate cut spike holes to restore some failed spike locations because drive spikes were thought to be stronger and might last longer. Several of the broken spikes found were these drive spikes (Figure 27), indicating a repeated spike failure problem at these locations. Local NS personnel mentioned that several of these curves had repeated broken spike problems, and that in one curve they had once found 150 broken spikes.

Figure 26. Broken drive spikes in repeat-breakage locations

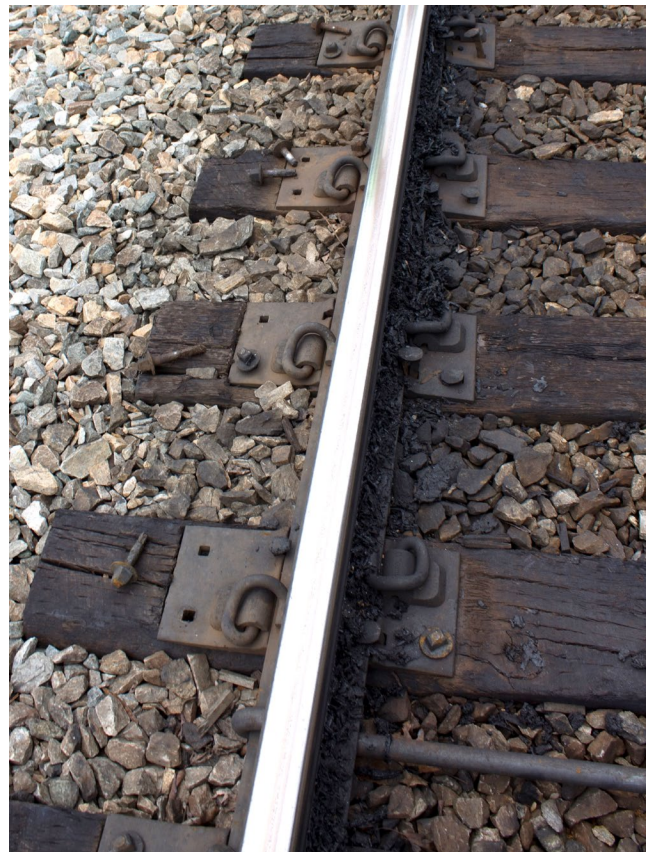
Figure 27. Location with cluster of broken spikes; note gage rod

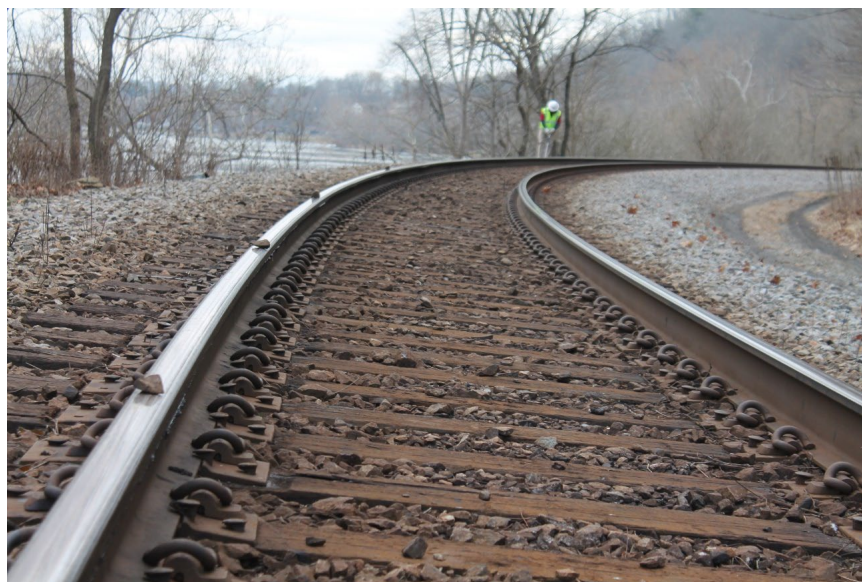
Figure 28. Broken spike clusters appearing at certain intervals, marked by ballast particles on the rail. Note the curve grease marks on the high rail gauge face.

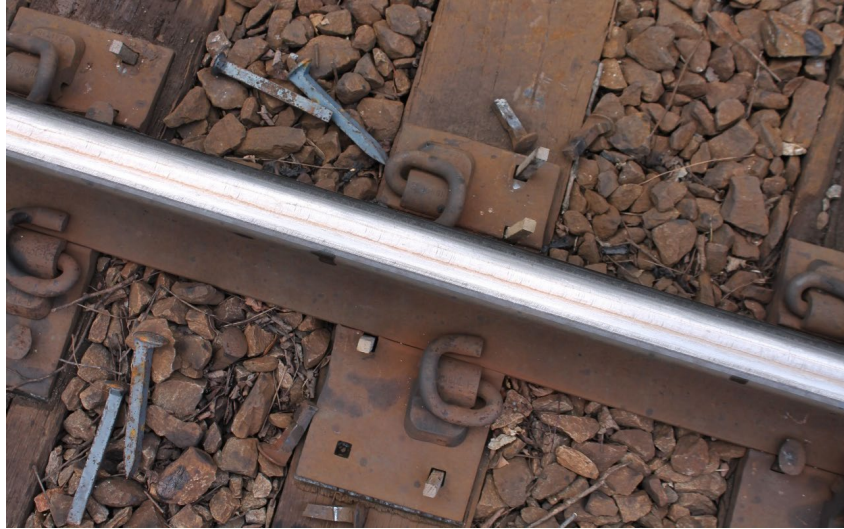
Figure 29. Plug wood and new spikes to be installed in a plate where all four spikes broke.

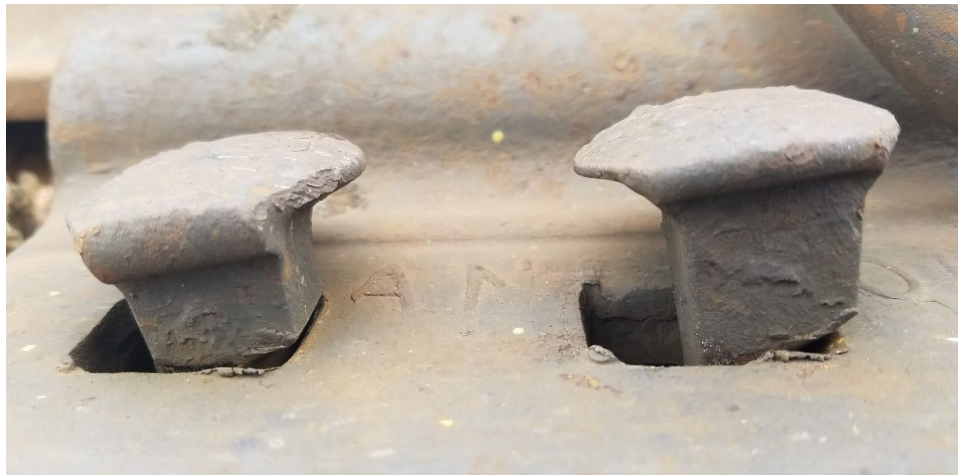
Figure 31. Wear of plate into cut spikes in the longitudinal direction in Pandrol plates

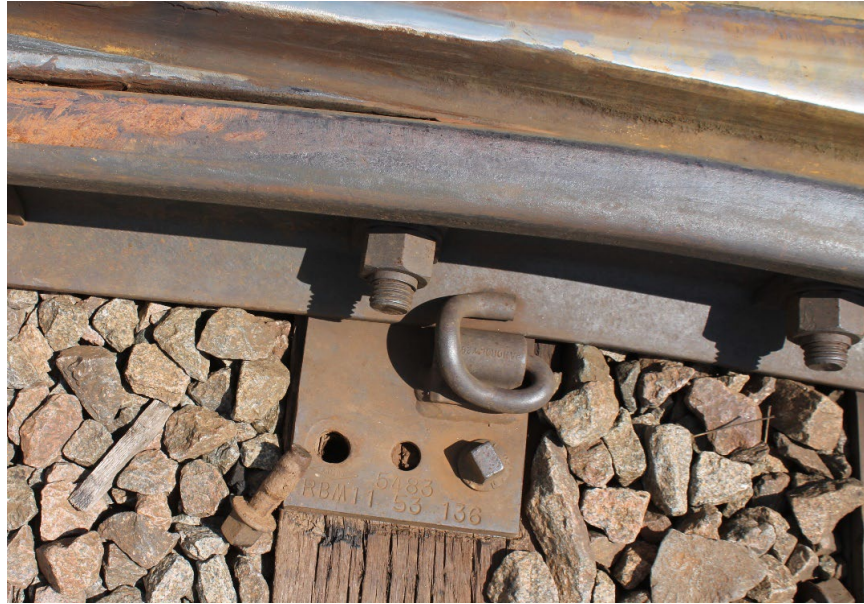
Figure 33. Broken spike around the frog of a turnout

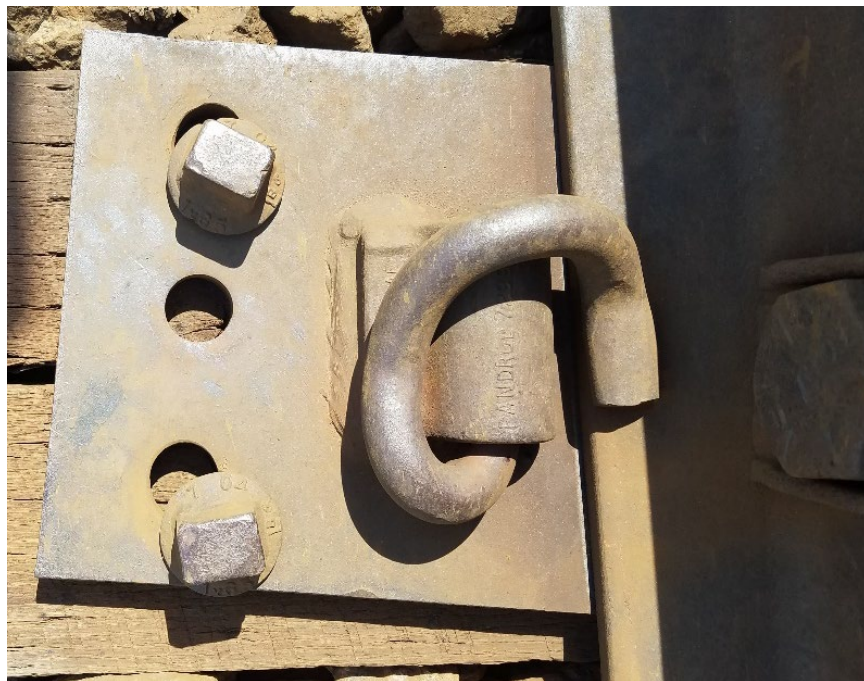
Figure 34. Longitudinal plate movement with stationary spikes

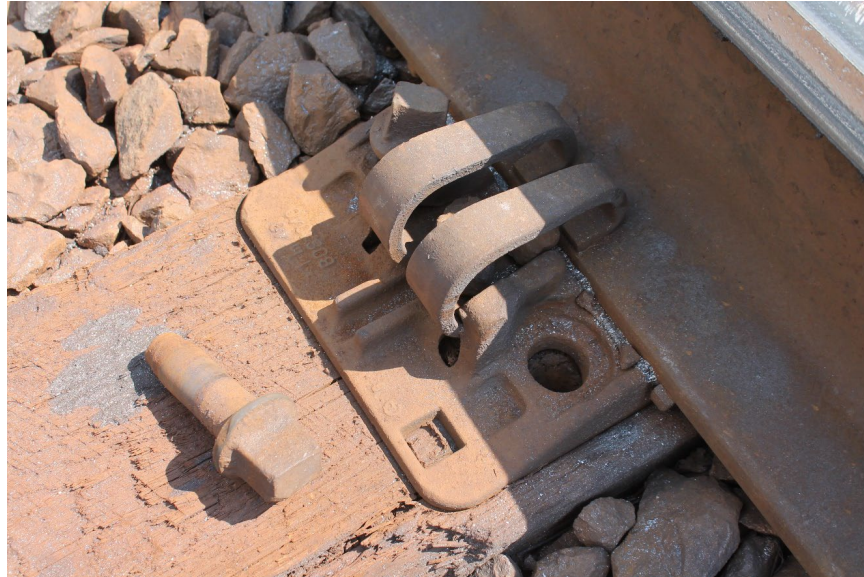
Figure 35. Broken lag screw removed from cast plate, typical of failures observed

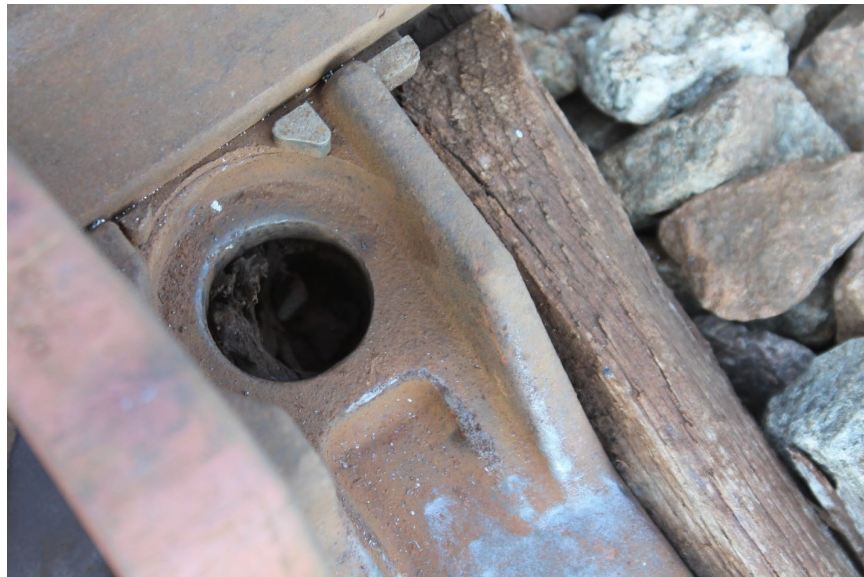
Figure 36. Timber visible in the spike hole, possibly suggesting plate movement and/or severe contact of the plate and spike

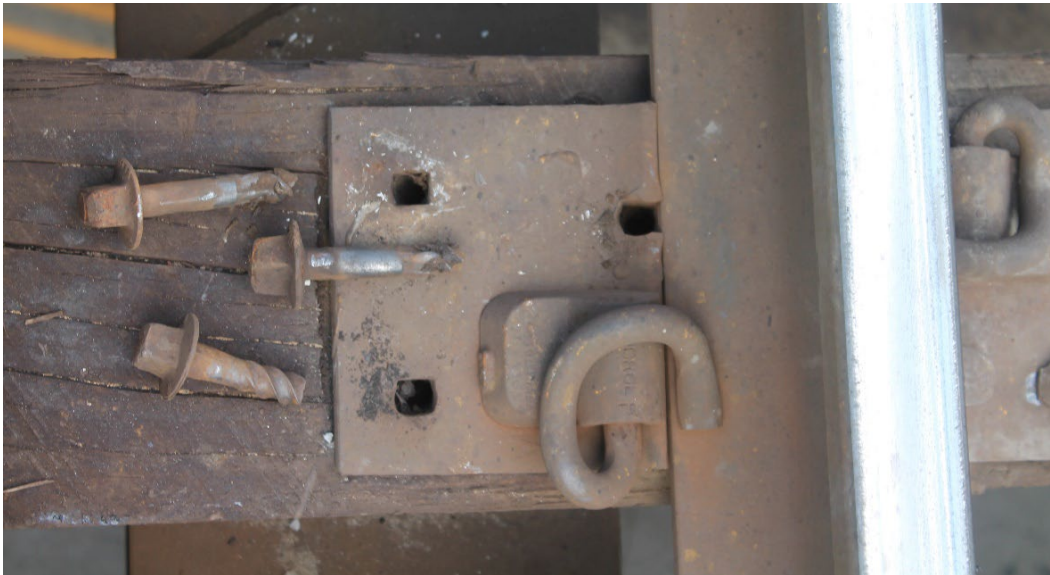
Figure 39. Three broken spikes removed from a bridge timber. The fact that these are drive spikes signifies that all three spike holes previously had cut spikes that broke

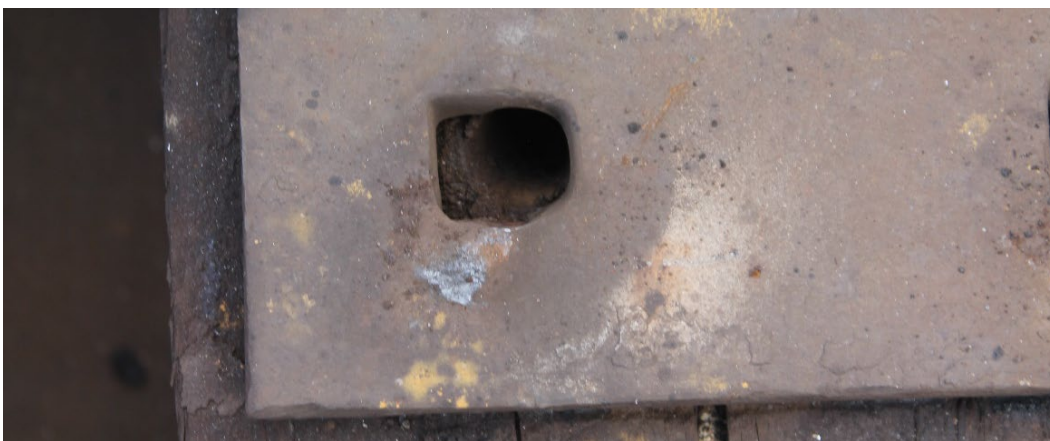
Figure 40. A spike hole with broken spike removed reveals that the spike was in a severe contact position with the plate. Spike hole wear is indicative of longitudinal plate movement to the left

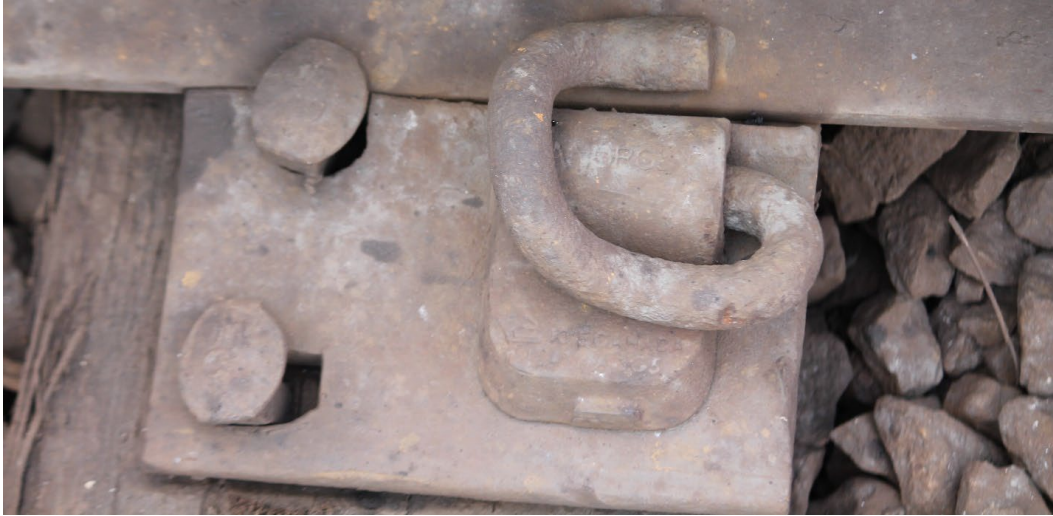
Figure 41. Spike hole and shoulder wear indicates plate rotation and severe contact between plate and spike

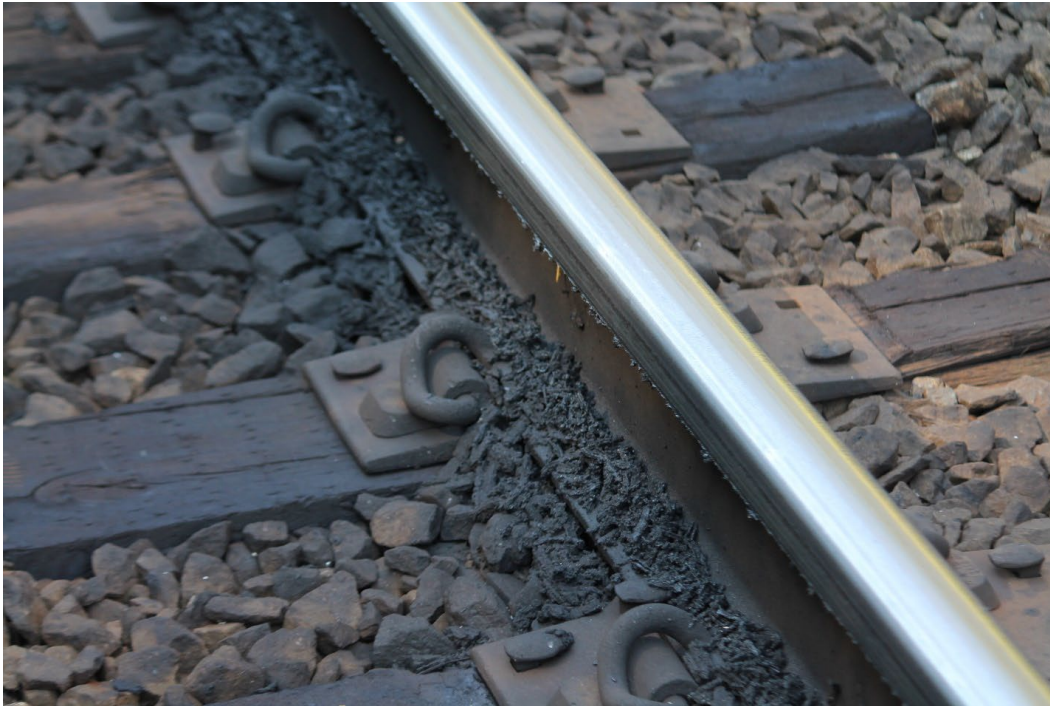
Figure 43. Curve grease build-up at Conemaugh, PA

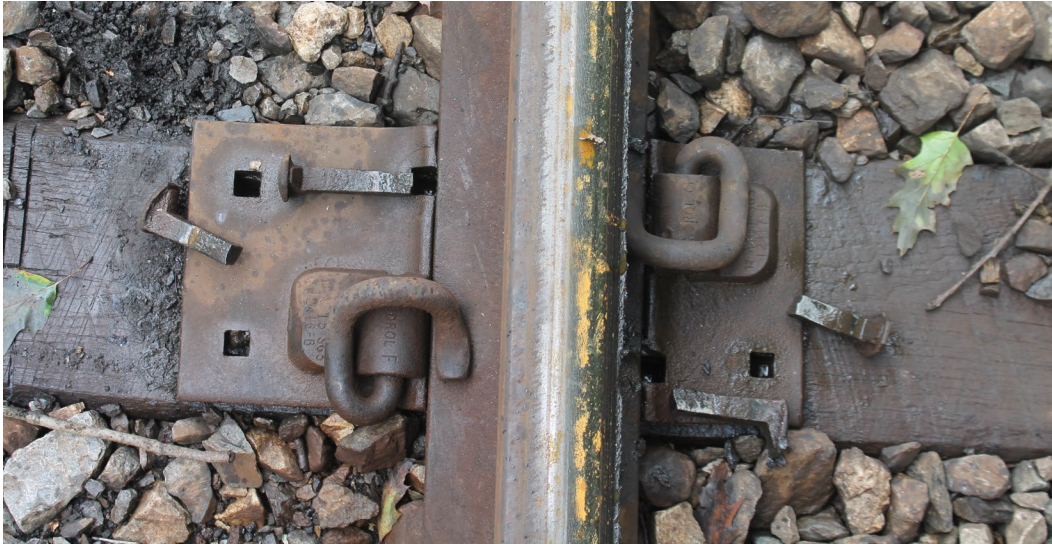
Figure 44. Four broken spikes removed from a Victor plate in the low rail

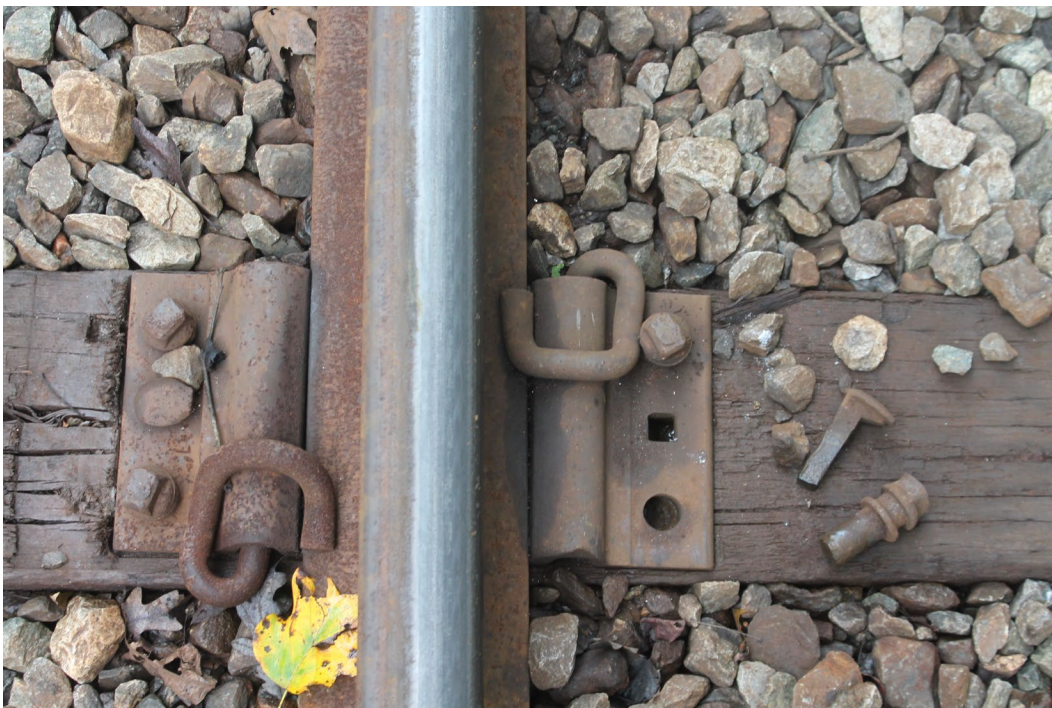
Figure 45. A broken Evergrip and a broken cut spike found in a Pandrol plate on the high rail at the second curve

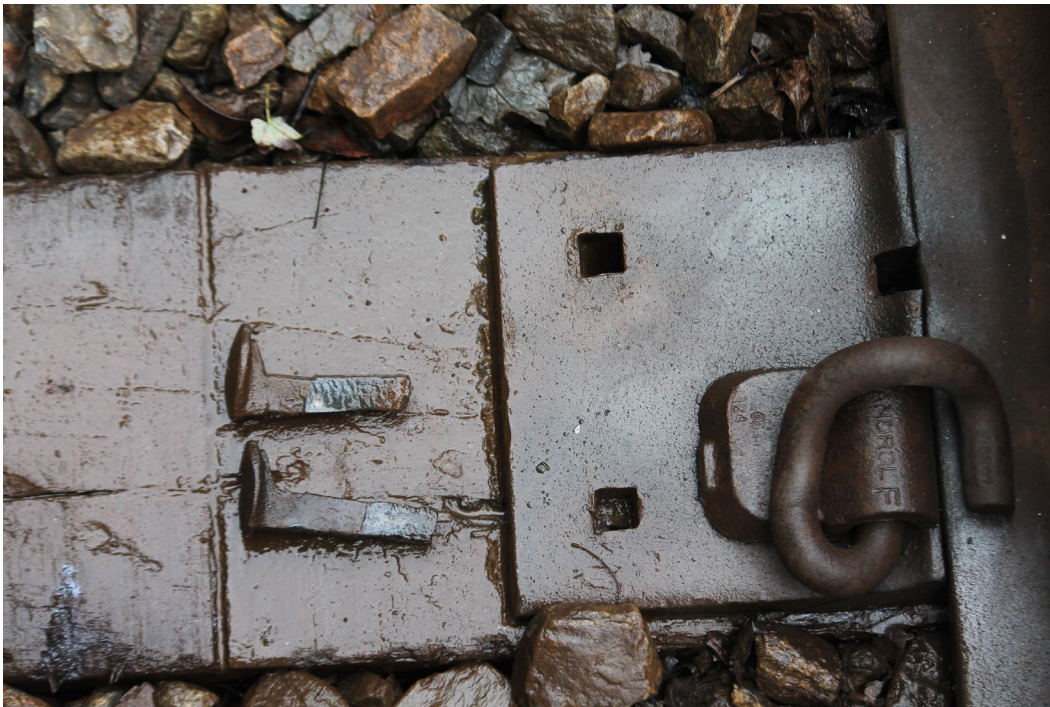
Figure 46. Two broken spikes in a Victor plate on a new crosstie

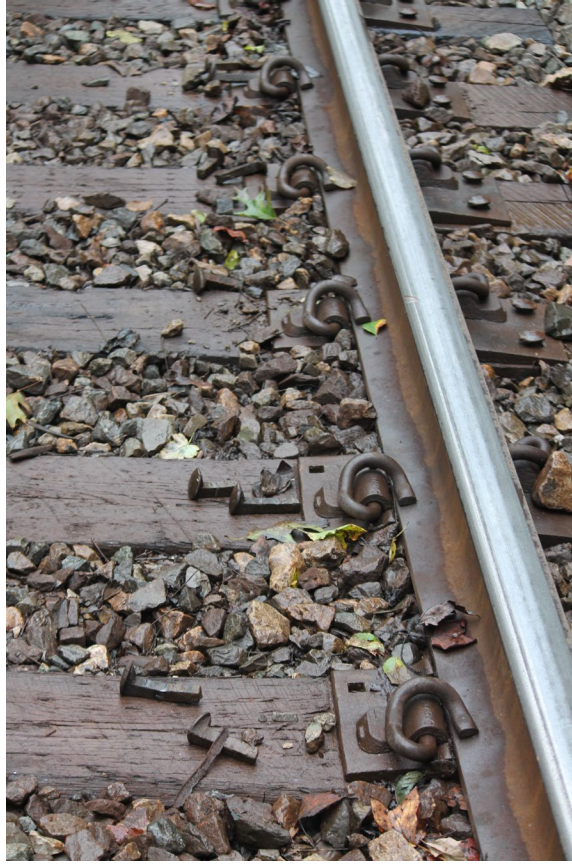
Figure 47. Cluster location with multiple plates in a row with broken spikes

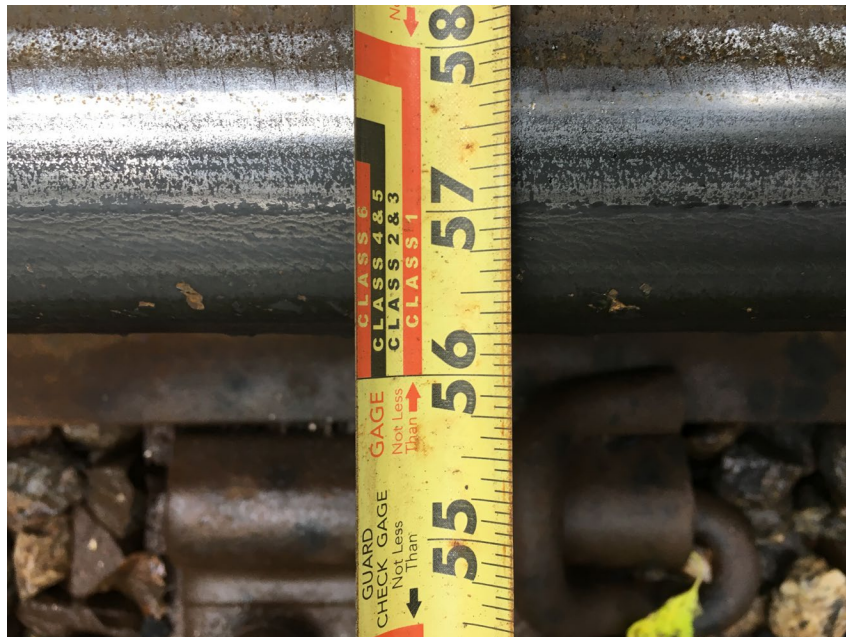
Figure 48. Slight tight gage found at one broken spike cluster

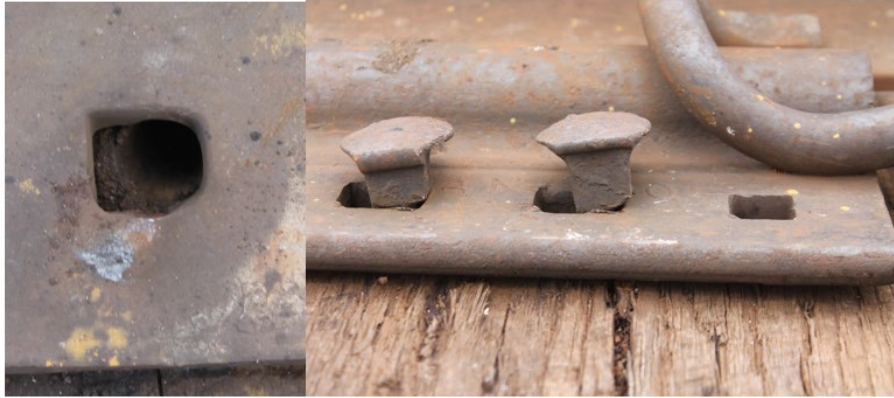
Figure 55. Left: A Victor plate spike hole showing significant wear in the longitudinal direction. Right: Longitudinal plate movement allowed by spike neck wear
