Improving Resilience of Transportation Infrastructure to Hurricane Damage

NCDOT Project 2021-08
FHWA/NC/2021-08
September 2023

B. Shane Underwood, Ph.D.
Brina Montoya, Ph.D..
Department of Civil, Construction, and
Environmental Engineering
North Carolina State University

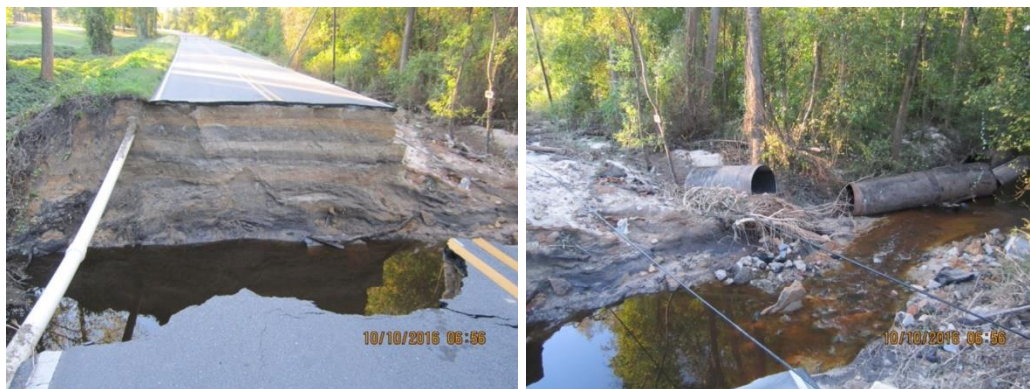
Pre – Matthew Structure	2 @ 60" CMP
Post – Matthew Proposed Structure	Alt. 1: 1 @ 13'1" x 8'4" STR.PL.PA w/HW Alt. 2: 2 @ 84" w/HW
Post – Matthew Actual Structure	1 @ 156" x 96" CAP w/HW
Costs	\$416,041

Figure 16. Photos of damage after Hurricane Matthew in Site 53-6-M.

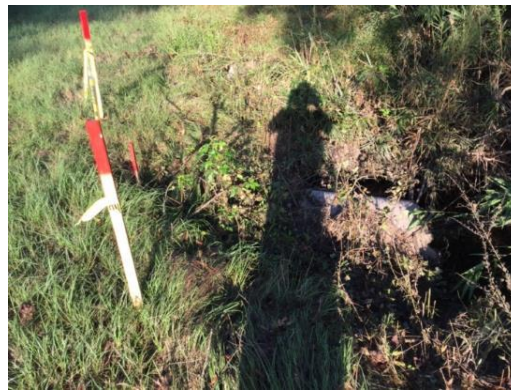
Pre – Florence Structure	1 @ 36" RCP
Post – Florence Proposed Structure	N/A
Post – Florence Actual Structure	1 @ 36" RCP
Costs	\$2,449.2

Figure 17. Photos of damage after Hurricane Florence in Site 77-6-F.

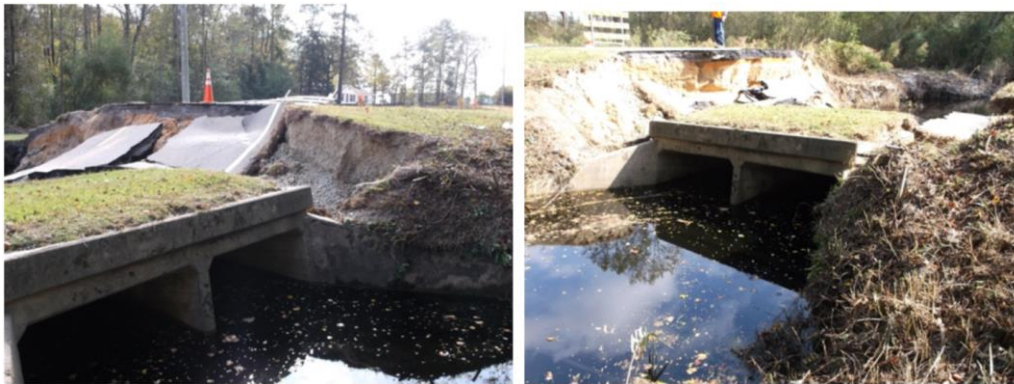
Pre – Matthew Structure	2 @ 6'X6' (72" X 72") RCBC
Post – Matthew Proposed Structure	1 @ 117"x79" CMPA w/HW
Post – Matthew/Pre – Florence Actual Structure	1 @ 96" CMP w/HW
Costs after Matthew	\$173,485
Post – Florence Proposed Structure	N/A
Post – Florence Actual Structure	1 @ 96"x74" CMPA w/HW
Costs after Florence	\$14,476

Figure 19. Photos of damage after Hurricane Matthew in Site 95-4-MF.

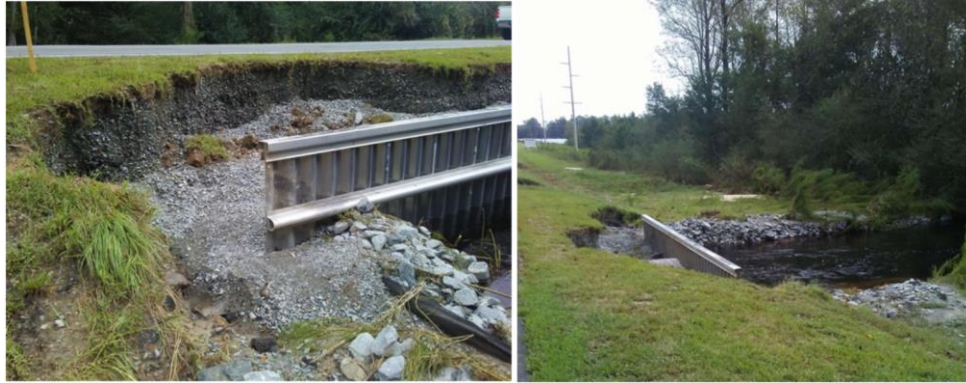
Figure 20. Photos of damage after Hurricane Florence in Site 95-4-MF.

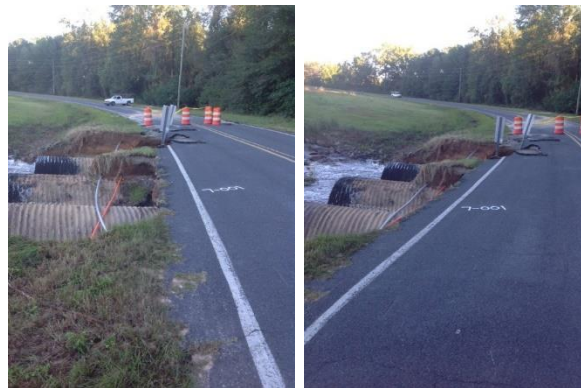
Pre – Matthew Structure	3 @ 48" CMP or CAAP
Post – Matthew Proposed Structure	1 @ 137" x 87" CMPA w/HW
Post – Matthew/Pre – Florence Actual Structure	3 @ 95" x 67" CMPA (Possibly the structure pre-Matthew is the same)
Costs after Matthew	\$13,592
Post – Florence Proposed Structure	Alt 1: 25'2" x 7'0" ABC w/ HW, Buried 1-ft Alt 2: 2 @ 11'5" x 7'1" SPPA w/ HW, Buried 1-ft
Post – Florence Actual Structure	1 @ 78" x 252" CMPA w/HW
Costs after Florence	\$528,964

Figure 21. Photos of damage after Hurricane Matthew in Site 42-1-MF.

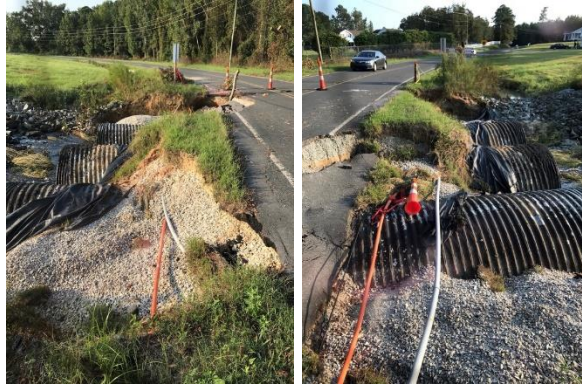
Figure 22. Photos of damage after Hurricane Florence in Site 42-1-MF.

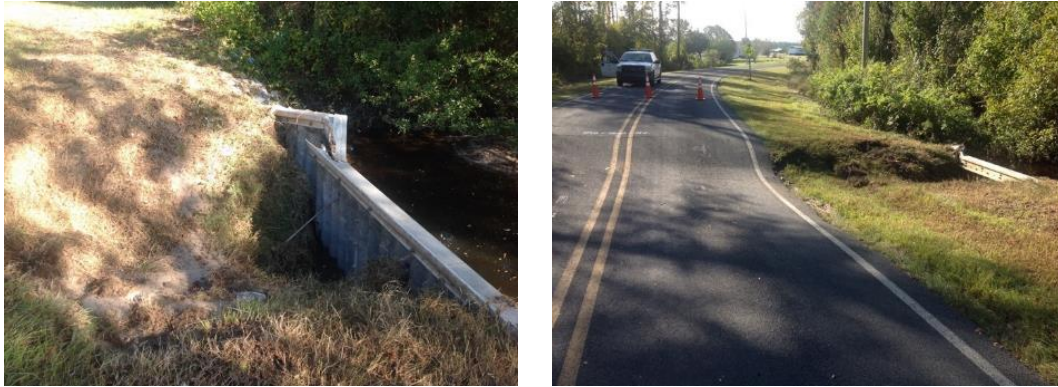
Pre – Matthew Structure	1 @ 24'1" x 6'6" AABC
Post – Matthew Proposed Structure	1 @ 24'4" x 8'2" ABC w/HW
Post – Matthew Actual Structure	1 @ 142" x 91" CMPA w/HW
Costs	\$646,150.9

Figure 23. Photos of damage after Hurricane Matthew in Site 77-10-M.

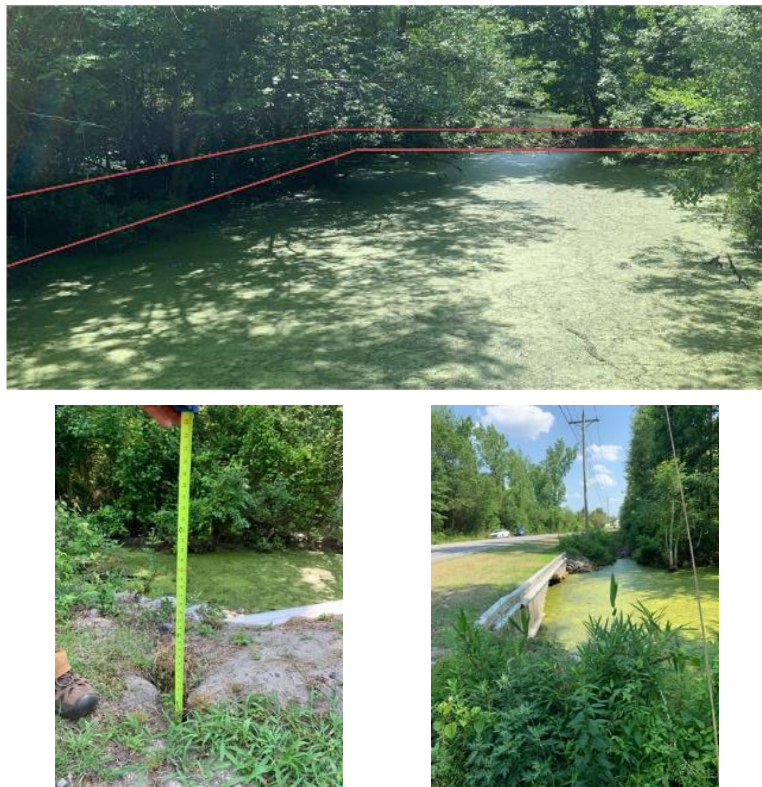
Photographs of the current condition at the site are shown in Figure 24. Measurements taken during the site visit confirm the size listed in Table 11 currently exists. The visit also found the existence of what is believed to be a very large beaver dam on the inlet side that appeared to have at least two major branches; one parallel to the culvert (visible in the first panel) and another perpendicular to the culvert extending to the wood line (not clearly visible in the first panel photo). The red lines in the first pane are drawn to help show where the dam exists. At this site, the ponded water extended as far to the left as was visible through the woods. In addition, as the second panel shows, it also appeared that hole approximately 1 foot deep existed occurring at the edge of the headwall on the side where the perpendicular branch of the beaver dam existed. Some ponding of the water on that side of the culvert can be observed in the third panel of Figure 24.

Figure 24. Current photos of Site 77-10-M.

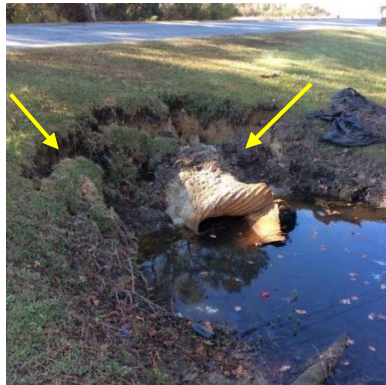
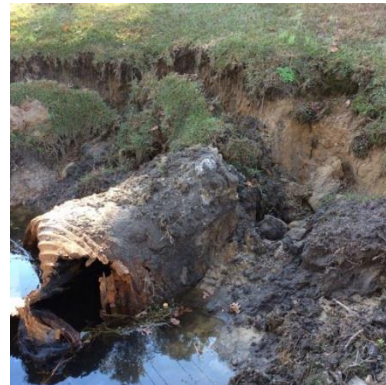
Pre – Matthew Structure	1 @ 48" CMP
Post – Matthew Proposed Structure	2 @ 66" CMP w/HW
Post – Matthew Actual Structure	1 @ 48" CMP
Costs	\$1,157.15

Figure 25. Photos of damage after Hurricane Matthew in Site 77-4-M.

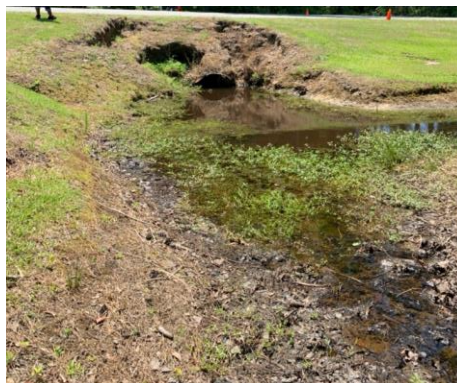
Figure 26. Current photos of Site 77-4-M.

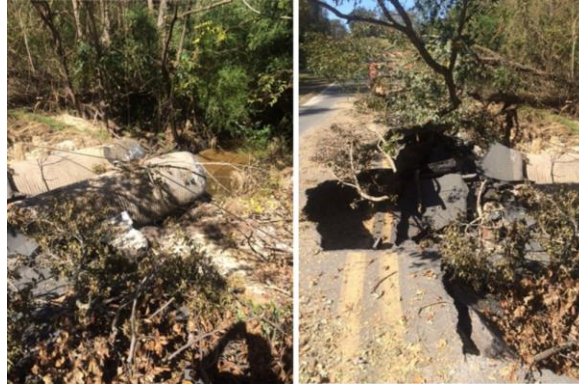
Pre – Matthew Structure	2 @ 60" CMP
Post – Matthew Proposed Structure	Alt 1: 1 @ 112" x 75" CAPA w/HW Alt 2: 2 @ 66' w/HW
Post – Matthew/Pre – Florence Actual Structure	2 @ 60" CMP
Costs after Matthew	\$60,655
Post – Florence Proposed Structure	Alt 1: 1 @ 11'-5" x 7'-1" CASPPA w/HW Alt 2: 2 @ 66" Pipe w/HW Alt 3: 2 @ 81" x 59" CAPA w/HW
Post – Florence Actual Structure	1 @ 79" x 134" CMPA w/HW
Costs after Florence	\$238,645

Figure 27. Photos of damage after Hurricane Matthew in Site 53-4-MF.

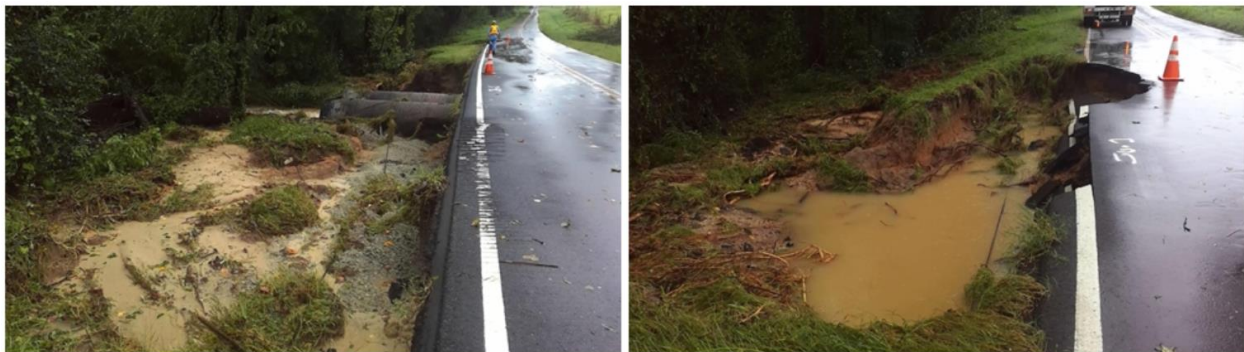
Figure 28. Photos of damage after Hurricane Florence in Site 53-4-MF.

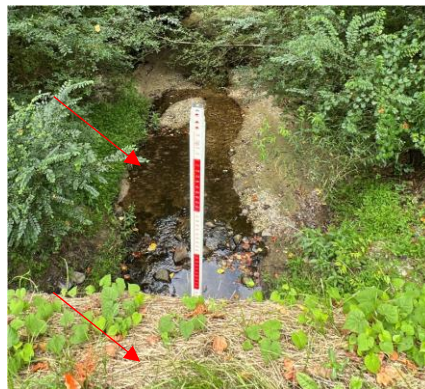
Figure 29. Current photo of Site 53-4-MF.

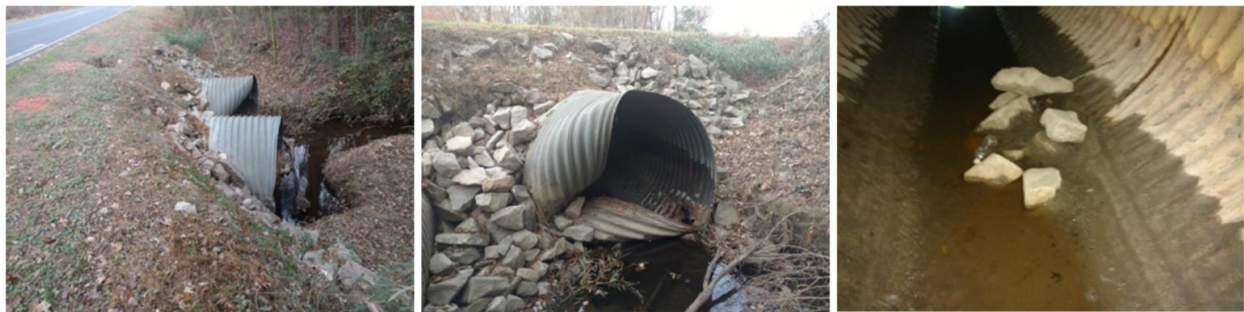
Pre – Matthew Structure	2 @ 84" CMP
Post – Matthew Proposed Structure	Alt 1: 2 @ 112"x75" CMPA w/HW. Alt 2: 1 @ 13'-11" x 8'-5" AASPPA (requested by Div.)
Post – Matthew Actual Structure	1 @ 171" x 115" CMPA w/HW
Costs after Matthew	\$421,593

Figure 30. Photos of damage after Hurricane Matthew in Site 95-3-M.

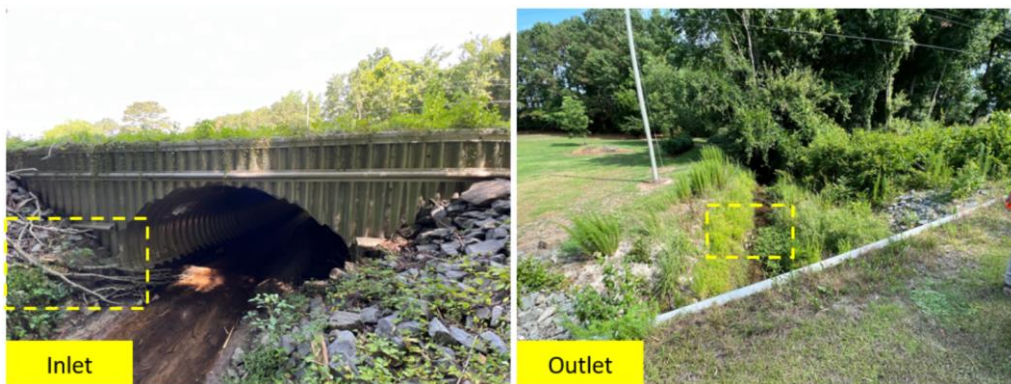
Figure 31. Current photos of Site 95-3-M.

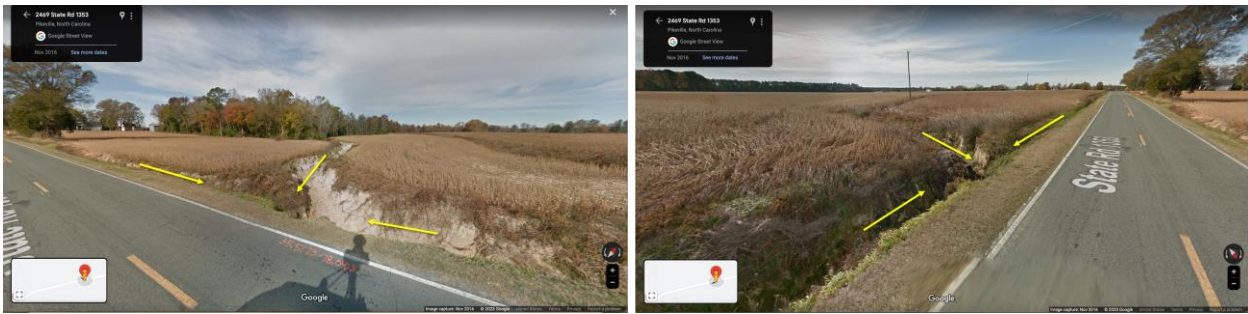
Figure 46. Photos from Google Earth in Site 95-1-F on the inlet side (left) and on the outlet side (right).

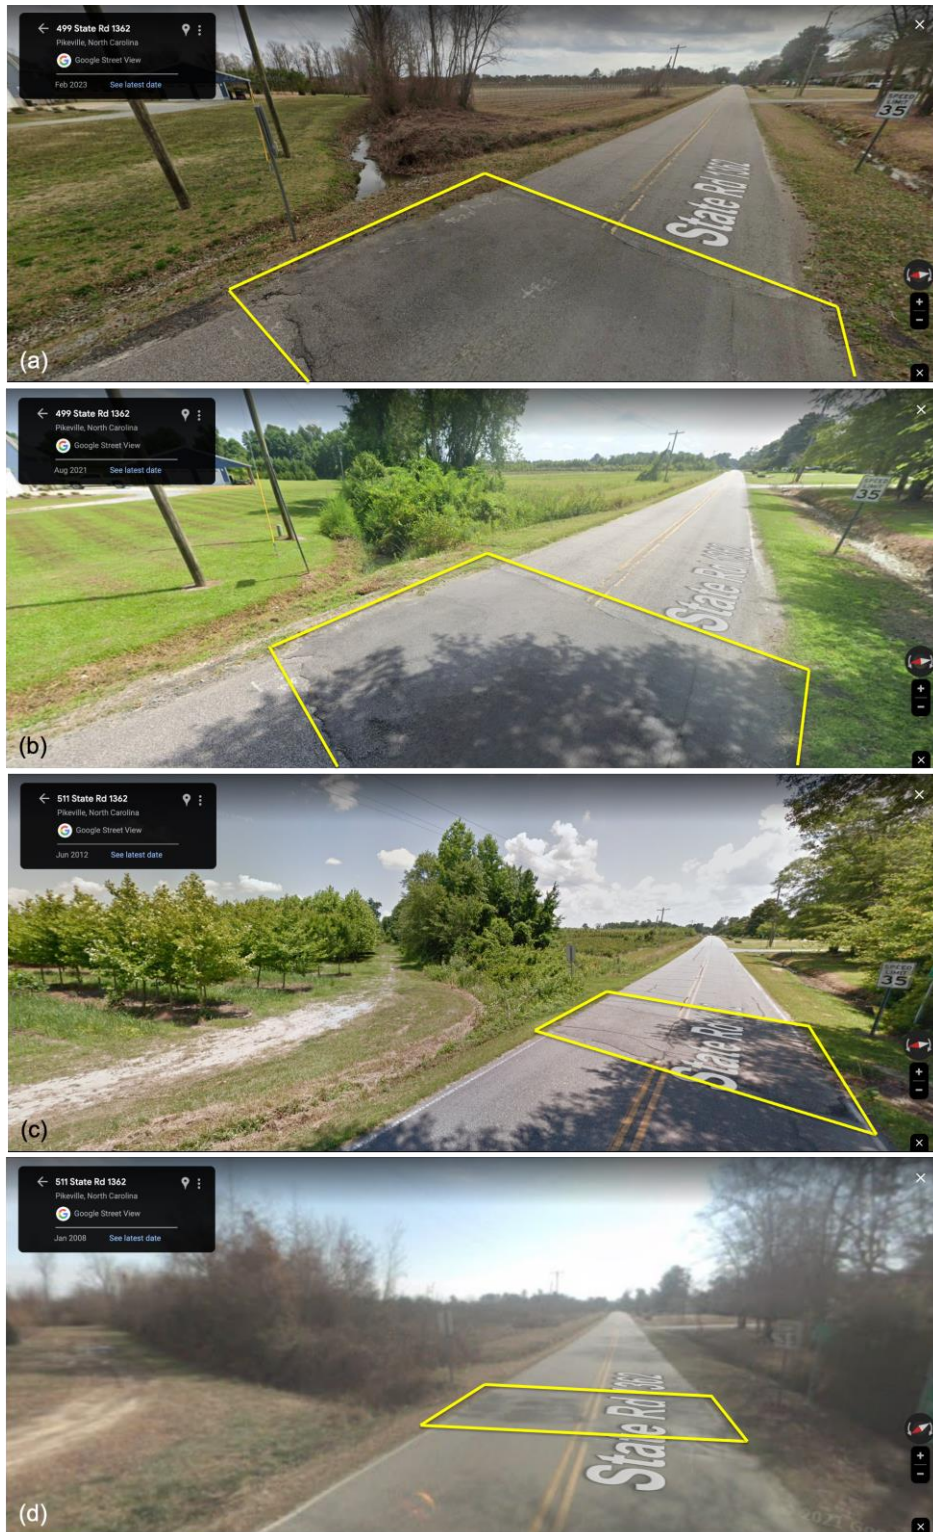
Figure 47. Photos from Google Earth in Site 95-2-F on (a) February 2023, (b) August 2021, (c) June 2012, and (d) January 2008.
