EVALUATION OF THIN POLYMER OVERLAYS FOR BRIDGE DECKS

FHWA/MT-23-006/9757-705

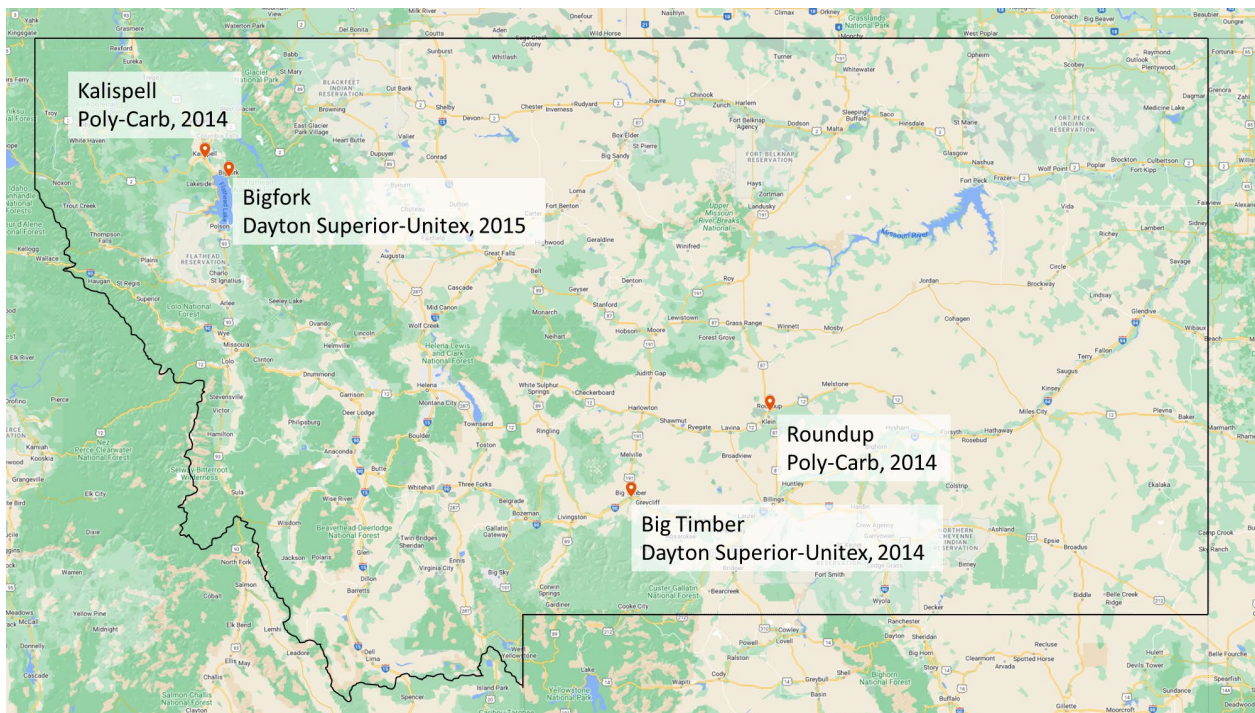
Figure 1. Map showing locations of four bridges in Montana with HFSTs applied in 2014 and 2015.

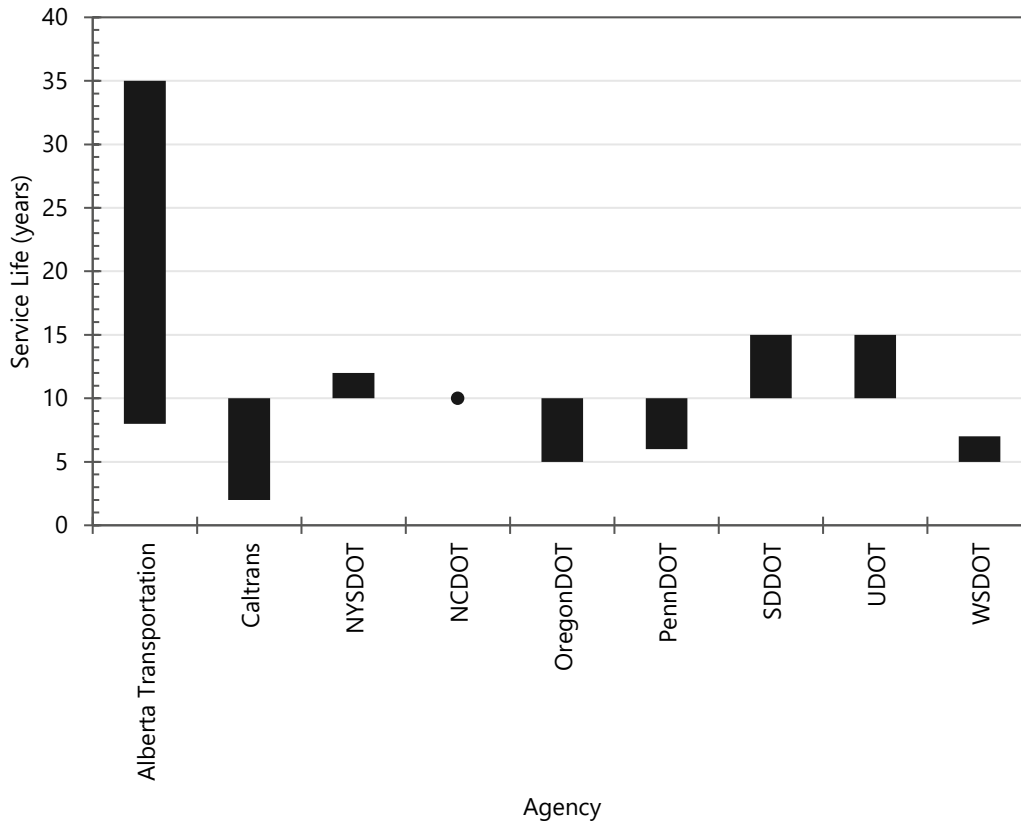
Figure 3. Reported ranges of service life for thin polymer overlays and high friction surface treatments. (PPC overlays are discussed in the next subsection.)

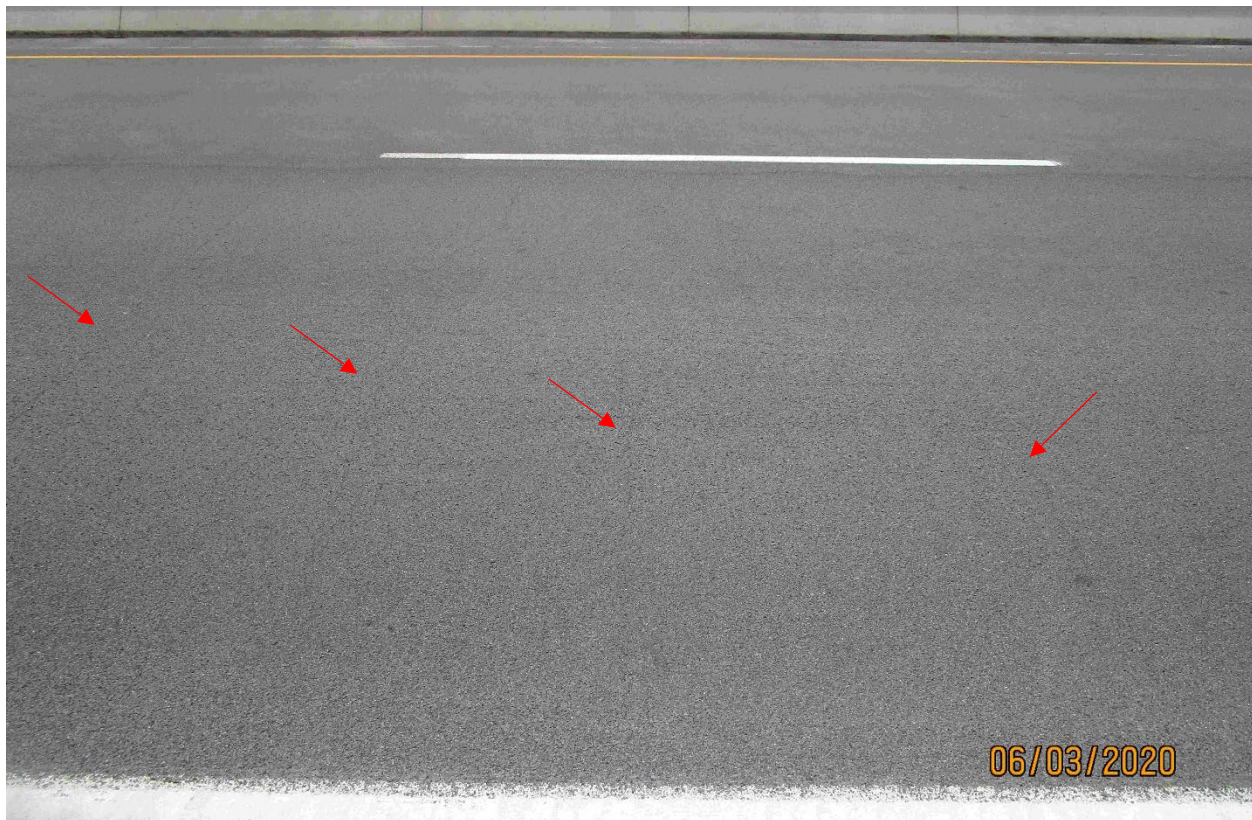
Figure 6. Transverse cracks in a HFST applied to MDT Bridge 1374, which is in the Missoula District. Image provided by MDT. Red arrows added by WJE to point out the transverse cracks.

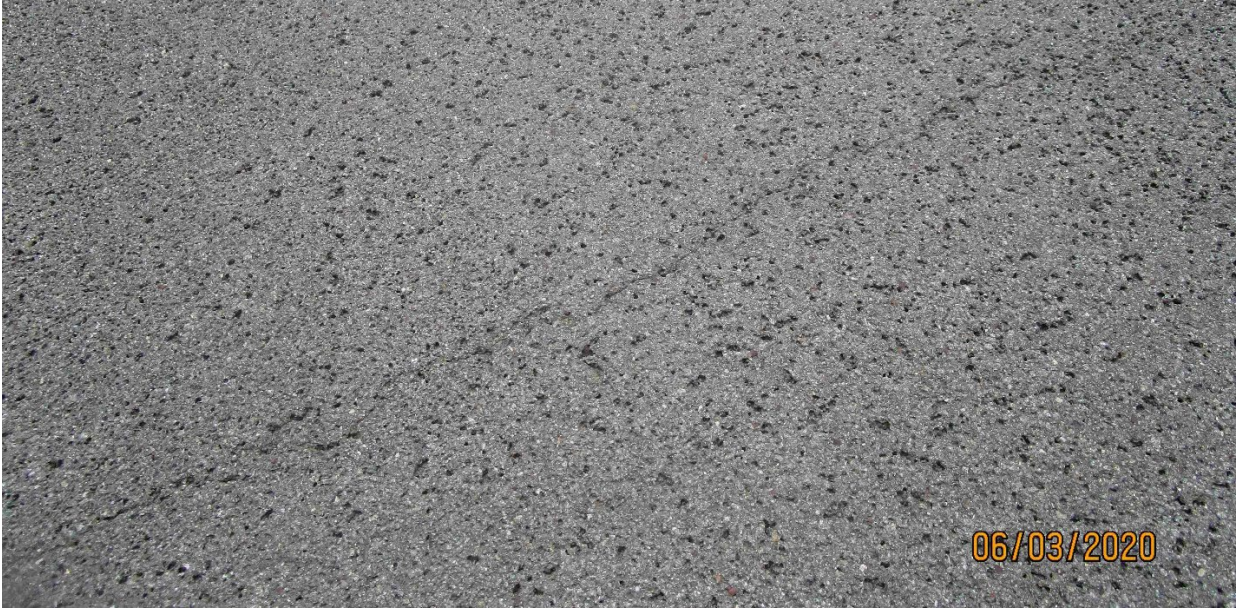
Figure 7. A transverse crack and aggregate pop-out in the HFST applied to MDT Bridge 1374, which is in the Missoula District. Image provided by MDT.

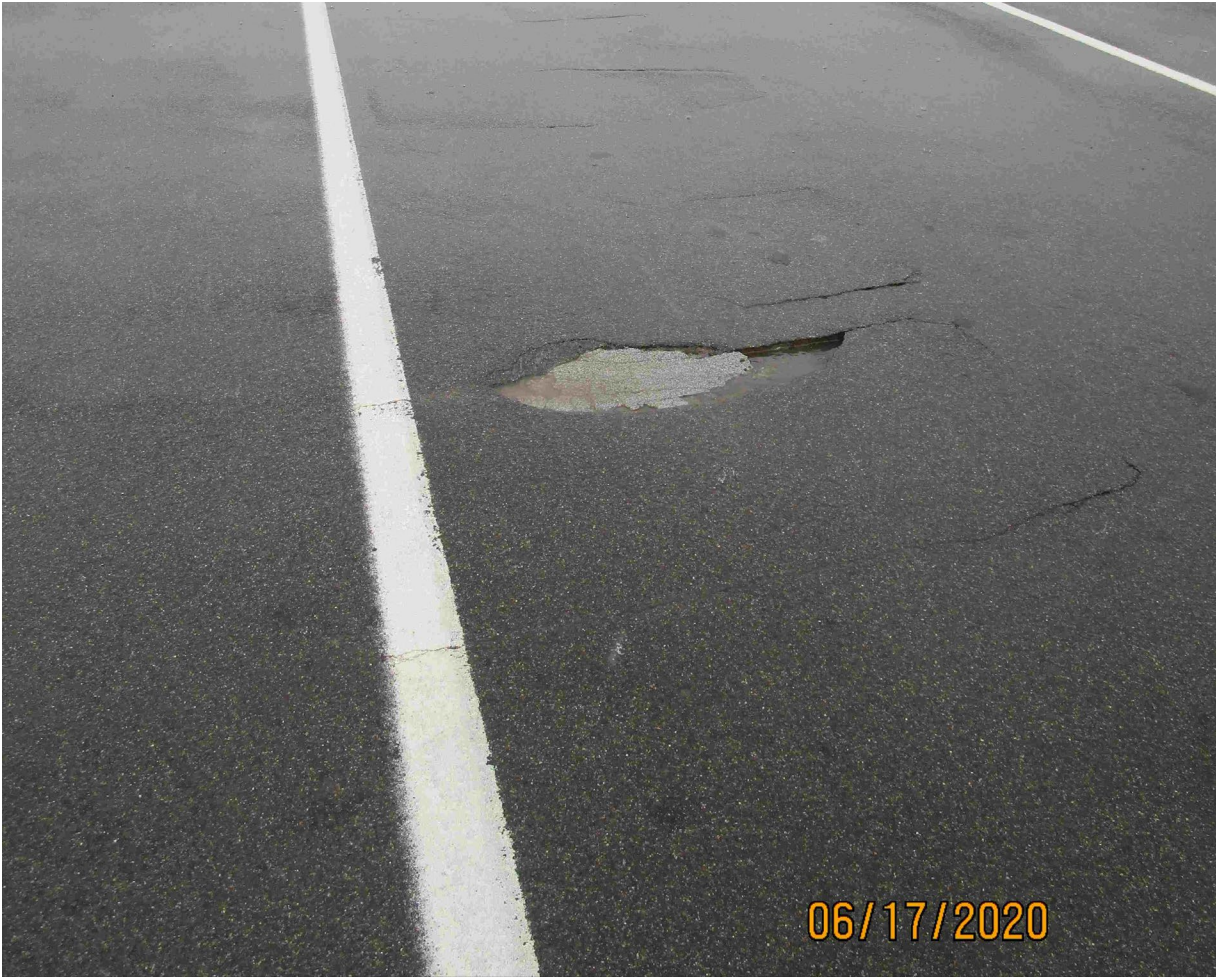
Figure 8. Reflective cracking and spalling over partial-depth repairs on Bridge 1682 in the Billings District. Image provided by MDT.

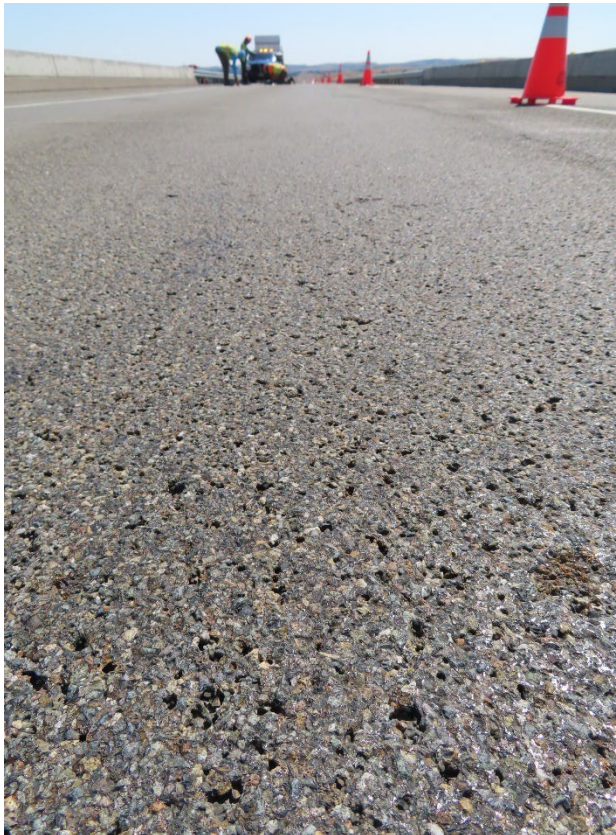
Figure 12. Photograph of wear and aggregate pop-out in driving lane of Bridge 1670 in 2020.

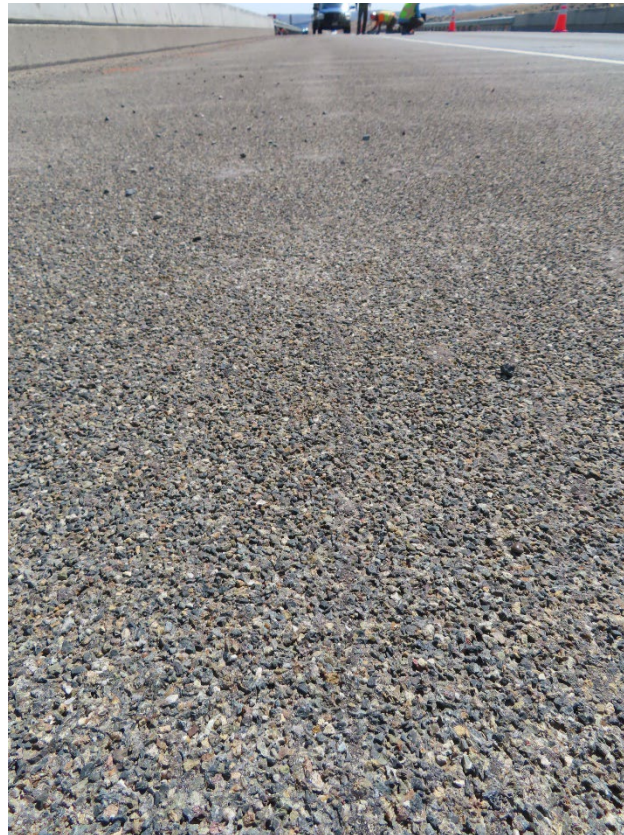
Figure 13. Photograph of minimal wear in the shoulder of Bridge 1670 compared to the driving lane in 2020.

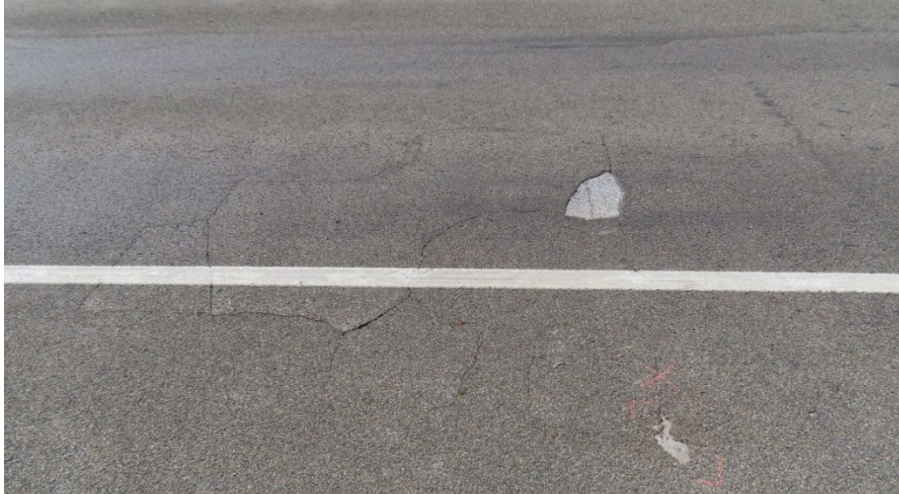
Figure 14. Reflective cracking in the driving lane of the HFST on Bridge 1670 and several spalls of the HFST, as of 2020.

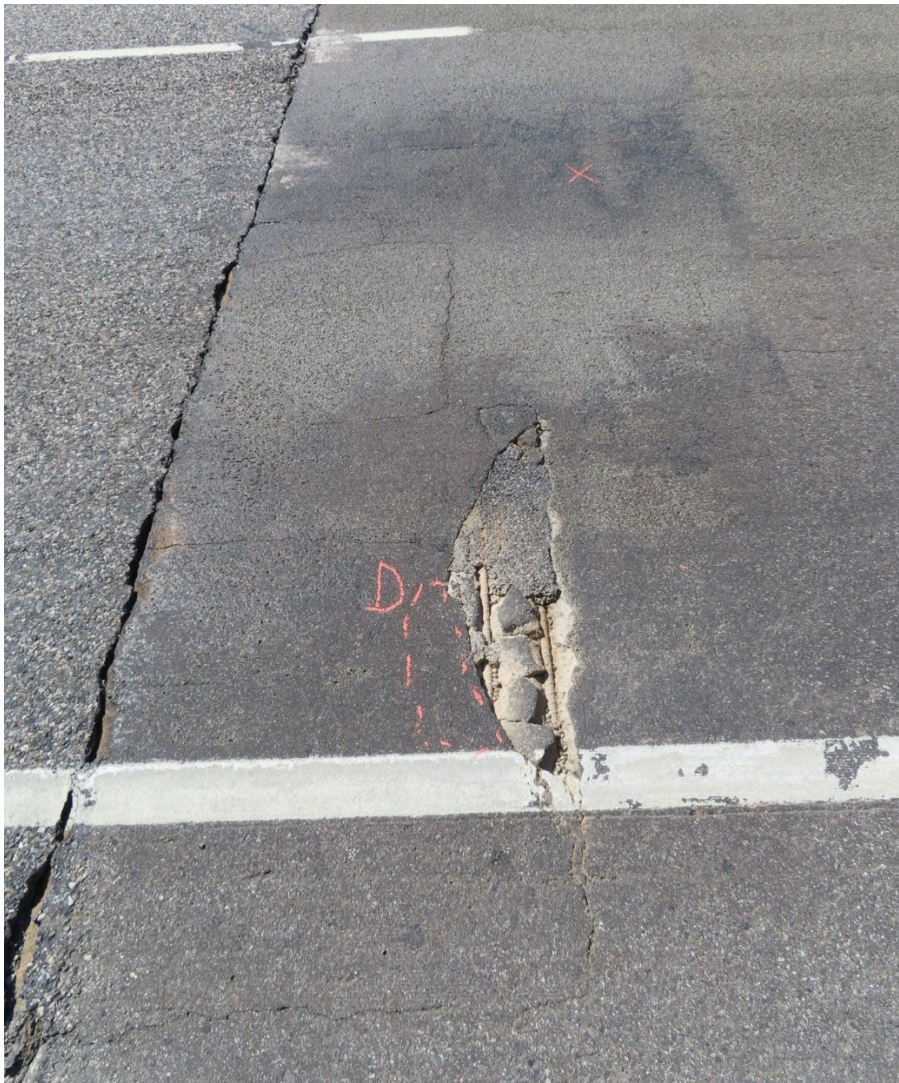
Figure 15. Spall exposing rebar and delamination on Bridge 1670, as seen in 2020 inspection. Loss of HFST at the bridge edge due to snow plow damage is visible in the upper left.

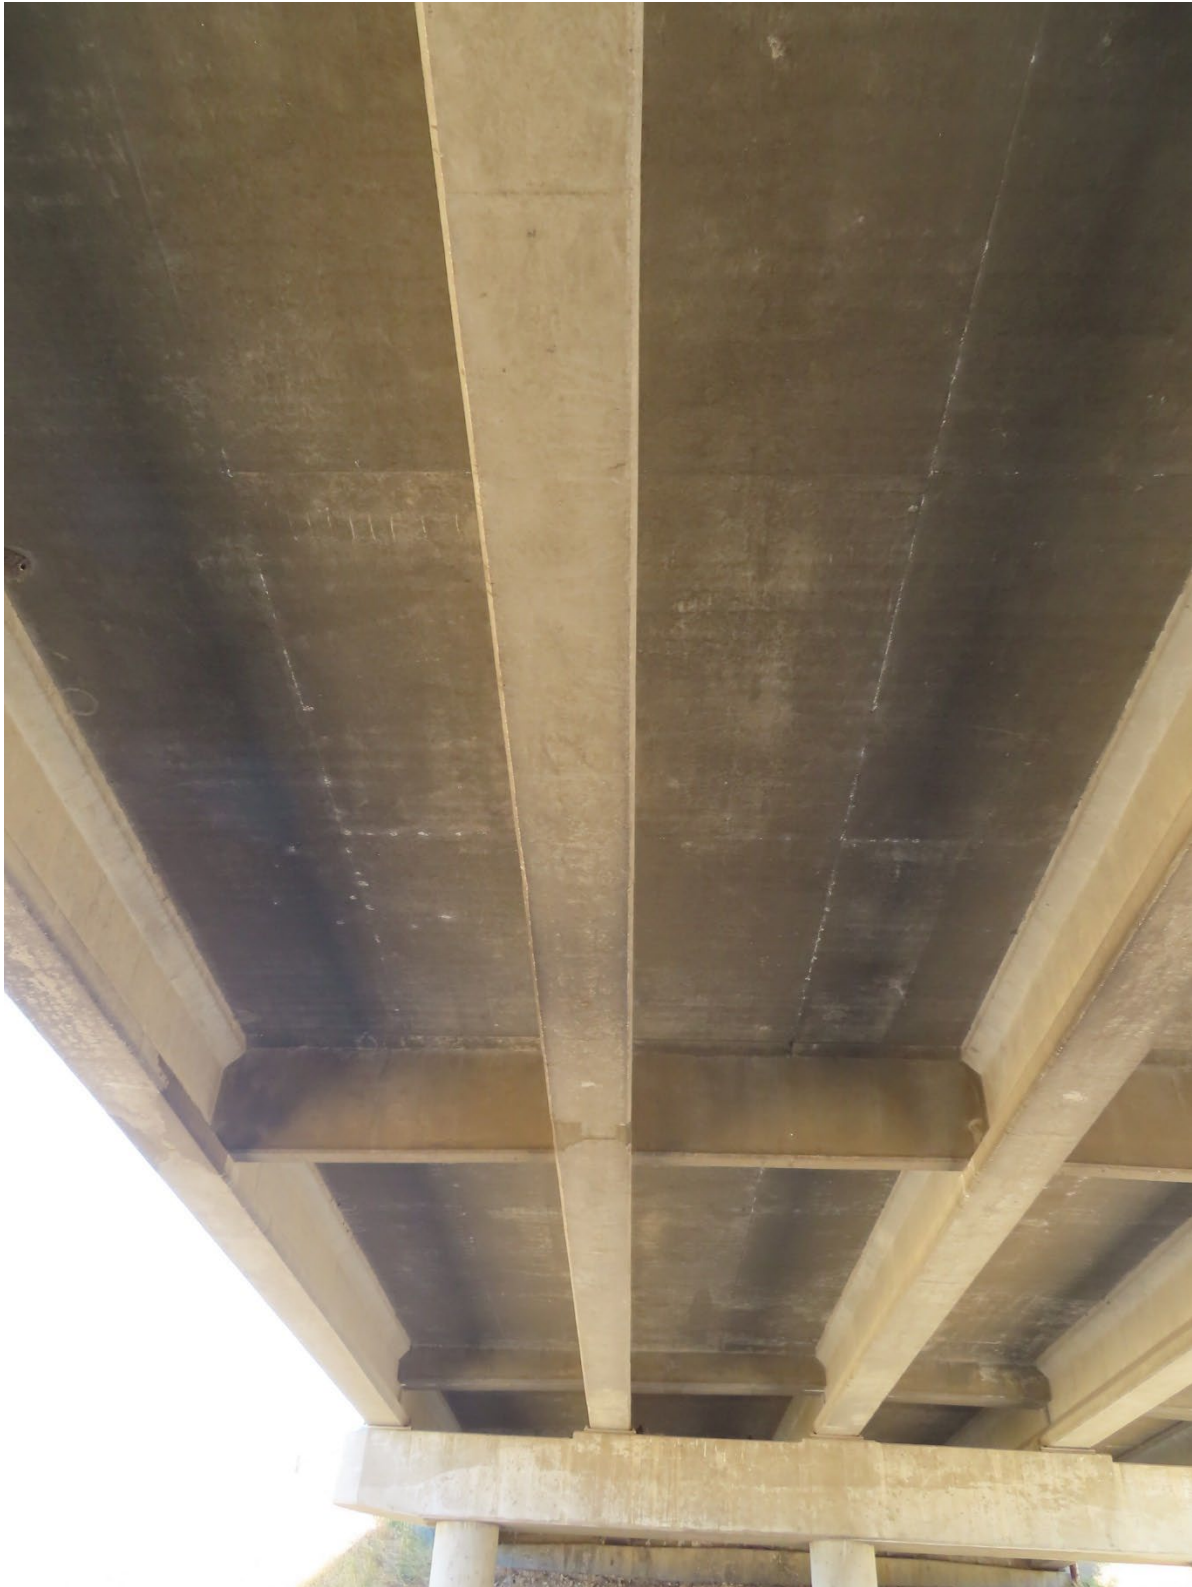
Figure 16. Image showing the typical conditions of the soffit of Bridge 1670 in 2020. Small amounts of efflorescence were present.

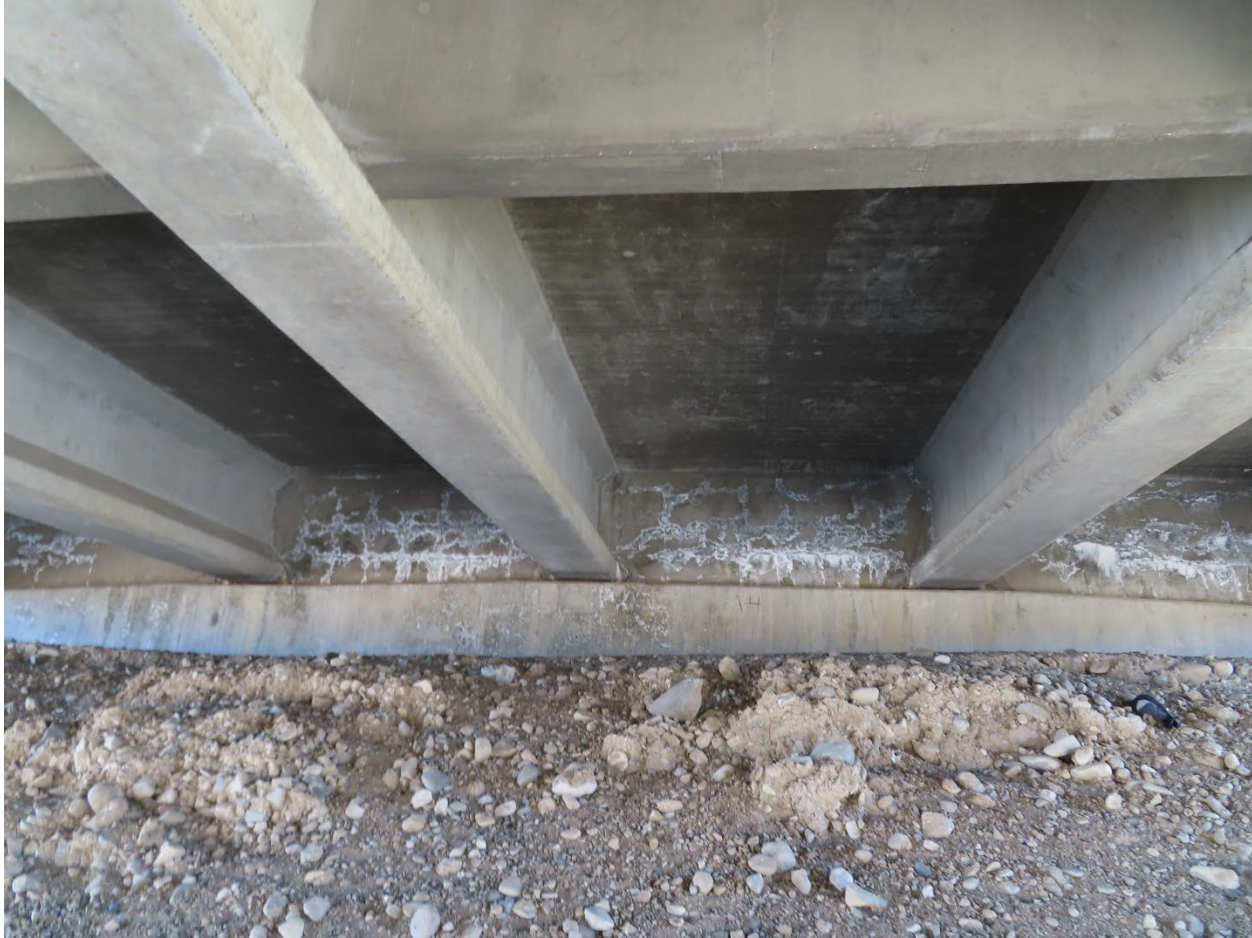
Figure 17. Photograph showing moisture efflorescence, cracking, and distress on the abutments of Bridge 1670 as of 2020.

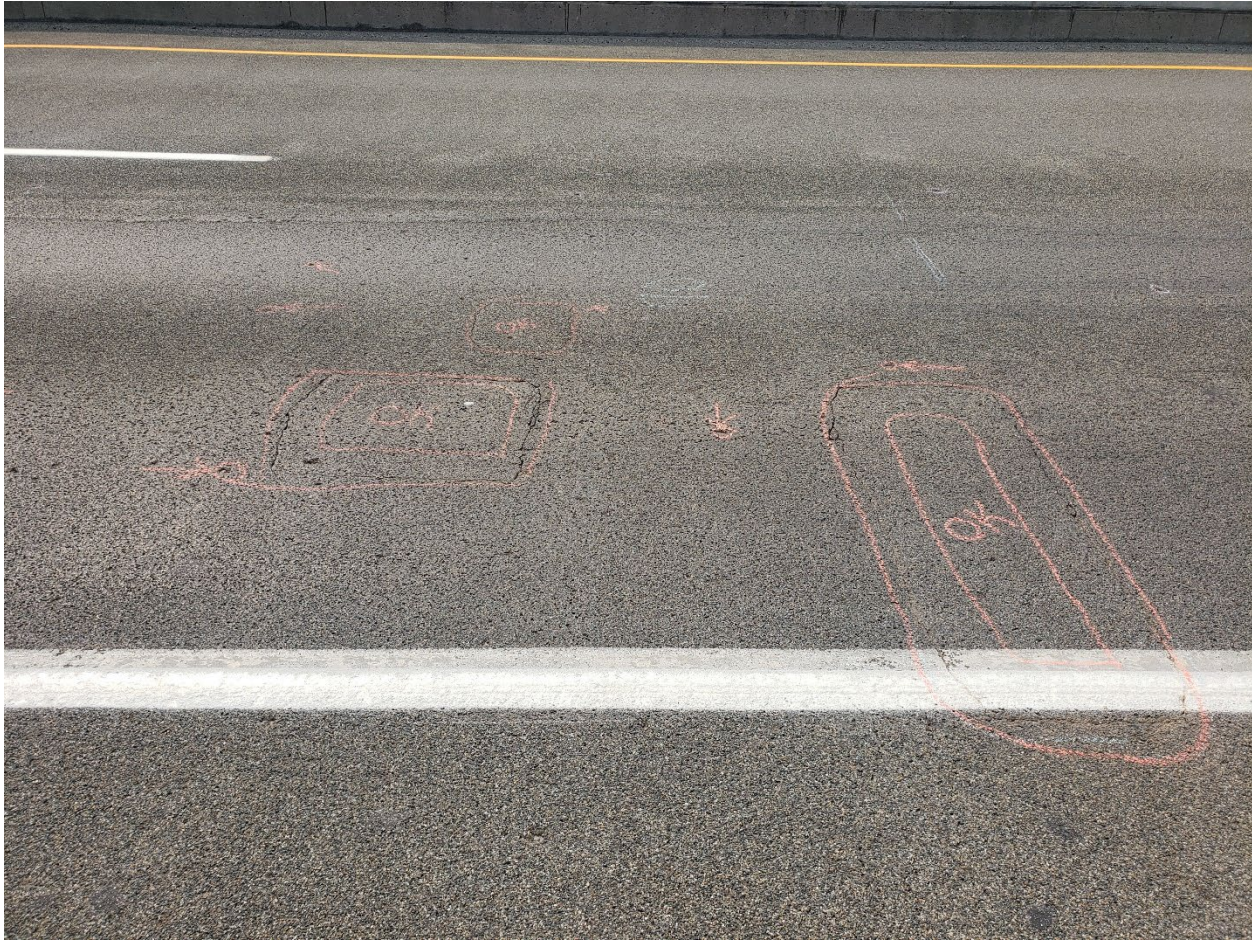
Figure 18. Photograph from 2022 inspection of Bridge 1670 showing delaminations around repair patches' edges that had reflective cracking previously. The centers of the patches remained sound.

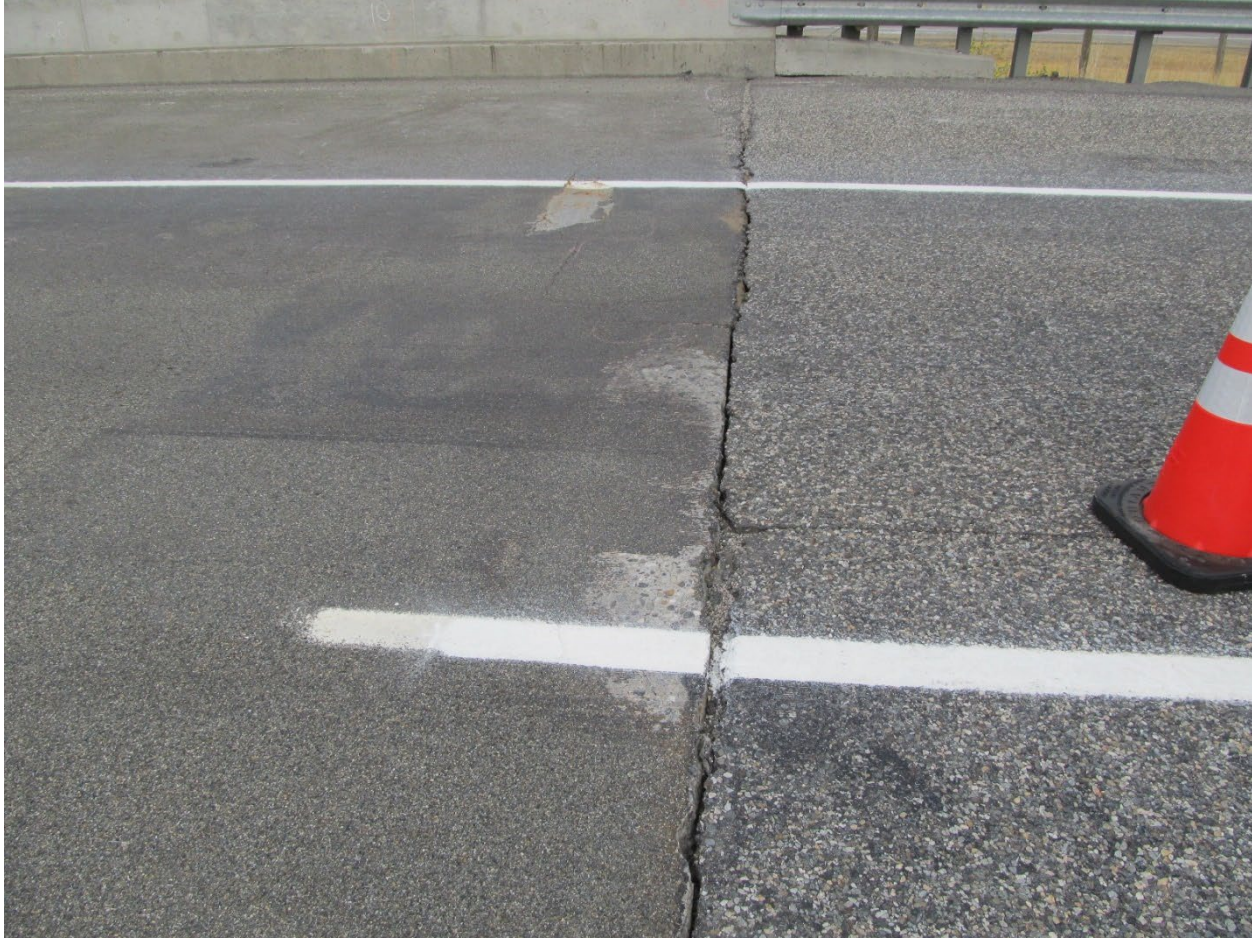
Figure 19. Photograph of snow plow damage and gouging at the entrance joint onto Bridge 1670 in the 2022 inspection.

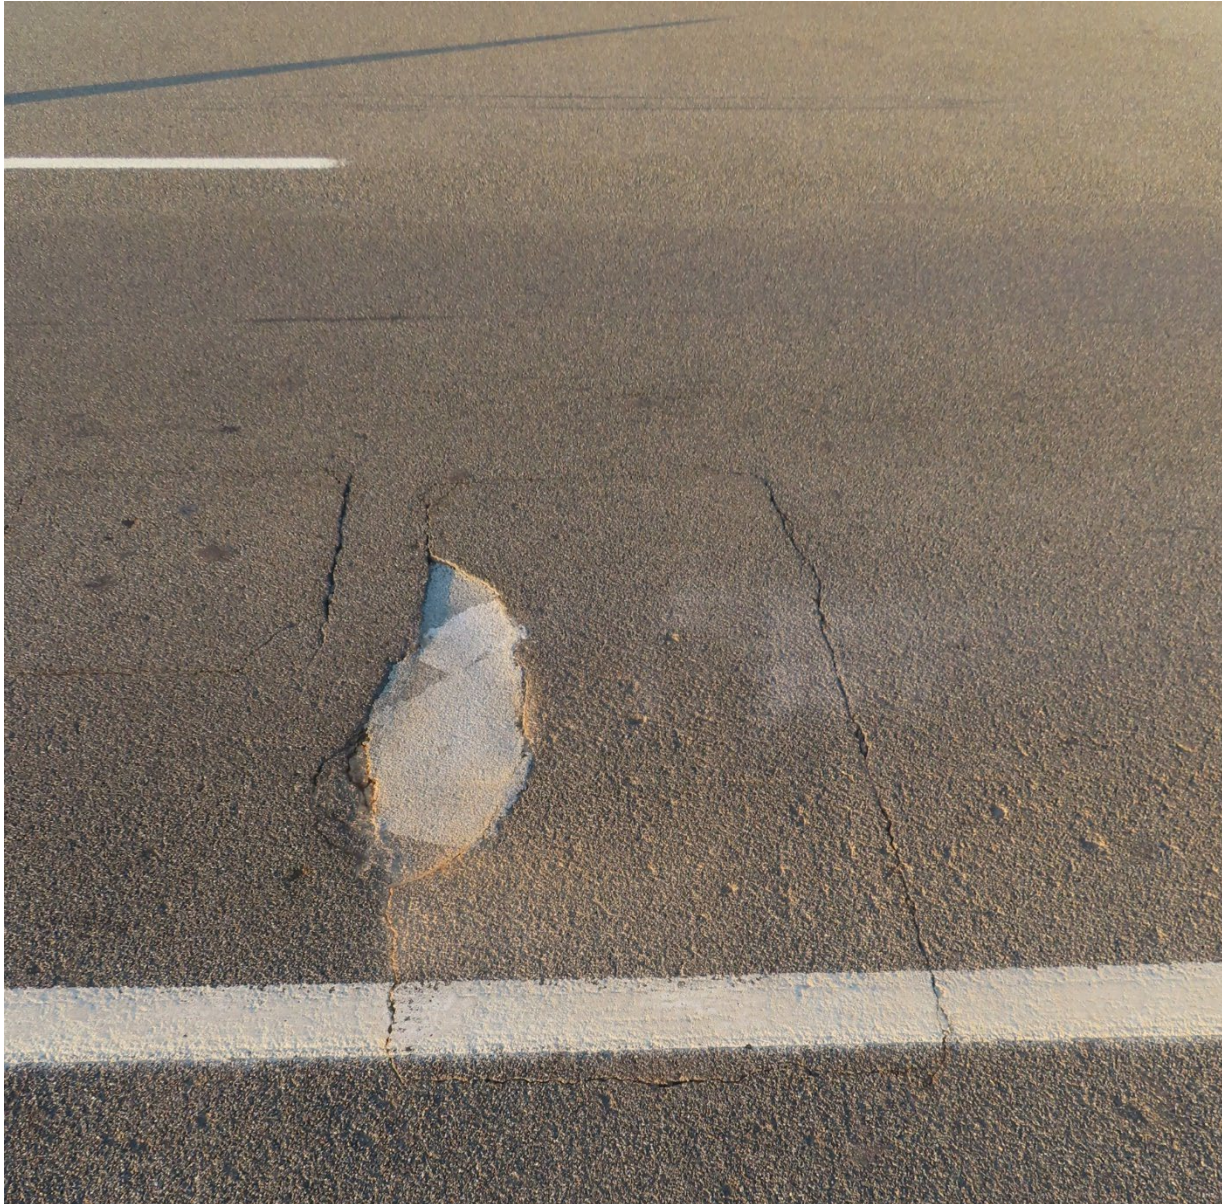
Figure 22. Photograph of reflective cracking and spalling of deck repairs and HFST on Bridge 1682 in 2020.

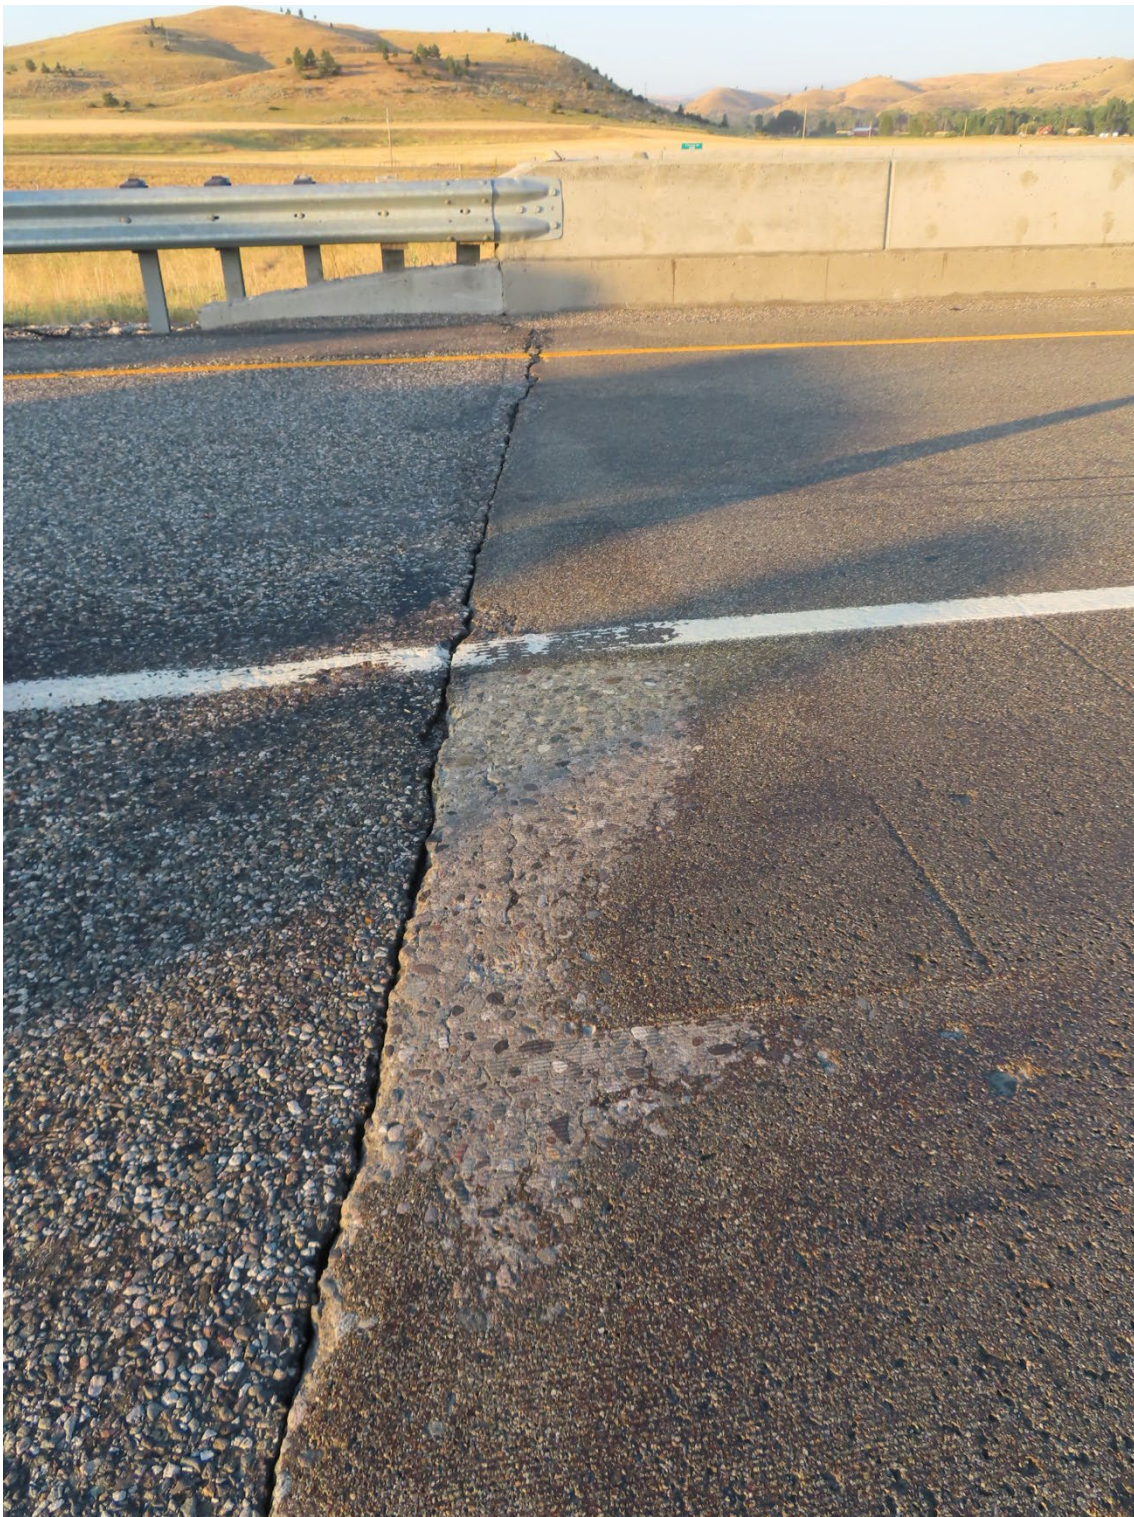
Figure 23. Abrasion/impact damage of the HFST at the leading approach edge of the HFST on Bridge 1682 in 2020.

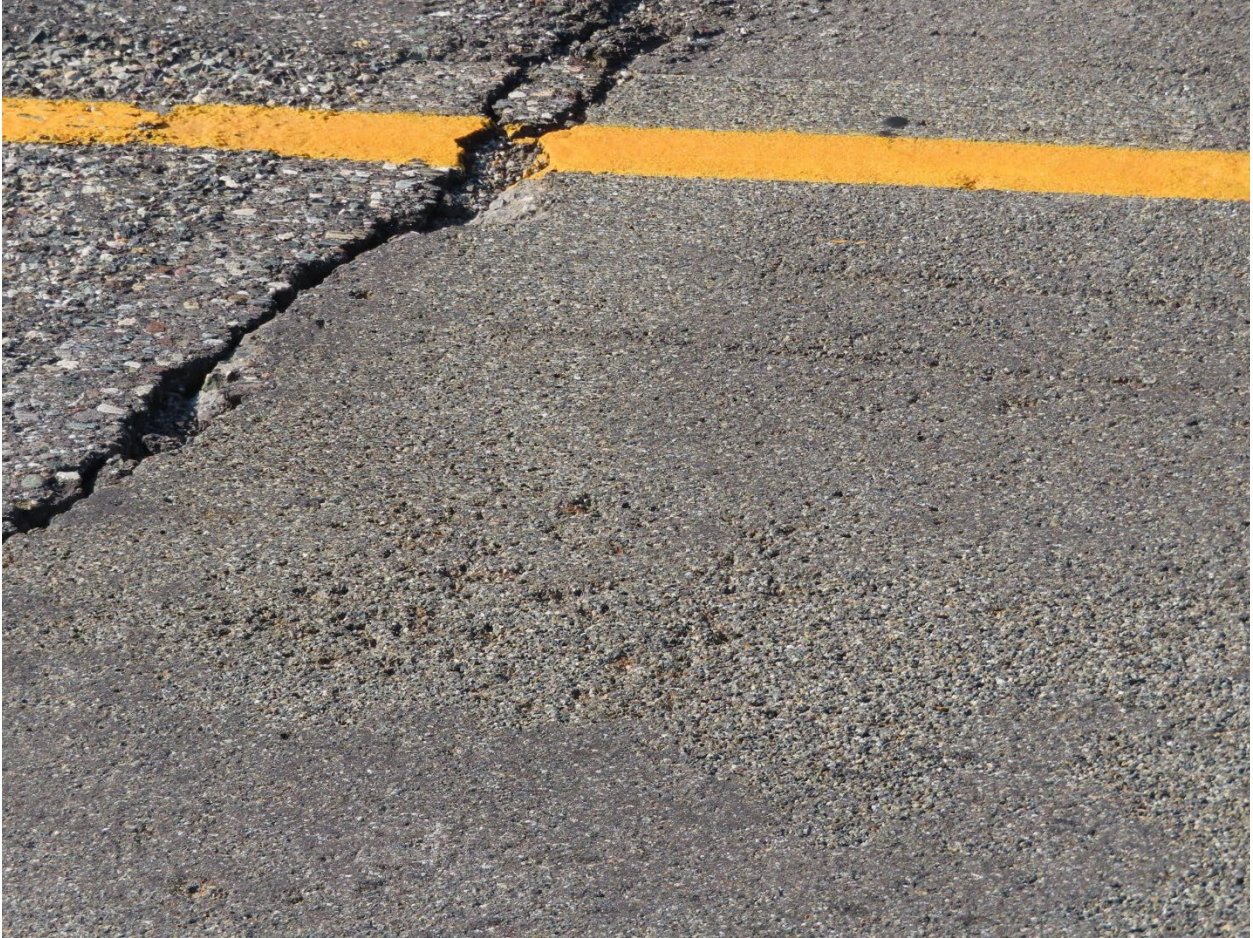
Figure 24. Area of overlay raveling and pockmarking in the HFST at Bridge 1682 in 2020.

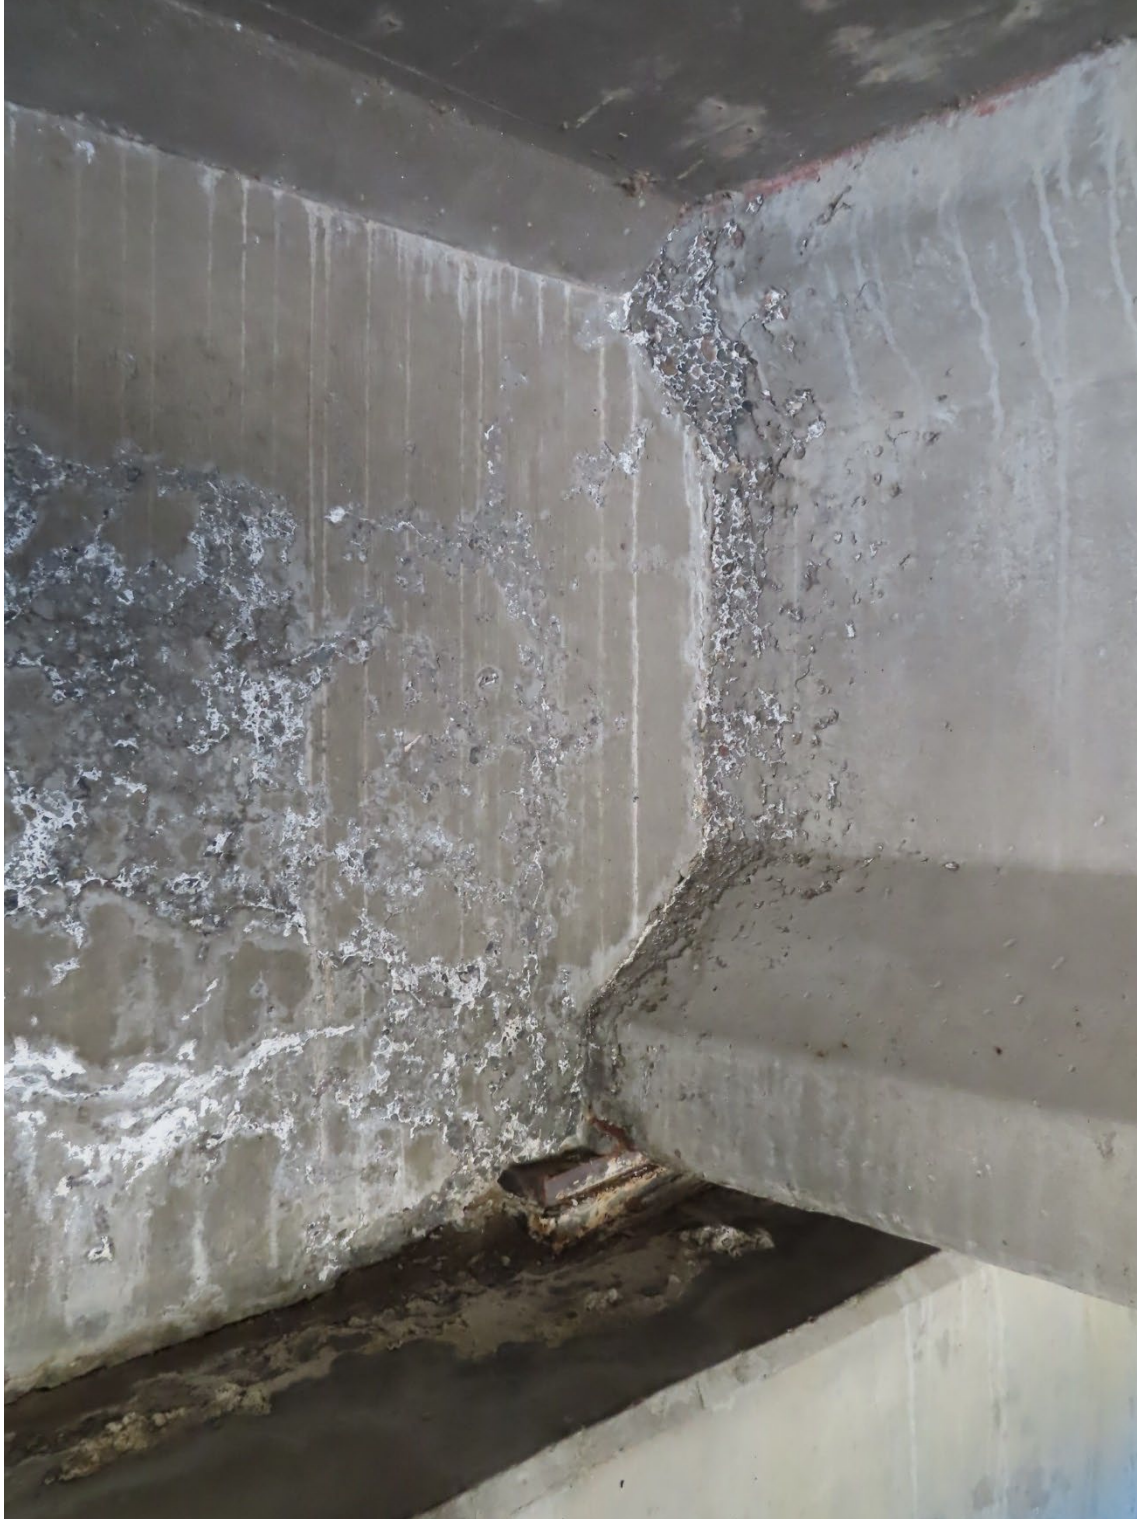
Figure 25. Close-up of distress on abutment and girder end at Bridge 1682 in 2020 suggesting significant moisture and deicer exposure.

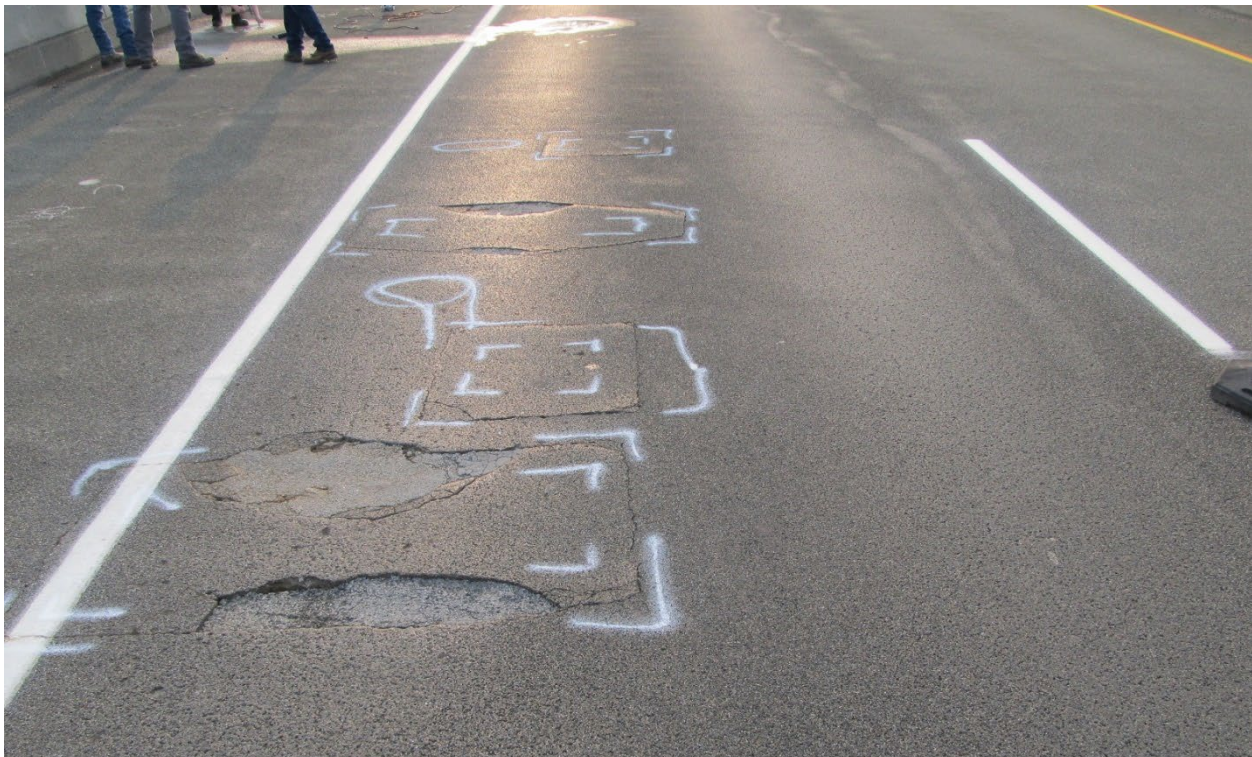
Figure 26. Reflective cracking, delaminations, and spalls around patch repairs in driving lane of Bridge 1682 in 2022.

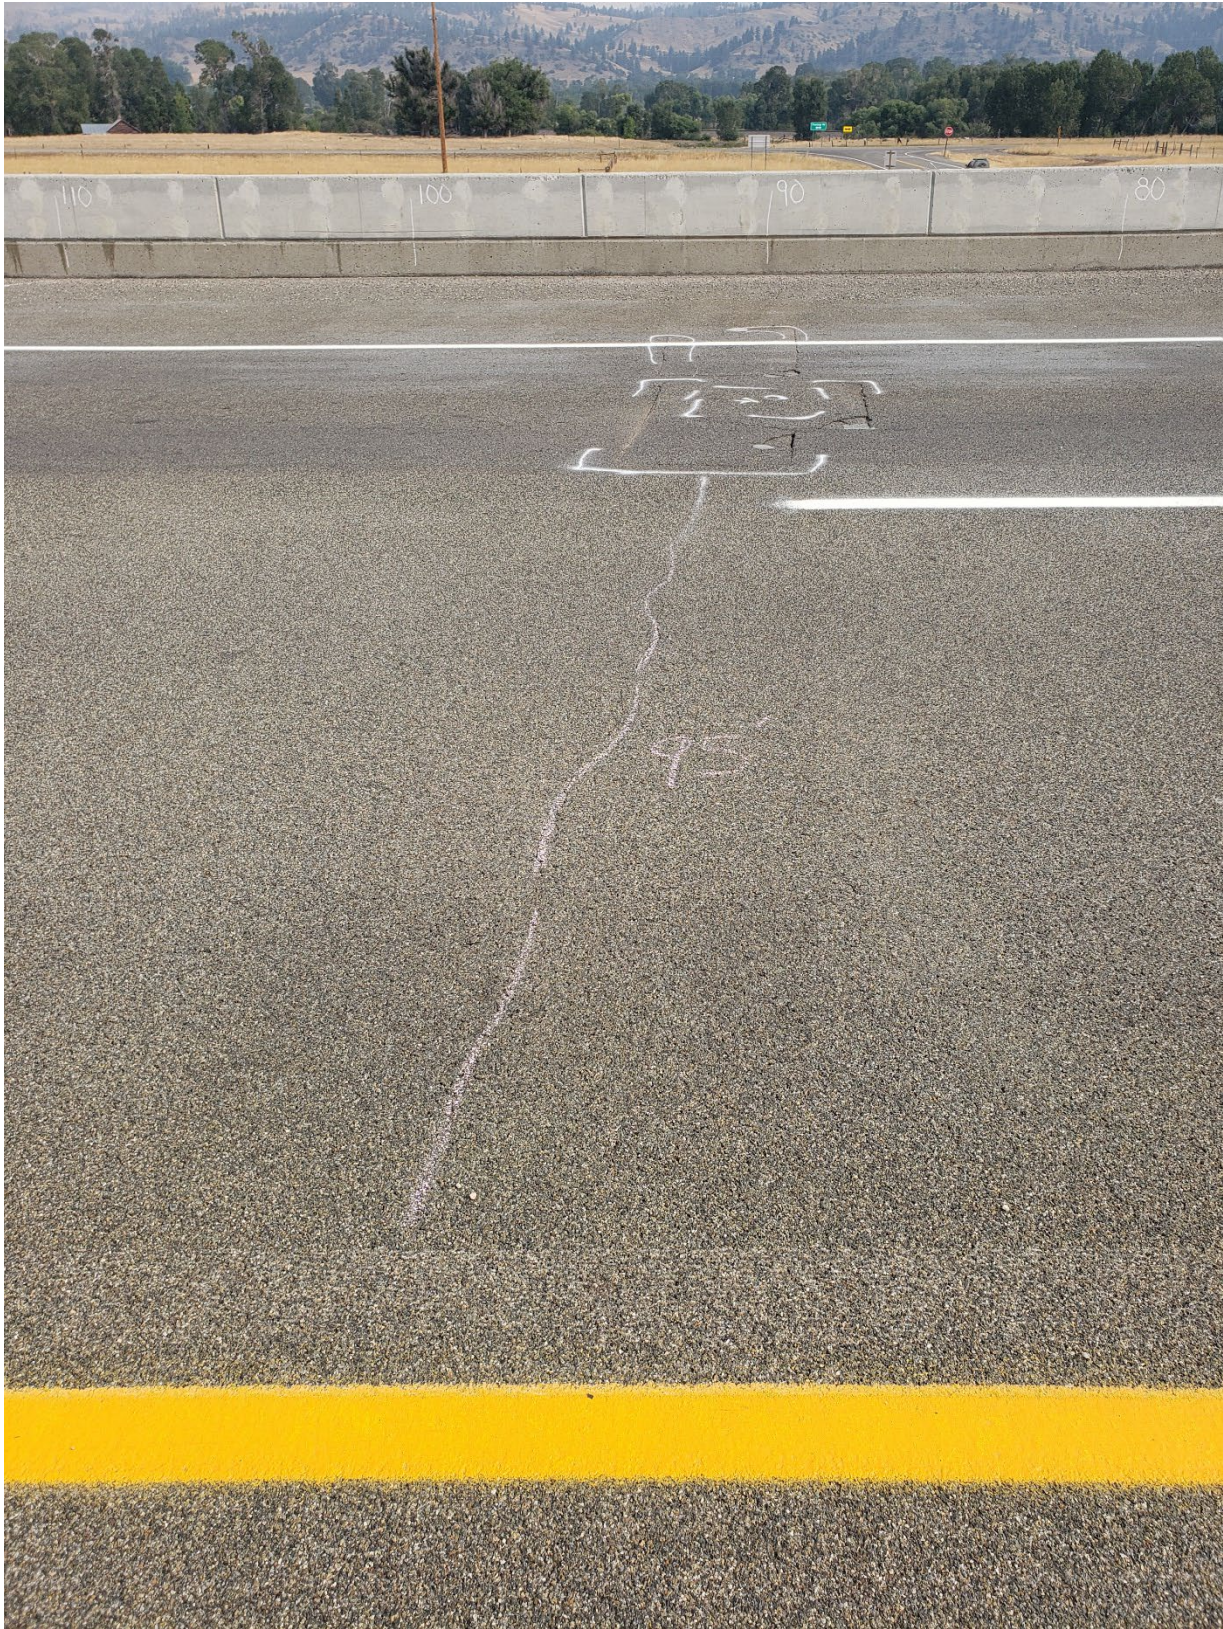
Figure 27. Transverse crack near bent in Bridge 1682 in 2022.

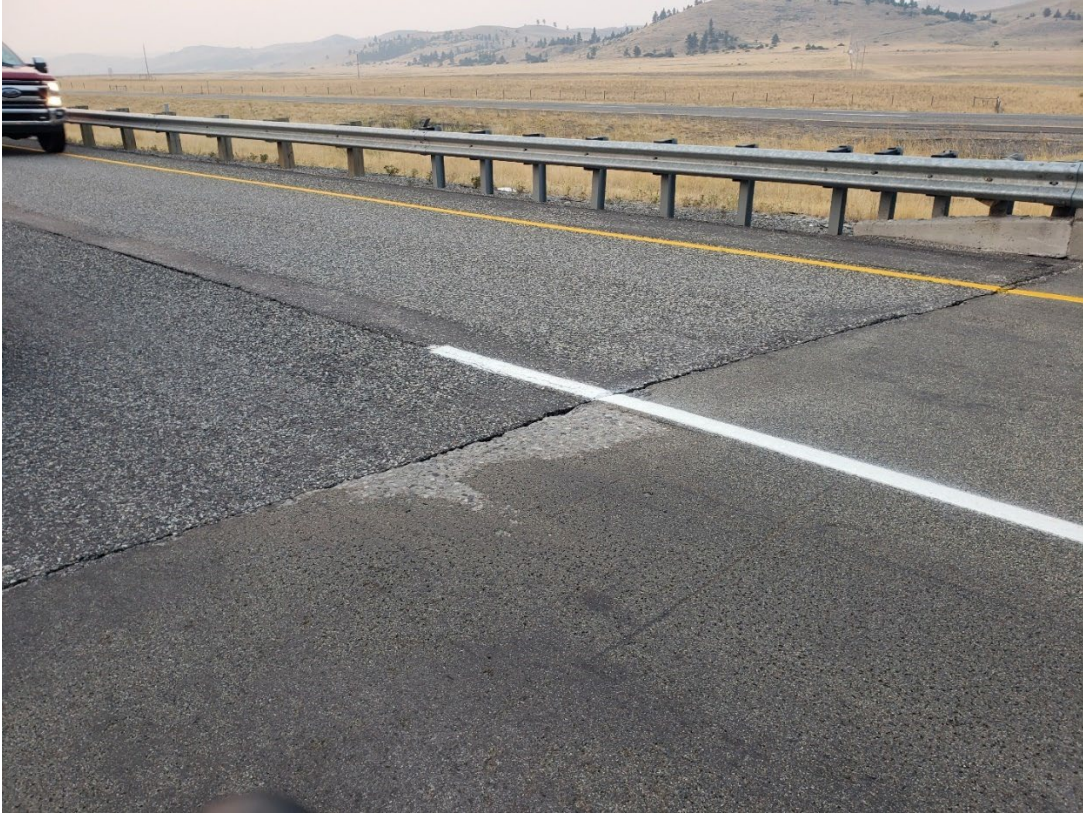
Figure 28. Area on leading edge of Bridge 1682 in 2022 where HFST was fully worn away.
