EVALUATION OF THIN POLYMER OVERLAYS FOR BRIDGE DECKS

FHWA/MT-23-006/9757-705

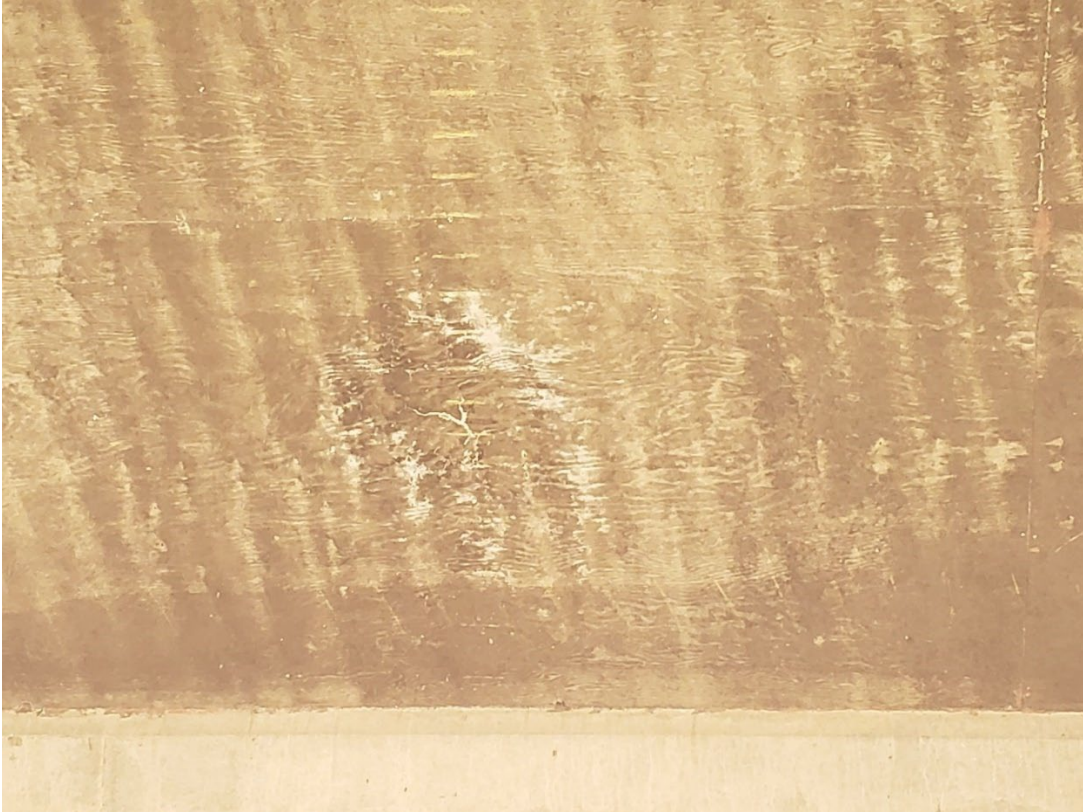
Figure 29. Area with a short, efflorescing crack on the soffit of Bridge 1682 in 2022.

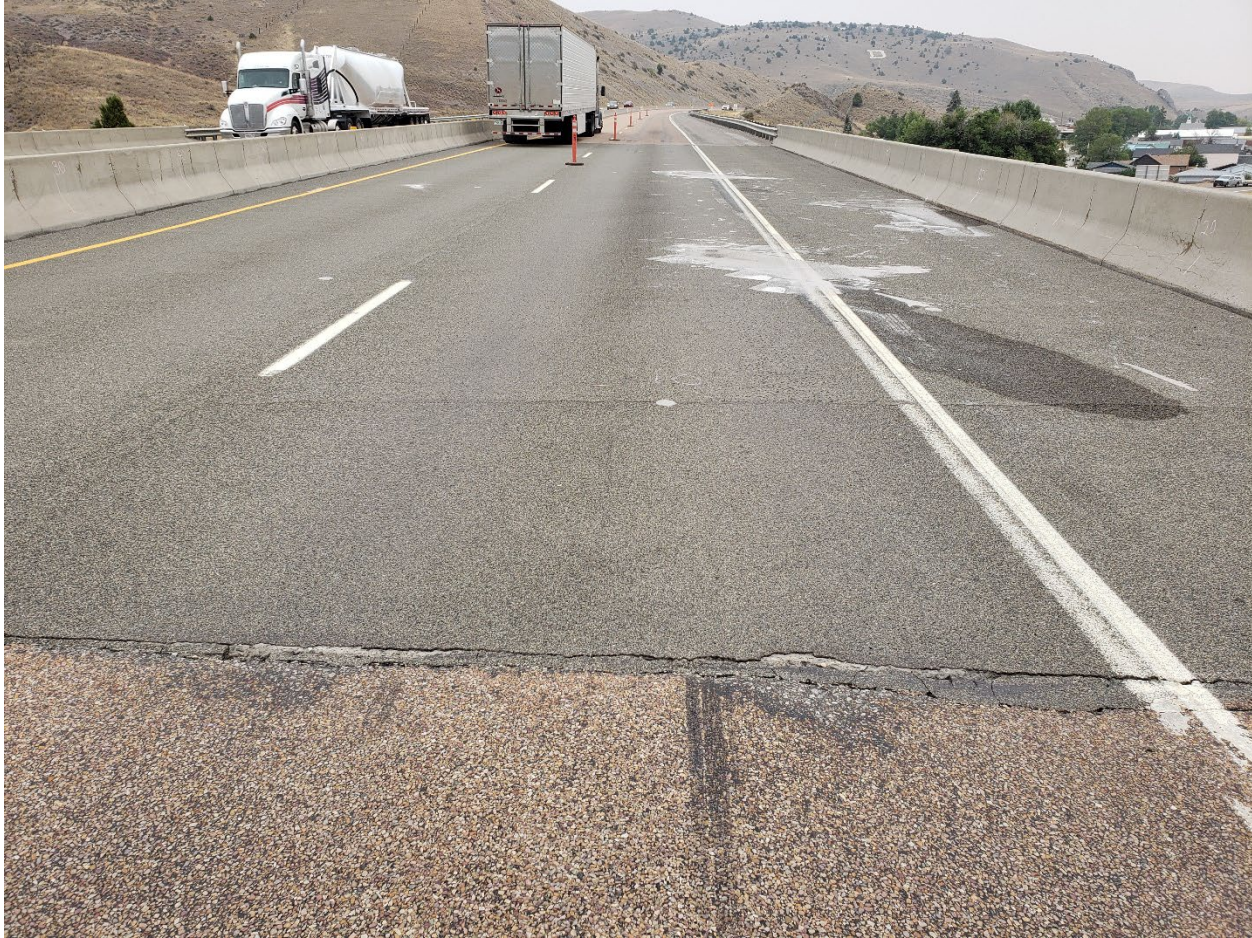
Figure 31. Overview of HFST on Bridge 1459 in 2022 (staining due to recent coring).

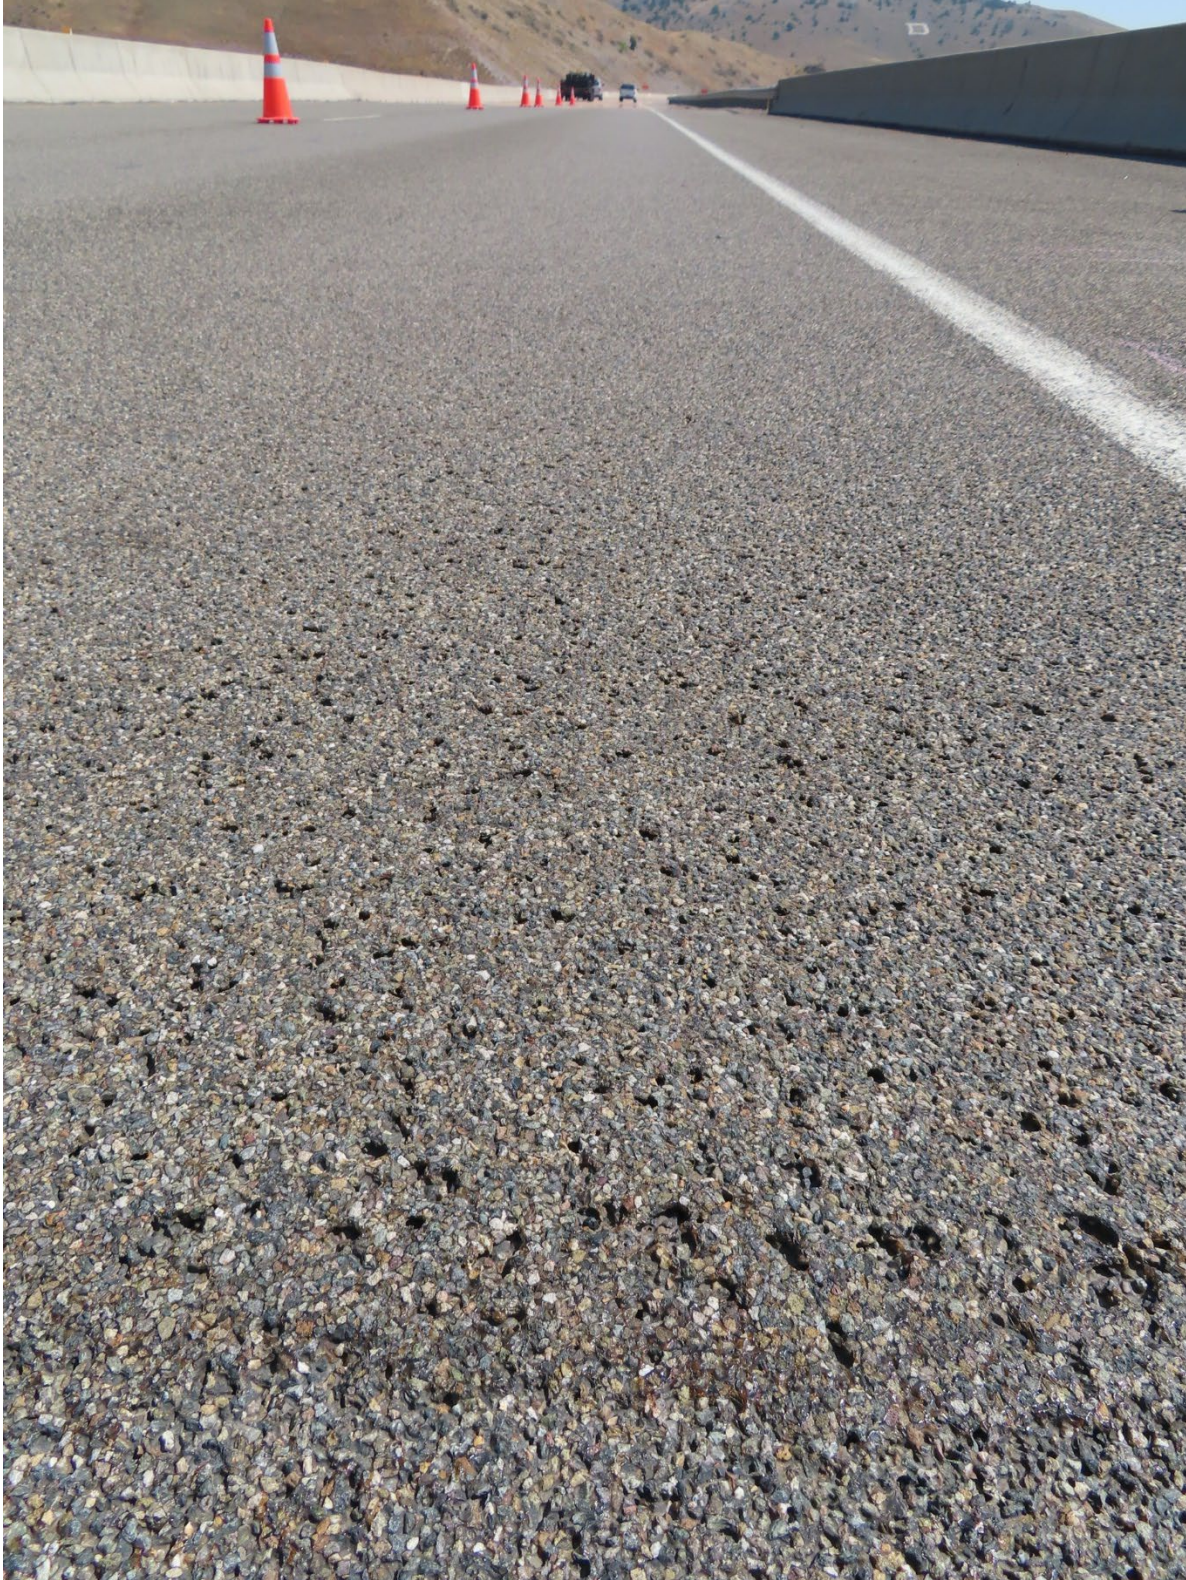
Figure 32. Photograph showing aggregate loss in the driving lane of Bridge 1459 in 2020.

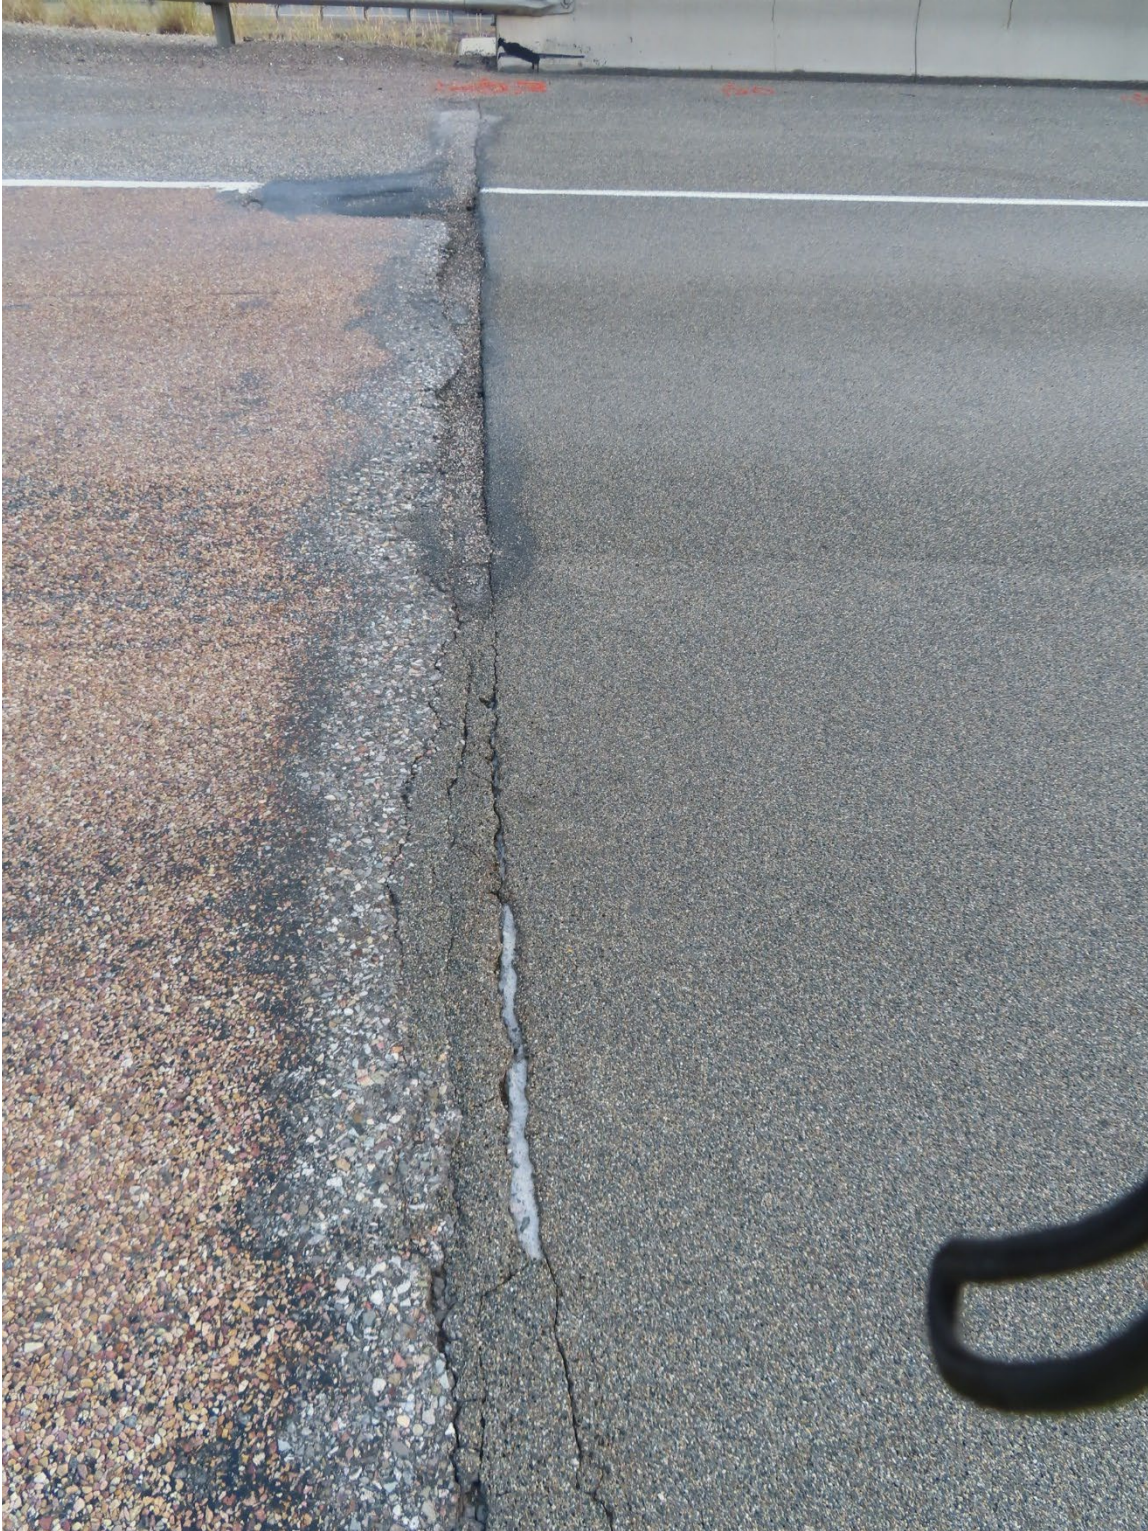
Figure 33. Cracking and spalling of the HFST at the end of Bridge 1459 in 2020.

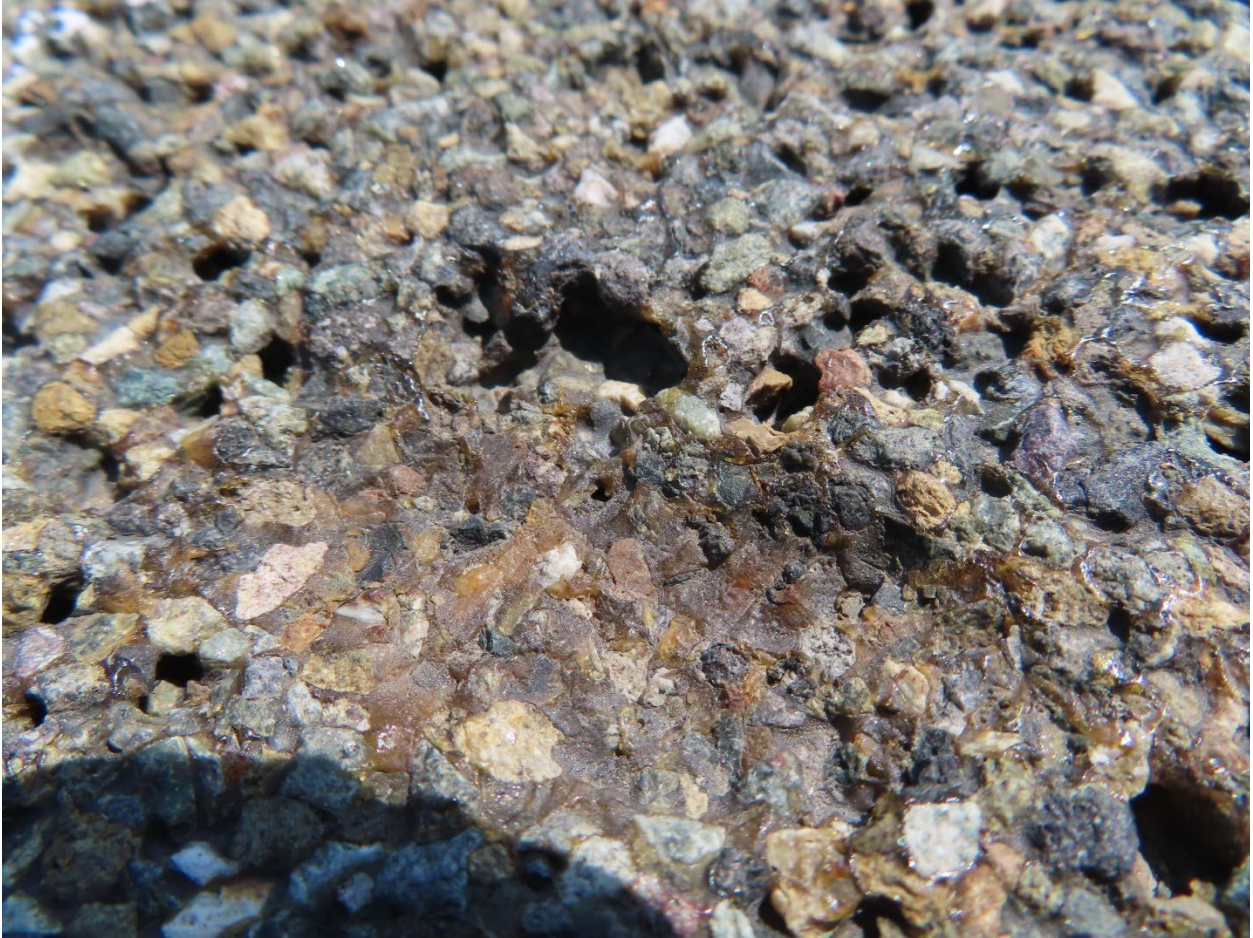
Figure 34. Close-up of the gouged area (likely plow damage) in the HFST of Bridge 1459 in 2020.

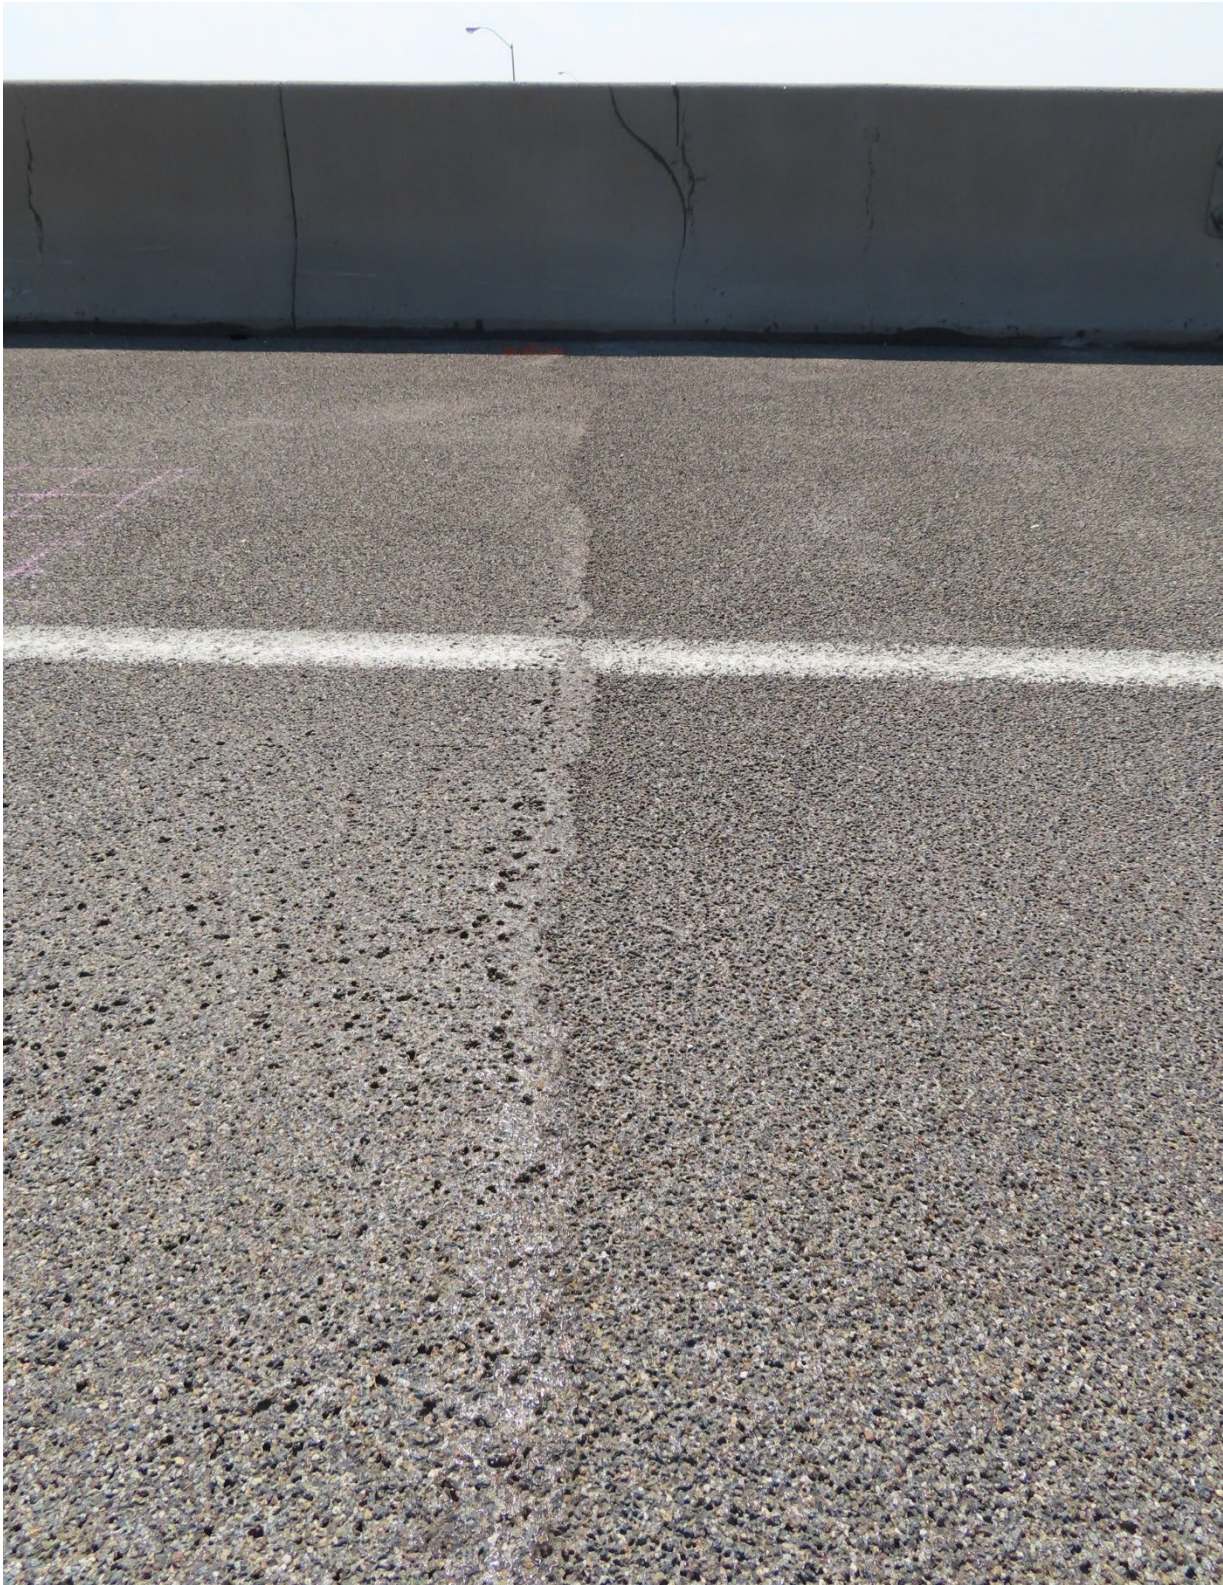
Figure 35. Close-up of the construction lap in the overlay of Bridge 1459 showing a clear difference in wear and texture in 2020.

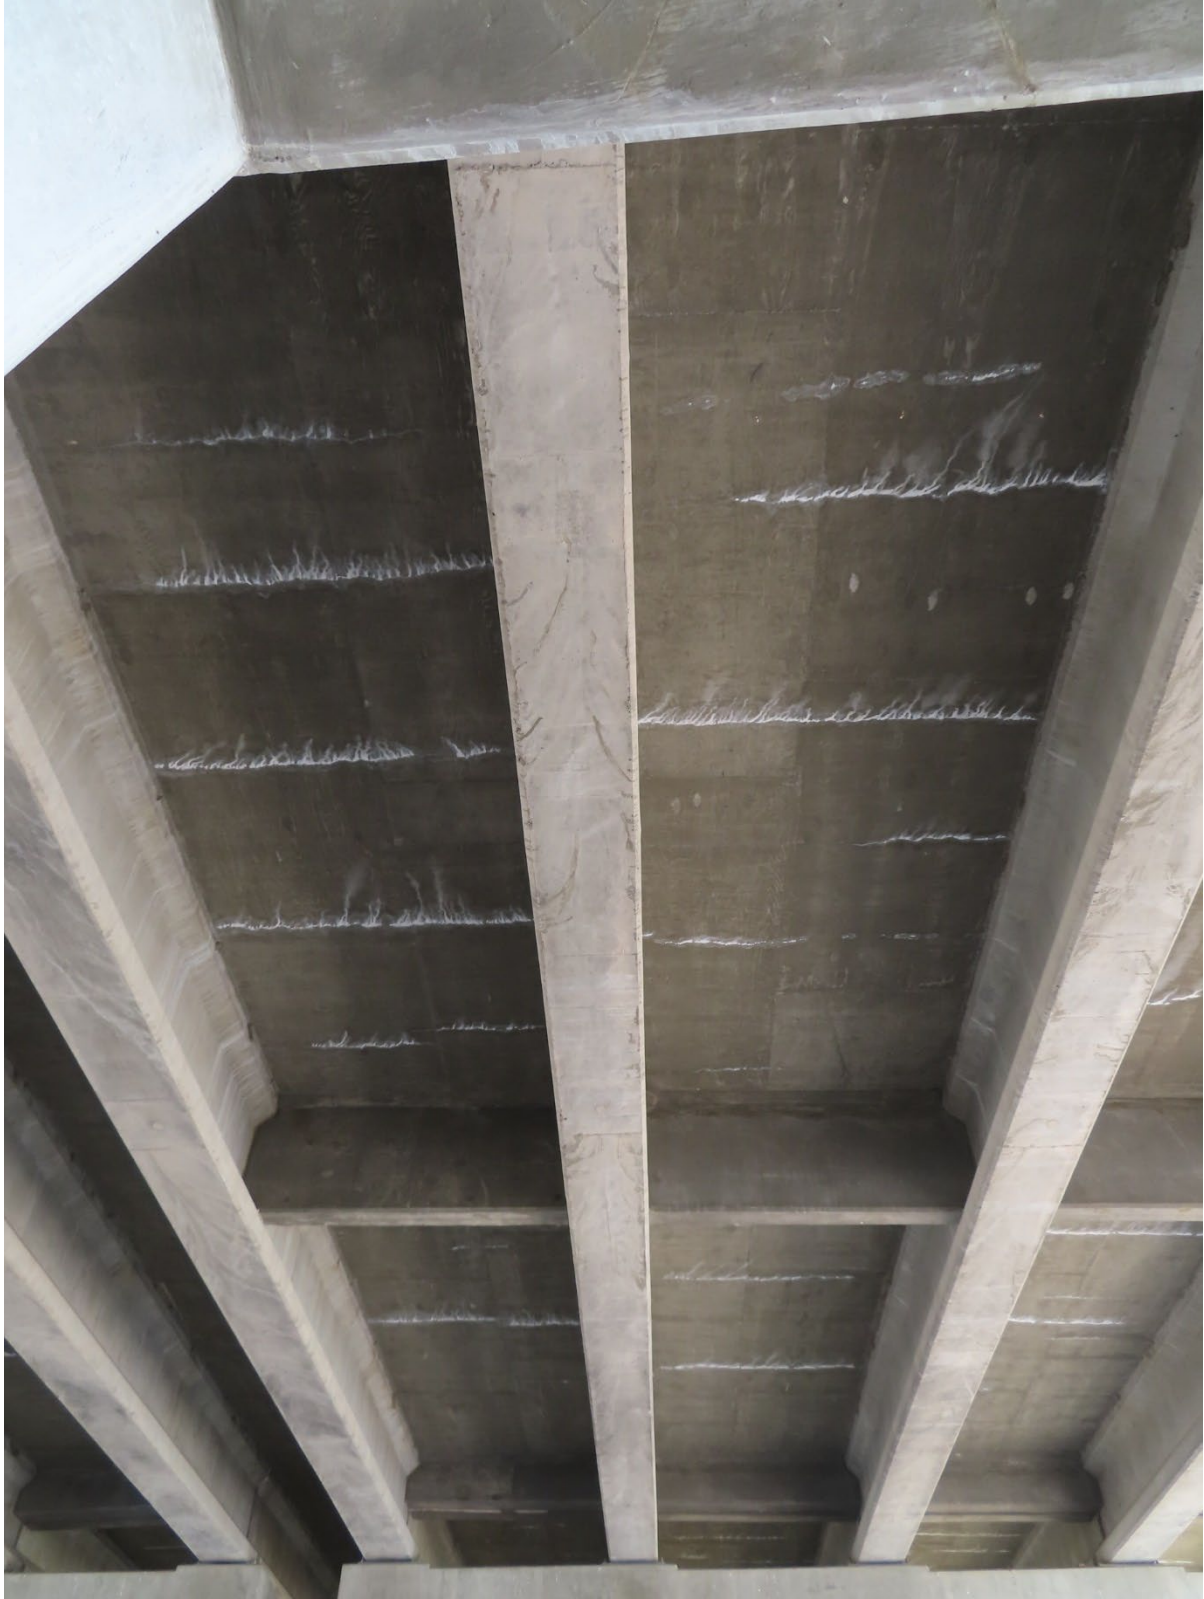
Figure 36. Photograph showing transverse cracking and efflorescence on the deck soffit of Bridge 1459 in 2020.

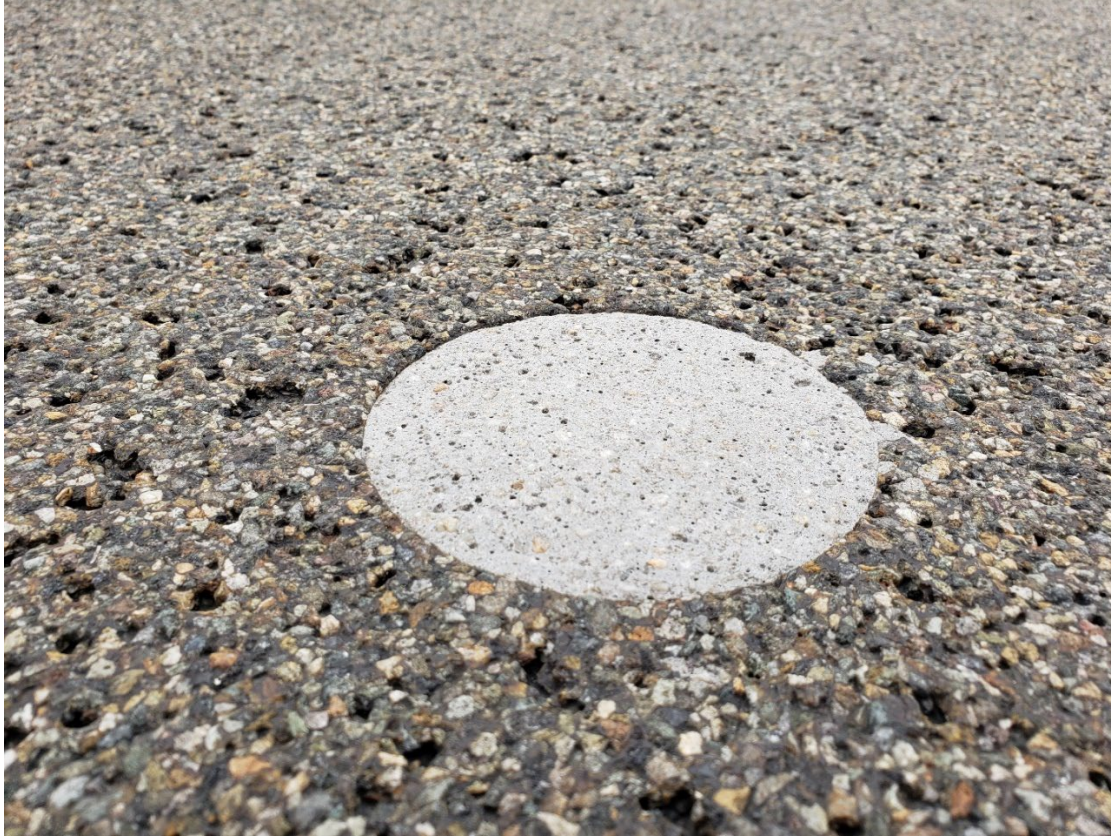
Figure 37. Close-up of the wearing surface in one of the wheel paths of the driving lane of Bridge 1459 in 2022 at prior core hole location. Polymer concrete is holding up well.

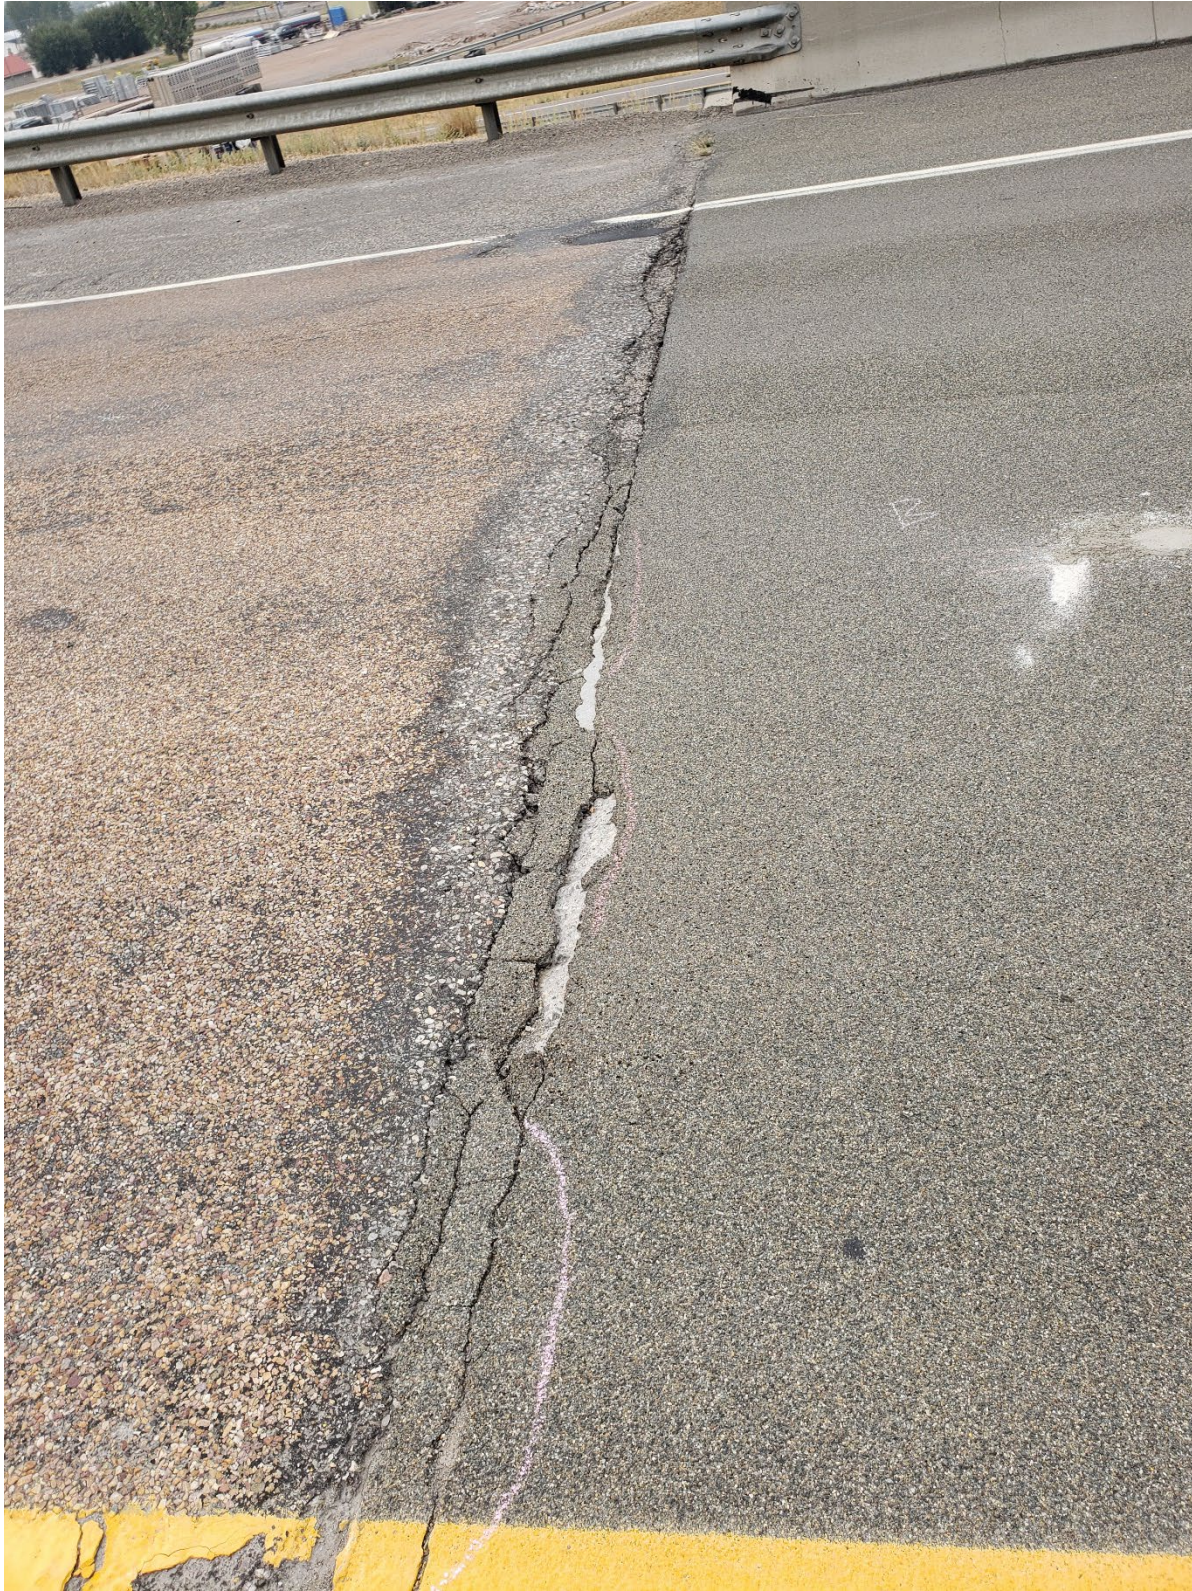
Figure 38. Cracking, spalling, and delamination of the HFST along the end of Bridge 1459 in 2022. Note this is the same joint as that shown in Figure 33 from 2020.

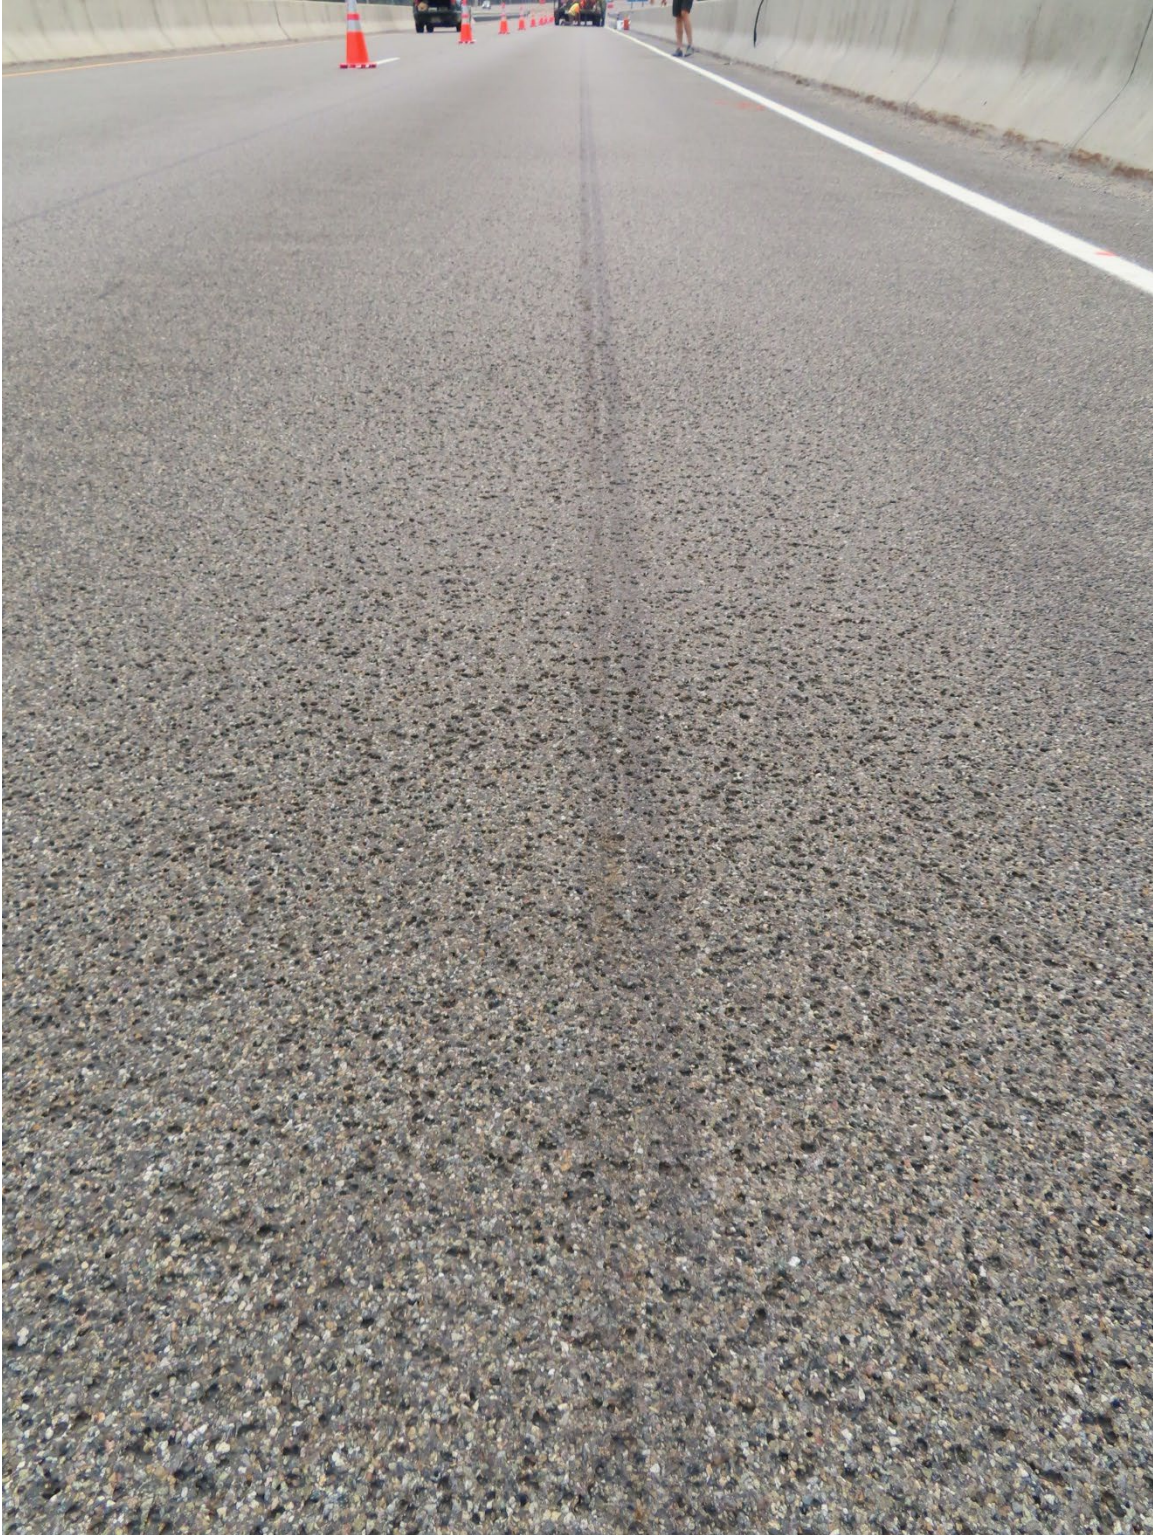
Figure 41. Photograph showing aggregate loss and polishing of the HFST in the driving lane of Bridge 1367 in 2020.

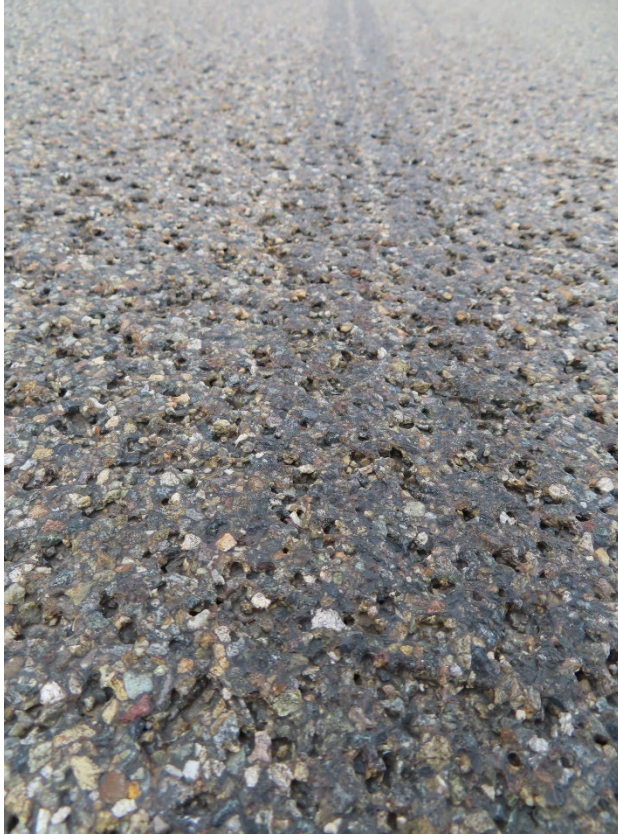
Figure 42. Close-up of overlay pop-out and wear in the driving lane of Bridge 1367 in 2020.

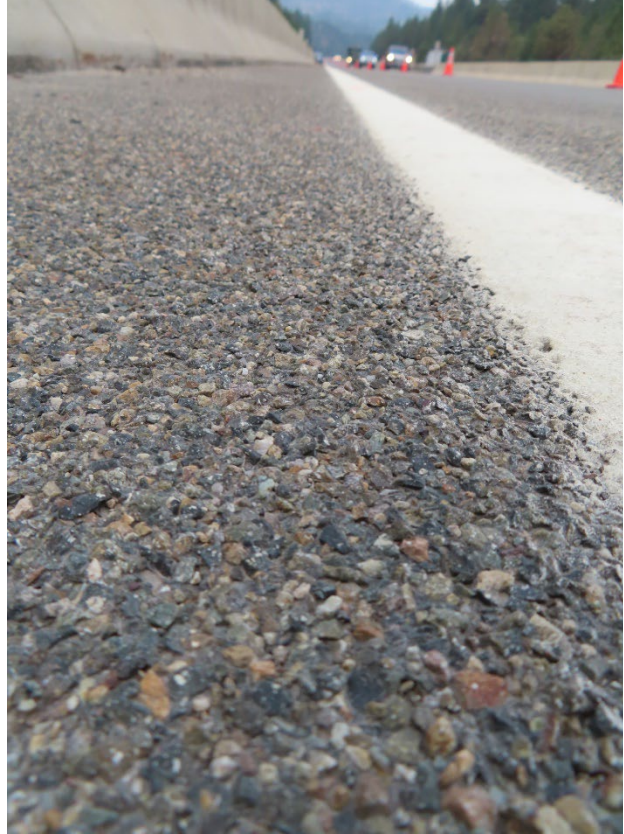
Figure 43. Close-up showing surface roughness and surface aggregates in the shoulder of Bridge 1367 in 2020.

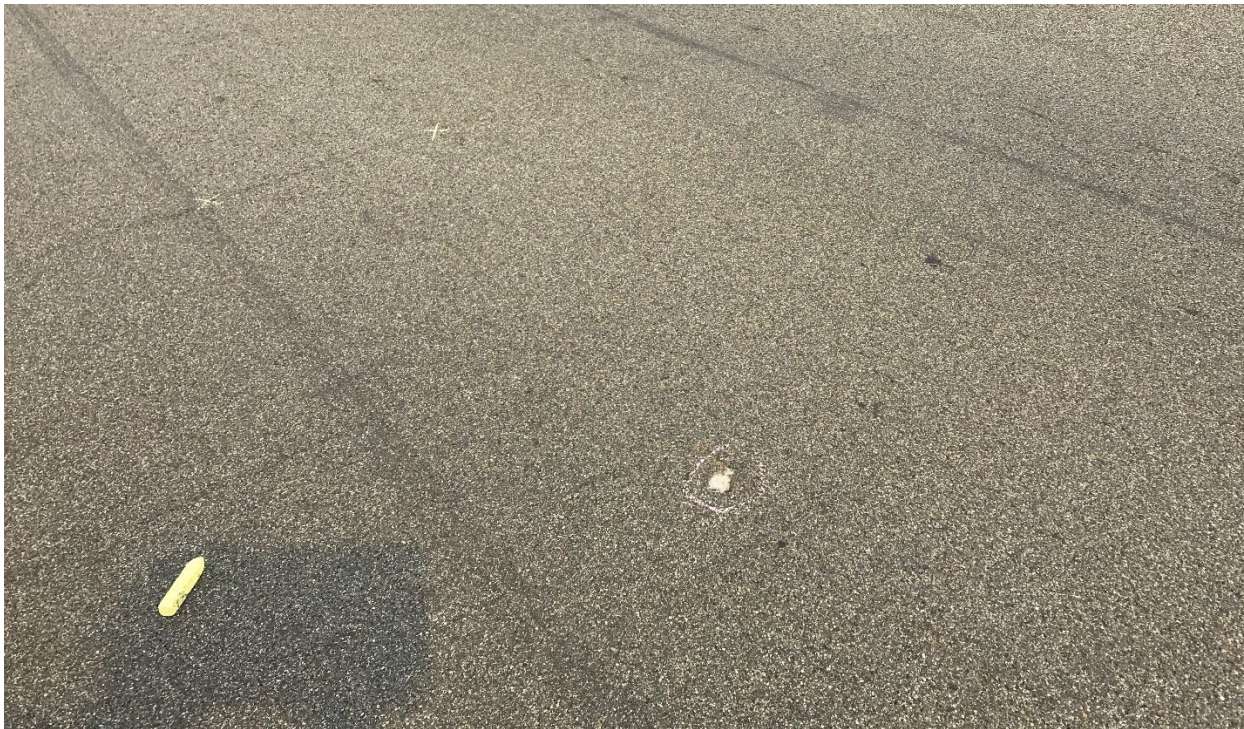
Figure 44. Small spall and transverse cracks in HFST on Bridge 1367 in 2020.

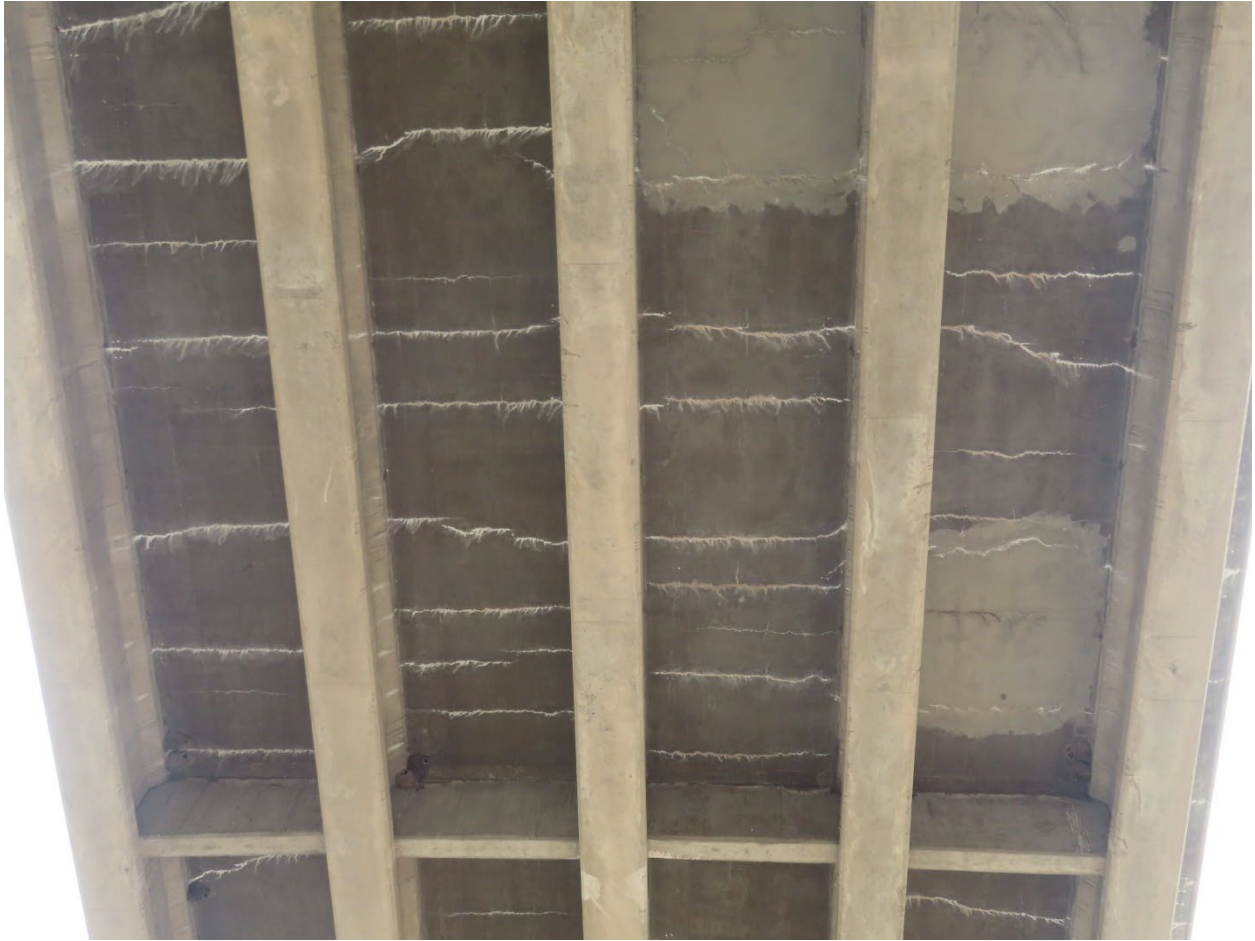
Figure 45. Photograph of soffit of Bridge 1367 in 2020 showing transverse cracks with efflorescence and full-depth repairs.

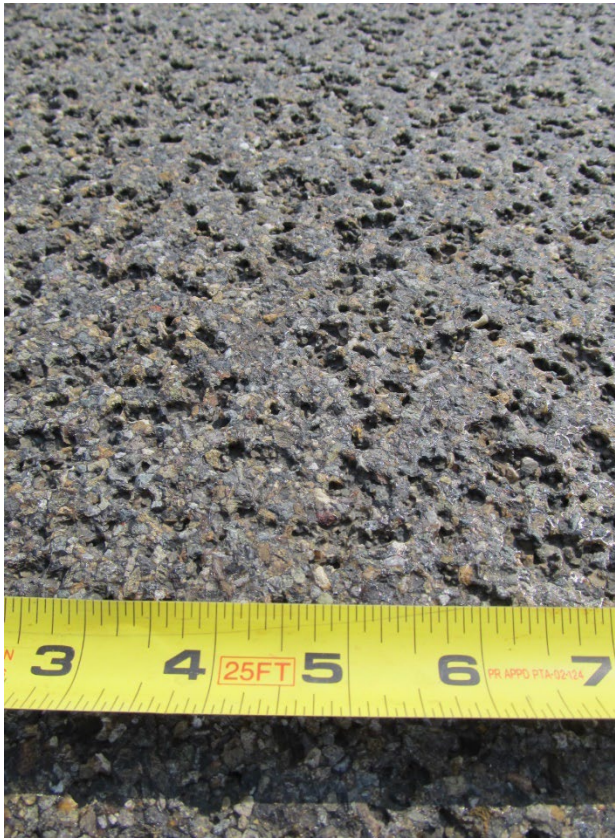
Figure 46. Close-up of wheel path surface on Bridge 1367 in 2022.

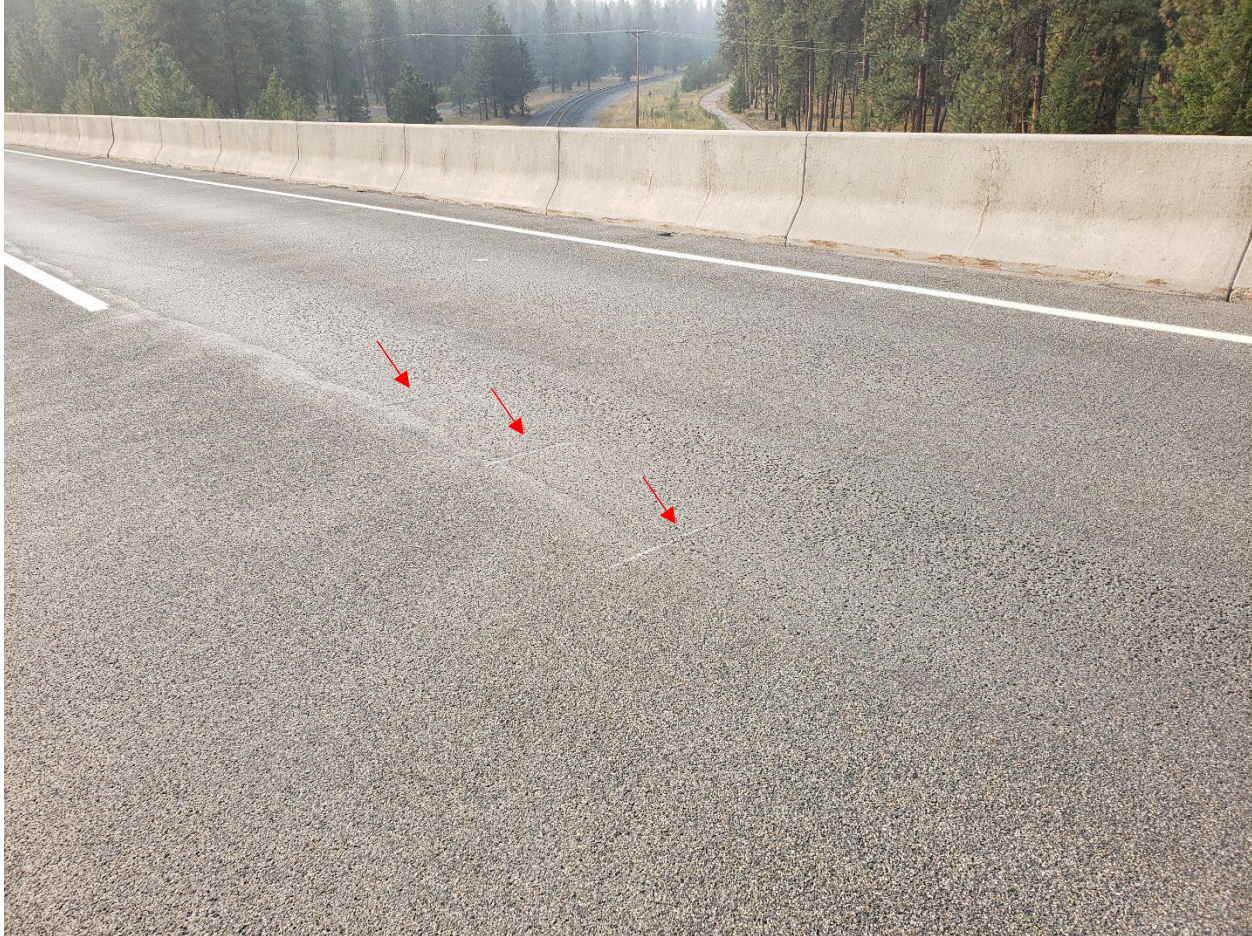
Figure 51. Photograph showing transverse cracking in the driving lane of Bridge 1367 in 2022. Some transverse cracks are identified with red arrows.

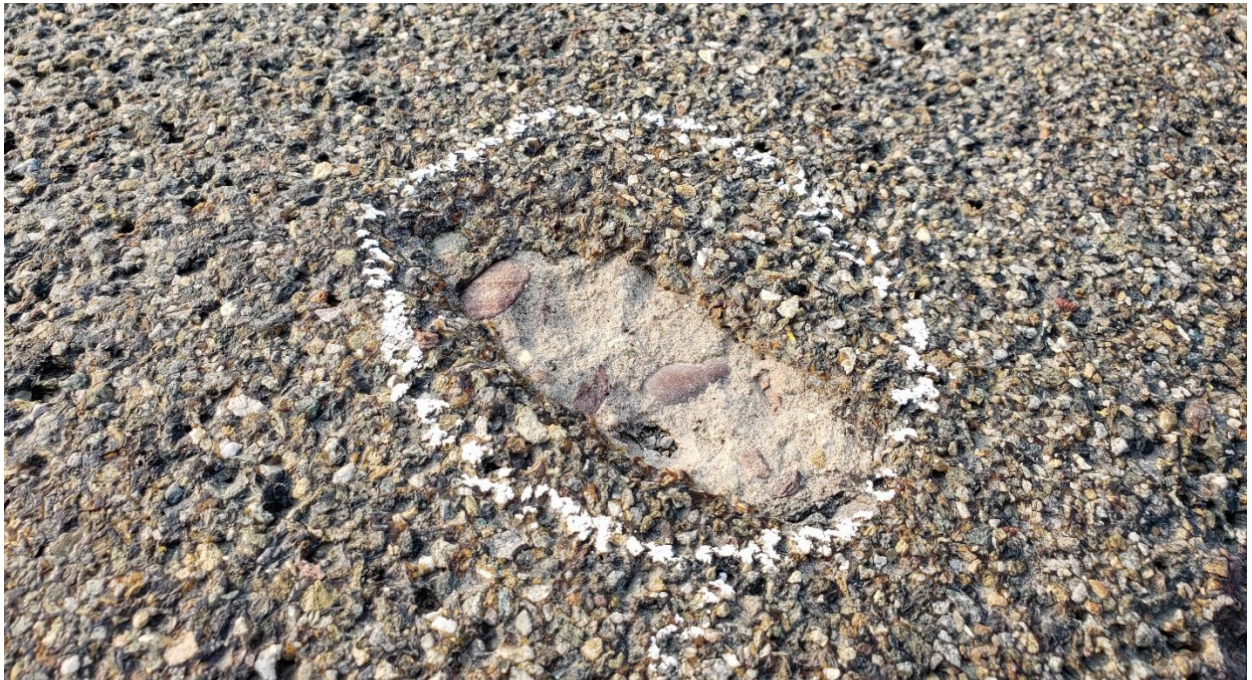
Figure 52. Close-up of small spall (gouge) in HFST of Bridge 1367 in 2022.

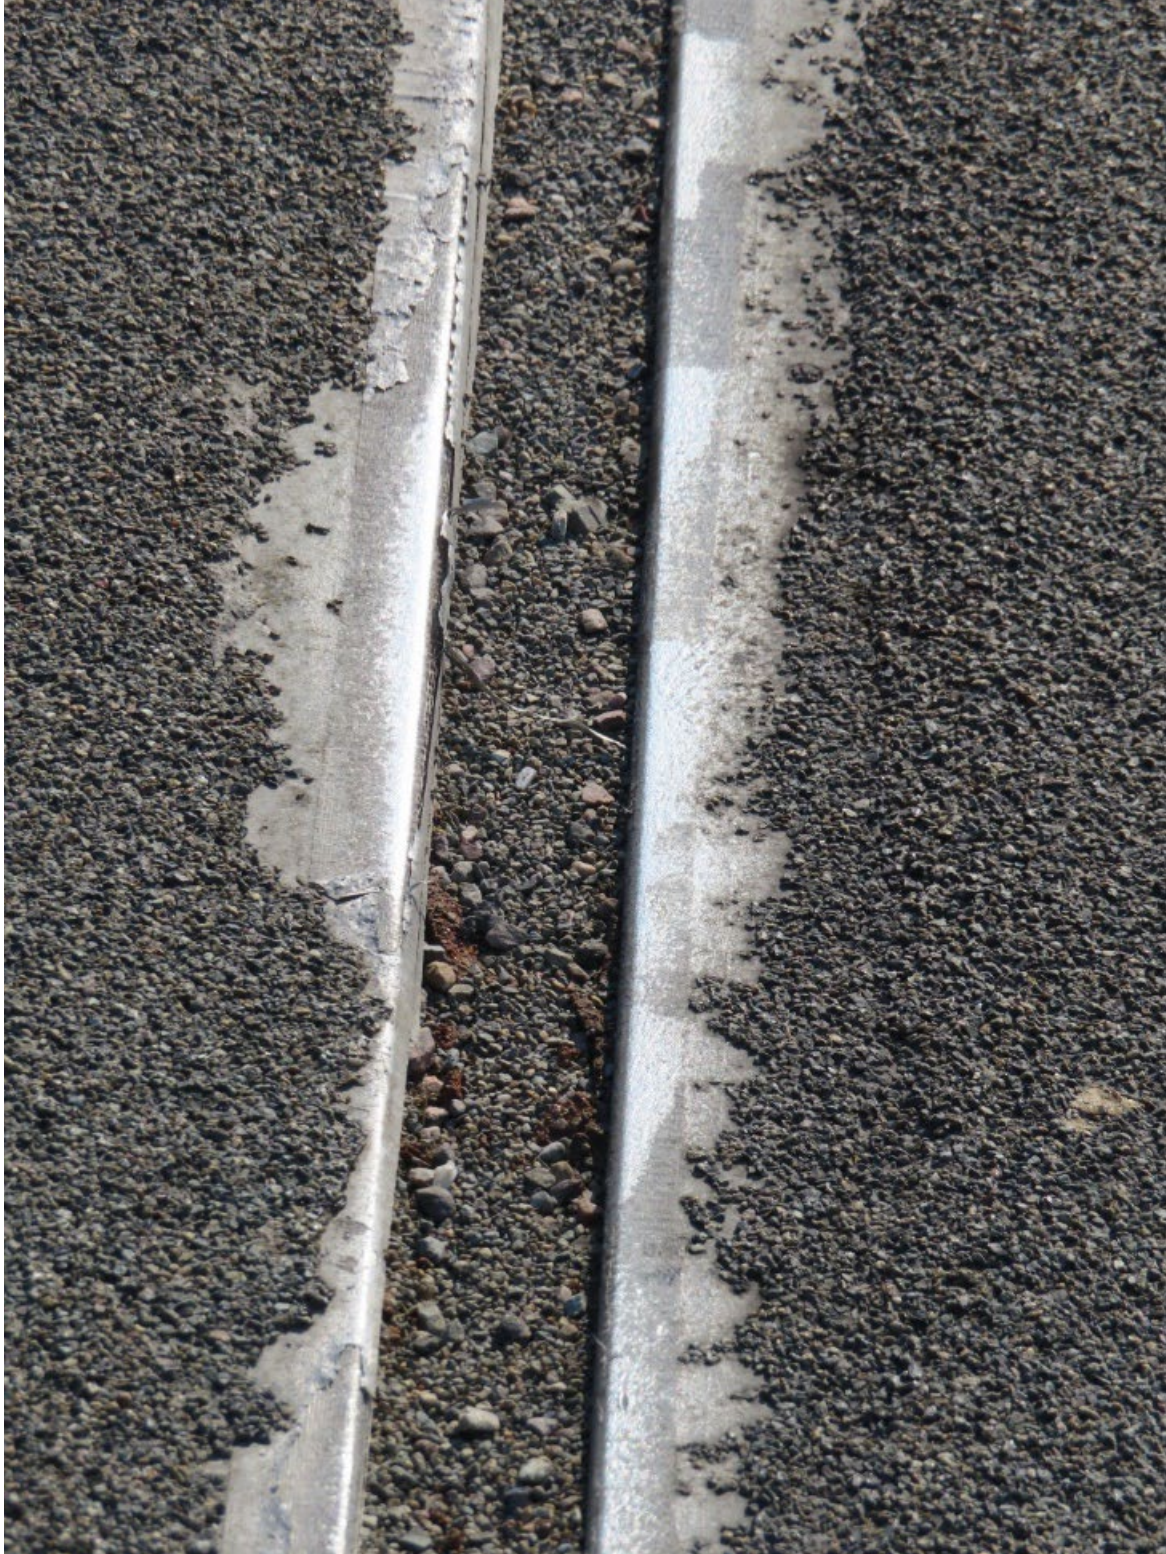
Figure 53. Photograph showing aggregate debris in an armored joint on Bridge 25 and encroachment of the polymer overlay onto the joint armor.
