EVALUATION OF THIN POLYMER OVERLAYS FOR BRIDGE DECKS

FHWA/MT-23-006/9757-705

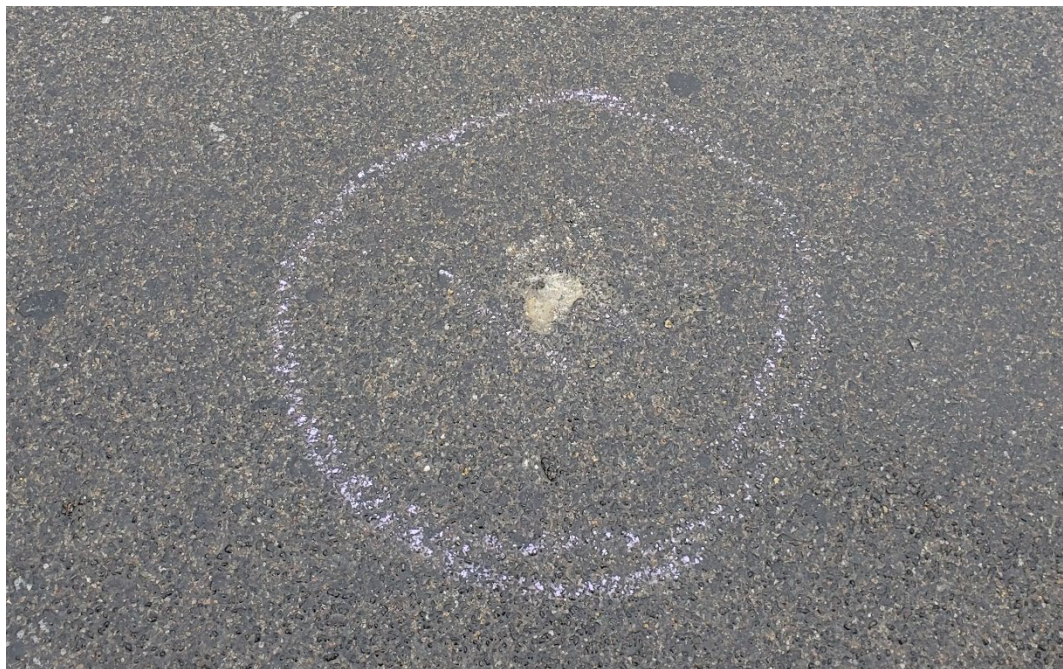
Figure 55. Area identified as delaminated on Bridge 3734 in 2022. The “spall” at the center is due to chipping the HFST away to determine if the delamination was at the HFST-deck interface or due to reinforcement corrosion.

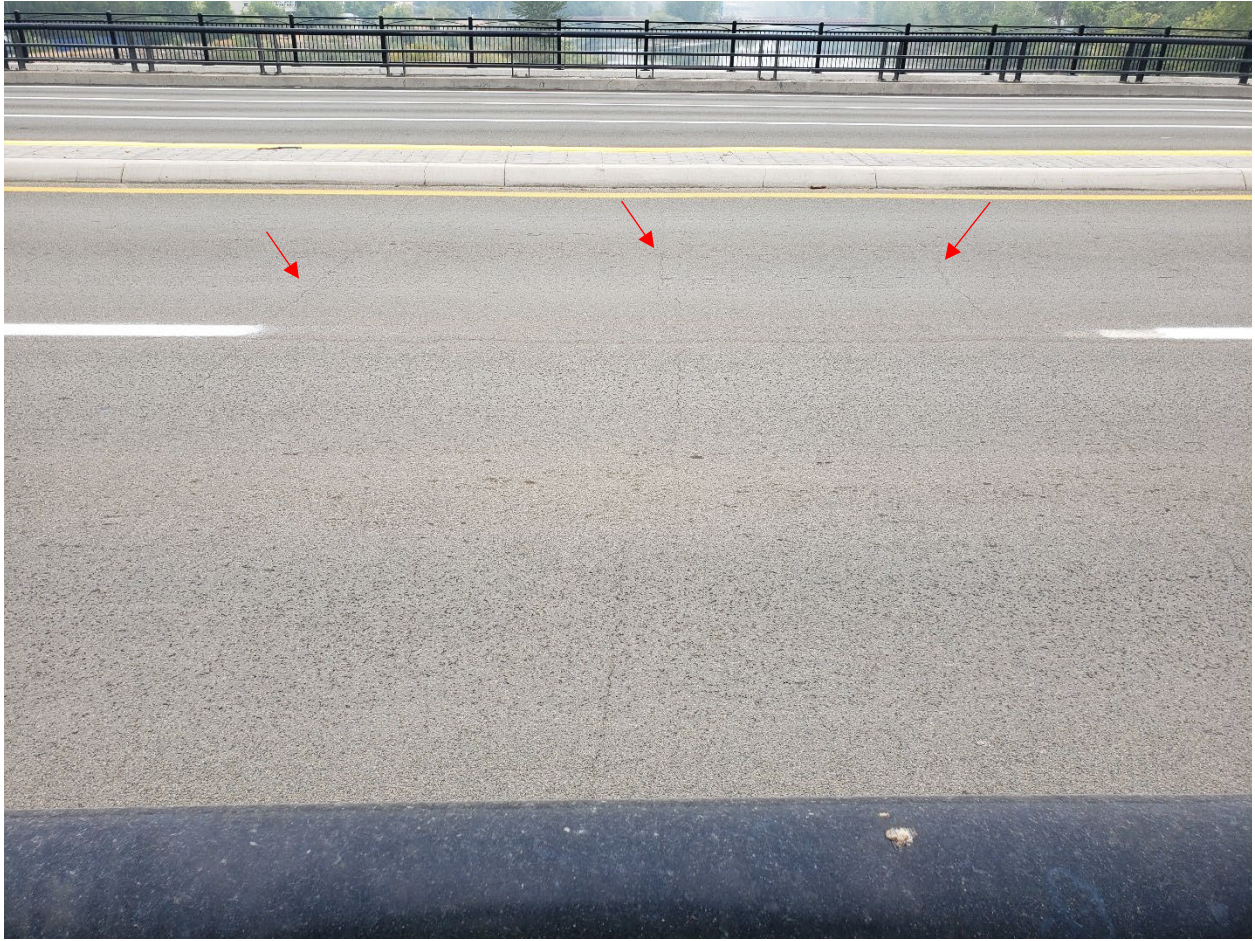
Figure 56. Photograph showing transverse cracking and wear of the SB lanes (foreground) on Bridge 25 in 2022. The NB lanes (Bridge 14) are in the background. Transverse cracks are identified with red arrows.

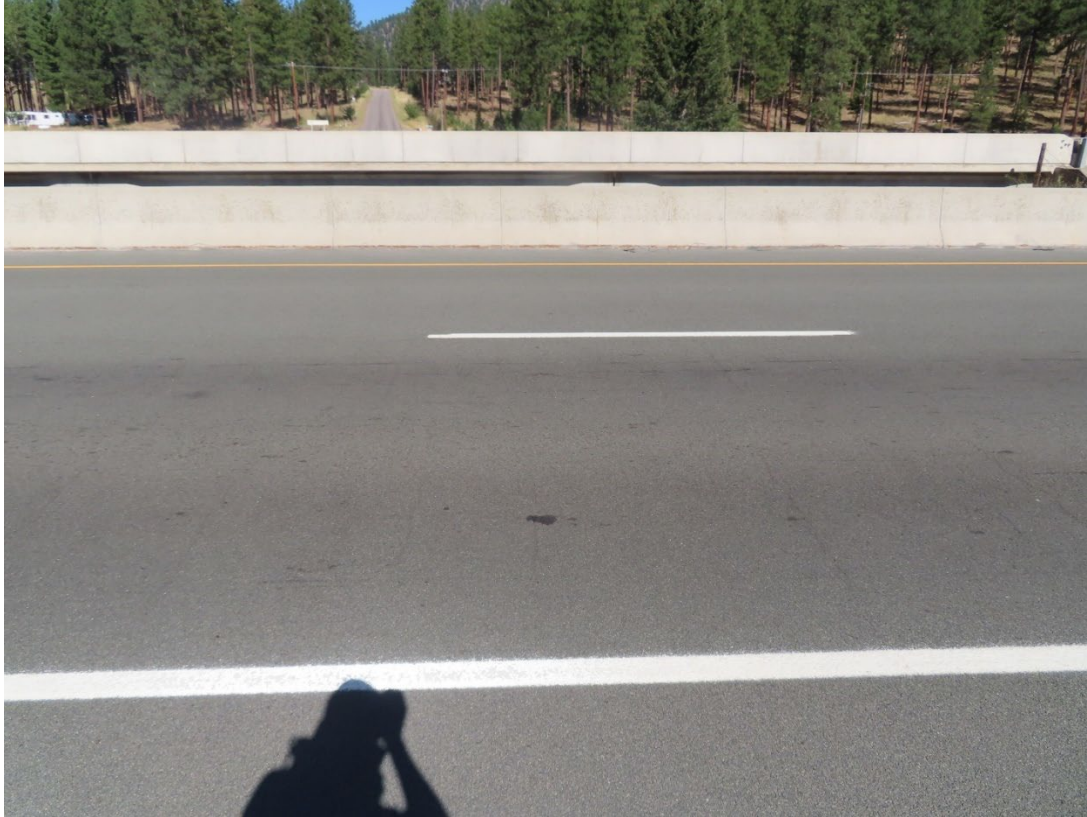
Figure 57. Photograph of a location on Bridge 1374 showing transverse cracking in 2020.

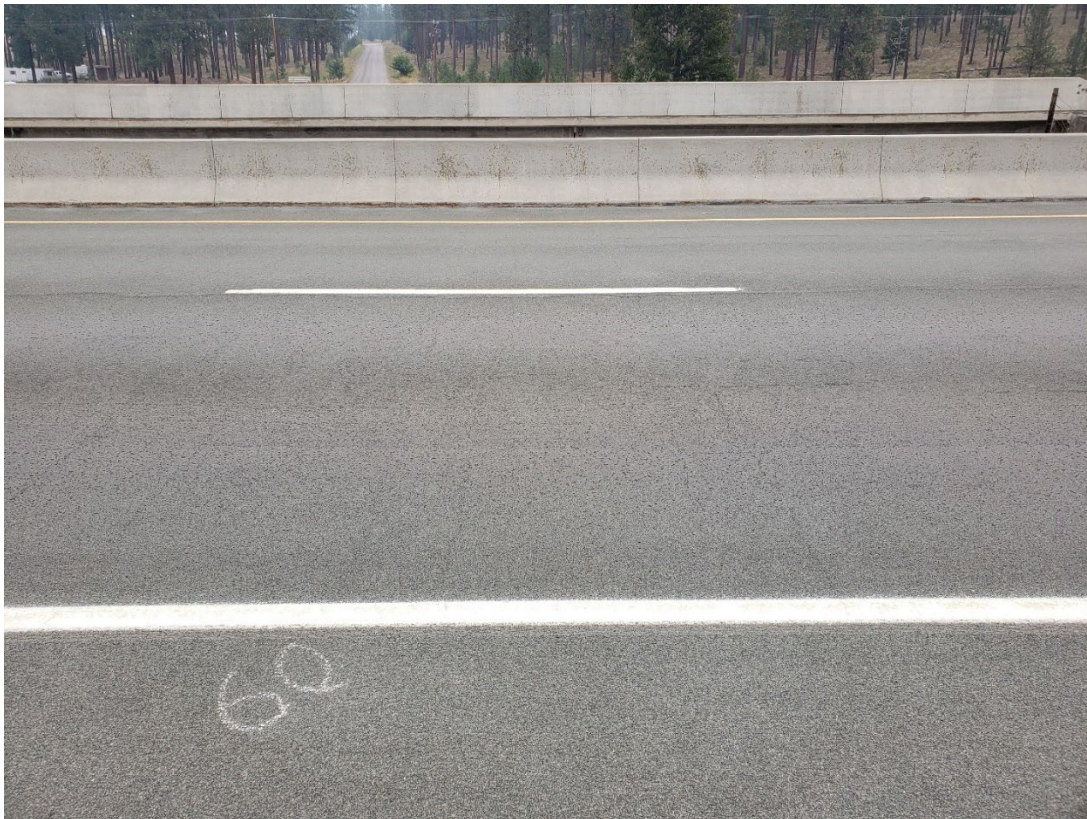
Figure 58. Photograph from 2022 of the same location on Bridge 1374 as shown in Figure 57.

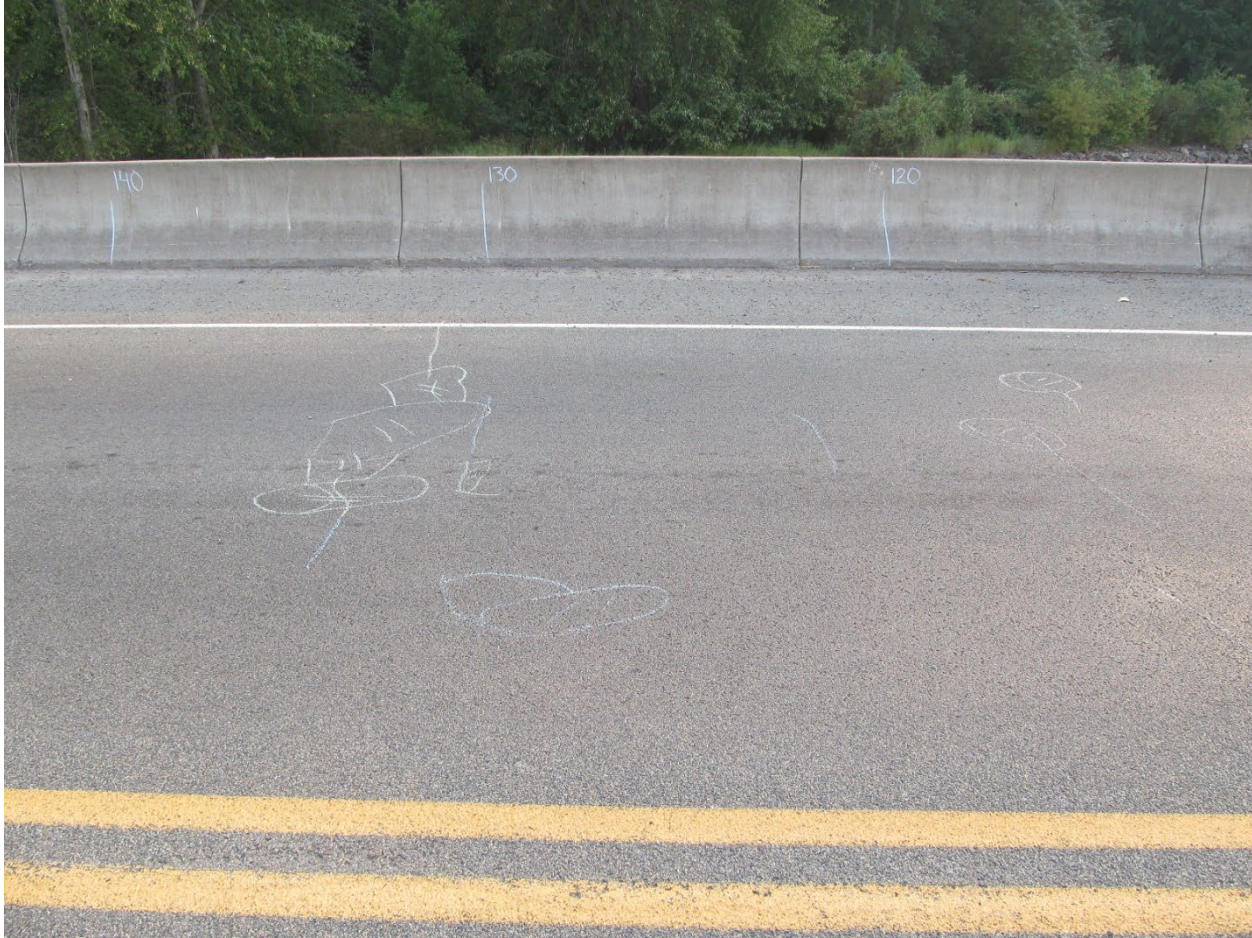
Figure 59. Photograph of largest delaminated area identified on Bridge 1333 in 2022.

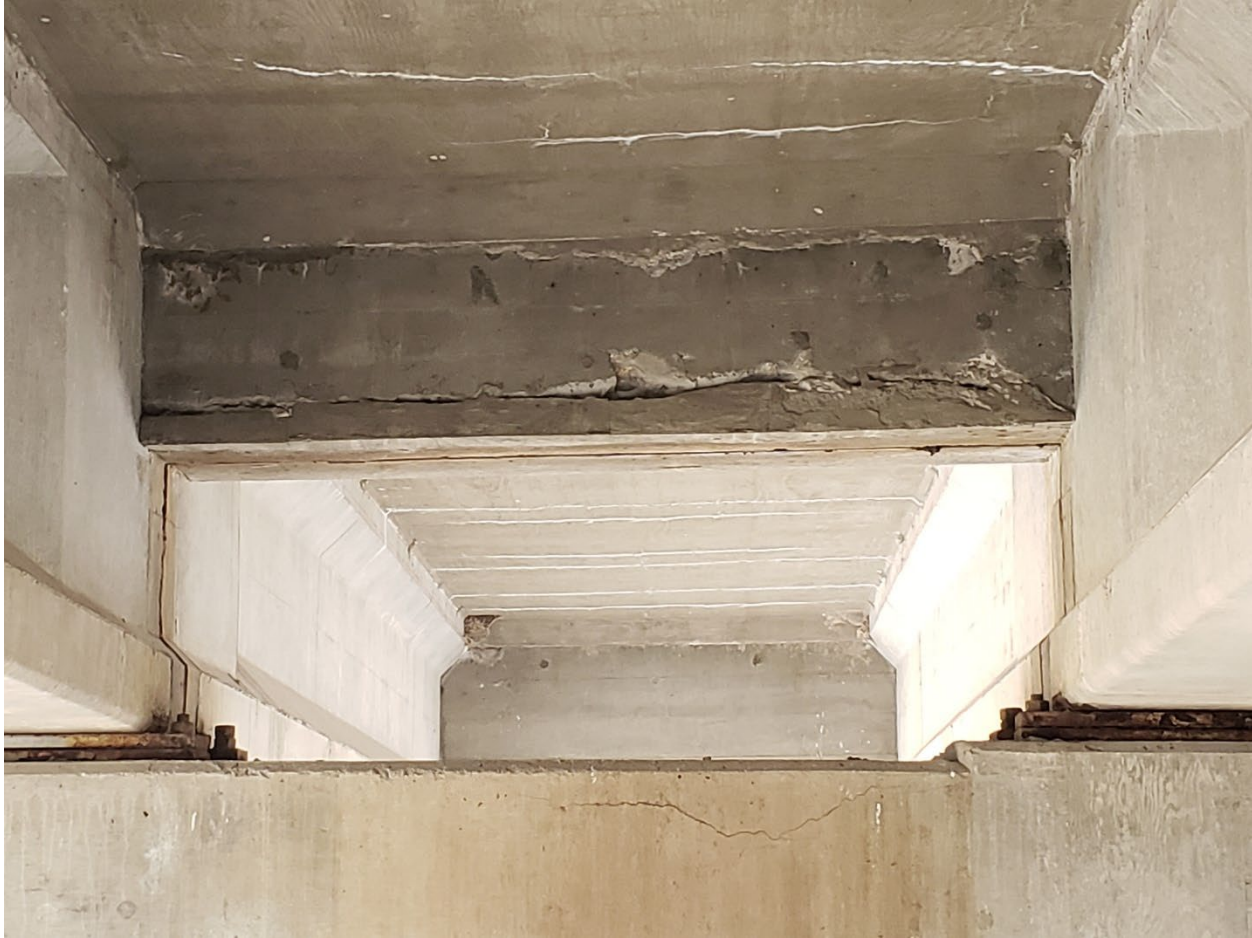
Figure 60. Cracks and spalls on the superstructure, deck beams, and pier cap of Bridge 1374 in 2022.

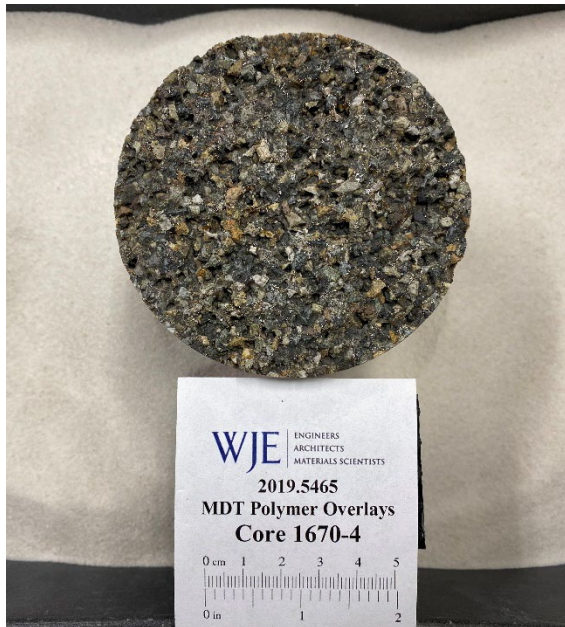
Figure 61. Photograph of Core 1670-4 before undergoing modified ASTM E965 testing.

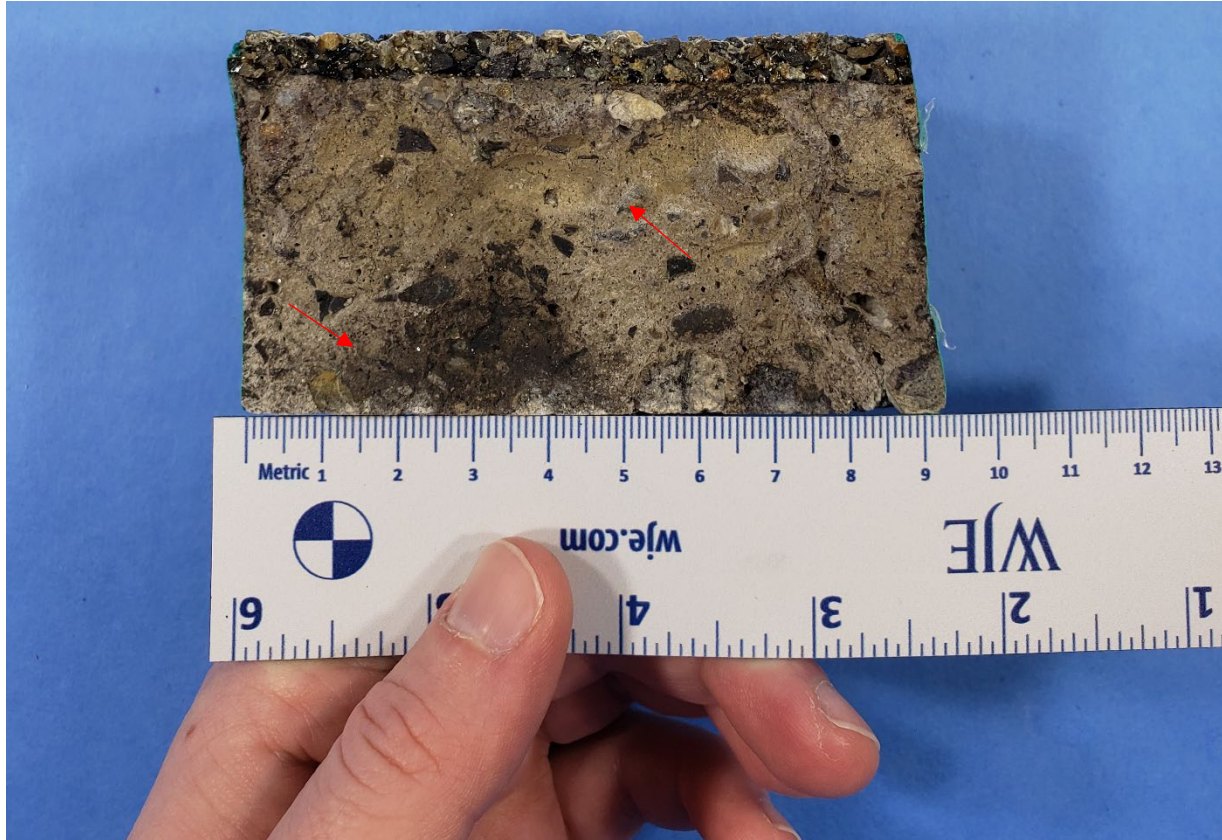
Figure 64. Photograph of the split test sample from core 1670-1 after AASHTO T 357 testing. The red arrows identify the color change lines.

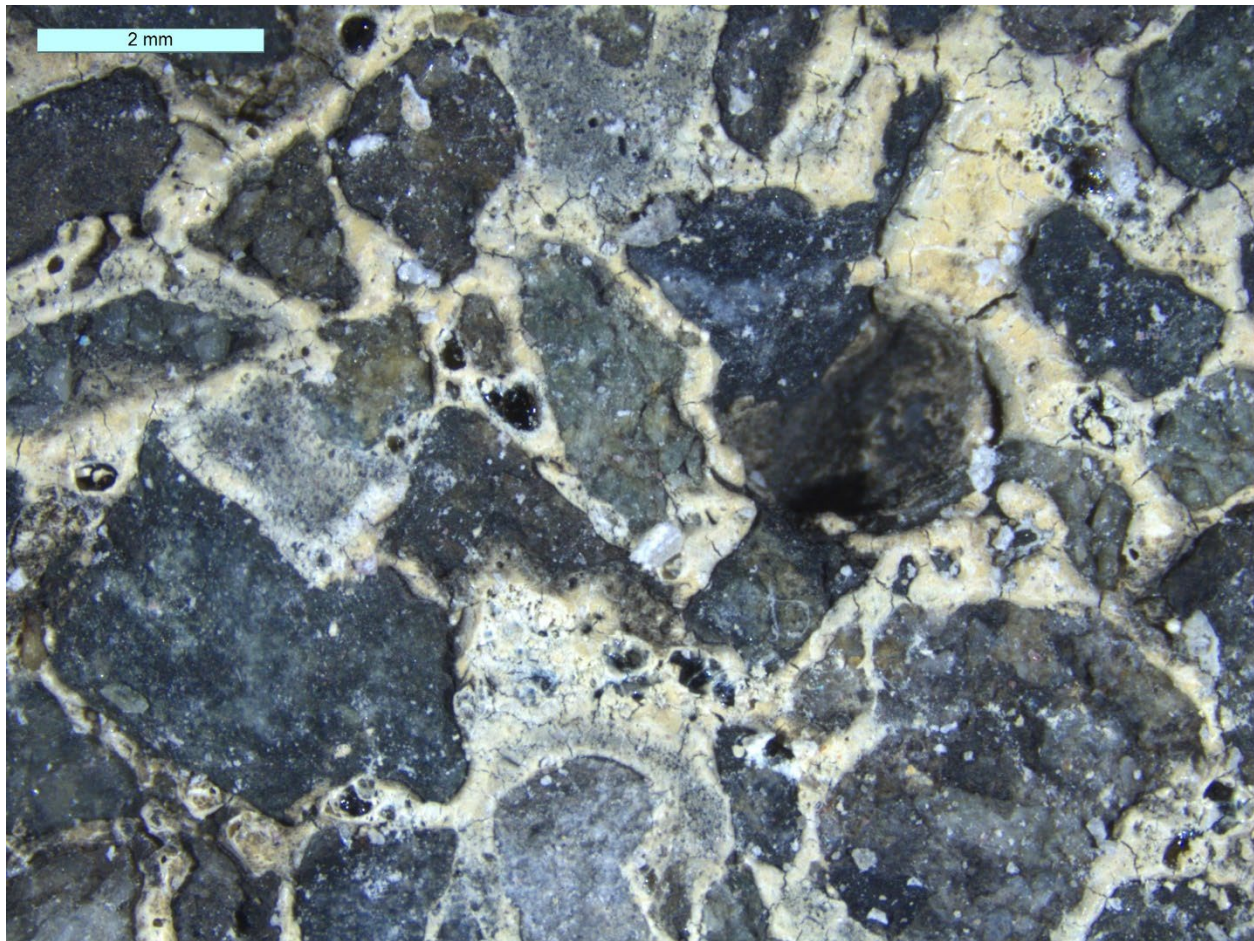
Figure 65. Photograph of the HFST on Core 1367-11 after AASHTO T 357 testing showing microcracks in the polymer matrix.

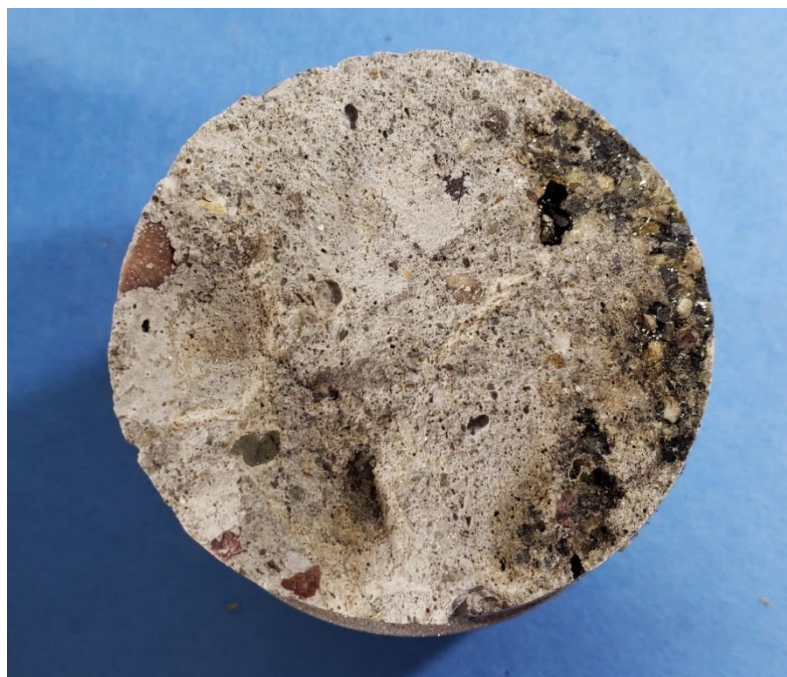
Figure 66. Top view of fractured surface from testing of Core 1367-12 showing that while the majority of the fracture occurred in the deck substrate, a small area (approximately 15 percent) occurred at the interface between the HFST and the bridge deck.

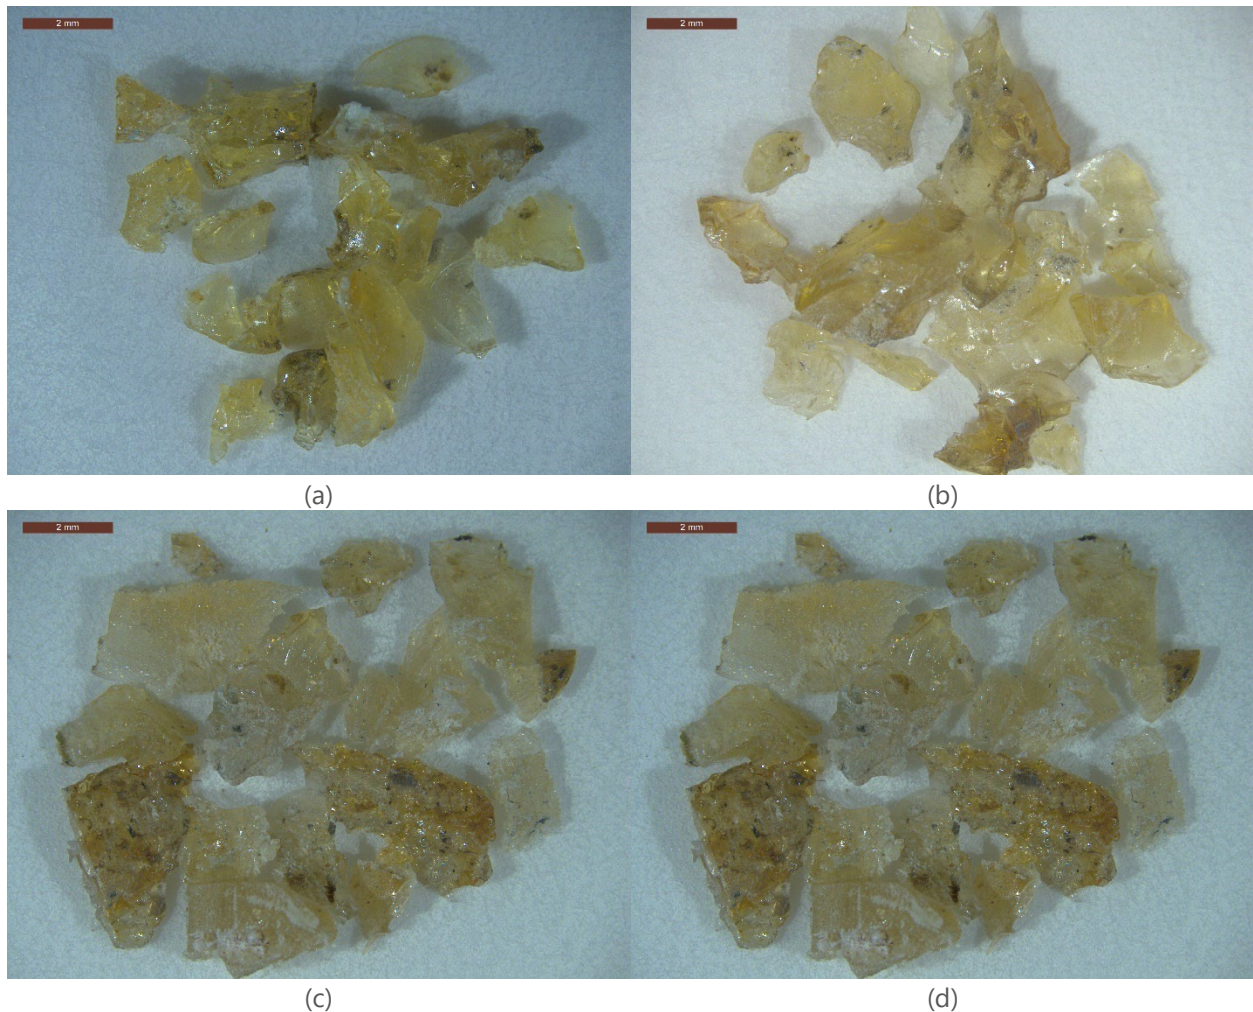
Figure 68. The binding polymer resins were isolated from aggregates. After the aggregates were crushed and brushed off, some aggregate material still remains in the binding resins. They are observed as black specks. (a) 1670-8, (b) 1682-7, (c) 1459-9, and (d) 1367-4. Captured at 16X magnification.

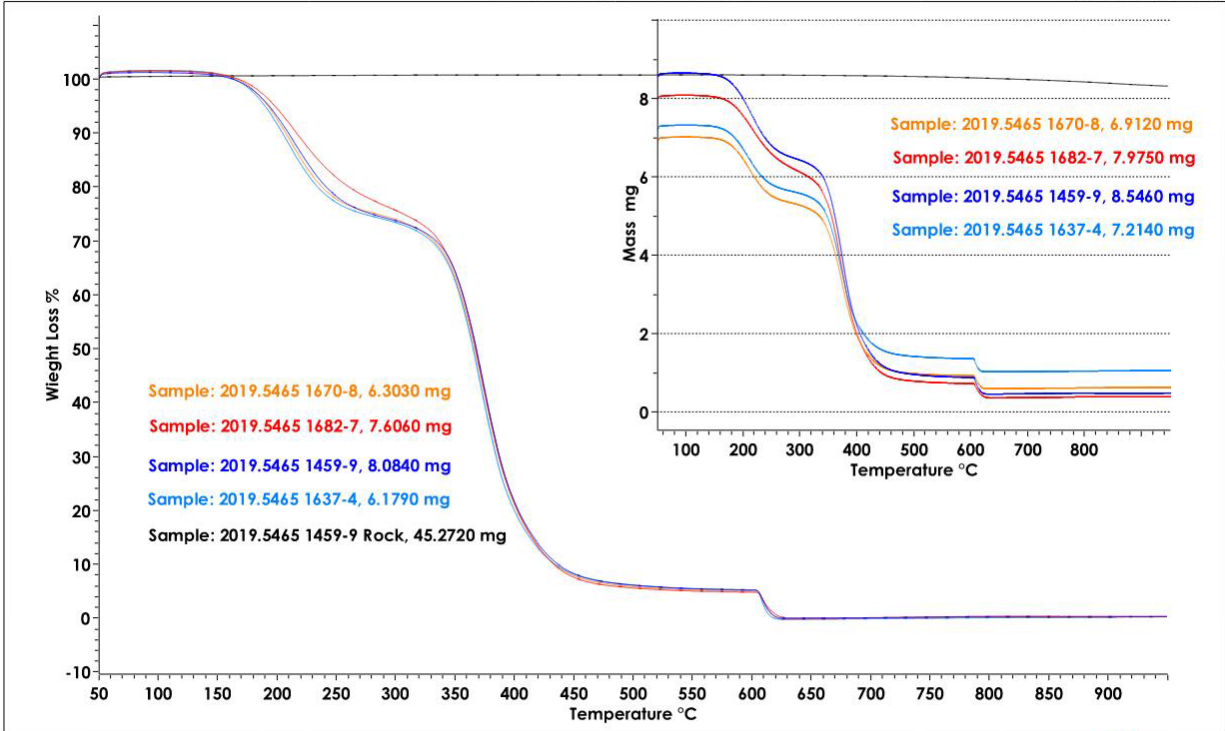
WJE-Janney Technical Center: ES

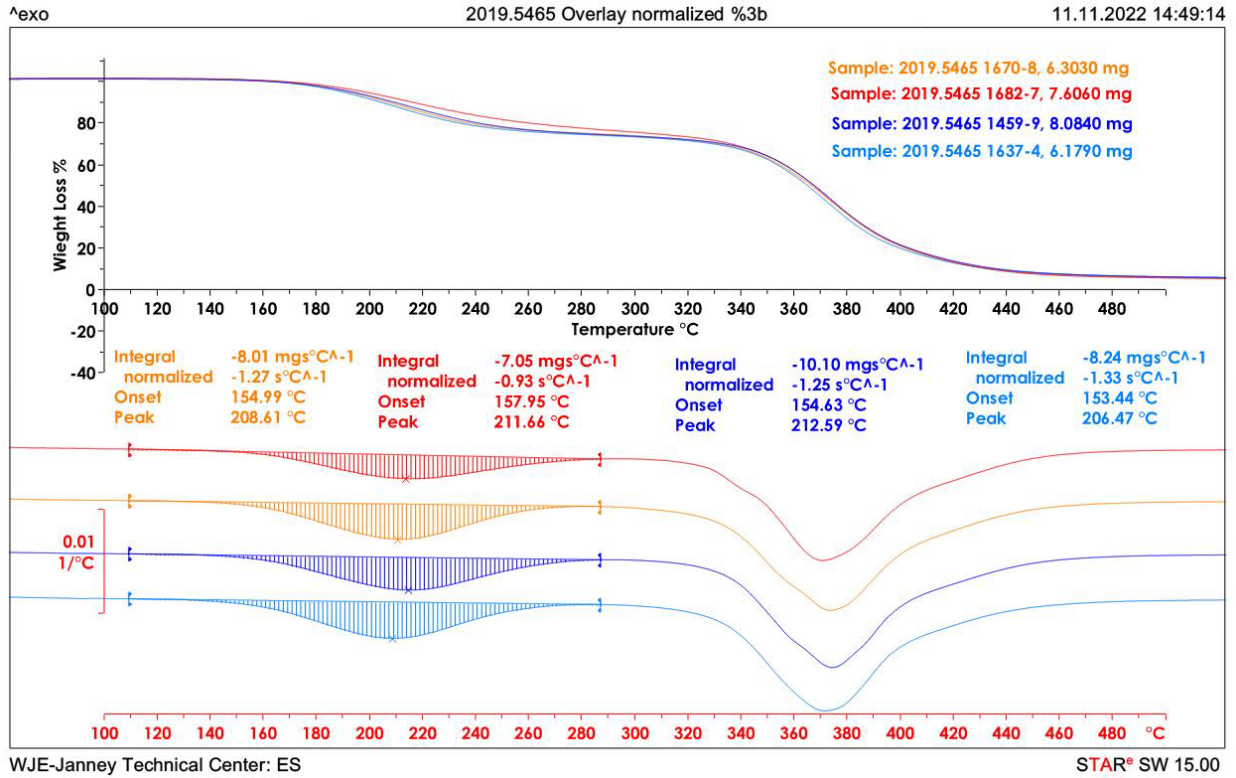
Figure 69. TGA thermograms of isolated binder samples: the atmosphere was switched from nitrogen to air at 600°C. The aggregates do not show any mass loss. As shown in the inset of mass change over temperature, noticeable amounts remain due to aggregate residues embedded in the isolated binding resins even after 950°C in air. The initial mass of the sample was calibrated using the remaining mass. The weight loss (%) of the binding resin alone was recalculated. The difference is observed below 350°C.

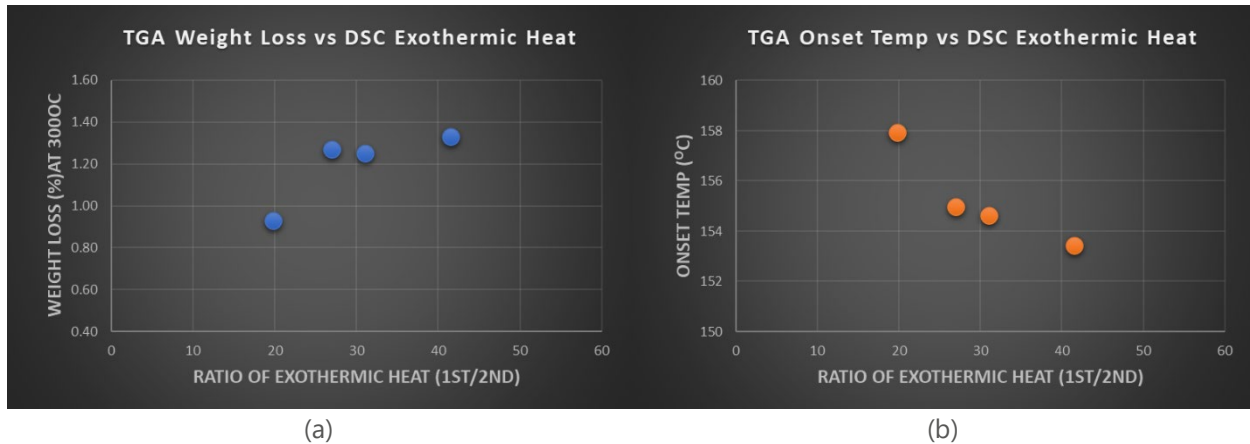
Figure 72. Positive correlation of weight loss (%) and negative correlation of onset temperature to the exothermic heat ratio: as the exothermic heat ratio of 1st peak to 2nd peak decreases and more curing occurs, the weight loss decreases and the onset temperature is delayed.

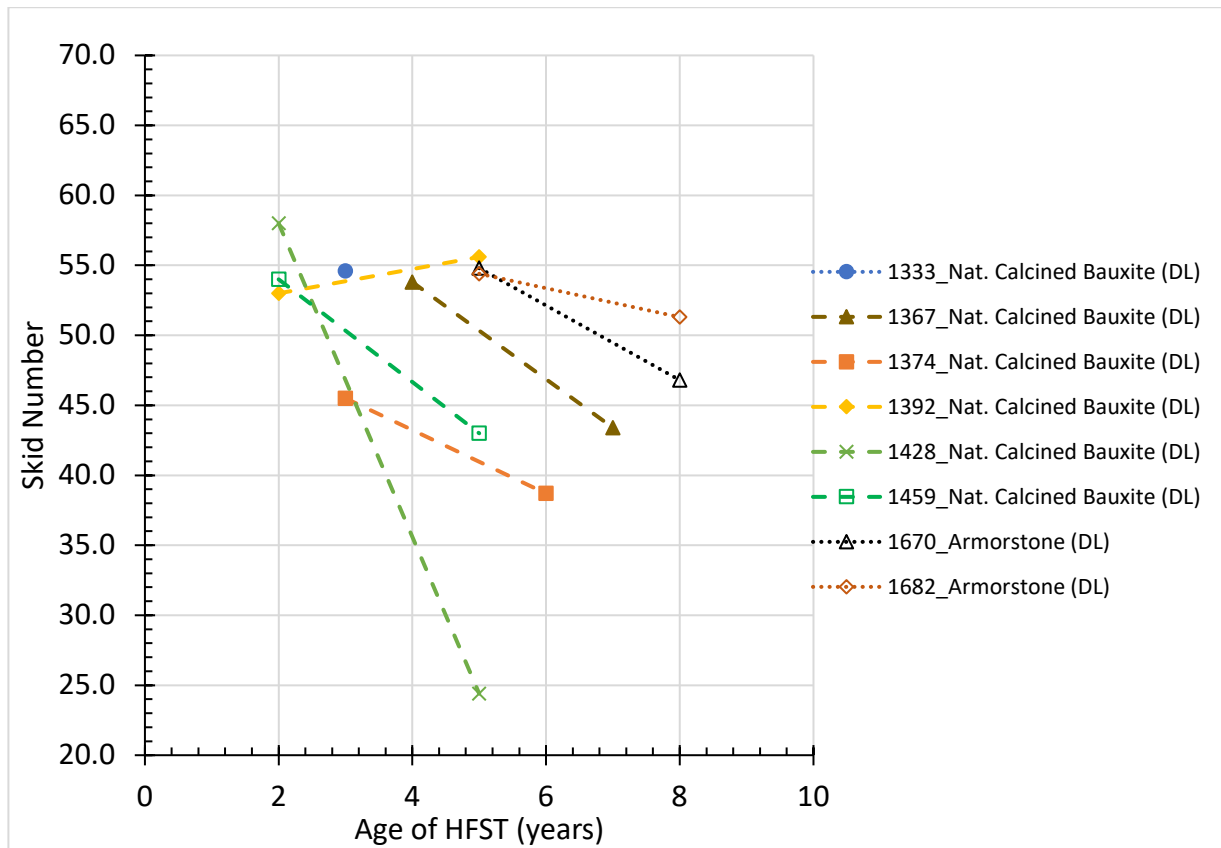
Figure 73. Comparison of driving lane (DL) skid numbers against age of overlay.

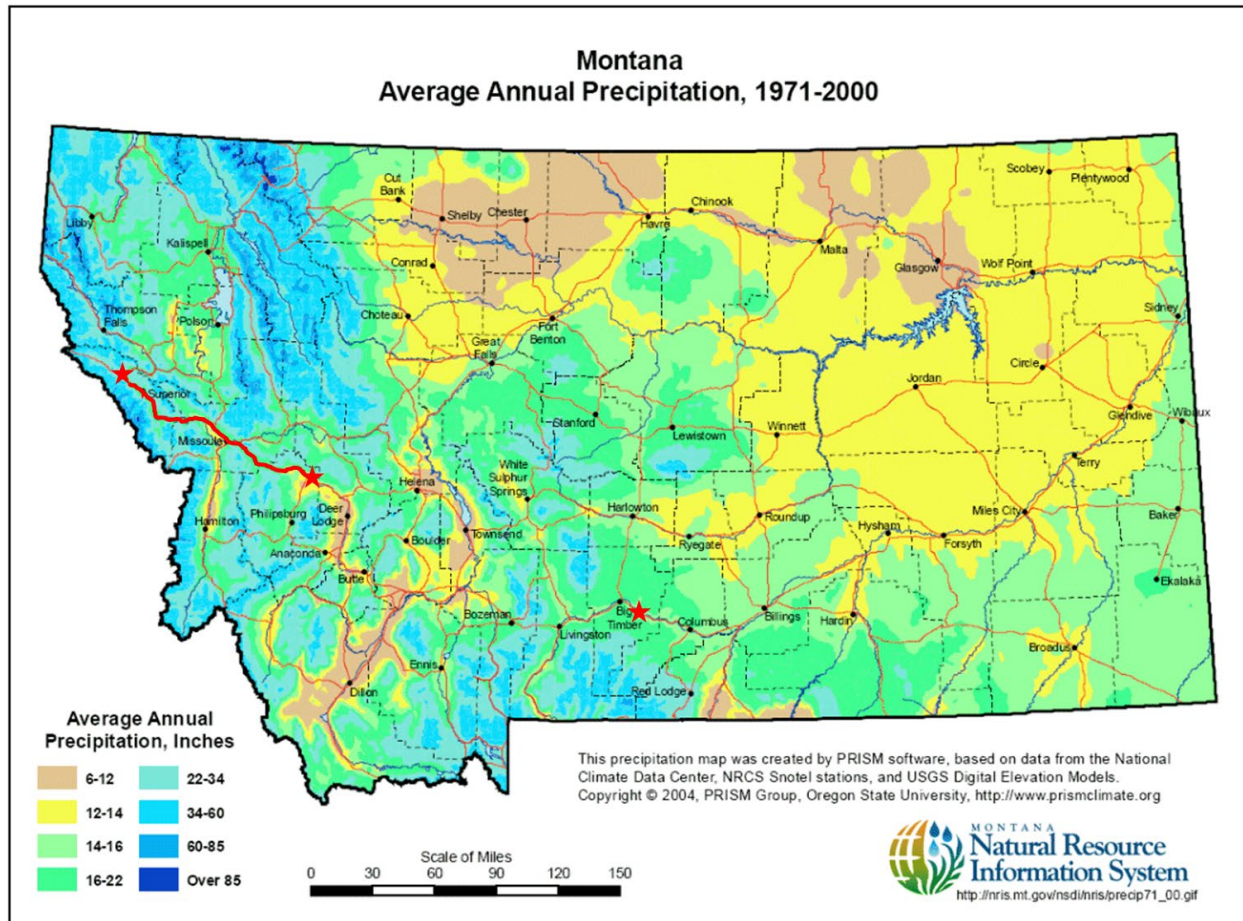
Figure 75. Map of average annual precipitation in Montana from Montana State Library (Montana State Library, 2022) with annotations by WJE. Red stars identify the location of the Billings bridges and the cities of Drummond and St. Regis, where the easternmost and westernmost bridges in the Missoula District are located. The remaining bridges in the Missoula District lay on the path between them, marked with a red line.

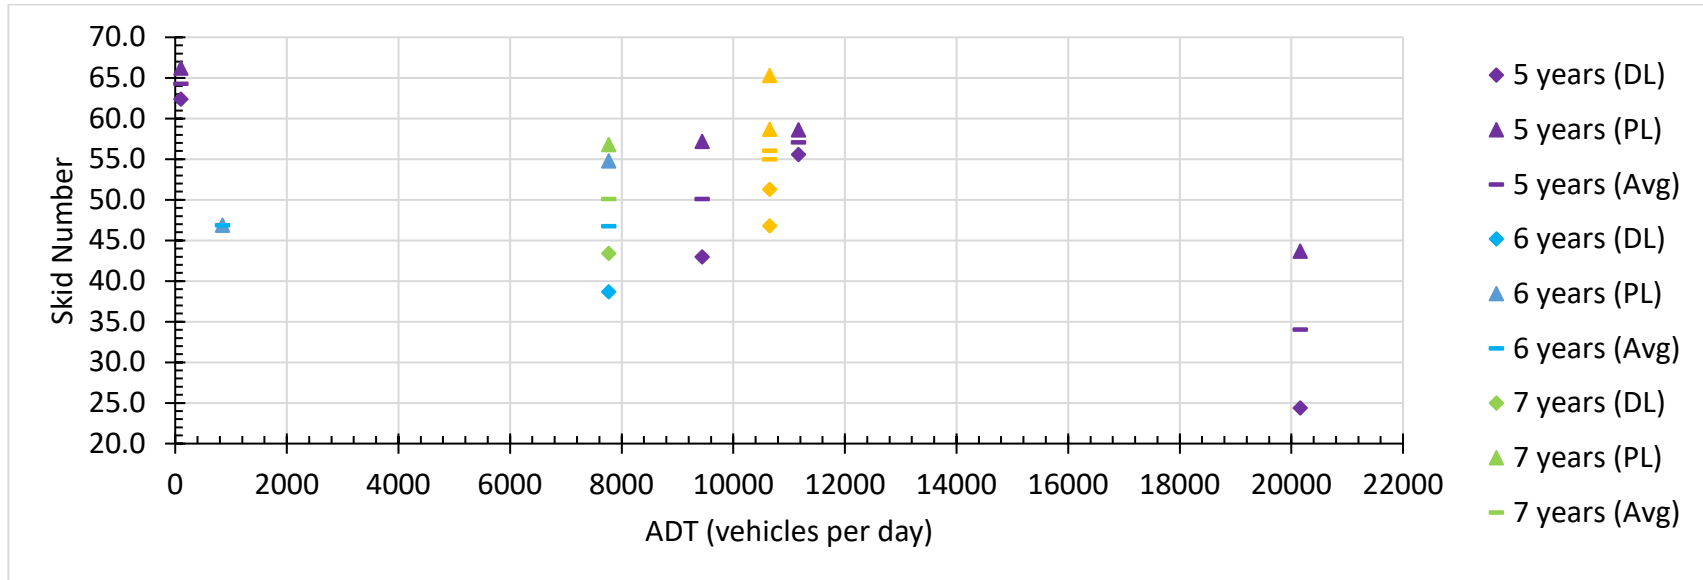
Figure 81. Plot of skid numbers measured in 2023 against ADT of bridge as reported in 2023. Data is categorized by age of the HFST and lane type with "DL" representing the driving lane, "PL" representing the passing lane, and "Avg" representing the average value of the two lanes. Note that the vertical axis goes from 20 to 70 instead of 30 to 70 as for the plots of the 2020 data.

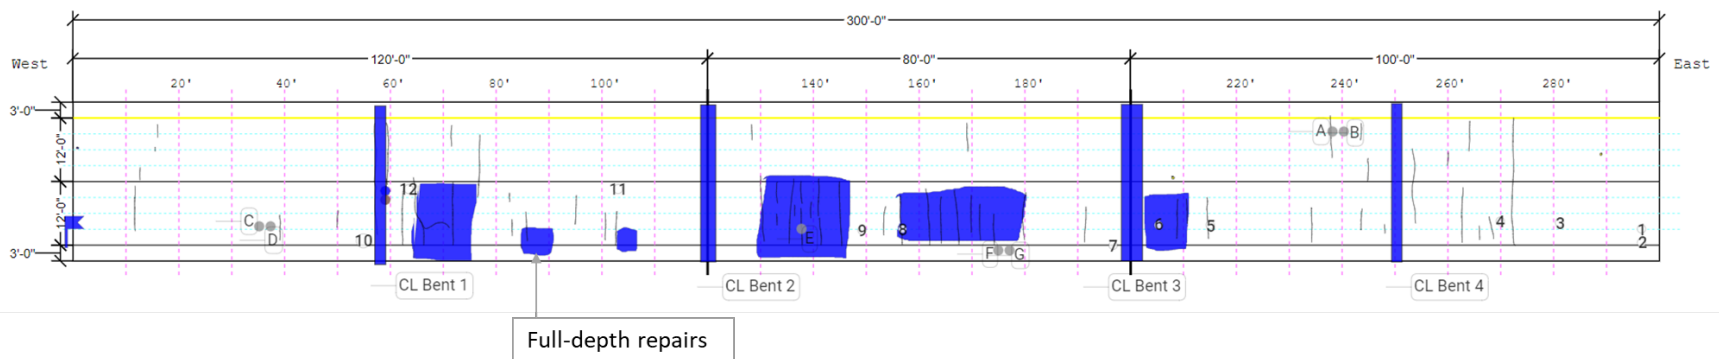
Figure D.11. Field notes for Bridge 1367, 2022 inspection, HFST, with full-depth repairs as identified from 2020 soffit inspection for comparison.

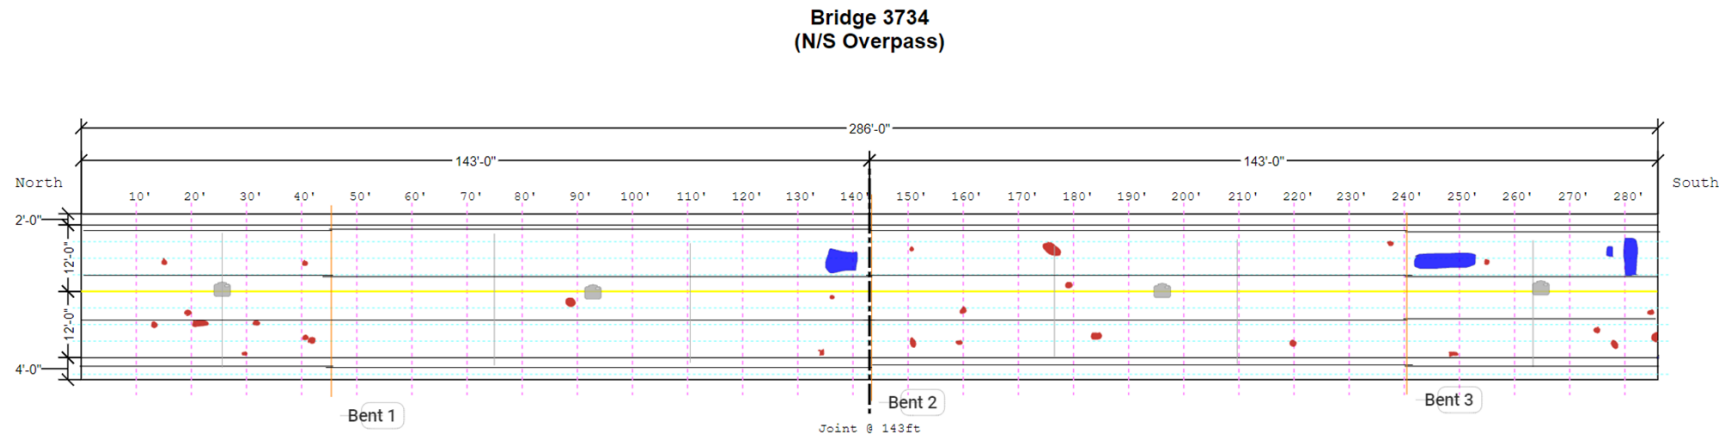
Figure D.18. Field notes for Bridge 3734, 2022 inspection, HFST with full-depth repairs from 2020 inspection shown.
