## Minnesota Drive Ramps Micro Surfacing Experimental Feature

January 2024

**Publication Number:** FHWA-AK-RD-4000(181), HFHWY00123

13. ABSTRACT (Maximum 200 words)  During the 2020 construction season, the Alaska DOT&PF Central Region installed its first application of micro surfacing at 17 locations on Minnesota Drive ramps in the city of Anchorage. This treatment offers the potential to be a more economical solution to the typical mill and fill hot mix asphalt (HMA) treatment used to address rutted roads.  Micro surfacing has not been used on roads in Central Region due to poor historical Prall testing (ATM 420) that is used to simulate studded tire wear. A new formulation of micro surfacing was evaluated in 2016 with significantly improved performance on the Prall test. This formulation uses fine aggregate and a high residual binder content with a PG64-40 modified asphalt binder and between 6%-8% SBS polymer. This is a very high percentages of both binder and polymer for a micro surfacing treatment.  There were difficulties encountered during construction with break and set times that made the micro surfacing prone to flushing and deformation rutting immediately after constr

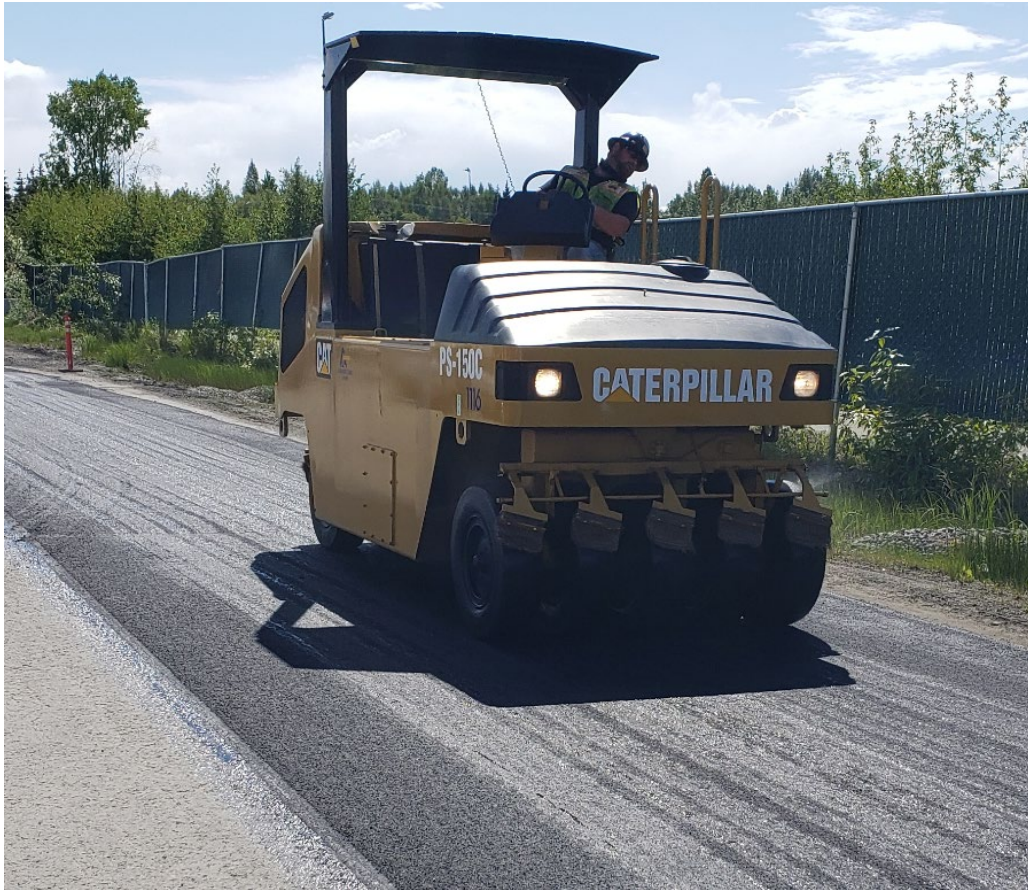
Photo 4 - Pneumatic Roller on Test Strip

It was intended for the pneumatic roller to finish rolling the mat within an hour of application so traffic would be able to return to the ramp shortly after. However, it took slightly over two hours for the pneumatic roller to begin rolling the test strip without damaging the fresh micro surfacing. The Department was informed this was due to the high emulsion temperature and the reduced lime content and that, with the full lime dosage and cooler emulsion, the pneumatic would be able to begin rolling the mat sooner.

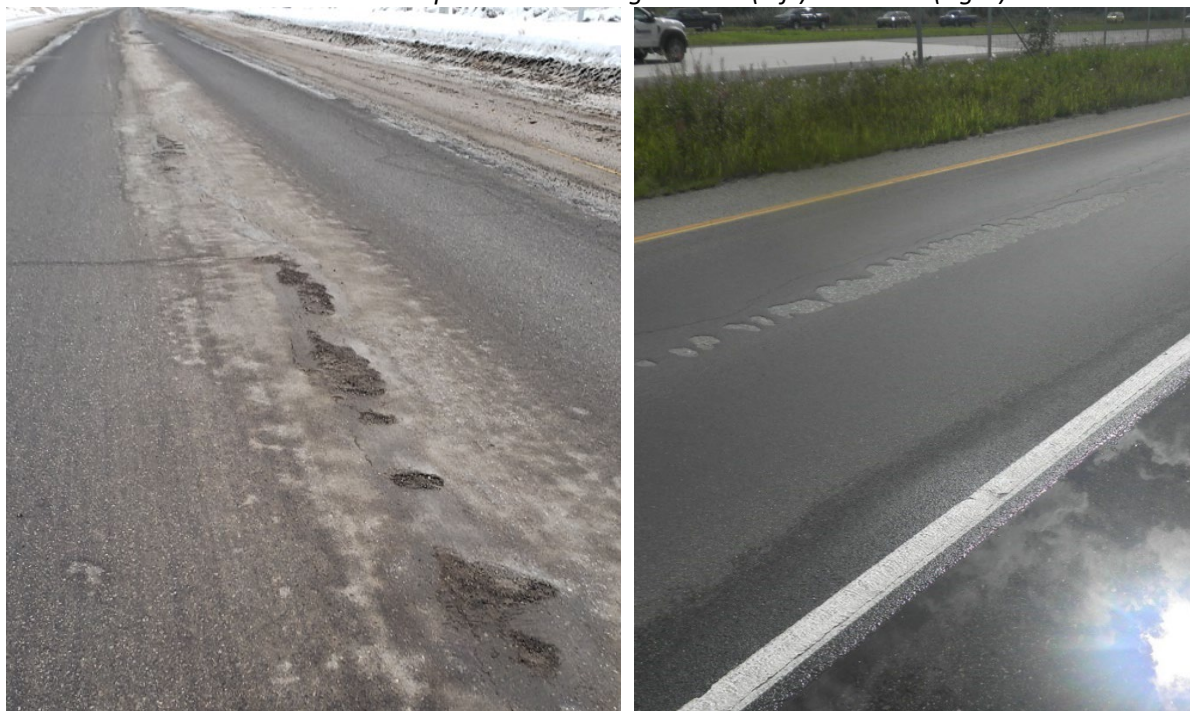
*Photo 10 - Ramp 12 Plow Damage – 2021 (left) and 2022 (right)*

In May of 2021 the summer inspection was performed. Ramps with micro surfacing applied over significant cracking saw more plow damage than those with minimal cracking, which held true in 2022 and 2023 as well.

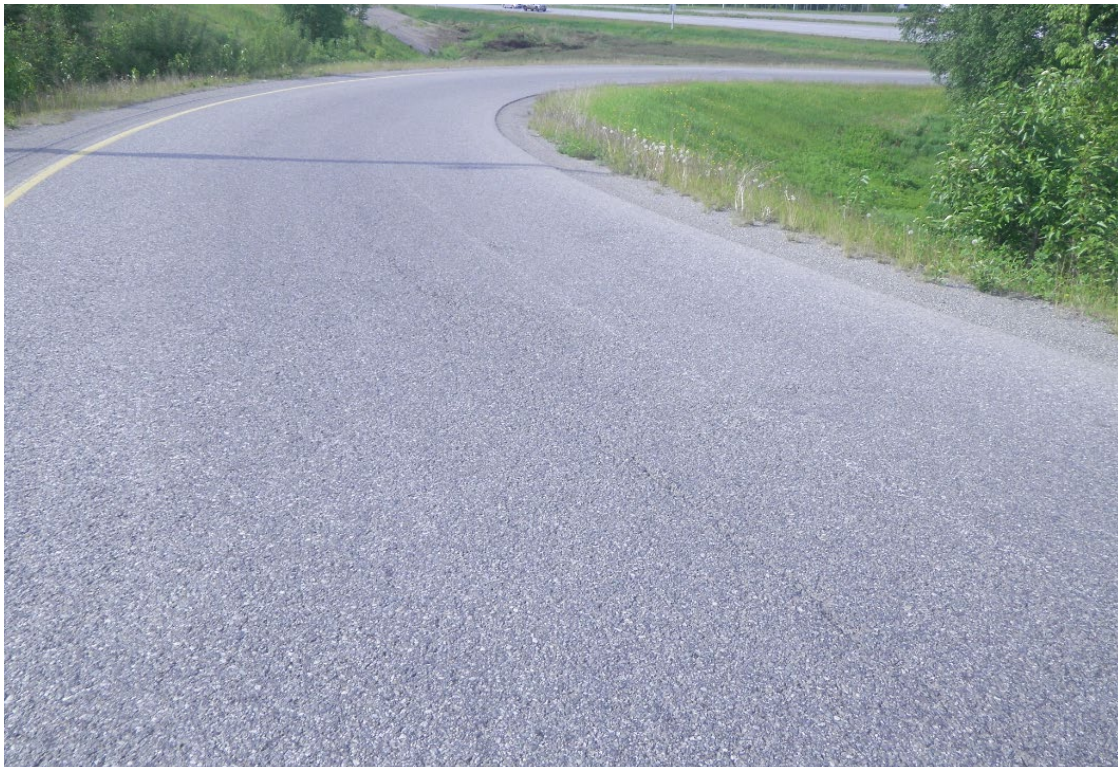
This ramp is a cloverleaf with minimal rutting, minor raveling and isolated moderate severity cracking.

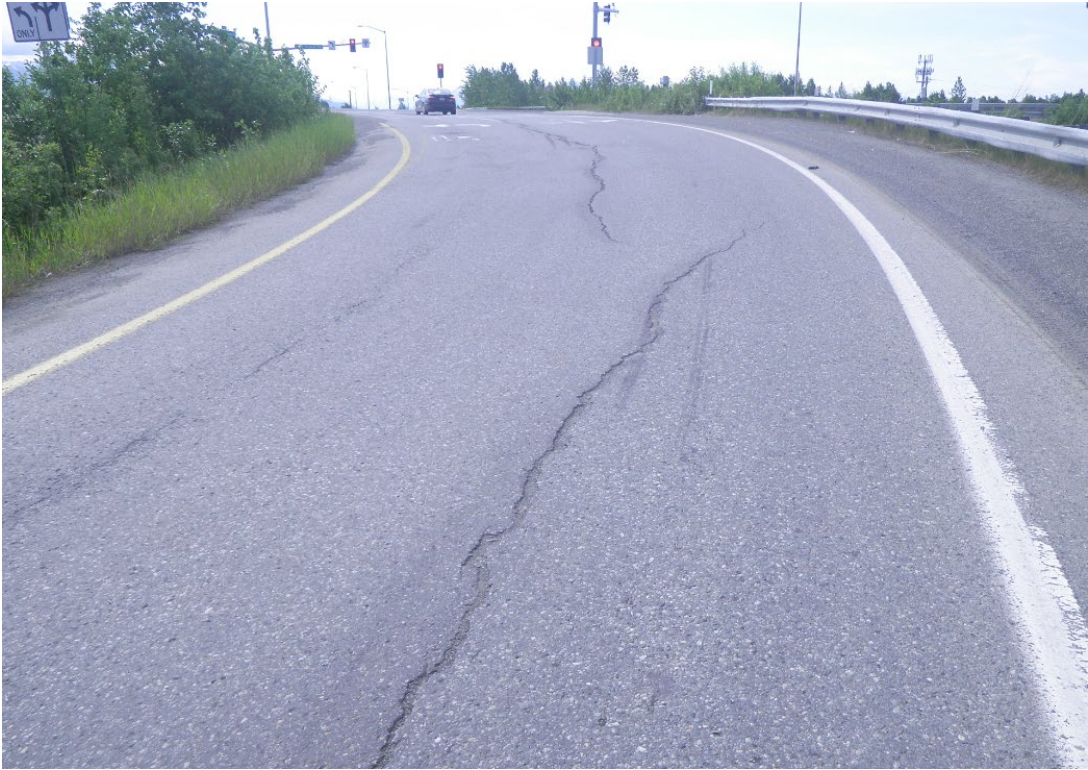
This ramp had minor rut depths but moderate to high severity longitudinal cracking.

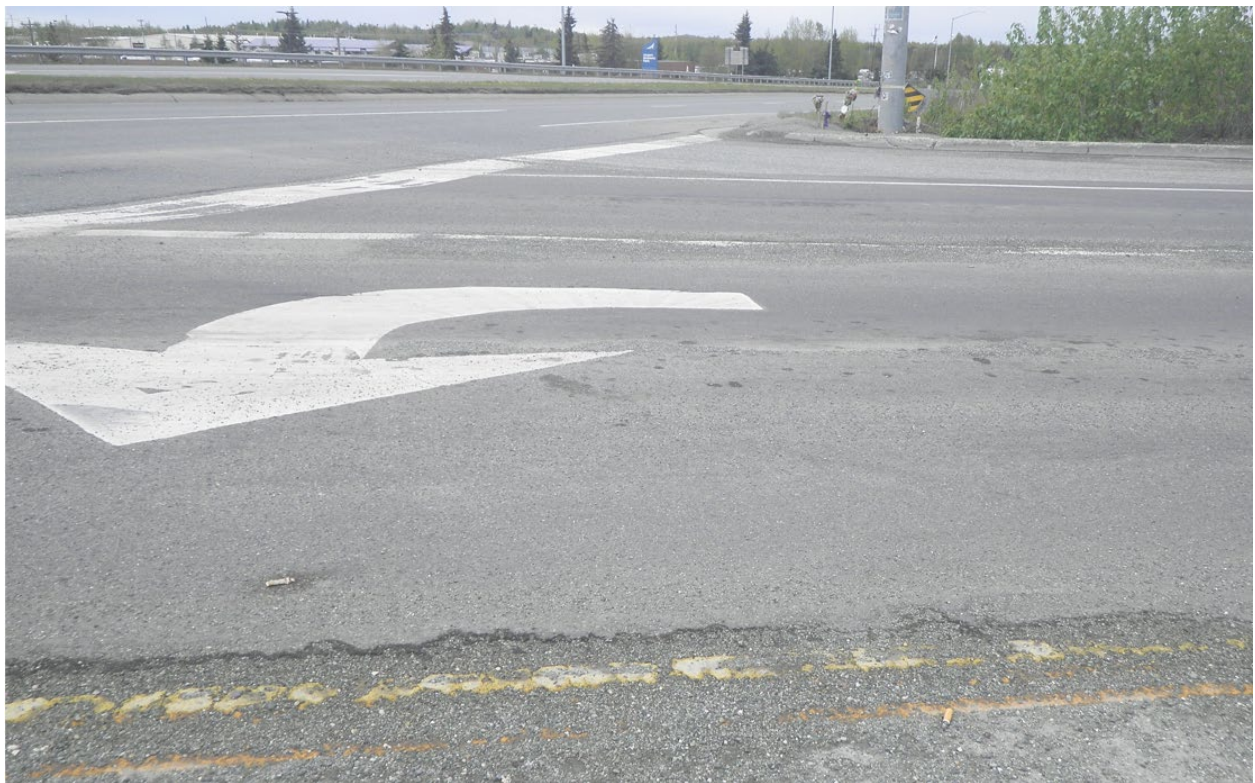
During year 1 of monitoring the cracks reflected through the microsurfacing, plow damage was present on the striping at the center of the lane and rutting from deformation was noted at the signalized intersection.

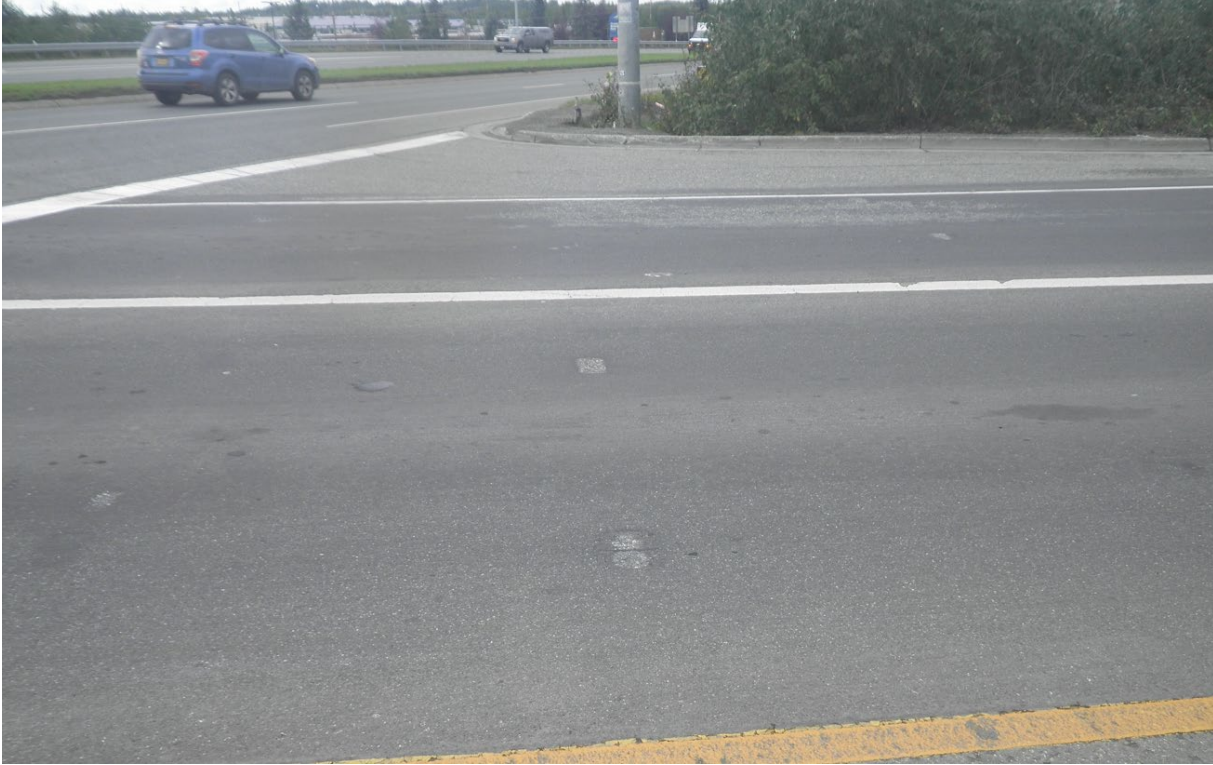
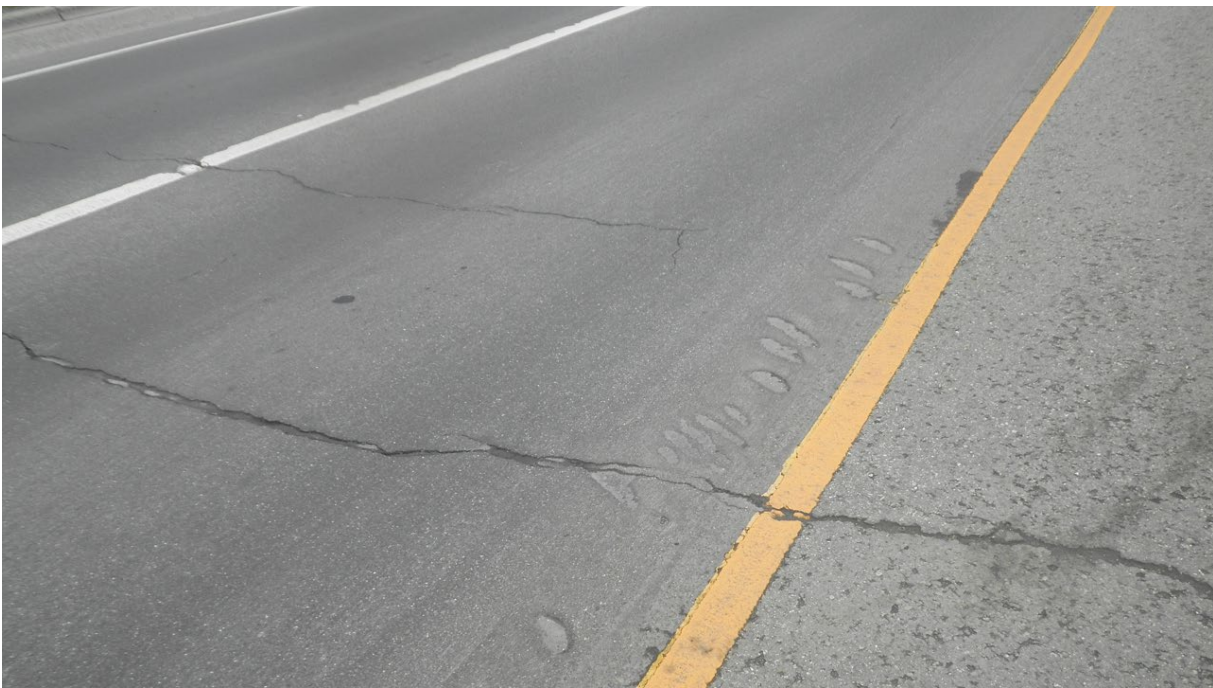
There is increased plow damage at the signalized intersection and cracks have reflected at higher severity than year 1.

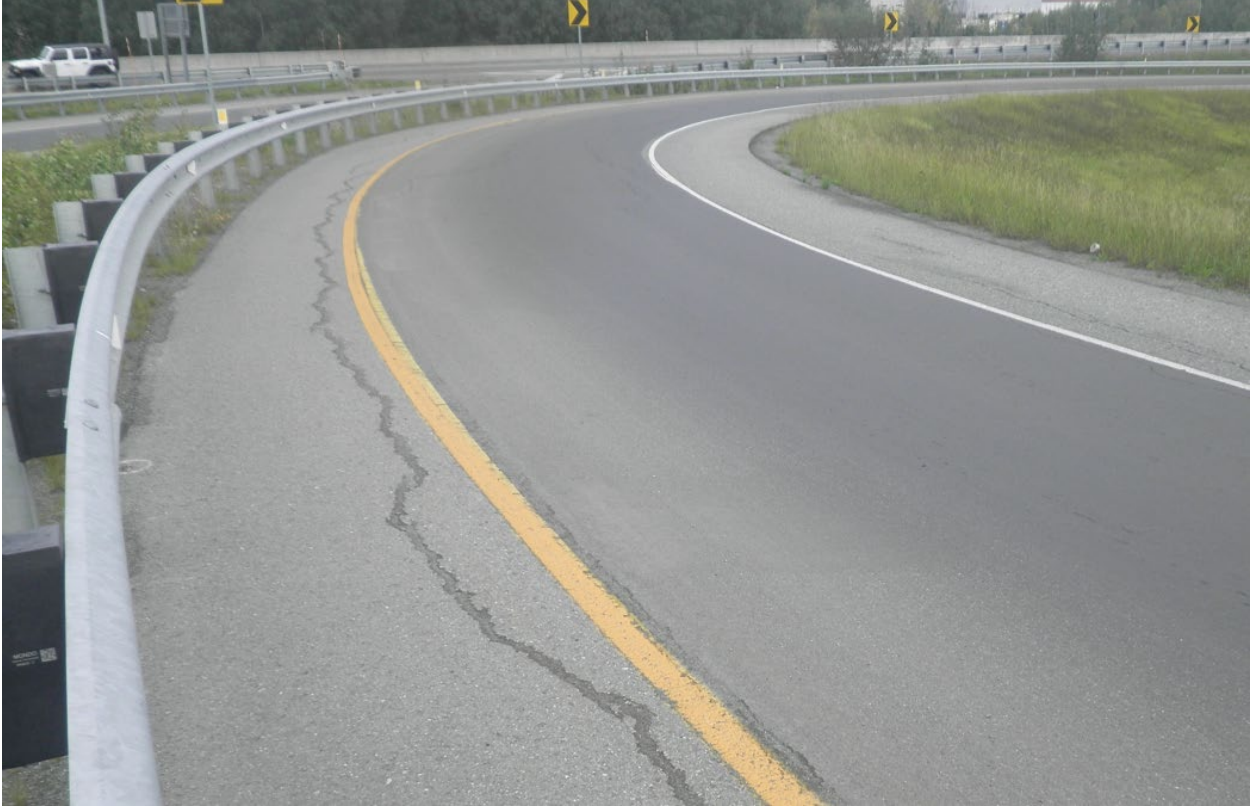
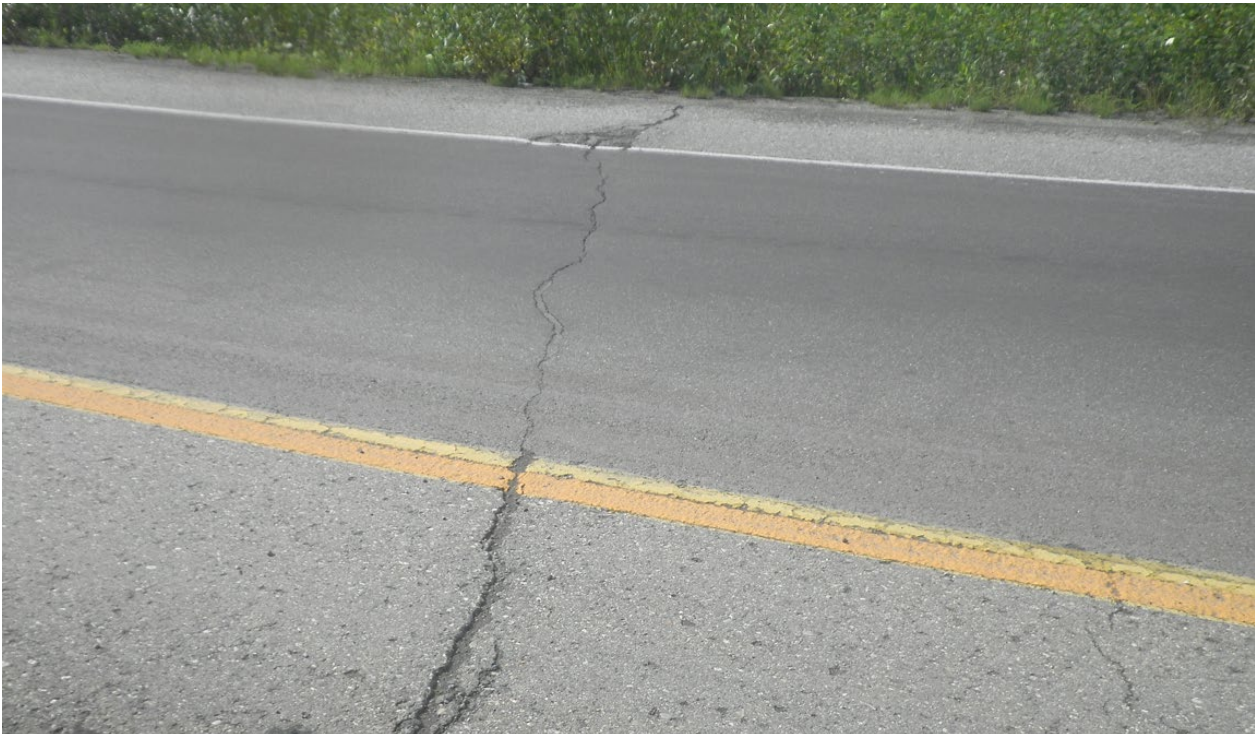
There is increased damage along longitudinal cracks where plows are catching and damaging the surfacing treatment.

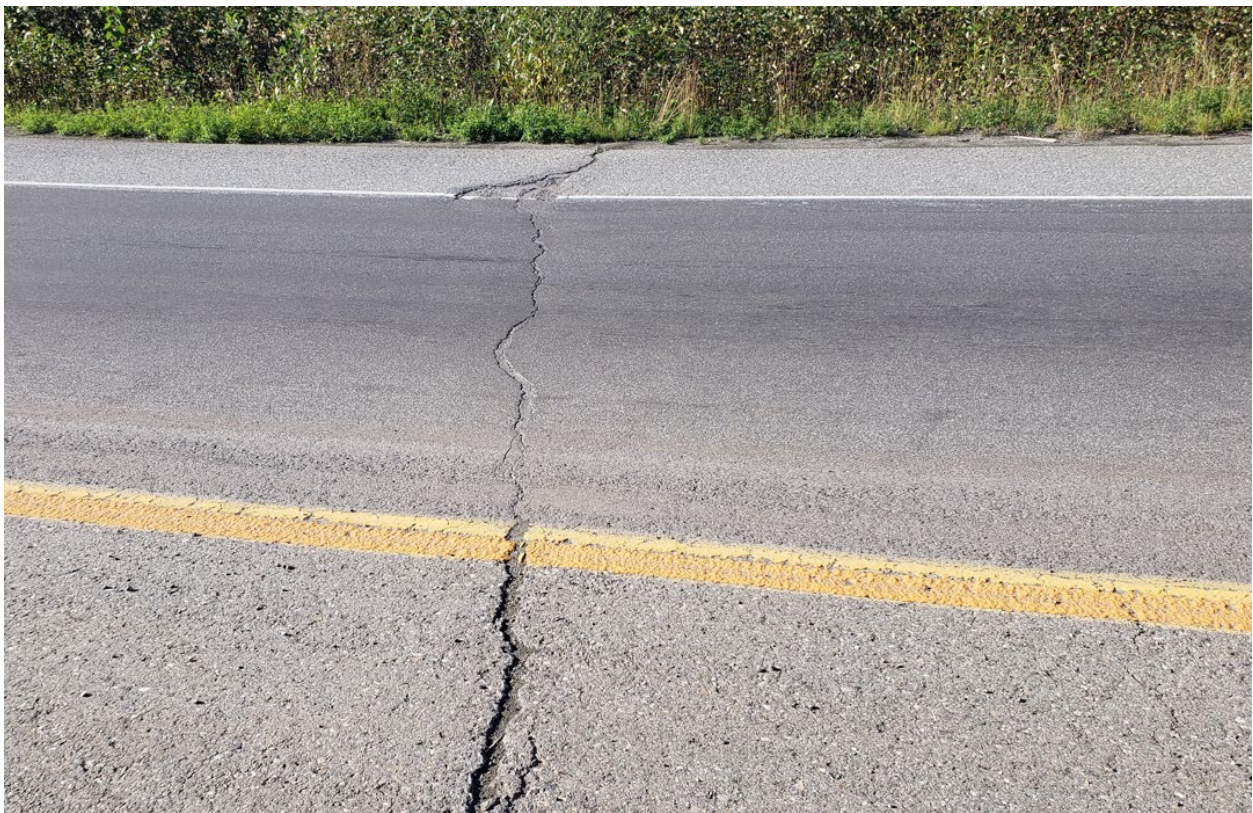
Cracks have continued to widen but are still largely of lessened severity. There is some plow damage along cracks, but the ramp remains in good condition.

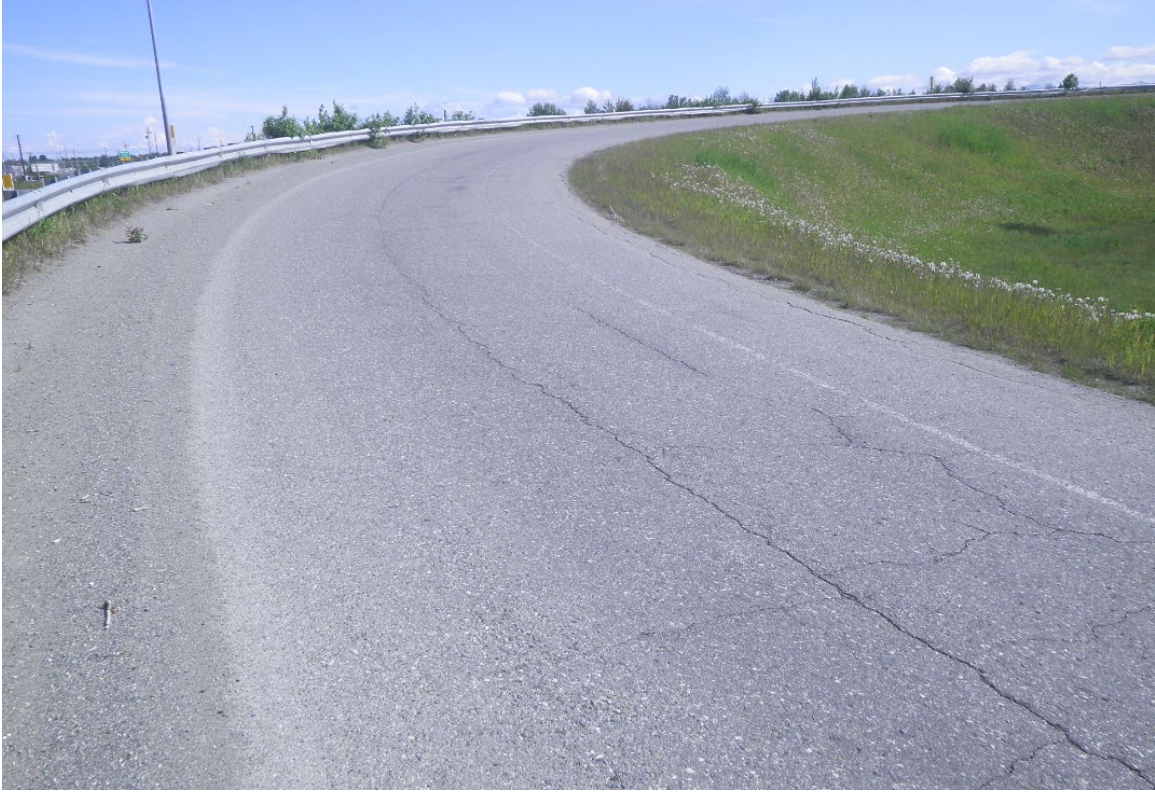
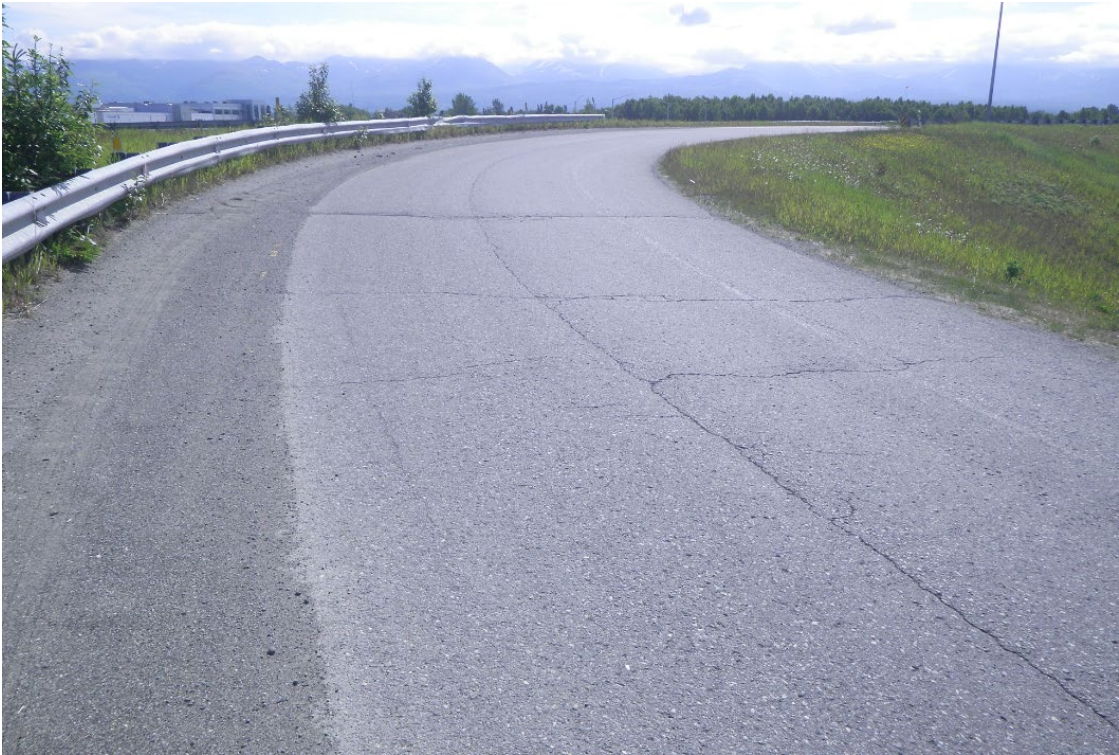
The entire ramp was blocked cracked with a centerline crack present for the entire length. Fatigue cracking was beginning to develop in the inside wheelpath.

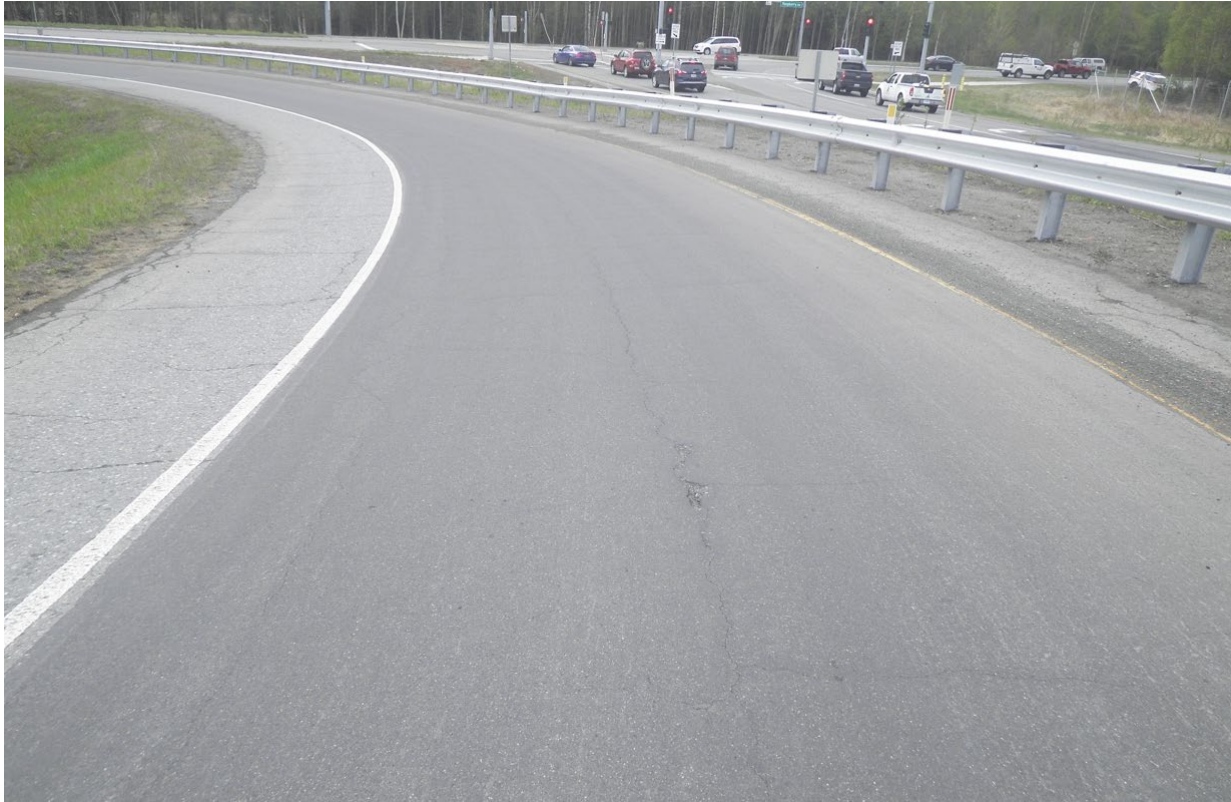
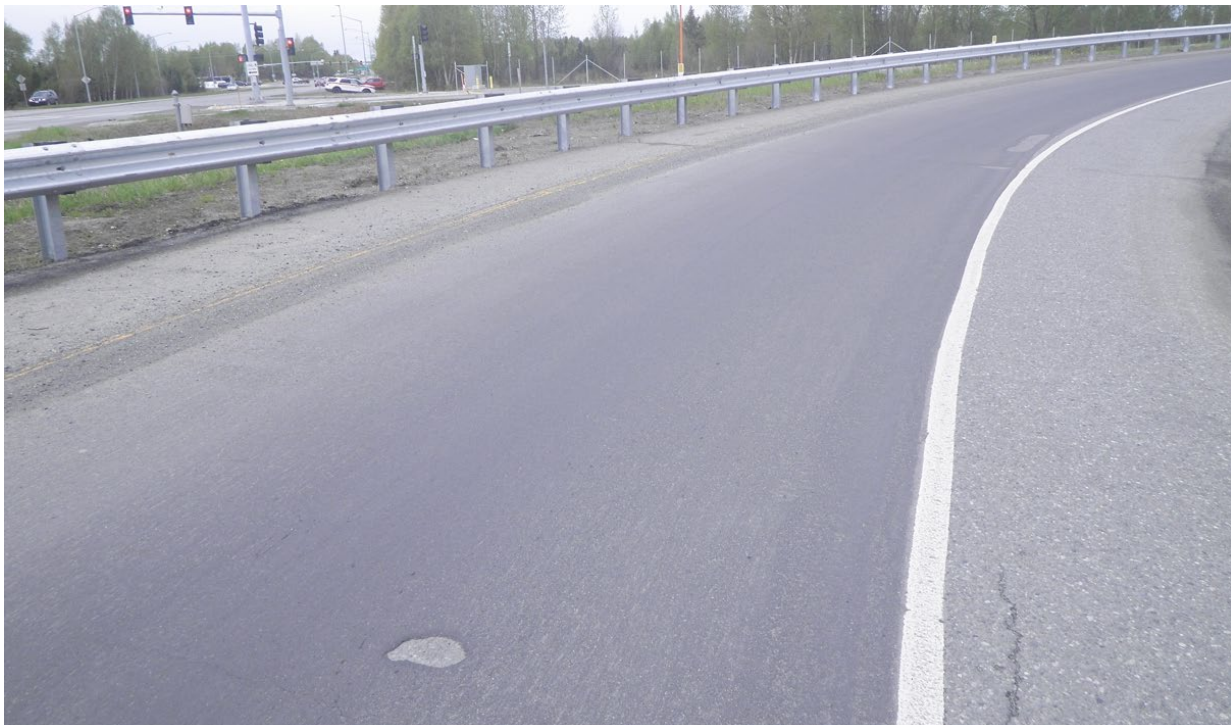
Cracks reflected through the ramp and plow damage was present having caused damage along the centerline and right side of the lane. The ramp is in moderate to poor condition.

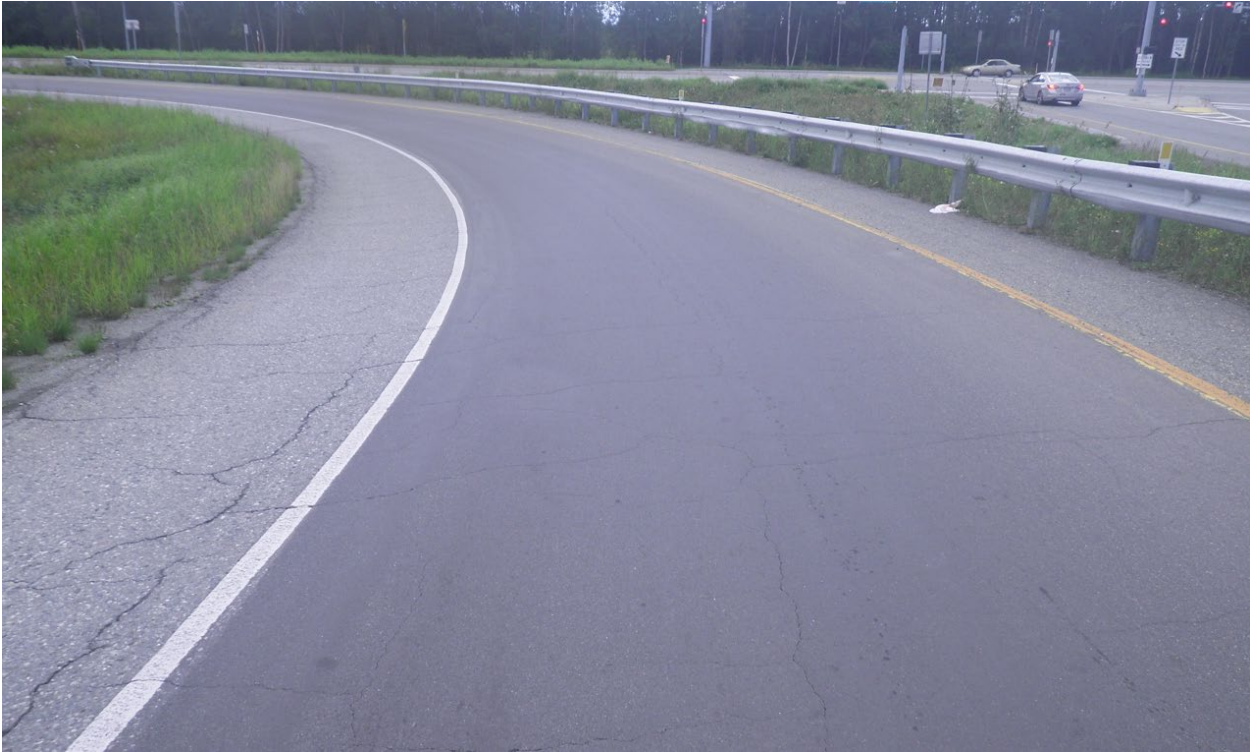
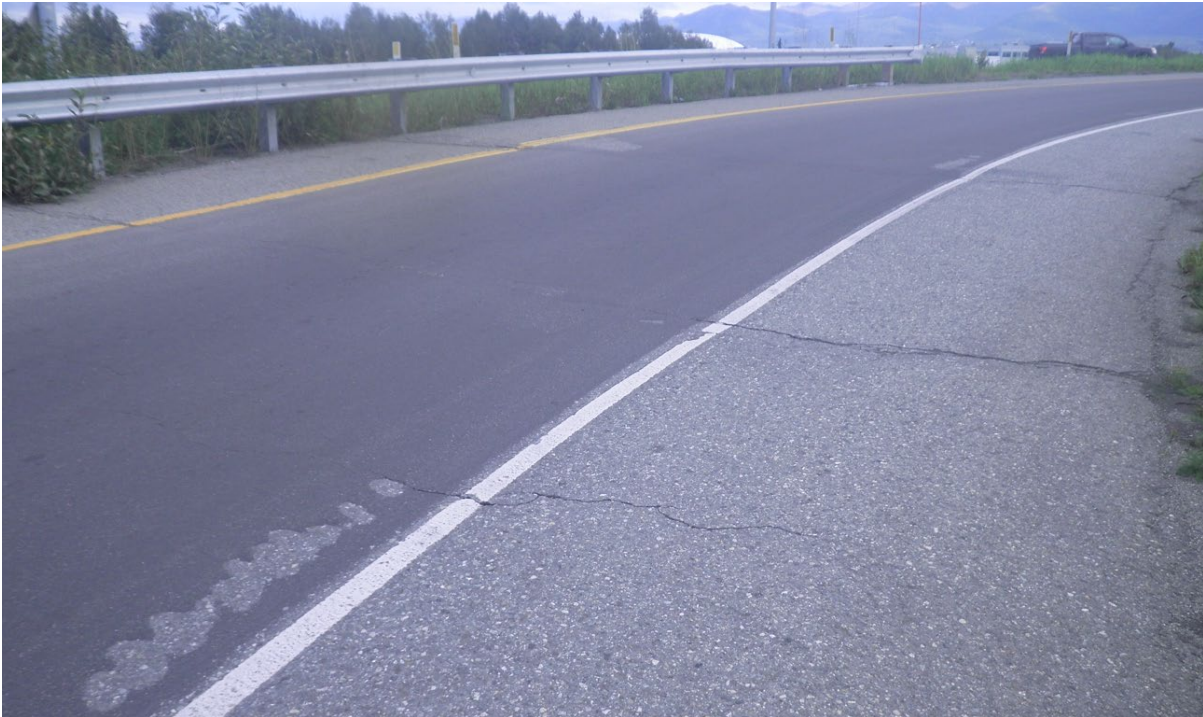
There is additional plow damage on the ramp in year 2 and increased damage over reflective cracking.

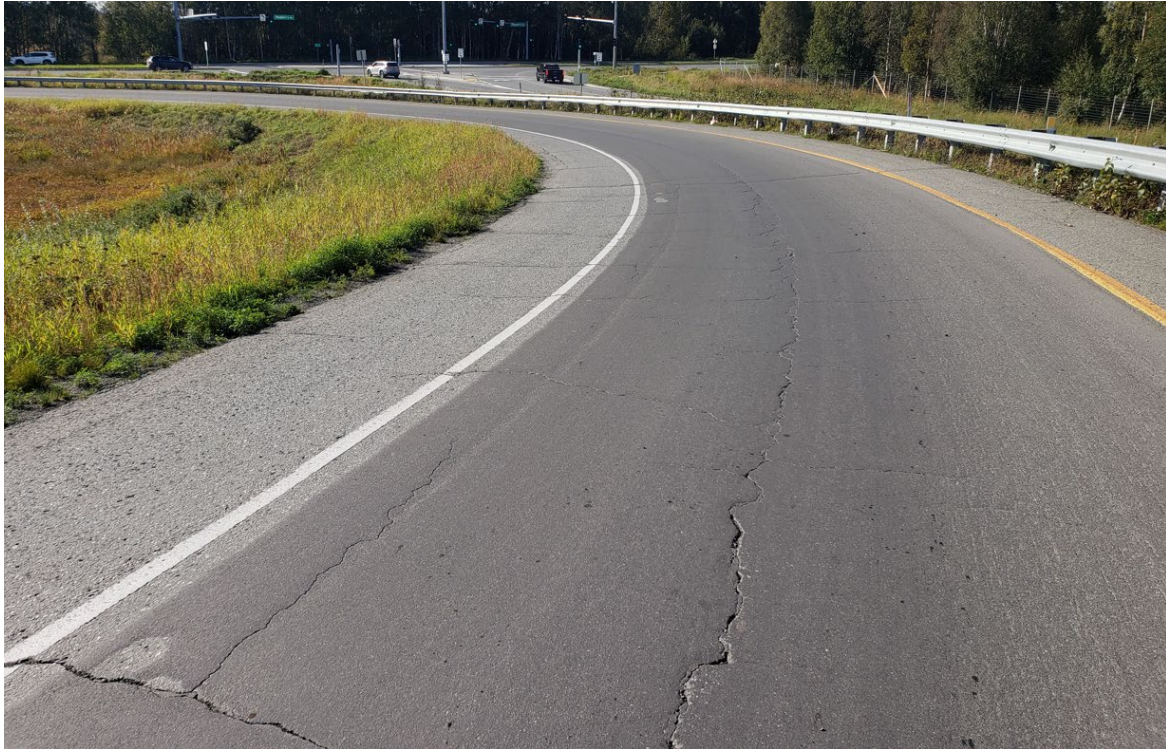
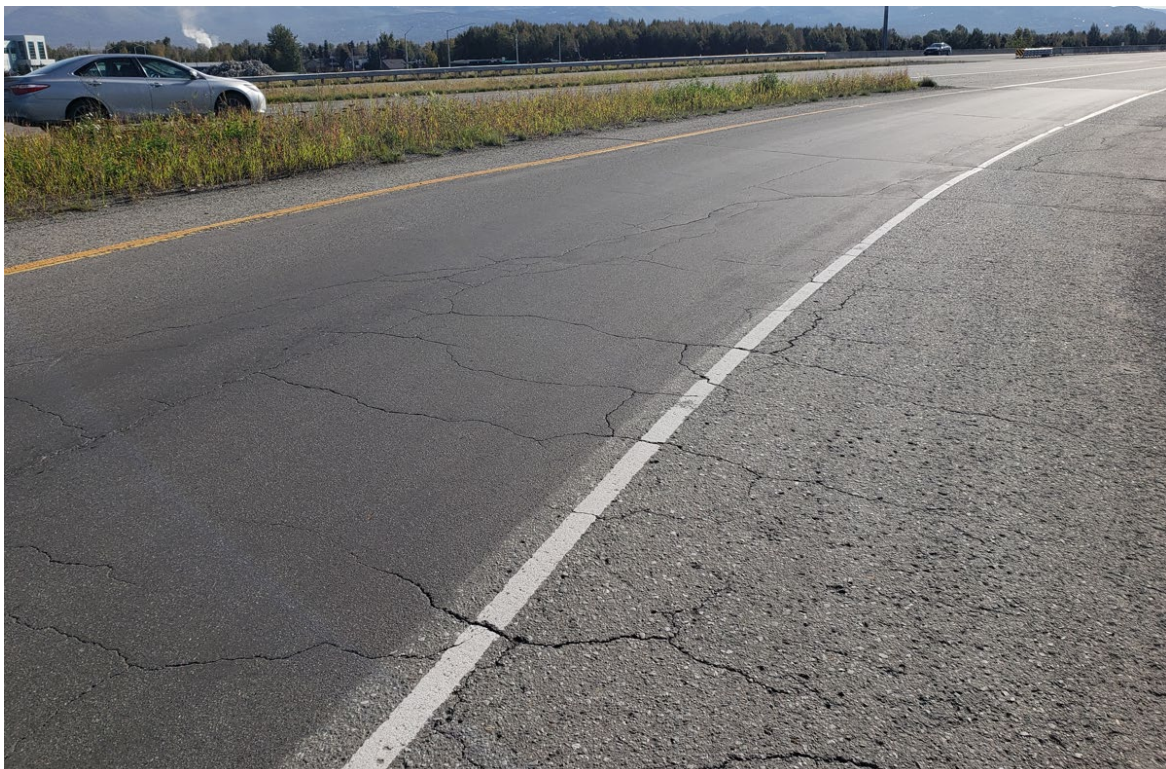
Cracking continues to reflect through the microsurfacing and there is plow damage and some spalling.

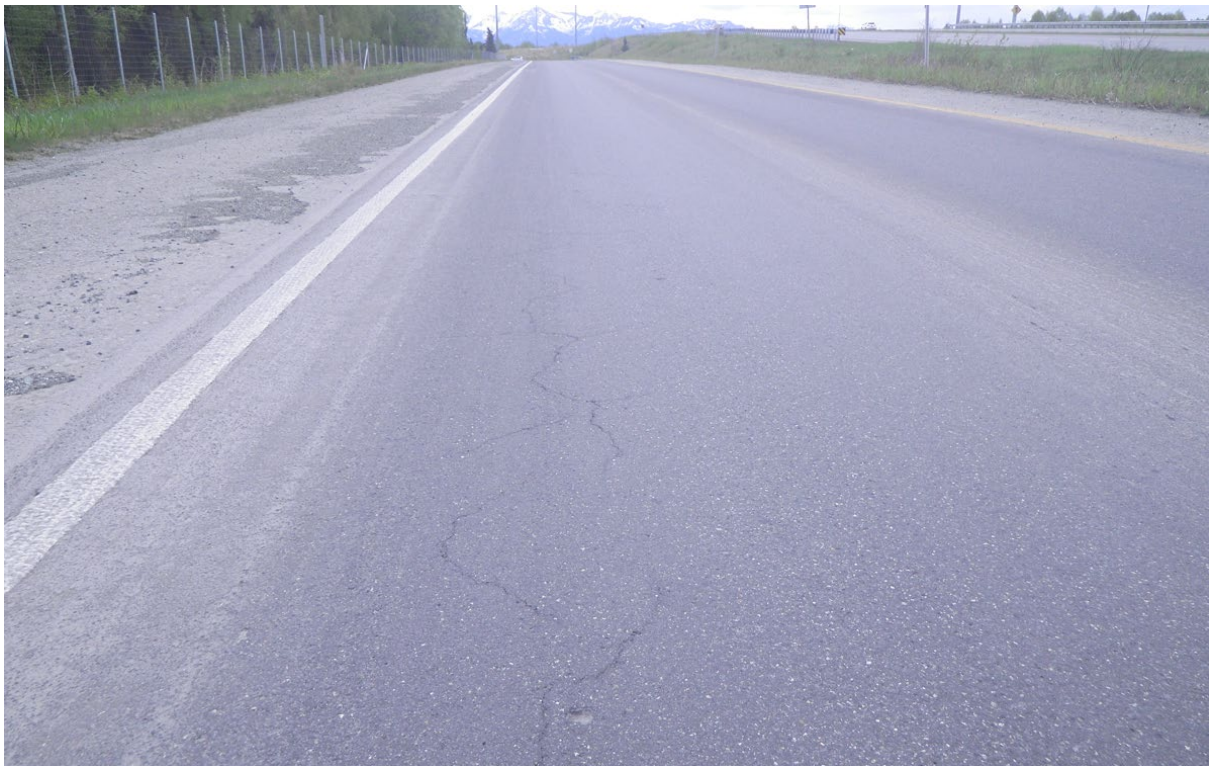
The block cracking and fatigue cracking reflected through the microsurfacing, but the largest cracks to reflect and experience damage were the transverse cracks on the ramp. The ramp remains in moderate condition.

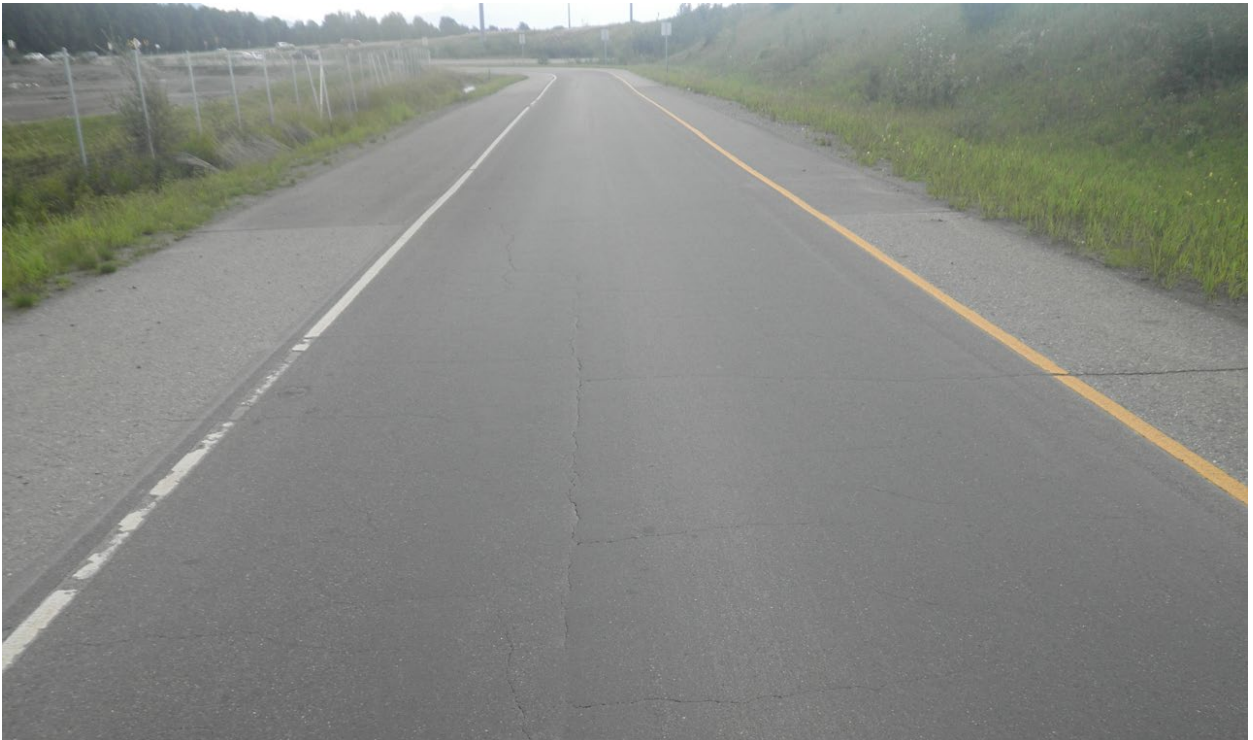
The quantity of reflecting cracking has increased from 2021 to 2022 and the ramp has deformation rutting that occurred post construction, but did not significantly increase in depth from 2021 to 2022.

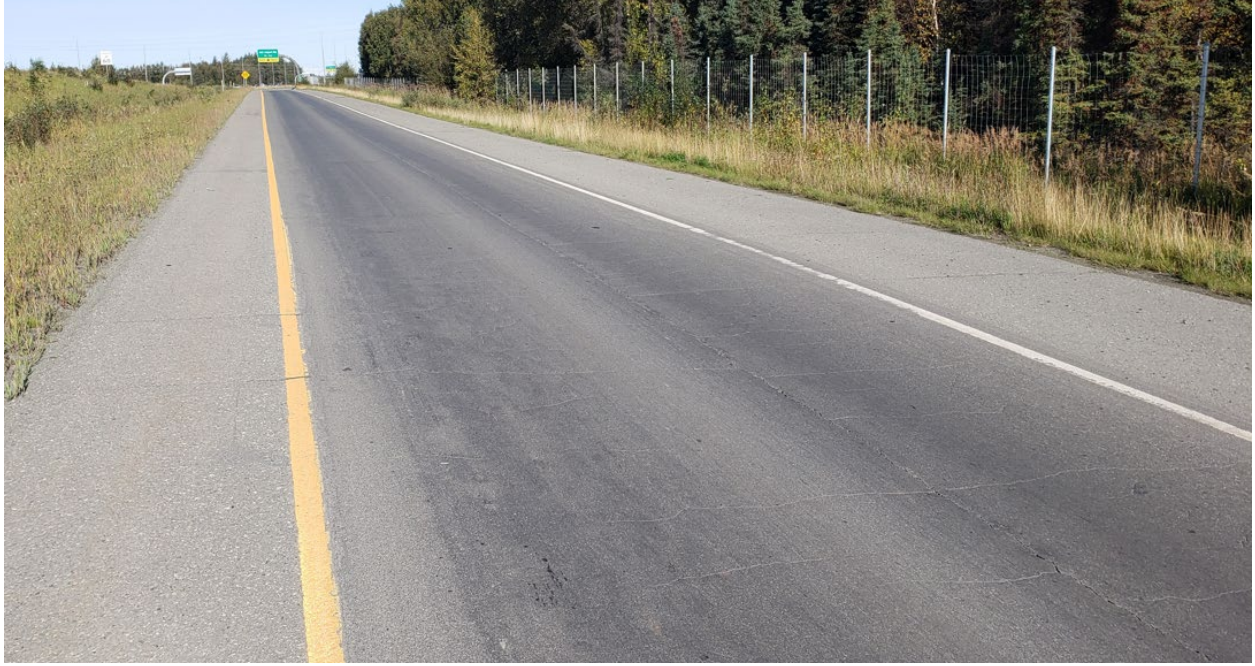
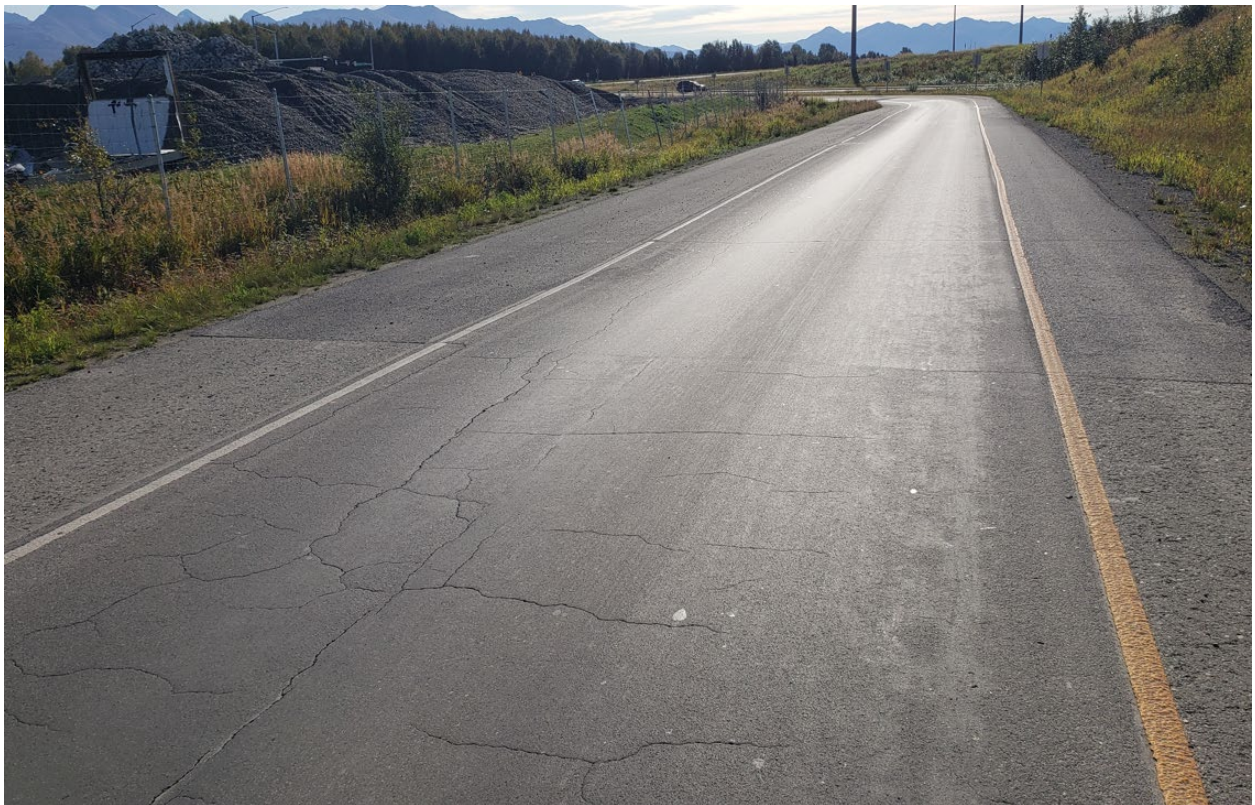
At the beginning of the ramp there is an area in poor condition with a spalling transverse crack and some patched potholes that are beginning to ravel out. The block and wheelpath cracking has fully reflected through, although spalling or raveling is minimal.

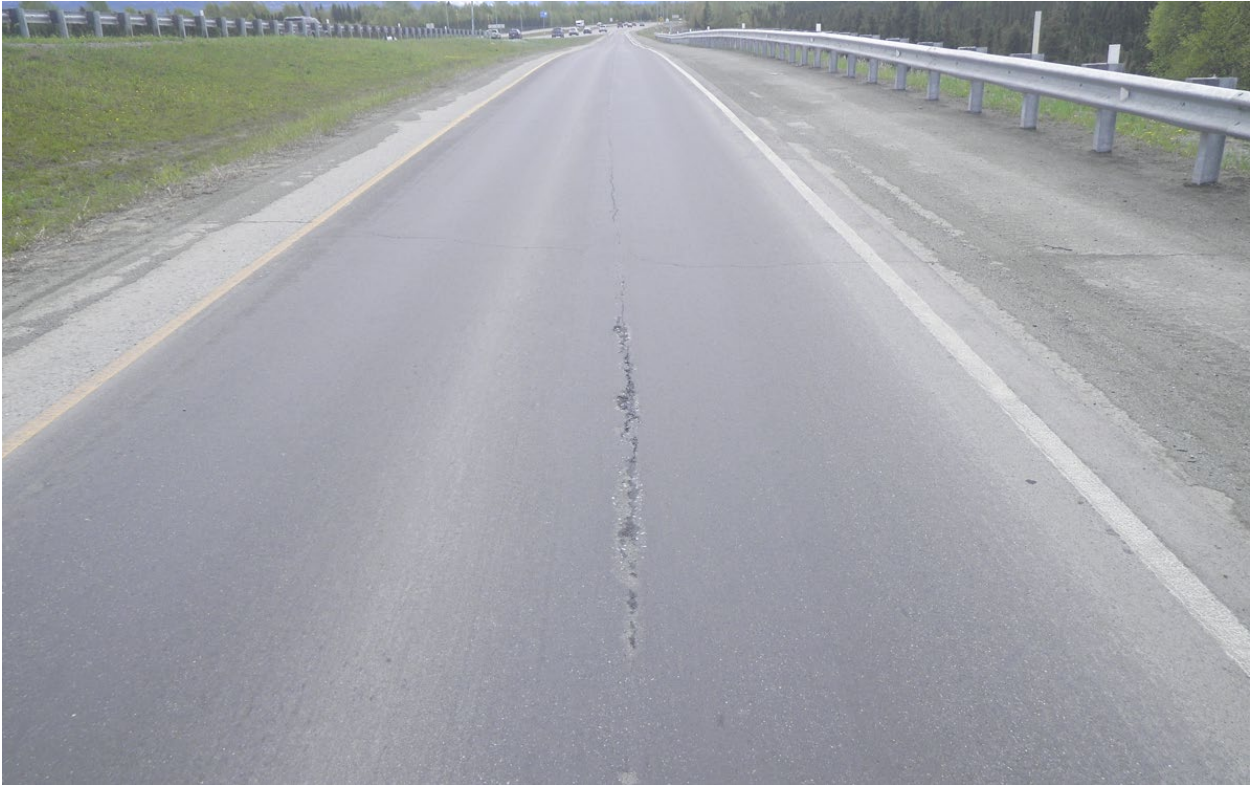
There was moderate flushing present on this ramp in the curve at Raspberry and near the end of the ramp. There was also damage along the centerline joint from plows.

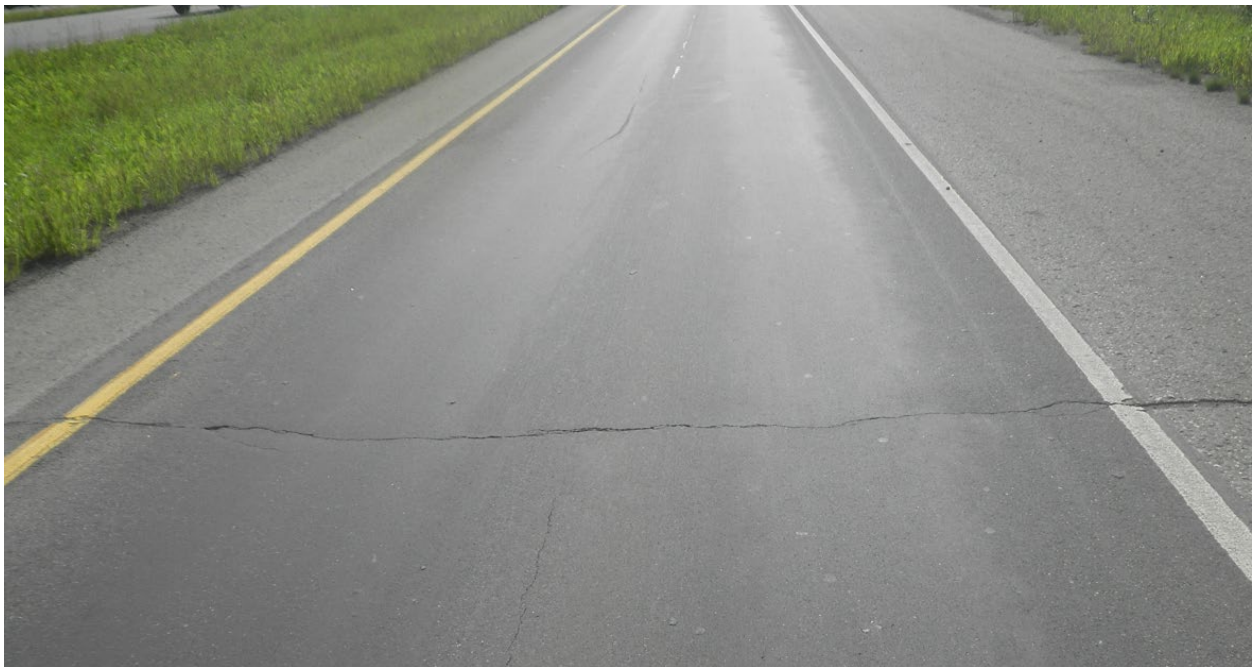
There is significant flushing on this ramp, especially at the beginning of the ramp in the curve and at the end where the deepest ruts were. The reflective transverse cracks are still significantly less severe than they were originally, but the joint raveling along the centerline is opening up since 2021.
